**Evaluation of the State of Conservation  
of the Site inscribed in 1982 on the World Heritage List as  
“National Historic Park – Citadel, Sans Souci, Ramiers”  
Criteria (iv), (vi).**

**Mission Report of the Survey**

**6-22 March 2012**

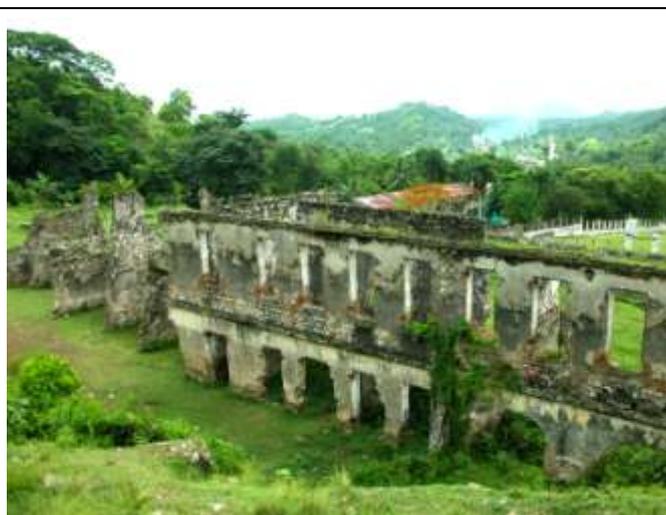
*Sans Souci - the remains of the Queen Palace*

the monument and the general image of the site. Thus, all monuments must be treated with the same methodologies applied to the conservation of the archaeological areas: cutting and removing of rotting plants, structural consolidation of the parts in danger of collapse using both direct and indirect solutions, cleaning of the surfaces and restoration of the original plaster, and finally capping the top of the walls by using suitable hydrophobic mortars particularly studied for the conservation of the archaeological areas<sup>1</sup>.

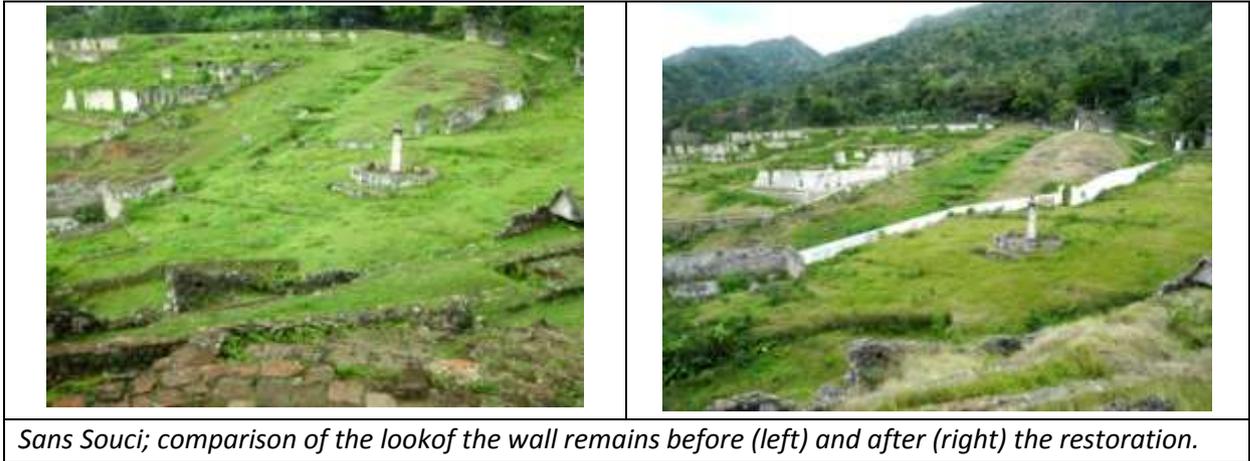
*Sans Souci; comparison of the look of the wall remains before (left) and after (right) the restoration.*

Furthermore, the choice of the restoration materials may not be adequate and this may apply to the rebuilding methodologies as some recent damage on the restored walls demonstrates.

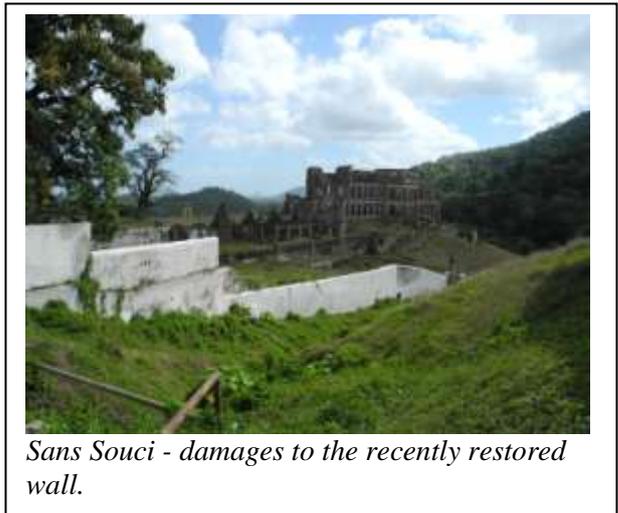
The damage is also due to the lack of ordinary maintenance that is necessary in order to prevent plants from growing within the masonry causing the restoration plaster fissure to detach so that the degradation rate increases.

*Sans Souci - damages to the recently restored wall.*

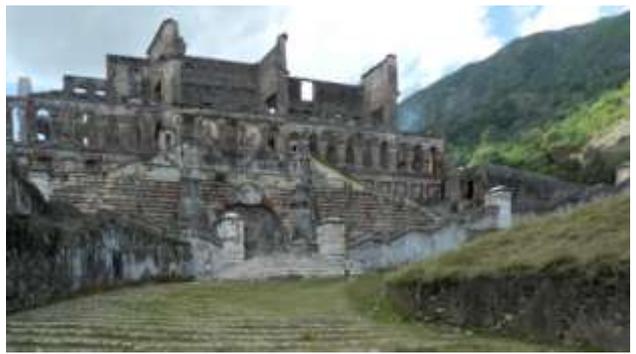
*Sans Souci Great Palace: view of the main facade from the North side.*

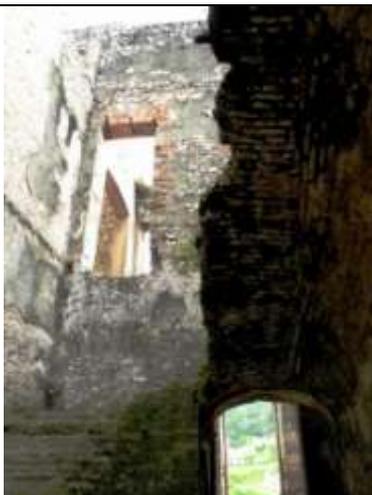
Observing the monument allows isolating many fissures located at the highest part of the walls and in the arches that may drastically affect the stability of the building. The entire building must be analyzed in detail in order to properly record by drawings the structural damages affecting the walls prior to any restoration intervention. The use of the quick photogrammetry, which is based on the instrumental analysis of the recorded images, will help to obtain in a very short time the distribution of the fissures and of the loss of masonry with reference to each single building unit. This will become the base for the projecting of the local interventions aiming to increase the mechanical resistance of the structure. Monitoring the fissures for a long time, by using strain gauges and data loggers, will also give information on the movements of the masonry which is fundamental to properly project the structural restoration. During the survey, the arch connecting the throne room with the South entrance of the Palace was investigated in order to assess how solar radiation could affect the width of the fissure.

*Sans Souci - fissures at the top of the walls may affect the stability of the building.*

1) Making a photogrammetric mapping of the building will allow the possibility of studying the fissuring distribution and of creating a reference mathematical model which will be useful to project structural intervention.

2) Erecting inside each room, scaffolding in order to mechanically support the walls and to allow punctual recording of the state of degradation of the masonry. This is a temporary solution which is absolutely necessary to acquire all the relevant data to define the restoration project. Once the scaffolding is built, the structural monitoring will start by using no more than 10 strain gauges connected with individualized data loggers, located in correspondence to the critical fissures, while three accelerometers will be located at the top of the most critical and solicited vertical walls to check the tilting induced by the wind and the mechanical stresses. The contemporary documentation of the degradation will be done. The presence of the scaffolding is also necessary to allow the execution of the restoration works, once defined by the project.

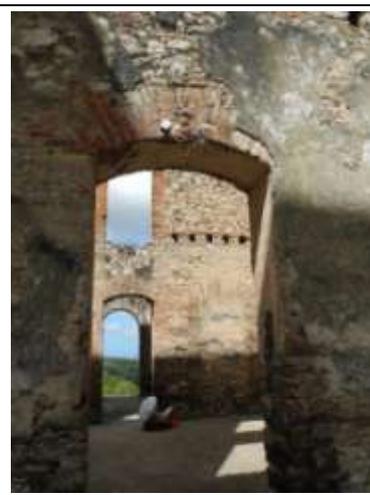
*Sans Souci - monitoring the fissure of the arch by a strain gauge connected with a data logger.*

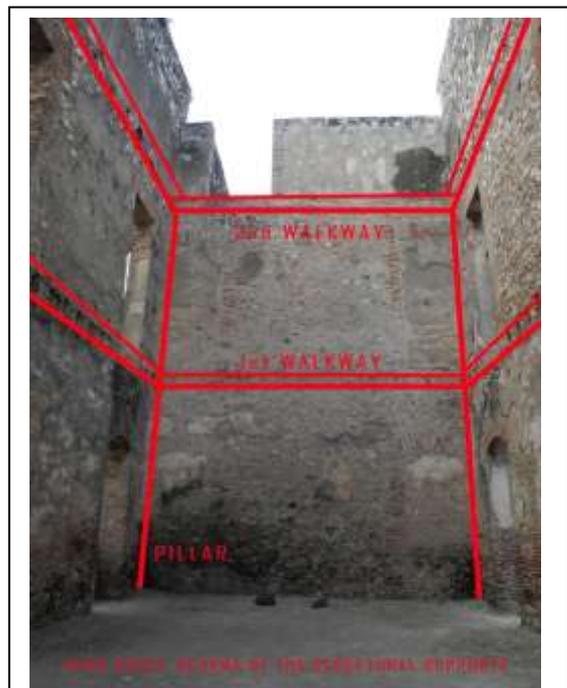
The aerial circumambulatory made of light and resistant grids (the industrial roofing made of epoxy might be used) will increase the mechanical resistance of the supporting structure and make it possible to visit. The perimetrical structure is 20-30 cm detached from the original wall, but directly connected to this by inserting suitable carbon fiber elements into the holes where the beams supporting the pavement were originally located. The second level might be consolidated with the same technique, while the upper third floor will be consolidated by vertical triangularly shaped elements connected by resistant dralon lines treated with epoxy resin. The suggested solution derives from the experience made in the archaeological site of

*Sans Souci; schema of the external structural supports.*

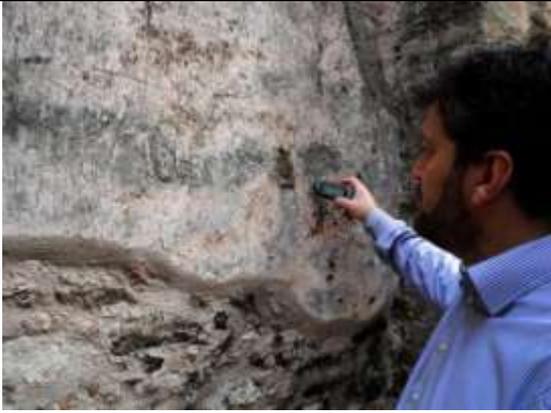
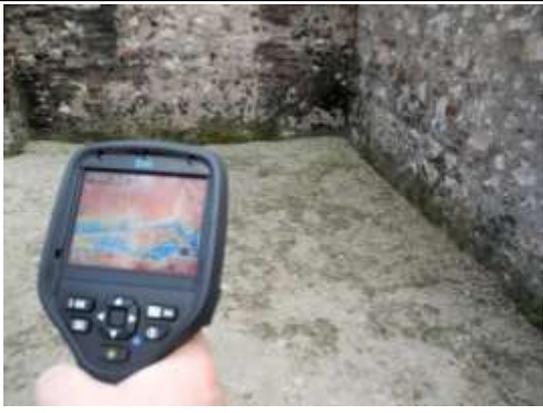
Part of the survey was finalized to isolate the causes of the damages induced by the presence of the water in/on the walls of the Palace. The field measurements were made by using the IR Thermography camera, which allows recording both the traditional and the IR image, and by a portable water-meter that gives the percentage water content of the masonry.

<p><i>Sans Souci - water content determination</i></p>	<p><i>Sans Souci - water distribution measurement by IR Thermography camera</i></p>

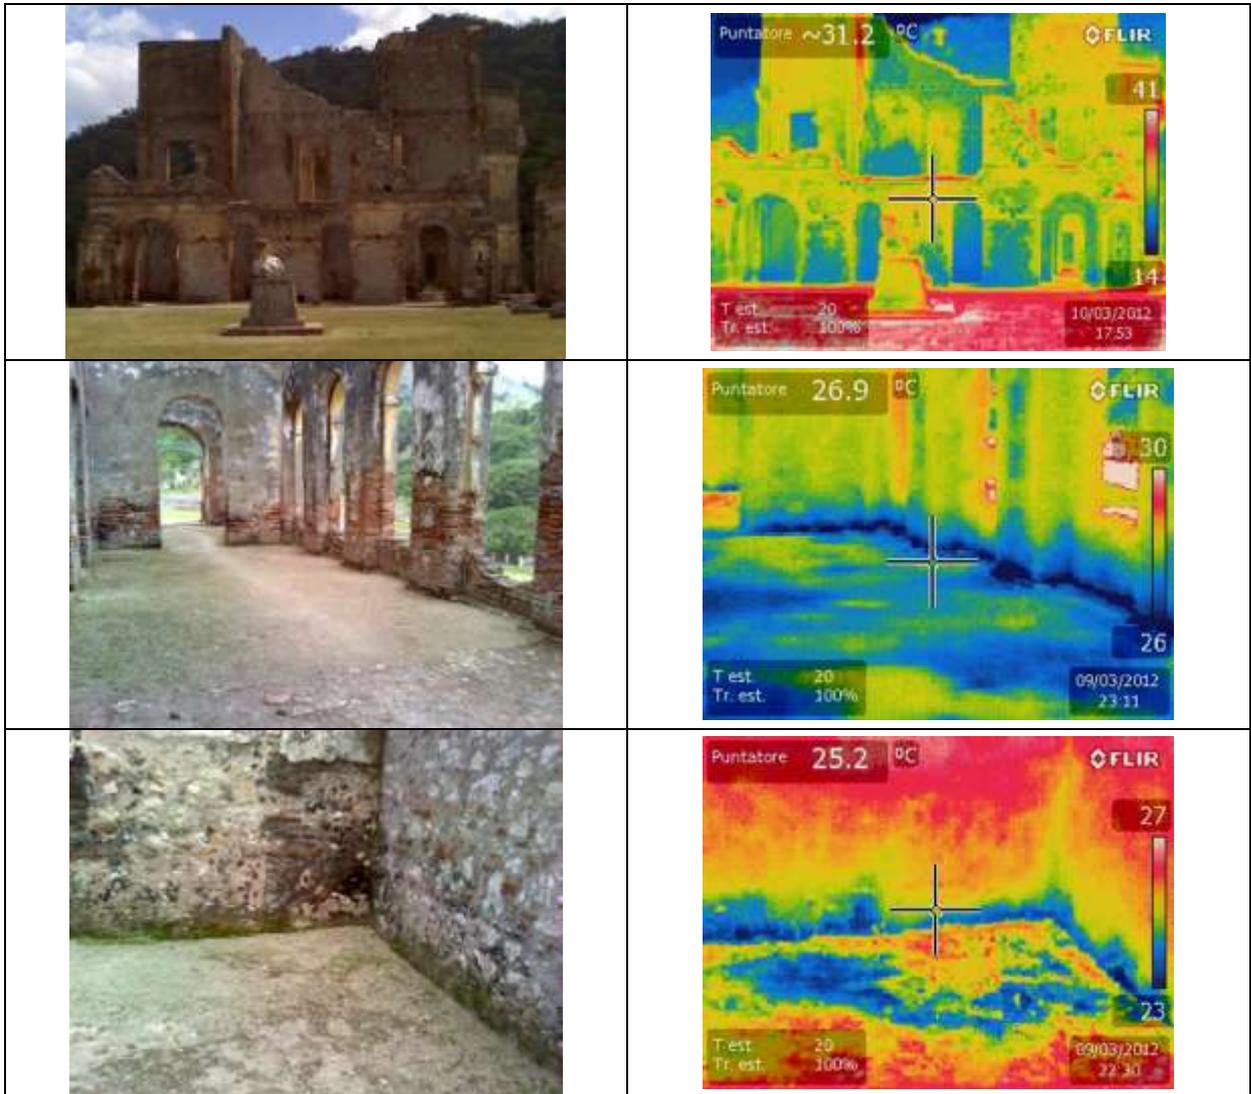
In the case of the North-West rooms of the Palace, the presence of water in the pavement induces the differential absorption in the wall and in the pillar, but also in the corners when the wall is linear.

*Sans Souci - the sequence of the IR thermographies clearly shows that the water concentrates in the pavement ascending by capillary into the walls.*

Drying the foundation is necessary in order to reduce the damage caused by the capillary and represents the first step of the structural intervention. Although the hypothesized project contemplates the excavation of the pavements and the collection of the rainwater in the middle of the room by flooring it in the suitable way and creating a new canal system to drain the water, the respect of the original structures and hydraulic system imposes the rehabilitation of the original drainage system and the collection of the rainwater and the underground water out of the building. Thus, the excavation must be executed by archaeologists in order to isolate the original building phase which refers to the project's restoration.

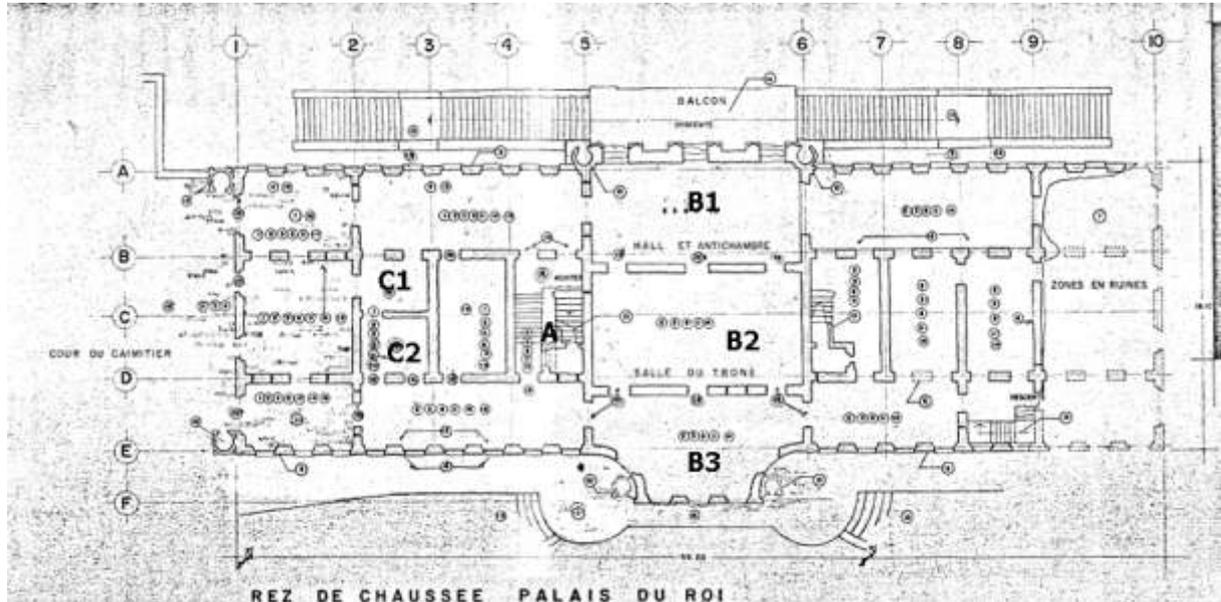
In order to isolate the most suitable restoration procedures and to define the conservation project, the central section of the Royal Palace has been analyzed from several points of view that allow characterizing the degradation mechanisms and the related typical damage. The survey involved the entire group of experts and a limited number of local people from ISPAN that were trained as for the recording of the several degradation patterns to be observed in the monument.

*The reference rooms were conventionally called A, B and C; this contains C1 and C2 units.*

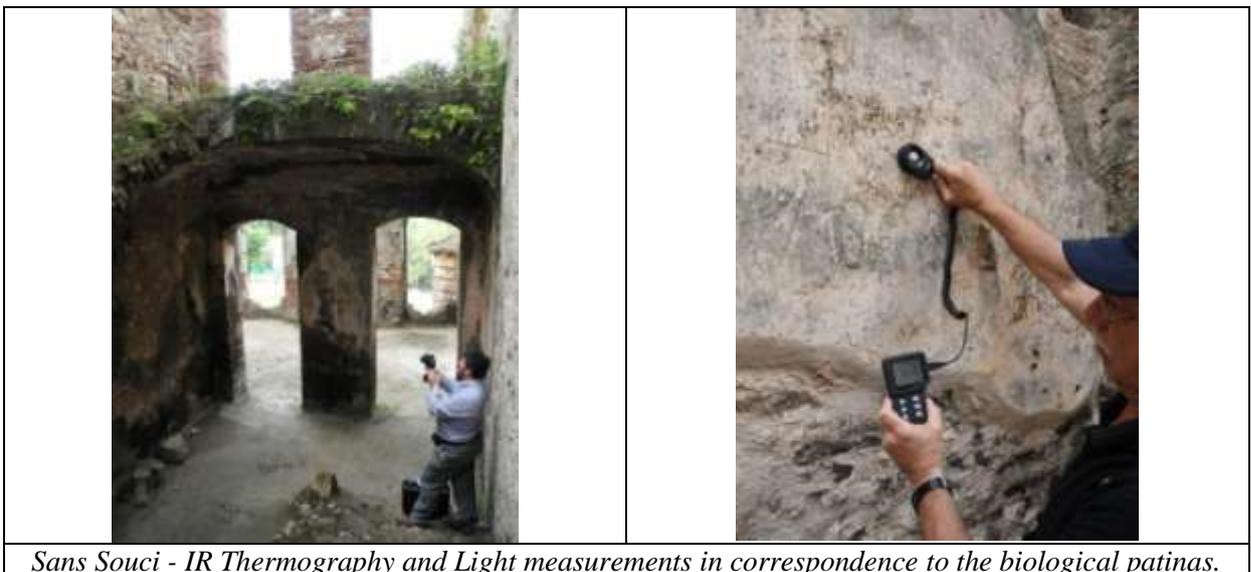
The biological patinas are massively present in all wet areas, as IR thermography confirmed, but also the impacting light affects their growth.

*Sans Souci - IR Thermography and Light measurements in correspondence to the biological patinas.*

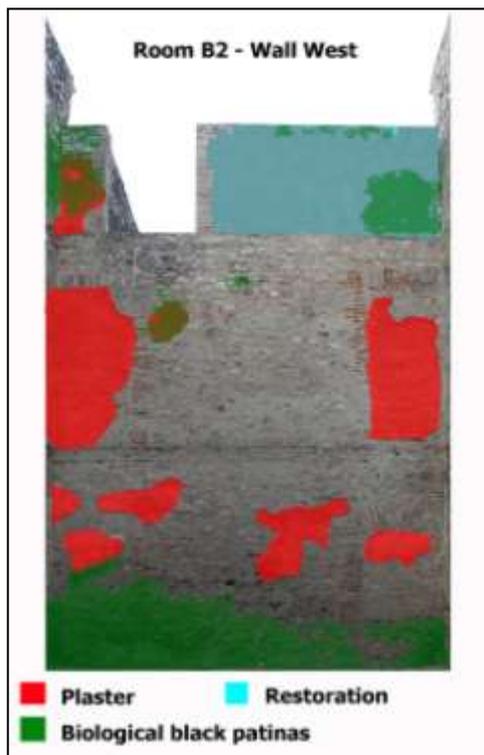
Representing the distribution of the original plaster remains and of the biological patinas,

as well as the restoration intervention on the reference wall is a mean to evaluate both the impact of the degradation on the original masonry and the intervention procedures. In the B2 West wall, for instance, the red areas indicate that the restoration of the remains of the original plaster will be extended to about 30% of the surface, while the biological attack also involves the restored wall. The distribution of the biological patinas correspond to the areas where water is present both because of the capillary from the soil and due to the rainwater penetration through the top of the wall. Extending this kind of analysis to all walls result in exactly projecting the restoration in terms of procedures, materials and costs. In the Sans Souci Royal Palace, the great problem is the presence of water in all pavements, which results in capillary

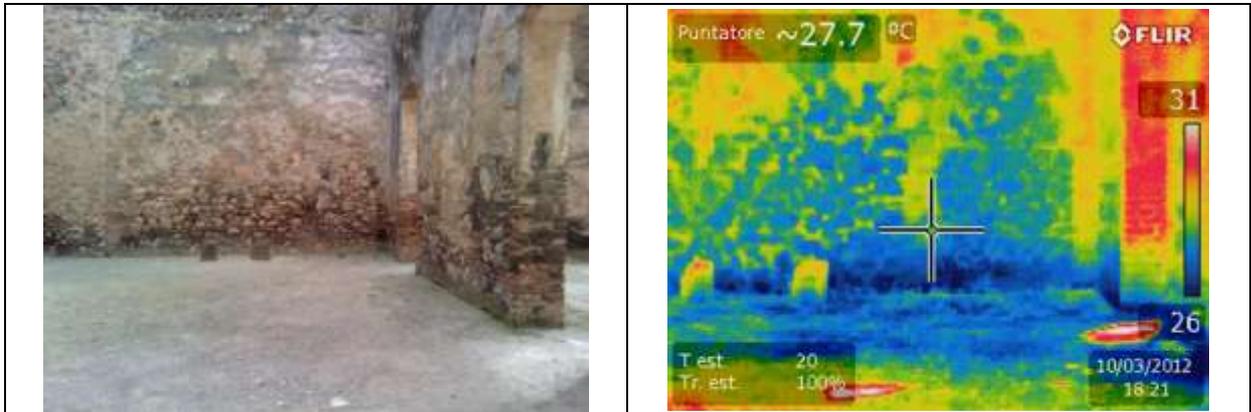
*Sans Souci - capillary causes that water retained by the pavement raises several meters into the masonry as the East wall of the B2 room proves. The blue areas are the areas most wet.*

The conservative restoration of the Palace will be focused on the restoration of the walls, with peculiar attention to the cleaning and the consolidation of plasters and masonry, but also to the capping of the top of the walls. In order to precisely describe the degradation mechanisms and to identify the most useful materials and methodologies for the restoration, many biological degradation patinas and both plaster and mural painting samples were taken to carry out peculiar analyses; brick and stone samples were collected as well to characterize the production technology and the provenance of the building materials.

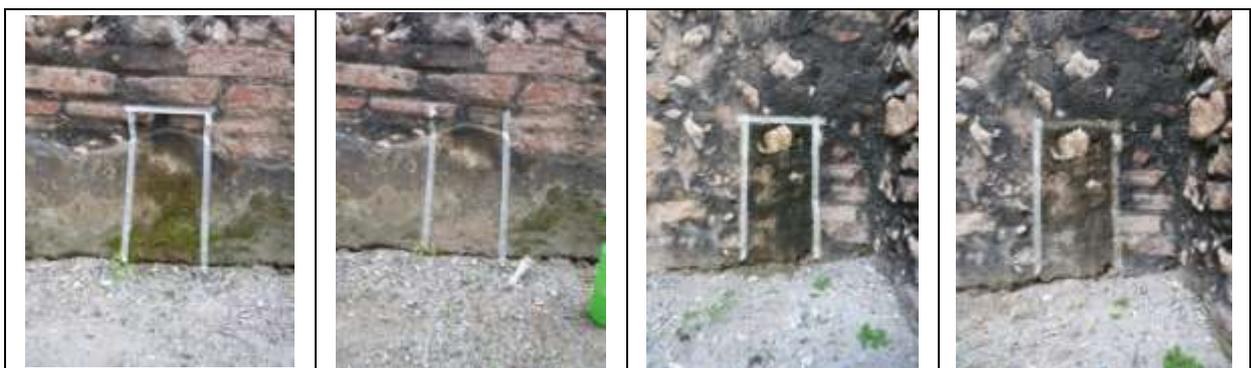
The cleaning of the surfaces will take into account the predominant presence of biological patinas that affect the wet surfaces. Aiming to assess the efficacy of the most common biocides, cleaning tests were performed in room B2 (the green patina on the plaster with light brown color at the bottom of the South wall, and the black patina affecting the bottom of the West wall close to the Southern corner) using Preventol 4% v/v.

*Green patina before and after 7 day treatment*

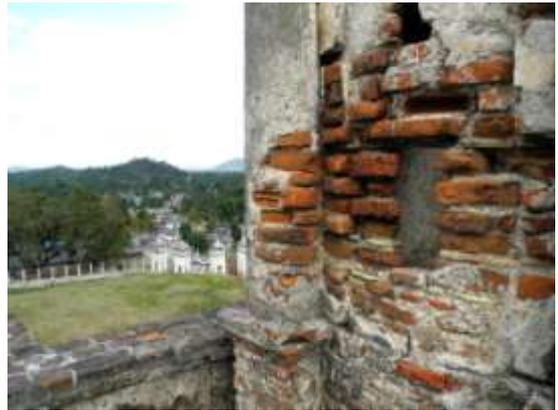
Some areas frequently show deep degradation of the bricks, probably due to the continuous presence of water and wind, which increases the evaporation rate of water. The visible degradation patterns, consisting in the powdering and scaling of the bricks and of the binding mortar, impose to strengthen the degraded materials by using both inorganic traditional materials and organic suitable chemicals generally allied for the conservation of degraded stones.

The conservative restoration will aim to increase the consistency of the original materials and to reduce the degradation rate to the minimum value so that the structural intervention may be carried out. The activities to be carried out are as follows.

- 1) Increasing the stability of plasters and mortars by the intrusion of suitable hydraulic liquid mortars and plastering of the boundaries with aerial mortar made of lime and sand;

- 4) Mechanical removal of cement mortars eventually applied during the previous restoration works and causing degradation of the masonry;
- 5) Locally strengthening, by using suitable chemicals of the several materials (stone, mortar, plaster, brick and metal) that need treatment, according to the necessities ascertained during the cleaning interventions;

- 6) Filling of the grouting and missing parts of the plasters and masonry with suitable mortar, according to the composition and the function of the masonry.

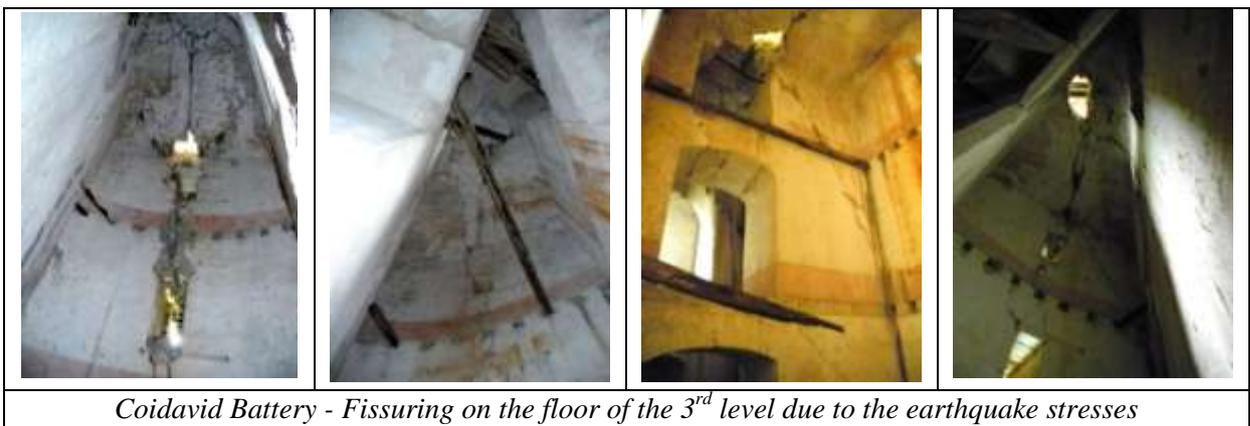
The survey of the external surfaces of both the Coidavid and its basement confirms the presence of angularly shaped fissures starting from the loophole of the first level because of the collapse of the roof (which is the horizontal resistant element) due to the mechanical stresses of the earthquake. Similar fissures are visible from the inside of the building as the survey of the ground floor of the battery shows. The lower two levels of Coidavid Battery are in fact collapsed reducing the mechanical resistance of the entire structure. Studying the distribution of the fissures will help in the diagnosis of the static of the building, allowing the precise definition of the criteria and the methodologies to be applied to properly restore the building. Referring to this philosophy, the monitoring system actually working in the third level of the battery aims to verify the stability of the building structure taking into account one of the most heavily fissured gun window of the Battery, namely the third of the North side.

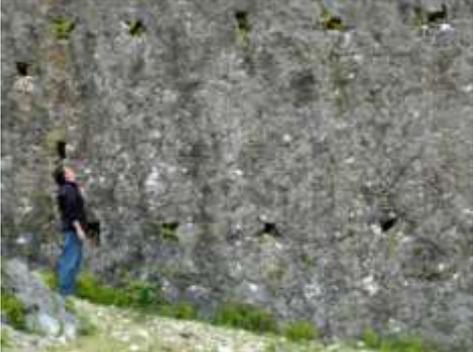
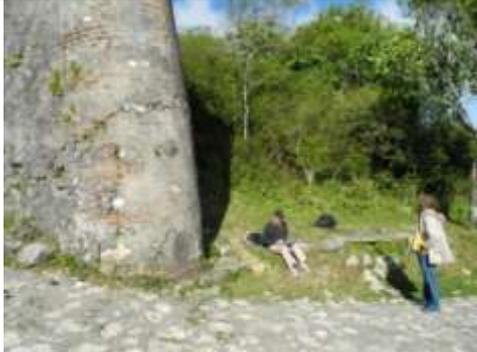
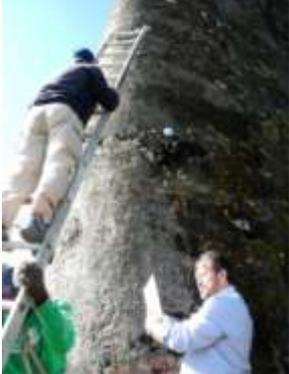
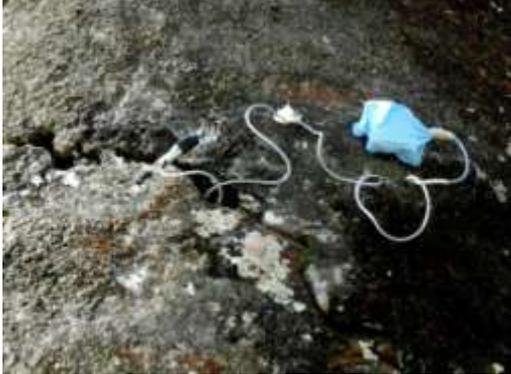
continuously record the values of temperature, relative humidity and width of the fissure in order to make it possible to verify if the movement of the fissure was cyclic or not, and consequently projecting the monitoring system. Unfortunately, the system was disturbed the first day, however the data recorded two days before in the same location allowed the confirmation that the fissure width increased by 0.020 mm with a non-cyclic movement.

<p><i>Spur - observing the fissures in the wall</i></p>	<p><i>Spur - preparing the monitoring system</i></p>

<p><i>Spur - verifying the functioning of the system</i></p>	<p><i>Spur - the monitoring system is working</i></p>

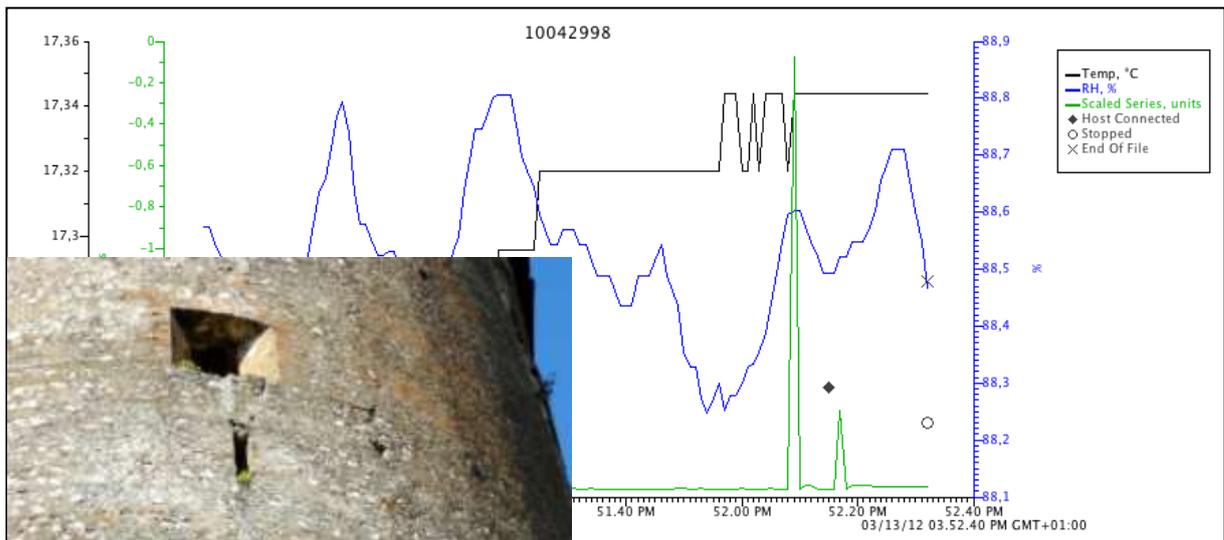
After 24 hours, all probes have been tested in order to verify the efficacy of the system. The strain gauge series work well and show interesting data in the SG1 location, owing to the variations recorded in the fissure size. A dynamic test was then carried out in order to verify the range of the movement and the location of the maximum solicitation.

The data recorded confirms that the highest solicitation is located between the corner of the Coidavid (where the fissure starts) and the opposite wall, immediately after the big hole due to the vault collapse. Observing the green

line allows identifying that each mechanical solicitation applied to the roof 2.5 meters far from the hole by jumping on it (the force applied is valuable to 1,000 Newton) causes an enlargement of the fissure by about 0.020 mm; on the contrary, the jumping close to the hole causes the fissure enlargement to reach 2 mm, while the solicitation applied on the left side of the fissure causes it to open 0.200 mm only. This preliminary test proves that the corner of the Coidavid is affected by very severe mechanical solicitations, which may cause the collapse of the structure if the elastic limit value of the masonry is reached.

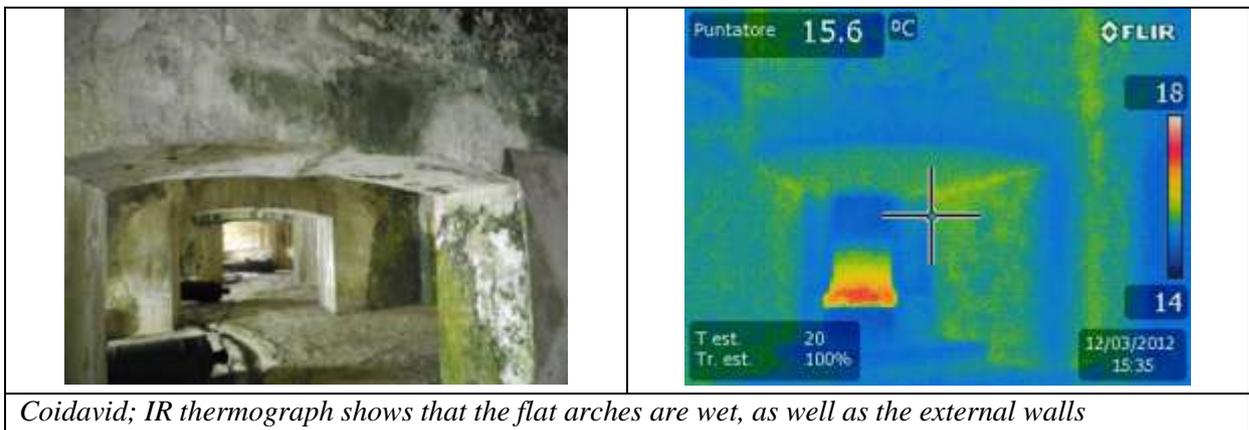
The 3<sup>rd</sup> level of Coidavid was also analyzed by IR thermography in order to individuate the anomalies due to the water presence: the origin of the seepage waters has been ascertained confirming that the penetration of water occurs mainly from the roof. Indeed, the vault of the 4th set right side appeared water saturated, while the walls were warm and dry. This may explain the degradation mechanism and also indicates that it is active at the moment.

*Coidavid; IR thermograph shows that the flat arches are wet, as well as the external walls*

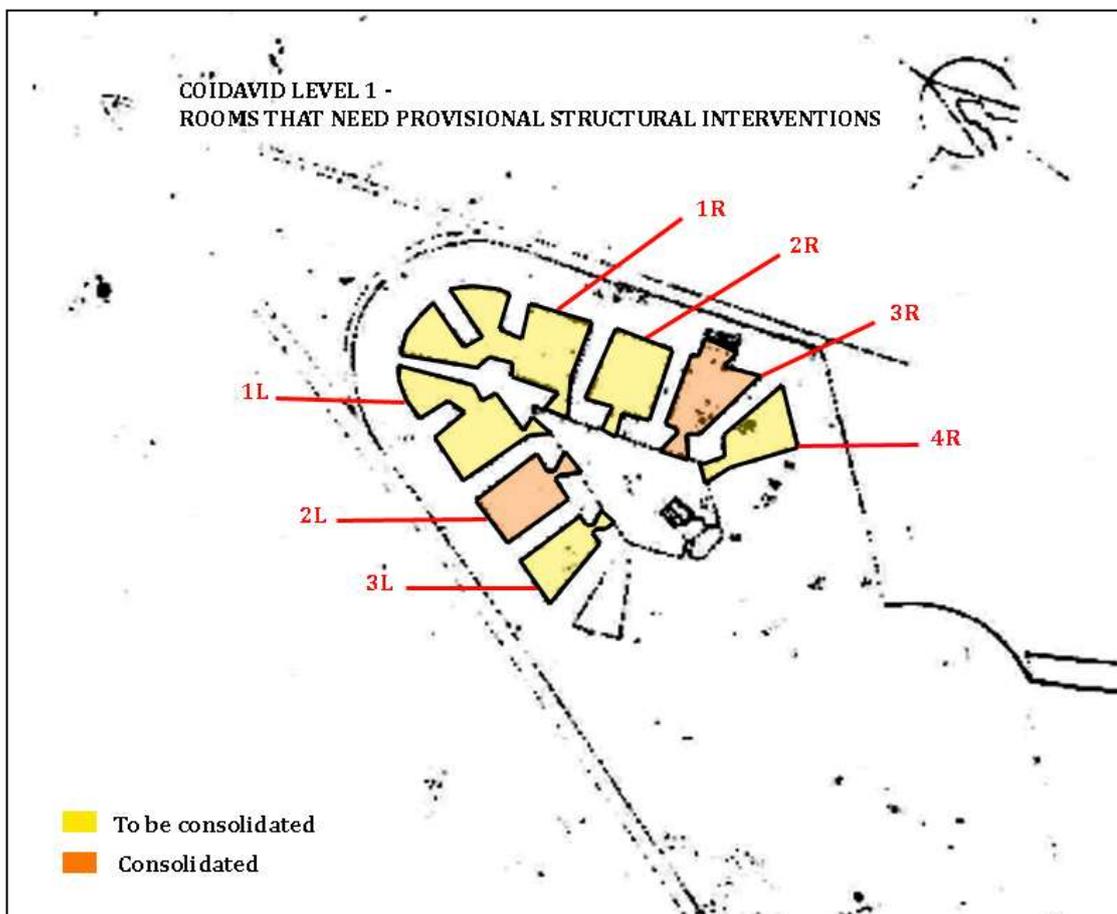
The above figure indicates the rooms where the collapse of the floors and of the vaults imposes the structural intervention; the room 3R was partially consolidated by using cement during the 1950 restoration, while the 2L room

The risk of total collapse of the Coidavid Battery determines that emergency measures will be immediately undertaken to assure the stability of the building. The emergency intervention consists of supporting the Coidavid 3<sup>rd</sup> level by wooden carpentry starting from the ground level in order to consolidate the vaults and to stabilize the fissures in the walls.

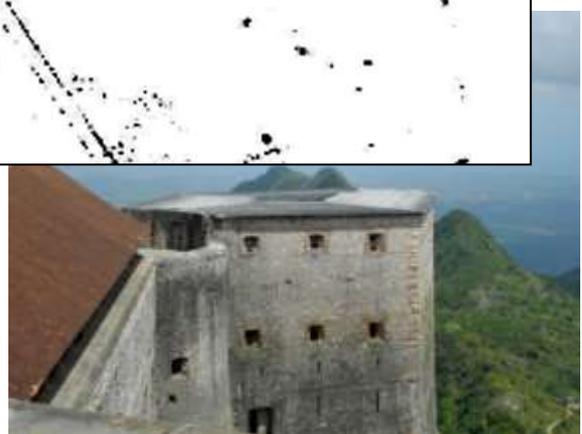
was stabilized by wooden carpentry during the restoration of 1982, and represents the example of functioning system for making simple and proper support to carry out the structural temporary consolidation of the building. The frames might allow ensuring the structural stability of the building in order to have the time necessary to define the details of the structural restoration. Once the structural restoration is made, the support frames should be removed room by room in order to make it possible for the definitive stabilization of the building, by rebuilding the floor and connecting horizontally the walls. During this time, the restoration project will be defined according to the several necessities of the monument's conservation.

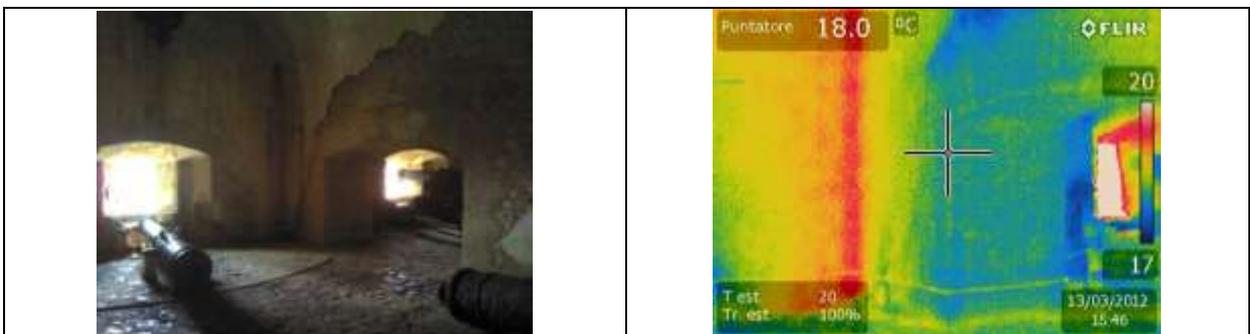
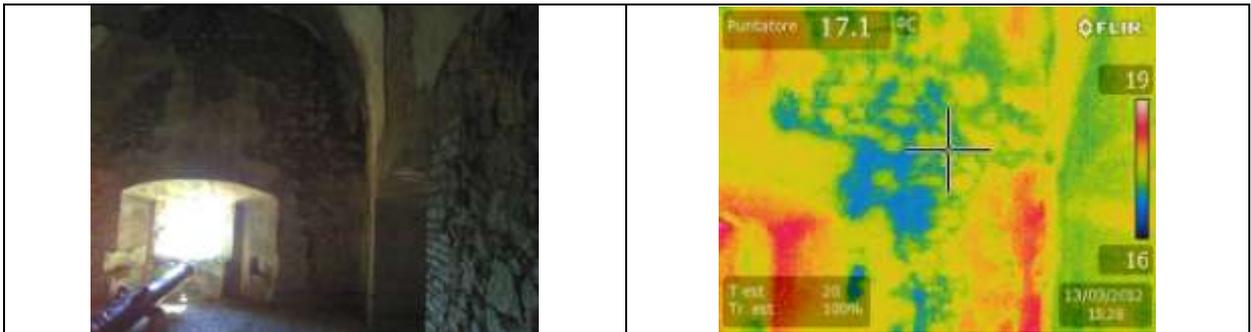
*Royal Battery - down level; IR Thermography confirms that water come from the upper levels*

As the above images show, the degradation concentrates in the plaster both of the external and the internal walls causing that the finishing layer of mortar detaches and falls down, but also that biological patinas develop where water still saturates the masonry.

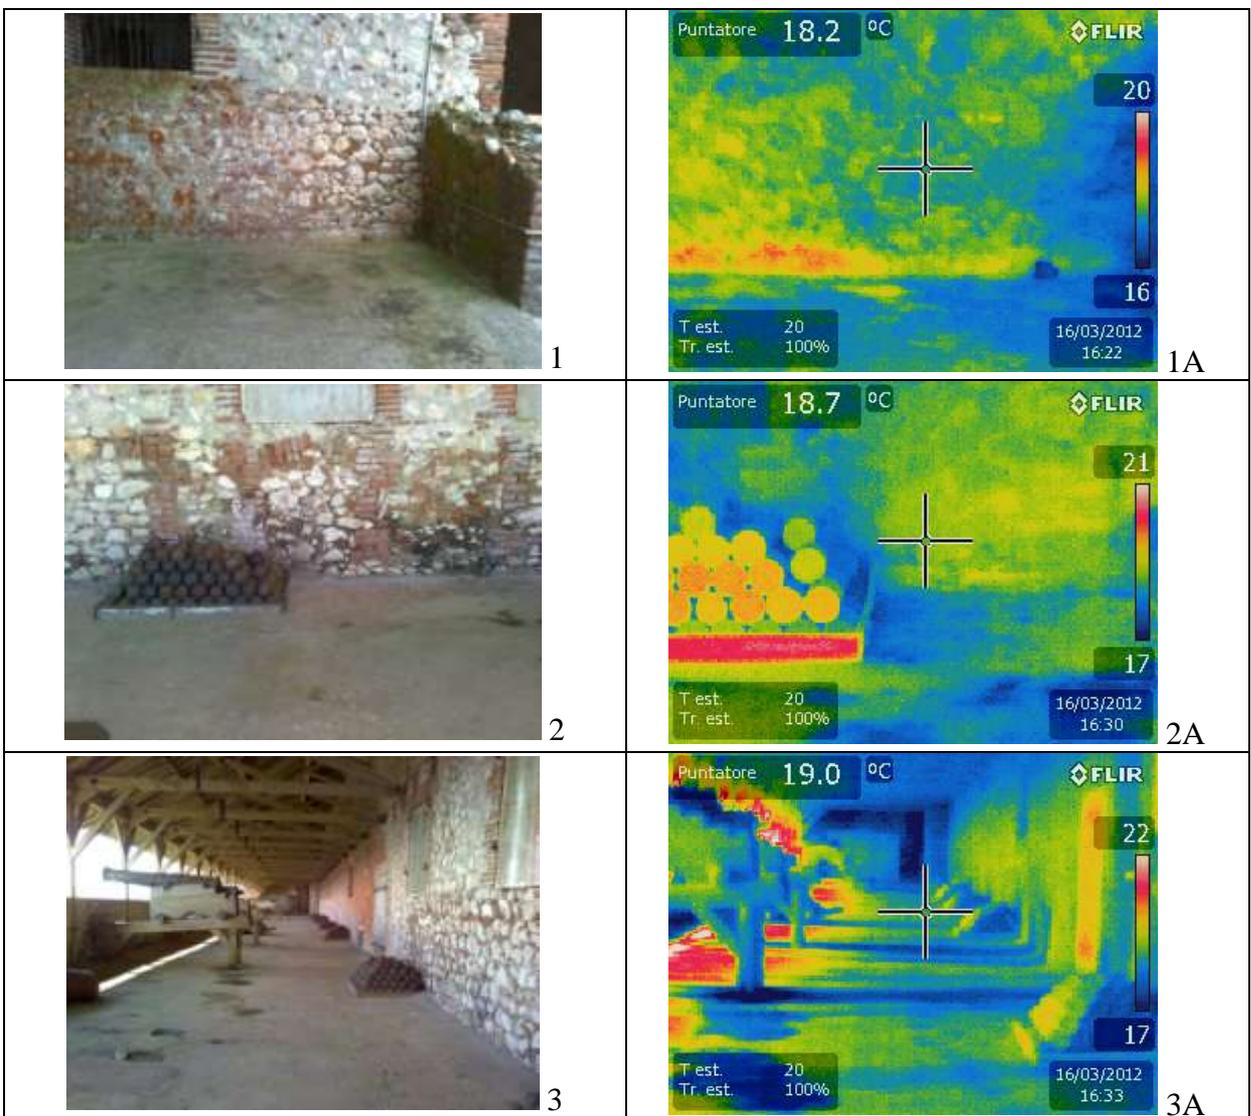
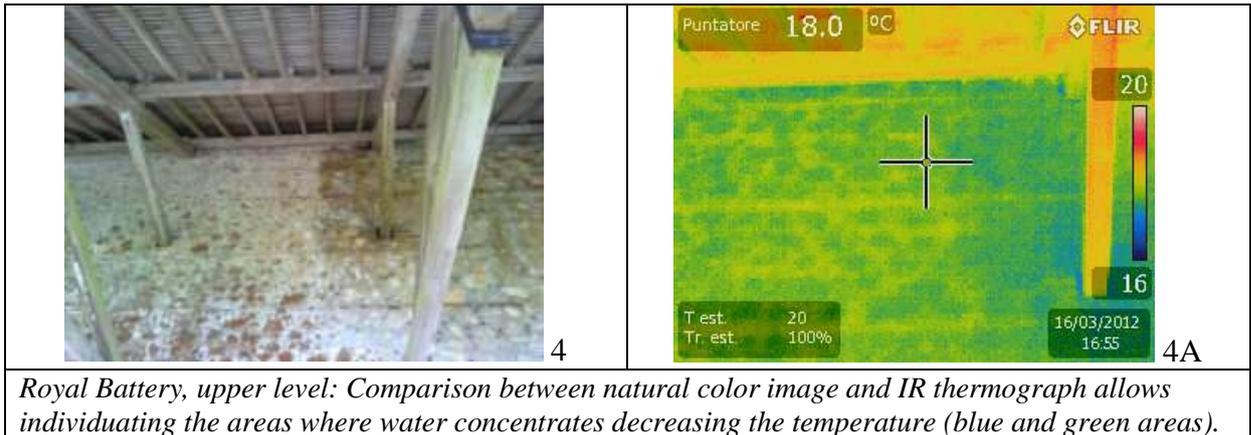
*Royal Battery, upper level: Comparison between natural color image and IR thermograph allows individuating the areas where water concentrates decreasing the temperature (blue and green areas).*

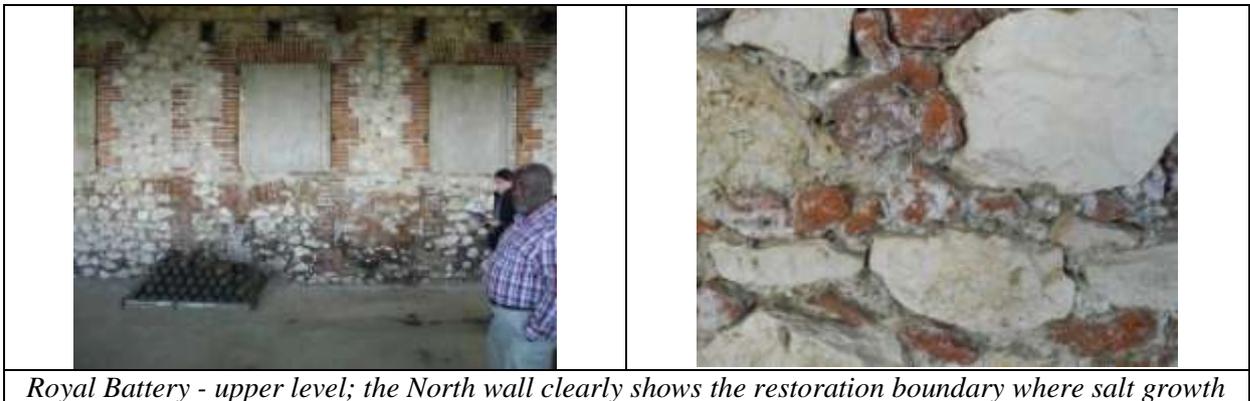
The upper level of the Battery is on the contrary well preserved because of the restoration works made by the ISPAN in the 1980s, with the rebuilding of the external wall and the roofing. The only areas where degradation is relevant correspond to the side in contact respectively with the Governor Place ruins in the East side, and that in contact with the Princess Battery at the opposite West side. The degradation is mainly caused by the water penetration from the top of the Governor Palace walls, which are unprotected, and from the terraces of the Princess Battery that are fissured. Making several infrared thermographies on the walls and the pavement of the battery allowed individuating the locations from where rainwater preferably enters. The presence of high concentration of water inside the pavement was not a surprise both because of the results of the investigations carried out in the lower level, and owing to the presence in the restored floor of several quarry holes filled by stone pebbles, corresponding to the location of the gun carriages, from where rainwater enters the filling of the below vault. Furthermore, since the vaults are filled with pebbles and clay, the water is retained for a long time and slowly released causing the Karstic processes that chemically affect the mortar integrity.

*Royal Battery - upper level; the North wall clearly shows the restoration boundary where salt growth*

The restoration of both levels is strictly related because the degradation of the plasters and of the masonry of the lower level is due to the water percolating through the pavement of the upper level. Indeed, rainwater accumulates in the layers beneath the existing pavement and penetrates the vaults of the down battery damaging the structures and increasing the risk of collapse of the vaults.

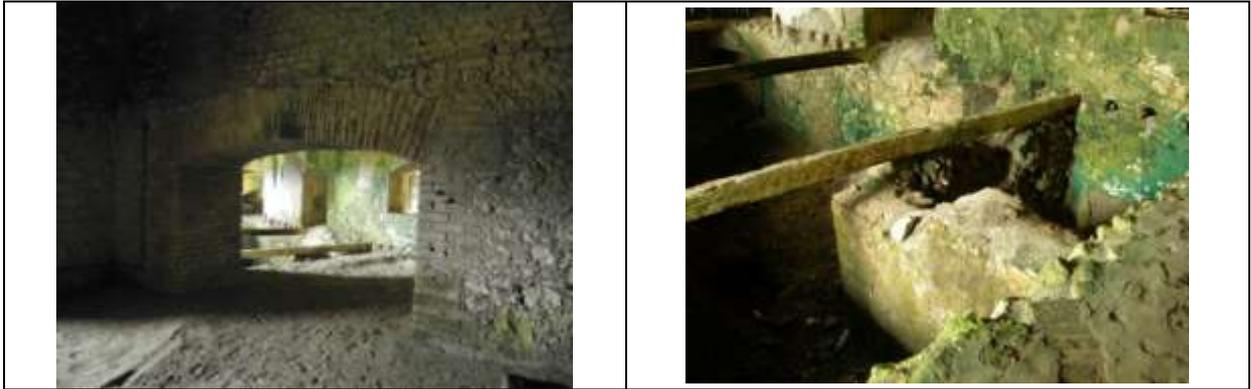
The three levels of the Battery present different state of conservation owing to the different use and damages induced by the earthquake of the last century. The lowest level, which is the prosecution of the down level of the Royal Battery, is unfit for use because of the floor is partly collapsed.

The intermediate level that is the natural connection with the upper level of the Royal Battery is actually closed because of the infiltration of water from the above level have caused structural damages in the rooms.

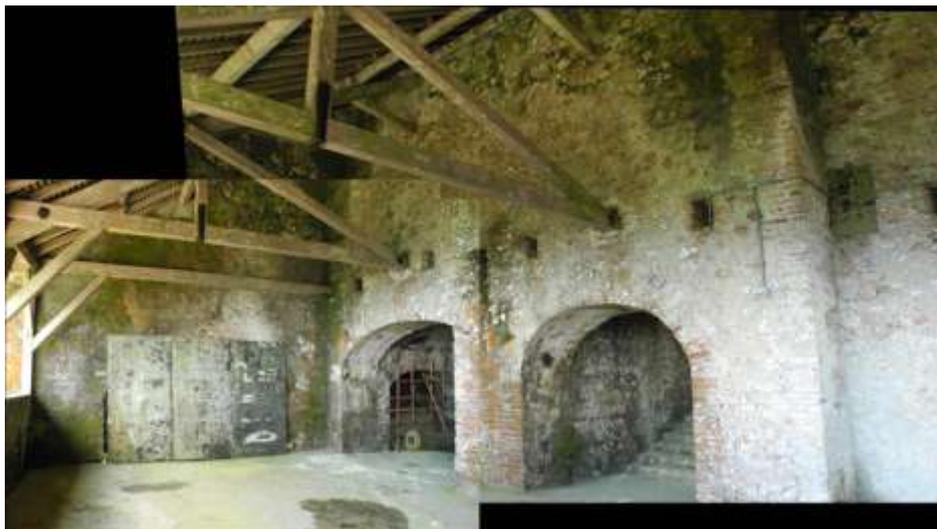
The last level, which was restored during the '80ths to host the exhibition regarding the restoration of the Citadel, is nowadays unfit for use because of the infiltration of water from the roofing and from the adjacent Queen Battery: the rainwater filters from the smoke leakage that are open in the ceiling, but also the fissures in the perimetrical walls allow that water enters the external walls of the battery.

This level of the Princesses Battery was then analyzed by IR thermography technique to assess the water distribution inside the masonry. The water penetrates both the East side and the West side of the battery coming from the thin fissures that are open into the roofing, which is heavily damaged instead it was restored about 20 years ago. Inspecting the roof indicates that the external perimeter row of concrete is partially detached from the wall allowing that rainwater may penetrate the walls diffusing inside the masonry. The review of the roof also confirmed that several small fissures affect the masonry layer of roofing, increasing the penetration of water inside the monument.

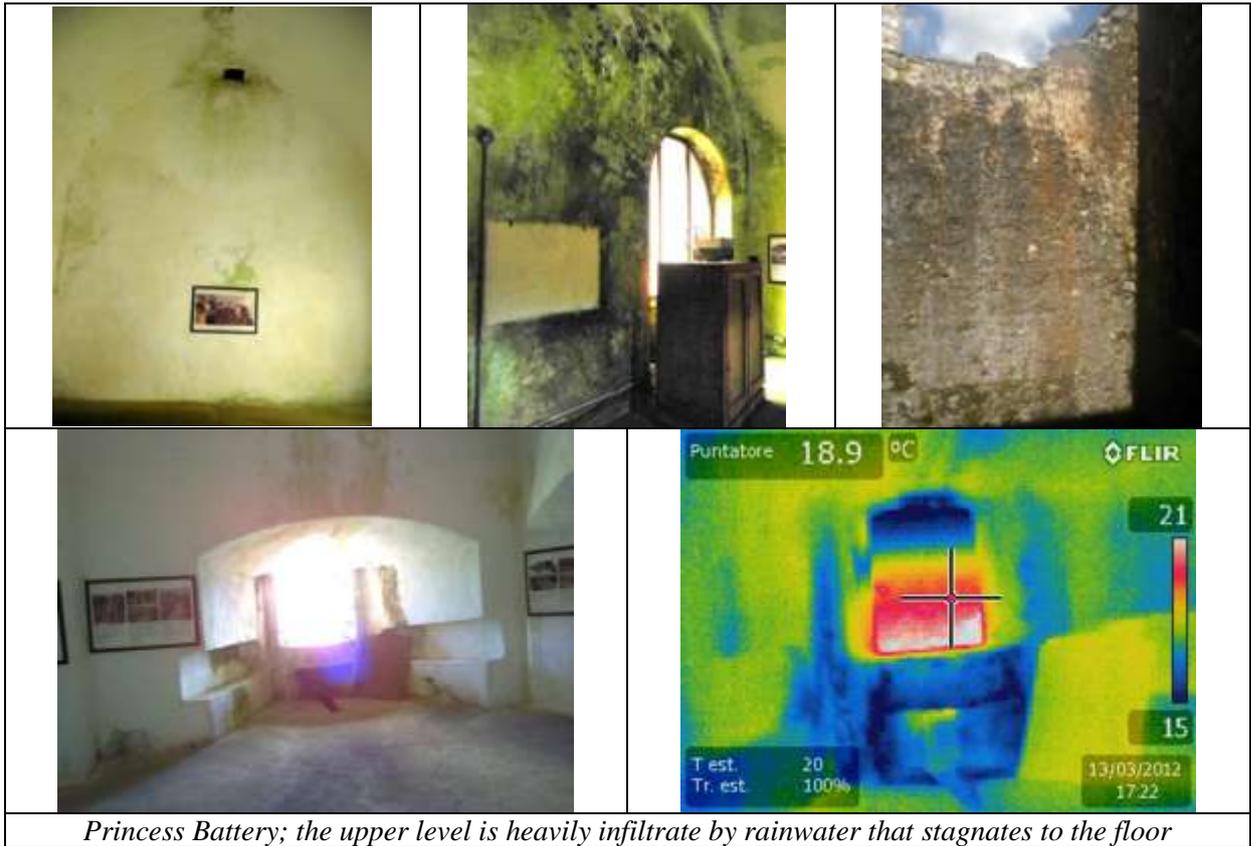
*Princess Battery; the upper level is heavily infiltrate by rainwater that stagnates to the floor*

water penetration inside the rooms; also the vertical fissure affecting the East gun mouth has to be explored and filled by insulating waterproofing mortar in order to stop the rainwater penetration and the structural damage.

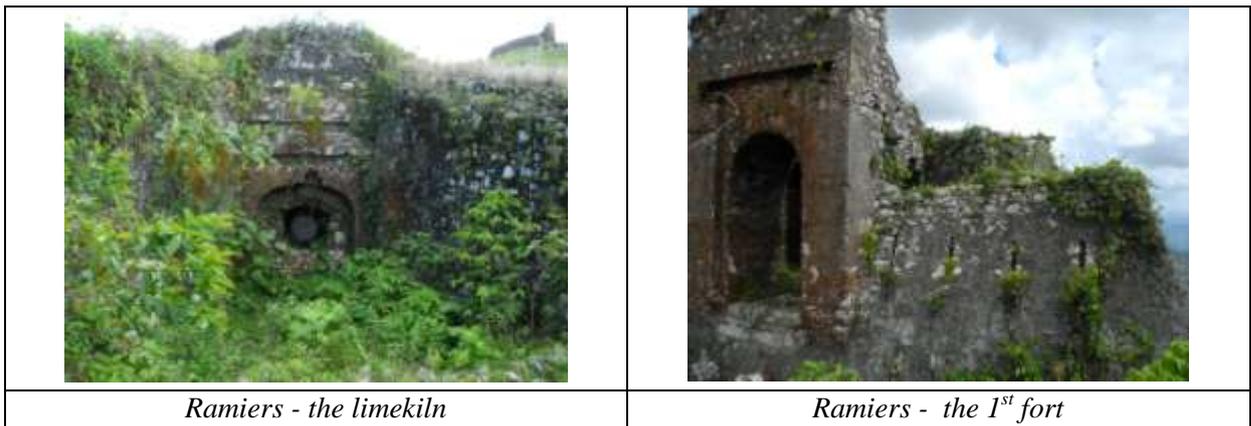
The entrance tower is fissured because of the earthquakes and the collapse of the roofing. The masonry is made of thin bricks and mortar, but to build the external canal and the main walls, rock fragments were also used. The plaster covering the masonry is hard and well adhering to the surfaces, as well as the hydraulic mortar of the pavement.

In the first room at the lower level a small well and a cooking kiln are present, probably to be used by the on guard soldiers.

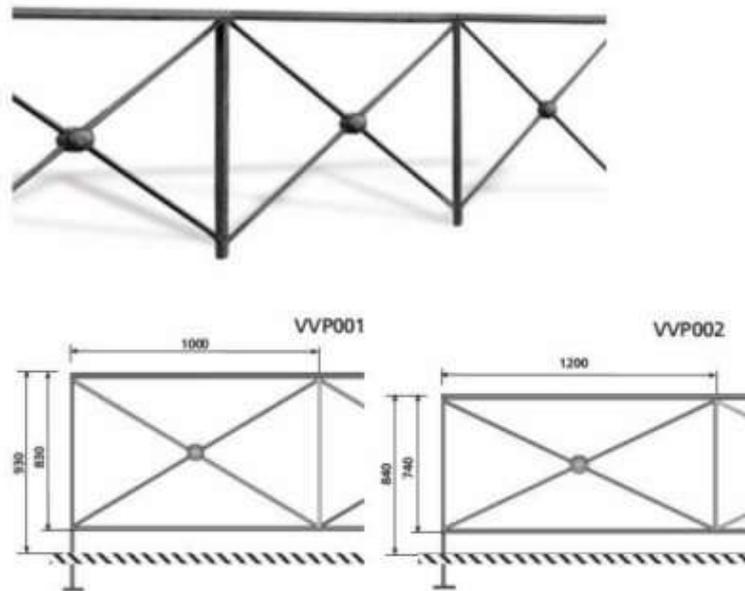
This kind of balustrade is made of iron and may be connected with transparent foils of poly-carbonate or anti-shock glass.
