**Evaluation of the State of Conservation  
of the Site inscribed in 1982 on the World Heritage List as  
“National Historic Park – Citadel, Sans Souci, Ramiers”  
Criteria (iv), (vi).**

**Mission Report of the Survey**

**6-22 March 2012**

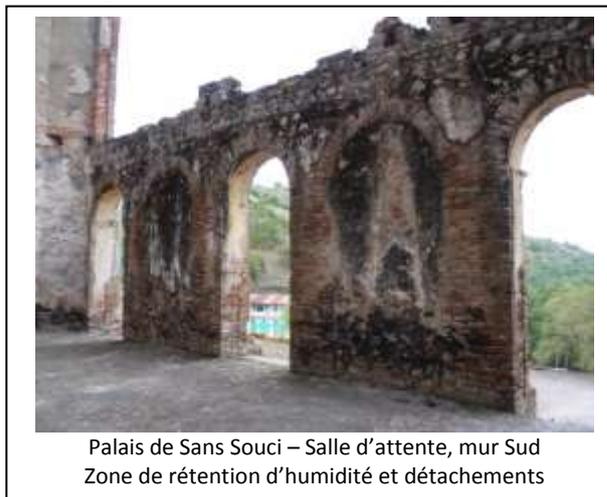
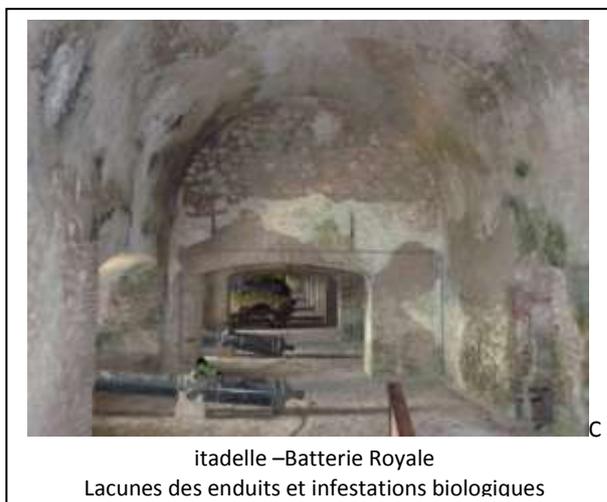
- L'activité des éléments météorologiques associée à des phénomènes de remonté capillaire agit sur les enduits et les mortiers sous-jacents provoquant des désagréments par lessivage et érosion, des phénomènes qui à leur tour, s'associent à l'action cryptocristalline des sels solubles présents dans les substrats.

La présence de contaminations biologiques associées à l'eau est responsable, de plus, de différences thermiques et mécaniques qui portent au détachement entre les couches des enduits plus superficiels et des crépis

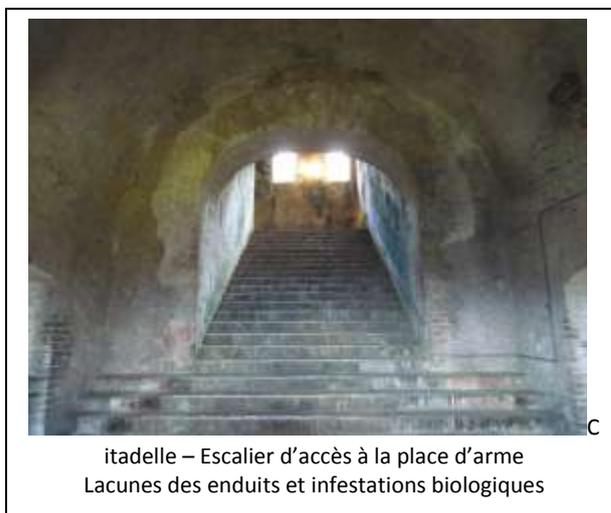
itadelle – Escalier d'accès à la place d'arme  
Lacunes des enduits et infestations biologiques

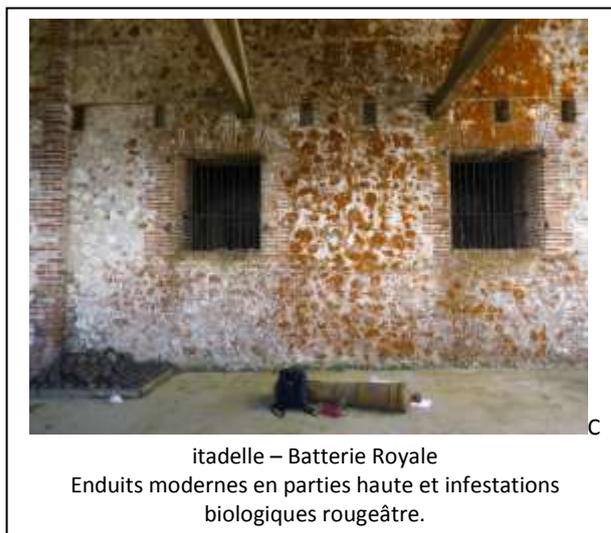
itadelle – Batterie Royale  
Enduits modernes en parties haute et infestations  
biologiques rougeâtre.

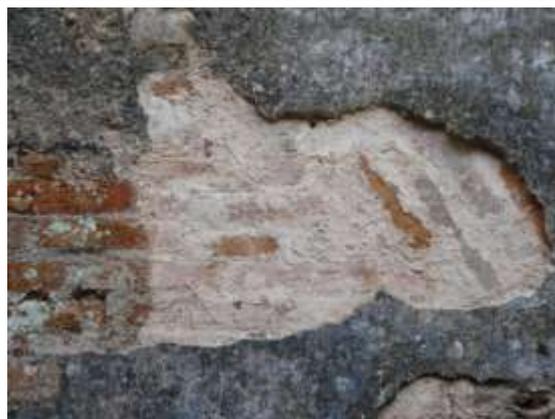
Palais de Sans Souci – Salle d'attente, mur Sud  
Détachement récent de parties d'enduit.

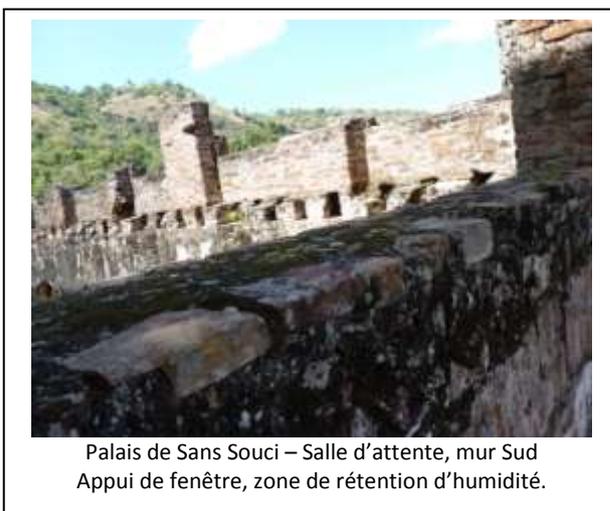
Palais de Sans Souci – Salle d'attente, mur Sud  
Appui de fenêtre, zone de rétention d'humidité.
