**MISSION REPORT / RAPPORT DE MISSION**

**Abu Mena (Egypt) (C 90)  
Abou Mena (Egypte) (C 90)**

**18-23 November 2012 / 18-23 novembre 2012**

**REPORT ON THE JOINT WORLD HERITAGE CENTRE / ICOMOS  
REACTIVE MONITORING MISSION TO  
THE WORLD HERITAGE SITE OF ABU MENA, EGYPT**

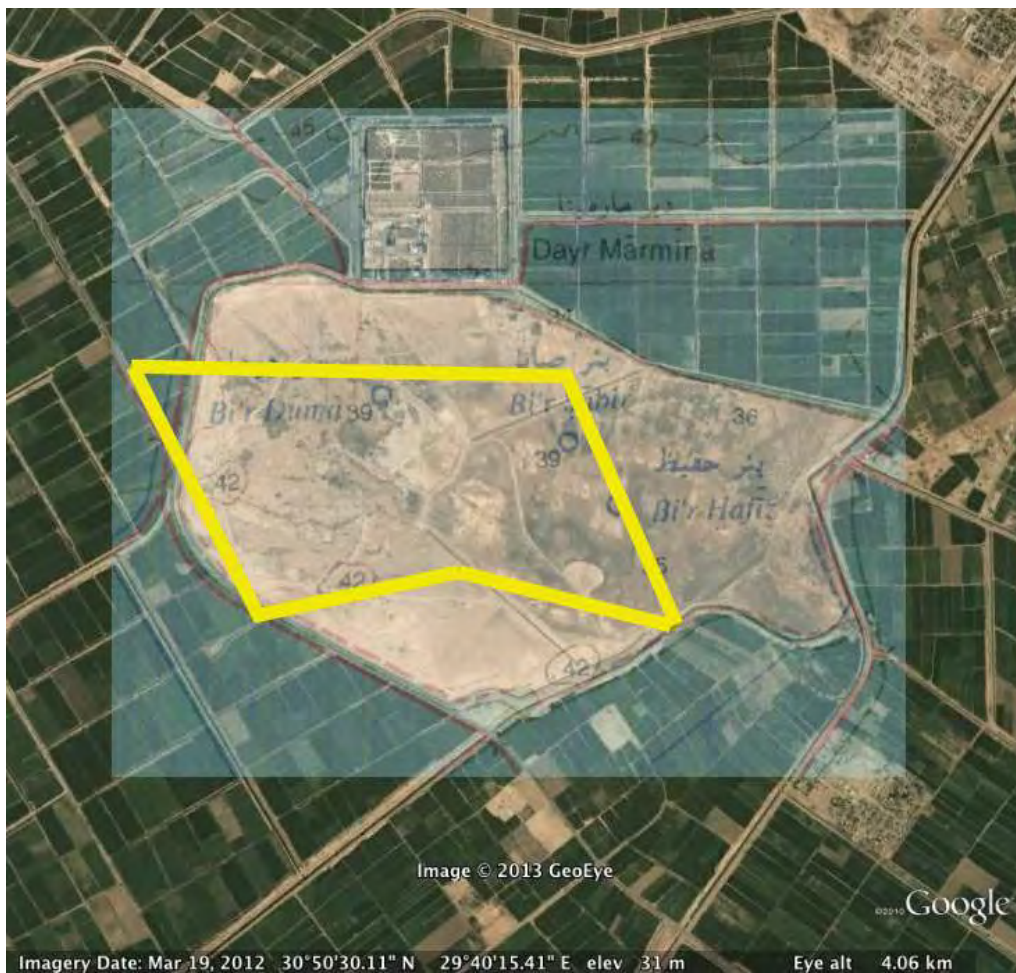
Figure 2. Published World Heritage property boundary overlaid on satellite image

When the published map of the boundary is superimposed onto a satellite image at the same scale, it is clear that the boundary of the World Heritage property refers more to the modern land distribution pattern than to the extent of the archaeology. A large section of the property lies outside the area enclosed by the agricultural drainage ditch on land that is now under cultivation and not subject to any kind of governmental control. It may well be that the original boundary choice reflects the parcel of land, which at the time of nomination was in public ownership (1959 official decree) and not to the position of the archaeological remains (Figure 2). On the site there is no indication of where the property boundary is located and it is near impossible, once within the enclosed area to know where the boundary is located.

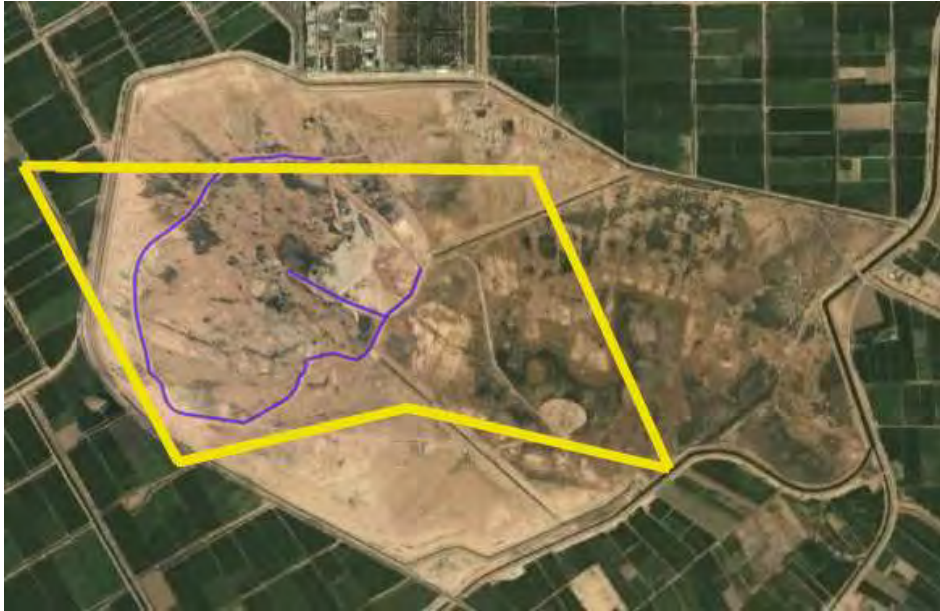
Figure 3. Central archaeological areas enclosed by pump line road (Violet)

The hypothesis that the current boundaries of the World Heritage property do not refer to the archaeological remains is further supported when the area formally described as the central archaeological region, as designated by the area now enclosed by the groundwater lowering pump line is superimposed over the boundary map, when it can be seen that a

portion of the central archaeological region is actually located outside the current boundary of the World Heritage property (Figure 3) and that located north of the pump line, outside the current boundary there are significant excavated archaeological structures. (Figure 4).

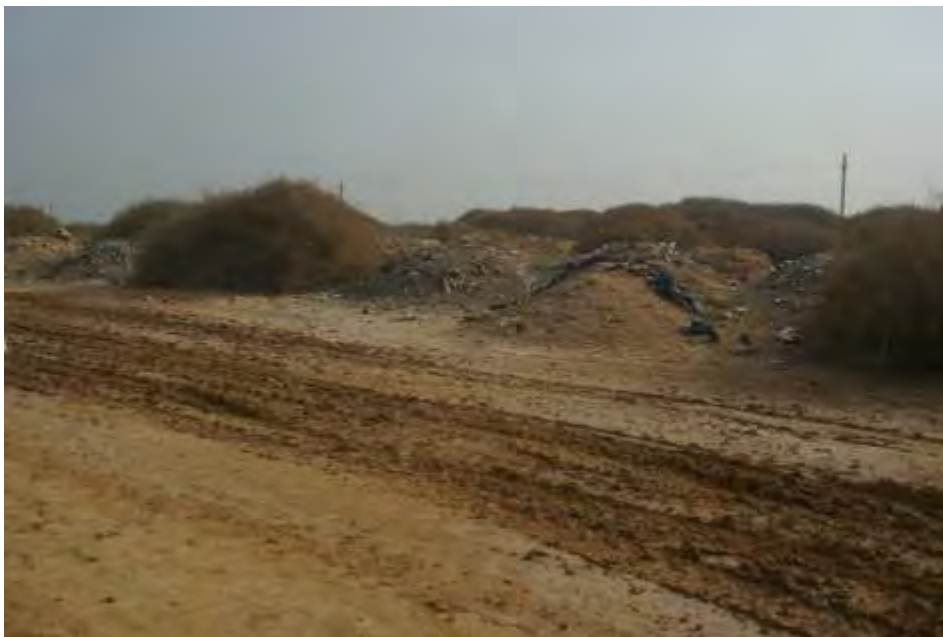
Figure 5 Construction waste dump

The World Heritage property is not permanently staffed or patrolled. The surrounding agricultural drainage ditch has crossing points around its circumference and unrestricted vehicular access is available at all times. There is evidence of vehicles accessing all areas of the zone within the agricultural ditch and it would appear that an area adjacent to the northern most drainage channel is being used as a dumping ground for construction waste. (Figure 5)

The construction dump is located close to the boundary of the property, but it is not possible to determine if it is located on the property or in the area referred to as the buffer zone.

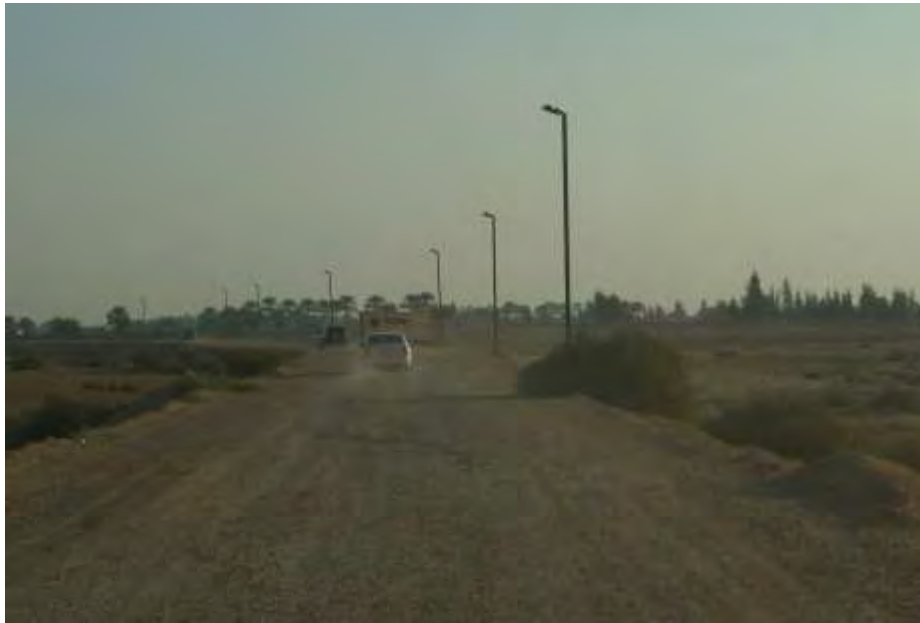
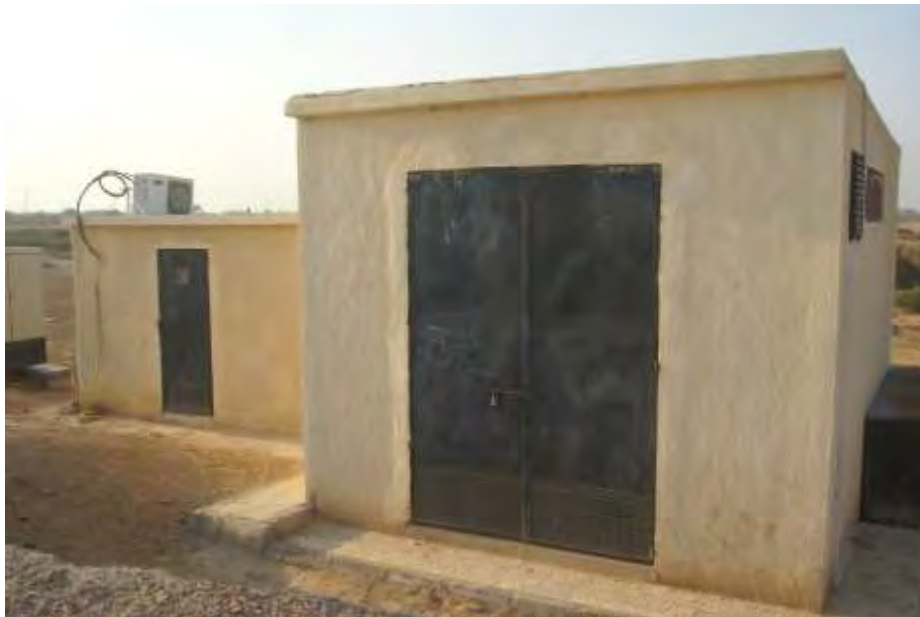
Figure 6. Illuminated access road leading to main basilica and one of several dewatering pump service buildings located along its length

Adjacent to the main Basilica at the culmination of the illuminated road, which was built for accessing the dewatering pumps and service buildings (Figure 6), a flat area has been developed. In this area, in addition to the wooden church built over the altar of the main Basilica, there is now a large pilgrims rest building and several other structures of varying degrees of permanence (Figure 7).

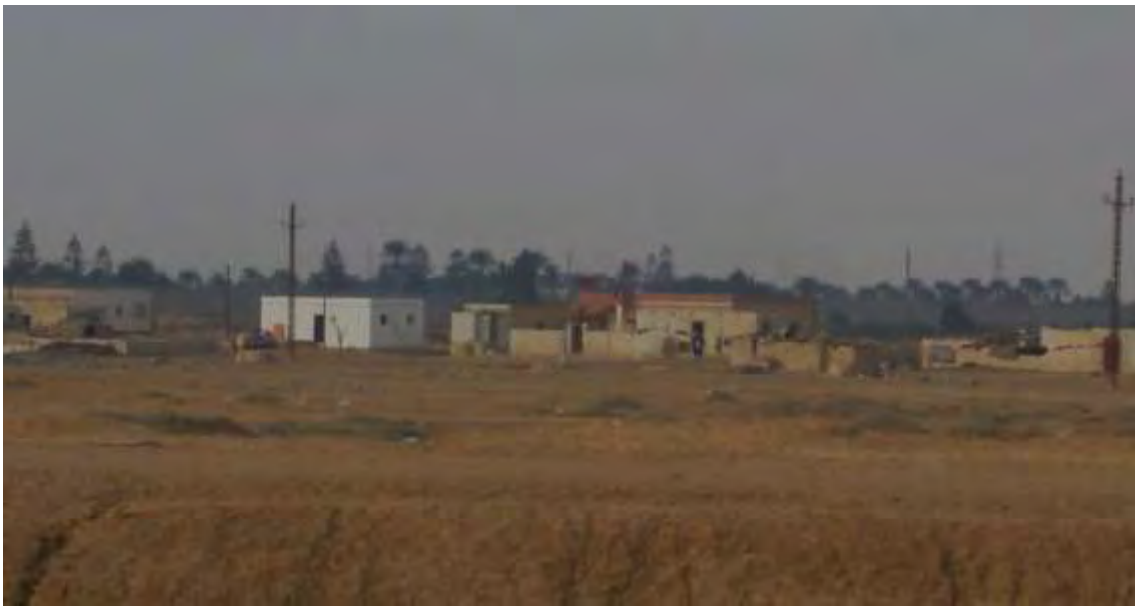
Figure 8. Buildings adjacent to the property

There is also a proliferation of building in both the 'buffer zone' areas and in the property: Figures 8 & 9.

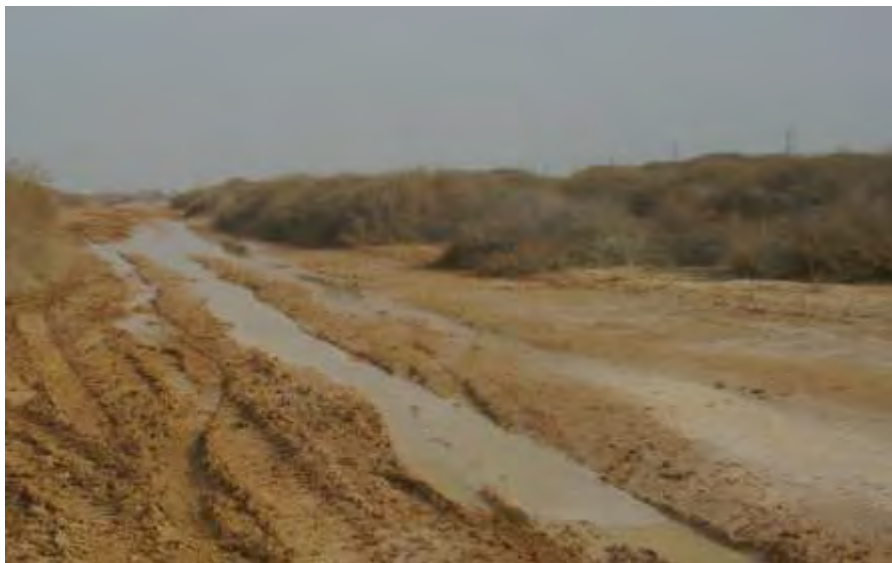
Figure 10. Flooding of eastern end of the property

Flooding still affects approximately twenty-five percent of the property and approximately thirty percent of the entire area enclosed by the agricultural drainage ditch.

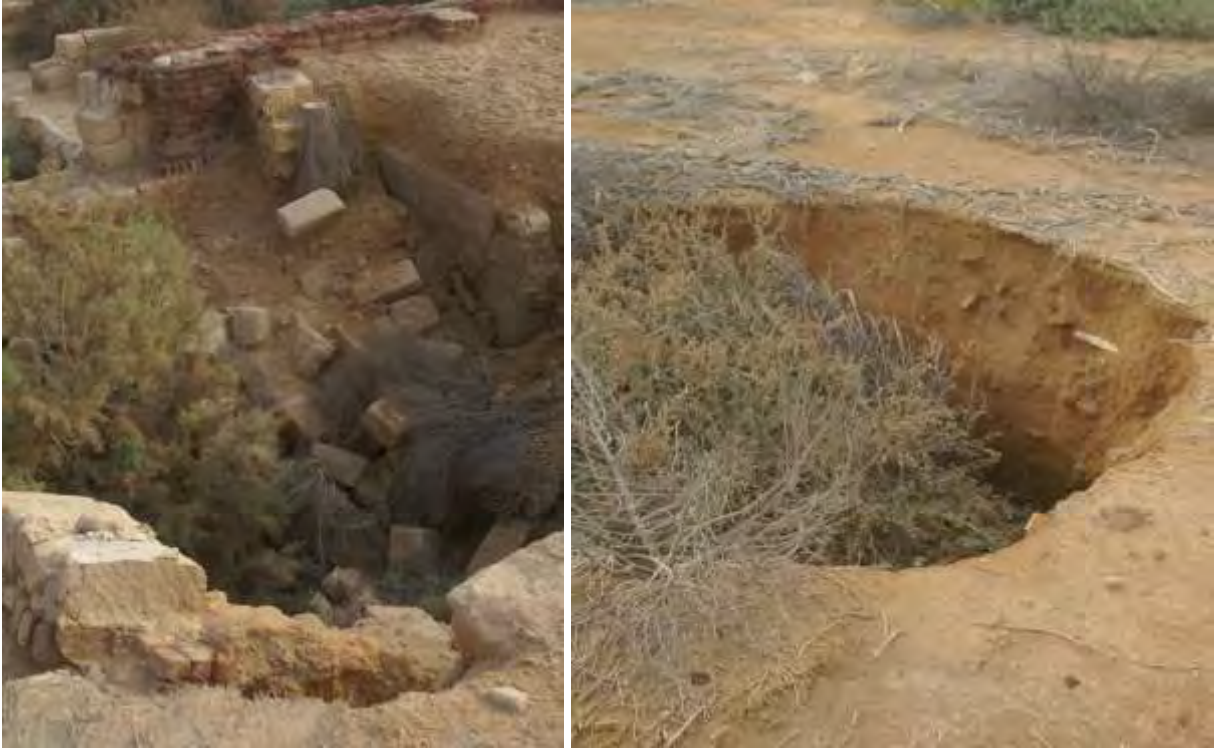
Figure 11. Collapsed cut feature and collapsed subsurface void

The erosion of soil has resulted in the creation of subsurface voids, which on removal of the water resulted in collapse of the surface. The erosion of the walls of cut features such as wells and shafts has resulted in the subsequent collapse of these walls at the time of drying (Figure 11).

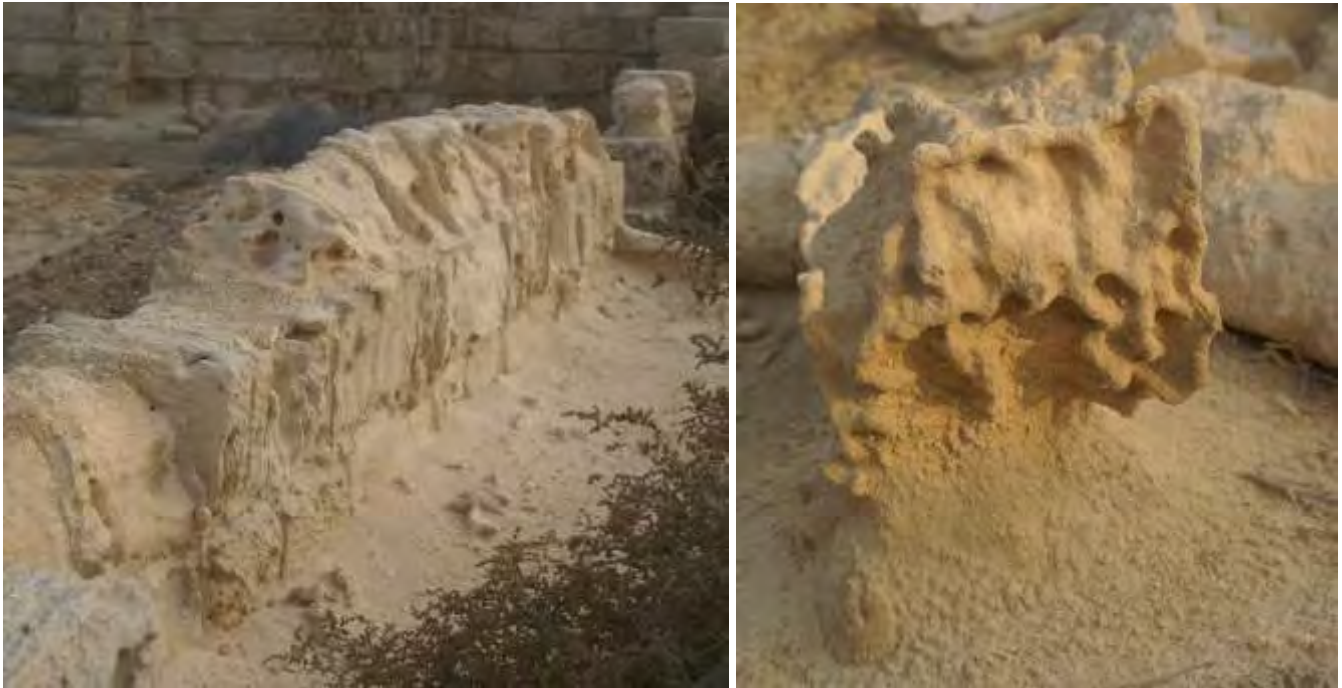
Figure 12. Extremely aggressive soluble salt deterioration of building blocks

The existence of soluble salts is not in itself a cause of deterioration in porous materials. The problem comes when the salts crystallise out of solution as the material dries. Crystallisation occurs just below the surface and the resultant pressure caused by the formation of crystals causes the surface to be pulverised or to flake away. If the salts are then wetted they will again crystallise below the newly exposed surface and again this new surface will again be destroyed.

At Abu Mena, as the ground water level fell as a result of pumping, the damp soil dried through evaporation from the ground surface. The result of evaporation was the transport of all the soluble salts in the wet ground being transported to the surface. In some areas of the site there is now a crust of salt over the ground surface and all the exposed stone is heavily contaminated and suffering badly from salt cycling deterioration (Figure 12).

A plant that looks like Golden Samphire (*Limbarda Crithmoides*) a perennial coastal species, which may be found growing on salt marsh or sea cliffs, was growing on the site, which indicates the level of salt contamination occurring.

The area and structures enclosed by the pump line are now dry or drying. This has resulted in a large deposition of soluble salts from the sub soil onto the surface and the exposed archaeology. This is an extremely serious problem, which needs immediate attention. A conservation condition survey needs to be carried out immediately to establish the level of damage and rate of deterioration of the constituent parts of the various exposed structures within the drained area. Once the survey data is collected it needs to be examined to establish a prioritized treatment programme for the exposed remains.

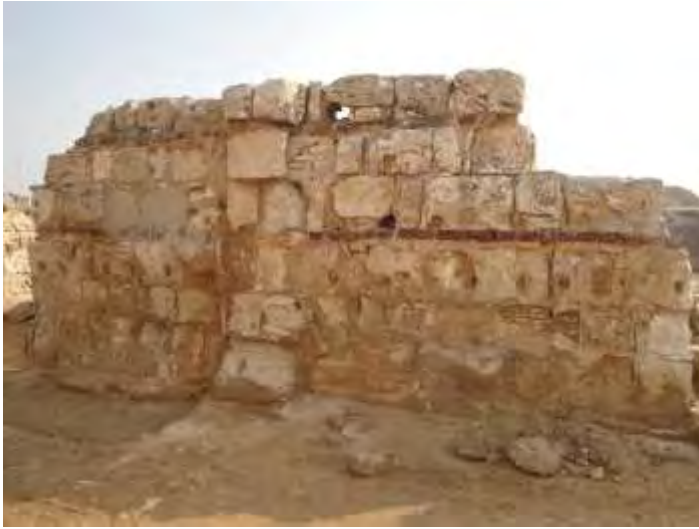
Original excavated wall

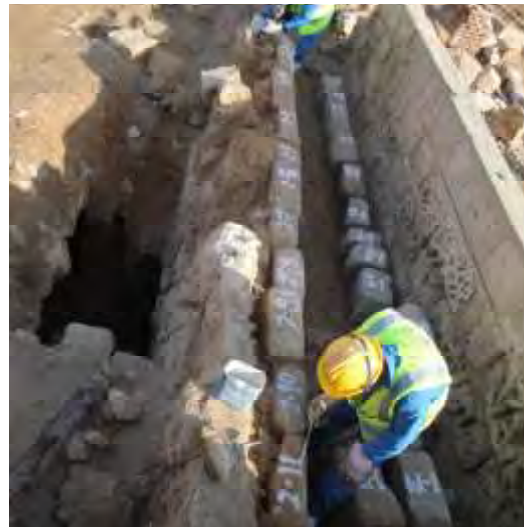
- The complete dismantling of the walls with blocks being numbered as the demolition took place;
- Removal of all historic mortar and other original construction materials from the stone blocks;
- Discarding of blocks not deemed to be in “usable condition”;
- The rebuilding of the walls with modern mortar and new blocks to replace those discarded;

Dismantling an original wall

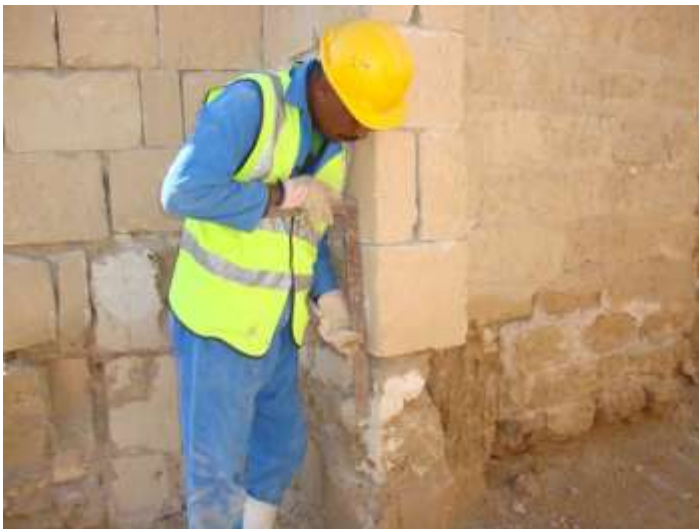
Determining new elevation for wall

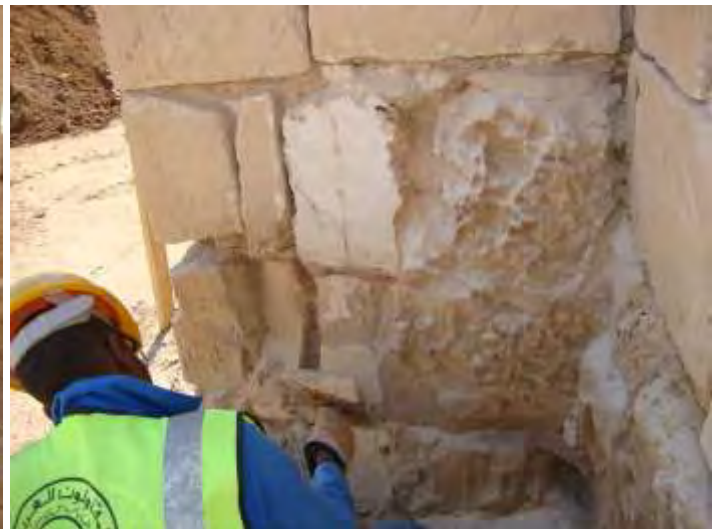
- The cutting back of the original face of the retained original blocks in order that they match the new material.

Re-facing of original blocks to new elevation

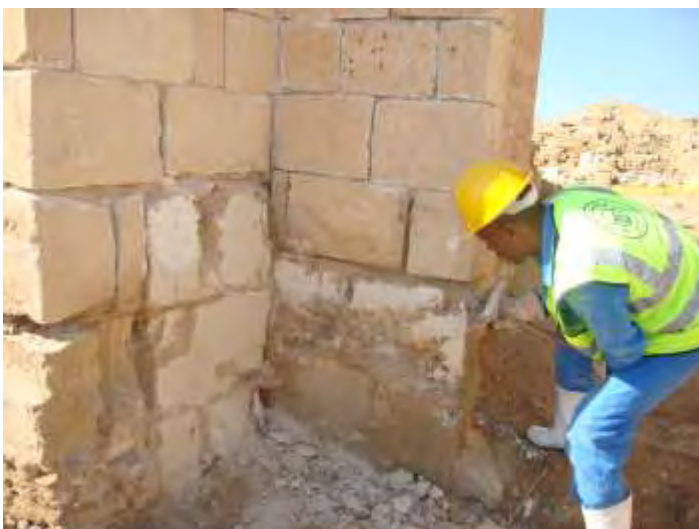
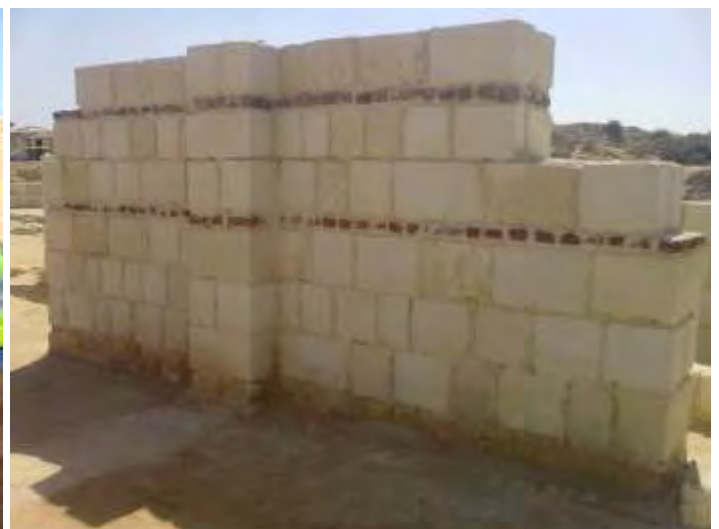
Figure 13. Replacement wall. Retained original refaced blocks can be identified as slightly darker in colour. Presumably the new stone is from a different source to the original.

Clearly option two was chosen and it is the initial stage of this project, the rebuilding of the original walls, to a level where they can be included as part of a new building, that we are now seeing. The original walls have added integrity that makes them structurally sound and able to support the new building. Unfortunately the price for the structural improvement is the total loss of all authenticity or historic context.

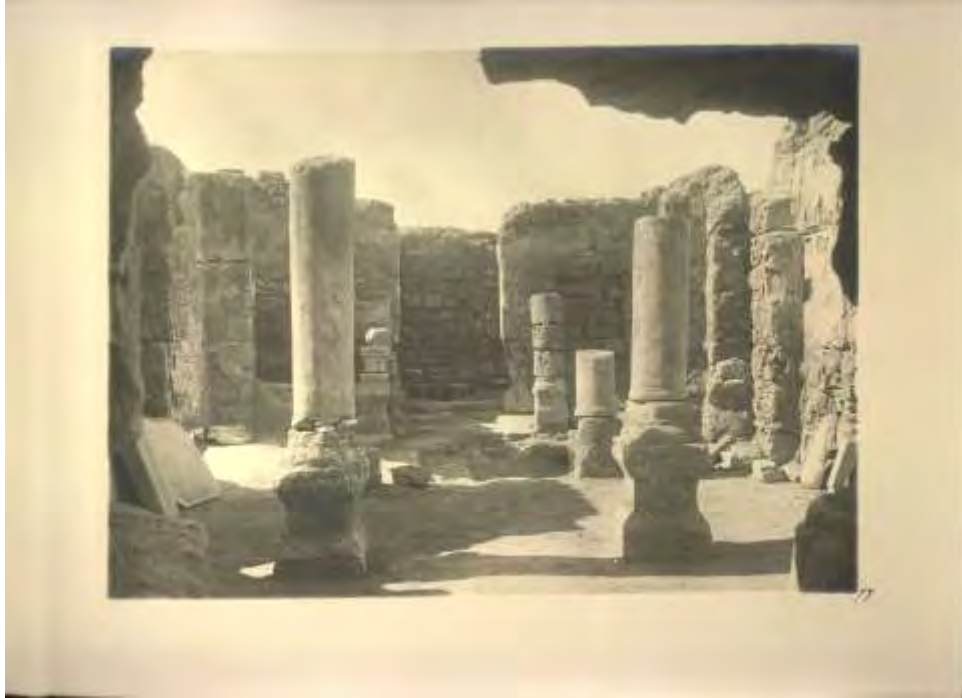
Figure 14. Historic justification for column anastylosis project

The only anastylosis work that could possibly be considered at Abu Mena is the re-erecting of some of the marble columns. Due to the fracture characteristics of the marble and the distinct marking of the stone it is possible to determine which fragments go together and from the fixing holes, which column goes with which base. Any such project and the methodologies used must conform to internationally agreed conservation standards and be submitted to the World Heritage office in Paris. There are in existence historic records (photographs) of the columns in position (figure 14). These and other historic documentation should be used as part of the justification for the project.

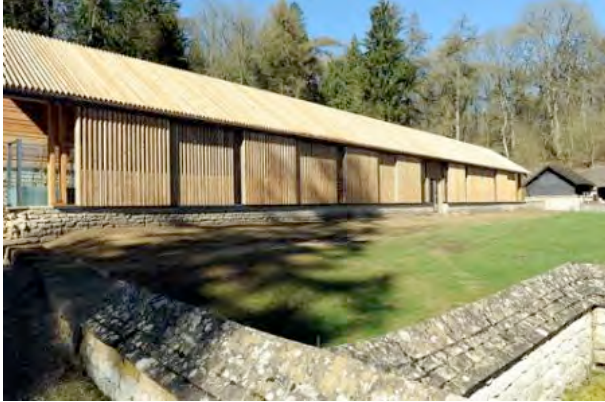
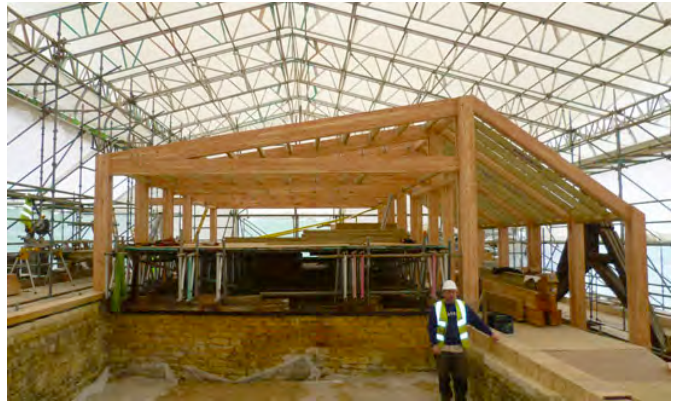
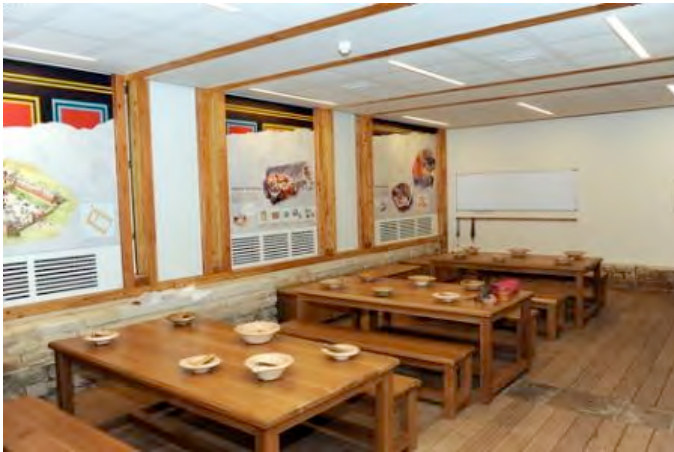
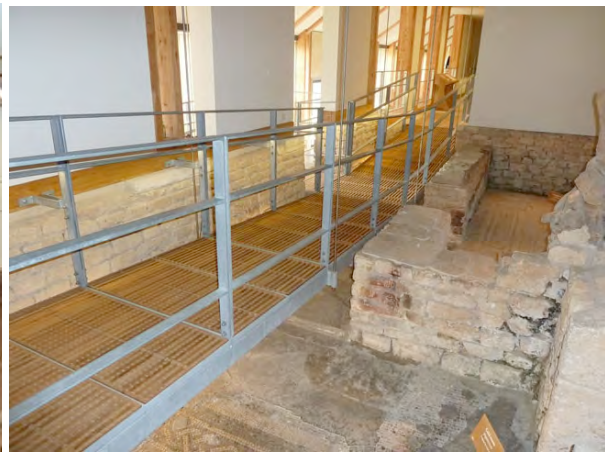
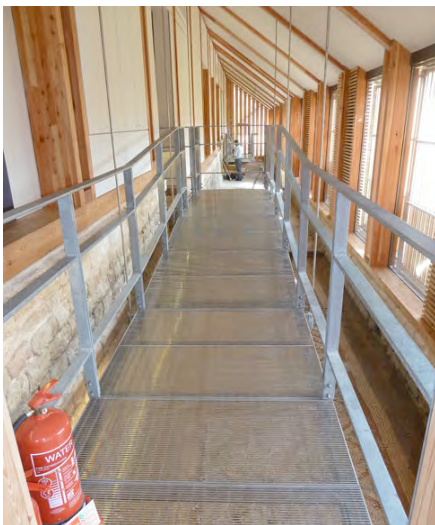
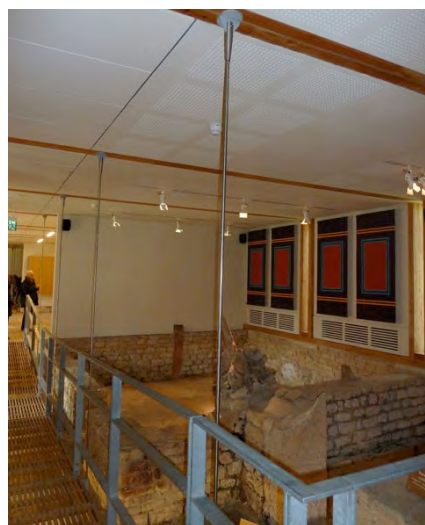
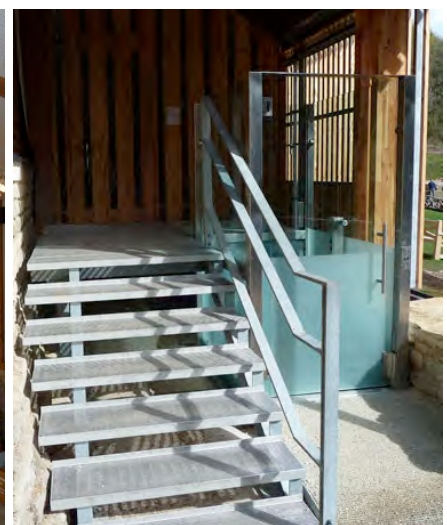
Figure 16. Cover Building, Chedworth Roman Villa, The National Trust, UK

The National Trust of Great Britain has recently completed a shelter building over one range of the Chedworth Roman Villa site. The building covers remains of the building, which contain one of the finest sets of high status in-situ Roman mosaics in the United Kingdom. While Chedworth Roman Villa is not a World Heritage Site it is a United Kingdom Scheduled Roman Villa and as such is protected to the highest level under United Kingdom law for the protection of heritage. Every stage of the design, construction and conservation was scrutinised to the highest degree and the building conforms to all requirements. The building at Chedworth is constructed from engineered timber and is designed to sit on the original roman structure without attaching to it. The Roman walls were conserved and new, clearly visible additions were added to produce a level surface for the new building. The building contains a visitor interpretation centre along with walkways and viewing platforms. All the viewing platforms and walkways are suspended from the new building and none rest on the archaeological structures. The Chedworth building has computer controlled passive heating and cooling systems that constantly react to changing relative humidity and heat levels, automatically opening and closing vents and adding heat in response to real-time monitoring of the internal environment. Heat is supplied from ground source heat pumps and the building requires minimal electricity. The building can react to an influx of people by “seeing” the rise in temperature or relative humidity and reacting accordingly. The building reflects without mimicking the volume and position of the original Roman building and thus infancies the understanding of the site without misleading the visitor as to what is original or authentic (figure 16).

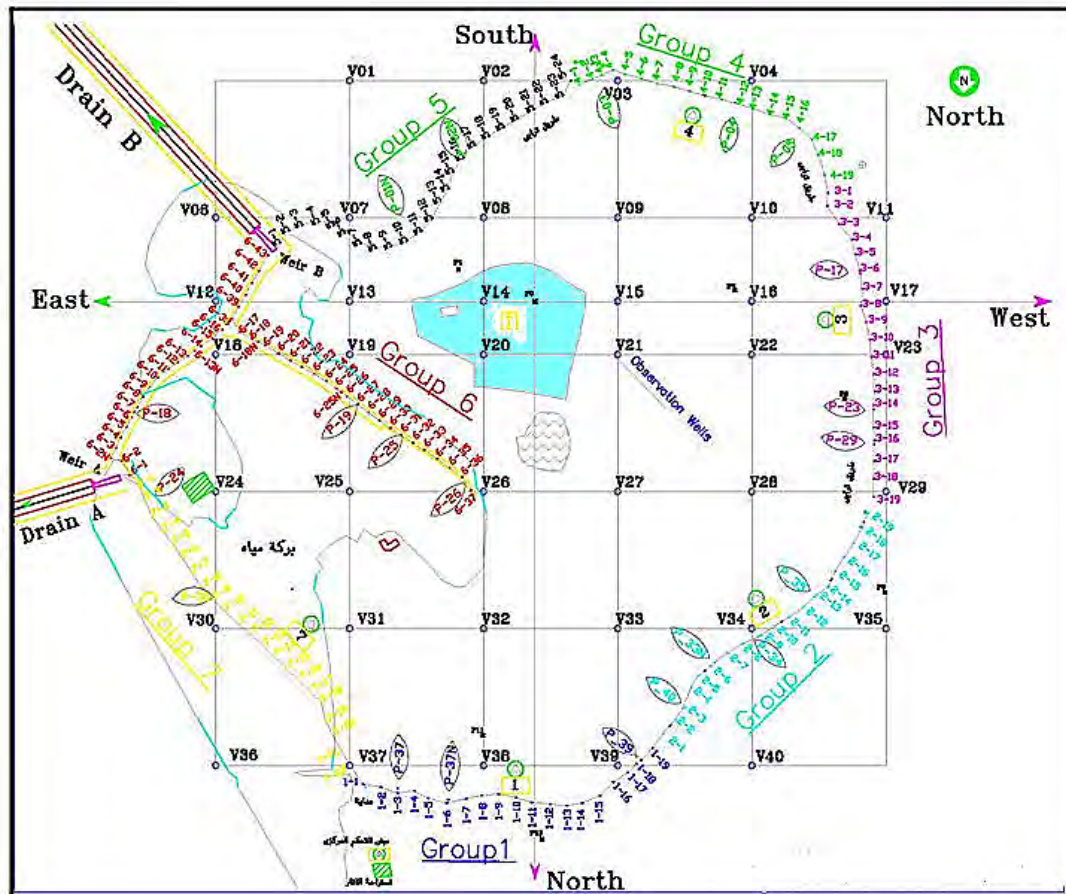
The project foresees 170 pumping wells with depth from 25m to 30m and lined up in seven groups, as shown in Figure 4.

**Figure 4** Implementation of the new project. The archaeological site (light blue area) is surrounded by 170 pumping wells, arranged in seven groups (1-1, 1-2.; 7-1, 7-2....). The water table is monitored at 40 observation wells (V1, ..., V 40). Water is conveyed to two open-air canals (Drain A, Drain B), which are connected to a main canal, about 30 km long, discharging in the Mediterranean Sea in the vicinity of Alexandria. [Document released by the Ministry of Culture]

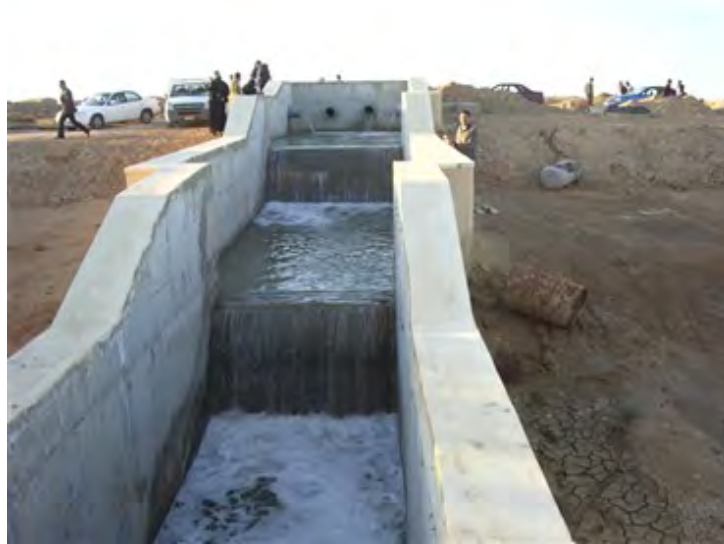
**Figure 5** One of the weirs discharging the drained water after two hours of pumping. The rate of flow is of the order of  $0.05 \text{ m}^3/\text{s}$

As an effect of the pumping wells, lowering of the water table will be monitored by means of 40 observation wells located in the most significant points of the area and provided with automatic and centralized recording equipment (see Figures 5 and 6).

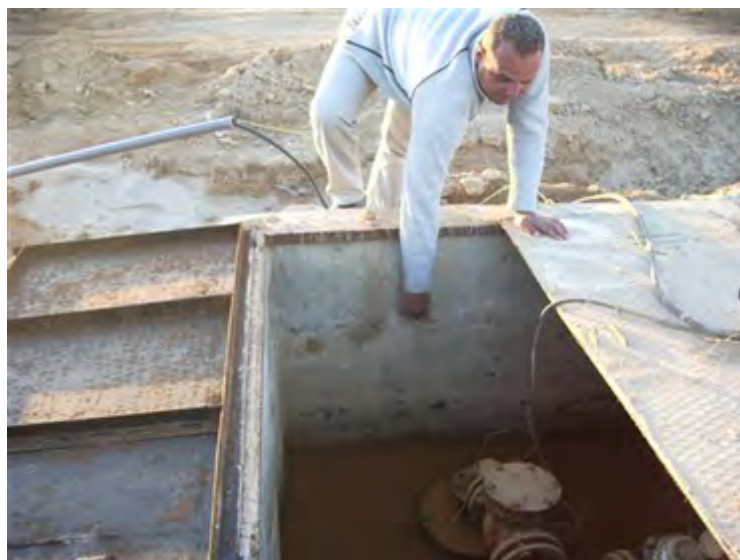
**Figure 6** An attendant shows how the water level has lowered after two hours of pumping

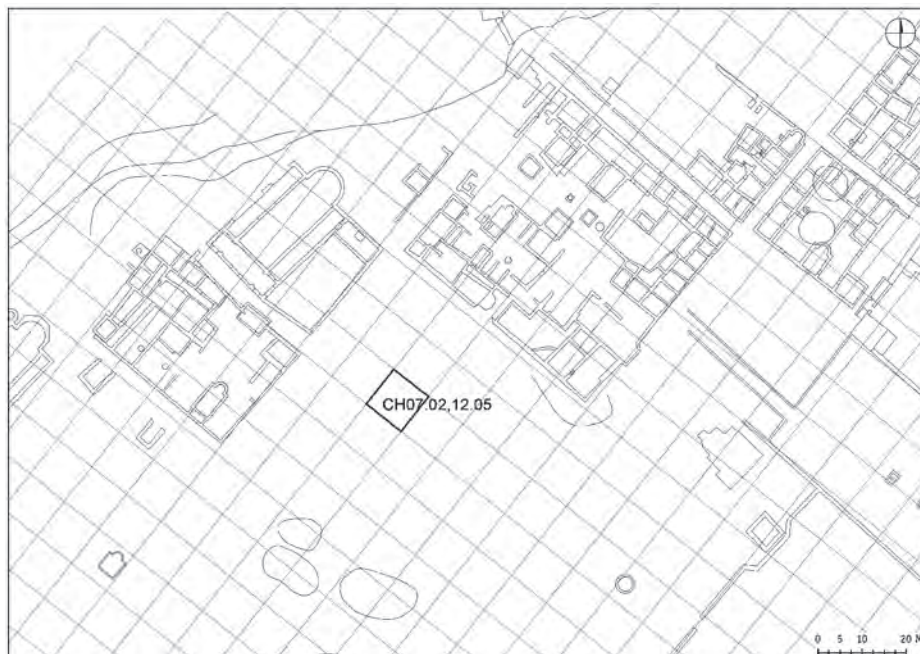
Figure 2. Section of the 10 m × 10 m grid overlaying a map of the city's northern region.

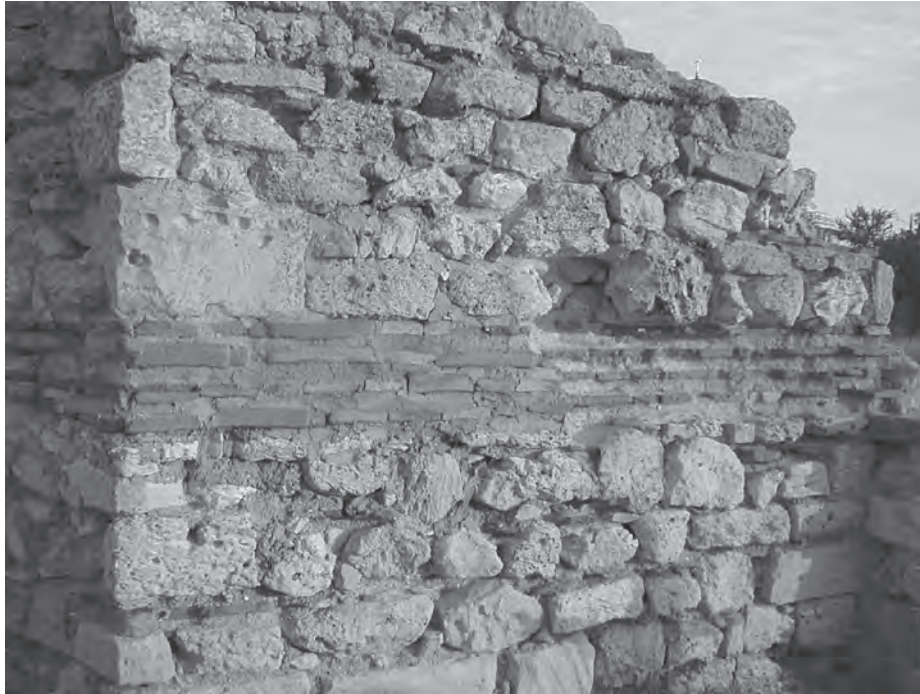
Figure 5. Example of wall elevation demonstrating several of the survey criteria. The wall has not been capped, but is reasonably stable and would therefore receive an average score for 'condition of wall top'. Accelerated loss from brick courses was highlighted by the staff of the NPTC as a particular problem on the site. The untreated area on the right would therefore result in a very low 'condition of wall elevation' score for the grid square in which this section of wall falls. The section of brick course to the left has been treated and is thus not an immediate problem and would not therefore result in a low score for 'condition of wall elevation' as, although inappropriate, the treatment is protecting the original material it is covering. It would, however, be noted as 'presence of previous treatment' and receive a very low score for aesthetic as it is crudely undertaken using an inappropriate grey cement mortar. The grid square containing this structure would be prioritized for conservation because of the rapid deterioration of the brick courses, but only the brick course section immediately treated. Capping of the wall will occur only when all lesser scored areas have been treated. Replacement of the previous conservation treatment would not occur until the upgrading of previous conservation treatments becomes a priority. Initially the preservation of original material is of higher priority than upgrading previous treatments.

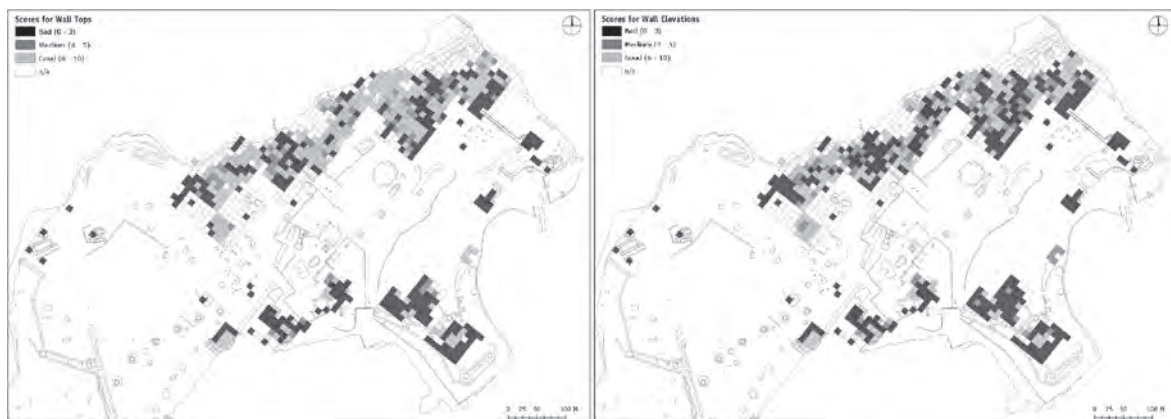
Figure 7. 2004 survey results for wall tops (left) and elevations (right).

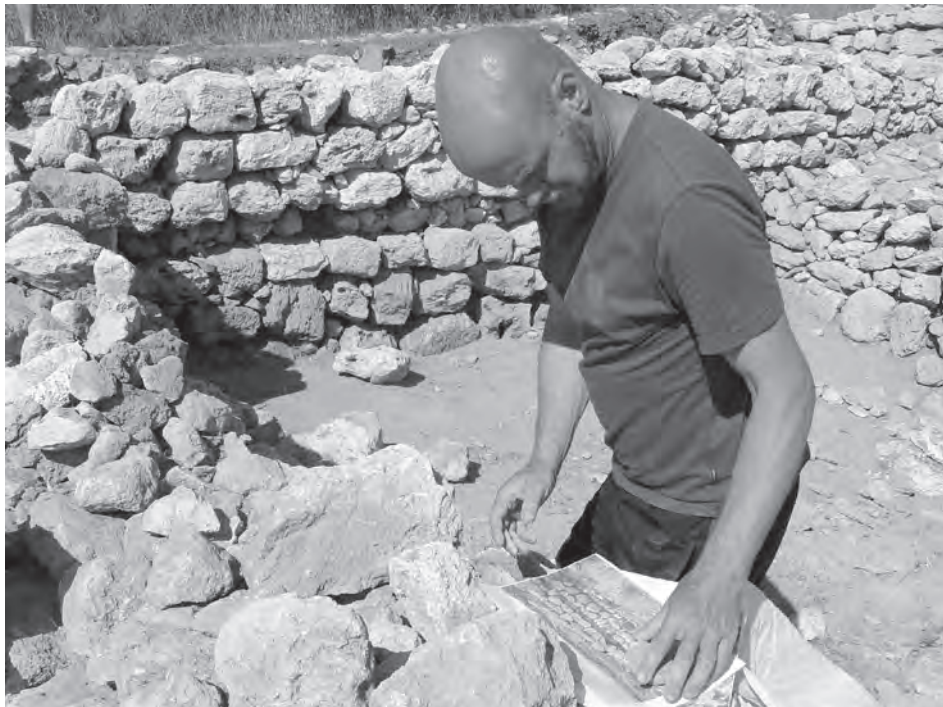
Figure 8. Conservator Jonathan Kemp uses a print-out of a detailed wall face photograph to help reconstruct a section of collapsed wall, 2004.

While detailed recording would normally be done after the general survey identified high priority areas of the site for conservation treatment, for the sake of developing methodology for this study, the detailed recording was begun contemporaneously with the general survey in an area where trial conservation is being conducted. This area, currently being excavated by the joint ICA/NPTC excavation team, contains over 650 individual structural elements that needed to be photographed prior to and after conservation treatment. The photographs, downloaded daily to computers and accessed through GIS software in the field, are already proving to be an incredibly useful tool for documenting conservation. On at least one occasion during the conservation season, conservators were able to call up pre-conservation photographs to help reconstruct portions of wall that had collapsed (Fig. 8).
