**Samarra Archaeological City  
State of Conservation Report  
World Heritage Commission of Iraq  
Jan . 2014**

## **8-1- Great Mosque, Prayer Hall.**

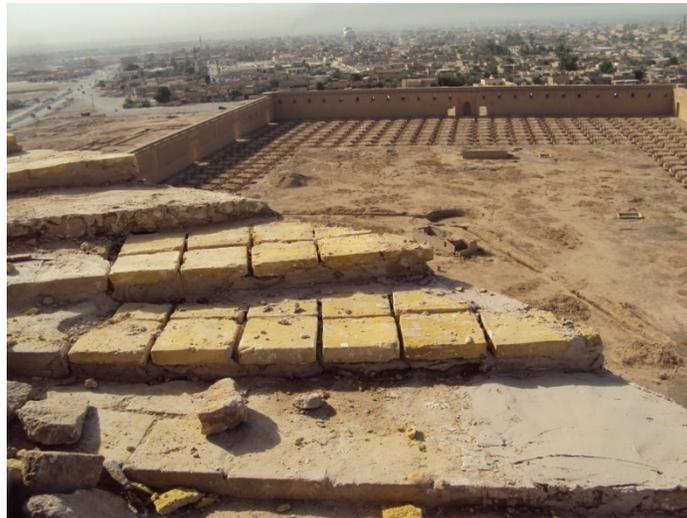
**Many significant changes have been made to this monument using intrusive methods and incompatible materials. The traces of the 1980s reconstruction project are still evident .**

**Fig. 2 General view for great mosque courtyard Source: Department of Antiquities of (Samarra**

**So after inscription the site on the world heritage list ,and many technical missions visited the site and requested the state party to dismantle and remove of the modern concrete columns constructed inside the open courtyard of the mosque.**

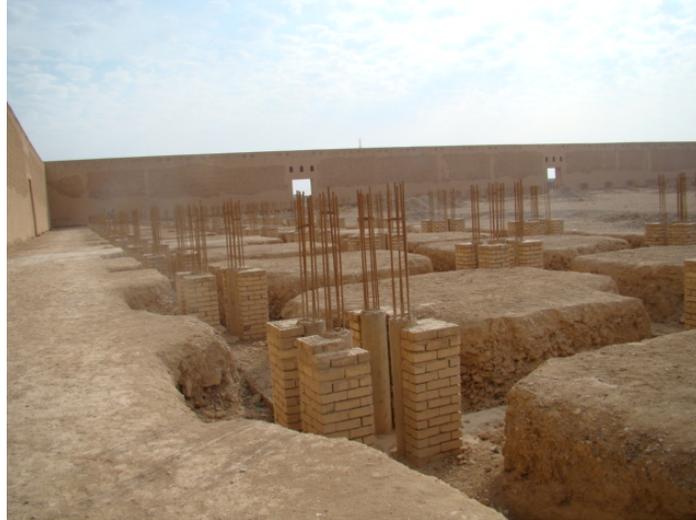
**The more visible are the reinforced concrete foundations and columns installed inside the open courtyard to reconstruct the roofed porticoes. More than 400 reinforced concrete columns constitute the intrusive infrastructure which has altered the authenticity of this valuable monument.**

**Fig. 3 Some of reinforced concrete foundation and column inside mosques courtyard  
(Source; Department of Antiquities of Samarra)**

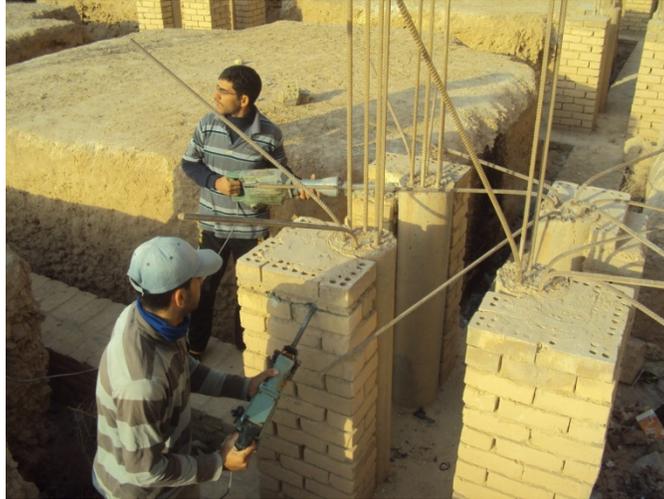
**In our work to dismantle and remove of the modern concrete columns it looks that columns connected with the outer wall of the mosque so as not to make more**

**Fig.4 The act of removing concrete columns –last season.**

**damage to structural design of the mosque, and after dismantling some columns last year and affected on the mosque walls so we began with new technique as follows to take out the cover of concrete columns only ( built by new brick) and to restore**

**new stands with its original measure (1,45 X1,45 cms) and to keep the concrete columns inside the new restored stands, in this case the additive column will disappear for ever.**

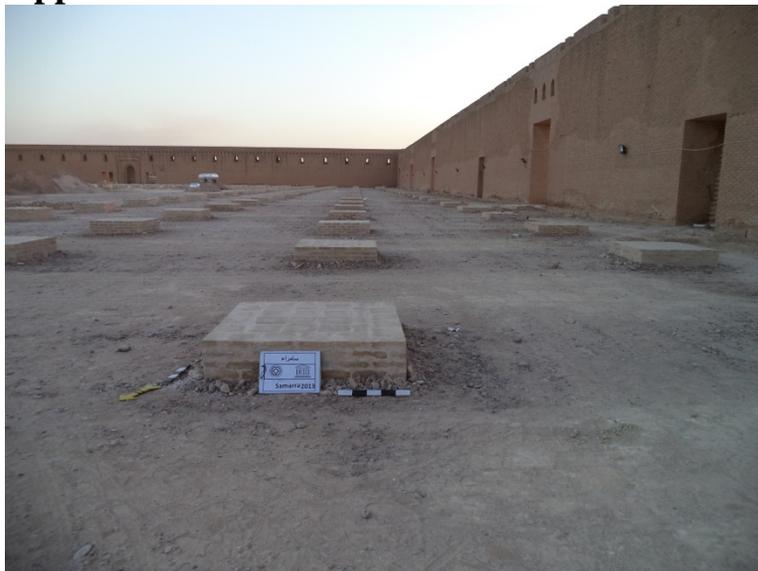
**Fig.5 New restored stands inside great mosque courtyard**

**From the pictures of Herzfeld's archive kept in Smithsonian institute it look the new stands parallel the old one as it mentioned by German expedition worked in Samarra in 1911.**

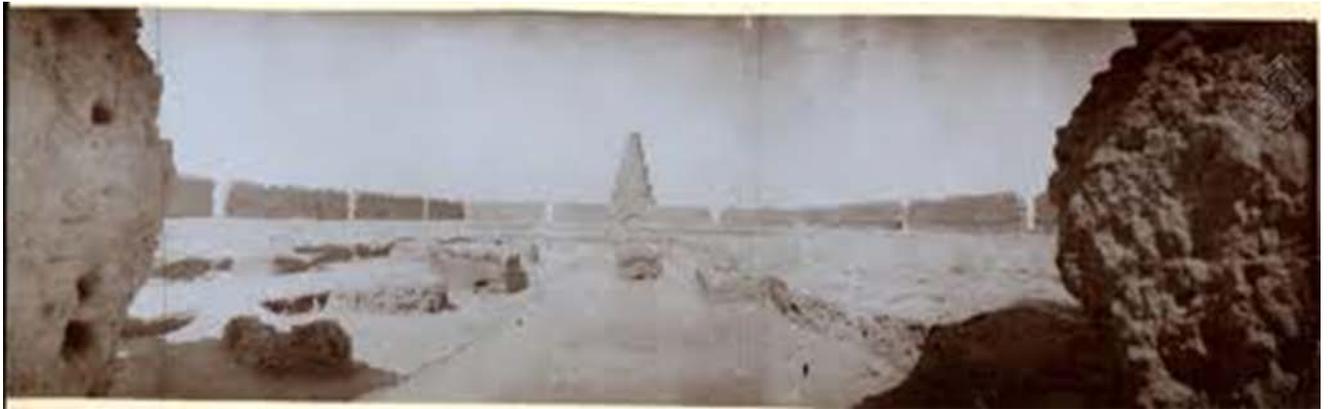
**Fig.6 Old stands of great mosque courtyard , German excavation,1911 ,it parallel with new stands**

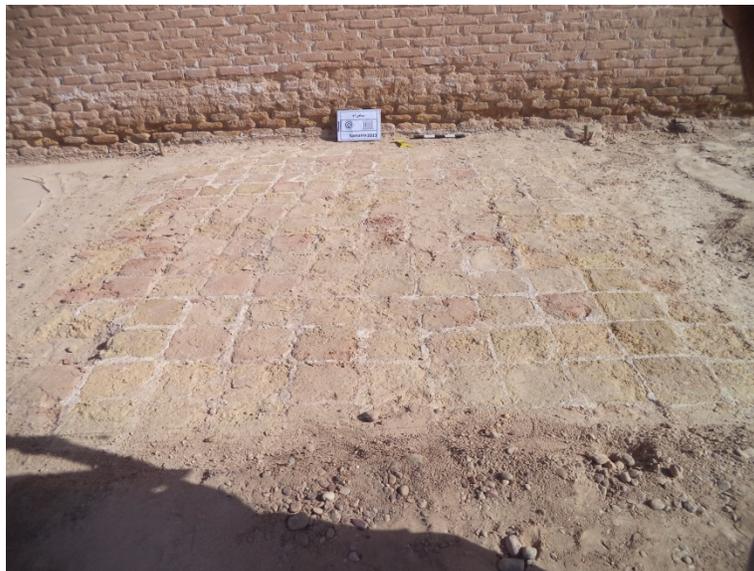
**Fig ,7 Some part of the original floor in the west side of the courtyard  
( Source; Department of Antiquities of Samarra,2013 )**

**After we complete restoration of new stands we are going to restore the floor of the courtyard after we distinguished some part of the original floor and it became very easy to complete it with the same traditional material with the same measures**

**We must mention that there are two floor one for the covered part of the prayer hall and the other floor will be for uncovered part of the prayer hall.**

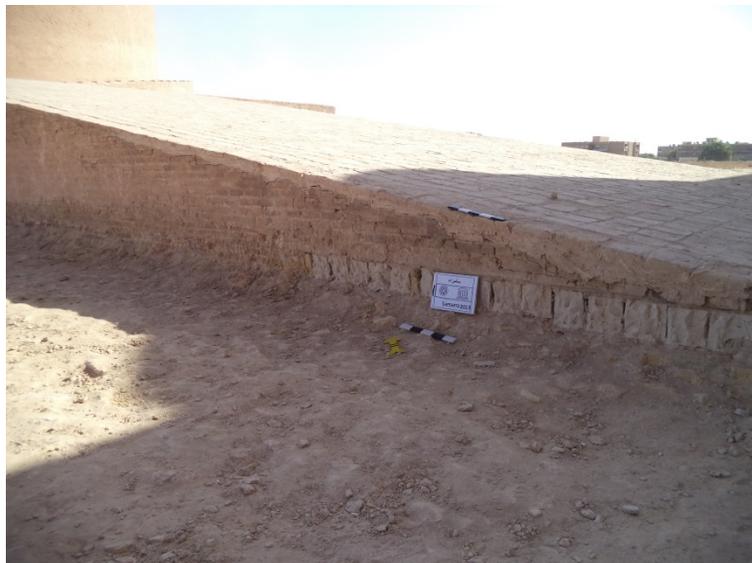
**Fig.9 From un inaccurate restoration using stone limestone beneath the ramp**

**During 1980s revitalization project in Samarra many un inaccurate restoration have been done beneath the base of minaret , such as blocks and new bricks so we are going to replace all these new additives according to international commitments.**

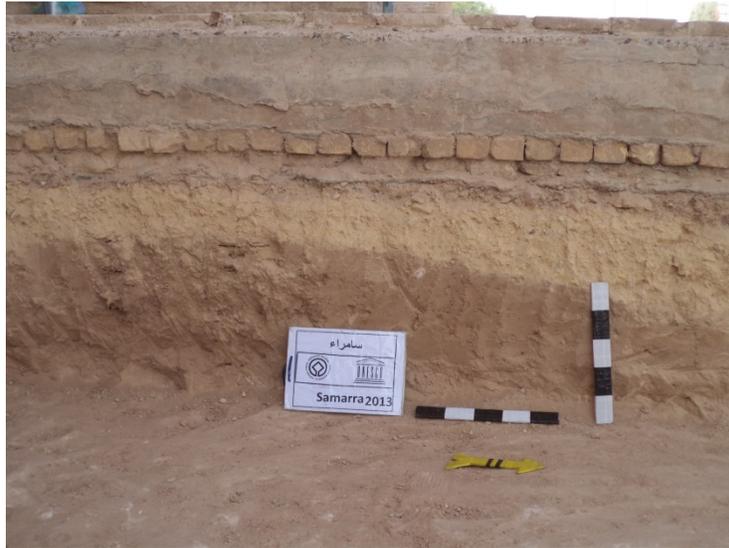
**Fig.10 From un inaccurate restoration using new bricks  
( Source; Department of Antiquities of Samarra,2013 )**

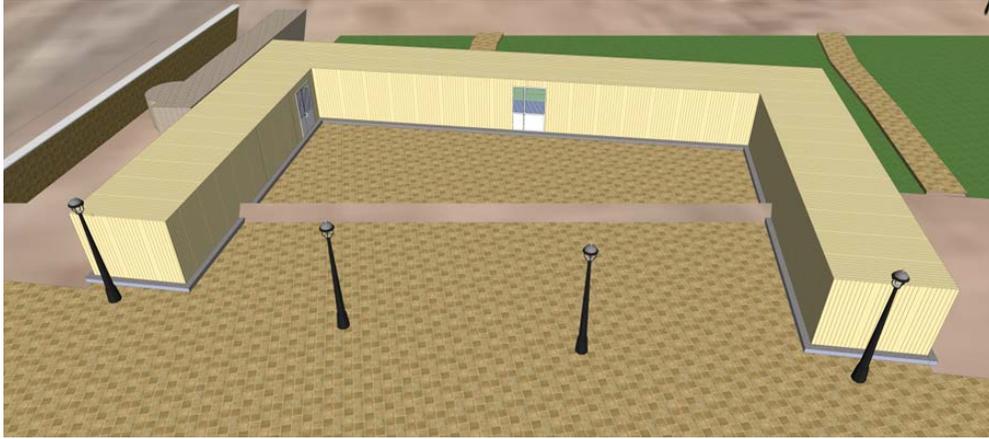
**Fig.11, A proposed site unit building in the site  
(Source; Department of Antiquities of Samarra,2013)**

**So our proposed site unit building will be from turnkey construction  
( Sandwich Panel) on the shape (U) ( Fig.10)**

**The, site unit building is from major infrastructure in World Heritage Sites , so it was agreed to establish this building in diameter of the site, which is located to the left inside of the site and after the visitors centre and its total space is 150 sq. - and up 2.30 M and includes building unit of rooms allocated for administration staff and manager of the site , equipped with furniture ( and office equipment and archives . See attached chart)**
