# International Experts' meeting for the elaboration of a conservation plan for Tiwanaku, (Bolivia)

27-29 Agosto de 2012

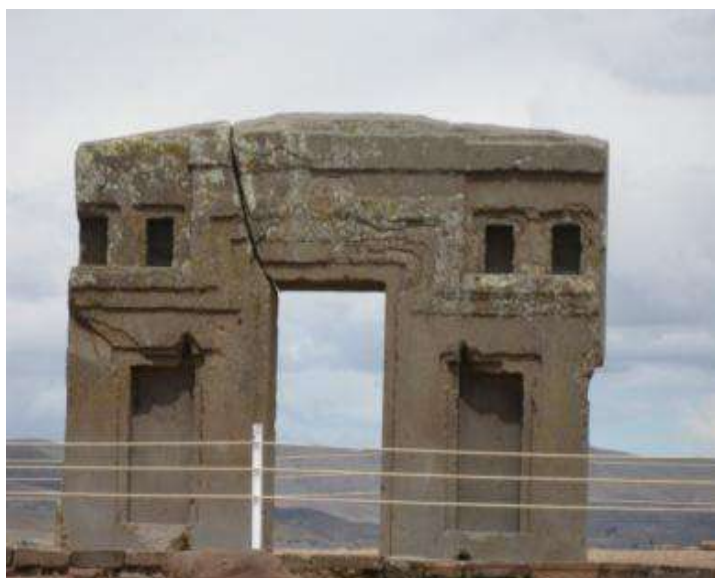
Figure 3-The entrance side of the Portal of the Sun atop the Kalasasaya mound

The experts considered that the state of conservation of the gate was acceptable, but requested a conduct and implementation of a structural evaluation of the gate's foundations and to identify an appropriate system to isolate the capillary base of the structure. It was brought to mind the need to collect all available information and introduce a periodic record that enables detailed monitoring of the structure. The experts insisted on the fact that given the acceptable state of the structure's conservation, the **current location shall be maintained** to avoid risks that might

arise with the structure's mobilization.

1. Implement a structural evaluation of the foundation.
2. Propose a system to isolate the capillary base of the structure.
3. Collect all available information and institute a periodic record that enables a detailed monitoring of the structure and its iconography.
4. Considering the current state of the structure's conservation, maintenance *in situ* is recommended given the risks involved in the mobilization.

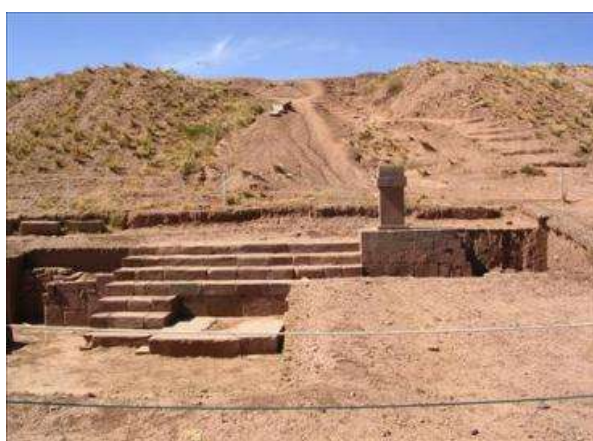
Figure 4- Remains of Putuni

Next was a site visit to Putuni, a neighboring building separated from the property Kalasasaya by a street and a wall. The influence of different periods' interventions on the structure was very clear.

The experts confirmed the view expressed by 2010 RMM that evidence from all the periods is of equal importance and that this construction's additions from all periods and timeline should be conserved, even if the architectural manifestations of all the periods are not as outstanding as the original monuments.

1. Assess the relevance of stone restitution of walls and the use of the drywall and ashlar technique after examining the art of differentiation in future maintenance and conservation in relation to the alignment of the original parts.
2. In the case that restitution of walls continues using adobe covered with mud, they must maintain alignment with the original stone elements considering that there is a clear difference in finishing materials.

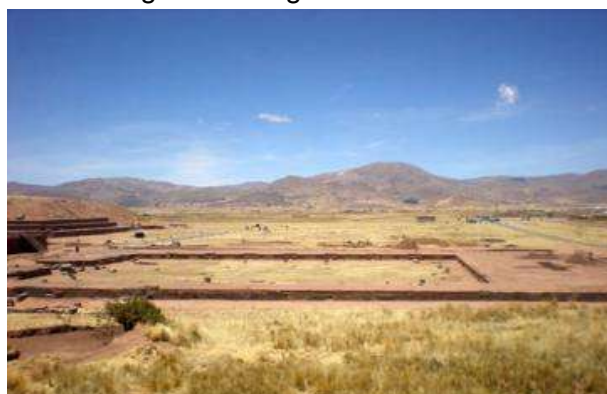
Figure 5- Remains of Putuni

The front walls are made of andesite, while the funeral chambers have blocks of sandstone. It was also determined that some of the latter show relevant biological colonization.

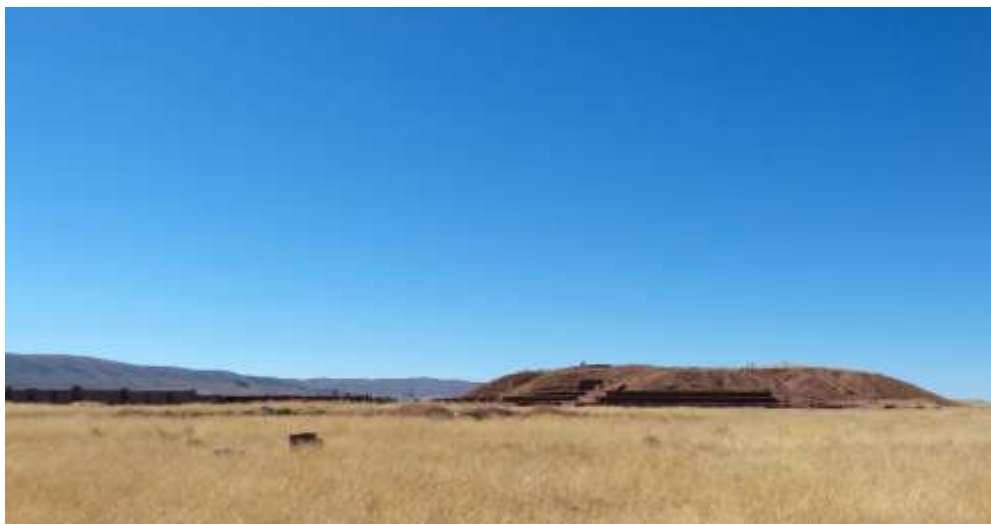
**Figure 8-Akapana's Pyramid**

At present, the pyramidal building is a great mound of earth, composed of clay, gravel, and sandy materials from the alluvial deposits and river-and-lake deposits of the valley, with a large hole at the summit, some platforms, a main stairway, and monoliths. The experts considered that the interventions that have been carried out on the Pyramid helped progress its deterioration as they were not based on any archaeological and topographic information.

A large part of the Pyramid was dismantled in the past. The new topographic plan commissioned by UNESCO in 2010, which covers a large area around the structure, shows this aspect clearly, in particular in the south and north-south quadrants.

The experts agreed that given the current situation, it was necessary **to restrict public access to the pyramid** in order to prevent soil degradation and that studies should be made on the soil mechanics, in anticipation of conducting future archaeological research.

As a preventive measure, the **implementation of a drainage system** to channel rainwater from the top of the Pyramid and help in storm control was recommended. The experts also mentioned the necessity to introduce a plant cover for exposed areas in order to mitigate the effects of water and wind erosion.

1. Make studies of soil mechanics a priority and use these studies in concert with the archaeological information.
2. Restrict public access to the pyramid in order to prevent soil degradation, in anticipation of conducting future archaeological research.
3. As a preventive measure, implement a drainage system for channeling rainwater from the top of the Pyramid and continue the storm water control.
4. As a preventive measure, introduce plant cover for exposed areas in order to mitigate the effects of water and wind erosion.

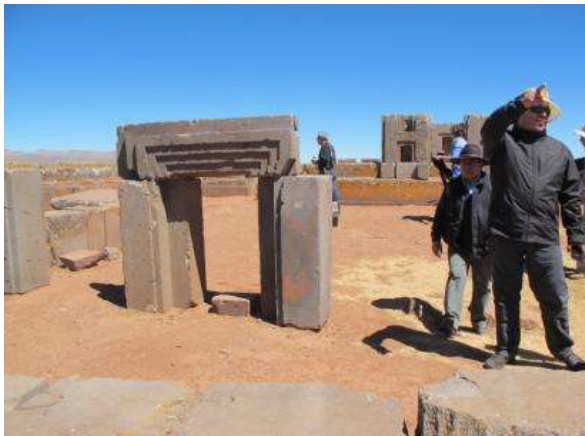
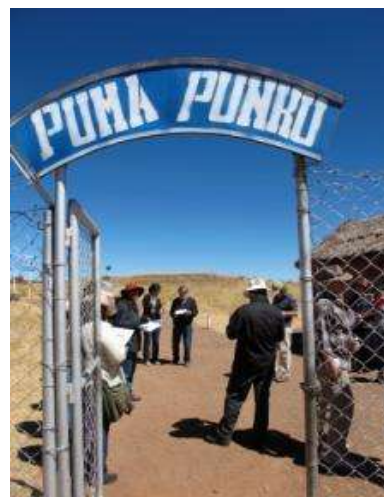
Figure 9- The Puma Gate

The experts considered that work has been conducted on this architectural complex on many occasions, sometimes without the necessary background information being taken into consideration. Many stones from this site were extracted during the colonial period. Problems of erosion, drainage and filtrations in old excavations were detected. The experts considered that the problems detected must urgently be solved.

- **Recording each stone in a database with the support of a 3D scanner**
- **Reducing the height of the existing excavation slope**
- **Preventing the acceleration of the wind-** a major factor in the erosion of the historical stones.

It was also recommended that the **final conservation project in the south sector should be implemented** considering that the archaeological excavations have been completed. It was also recommended to use geo-blocks and/ or crushed stones on the floors of the platforms in order to prevent erosion.

1. Record and collect each stone with the support of a 3D scanner.
2. Reduce the height of the slope of the excavation already conducted to prevent the acceleration of the winds that increase the effect of erosion on the original stones.
3. Develop and implement a final conservation project in the south sector considering that the archaeological excavations are completed. It is also recommended to use geo-blocks and/ or crushed stones on the floors of the platforms in order to prevent erosion.

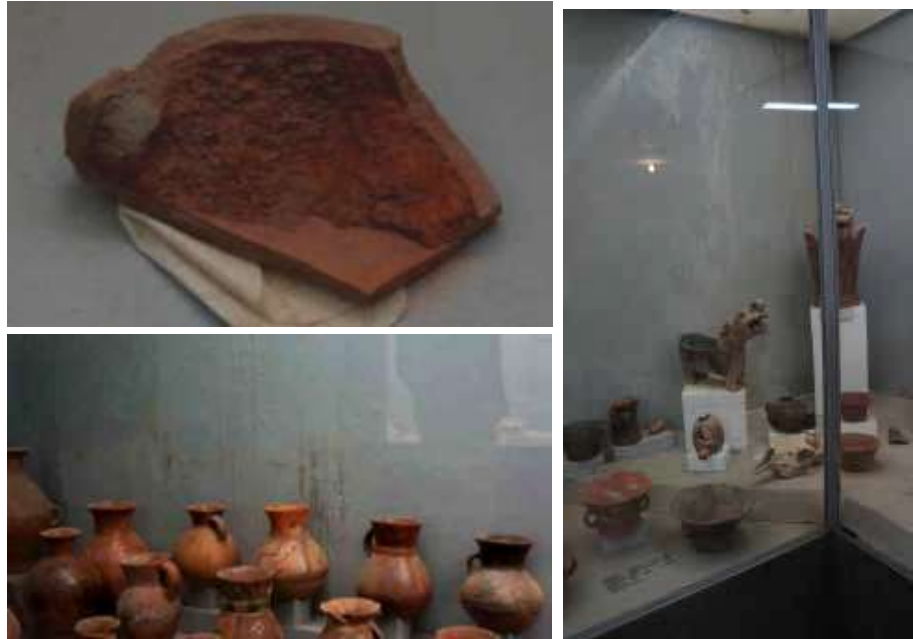
Figure 10- Ceramic Artifacts- in the Ceramic Museum

The museum is managed by the Municipality of Tiwanaku. The experts pointed out that, although the museum is open to the public, maintenance on the artifacts inside the showcases cannot be performed because they cannot be accessed. Water leaks were observed affecting the collection and major problems caused by this factor were identified. The completion of a detailed inventory of existing pieces in the museum is considered an urgent matter in order to determine the amount of artifacts, their degree of importance and degree of conservation. In addition a record shall be prepared for the identified pieces based on the work being implemented by the Ministry of Culture, taking into account the established international guidelines.

The experts considered that it was necessary to initiate a maintenance project on the building cover and to evaluate the possibility of establishing cooperation with specialized organizations in the area of movable heritage conservation in order to provide optimal conditions for the preservation of cultural material with higher levels of vulnerability.

1. Urgent completion of a detailed inventory of existing pieces in the museum in order to determine the amount of cultural material, their degree of importance and degree of conservation. Subsequently a record shall be prepared for the identified pieces based on the work being implemented by the Ministry of Culture, taking into account the established international guidelines.
2. Plan and implement a maintenance project on the building cover.
3. Evaluate the possibility of establishing cooperation with specialized organizations in the area of movable heritage conservation in order to provide optimal conditions for the preservation of cultural material with higher levels of vulnerability.

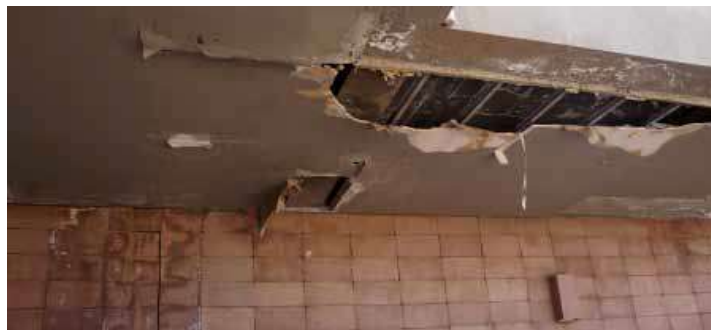
Figure 11- Poor maintenance- Museo Litico

During the field visit it was observed that the museum was in a very poor maintenance state. Water leaks were observed. There was evidence that the water leakage present was a major factor in the stone artefacts deterioration. The structure system of the museum was also proven to be unreliable.

1. Urgently develop a project that includes detailed engineering plans to ensure the repair of the museum's roof and submit it to study at the World Heritage Centre.
2. Develop a project of museology and museography with the identified pieces following the established international guidelines.
3. Elaborate a detailed diagnosis of each stone piece in order to develop a restoration program and to ensure their conservation.
4. As an urgent priority, reduce the water level and the moisture at the base of the monolith Bennett.
