Kathmandu Valley World Heritage Property (Nepal)

*A report on the implementation of the decision of 37th decision of
World Heritage Committee in 2013 and on the
State of Conservation of the Property*

January 2015

Submitted by:
DEPARTMENT OF ARCHAEOLOGY
Government of Nepal

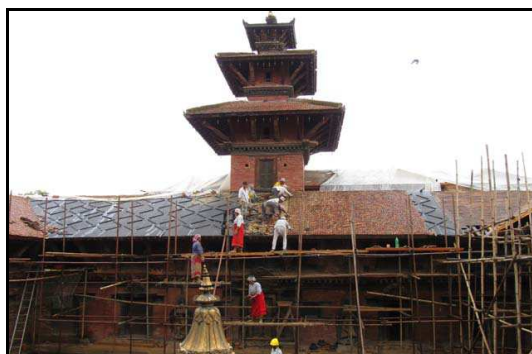
Mul Chowk, East Wing, East Facade

During and after the laying of traditional roof tile (*jhingati*) on a 4” thick mud bed was completed.

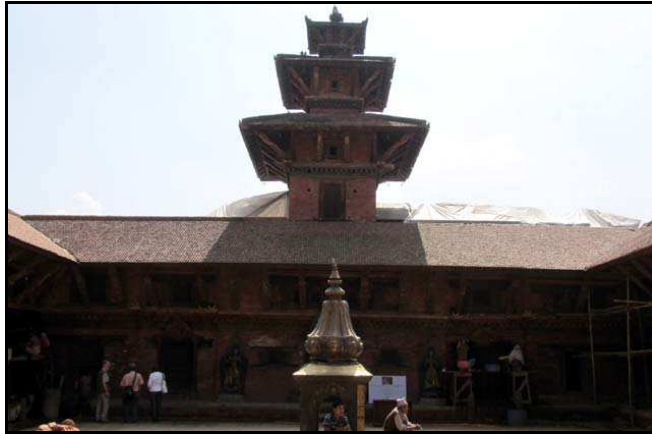
Mul Chowk South Wing

Above and below: Traditional tillers, awales, are laying traditional roof tile over a mud bed on the courtyard-facing side.”

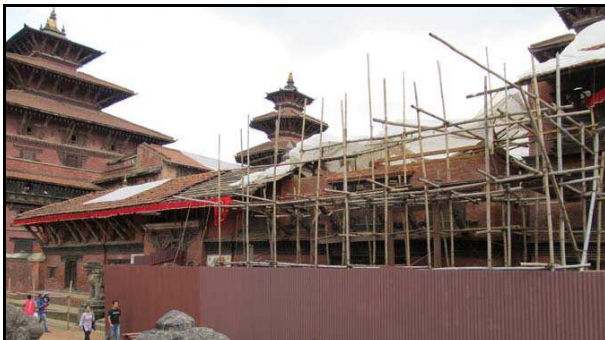
Mul Chowk South Wing

Courtyard facade after jhingati laying completed.

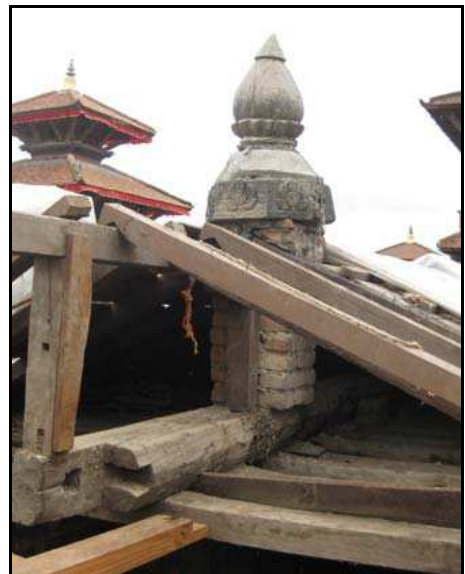
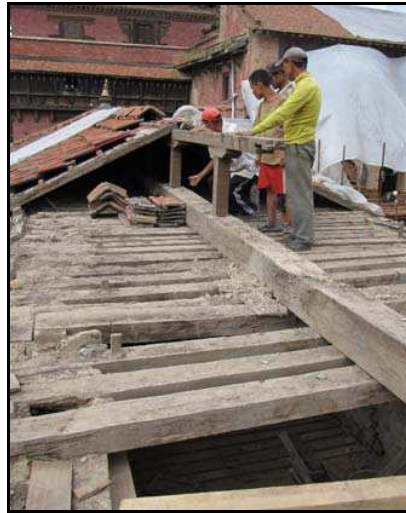
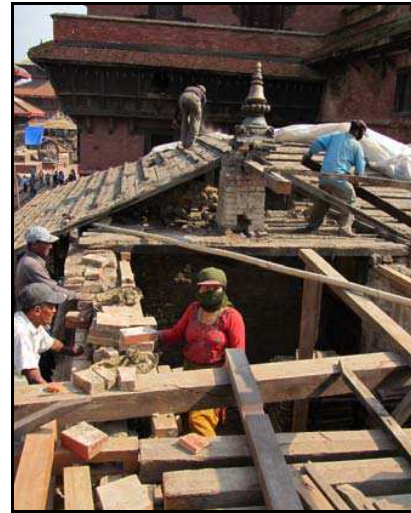
Mul Chowk, West Wing

Above photos display the dismantling of the unhistorical roof of Mul Cok's west wing over successive periods of time.

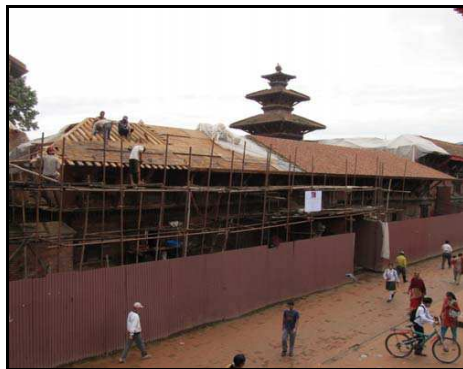
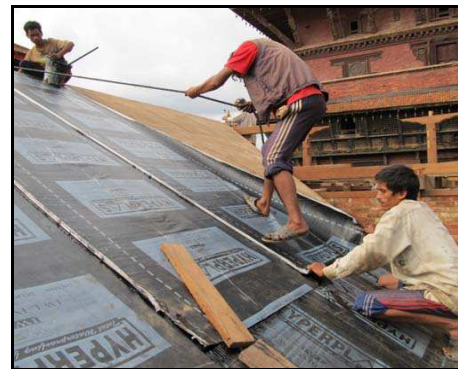
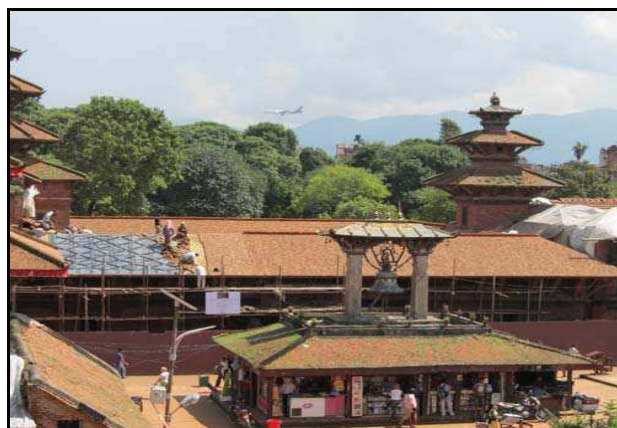
Mul Chowk West Wing

Views of carious stages of roof reconstruction where the process of wall plate, beam, pillar base, pillar, meth (capitol), ridge beam, rafters, sal planking, marine plywood, and jhingati roof tile installation is ongoing.

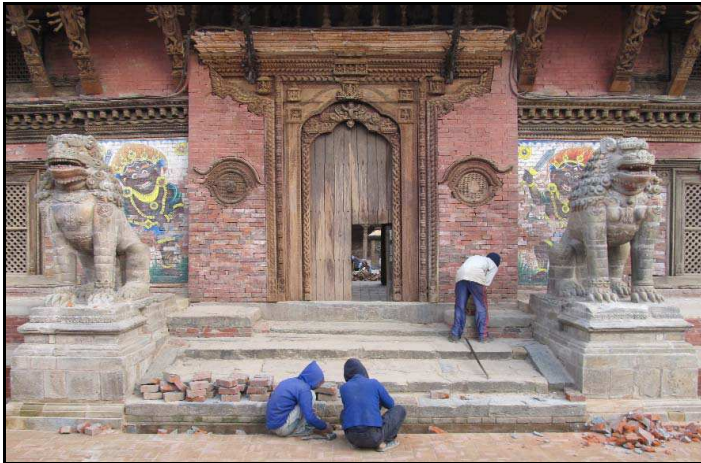
Mul Chowk West Wing Main Gate

View of main entrance steps before restoration

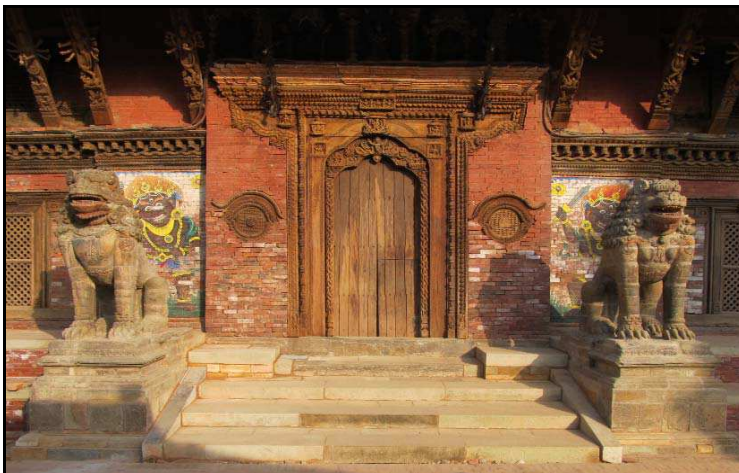
Mul Chowk West Wing Main Gate

View of main entrance steps after complete rebuilding

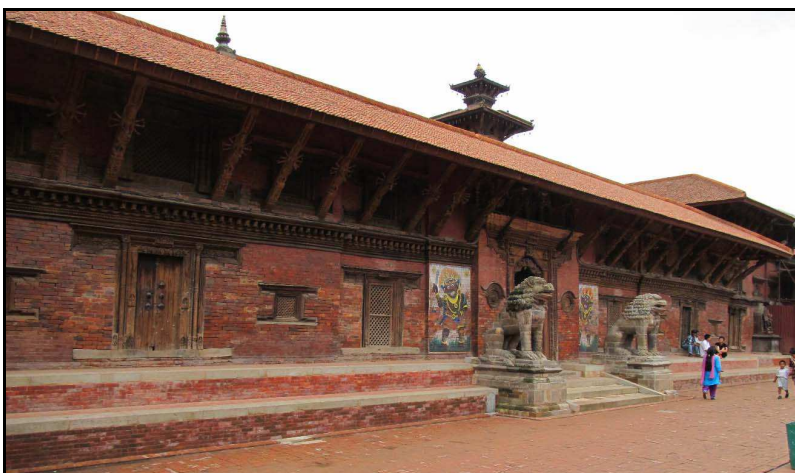
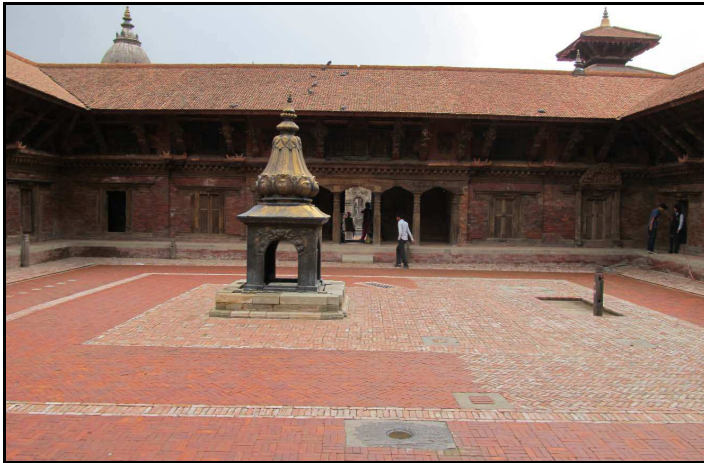
Mul Chowk West Wing

View of west wing's west (exterior) and east (courtyard) facade after restoration was completed. Note the completed courtyard pavement.

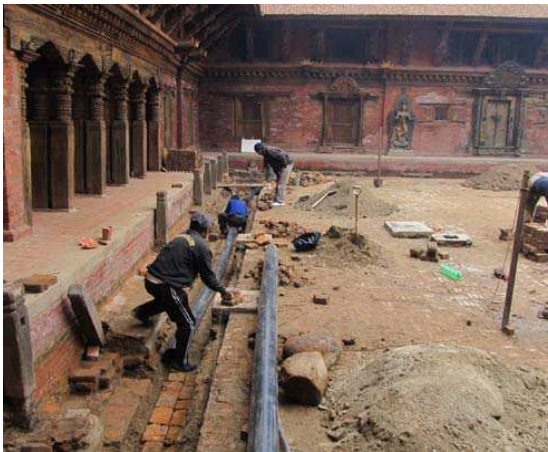
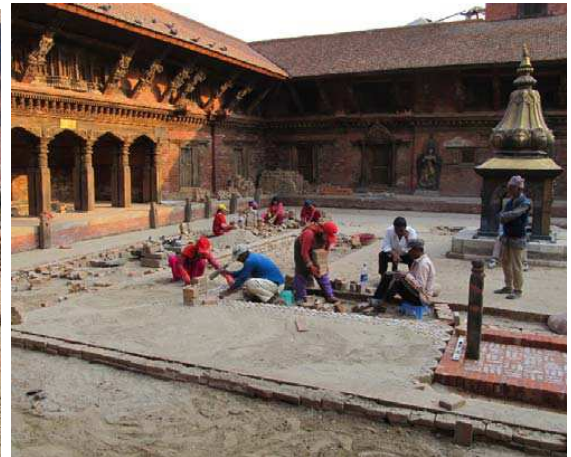
Mul Chowk, Courtyard

Courtyard pavement nearing completion - Bricks were installed on edge over a sand bed

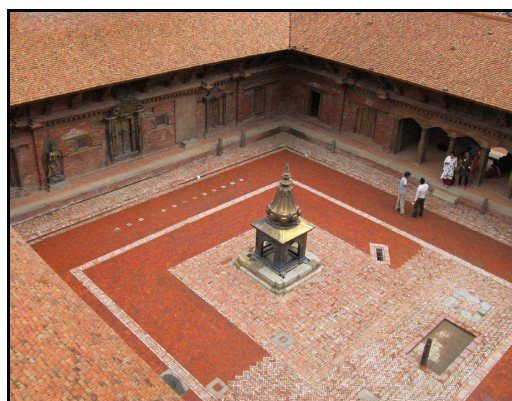
Mul Chowk, Courtyard

Courtyard pavement completed with brick on edge paving in the original, historic pattern.

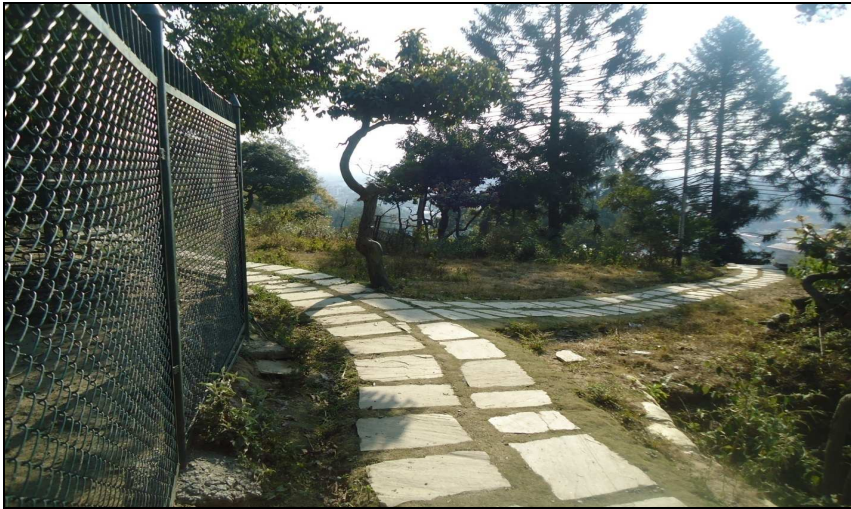
created to squish the deer in flat area. Finally, after the prohibition of deer and other actions that had undertaken in sloped terrain gives quite a good result in the regeneration of vegetation and protection of soil erosion. Planted trees with tree guards are also growing quite satisfactorily.

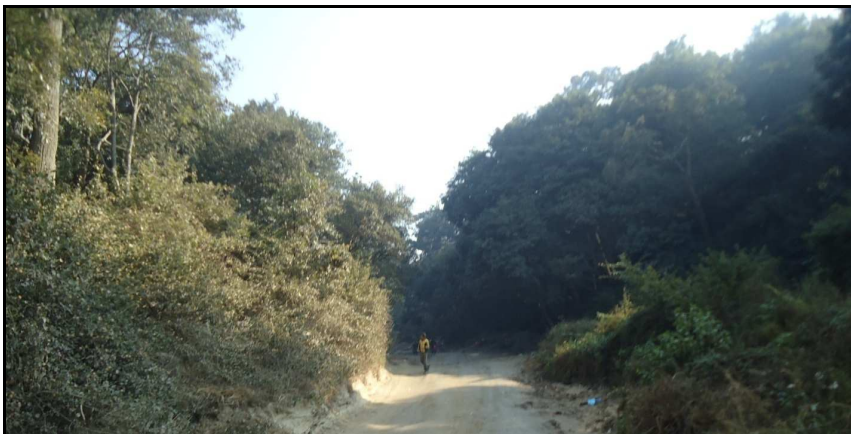
Pedestrian in Tilganga-Tamragana Street

It was an accident to open the track in this area. This road caused heavy loss of natural terrain and forest in Shleshmantak Forest area. Vishwarupa, one of the important monuments of within Pashupati Protected Monument Zone, is also in risk due to this road.

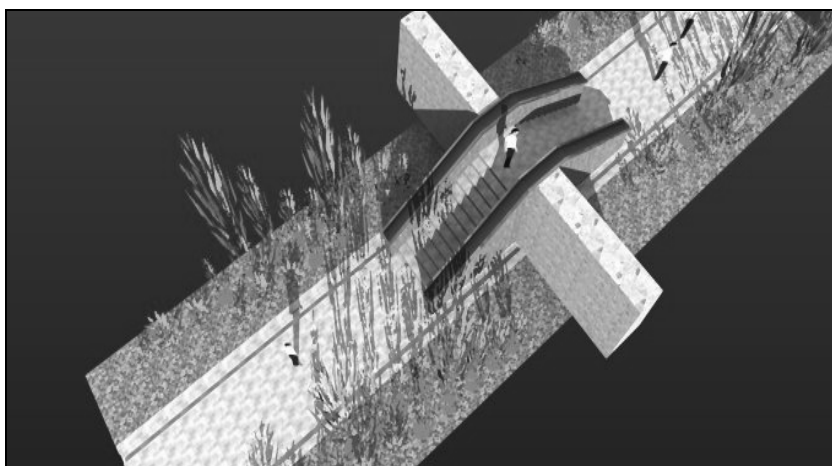
Vehicle Barrier & Proposed Street for Tilganga to Tamraganga

After stopping the vehicular movement in this road, losses are being reduced and vegetations are growing up gradually.

As it was reported in previous SoC Report, as a result of series of talk and discussion with stakeholders and different concerned authorities, there had been a mutual understanding to stop the road two years ago. An authority and site manager, PADT already stopped vehicular movement in this road. Securities are provided to stop the movement of the vehicle in this area. Now PADT has prepared the design and drawing for the construction of barriers in both ends of the road.

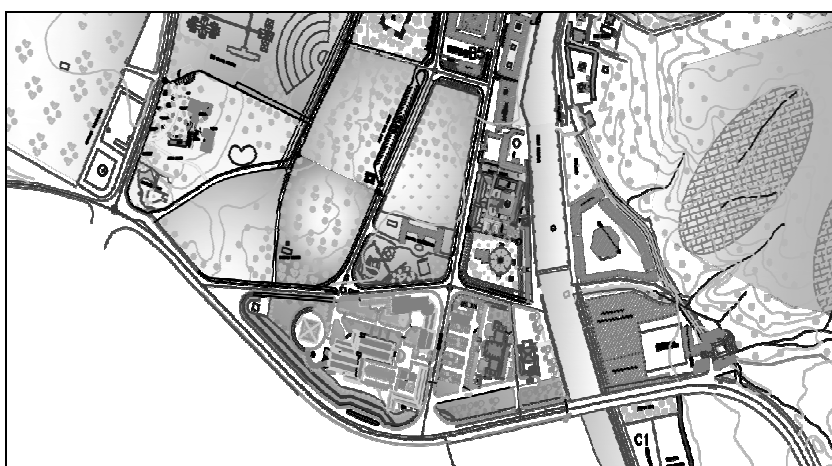
Public Vehicle Parking

Master plan of Pashupati area proposed the Parking in B12 area and near Ban Ganesh at B5 Area for the visitors and tourist. In B12 Area According to Master plan of Pashupati Area deck parking is proposed but now Surface Parking is being constructed for the vehicle.

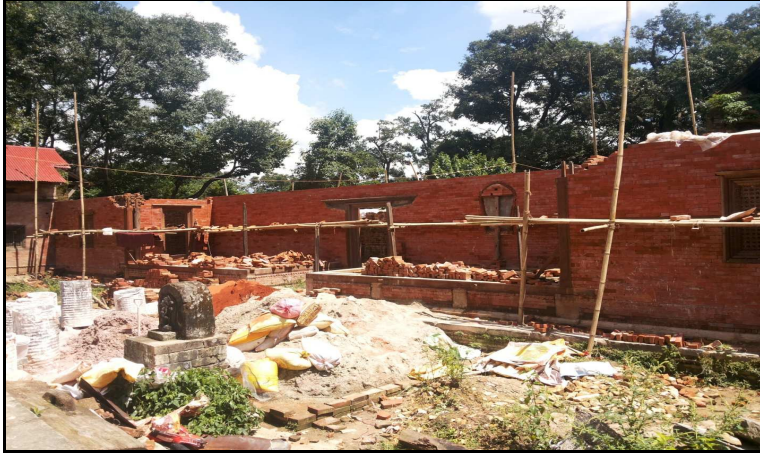
Rakshaswar Sattal Conservation (Gorakhnath Area)

Some of the public rest houses are being restored in Pasupati Protected Monument Zone by PADT under the supervision of Department of Archeology. Banamukteshwar sattal, also known as twin Sattal and Dhunighar at Gorkhnath area are being completed soon. Conservation of Raksheshwar Sattal is in the process. The wooden emblems and bricks were reused as much as possible in the conservation work. The mixture of lime-surkhi was

used as mortar and the traditional *Dachi Apa* was used in facade to make the monument more compatible in the area. Due to the activities of monkey, use of traditional *Jhigati* tile is worthless that red corrugated sheets were used in roof compatibly as per the bylaws for the entire site.
