STATE OF CONSERVATION OF WORLD HERITAGE PROPERTIES

Name of World Heritage property:	Hill Forts of Rajasthan
State Party:	India
Identification number:	247rev
Date of Inscription:	2013
Criteria:	(ii) (iii)

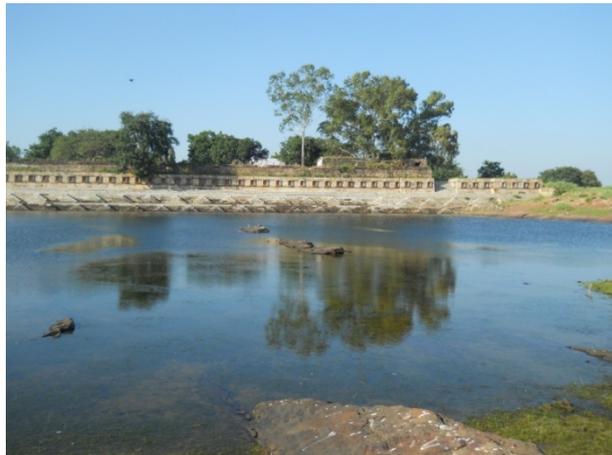
A. Sukhadia tank

This is a large tank located at the centre of the fort. A long bund, 100m long in the east-west orientation, with flight of steps was constructed to trap the surface water. The flight of steps was preserved for about 20m on the eastern side. The flight of steps was restored for the past three years in phases. A small segment on the JJ side was restored as per the original during the year 2013-14.

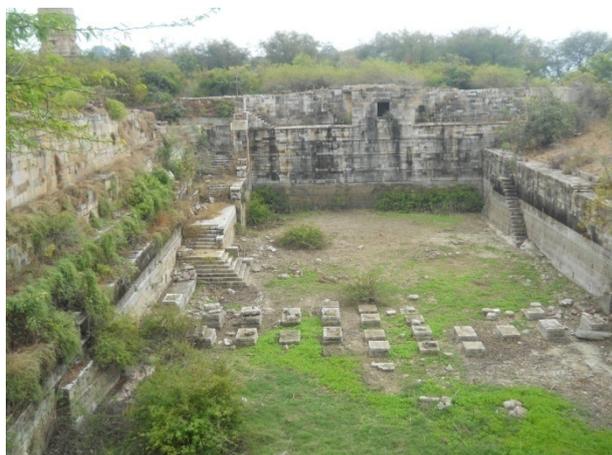
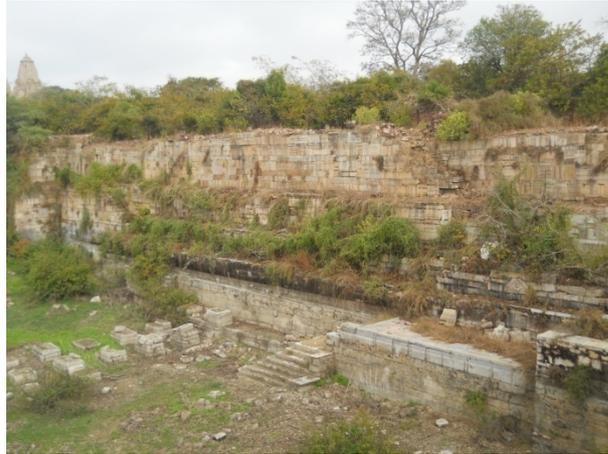
B. Ghee Boadi:

This is large reservoir for water and one among the sixty odd water bodies identified in the fort. This reservoir is located to the west of the Vijay Stambh. It was in a dilapidated condition as the ashlar masonry on the eastern side is missing at many places. There was huge growth

of vegetation through the masonry further leading to disintegration of the original structure. The floor of the reservoir was covered with 1 to 3 m debris consisting of silt and few architectural members. The ashlar masonry on the western arm was completely missing for about 3m on the top.

To begin with the accumulated debris on the floor of the reservoir is being cleared. Any architectural fragments and ashlar stones recovered from the debris will be reused appropriately. Further, conservation and restoration of the eastern arm to stabilise

the existing masonry will be taken up soon.

The removal of debris in a part of the floor of the tank revealed a high quality lime concreting of the entire floor of the tank to ensure that there is no seepage of water through the joints of the bedrock.

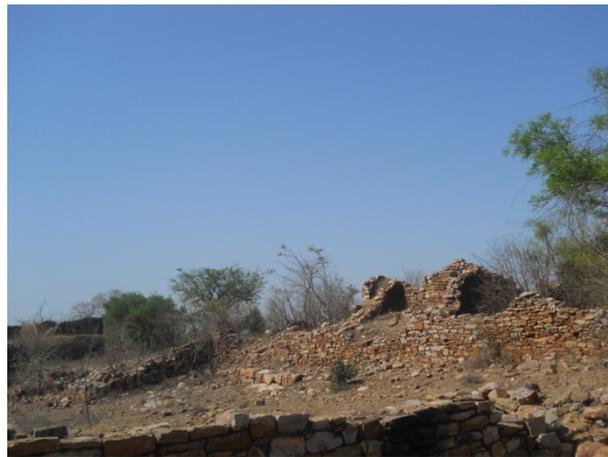
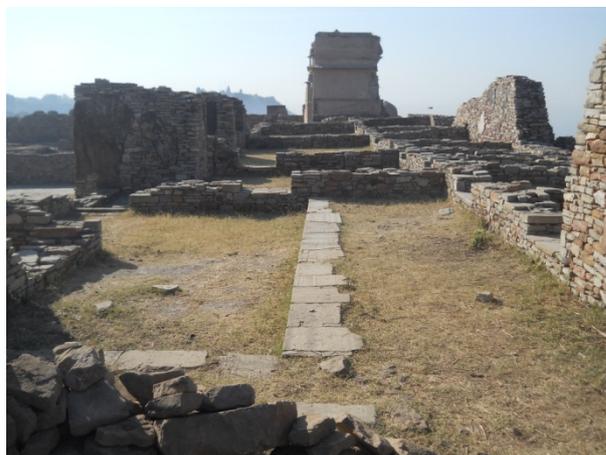
C. Manpura-Bhanpura Haveli

This is a Haveli located further east of Kalikamatha temple. It is datable to 17th century. The rubble structures within the enclosure wall are in complete ruins and are hardly recognisable. In order to provide an idea of the layout of the enclosure, the walls of the structures are

traced and reconstructed to the available height in matching dry rubble masonry by using the available rubble from the enclosure. The top of the reconstructed portion of the walls will be water-tightened with liquid lime mortar. This restoration work is in progress.

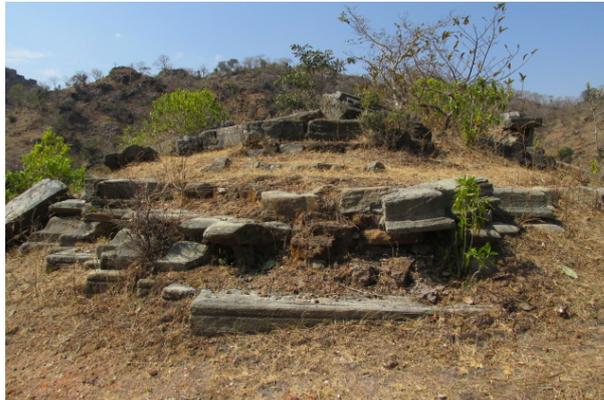
A. Ruins of a Temple near Bund No 2

There is a ruin of a small temple having the *garbha-griha* and *mandapa* in front located above the Bund No 2 is taken up for exposing and restoration to extant available clue. As on date, the plinth of the temple is exposed full by removing the debris.

Further work is in progress.

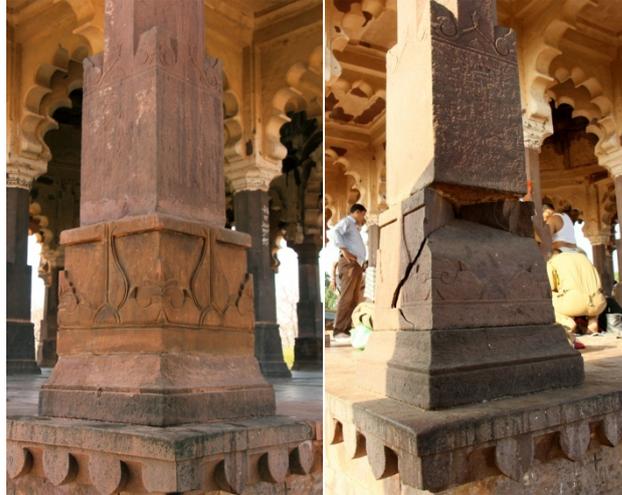
A. Battis khambha Chhatri

The broken base, shaft and capital of the stone pillars of Battish Khambha Chhatri have been taken up for conservation. The broken part is replaced with a new one, matching with the original. The broken/missing *pan*

dasa stones have also been conserved. The damaged/missing *chhajja* stones of small chhatris were replaced as per original.

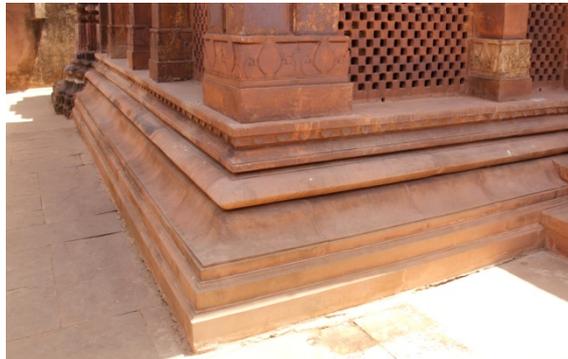
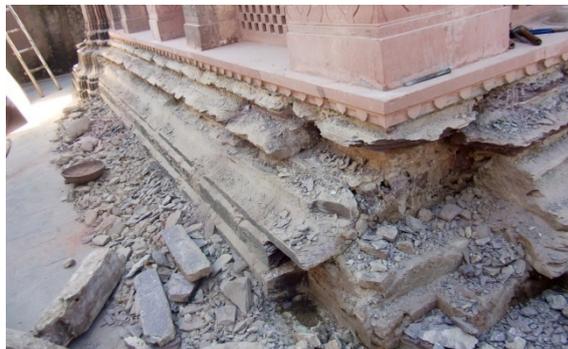
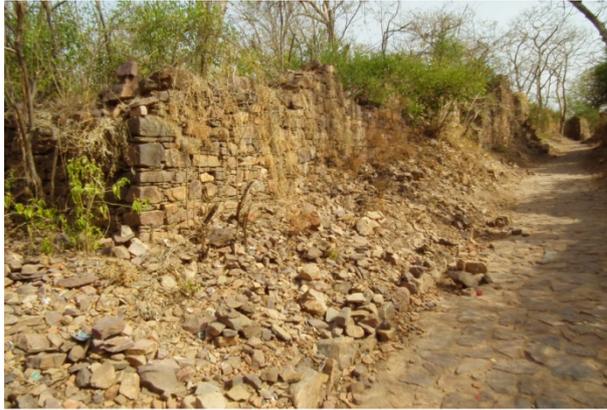
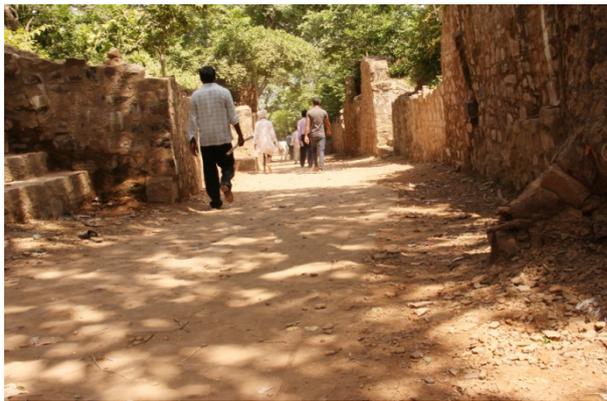
B. Jain Temple

The broken/missing Jali of the mandapa of the Jain temple is replaced with the newly constructed Jali, matching with the original. The damaged stones of inner ceiling of the mandapa are also conserved. The old worn out/broken stones have been replaced with the new stones. Crushed stones on the outer wall of the main temple up to Jangha part have also been conserved matching with the original.
