Concise ICOMOS Advisory Mission Report

Tombs of Buganda Kings at Kasubi A World Heritage property of Uganda

CONCISE REPORT ON THE ADVISORY MISSION TO
Tombs of Buganda Kings at Kasubi, UGANDA
(C 1022)

This document is the result of the mission undertaken in Kampala from 12TH to 15th May 2014

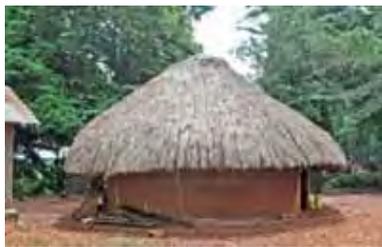
Small temple at Kyerero

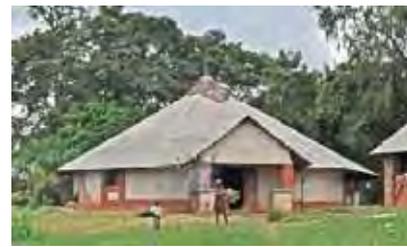
Kyebando tomb at Kyaddendo

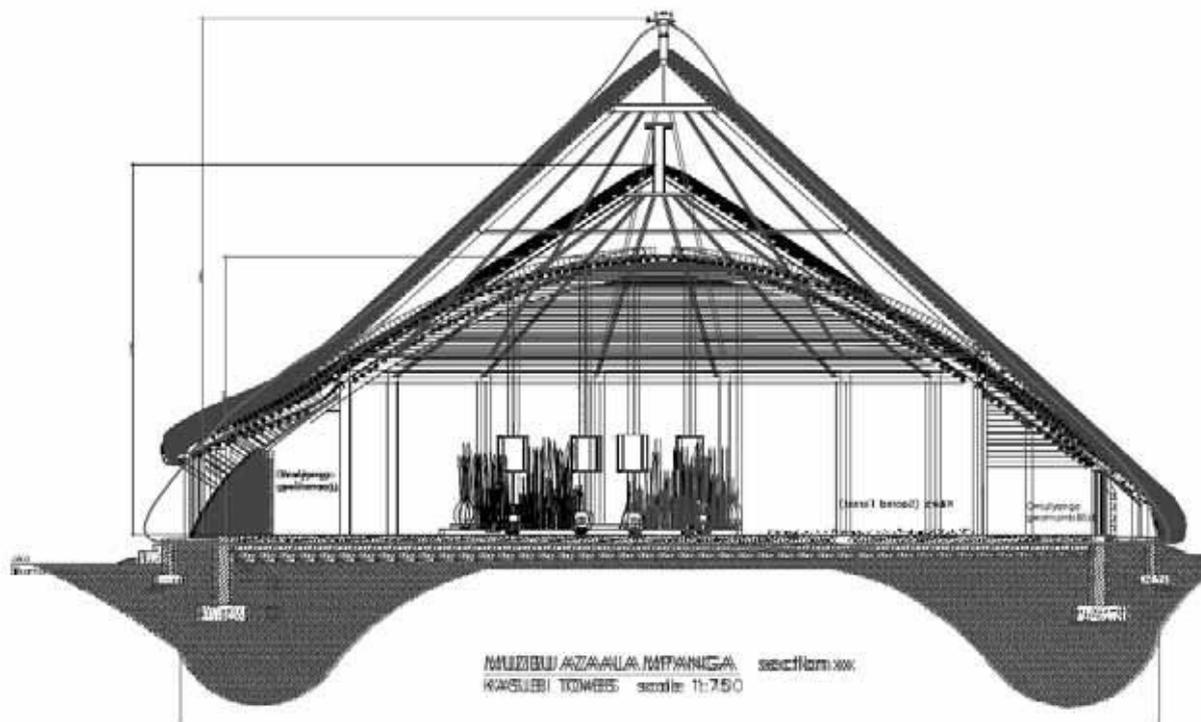
In the 1938 version of the tombs – the one that burnt down – an inner circle of concrete support columns and a steel roof structure were introduced: This roof did not follow the roof pitch of the version it replaced, and had a very shallow pitch, that over the years caused problems with thatch deteriorating fast because the water seeped into the thatch. The Reconstruction Strategy included for the reconstruction of the concrete and steel elements (that were sanctioned by the *Kabaka* at the time) but to have a steeper pitch like the preceding version. This is therefore not a new change – it was approved in the original Reconstruction Strategy - but the author would like to show the efficacy of this decision which has been recently demonstrated through a superimposition of the 1938 version that was burnt down and the version that is being constructed (note: the new roof end detail is not yet included in this drawing):

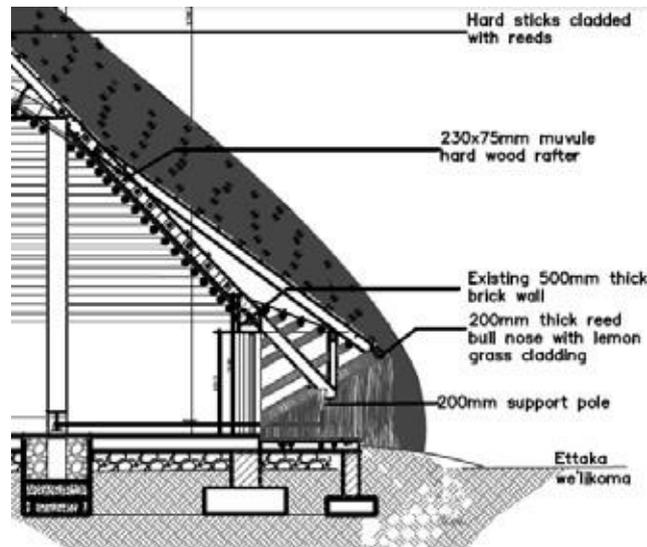
A very interesting change that has been effected since the 2011 Reconstruction Strategy is the roof-end detail – as shown below and in the 2011/2014 comparison in **Annex 4** - This change includes for new insights from the research on thatching techniques and the need for better termite protection through omission of the outer support poles.

The mission advises that the total set of Final Reconstruction drawings, project timeline and specifications that form the basis of the tender and execution of the Reconstruction Project, inclusive of a clear definition of how the work is to be carried out, monitored and recorded, and with the agreed to timeframe, be collated and formally submitted to the Advisory Body as the master set for the project. and as a record of precisely what is to be built. These will be kept in the WHC archives. If changes are proposed as the project progresses, then further details should be submitted with an appropriate justification before the changes are accepted.

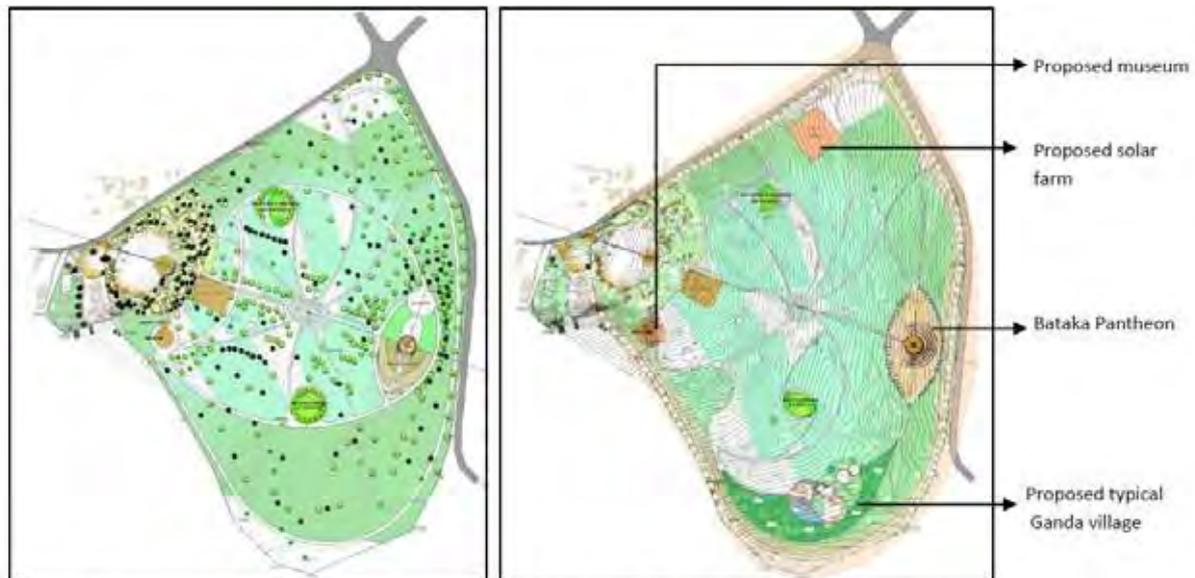
The architect made a site development proposal that would explain the essential aspects of Baganda culture - it contains paths through the site, a reproduction of a Baganda village, a museum and 'pantheon' to display historic artefacts and the achievements of the 4 Kabakas, a place of commemoration of the fire - where the remnants of the Tomb's steel roof structure could be displayed - as well as a solar farm to provide energy for the site components.

Fig. 13 c: further development of routes and layouts. The second master plan integrates the typical Ganda village as well. These are proposals by the Architect. Drawings by j.e nsubuga & Associates.

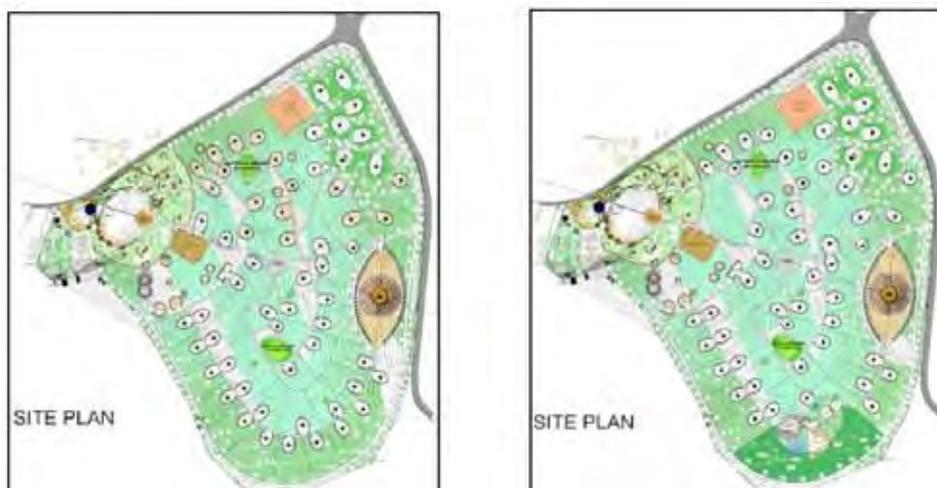
The Baganda, through the *Katikkiro*, have decided to propose an alternative plan to develop the whole site as a 'living museum' to generate finances for the upkeep of the most significant components of the site, ie. the Royal Enclosure with the *Muzibu Azaala Mpanga* and the perimeter houses and shrines as well as to display Baganda culture. This will occur through living museums' for each of the 65 Buganda clan to display their individual cultural achievements and their role in Buganda to the world (tourists and visitors). The plan requires that the lower site be subdivided into 65 plots of 0.6 acres. This proposal was drawn out by the architect (Nsubuga 2014: 20 and Fig.14).

Figure 14: drawings done as per the Katikkir's idea. Each clan is given a size of land and a clan house is built within, for activities showing what those clans used to do/ are specialised in.

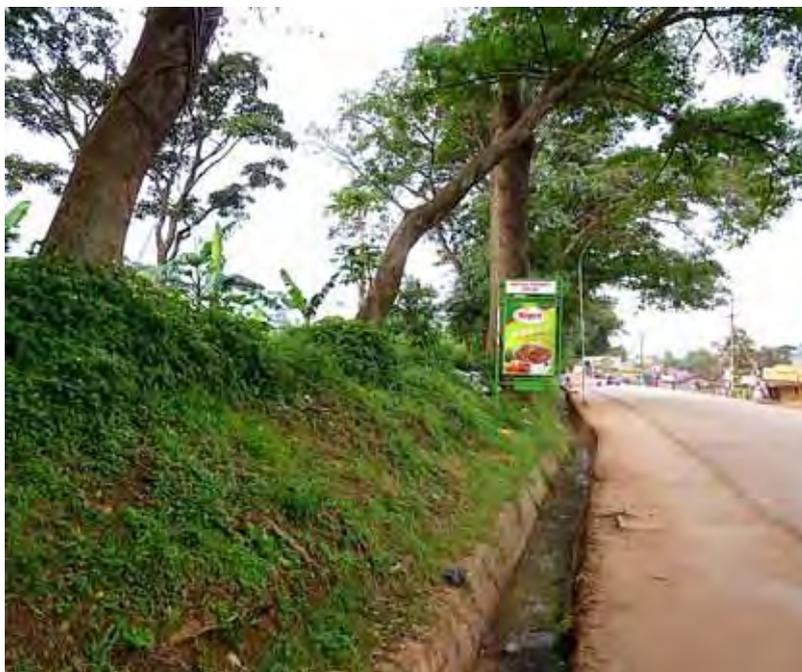
Site boundary condition in 2010: Shrubs and Bark Cloth Tree lane.

The Advisory Mission of 2013 had recommended that the site boundary of Bark Cloth Trees be reinstated and that a reed fence - similar to the new inner courtyard fence that is a strengthened version of, but similar to, the historic fence - be used to designate the property. The Baganda committee for the property has proceeded in fencing the site in a different manner, without first informing the WHC as required by the *Operational Guidelines* para 172.

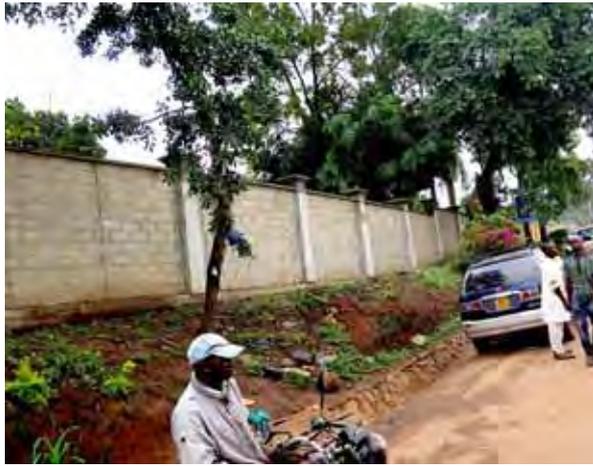
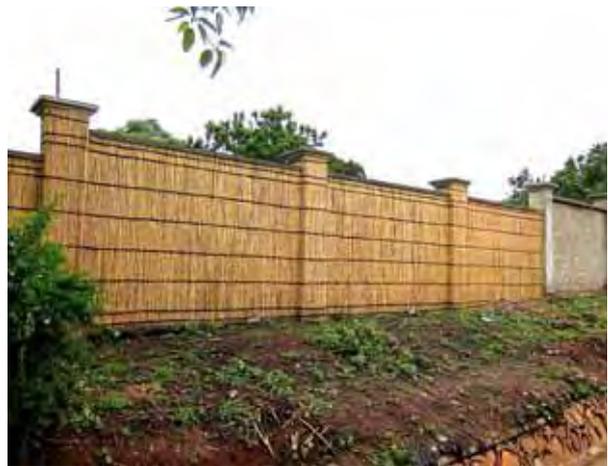
The mission encountered a contemporary concrete block, stepped boundary wall with coping blocks on the columns, and with reeds attached to steel fasteners onto the wall and support columns, following the rectangular shape of the stepped wall.

Left: newly constructed concrete block perimeter wall. Right: Cladding of wall and columns with reeds.

The concrete block wall is radically different from the historic boundary of shrubs and the dense tree lane. Additionally, the attempt at a traditional feel for the wall through the wrapped application of reeds onto the wall and column surfaces in a rigid geometric fashion dictated by the form of the stepped wall, has the opposite effect: the wall shouts out its incongruity in terms of traditional vernacular architectural values.

Since this wall has been erected with funds raised by public conscription through the offices of the Baganda Kingdom, and since the *Kabaka* and *Katikkiro* have (and again in the debriefing session of the mission) stressed their resolve to secure the site and protect it from vandalism and crime, the removal of this wall would be difficult – it is therefore recommended that the perimeter wall (excepting at the entrance) not be demolished, but that the method of wallpapering with reeds not be continued with due to its extreme inauthenticity and the drain on resources to maintain it, but that the wall be covered with indigenous creepers present in the area, to present a green perimeter closer to the historic situation, and that the missing Bark Cloth trees be replanted to visually express the historic condition as well as to provide material for the bark cloth making on site, used for covering components of the architecture, as screens and as sacred dress used in the royal compound.

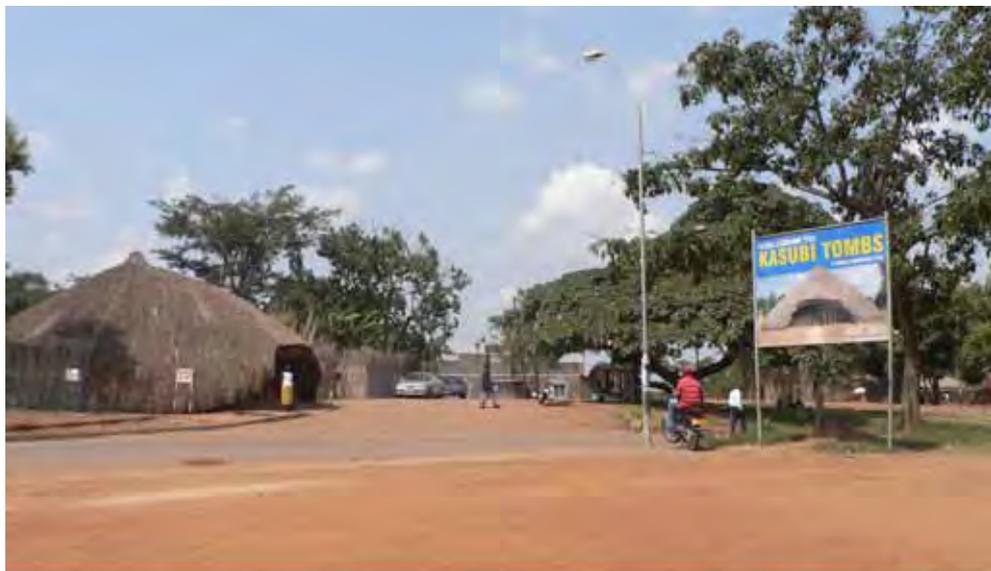
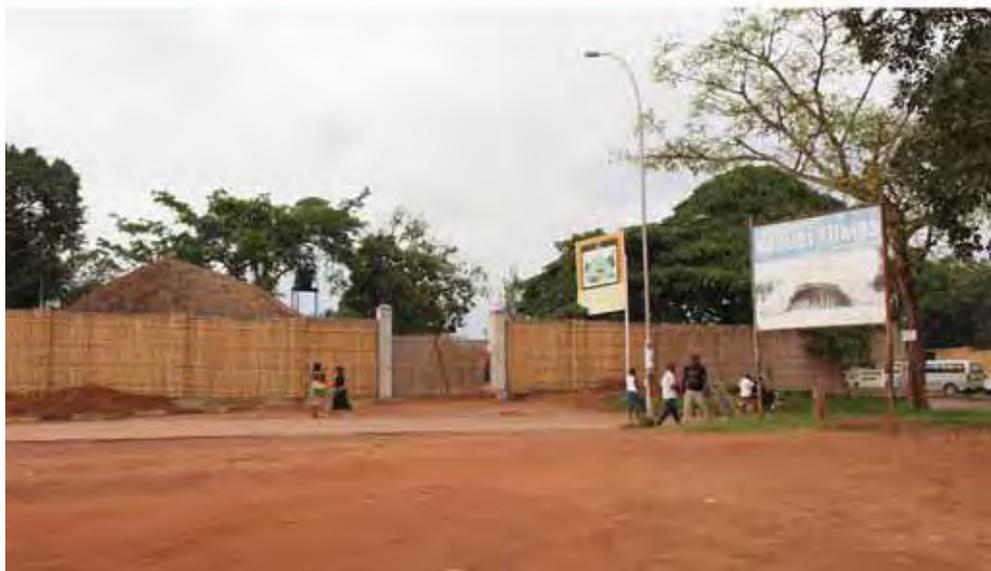
Top: gatehouse in 2009. Bottom: New perimeter fence cuts off gatehouse from street and contact with the people (Comparative collage by S Moriset 2014).

Additionally the historic arrival space at the gatehouse (*Bujja Bukula*) that historically - and up till recently - has connected the royal site to the surrounding urban space, and that is axially connected to the adjacent hill and also to the Tomb at Wamala (tomb of the ancestor of Muteesa 1) – has been walled in, so disconnecting the site from its immediate setting as well as the larger spiritual setting of the ancestral royal lineage.

From a deep understanding of the contribution of the gatehouse and its relation to the *Muzibu-Mzaala-Mpanga* and a wider spatial and historic politico-religio context – as an attribute of the OUV of the property, the mission strongly recommends that the wall at the entrance space of the site be demolished and a secure reeded screen - that memorialises the historically present screen walls - be erected on its historic position, and that security at the entrance space of the property be effected through the historic offices of the royal guardians.

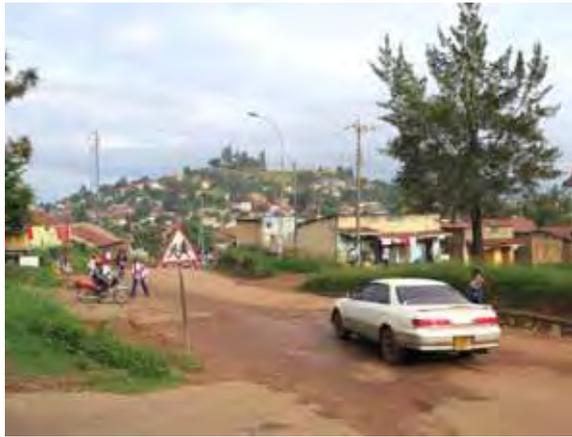
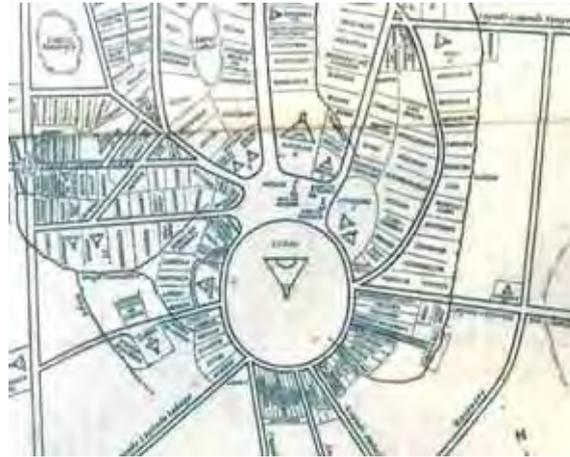
Left: Axial view from the gatehouse – on an urban scale this site related axial planning is in relationship to the adjacent hill in Kampala, and on a regional scale has an axial relationship between Kasubi and Wamala tombs. Right: Historic relationship of palace compound to public space of the city – capital in 1856-84.

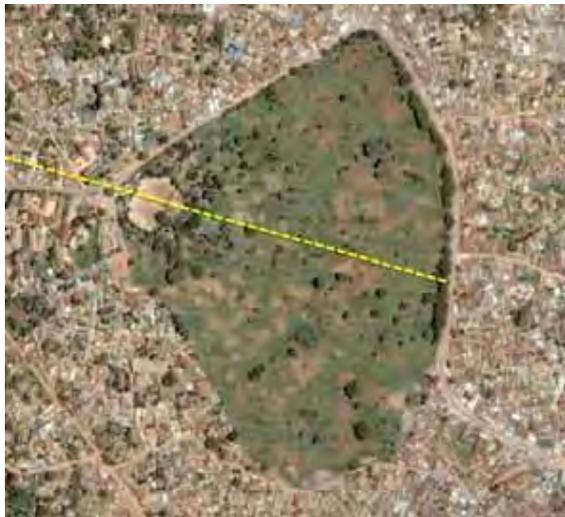
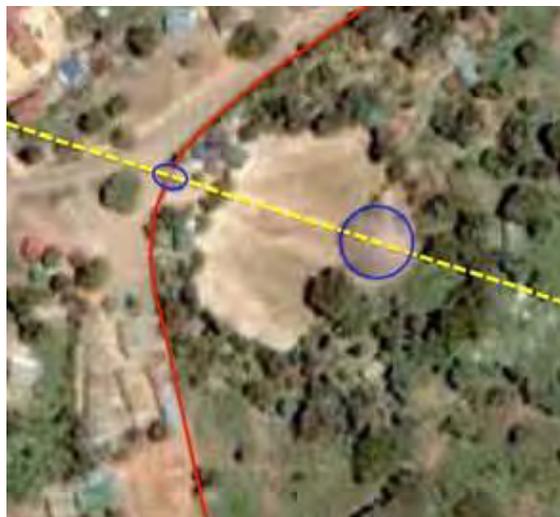
Figure x. Left: Spatial axial connection on site scale; Right: Relationship of historic perimeter boundary to gatehouse and public nature of gatehouse relative to the public space of the city.

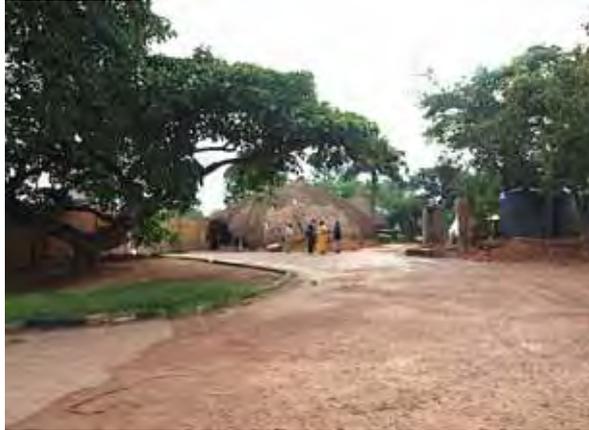
Left: Spatial/visual connection between gatehouse and street has been blocked off by new perimeter wall.

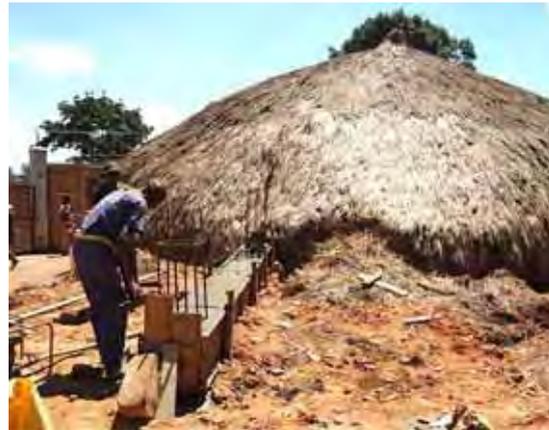
Right: New concrete inner wall abutting into thatch gate-house.

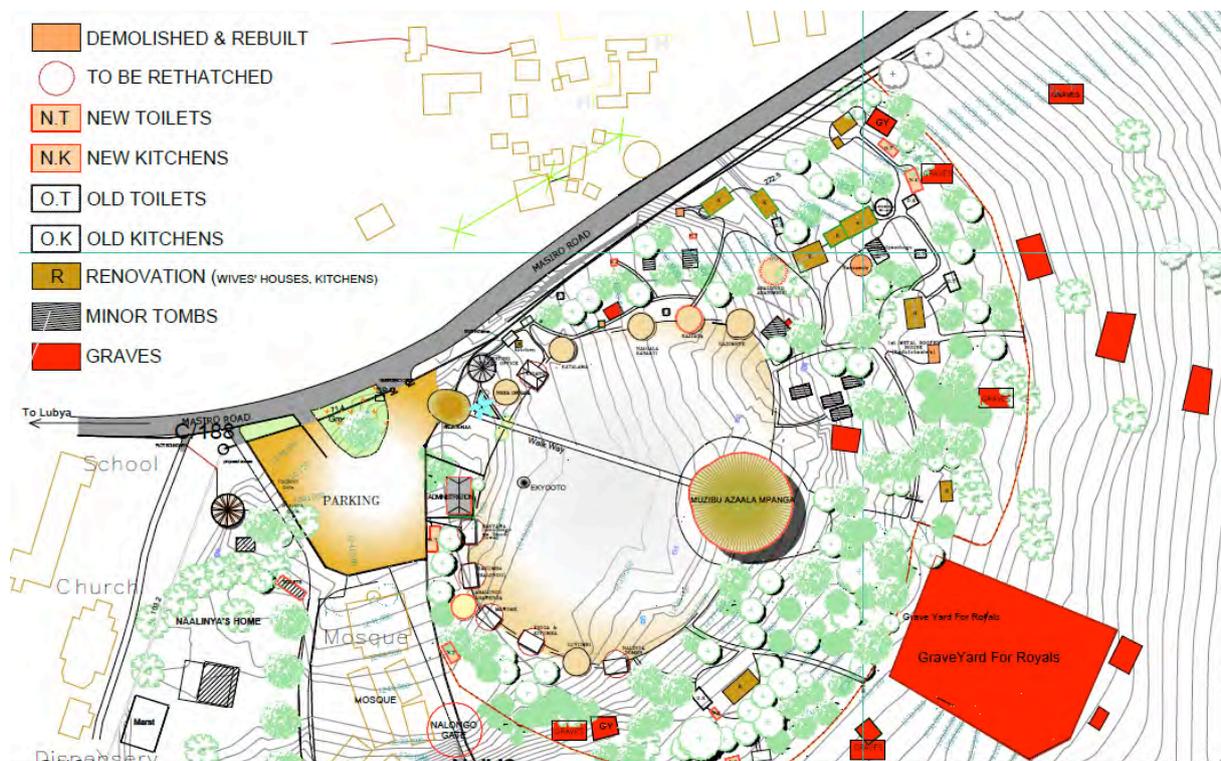
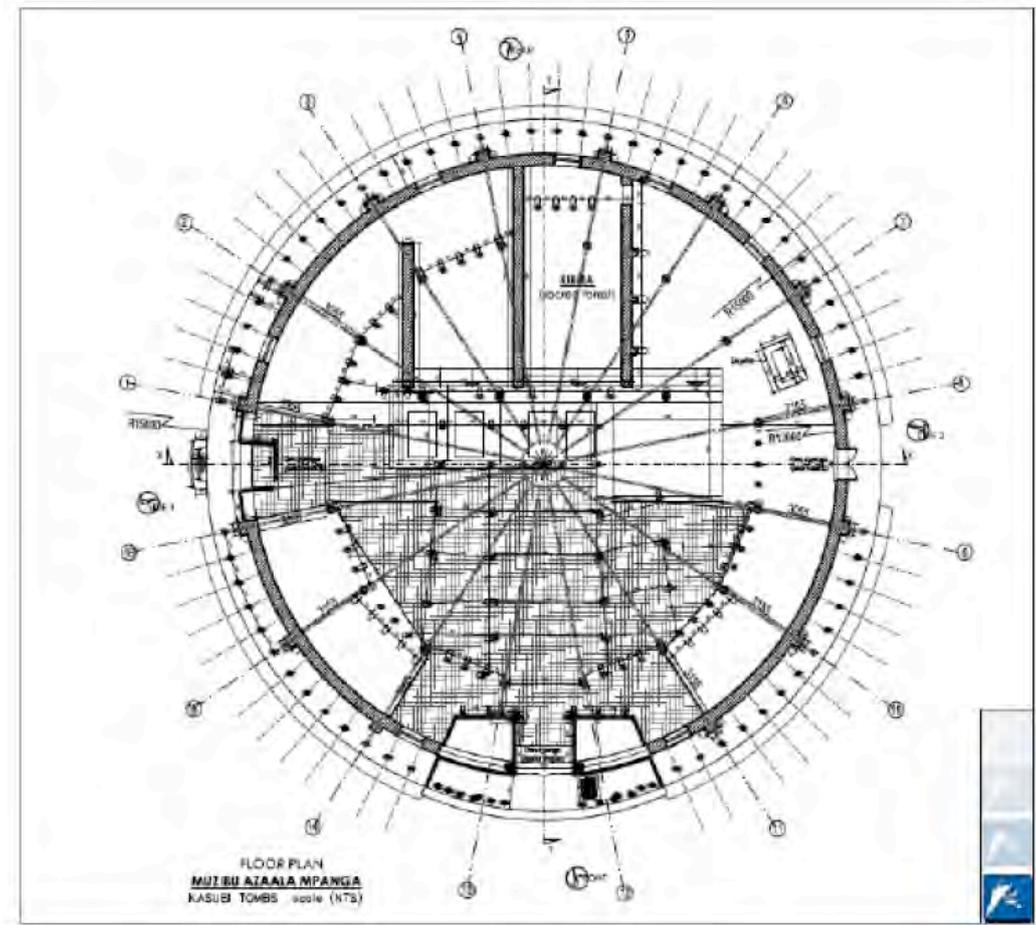
Top: Plan of the Tomb building shown in the Reconstruction Strategy (2011)
Bottom: Plan of the Tomb Building as revised (Nsubugu 2014.)

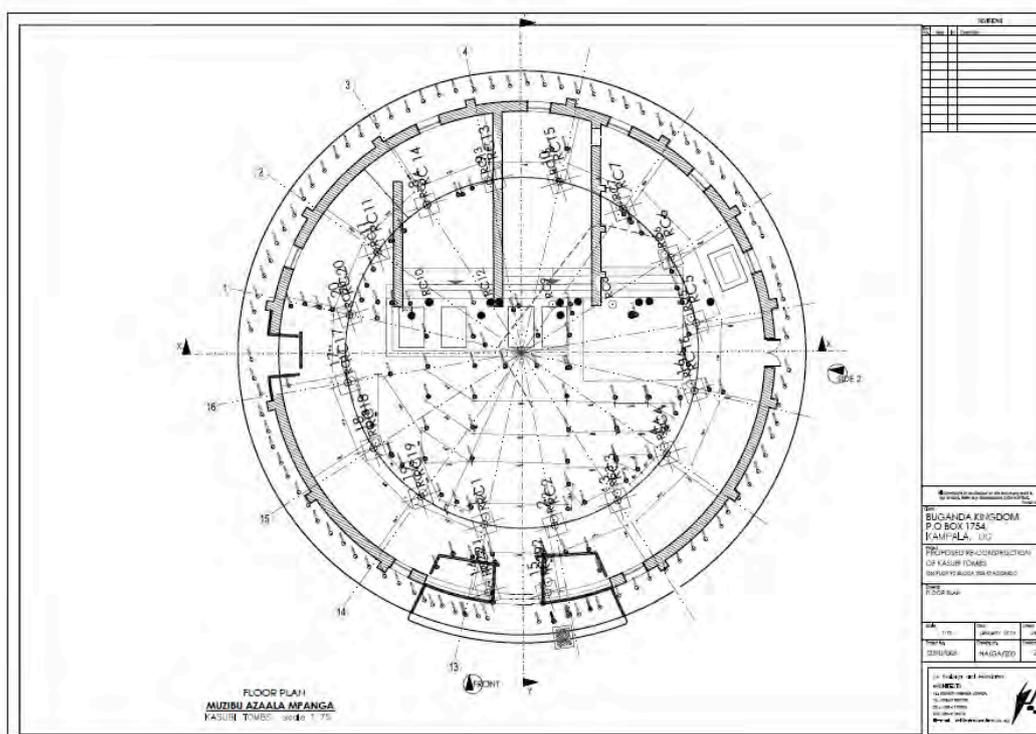
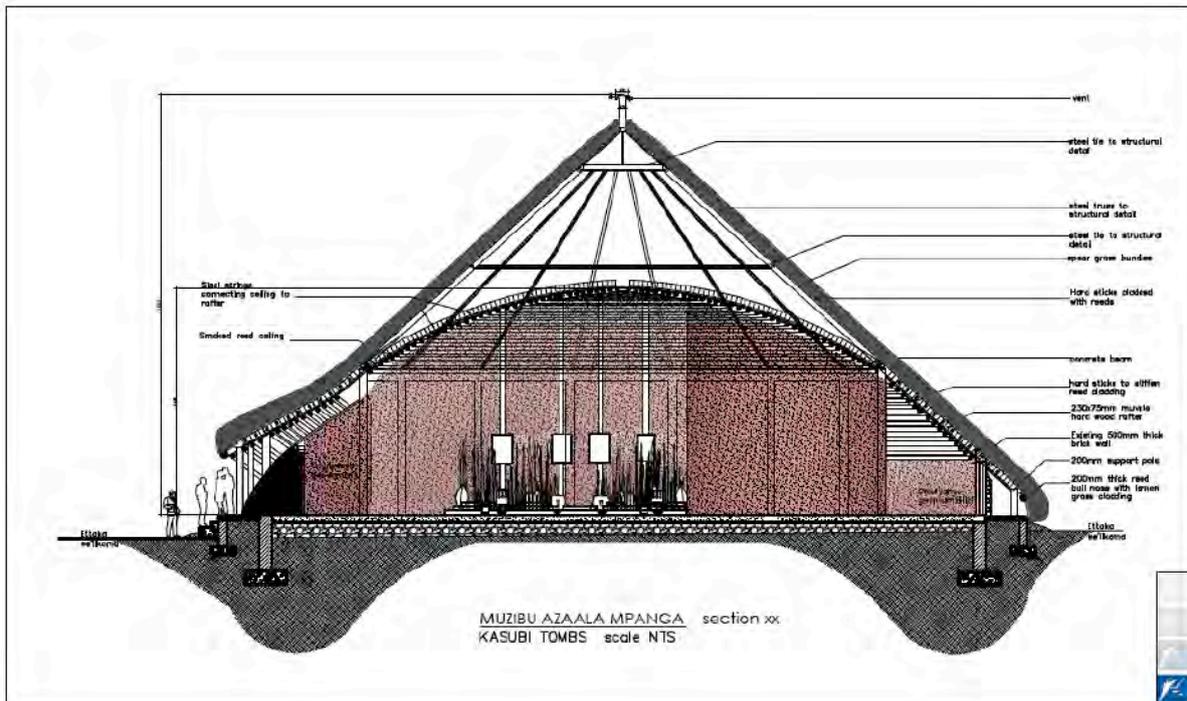
SECTION XX : MUZIBU AZAALA MPANGA

Top: Section through building as shown in the 2011 Reconstruction Strategy document.

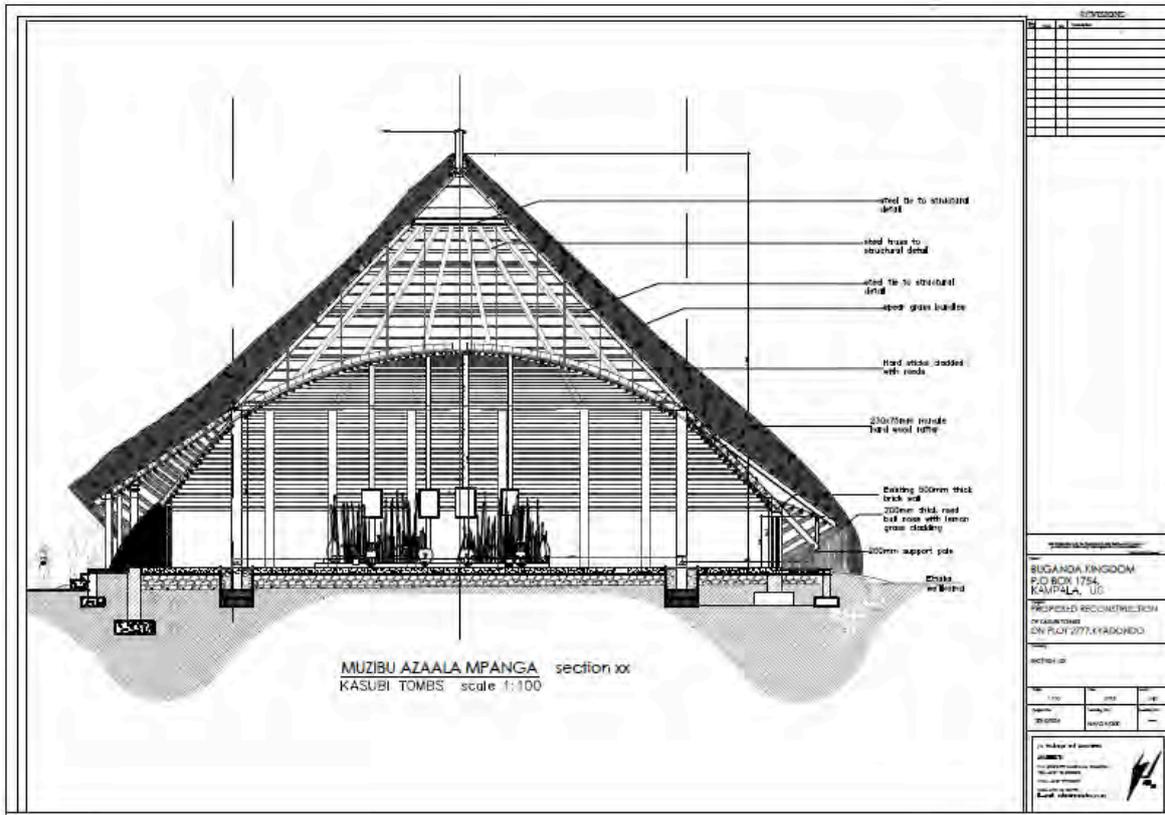
Bottom: Section through building as shown in the 2013 revised drawing.

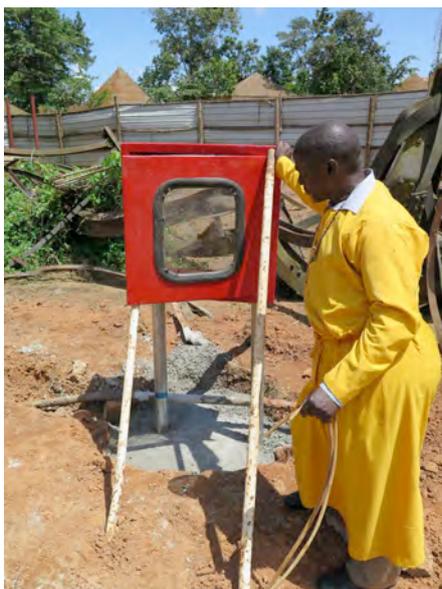
Temporary Fire Protection Equipment in front of tombs.

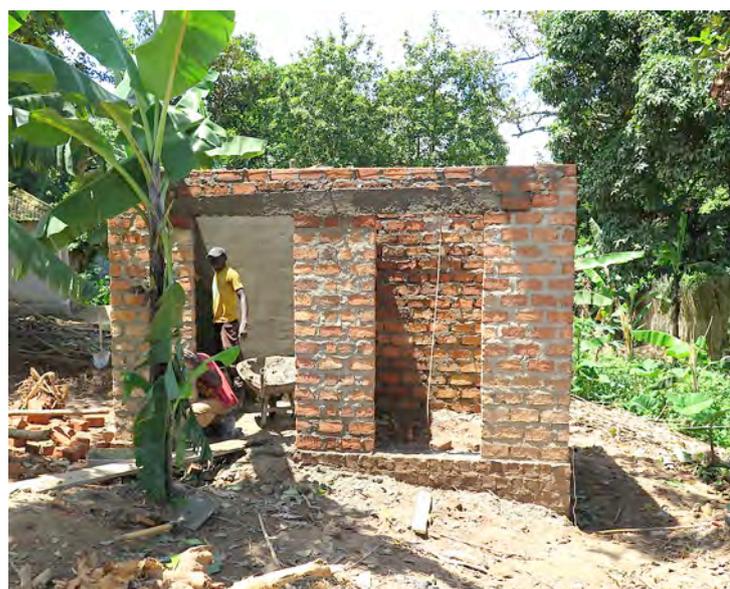
New cooking and ablation facilities in contemporary construction – brick, cement mortar, concrete floor and galv. monopitch sheet metal roofs.

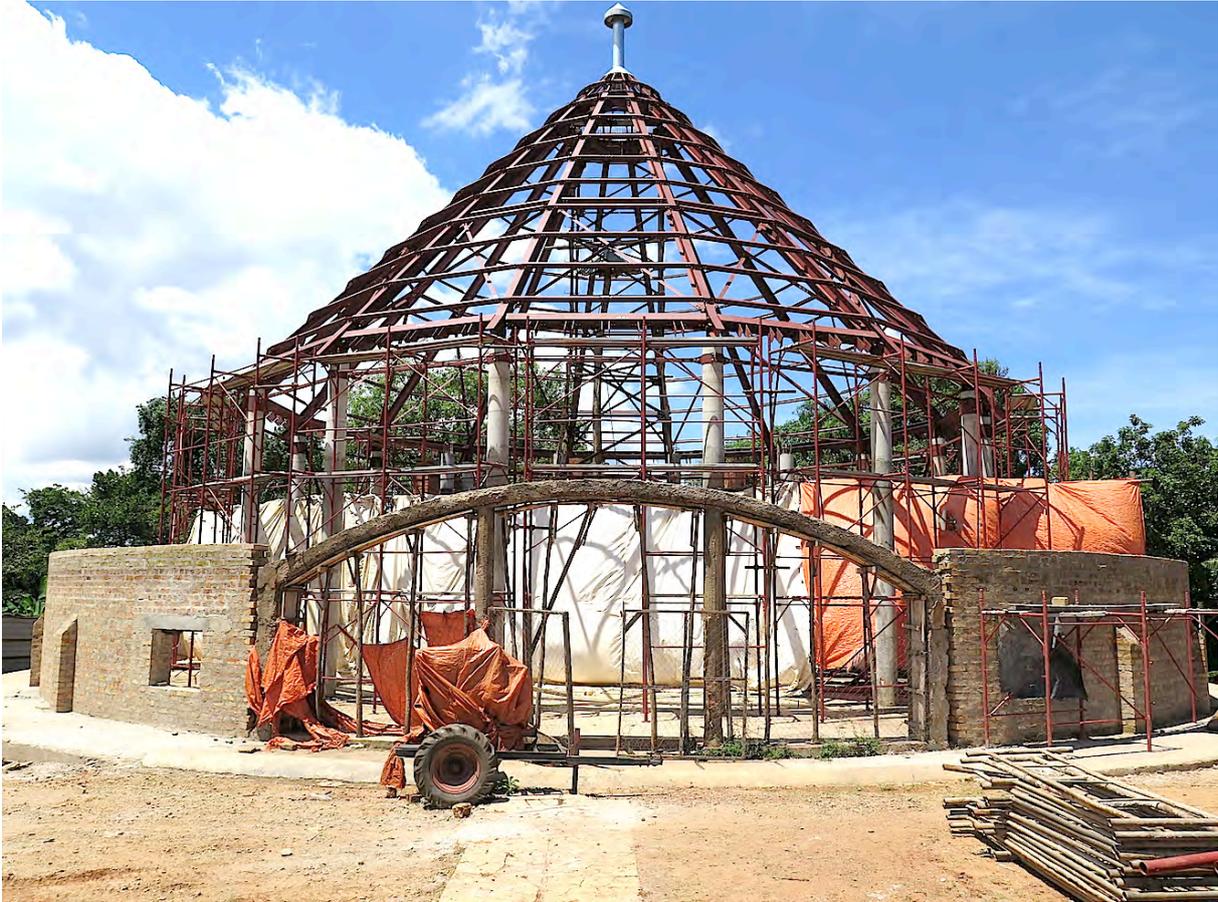
The *Muzibu-Azaala-Mpanga* of 1938 that is being reconstructed was a hybrid building with traditional thatching on timber beams and purlins and with inner rings of reeds and grass, timber columns and bark coverings and screens, but with a buttressed brick outer wall, and concrete columns and steel truss-work for the inner circle – the photograph provides the state of reconstruction on 13 May 2013,

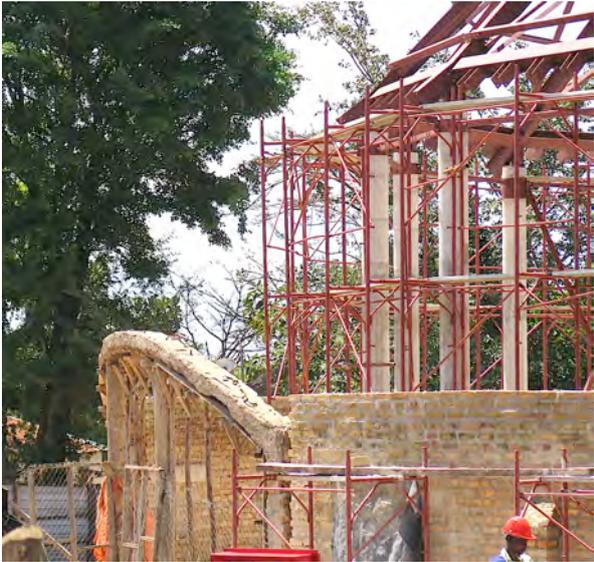
Detail of the concrete entrance portal damaged in the fire and to be rebuilt to adjust for the new roof pitch.

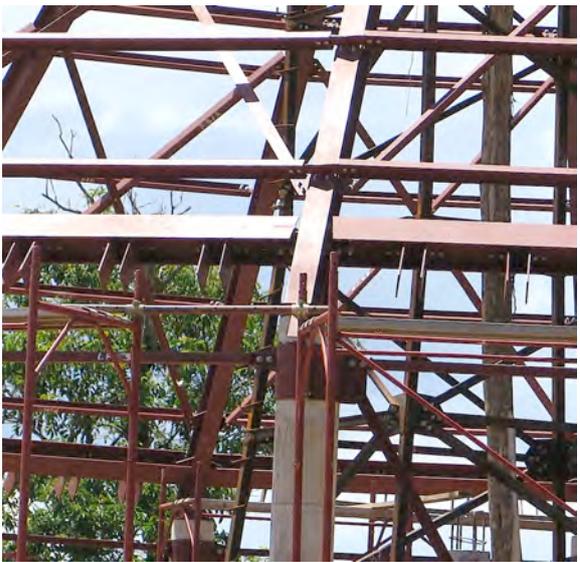
The bottom tension ring of the steel roof structure has brackets for the timber beams that take the roof down to just above the level of the existing outer apron of the tomb building. The outer beams rest on the outer ring wall, and then lastly on short timber columns stubs, all as the building before it burnt down. In order to determine the exact height of the outer wall – that had to be partially reconstructed with new material due to fire damage and loss of bearing strength – a timber test beam was installed and the wall height determined, and constructed.

Detail of the steel truss-work of the inner circle roof with brackets to attach the timber beams of the lower roof.

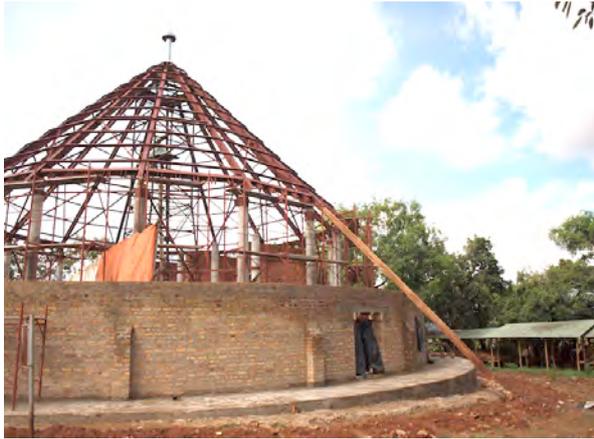
Timber beam indicates full extent of roof (Photo S Moriset).

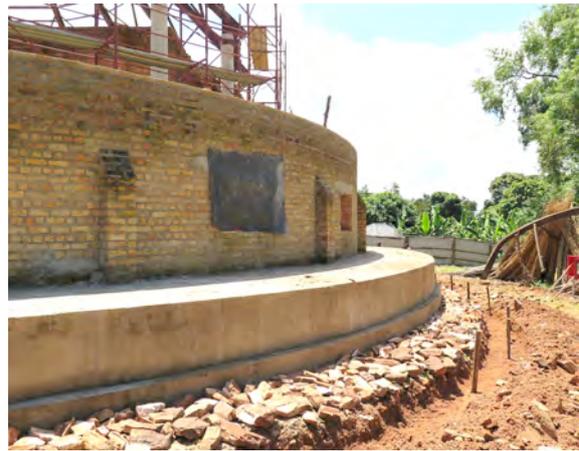
New outer paving to further prevent termite infestation.

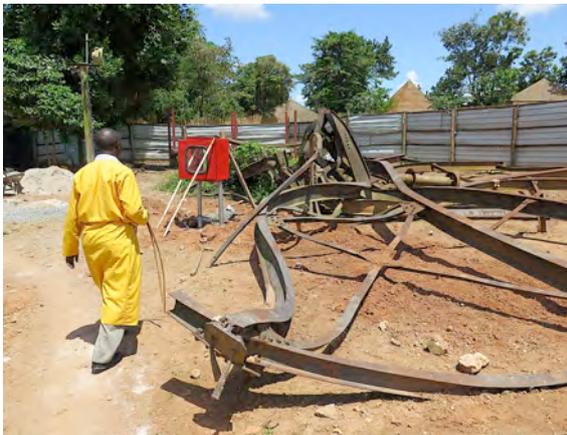
Remains of the 1938 steel roof truss-work burnt in the fire.

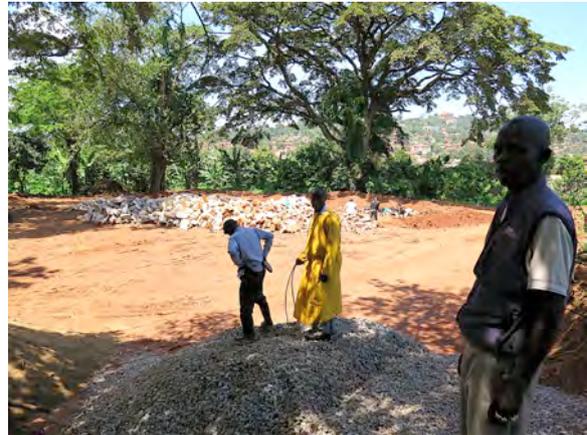
Preparations for a platform and shelter for displaying the remains of the burnt steel trusses and other objects from the fire. This area is behind the ring of houses around the inner court. No archaeological survey performed.

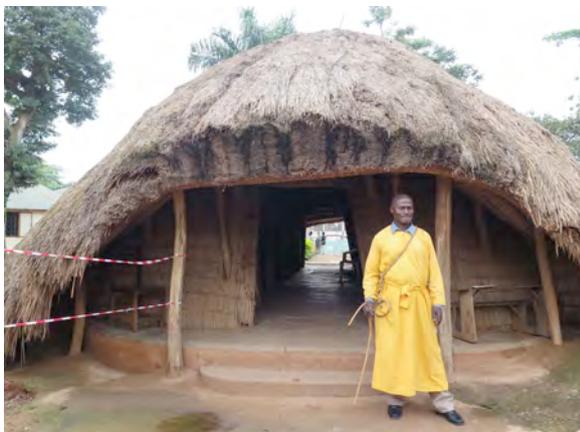
- j) The *Bujja bukula* / gatehouse is sagging – the structure has been documented (see Status Report) and there are plans for its repair and renovation.

The gatehouse is leaning due to structural failure from termites. Documentation is complete and reconstruction is envisaged.

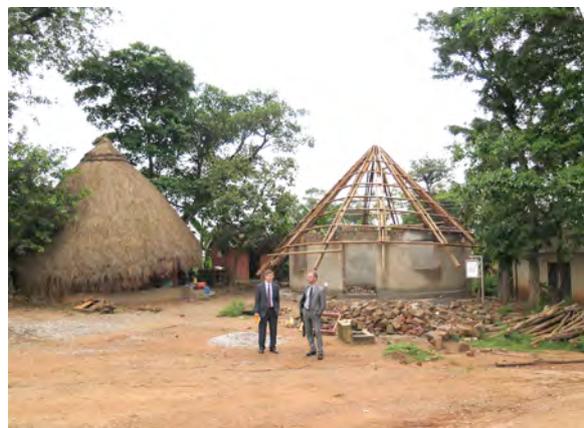
Metal roofs of inner ring houses are removed and replaced with roof poles and thatch.

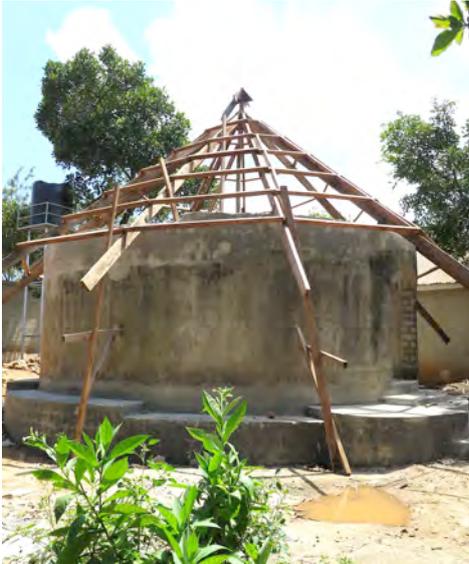
New concrete, brick and cement-plaster house with timber beams to be thatched.

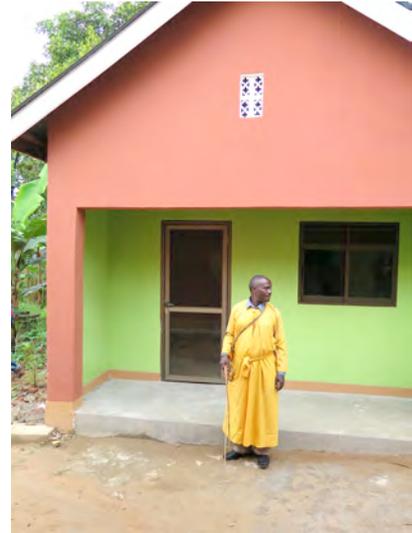
New tomb for royal wife - conventional concrete, brickwork and cement-plaster, with pitched saddle-roof aluminium window and door frames.

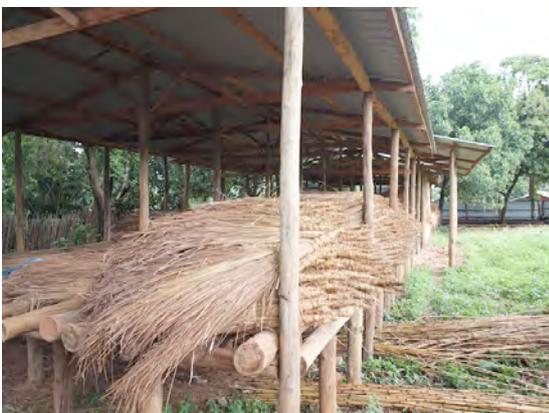
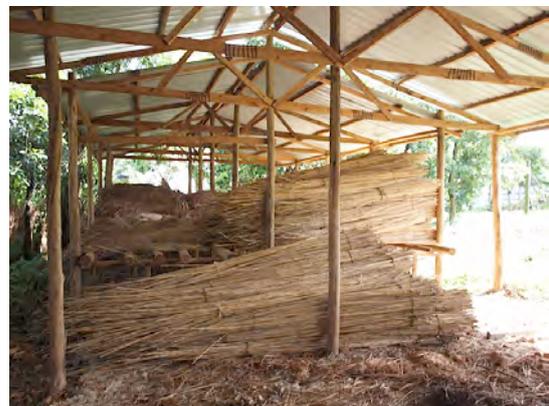
New roofed drying racks for thatching (This is a very large improvement on the site – however the thatch bundles are lying flat – research by Japanese experts shows that this method still causes moisture so drying cables/rods have to be installed).

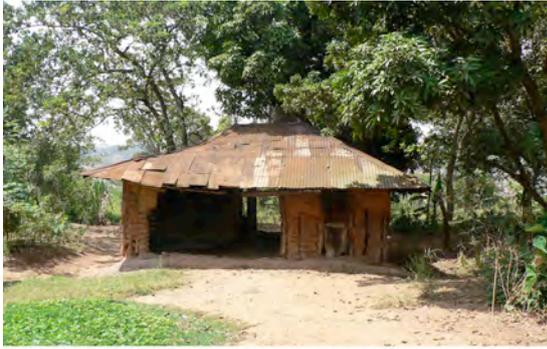
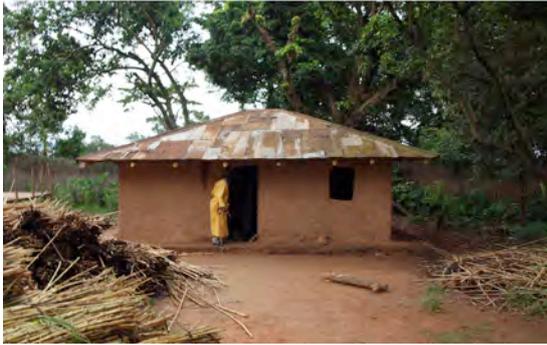
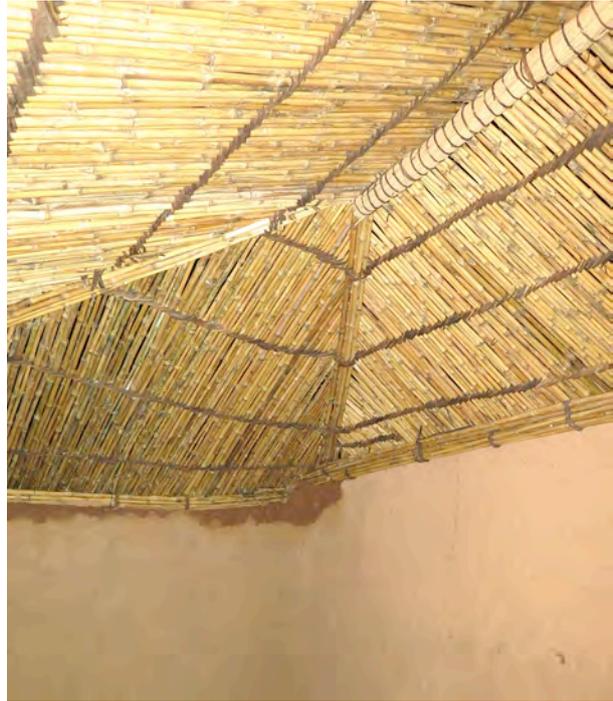
Top: Condition of the oldest surviving wattle-and-daub building on the site – the flat tin roof sheets arte original. Bottom: Repair of walls, roof trusses and inner thatch ceiling (Comparative photos S Moriset). Right: Detail of the roof repairs on the interior.
