STATE OF CONSERVATION

TOMBS OF BUGANDA KINGS AT KASUBI (UGANDA)

PROPERTY ID NO C1022

1st FEBRUARY 2016

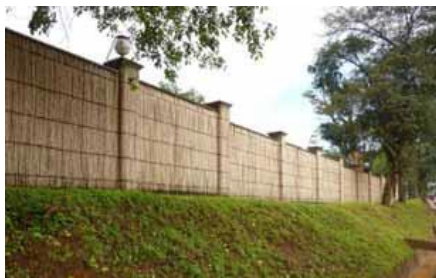
3.1.5Fence

The fences remain a good protection for the site. Already its presence has protected the site from being encroached upon by the expansion of the road. The expansion now will be inclined to the opposite side of the masiro where by the residents will be compensated to allow for the expansion.

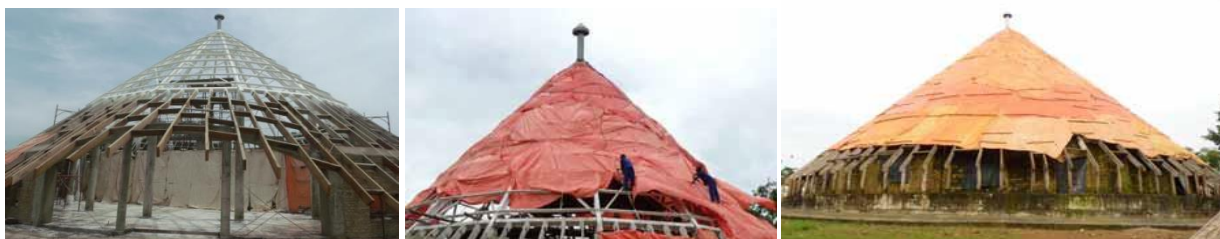
3.1.6Bujjabukua

Bujjabukula is the oldest and most authentic architectural elements of the site, much as it is right now threatened by rot and deformation, plans are already underway to reconstruct it as soon as the pressure on Muzubu Azaala Mpanga is reduced.

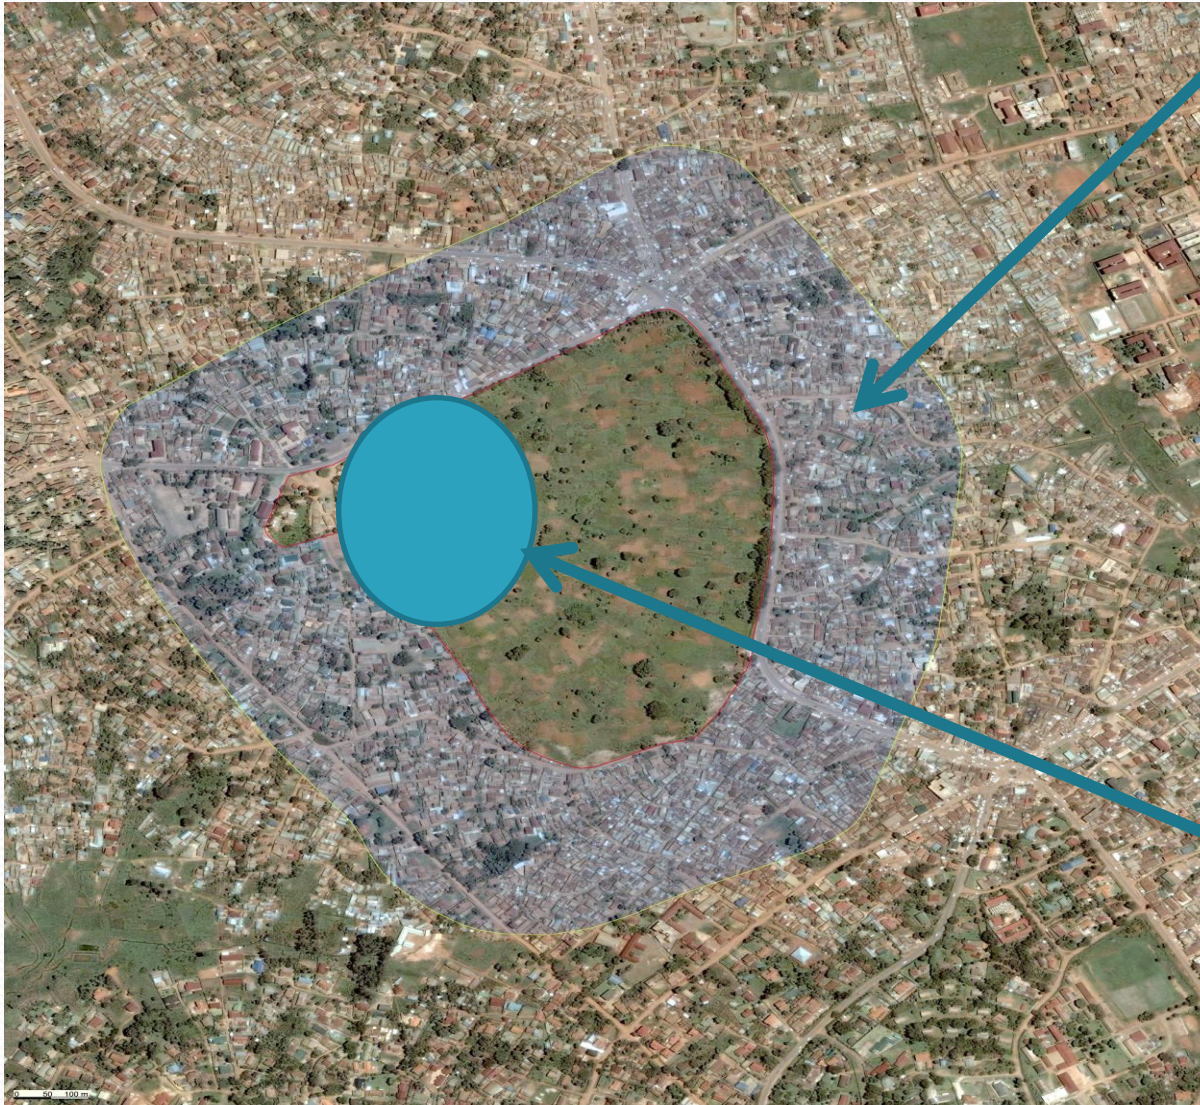
**AREA
VULNERABLE TO
HAZARD OF FIRE
GRASS THATCHED
HOUSES LOCATED**

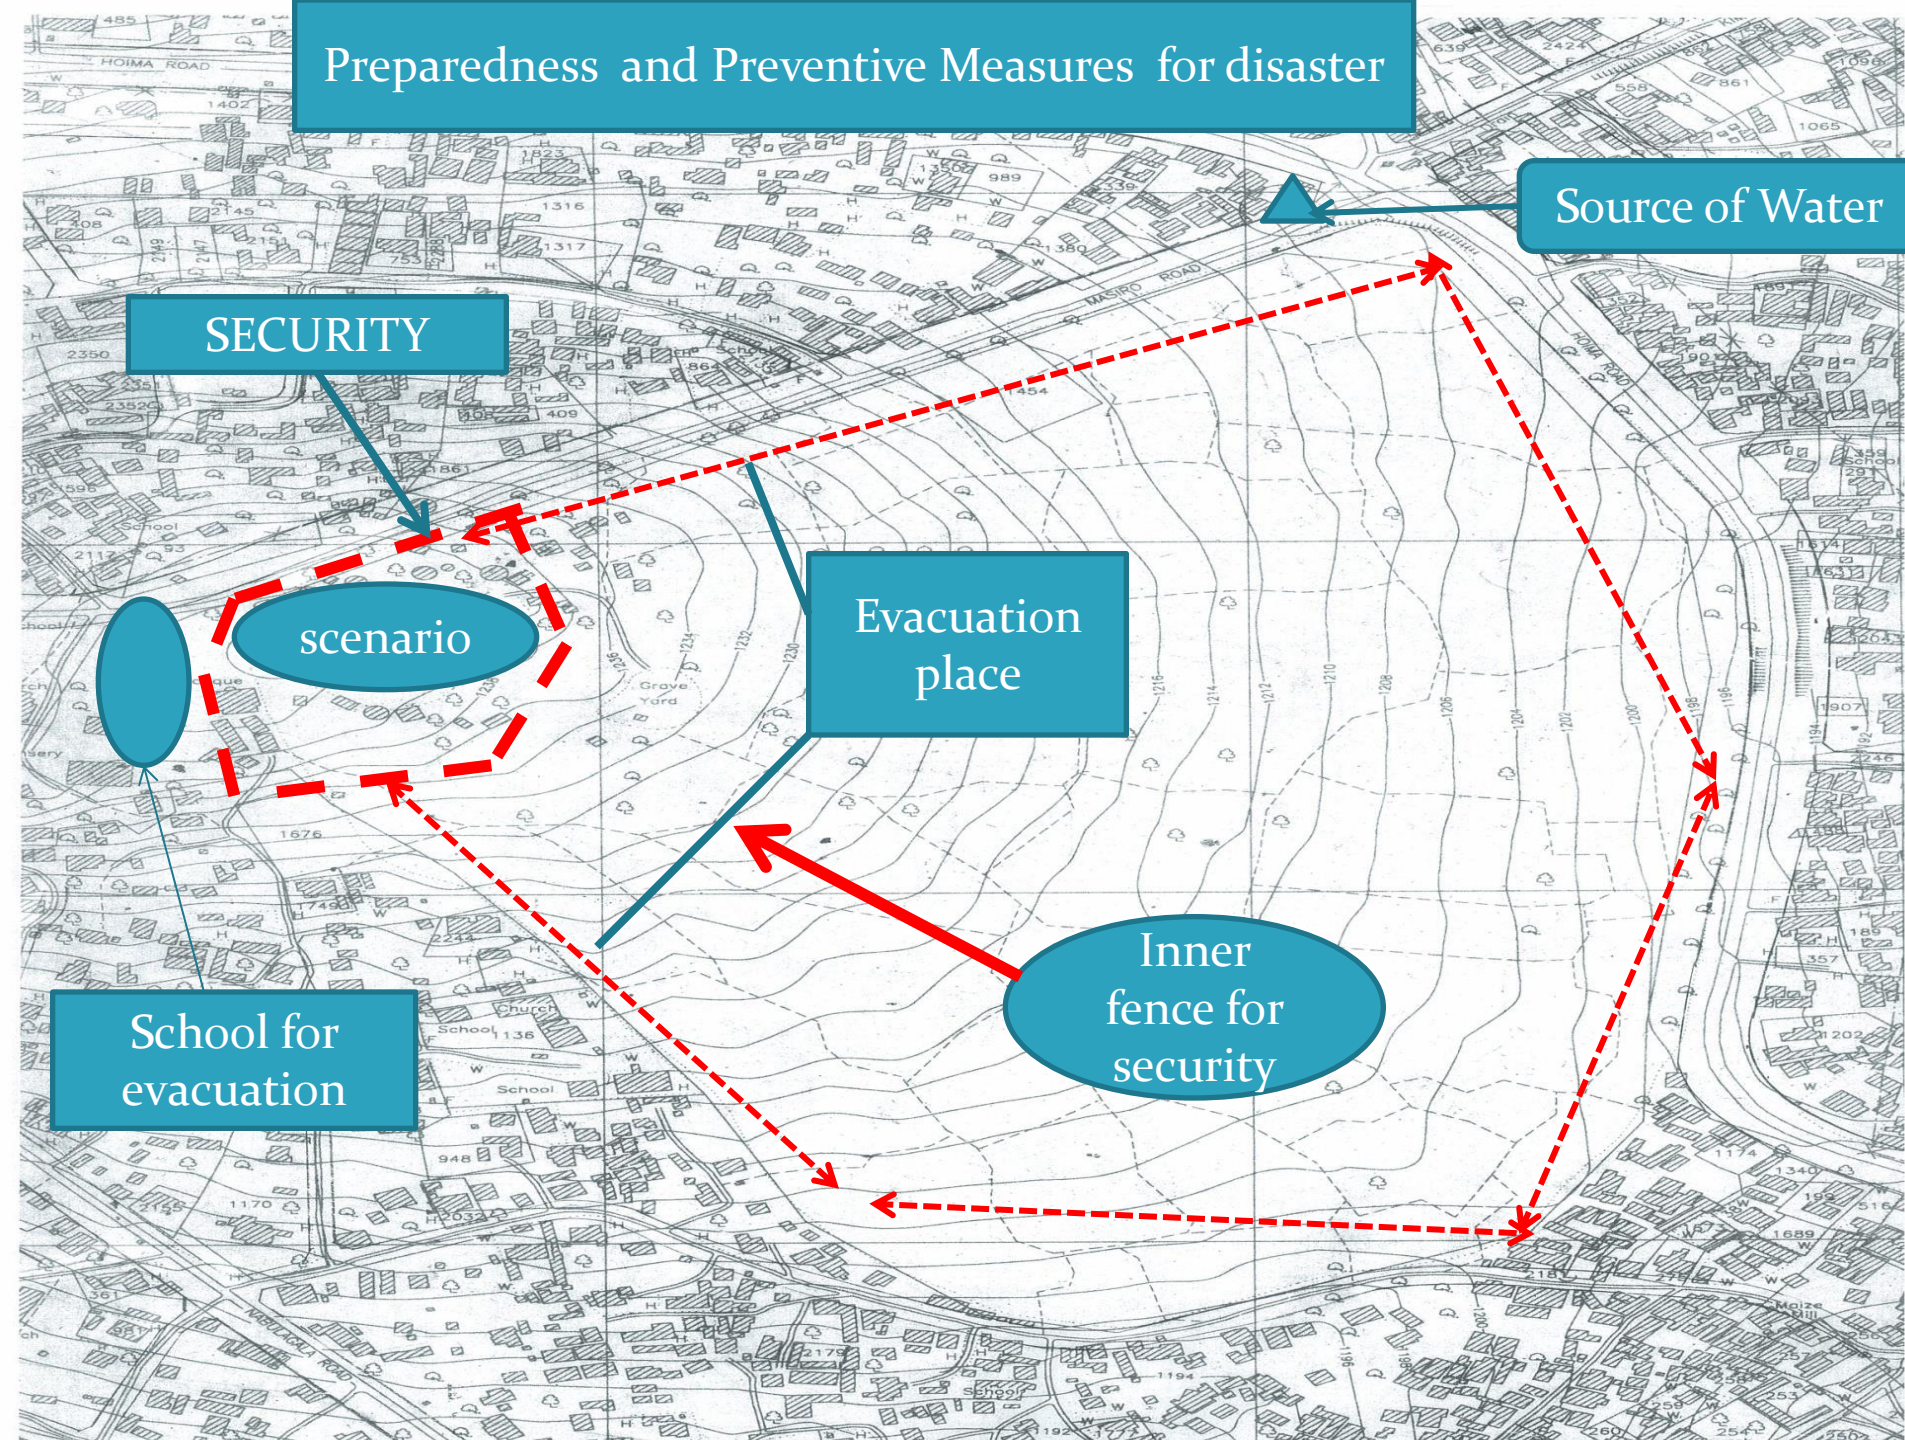
Drawn: SITE PLAN: FIRE FIGHTING DESIGN

FOR DETAILS OF FIRE POINT (FP) SEE DRAWING MEA634-02
