**Subject: Submission of SoC Report on Kathmandu Valley World Heritage Property, (Nepal) (C121).**

**KATHMANDU VALLEY WORLD HERITAGE SITE**  
(Nepal) (C 121 bis)  
**1 FEBRUARY 2016**

**STATE OF CONSERVATION REPORTS FROM  
INDIVIDUAL MONUMENT ZONES**

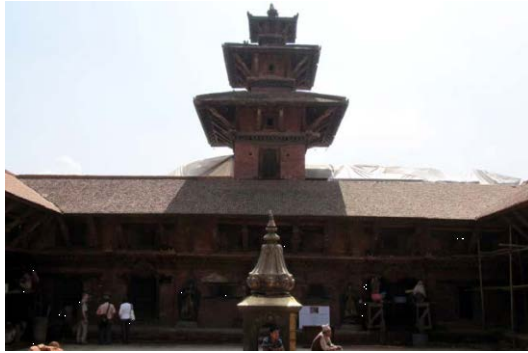
Mul Chowk West Wing Main Gate  
View of main entrance steps before restoration.

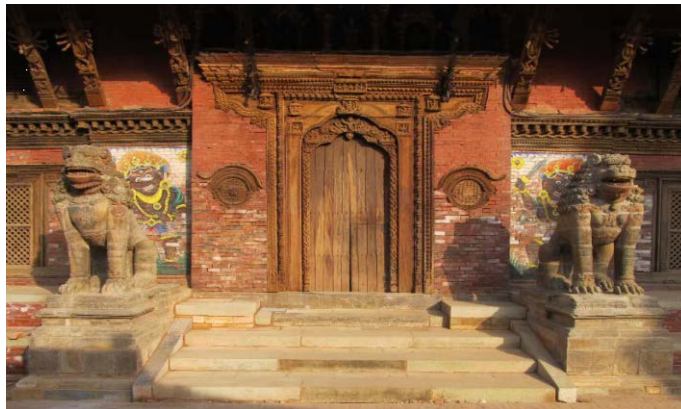
Mul Chowk West Wing Main Gate  
View of main entrance steps after complete rebuilding .

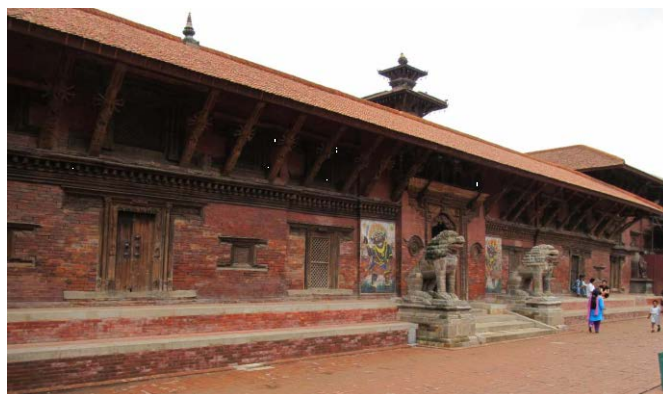
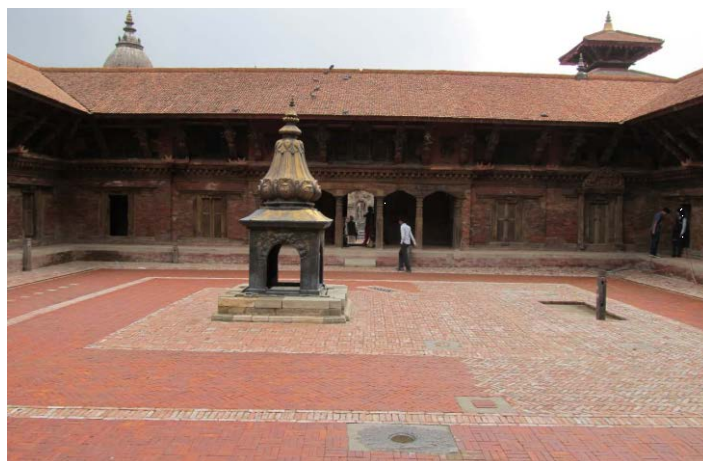
Mul Chowk West Wing

View of west wing's west (exterior) and east (courtyard) facade after restoration was completed. Note the completed courtyard pavement.
