THE STATE OF CONSERVATION OF THE HISTORIC CENTRE OF VILNIUS
Report of the Mission 20 - 25. January 1994 Panu Kaila

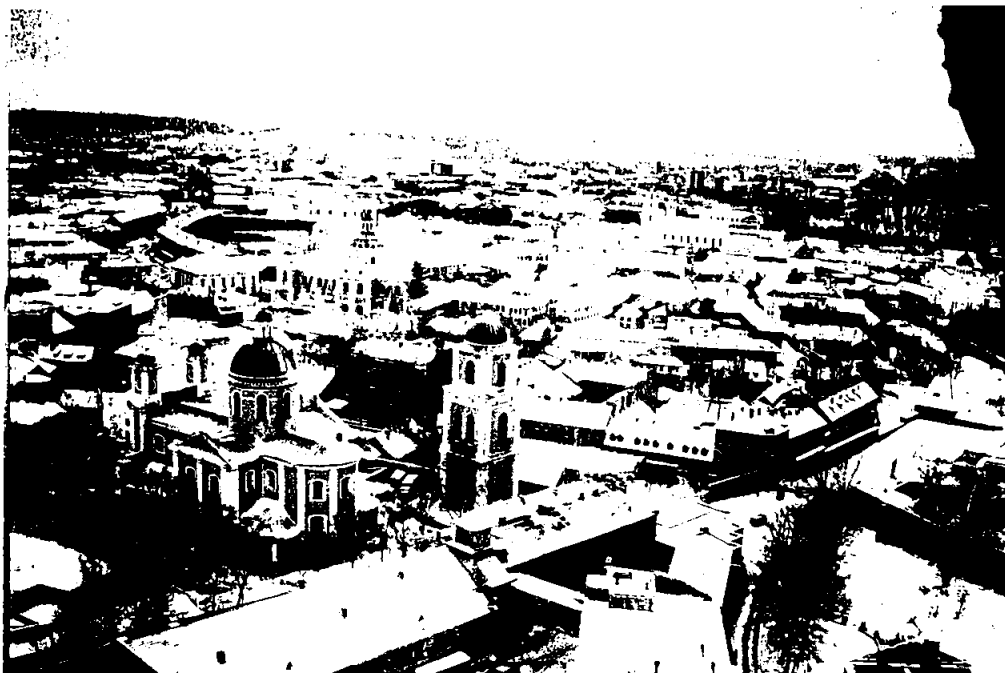
fig. 1. The Historic Centre of Vilnius from the south. The Castle Hill can be seen in the background on the right side, and far away in the middle there are the towers of the new centre on the other side of the Neris river.

Vilnius suffered considerable damage during the Second World War. From the 1960's onwards there has been an active period of building, reconstructing and protecting the Historic Centre of Vilnius. (fig. 1., fig. 2.)

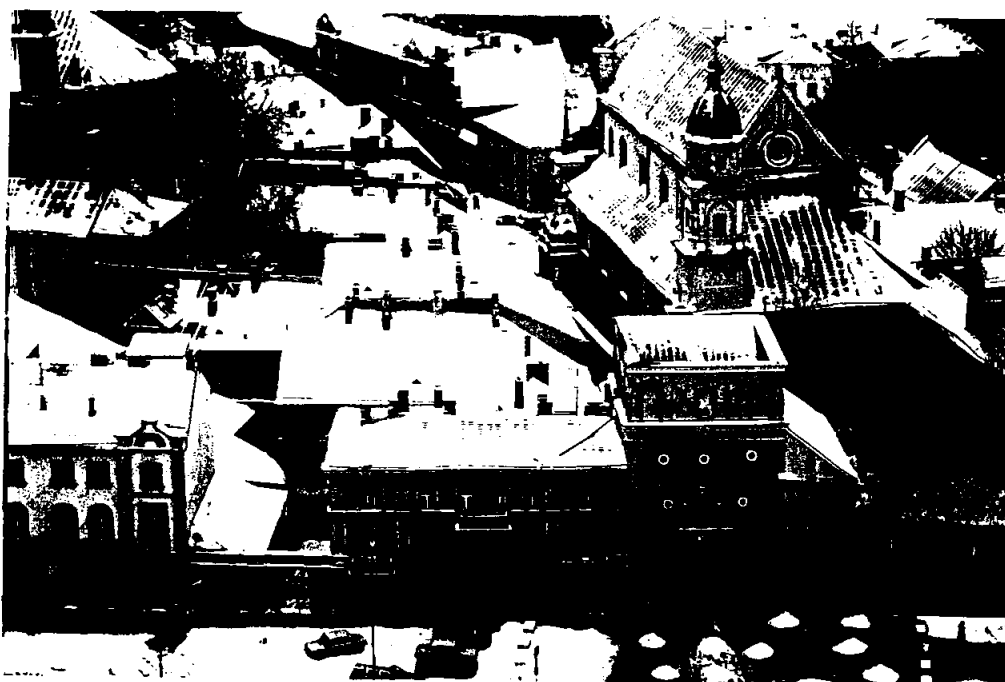
fig. 2. Part of the defensive wall, on the right, and Ausros Vartai Gate, the only one which remains. Behind the gate there is the early Baroque church of St. Theresa. On the same side of the street there is the Medininku House, a Gothic warehouse with reconstructed gable and below it the Renaissance frescoes in sgraffitto.

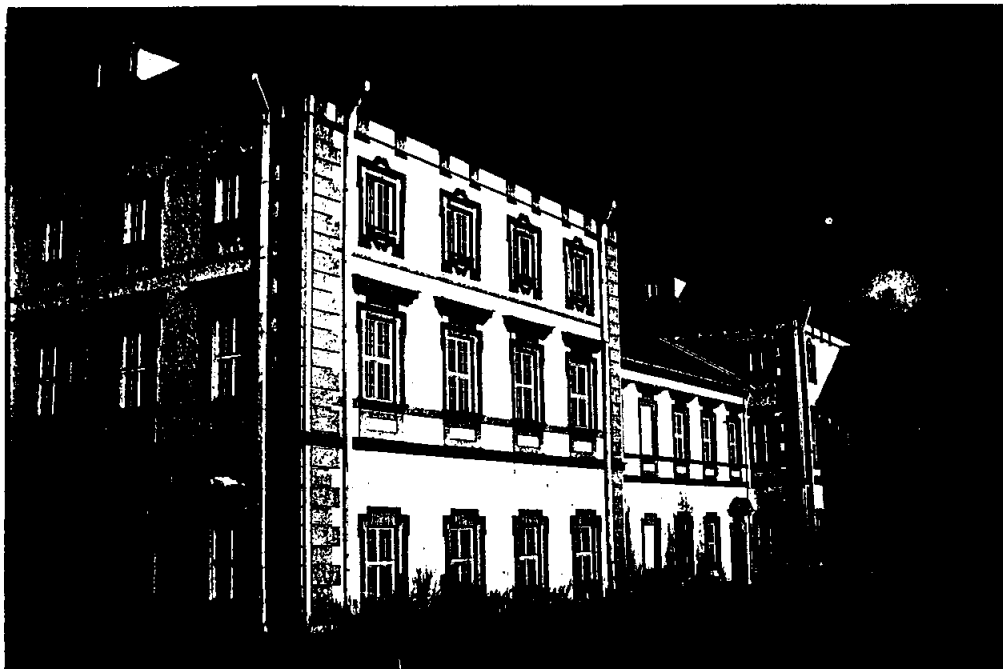
fig. 3. The Great Radvilu Palace. In the foreground the reconstructed pavillion, then the restored northern wing and pavillion, and part of the eastern wing.

- The Great Radvilu palace in Vilniaus street consisted of four three-storied corner pavillions connected with three two-storied wings. Only the northern half of the palace is seen today. The north-western pavillion was reconstructed in 1986, the northern wing and the north-eastern pavillion were restored in 1991. Part of the long eastern wing is still waiting for restoration. In this case, the reconstructed pavillion does not differ from the restored parts, and easily results in misinterpretation. This could be easily helped by placing a signboard with the date on the facade.

There are plans to rebuild also the other half of the palace, of which some remains of the south-eastern pavillion and the southern wing have been preserved as a part of an apartment house of Jugend style built in 1912. The rebuilding will result in reconstruction of this house. 2/3 of the palace will then be a reconstruction. The reconstruction of the palace is considered to be important for town planning aspects. (fig. 3.)

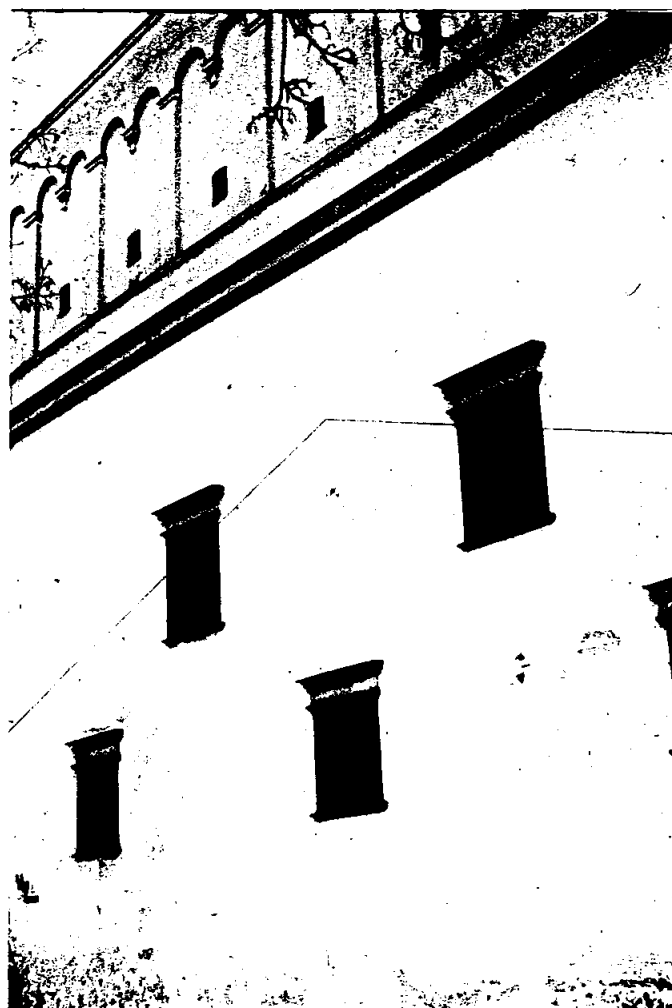
fig. 4. The restored gable of the Arsenal. The line in the facade indicates the preserved part of the wall. The window frames are of concrete, with small fragments of original sandstone.

- The Arsenal is a vast building by Vilnius river below the Upper Castle hill. The upper part of it was destroyed in the 18th century. In our

century it was used as garage for tanks. The building was restored in 1983 and houses now the Museum of Applied Arts. The upper half of the walls were reconstructed, like almost all of the structures inside. The preserved part of the ground floor is now shown as an archaeological excavation, and the few original arches or parts of them are shown as "windows" in the new structures. In the gable facade, a line marks the extent of the authentic wall. (fig. 4.)

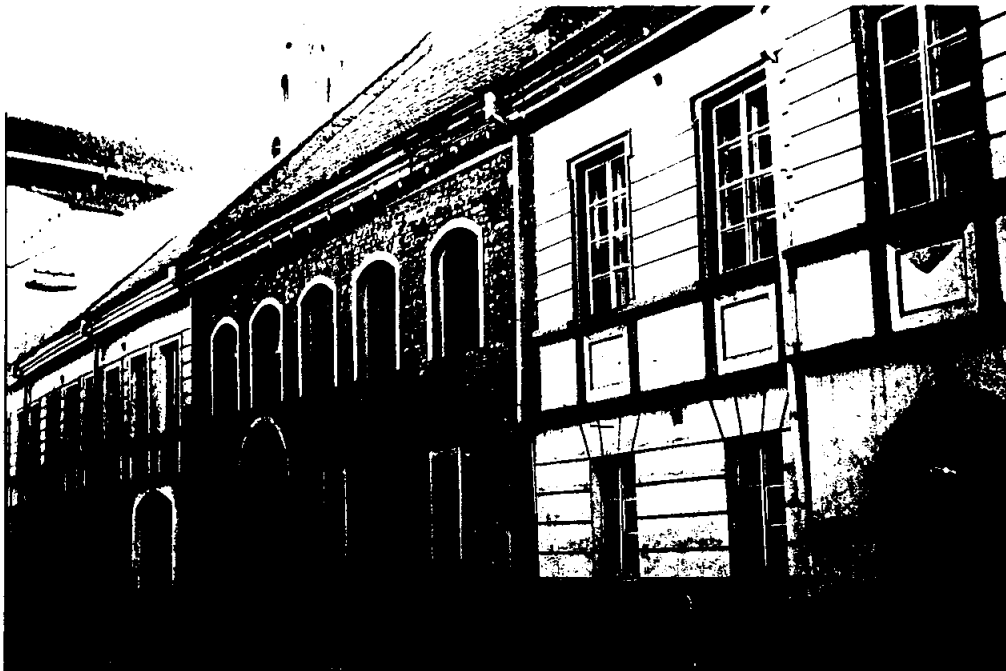
fig. 5. The houses in Pilies Street 13 and 11. Of the three Neoclassical facades, the one in the center was restored to its Gothic looks. The dark bricks are original, the light ones modern.

- Gothic houses in Pilies 12 and Pilies 11. The damages of the war revealed that the Neoclassical facade in Pilies Street 12 had Gothic details behind the renderings and square windows. The house had been rebuilt behind the facade, so only the red brick facade was restored to its Gothic form in 1960. The high gable was at first reconstructed only in form and built of wood, but later it was made of brick. On the opposite side of the street, in Pilies 11, there were three similar Neoclassical facades. The one in the middle was occasionally found to have Gothic bricks, and it was recently restored to its Gothic looks. In both of these cases, like in many other Gothic facades, the filling of lost parts is distinguishable from the original but not too much, as it is done with new bricks of the original size. (fig. 5.)

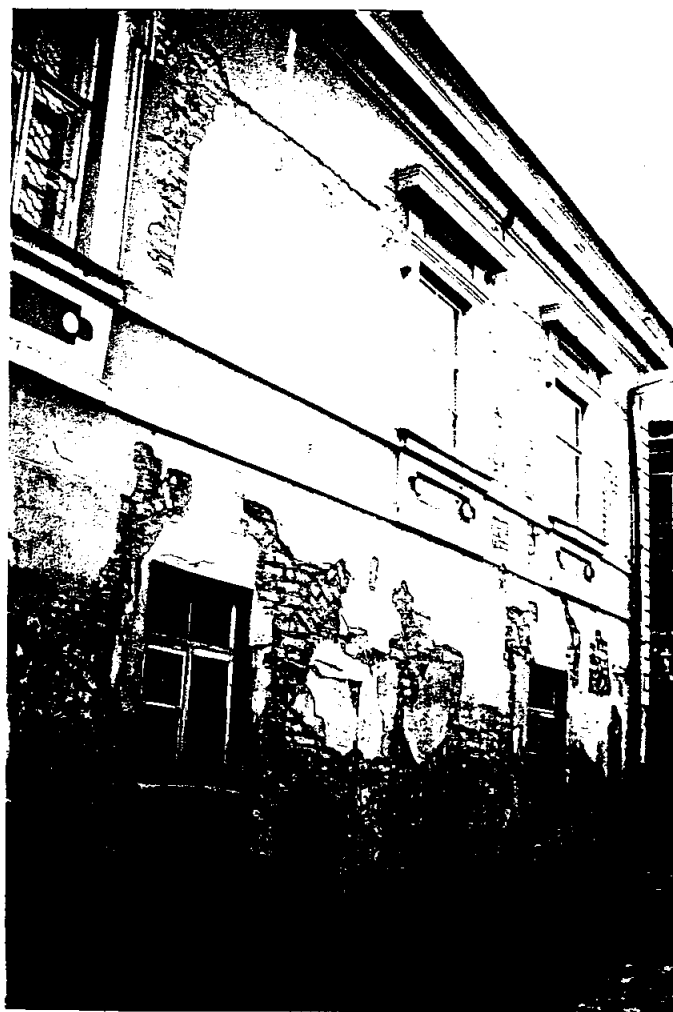
fig. 6. Building archaeological research openings on the facade of the house in Bernardinu 6. The decision of the restoration is not made yet.

The Gothic facades bring back a hidden feature of the Old Town and visualize its long time dimension; on the other hand they often break the uniform 19th century street scene. In rather many facades there are small openings in the rendering which have been made in the search for Gothic bricks. These facades are meant to be restored to Gothics. I think that those already realized examples, like the beautiful facade in Pilies 12, or the house with important Renaissance sgraffitto frescoes in Ausros Vartu Street, are sufficient testimonies of the period, and that the rest should keep their facades as they are, with all their historical stratigraphy. Such houses are e.g. Bernardinu 6, which ought to preserve its peculiar Baroque rendering, and the Renaissance house with Neoclassical front in the complex of St. Michael's Church in Volano Street. (fig. 6.)

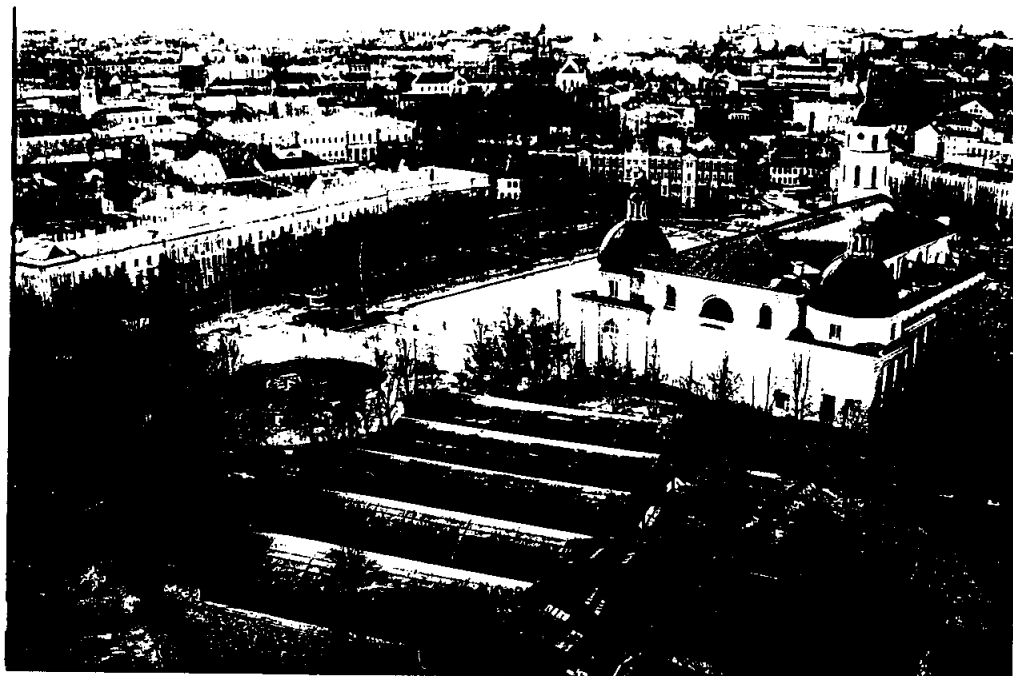
fig. 7. The Cathedral. On the left hand corner there is the Baroque chapel of St. Kasimir, on the right its Neo-classical pendant. In the foreground the temporary shelters of the archaeological area of the Lower Castle can be seen.

After these somewhat critical remarks I would like to stress that not at all and every restoration in Vilnius Historic Centre is stylistic. Most of the monumental buildings, like so many churches and monasteries still have their full richness of different ages. The Cathedral itself, which is a conglomerate of seven centuries, is a most interesting and well restored entity, from its underground archaeological excavation to its Gothic vaults with Neoclassical decoration and the imposing Neoclassical facade. The 17th century chapel of St. Kasimir has recently been structurally strengthened and its interior restored. (fig. 7.)

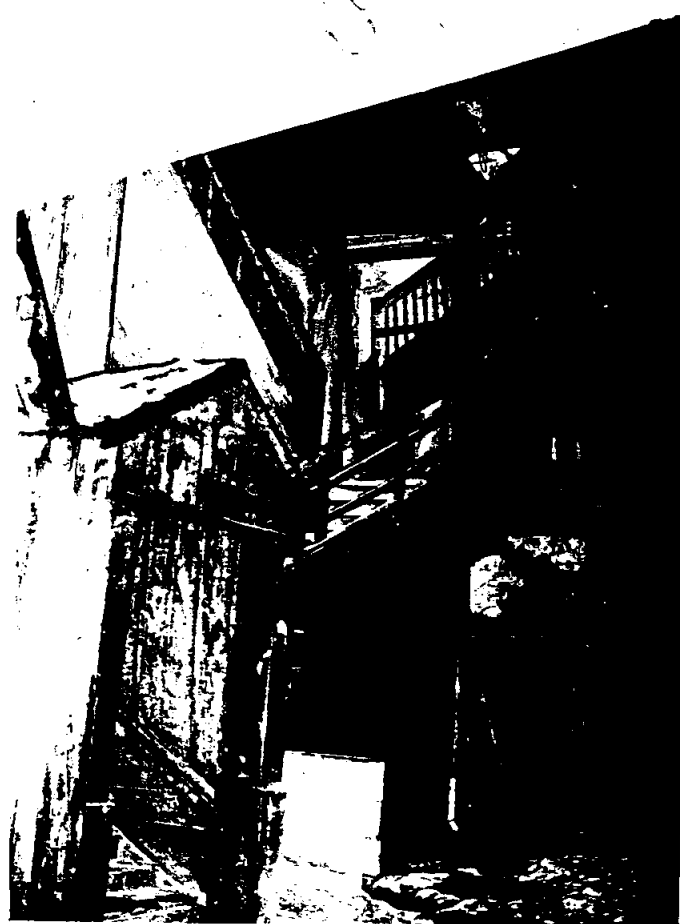
fig. 8. Backyard charm in the Old Town. Wooden porches, galleries and stairs - maintenance is needed!.

The charm and richness of a living historic town is very strongly present in many small streets of Vilnius. Especially the back yards form a vivid accumulation of different small houses, a genuine collection of historic structures from the gothic into the modern age. Every one of them, regardless to its age, should be treated very carefully, respecting the honest and true picture of history and the way of living it presents. (fig. 8.) The same is true to the historic suburb Uzupis, which is a rich and fully authentic milieu. However maintenance is badly needed.

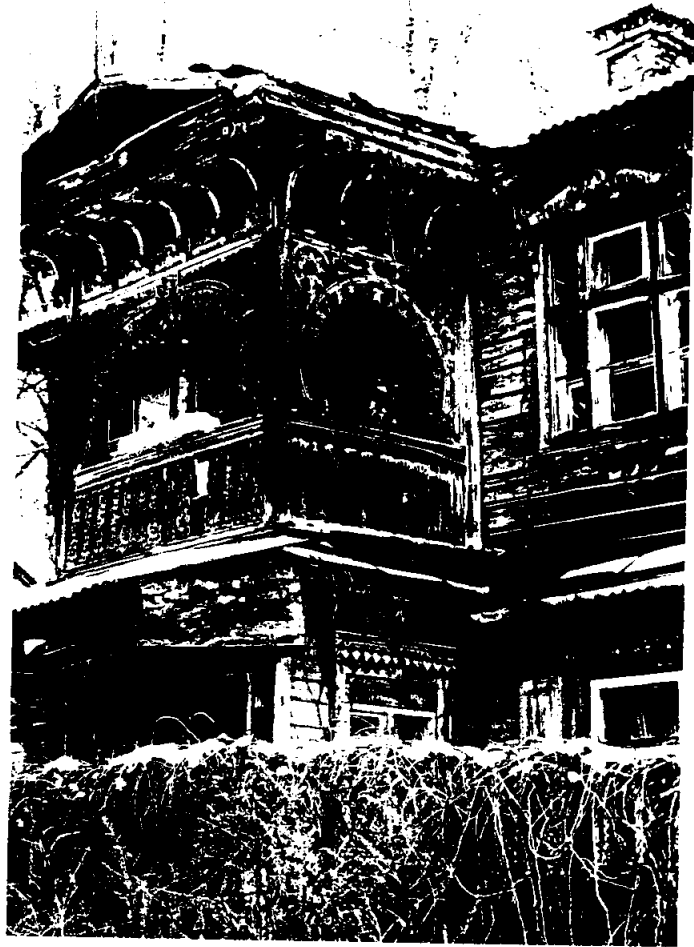
Among buildings at risk there are two small houses, Stuokos-Gucevicius 5 and 11, which ought to be preserved as rare representants of wooden architecture in the Historic Centre. The same applies to decorated wooden houses in Uzupis. (fig. 9.) Again the lack of maintenance is visible, and as wood is a very vulnerable material, it is important to organize proper maintenance as soon as possible. Outside the centre there are interesting areas of wooden houses, which are protected.

fig. 9. A richly decorated wooden villa in Uzupis.

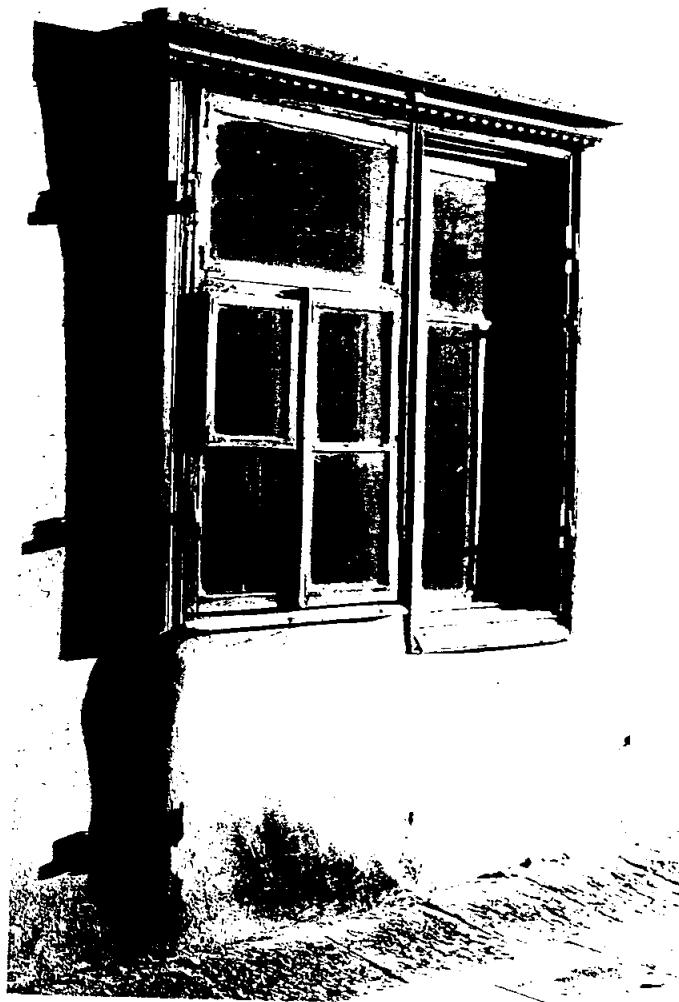
fig. 10. A beautiful but neglected wooden window in Bernardinu 10. Some of the windows of this house have already been changed into new ones of inferior quality, possibly because oil paint and putty for restoration are not available.

To take an example: it is very very rare to see a repaired window. The existing ones, mainly dating from 19th or early 20th centuries, are replaced by new windows, which are not copies of the old but a stylistic restoration. As glazing putty is not available, the new windows have wooden glazing lists so that the water will soon penetrate into the mouldings; likewise the wood stains used in place of oil paints make the mouldings apt to crack. (fig. 10.)
