Annex 1: State of Conservation Report, Historical Monuments of Mtskheta

Historical Monuments of Mtskheta (Georgia), (C 708)

Rescue archaeology works were carried out on the western area (40 m²) of the church of the Holy Transfiguration of the Savior at Samtavro monastery

Urgent conservation works on wall paintings
and building materials of sanctuary of the
church of the Holy Transfiguration of the Savior
at Santavro monastery

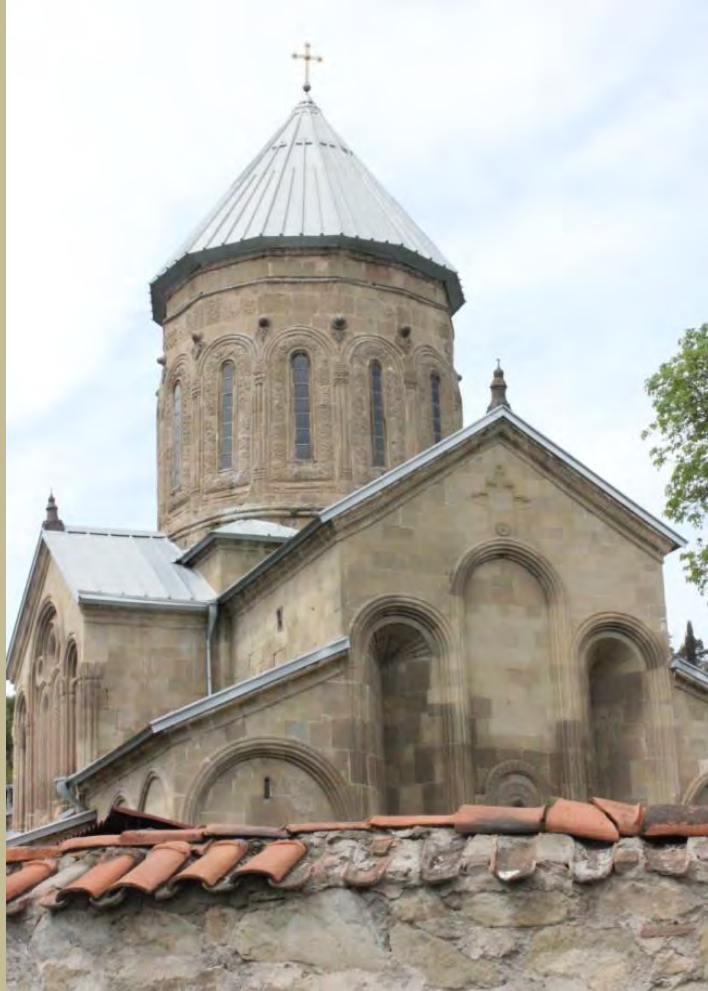
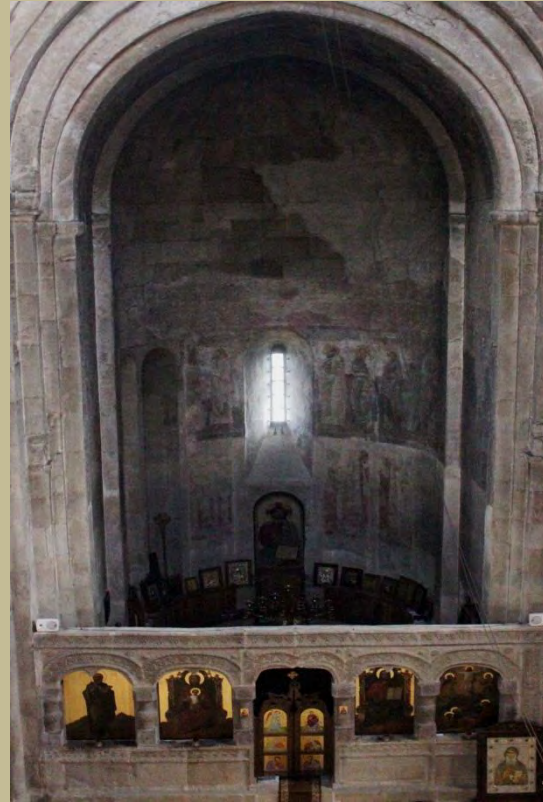
Photo: Interior of the church

Different types of damages were observed over the key building material used – the stone; small size losses and surface lamination were observed on surfaces of facial stones.

The most obvious and widespread damage was thick layer of soot, which covered whole space of church and its gate-ekukterion (small size chapel); it was deeply rooted within the pores of the stone and was damaging the stone surface. The stone cleaning works (with the exception of sanctuary) have been carried out in the church interior during May-June of 2015, in addition, the damages on the surface have been eliminated.

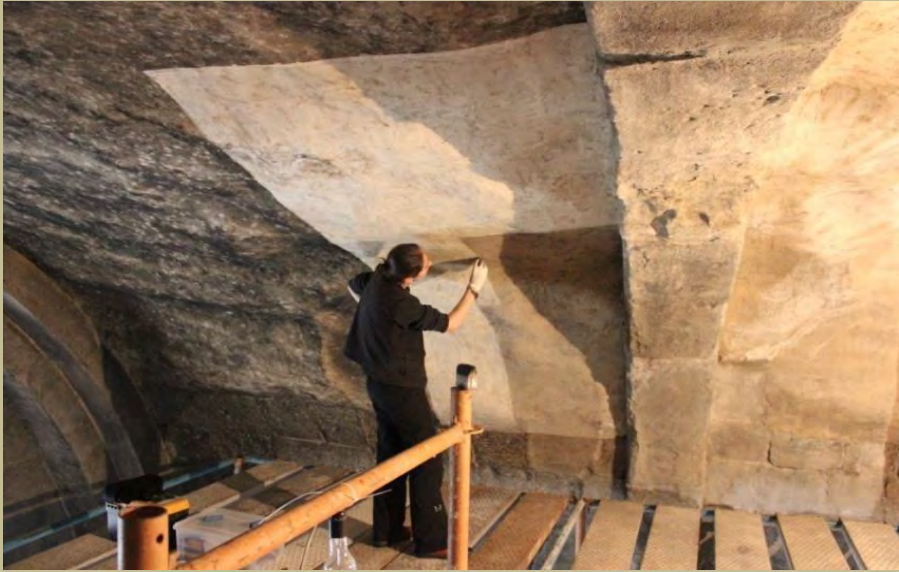
Photo: Process of cleaning, the Western wing.

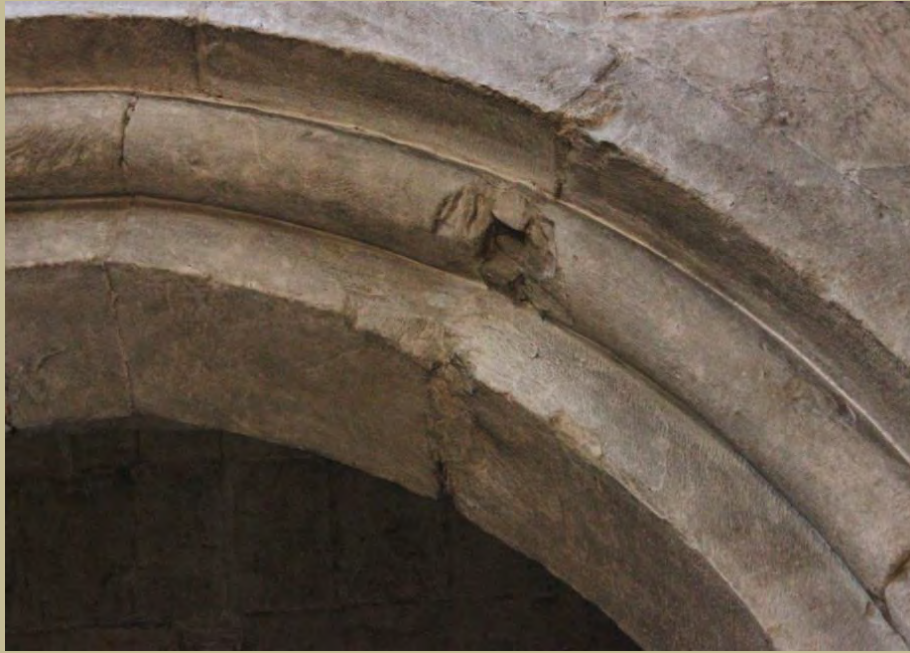
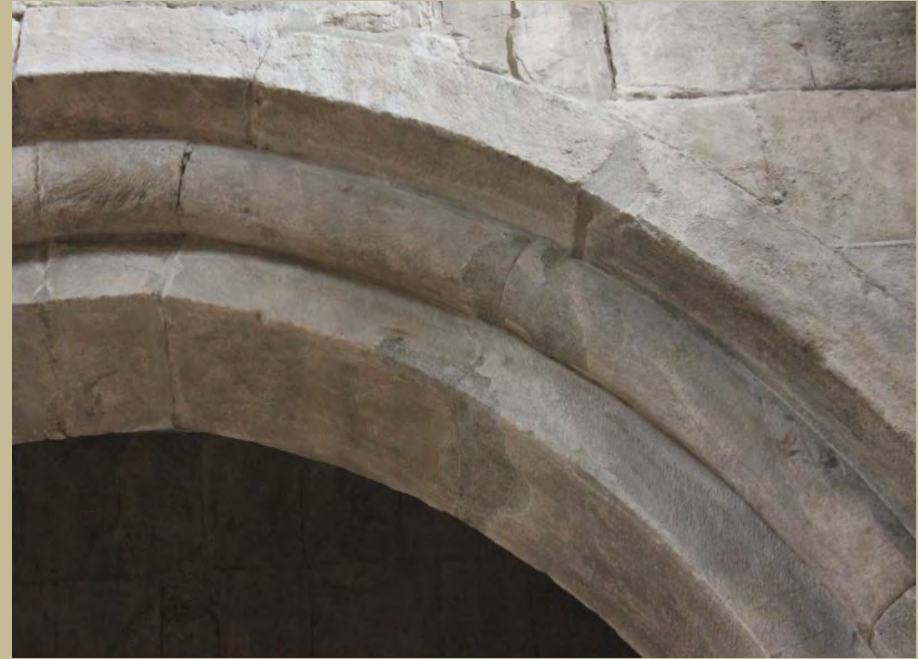
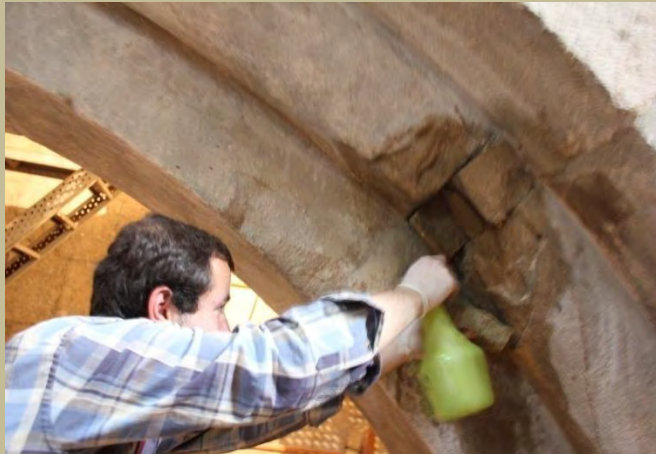
In the interior, where the facial stone has losses in the form of chips, was filled with lime solution. Proportion: 1 lime, 1 quartz sand, 2 coarse fraction black sand, fiberglass tabs.

Up: Photos before and after filling with solution
To the left: Process of filling

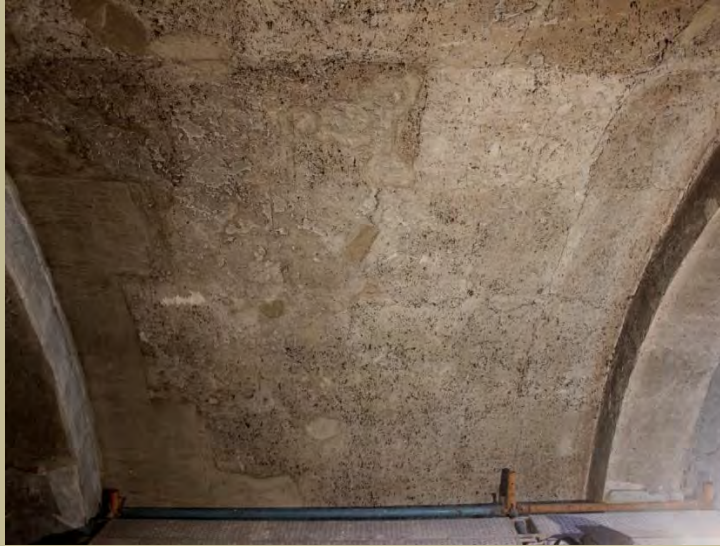
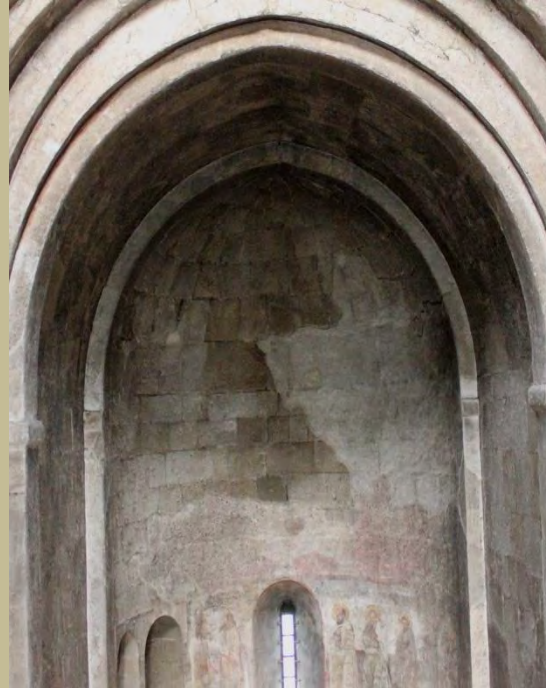
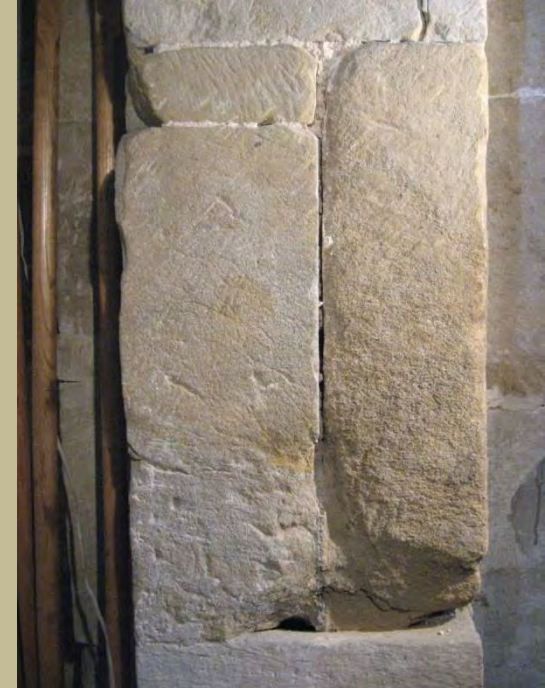
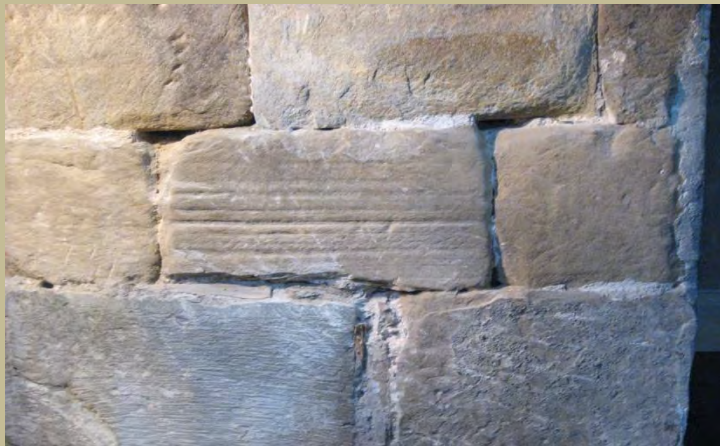
Similarly, as it was observed around the church, the various damages of the stone were observed in the sanctuary: a thick layer of soot, various size chipped sections of facial stone, mortar loss.

Photo: Sanctuary of the church (detail)

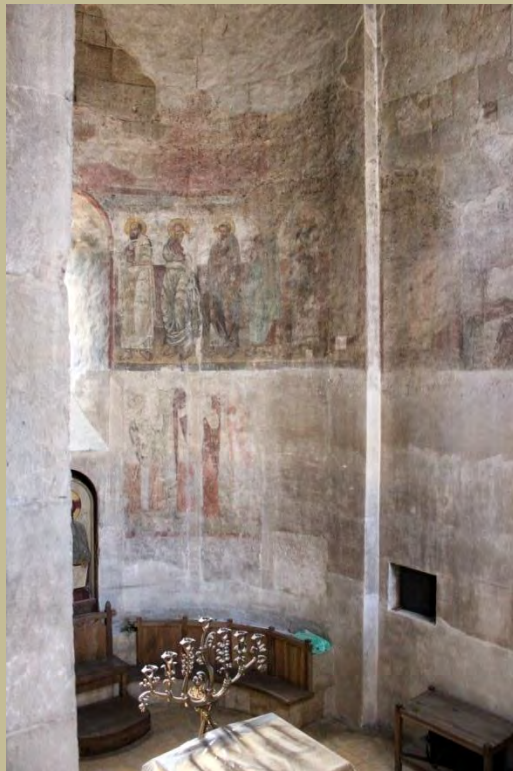
To the left: Sanctuary of the church

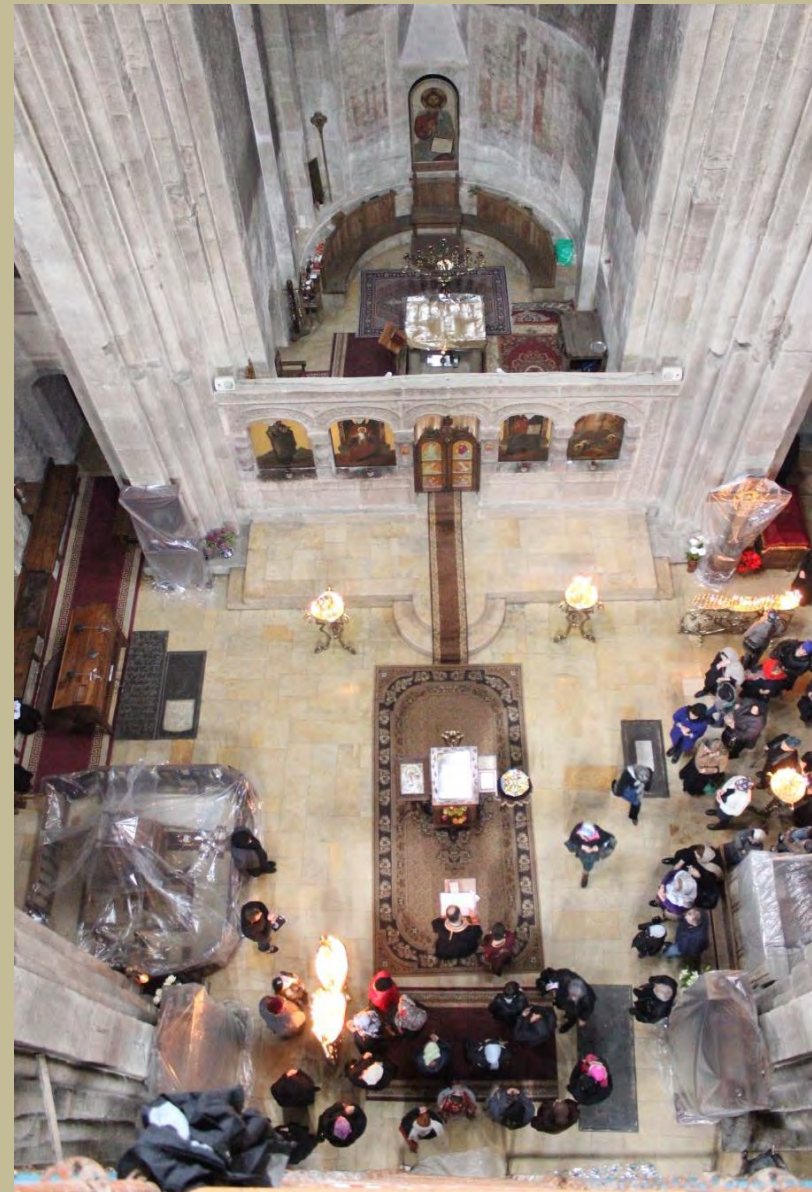
The large flow of prayers in the church for the recent times could be considered as the reason for the soot – one of the damages to the painting layer in the sanctuary, the influence of which is clearly evident in interior environment: sweltering, oxygen-free air, the heat of candle flame and the fog-like exhaust – the members of the monastery also confirm the permanent existence of this problem.

It is impossible to comprehensively assess the condition of painting plaster and painting layer without the examination of the painting from scaffolding. However, the main problem, which poses a threat to the safety of the paintings, is obvious – thick layer of diesel soot, the formation of which is the result of exposure of diesel furnace, which was arranged 1 year ago in the church.

To the right: Interior of the church

Due to the heavy condition of painting layer, it requires full strengthening. Above mentioned implemented works considered only urgent point-by-point type strengthening of painting layer, as defined under the project. In future, it is necessary to take into account the fact that the painting layer requires full conservation works, in order to thoroughly strengthen and maintain the above-mentioned wall painting, in the up-to-date form.

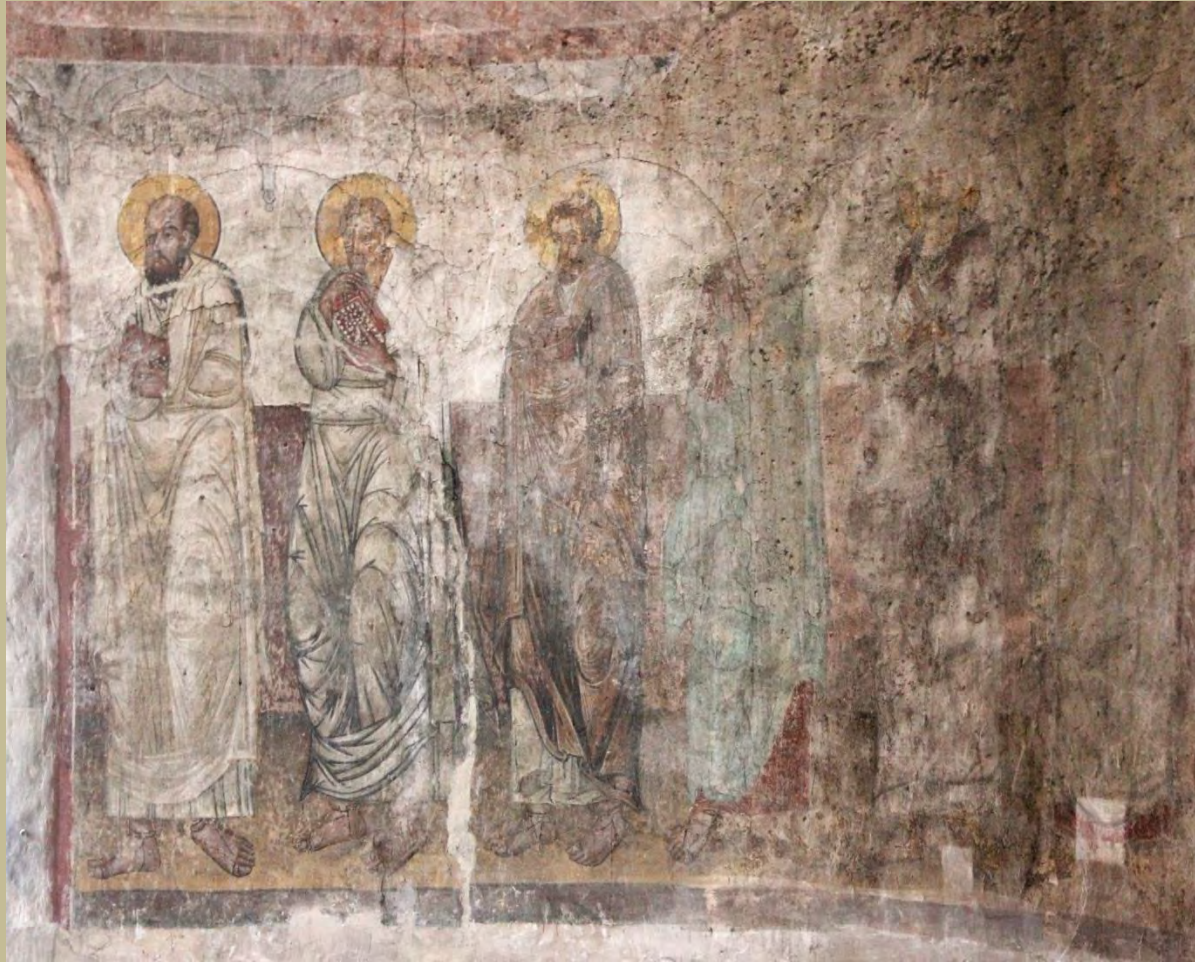
In many areas, the thick layer of soot on sanctuary painting is hung as unusual scraps on the surface. Presumably, under the influence of surface dirt, the diesel emission has created such an unusual and oily cover, which undoubtedly poses a threat to the painting surface.

To the left: Sanctuary of the church (detail 1)

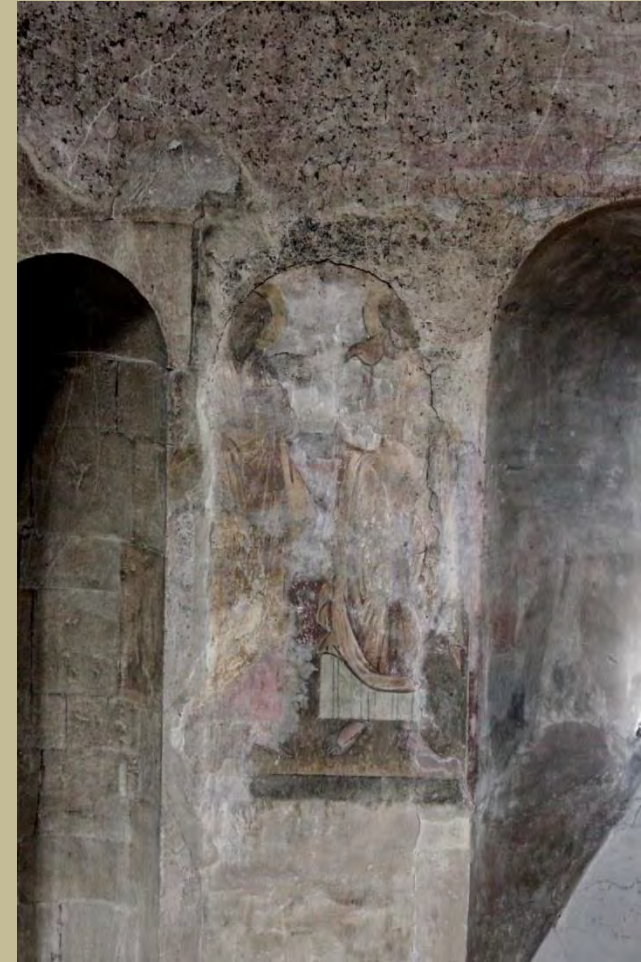
To the right: Sanctuary of the church (detail 2)

Based on the visual examination, the cracks are observed on the layer of painting – it is also clear, that the exhaust has penetrated into the plaster cracks.

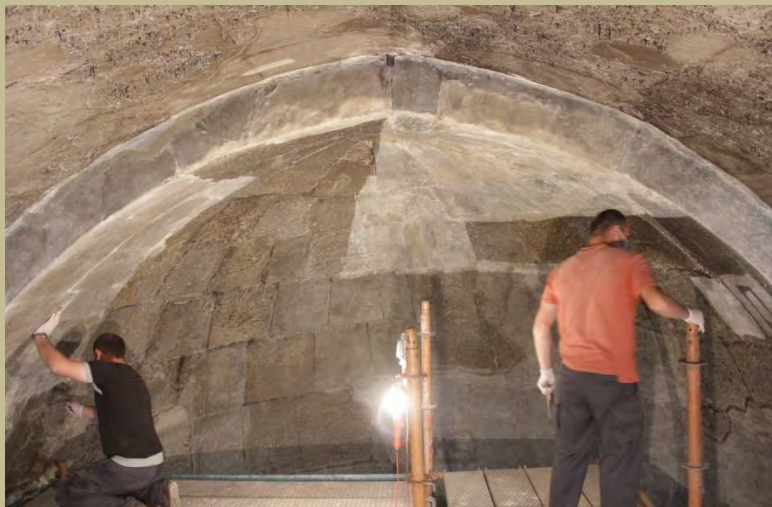
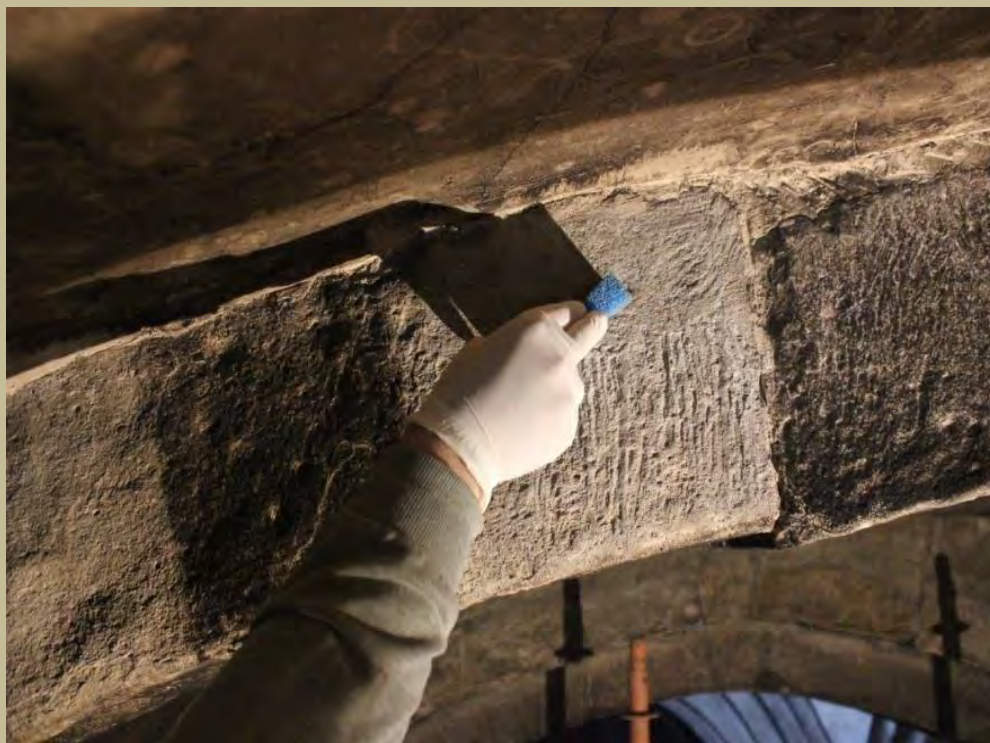
Photo: The process of cleaning of stone surface with sponge

In the church interior, the stone surface was cleaned via dry method, using the brush; and in some places, where the soot layer was firmly rooted on the stone surface, has been brushed off with sponge.

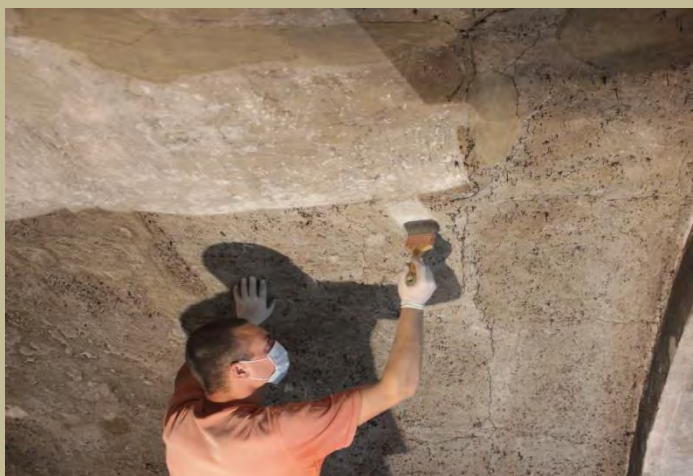
Photo: the process of cleaning of stone surface

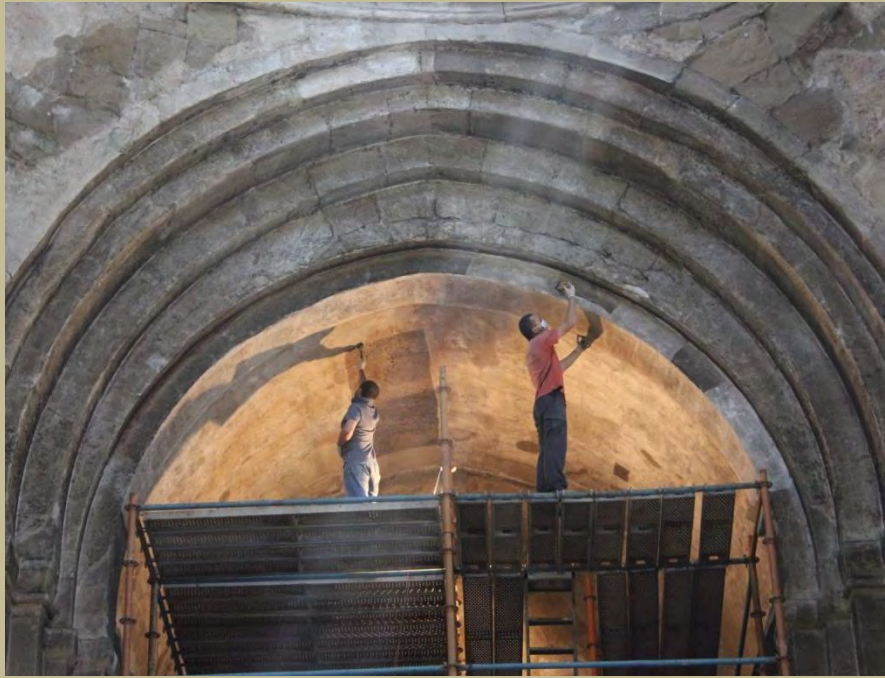
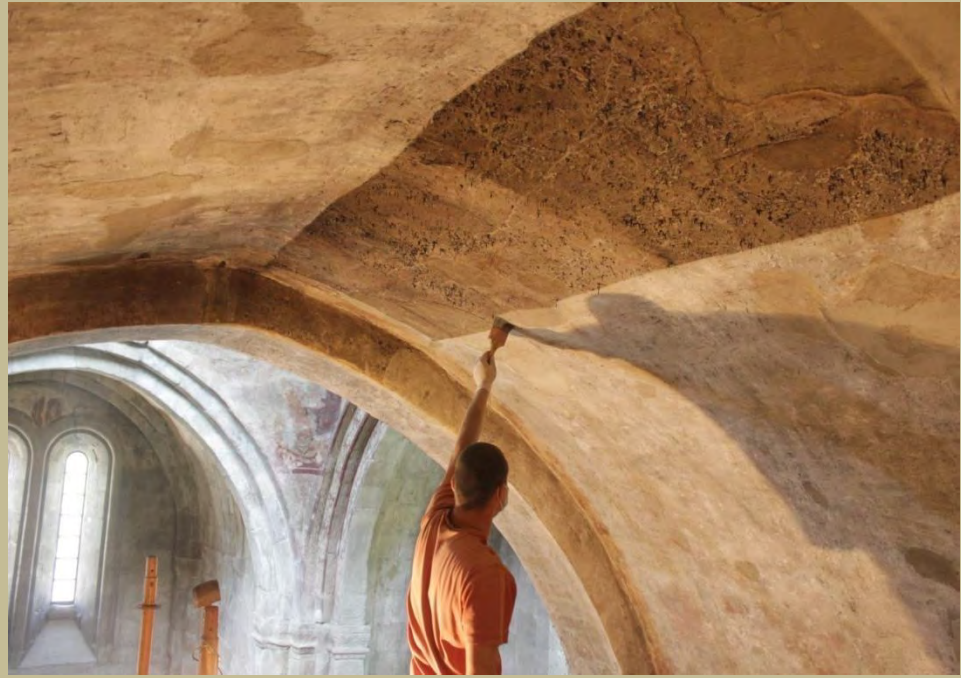
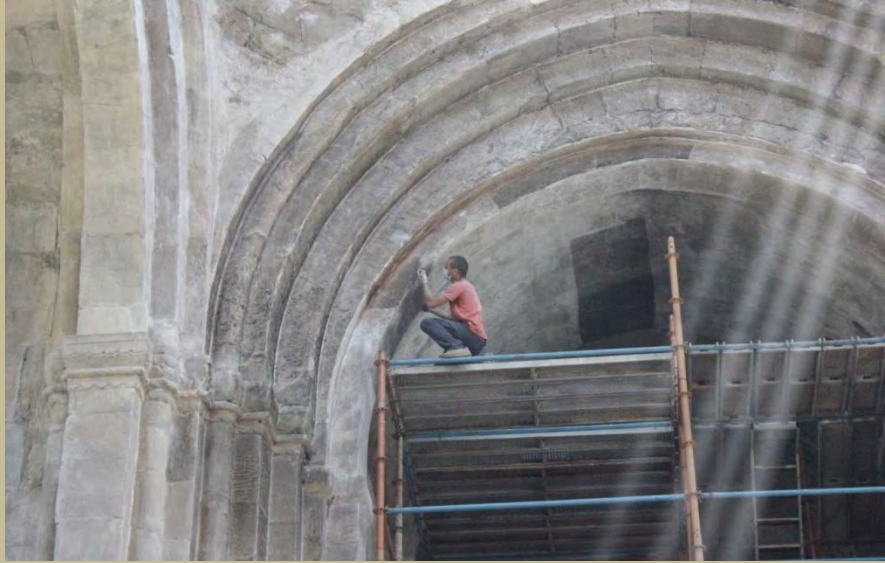
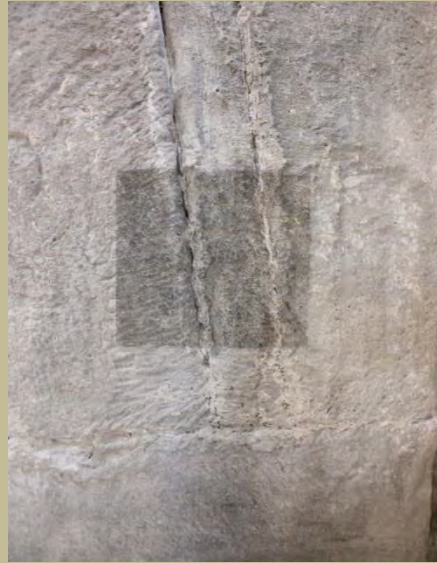
Photo: The process of cleaning of stone surface in the sanctuary

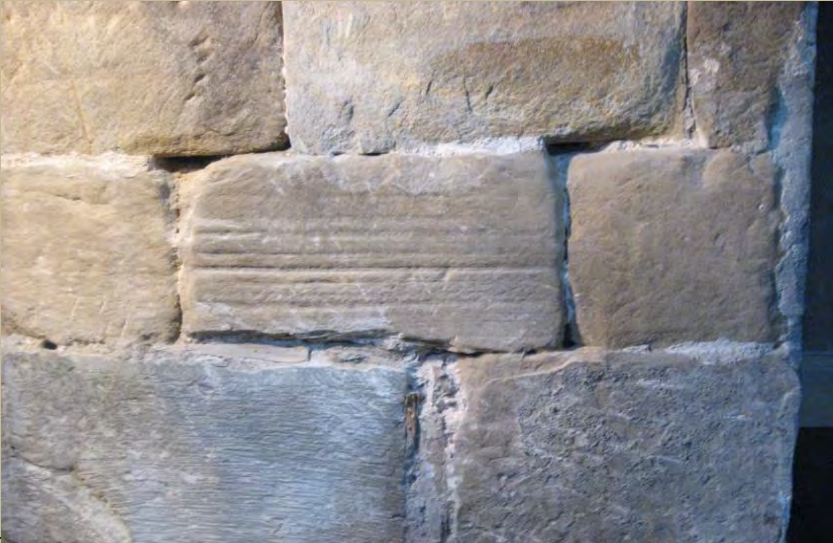
In the sanctuary, where the facial stone had losses in the form of chips, the gaps were filled with lime solution. Proportion: 1 lime, 1 quartz sand, 2 coarse fraction black sand, fiberglass tabs.

Photo: Before filling with solution

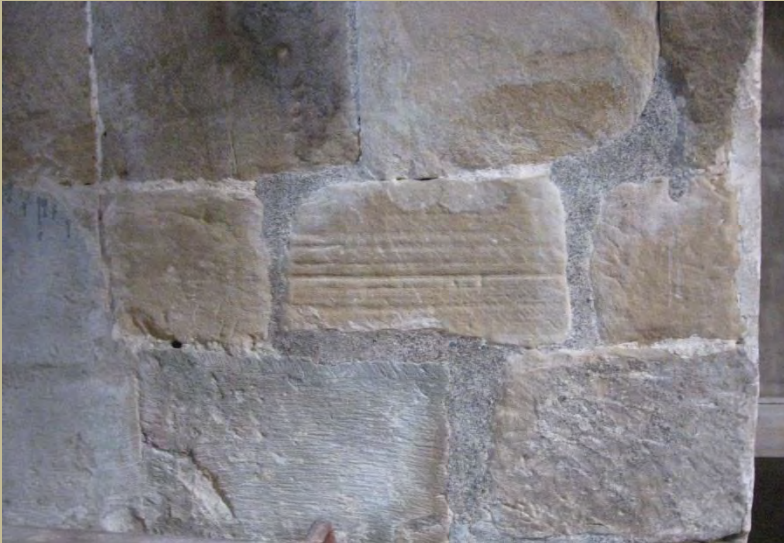
Photo: After filling with solution

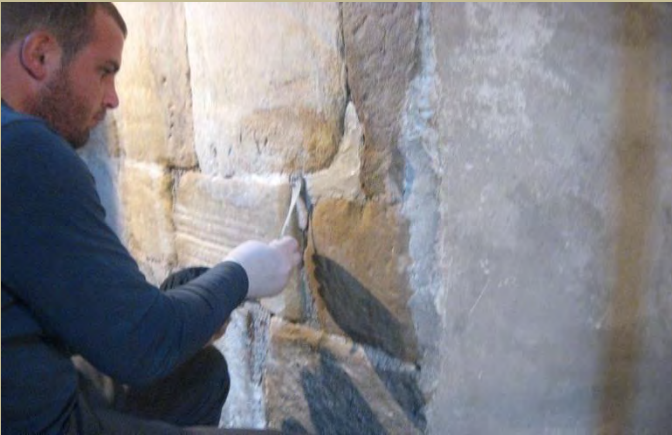
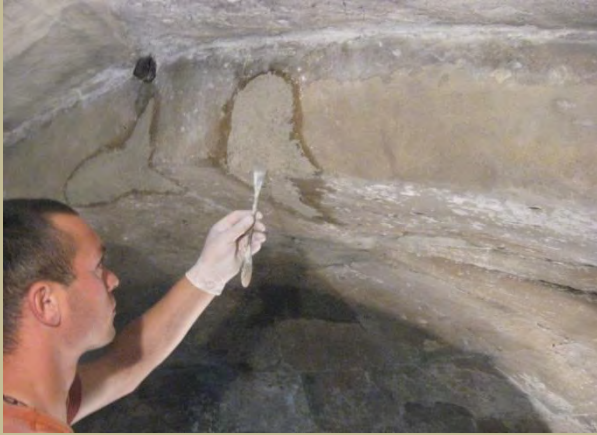
Photo: Working process

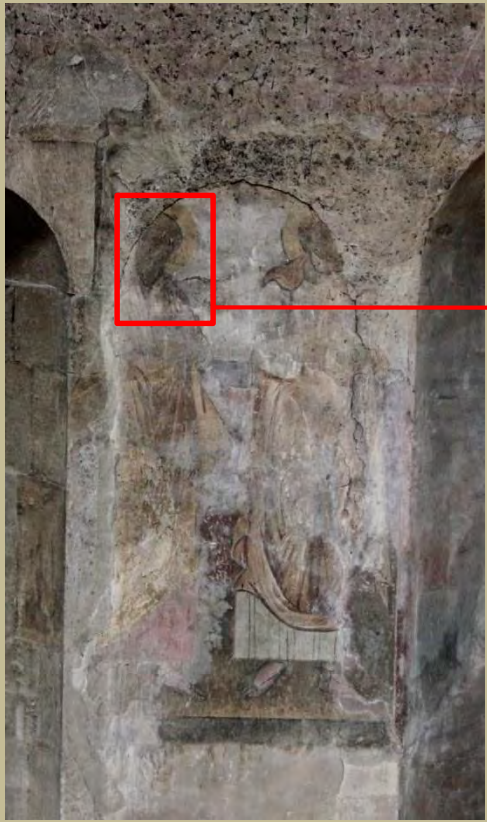
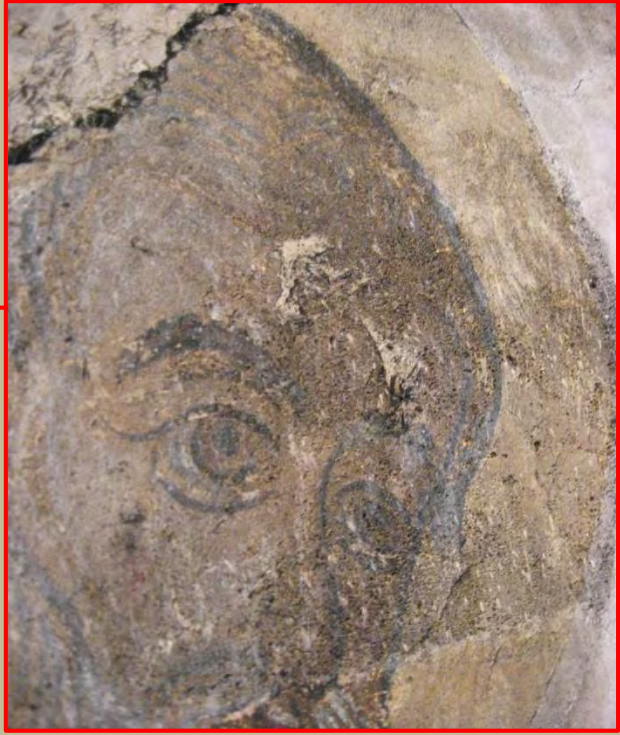
Photo: Before strengthening, detail 1

In order to keep the painting layer, initially peeled and damaged sections have been slightly moistened with alcohol-water 30% solution; the solution was applied using syringe, in order to make it easier to subject it to the strengthening processes. Following this process the surface was strengthened with 2% primal (SF 016). In the sections, where the painting layer was stable, the soot layer, existing on the painting, has been removed using a soft brush.

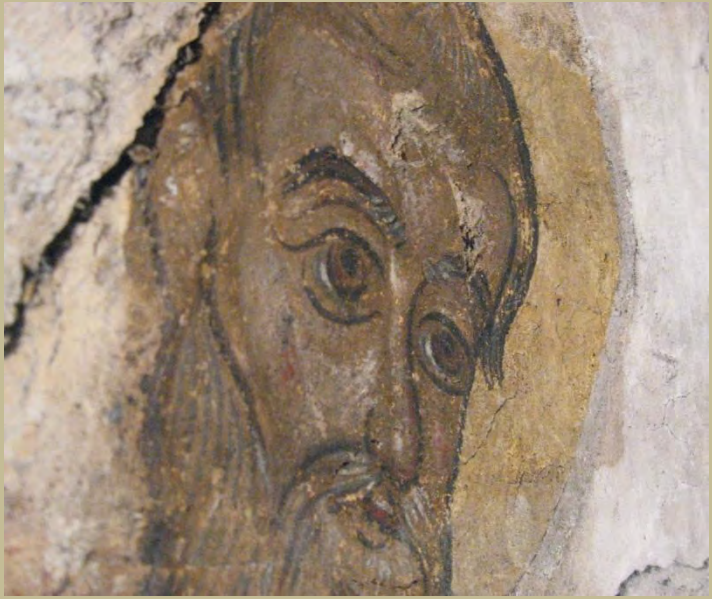
Photo: After strengthening, detail 2

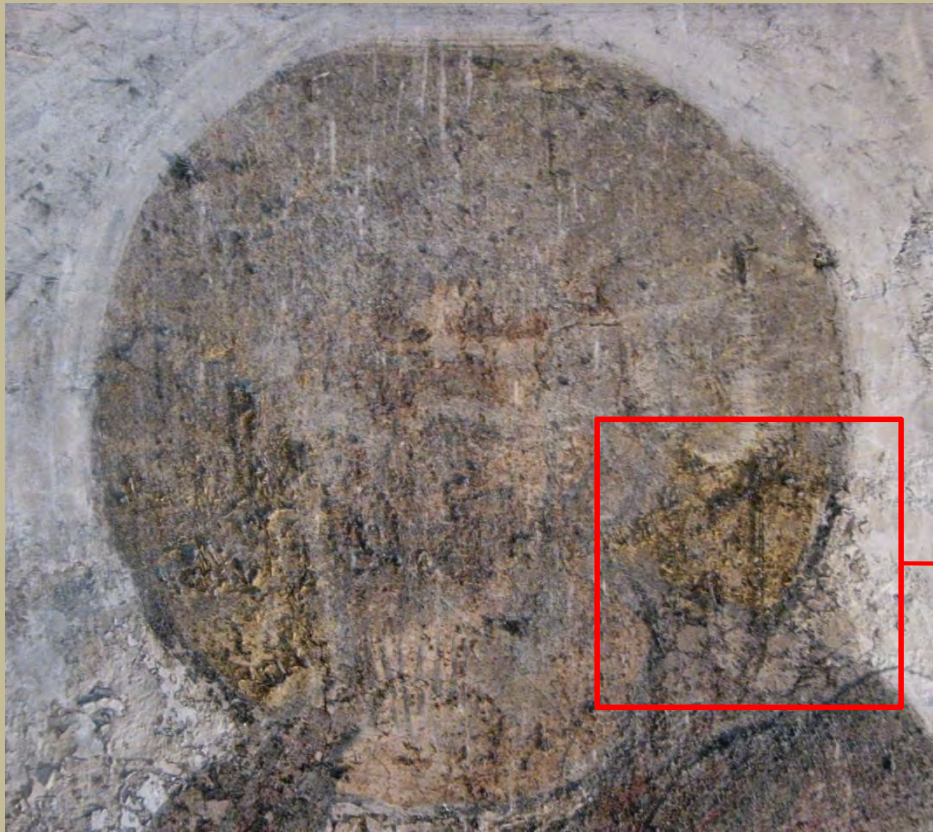
The damage of the color layer, peel off and loosening, which covers the whole area of sanctuary painting, could be considered as one of the strongest damages.

The photo above: The church sanctuary, the Saint's image before strengthening of color

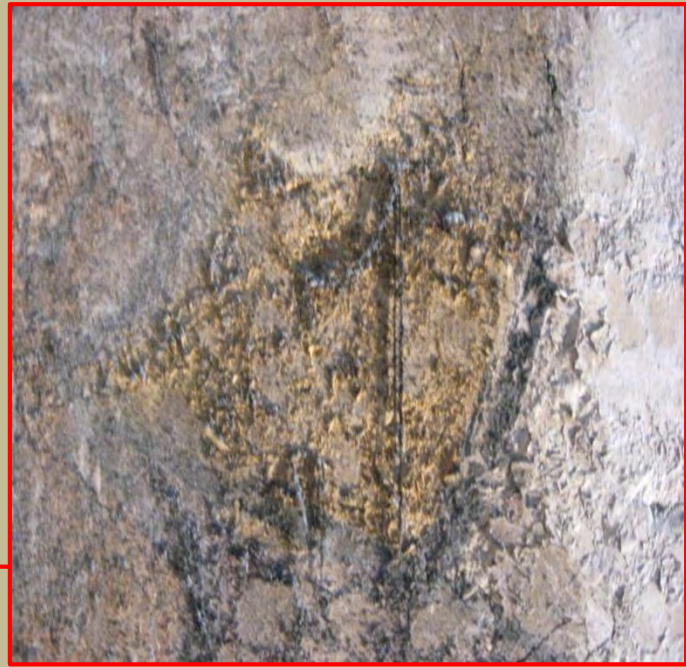
Photo: detail 1

Photo to the left: Before strengthening: detail 1

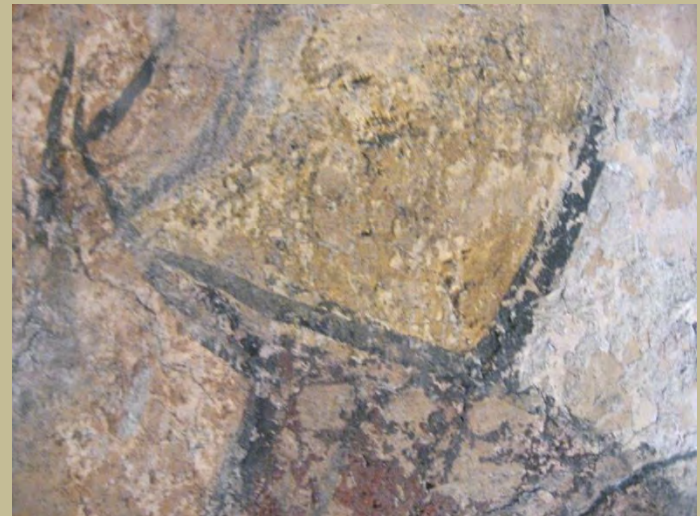
Photo: detail 2

Photo to the left: After strengthening, detail 2

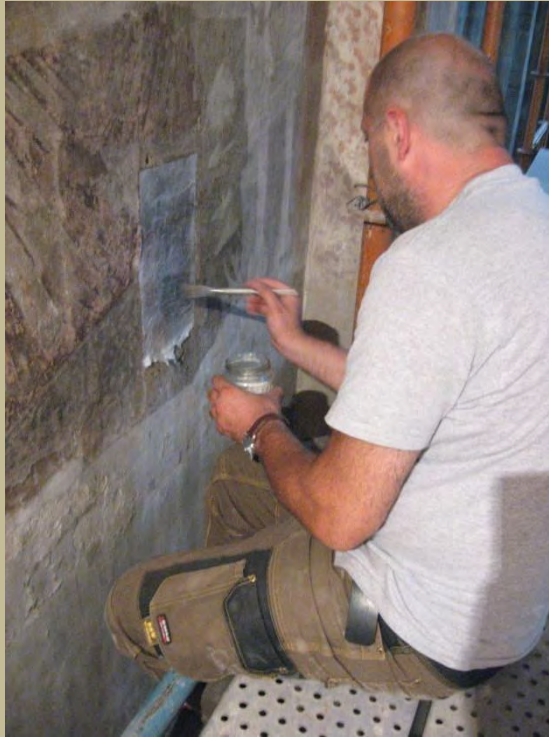
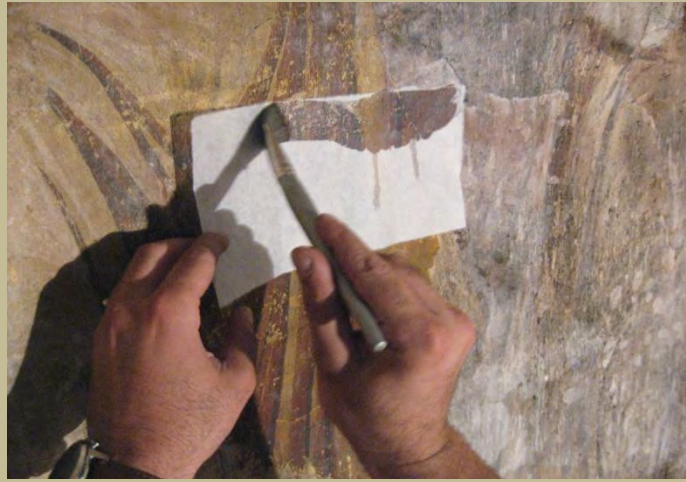
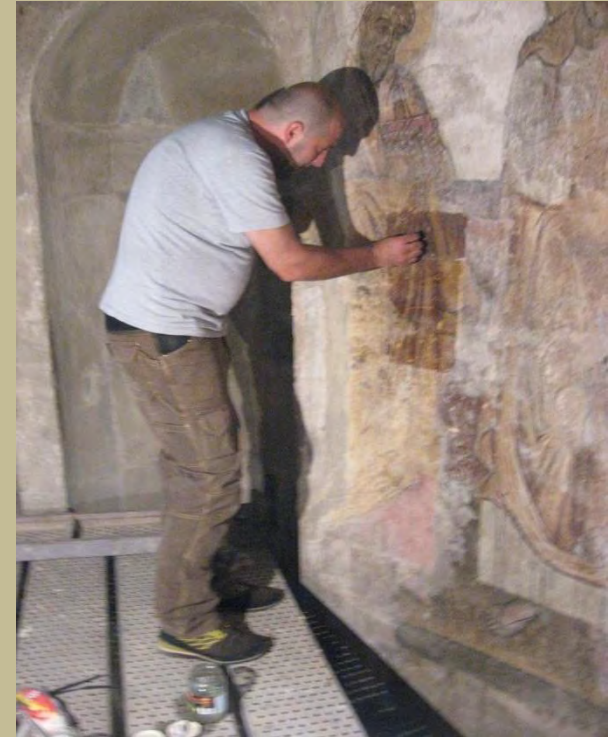
Photo: The process of strengthening of color layer

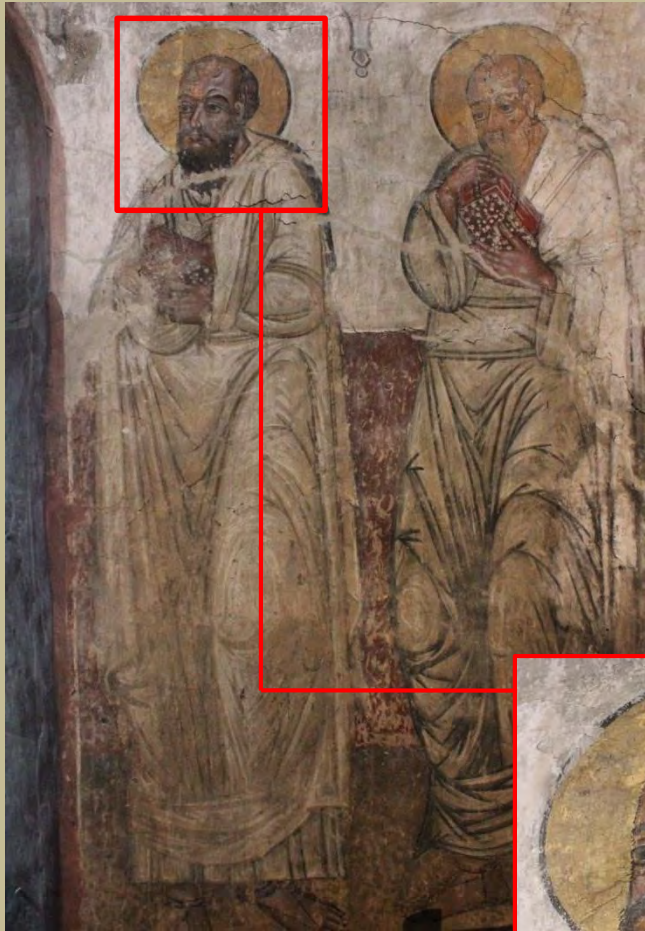
Photo: After restoration

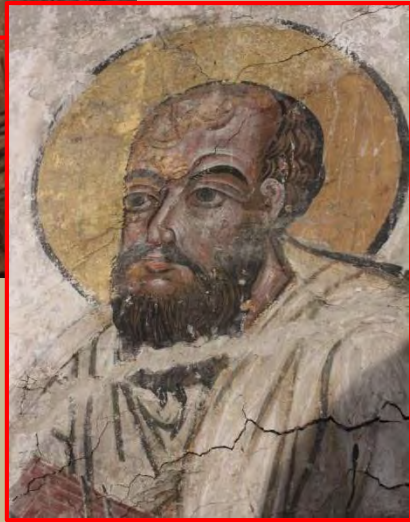
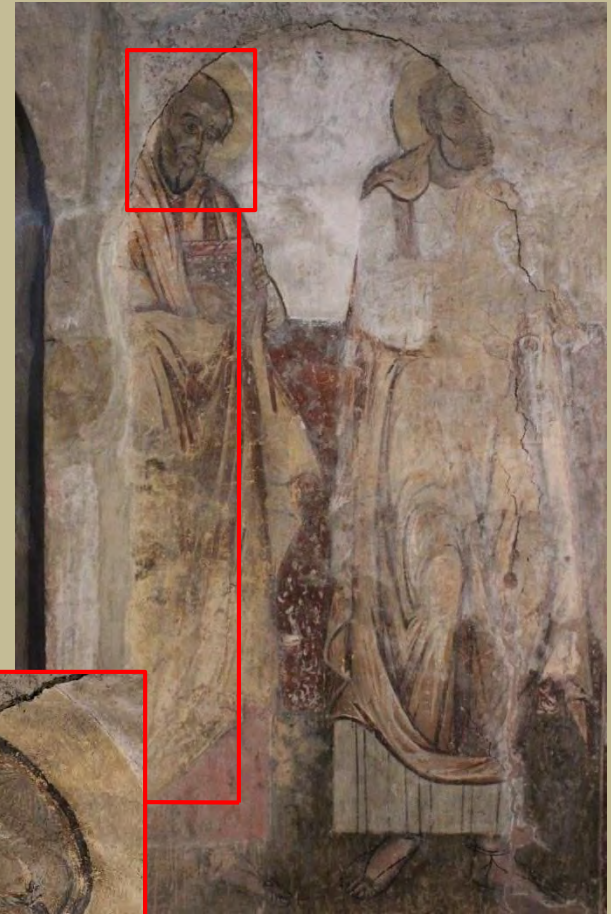
Photo: After restoration
