Evaluation mission 1
on the reconstruction of

Muzibu-Azaala-Mpanga
Tombs of Buganda Kings at Kasubi

A World Heritage property of Uganda

*Mission undertaken from 9th to 23rd May 2014 by
Sébastien Moriset, architect, CRATerre-ENSAG*

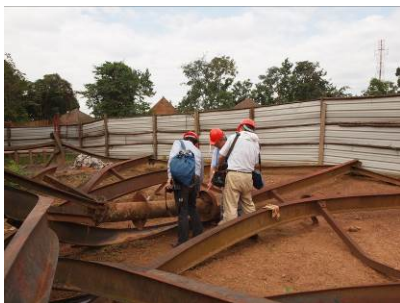
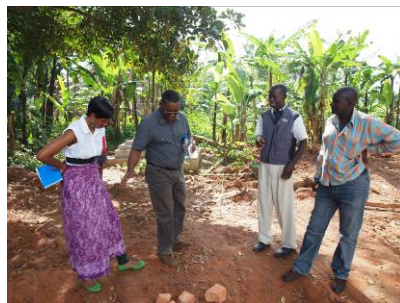
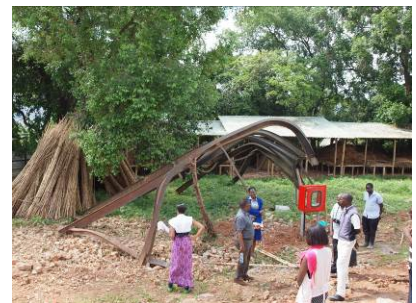
Site inspection and discussion on new developments with contractors and architects Nsubuga and Namayanja

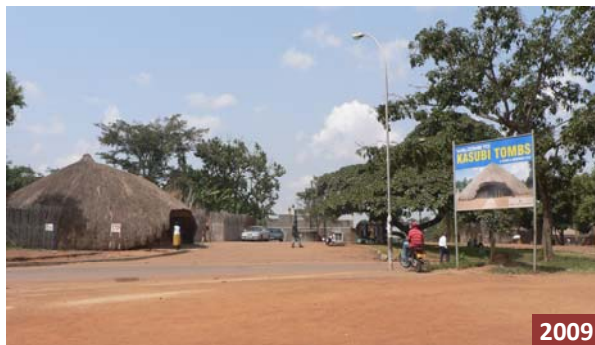
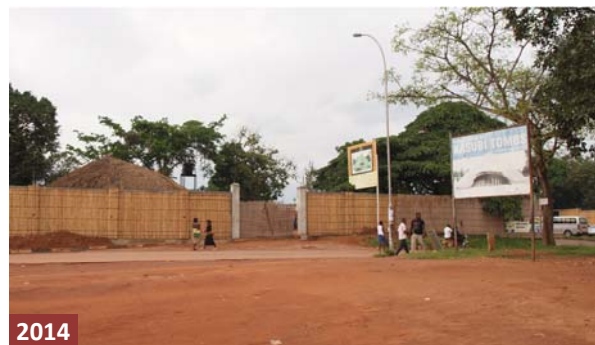
The site entrance has however been altered with the addition of a high wall hiding the entrance. The former large esplanade that marked the site entrance has disappeared behind this new fence. Bujjabukula is also hidden, whereas it should strongly mark the entrance. This affects the authenticity of the spatial layout in a significant way.

Entrance to Kasubi in 2009 and 2014. Bujjabukula and the esplanade have disappeared. There is no more space between the road and the entrance.

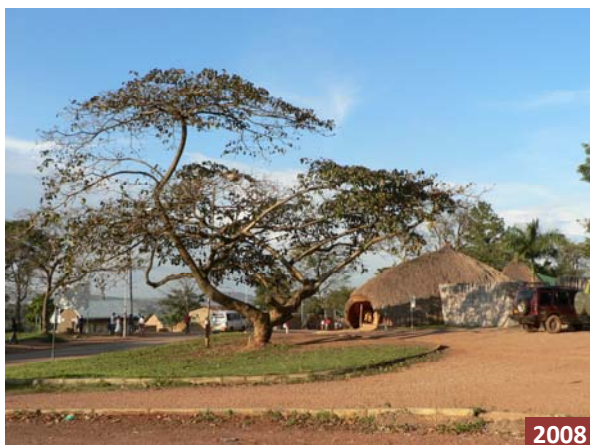
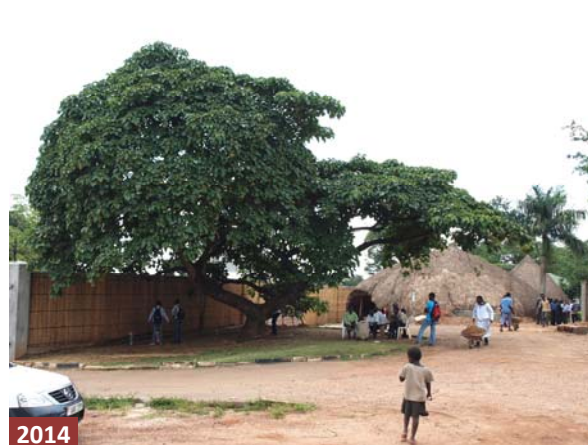
Entrance to Kasubi in 2008 and 2014. This large area is no longer accessible to public. This is unfortunate, because it allowed exchanges between the custodians and the local population. The guards have expressed their feeling being locked up. They are no longer able to communicate with the outside.

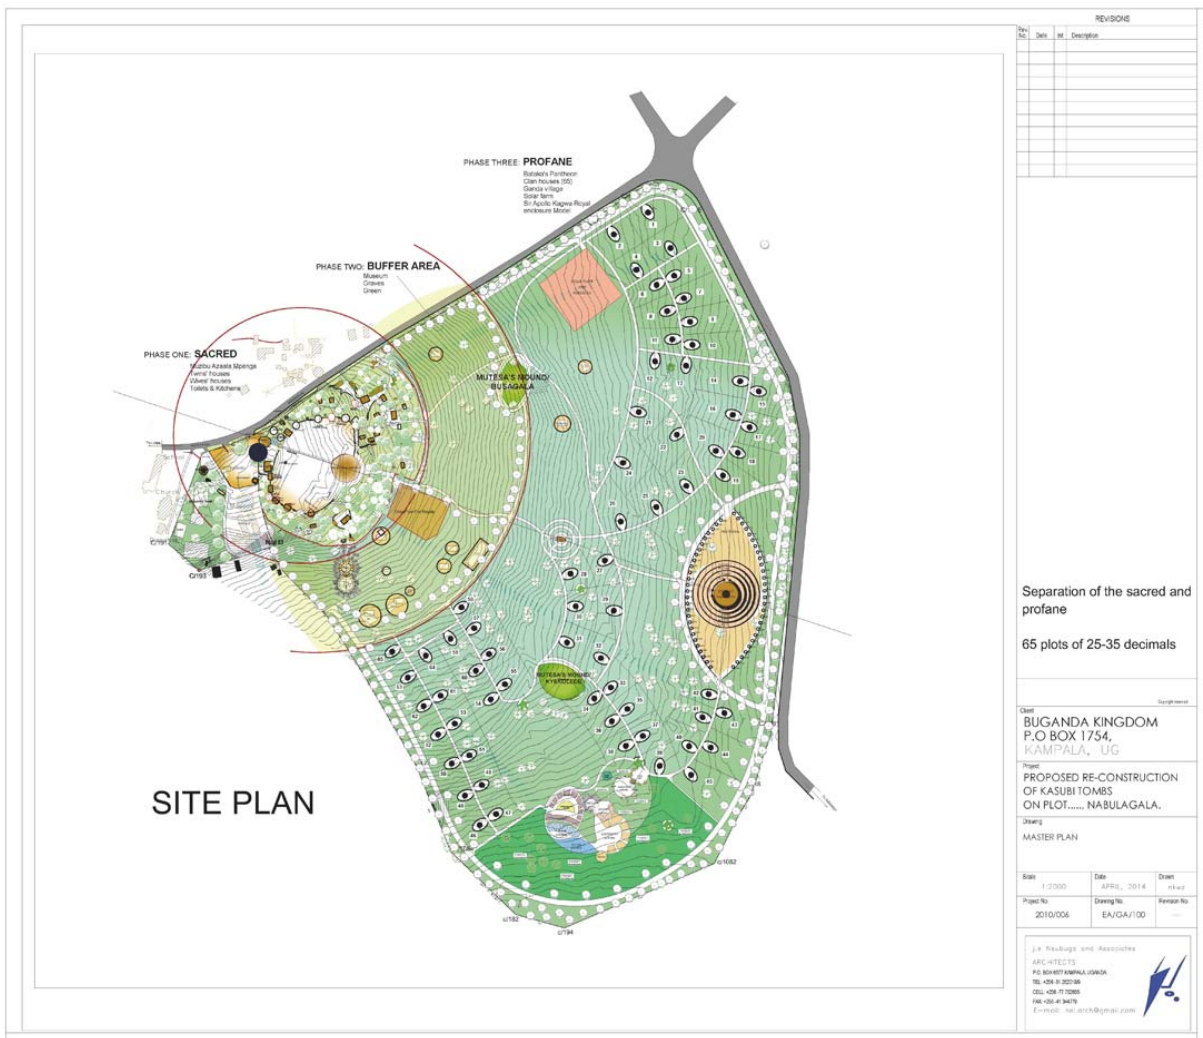
One of the Master plan options prepared by J.E. Nsubuga & Associates

The transformation of the farmland into a recreation area will completely disrupt the existing balance between sacred and profane activities.

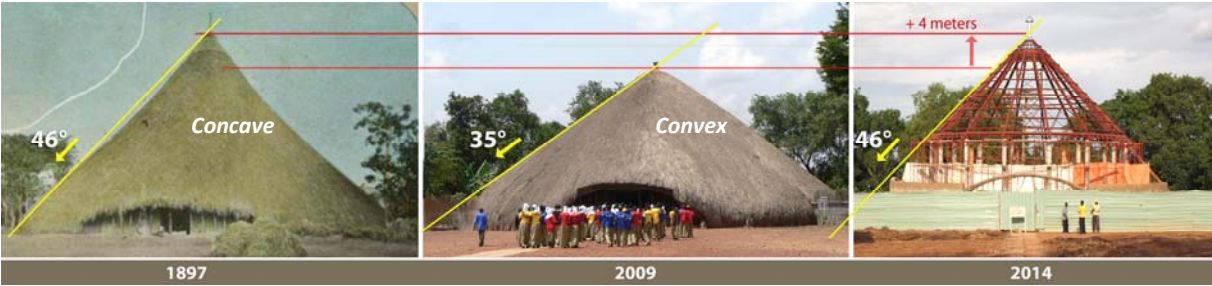
The steel structure is now in place. The structural engineers and the architect have done an excellent work. The roof has been restored to its 1895 shape with a steep slope that will better drain off rainwater. The new structure is also designed to be more resistant than the previous one, and will receive a special coating to resist fire. The beams sections and material strength have been increased. The place is now set to receive the wood structure, the reed work and the thatched roof.

Comparison of the roof shapes in 1895, 2009 and today

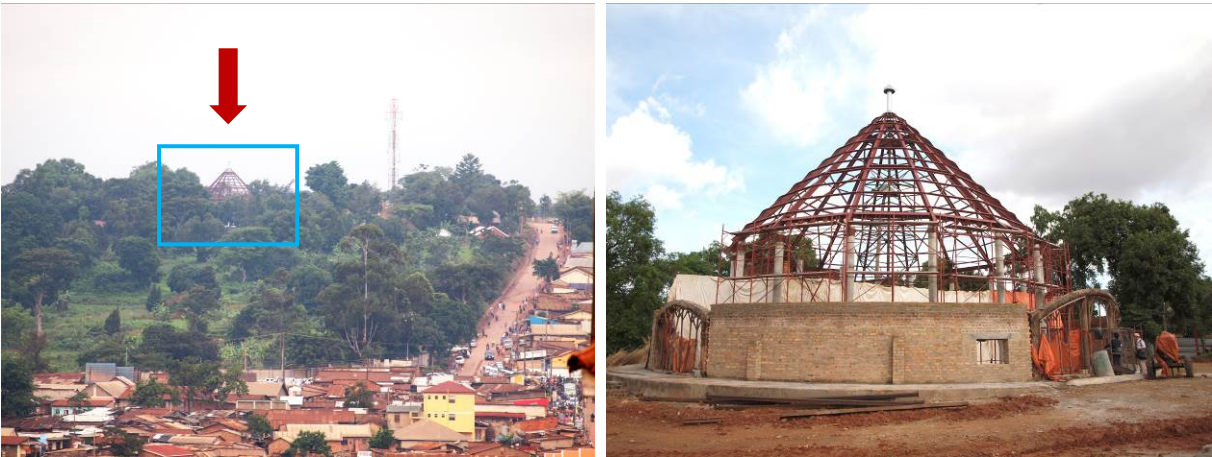
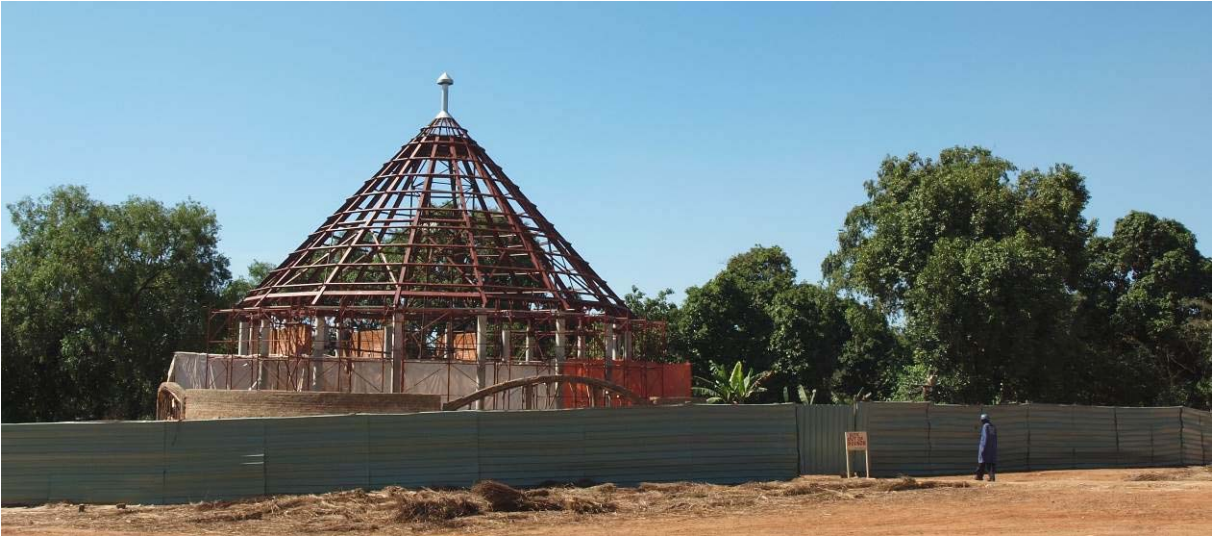
Muzibu-Azaala-Mpanga in May 2014

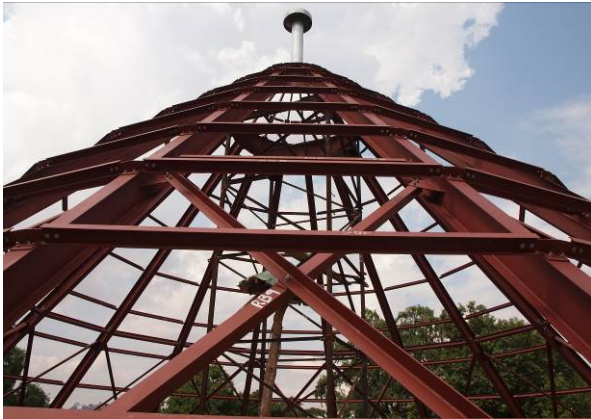
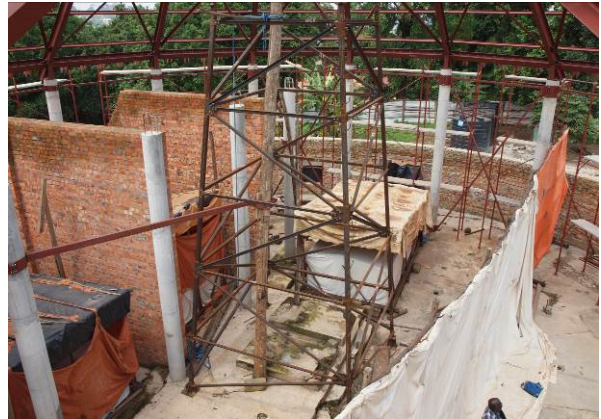
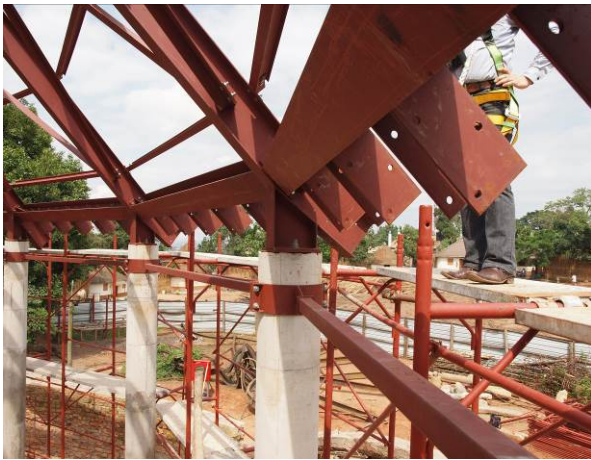
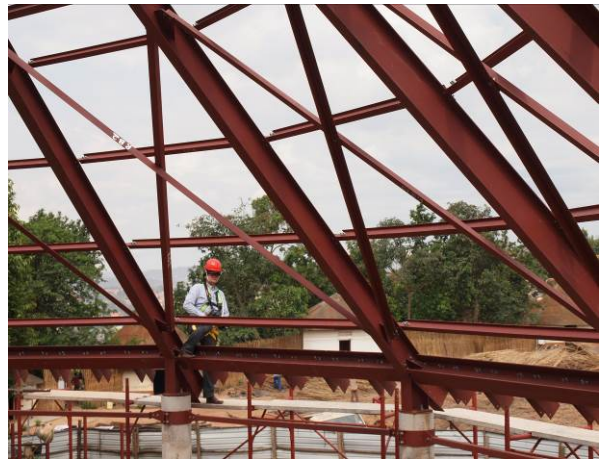
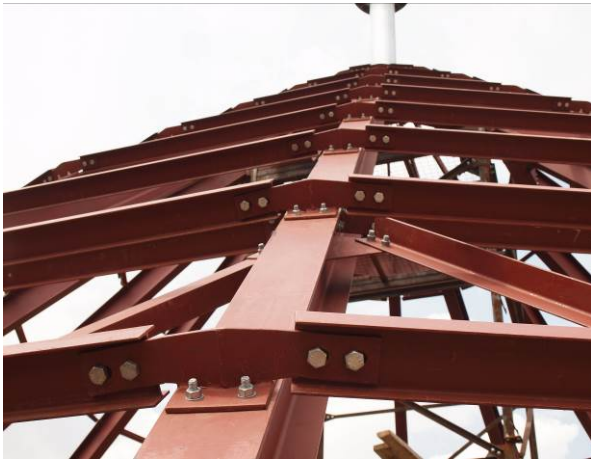
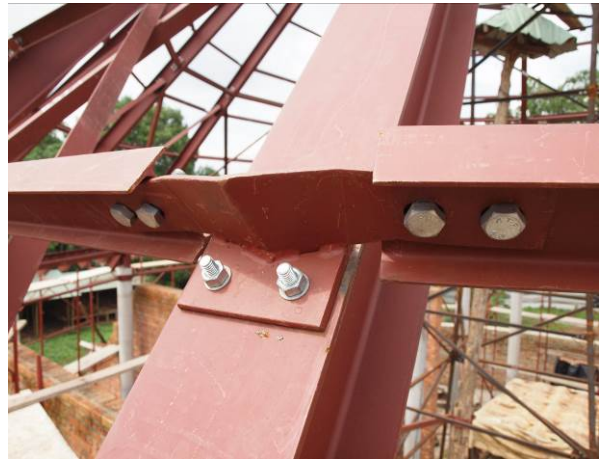
Details of the new roof structure

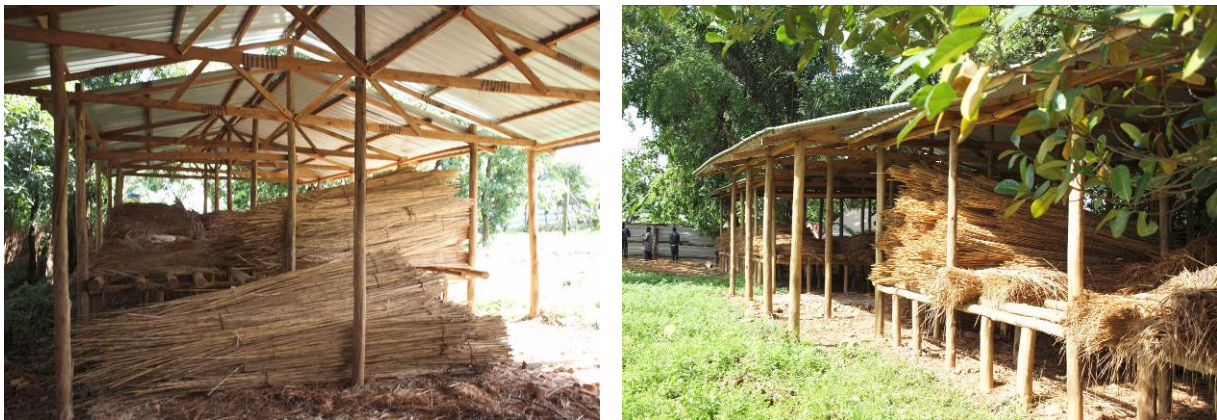
Both Wamala and Kasubi will need permanent storage houses to keep thatch bundles for repairs. Temporary houses have been erected at Kasubi and Wamala for the duration of the restoration campaigns. The Wamala version with shelves is the most efficient one. It allows perfect ventilation and storage of high quantities of grass in 6 layers. After completing Wamala, this house can be dismantled but a smaller version of it should remain at the site to constantly supply grass for regular maintenance.

Storage houses behind Muzibu-Azaala-Mpanga at Kasubi

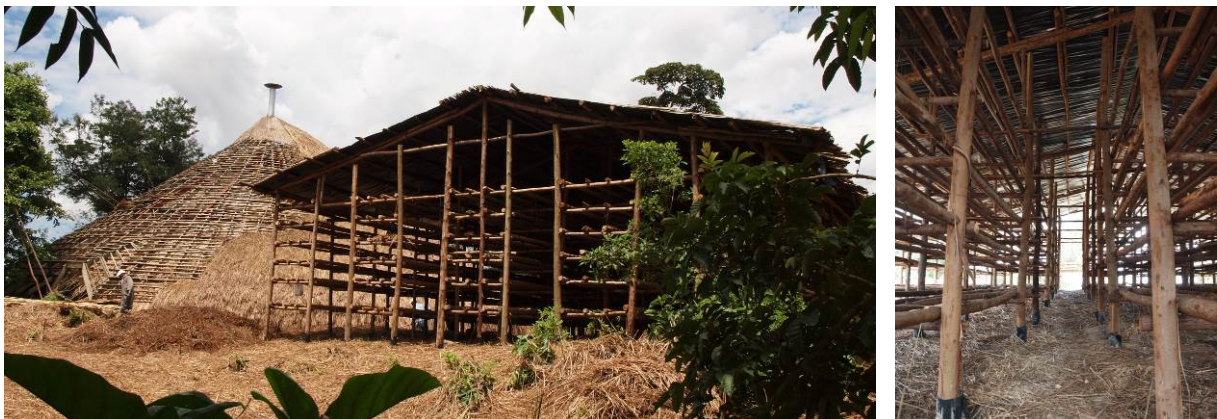
Ideal storage house with shelves at Wamala

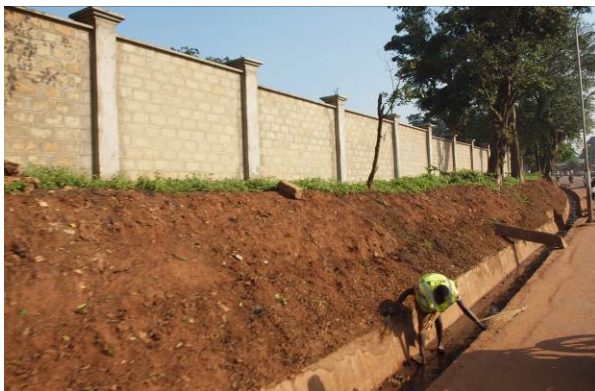
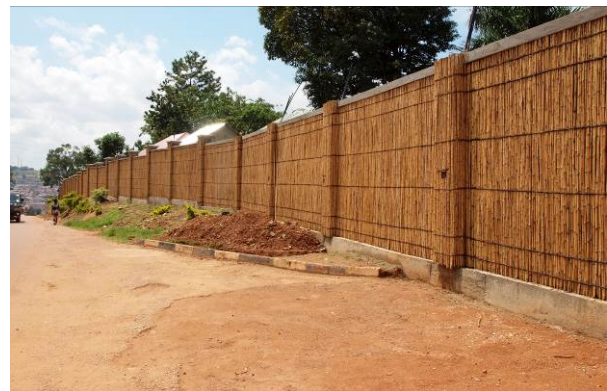
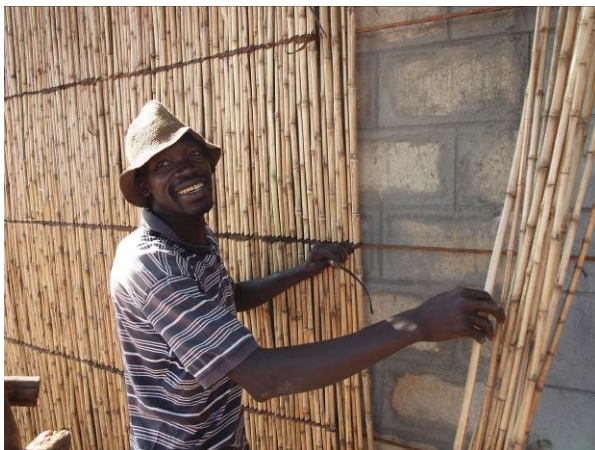
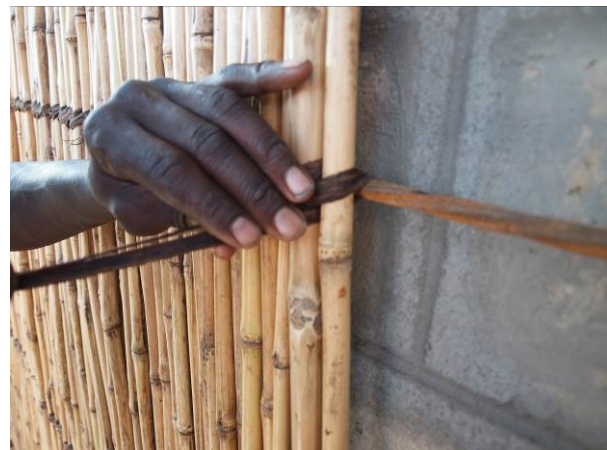
The new fence is made of concrete blocks instead of the traditional reed fence. Considering the urban context and previous experiences, the choice of a more resistant material can be understood. However, the design should have been discussed with the Museum conservators and UNESCO, to share ideas on the various options and analyse archival materials. The paneled wall with capitals and lamps on each pillar does not refer to ganda architecture. To minimize the visual impact of the wall, reeds are currently placed on the external wall face, carefully tied to a metal structure. This is much better than the exposed cement wall, but a preliminary impact assessment would certainly have simplified the design. This make-up operation will not restore the authenticity of the place.

The new perimeter wall and the current installation of reeds to hide the cement blocks

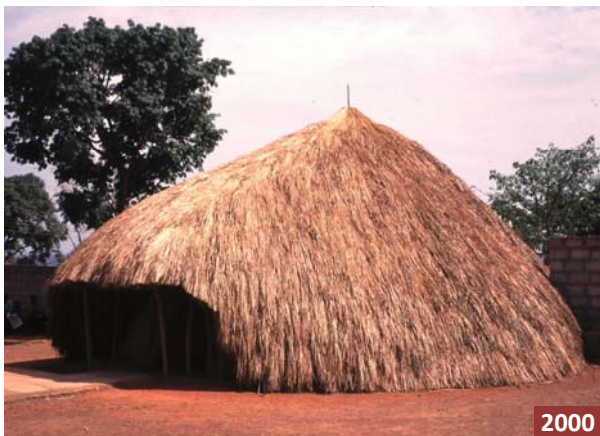
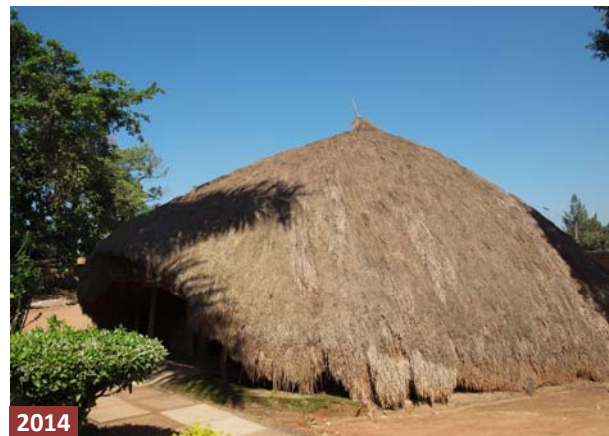
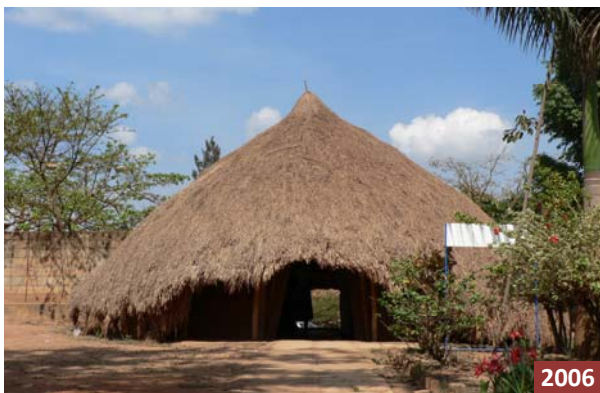
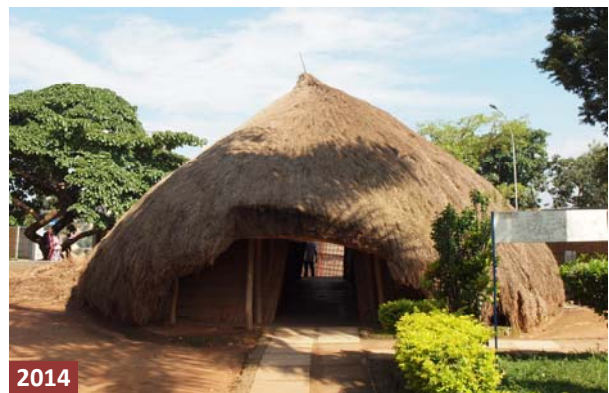
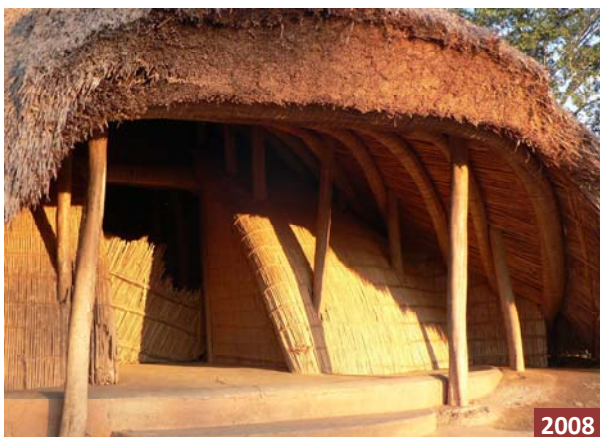
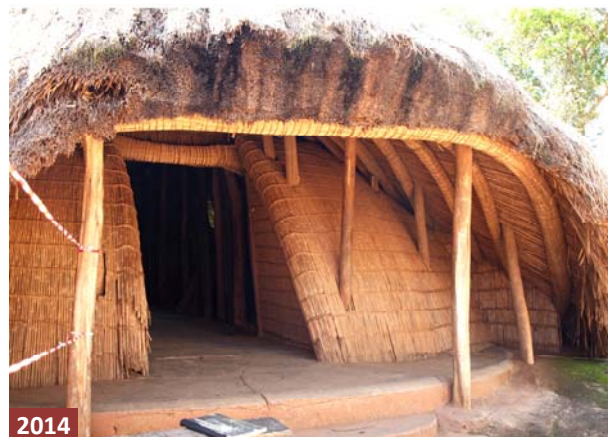
Bujjabukula is one of the strongest architectural elements of the site in terms of authenticity and integrity, hence the importance of keeping it in the forefront. All the building details have maintained a high degree of authenticity. The roof however needs repairs; it seems to have sunk in the center, and several gullies in the thatch need to be fixed. The photo comparison below shows that the building is well preserved. The main threats to this element are twofold:

- Construction of inappropriate concrete walls in front and on the sides, which overshadow this jewel
- Preparing food with an electric hob inside, increasing the risk of fire

Comparative analysis of Bujjabukula over the years

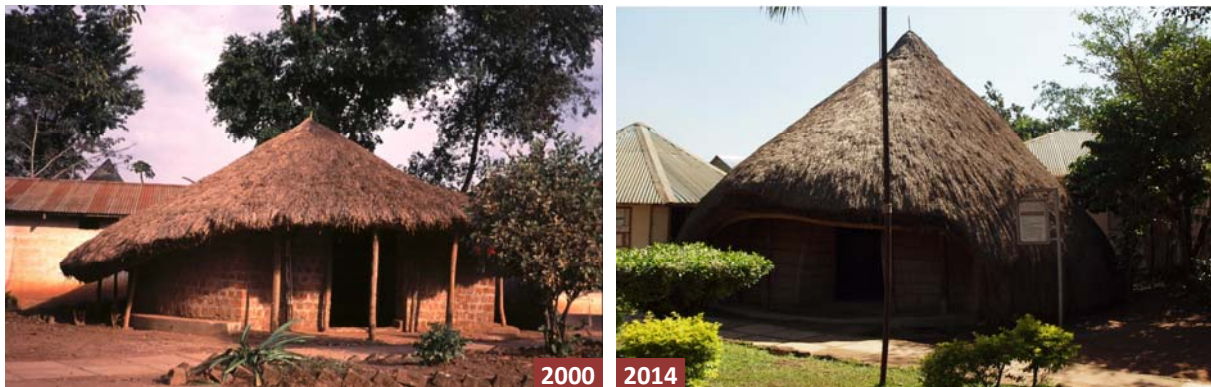
Ndogo-Obukaba before and after the 2006 restoration

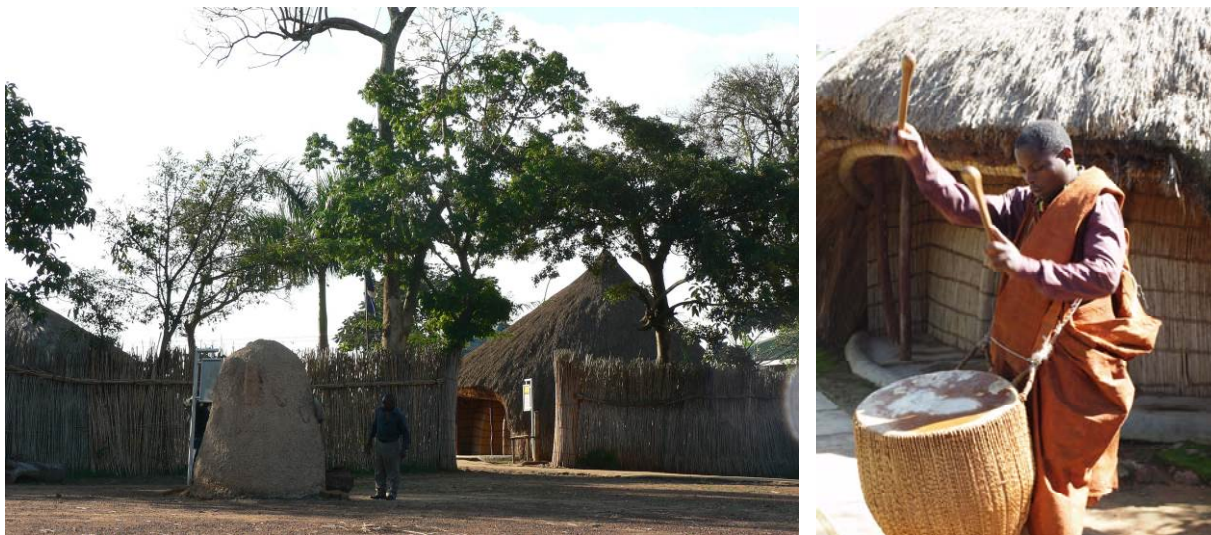
In 2014, Ndogo-Obukaba is one of the key features contributing to the site authenticity

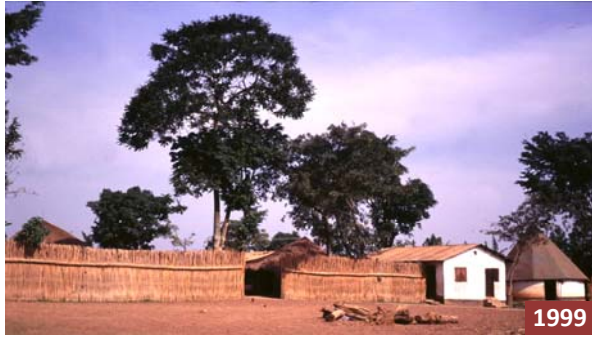
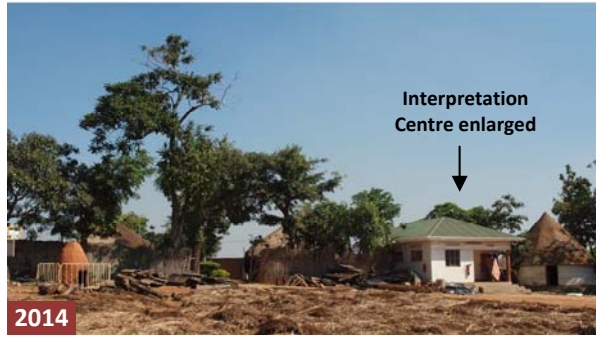
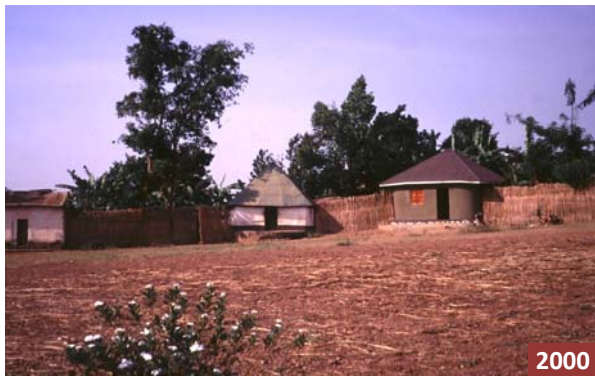
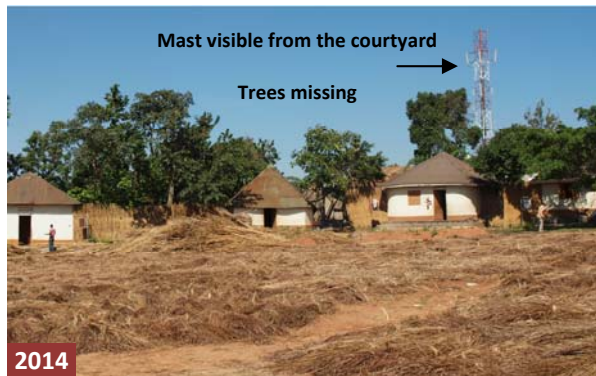
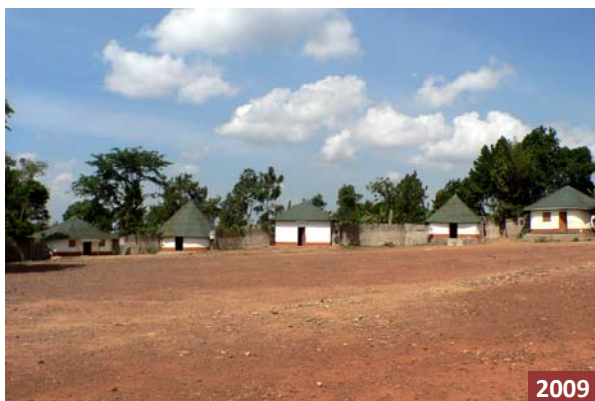
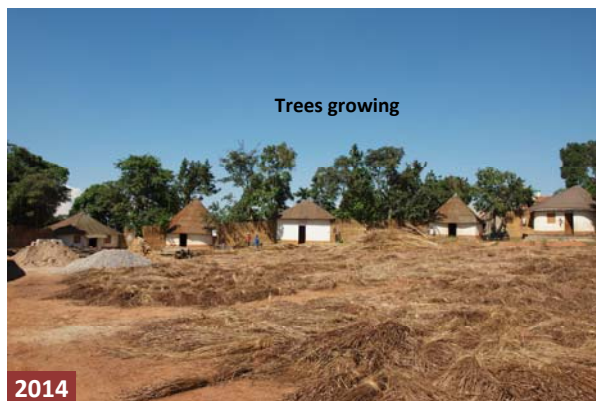
All the other buildings around the courtyard were rebuilt with bricks and metal sheet roofs in the 1960/70s. They have withstood the test of time but still lack authenticity. The green oil paint applied on the roof has been washed away. The roofs now have turned brown because of the corrosion of metal sheets. This new color is much more discreet in the site because it resembles the colour of thatch but still, the thatched roofs are the only option to reinforce the site authenticity. They are also the only roofs that Wabulakayole and his clan members are supposed to build on this site.

Evolution of buildings around the courtyard between 2000 and 2014

In the medium term, consistency must be restored in the architecture. All buildings should be representative of the Ganda construction techniques and be consistent in terms of roof pitch, materials, colour...

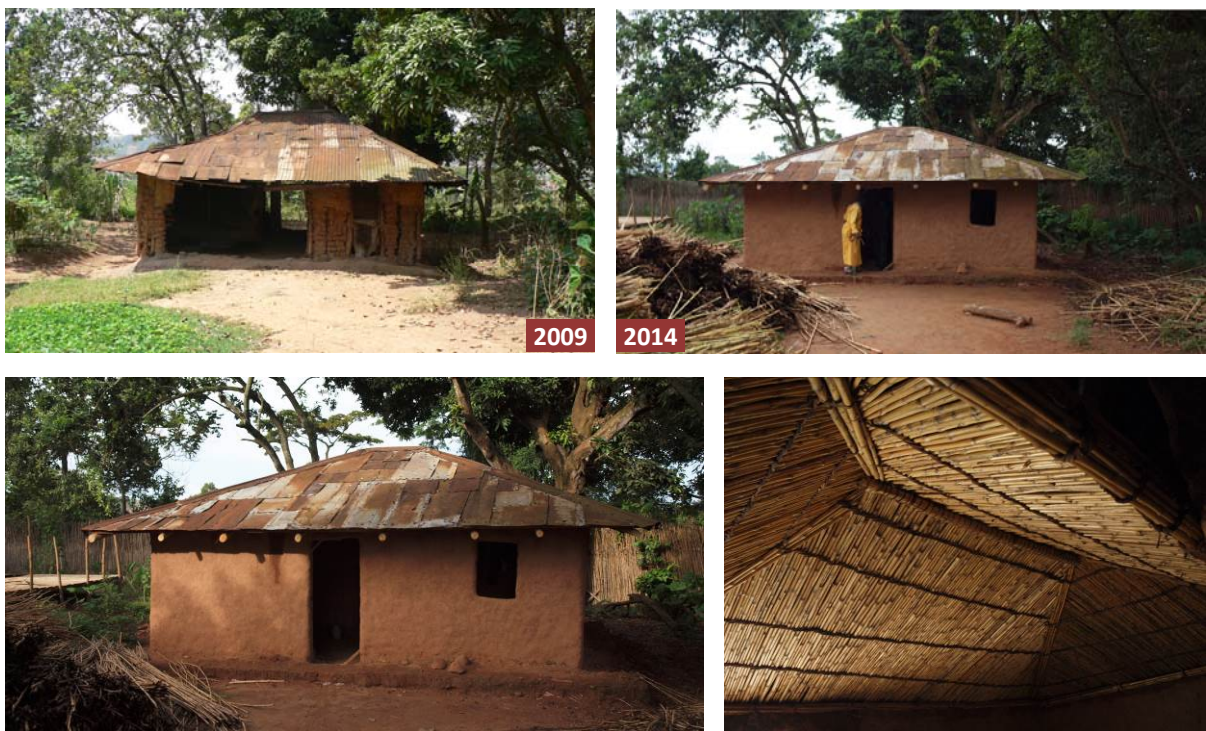
Wattle and daub house under restoration during the mission. This work is perfectly in line with the conservation and development of traditional skills

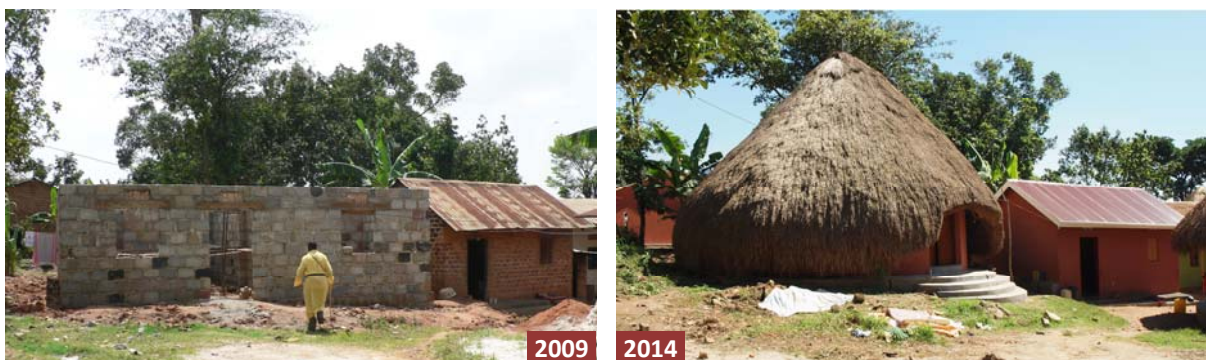
Abalongo Abasimbiri covered with thatch. This house replaces a cement building (left).

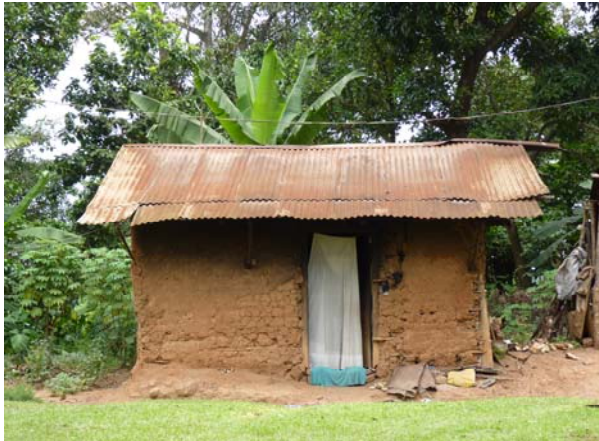
Mud house destroyed

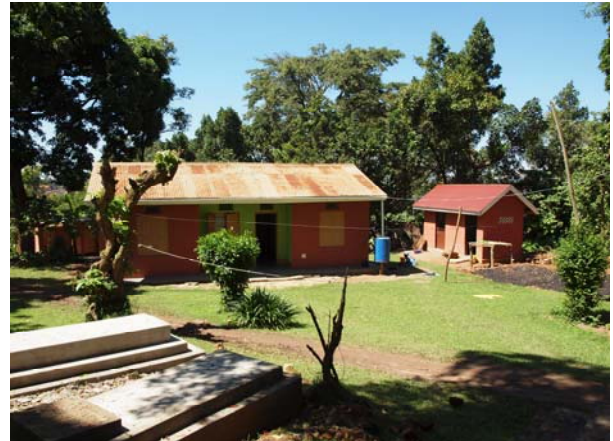
New concrete house with kitchen and toilet block built in the same location

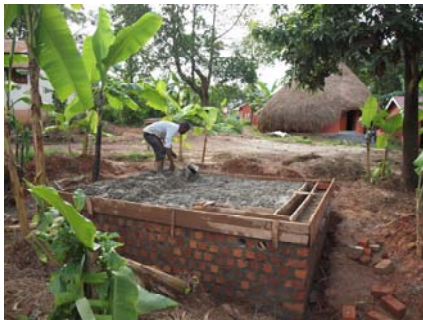
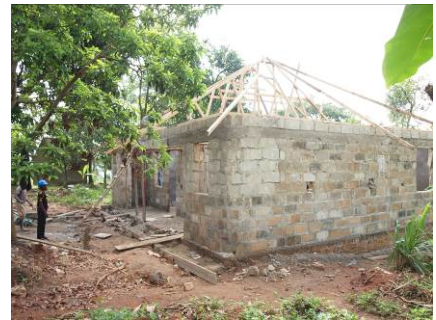
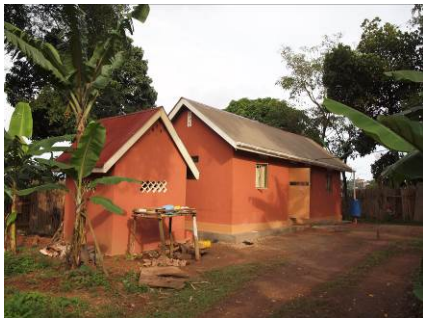
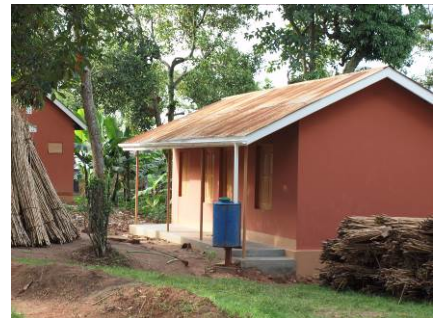
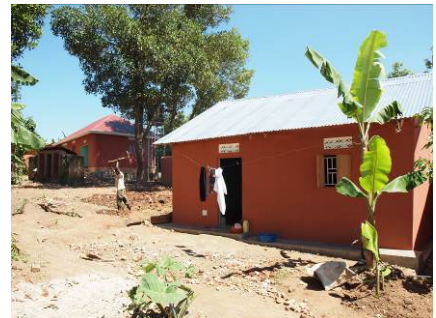
We regret that the architect who prepared the reconstruction strategy was not involved in the design of these houses that import an entirely new architectural style on site, which makes no reference to Ganda architecture and does not give the opportunity to Ganda craftsmen to practise their creative genius. Rebuilding these houses in a more traditional way would have offered the possibility to practice traditional skills and train more craftsmen.

New concrete houses built behind the courtyard in 2013/2014. Such buildings can be seen all over Africa, they do not reflect the fantastic skills and materials of the Buganda Kingdom.

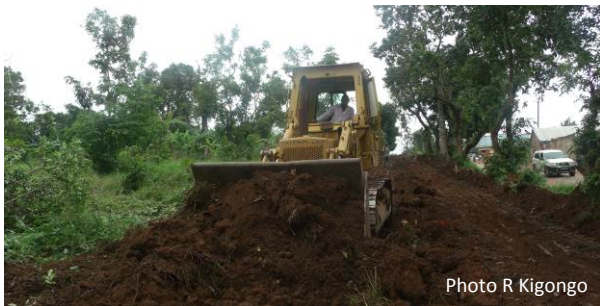
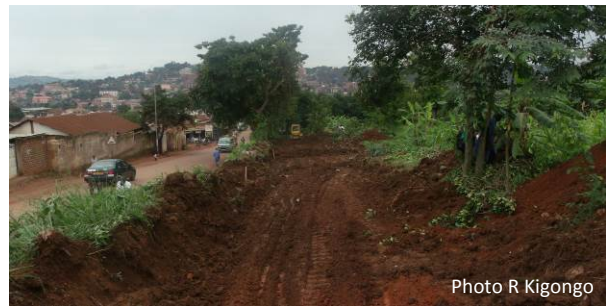
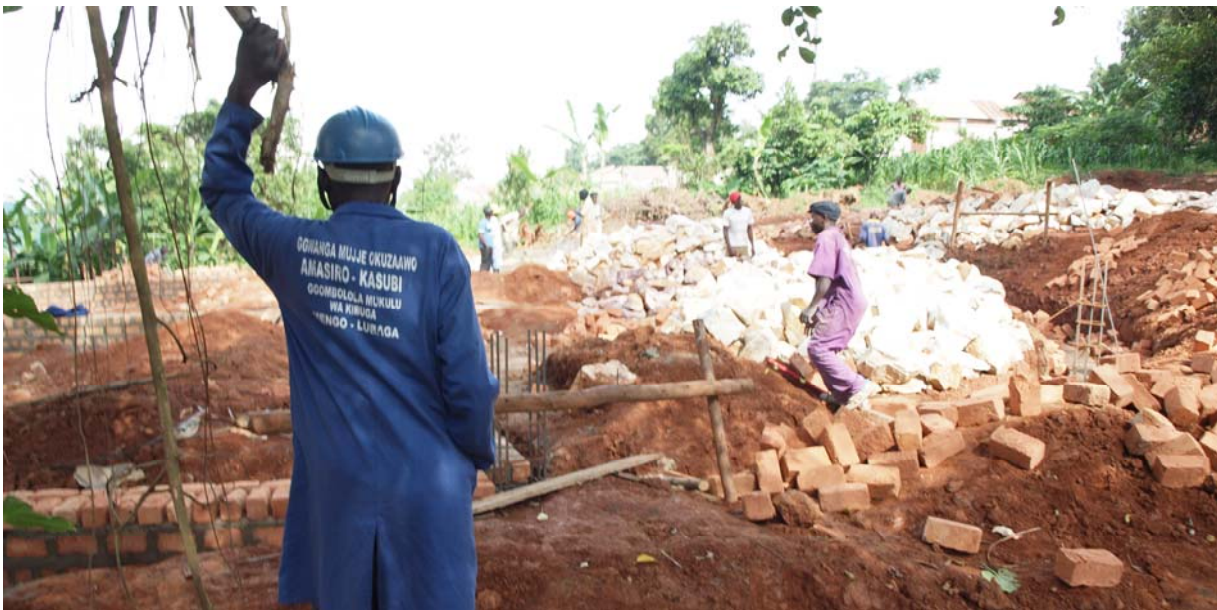
Works implemented without archaeological assessment. Historic data may potentially be disturbed or destroyed whenever new projects are implemented. What may be seen as an ordinary lateritic soil by contractors might actually contain valuable historic information that only archaeologists can recognise.

It is a key dimension of any historical site that experienced different phases of occupation, which is the case for Kasubi Hill. Any movement of ground must be preceded by archaeological studies to record traces of the past. Extensive works such as the perimeter wall or the platform under construction irresponsibly destroy layers of information that archaeologists can study and interpret, to enrich the historical value of the site. Kasubi is located near the university and the museum where archaeologists are easily accessible.

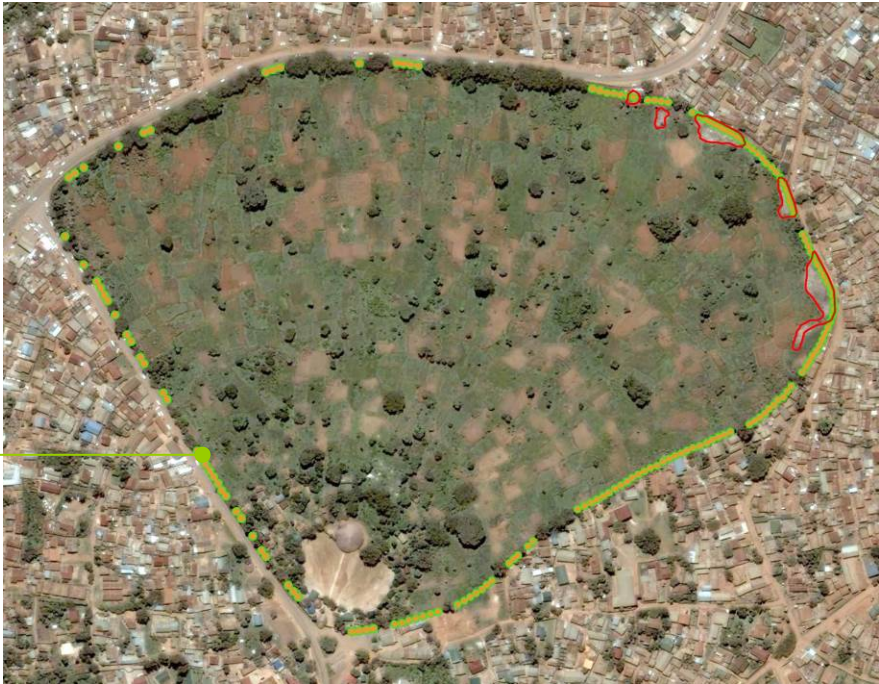
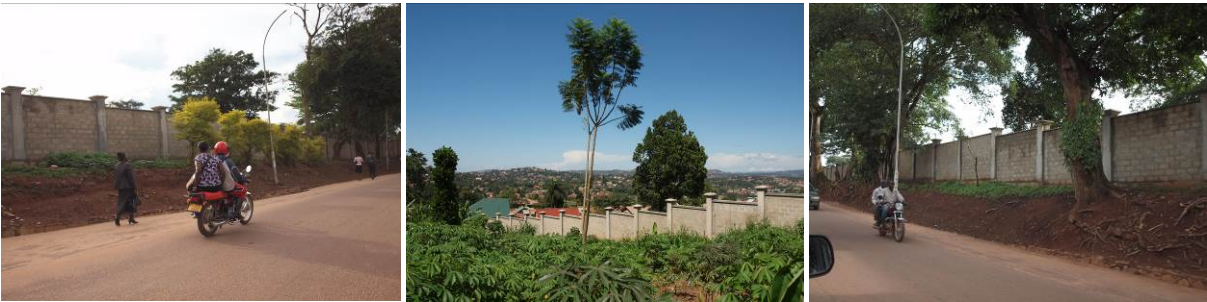
The number of trees missing has increased since the preparation of the inscription in 1999. During the preparation of the management plan of 2009, we counted 110 trees missing. More have been cut down in the past 5 years. We fear an acceleration of this trend after the erection of the enclosure wall, because the trees are now outside the fence.

Missing trees
(Approximatel
110 for the
fence alone)

Sections of the boundary where trees are missing
Replanting trees will contribute to mitigate the visual impact of the newly built cement wall.

Surrounding population is the main threat to these trees. It is only by involving those people in the protection of the trees that we could safeguard this green curtain which represents a major component of the site. To protect future tree seedlings, we recommend involving local communities in monitoring and watering trees. Nearby schools could also take part in the programme.

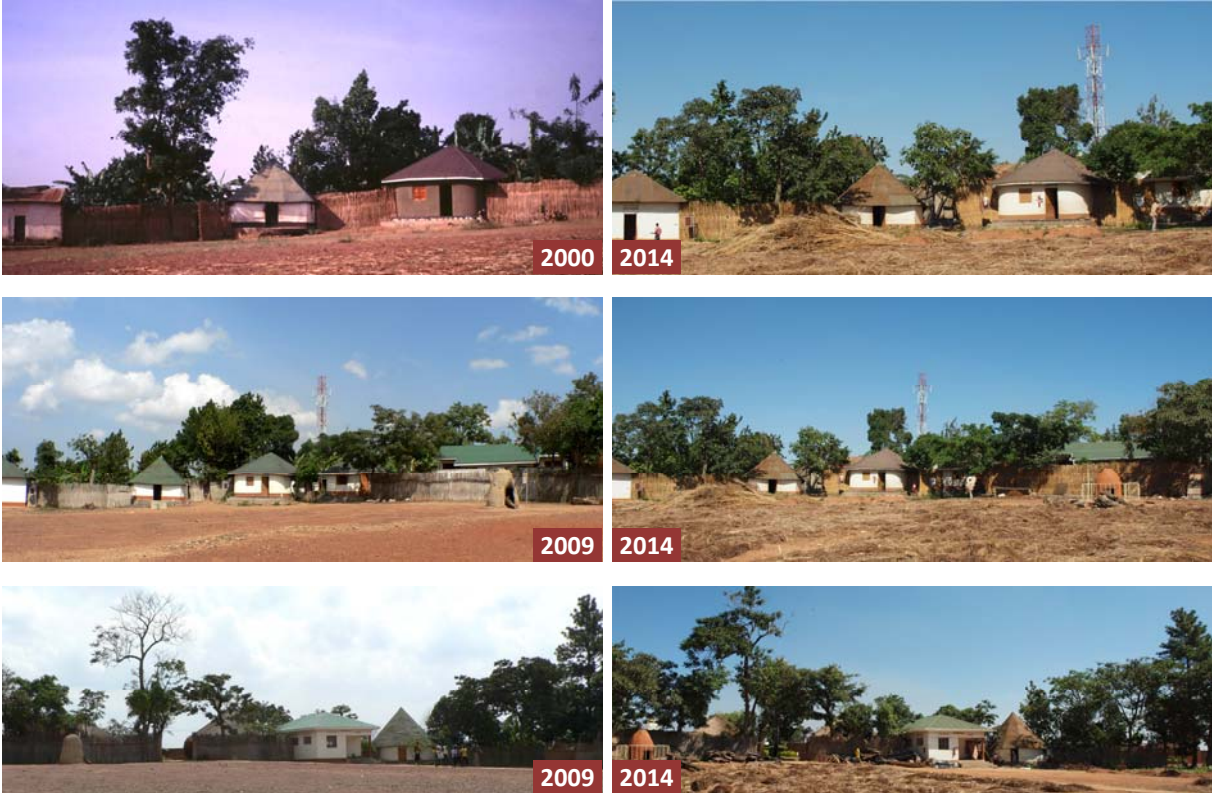
The courtyard is also traditionally surrounded by a curtain of trees. Comparison of images over 15 years shows that some trees have grown, but others have disappeared. A tree planting program in the periphery of the courtyard would be necessary. As for the fence, only fig trees (*ficus natalensis*) should be planted around the courtyard. Other trees can be planted at the back or in the farmland.

Evolution of the trees around the courtyard over the years

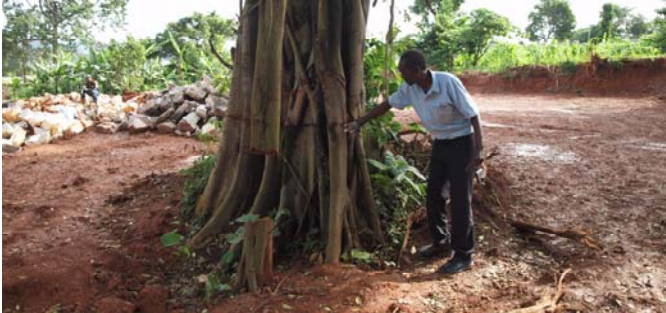
Tree saved in extremis near the cemetery

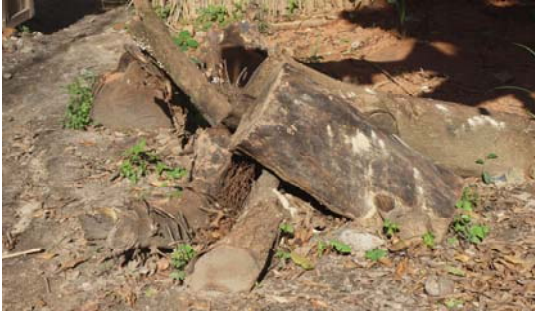
cut tree

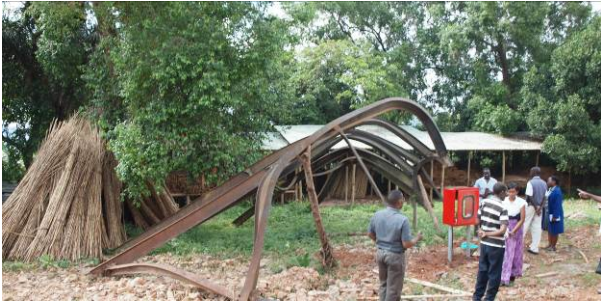
The steel structure rescued from the fire will remain on site, to respect cultural norms and testify of the tragedy. It will be shifted to the back of the site, some 250 meters away from Muzibu-Azaala-Mpanga on the south-eastern side. The plan presented to us during the mission was to cast a 314 m² concrete platform to hold the structure. We recommend avoiding pouring concrete on site, and simply displaying this sculptural element on the ground, in its natural environment. A concrete platform will neither add value nor protect the steel.

Remains of the previous roof structure

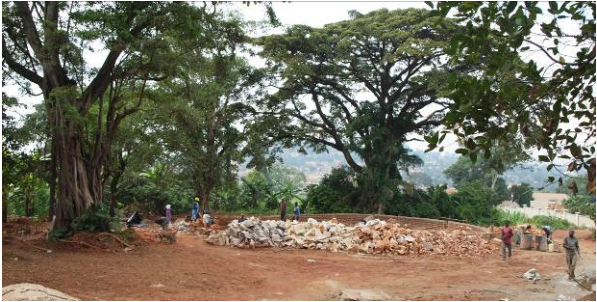
Slab under construction to exhibit the burnt steel

*Alexander Calder sculptures displayed in Parks in France
The burnt steel remains could also be simply presented on the ground without a concrete slab.*

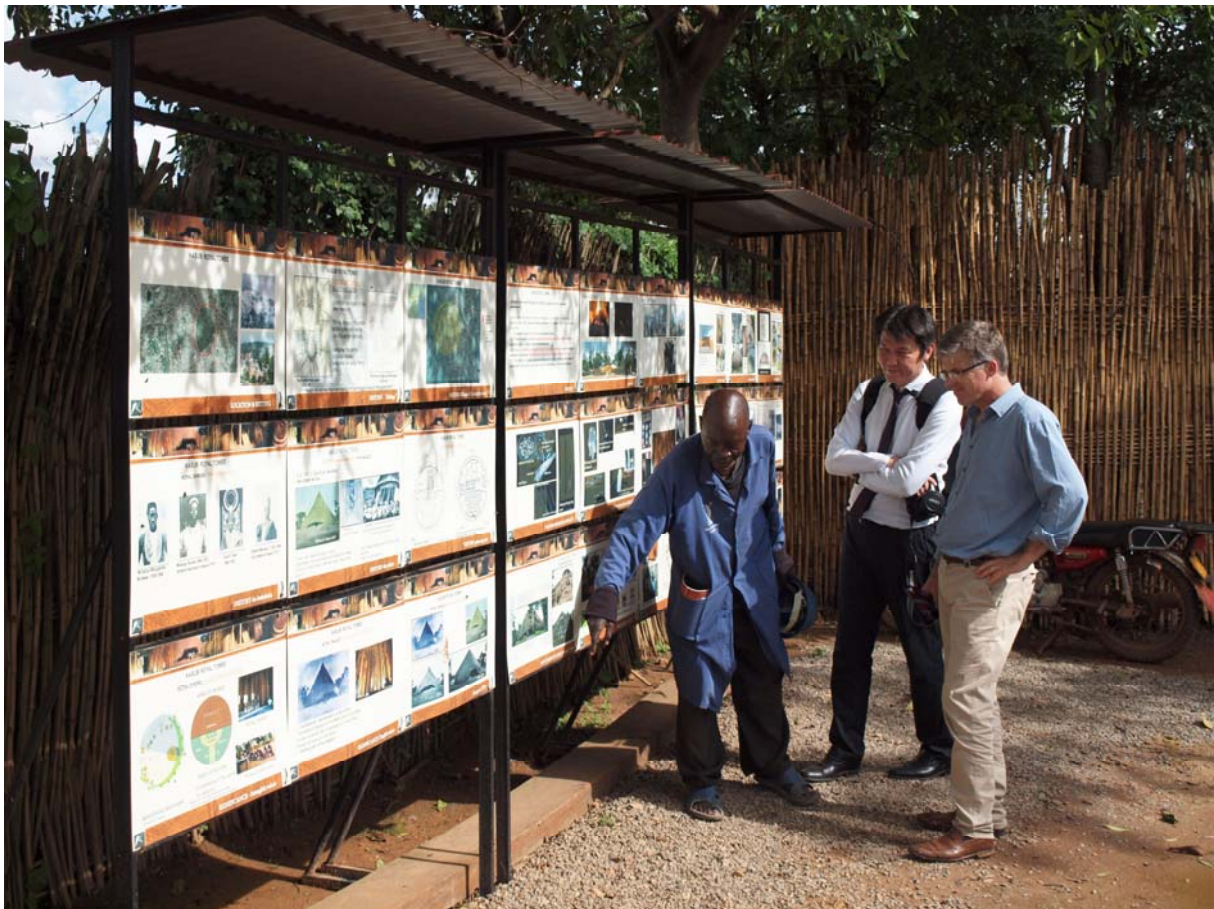
*Very efficient information panel installed at the site entrance
Christopher Kawoya Wabulakayole, head thatcher, using the panel to explain the roof
to the UNESCO-Nairobi team*

The idea of the exterior panels is very interesting for presenting the site as it allows a permanent and very democratic access to information, which would not be the case if these panels were locked into an interpretation centre. We recommend such exhibition panels to be installed on site, in different locations but in smaller versions. This does not exclude having a secure place to present valuable objects, including the artefacts rescued from the fire.
