# REPORT OF THE UNESCO RAPID ASSESSMENT MISSION TO THE WORLD HERITAGE “SITE OF PALMYRA”

## SYRIAN Arab Republic

23–27 April 2016

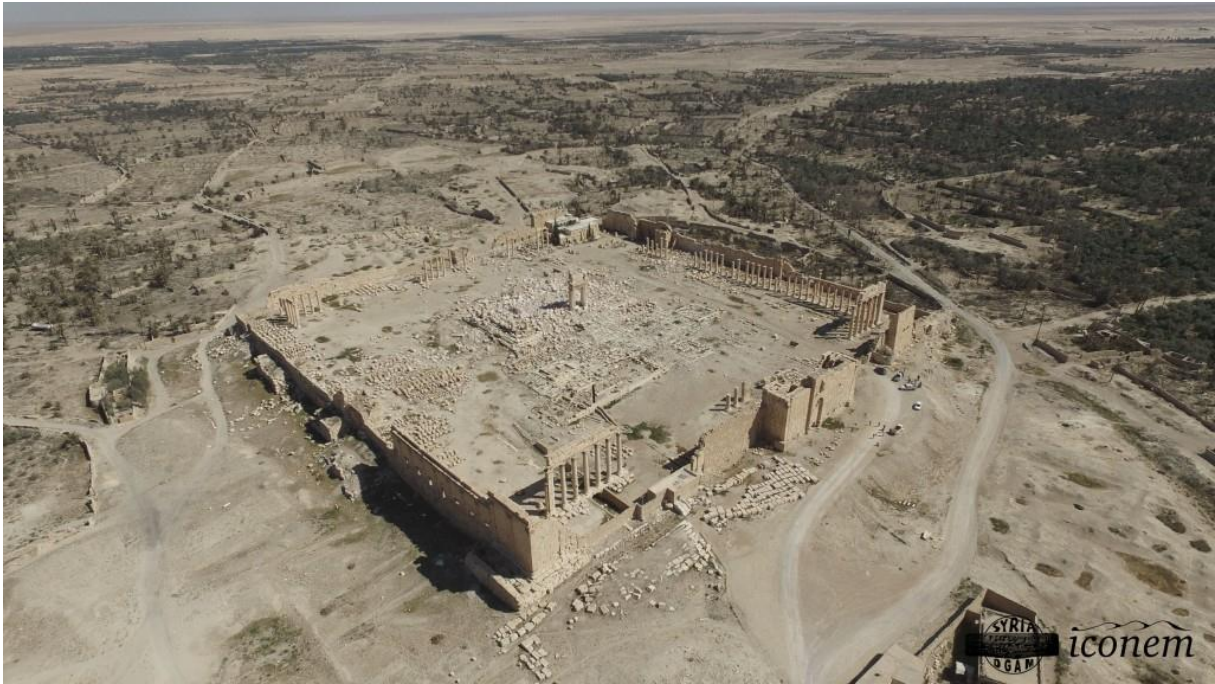
Fig. 3: Aerial photo of the Ba'al Temple (April 2016, DGAM / ICONEM)

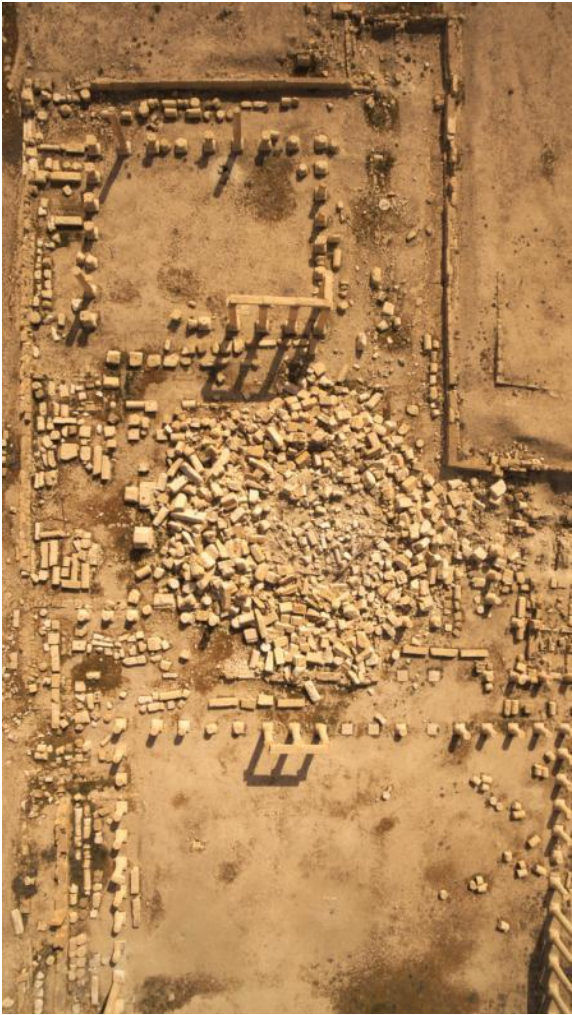
Fig.4: Aerial photo of the Ba'al Shamin Temple (April 2016, DGAM / ICONEM)

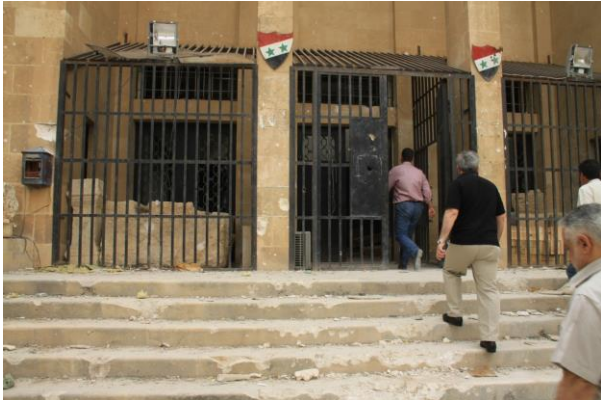
It is noted that the museum is principally a solid reinforced concrete building with stone cladding. Due to the armed conflict, the museum presents several important damages to its structure, showcases, exhibition and storage areas, and collections:

- Exterior walls: bullets traces, cracks, broken stone cladding, open joints, holes and damages in the walls;
- Stairs and access to the museum: damages and gaps, degradation;

Fig 5: Museum entrance

The mission team noted that museum requires urgent emergency consolidation and securing of its building (structure, ceiling, windows and openings), completing the evacuation of damaged items and fragments, continuing the emergency inventorying and documentation,

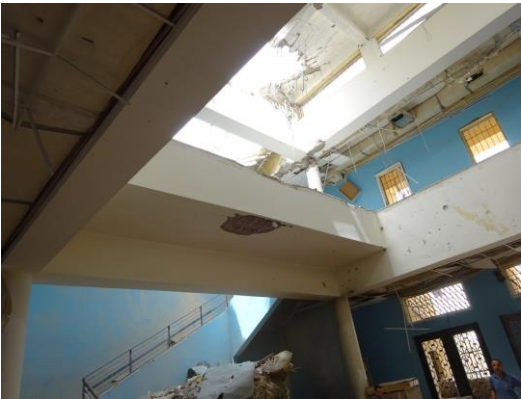
- Interior / structural stability: bullet traces, gaps in the materials, destruction of all false ceilings, lack of stability in several areas;
- Windows: glazing totally broken, frames destroyed/degraded, metallic protection frames degraded;

Fig 7: Museum interior

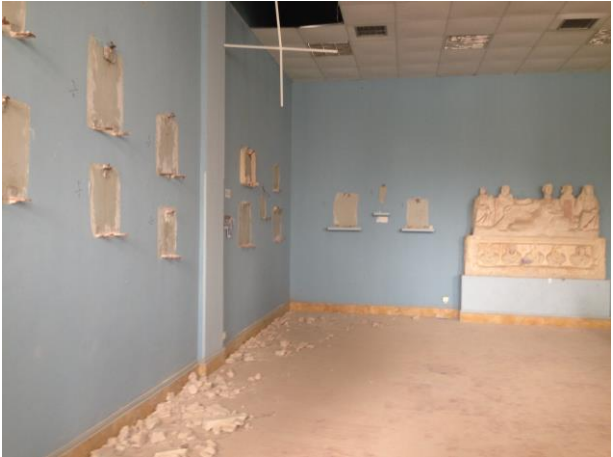
- Type of damages to the collections: vandalism, beheading, splitting, cleaving, fragmentation, de-contextualisation;

Fig7: Museum collections (evacuated and looted)

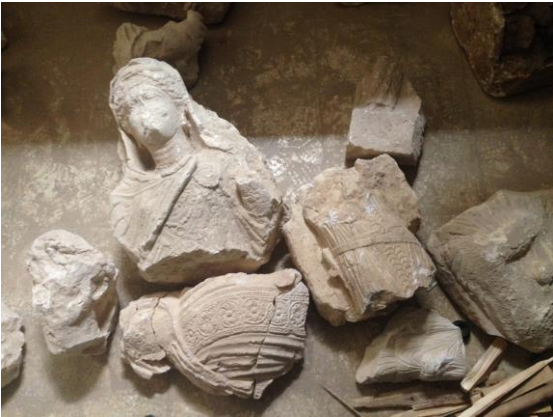
- Exhibition areas, basement and storage areas: bullet traces, destructions of supports, damages of walls, floors and ceilings; showcases: totally destroyed; the artefacts in the storage have been gathered in one room like a pile of rubble

Fig9: Current sorting of artifacts in museum storage

- Preliminary assessment of the damages (collections, museum storage, museum building);
- Numbering of all large and small fragments;
- Reassembly of fragments in boxes;
- Emergency inventorying;
- Evacuation of the most important damaged collection items and fragments of sculptures to other premises;
- Starting of the sorting processes of the artefacts' fragments

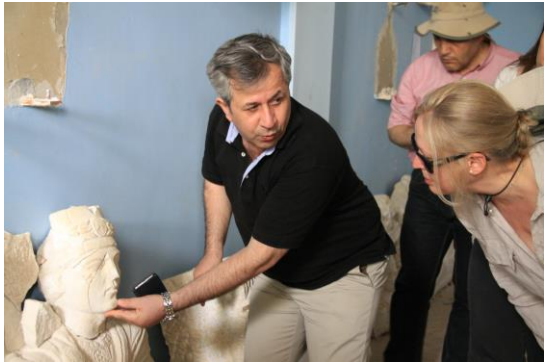
Fig 10: Assembling vandalized fragments

- The mission recommends the restoration of damaged statues, busts and objects taking into account priorities in terms of value;
- The mission also recommends securing the restored items in safe locations, with appropriate packing and climatic conditions;

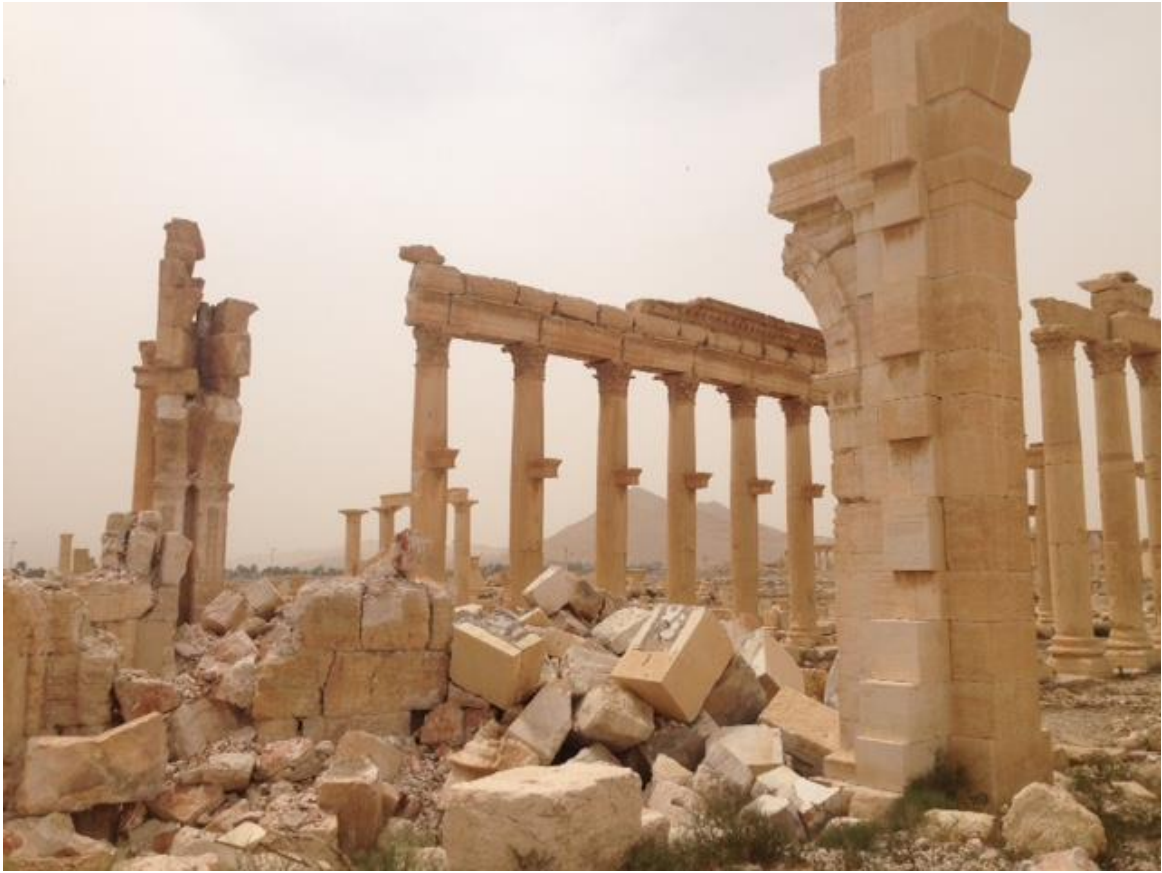
The rapid damage assessment of the destroyed attributes and structures shows that a certain percentage of the stones after intentional explosions (to be detailed in future studies and extensive field work) were in fairly good shape, in view of future considerations related to potential anastylosis projects. Indeed, the mission observed that while the explosions inflicted on the architectural elements pulverised important parts, others, such as the cylinders of the columns, fell without being severely damaged; some large portions of decorated elements could also be seen under the triumphal arch.

Fig 11: Destroyed Triumphal Arch

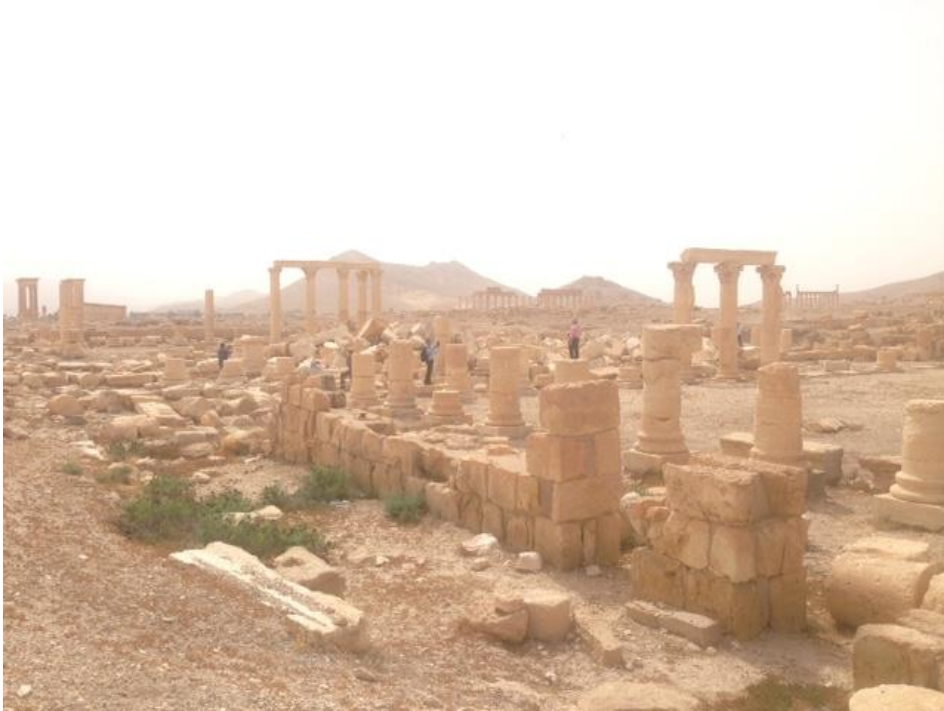
Fig 15: Destroyed Cella of the Ba'al Shamin Temple

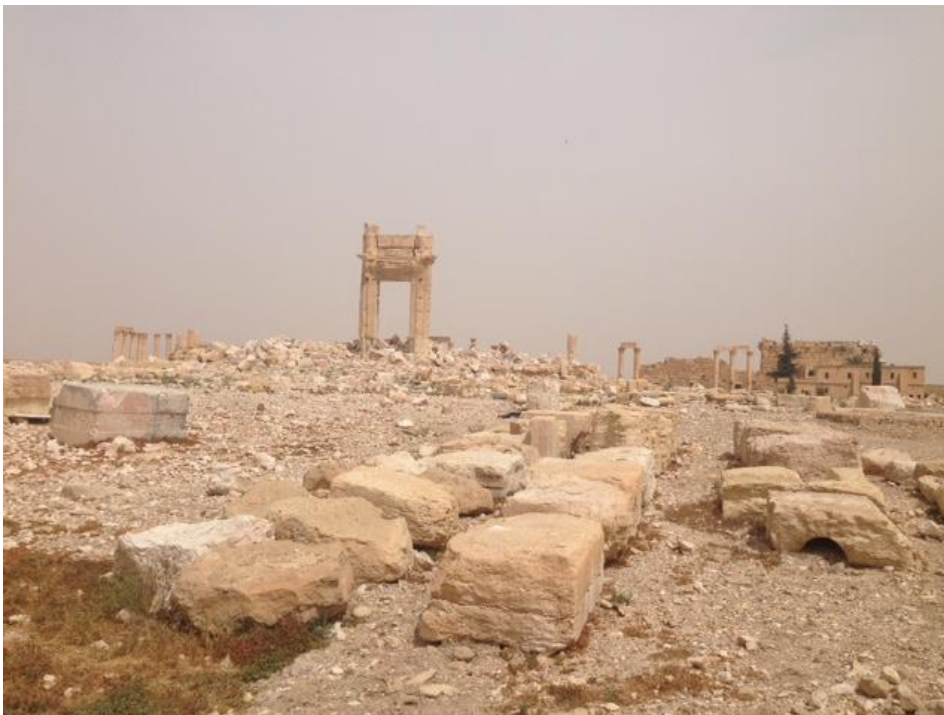
Fig 16: Destroyed Cella of the Temple of Bel (Ba'al)
