UPDATED REPORT

**KATHMANDU VALLEY WORLD HERITAGE SITE**  
(Nepal) (C 121 bis)  
**1 FEBRUARY 2017**

### **STATE OF CONSERVATION REPORTS FROM INDIVIDUAL MONUMENT ZONES**

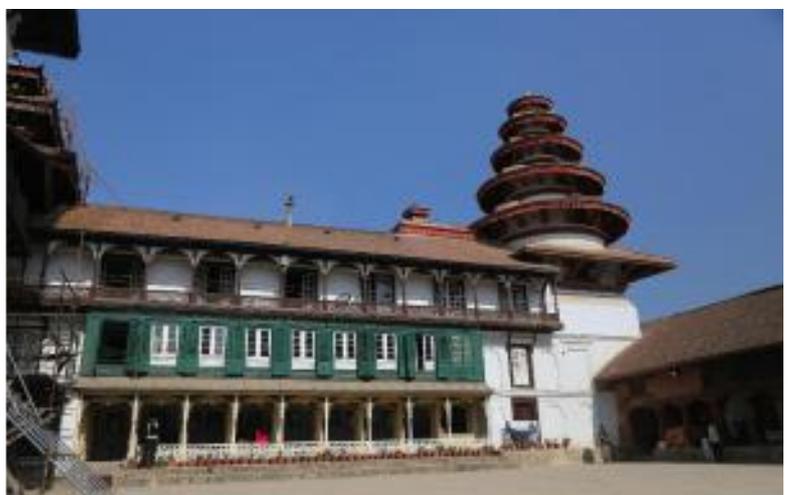
The conservation work of Panchamukhi Hanuman Temple, a prominent multi roofed temple in the palace premises is completed as first completion after the earthquake. The southern wing of the Mohankali chowk is also conserved as well within the same project budget. However, the project was started before the earthquake, but due to the earthquake it was obstructed for some months.

The project was under taken by the joint fund of Hanuman Dhoka Museum Development Committee and American Ambassadors fund for Culture Preservation; in the supervision and monitoring by the Department of Archaeology. The Temple and southern wing of this complex was more damaged by devastating earthquake on 25th April, 2015 as well. The

conservation work was carried out using traditional material, technology and craftsmanship.

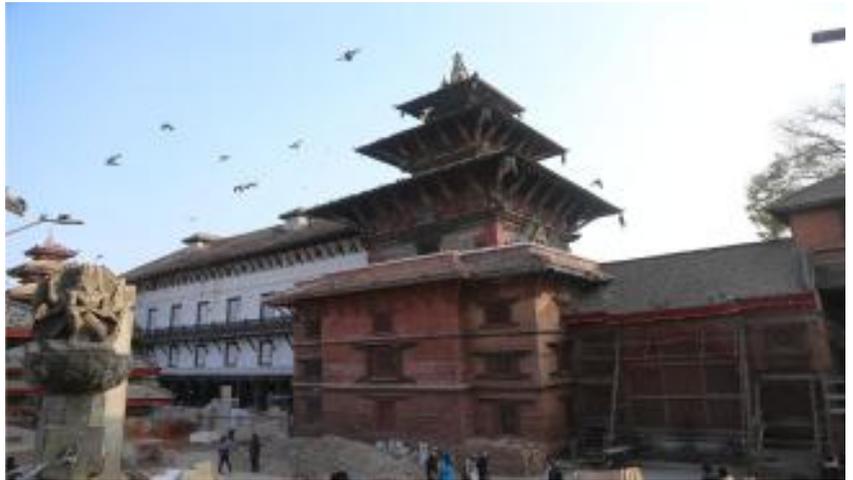
The conservation work of Degu Talezu is completed recently. This temple was under consideration for renovation and the bidding process had already completed before the earthquake; and the devastating earthquake had increased the damage portion of outer part of bulged wall of the temple.

The conservation work of this temple is completed with traditional material and technology.

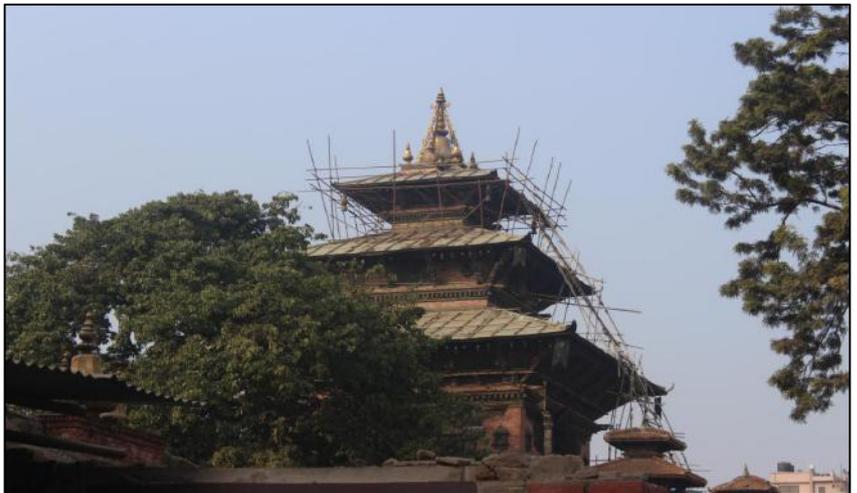
## 1.3 Conservation of Taleju Temple.

Taleju Temple is landmark of Hanumandhoka Durbar Square. Taleju is a tutelary deity of Malla Kings. The temple also was affected by the earthquake; especially in top and second roof. The renovation of damaged upper two roofs of this temple has been carried out now.

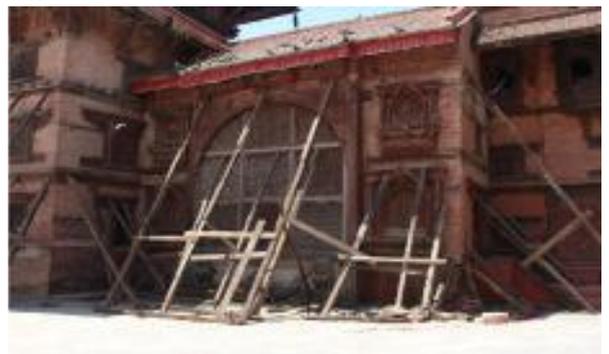
## 1.4 Conservation of Sweta Vairab Temple

The Sweta Vairab Temple attached to Degutaleju is under conservation. The recently restored temple of Vairab was partially affected by the earthquake and well shored just after the quake to protect from the further destruction. Hanumandhoka Palace Museum Development Committee has taken total responsibility of the conservation under the close inspection of DoA.

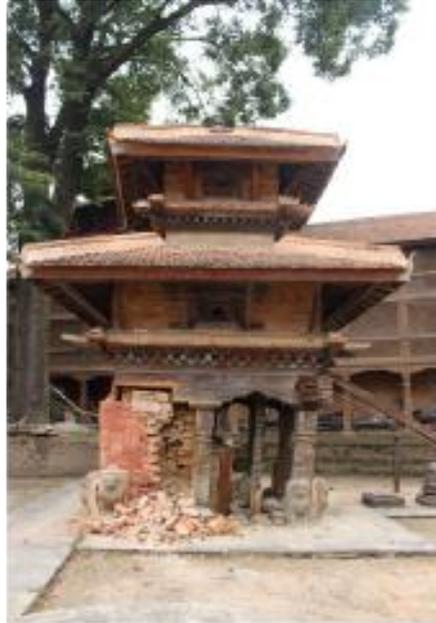
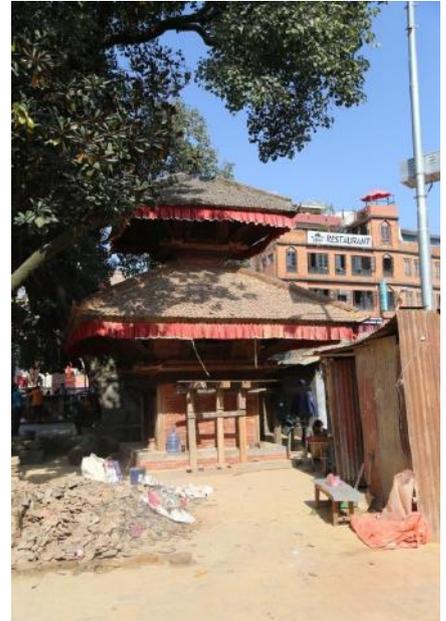
## 1.5 Conservation of Natyeshwor Temple

The conservation of temple by Hanumandhoka Durbar Museum Development Committee is under progress. The temple was partially collapsed by the earthquake. Replacing the mud mortar by lime mortar the temple is conserved with traditional method and material as it was built before. Though small in size, the temple inside the palace premises holds the major cultural and religious importance.

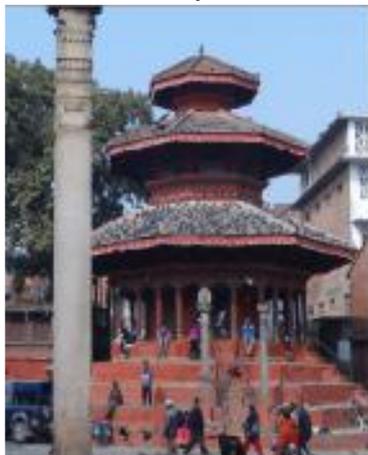
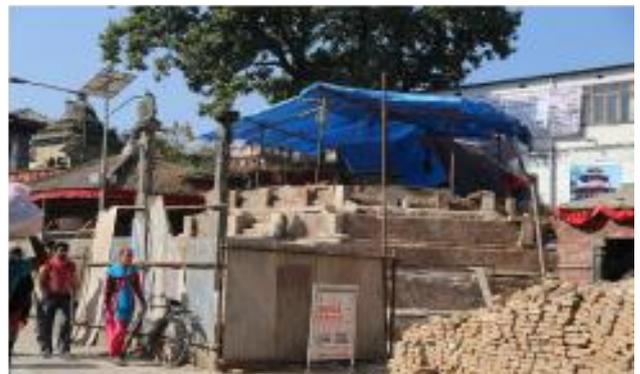
### 2.1 ChyasinDega Reconstruction

Chyanin Dega, a prominent multi roof temple in octagonal shape, devoted to lord Krishna was completely damaged by the earthquake. The temple is under restoration under the multiyear restoration project of Department of Archaeology. As the temple

was built by the massive use of traditional brick, wood and terracotta tiles, full consideration is paid to restore the temple with the use of traditional technique and materials reusing the old wooden and other elements as much as possible. Since the 'Surkhi mortar', the mixture

der, is accepted as a traditional construction material, Surkhi mortar is used in restoration of the temple instead of mud mortar.

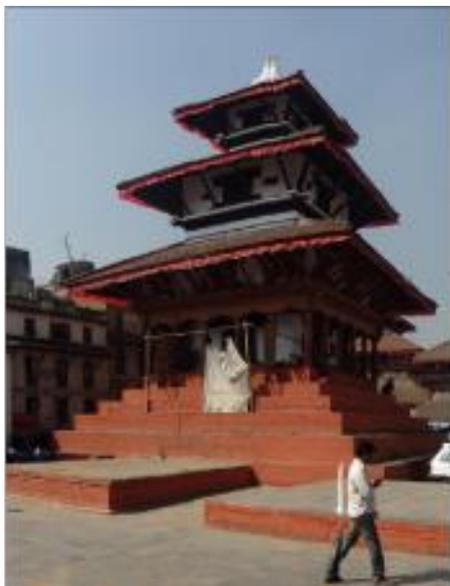
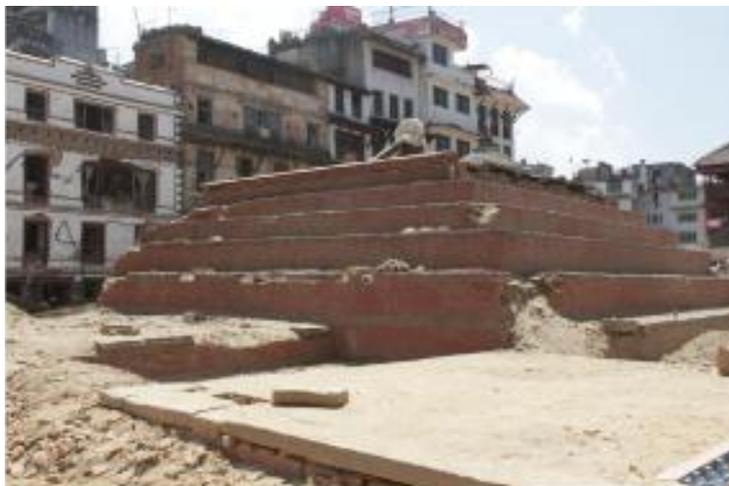
## 2.2 Restoration of Trailokya Mohan Narayan Temple

The Trailokya Mohan Narayan Temple also known as Dasavatar temple on north-west side of Kumari Temple was built in early 18<sup>th</sup> century. The over structure of the three tiered multi roof temple was completely destroyed by the earthquake. After the detail investigation with emergency archaeological excavation, the restoration work is already started with the concept of utilize almost wooden artistic and other remaining material of the same temple replacing the damaged by new one.

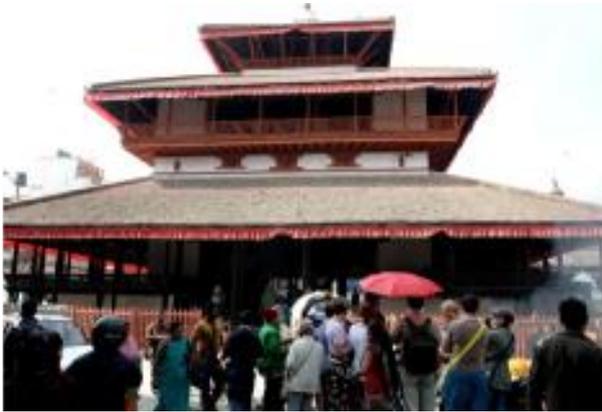
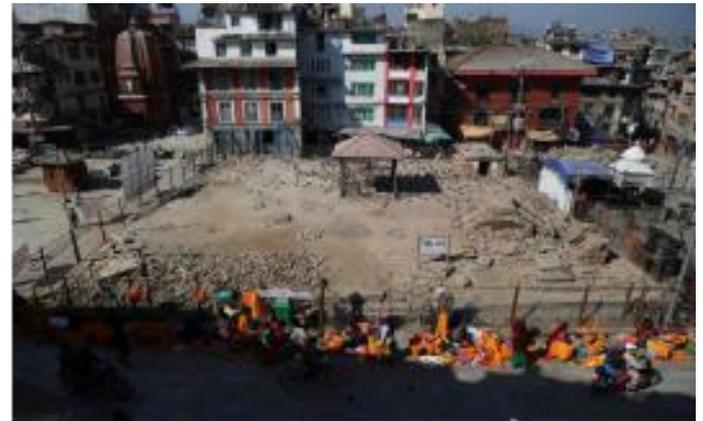
Regarding the restoration of Kasthamandap, Kathmandu Municipality has taken the responsibility; and detail approved drawing with detail documentation and conservation note is already handed over to Municipality.

Under the project funded by UNESCO, all the remaining wooden and other materials of the temple are salvaged and well documented. On the restoration of the temple, all those salvaged reusable elements of the structure will be reused.

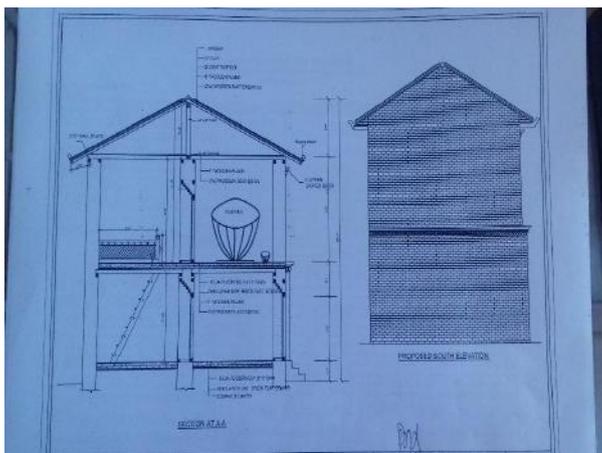
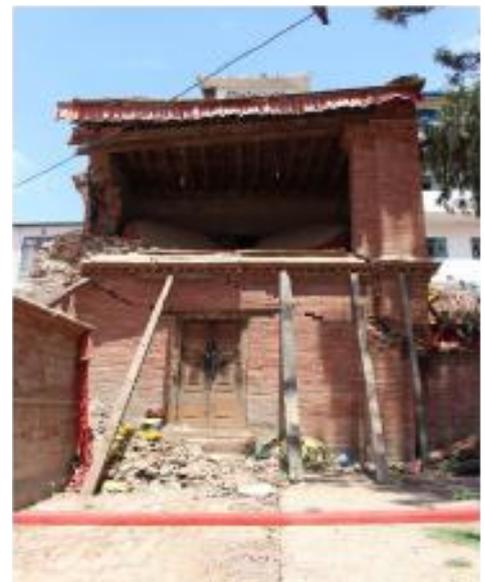
### 3.2 Restoration of Nagaraghar

The Nagaraghar, Big Drum house, situated west of Degutale temple in Hanumandhoka Palace Square is under restoration. The traditional building of cultural importance was largely affected by the earthquake. The state of conservation of *Jhigati* roof was almost fallen, the brick wall was cracked and the entire structure was tilted as well. To be restored with perfect traditional method and materials, under the direct inspection of DoA, Kathmandu Metropolitan City has invested for the entire restoration of the structure.

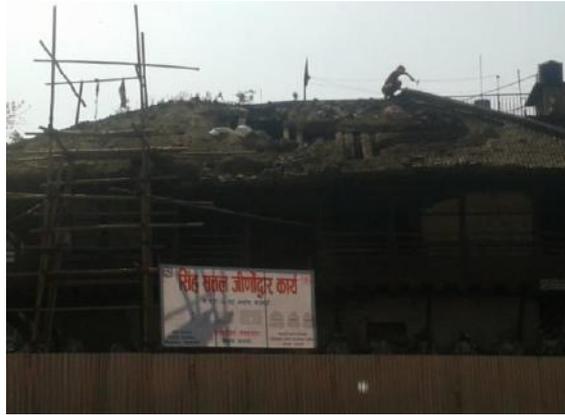
The Singha Sattal, popularly known as Silyan Sattal (Traditional Rest House) is on the phase completion of restoration work. The Sattal with a shrine of Natyeswar (god of dance) inside it was in dilapidated condition for a long time. Under the direct inspection of DoA, with detail documentation, it is conserved by KMC and Guthi Sansthan. Traditional types of bricks, *Jhigati* roof tile and timber are the major construction material as it was used before.

Since the construction of the structure is traditionally and mythically connected with Kasthamandap, it was believed to be built in the 12th century; since the recent

archaeological investigation has proven the Kasthamandapa older than that period, while restoring this monument, the architect and archaeologist involved have paid very careful attention.

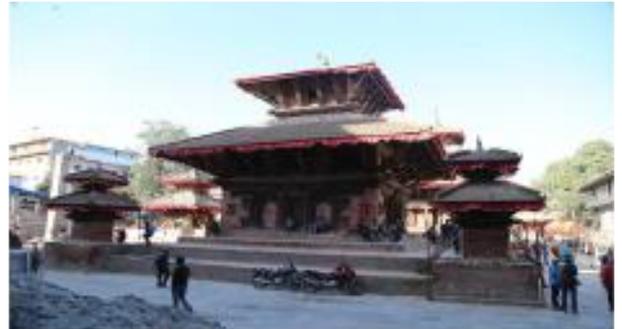
Jagannath temple in front of main entrance of the palace is under conservation. The temple is being conserved under the UNESCO-JFIT project. After the detail structural assessment of the temple, drawing and cost estimation for strengthening the present structure proposed by the project is under the approval process.

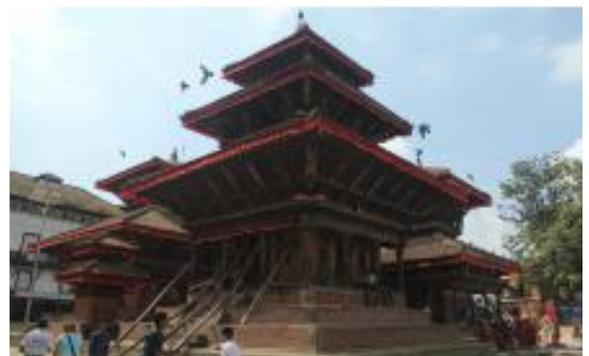
##### **4.2 Conservation of Shree Krishna Maha Vishnu Temple**

Among the two monuments to be conserved under UNESCO-JFIT Project, Shree Krishna Maha Vishnu Temple, also known as Gopinath, is another one. The temple also was partially affected by the earthquake. After the detail structural assessment of the Jagannath temple, the expert team has started the structural assessment of Gopinath temple. After the completion of the assessment it is assumed to be strengthen the structure minimizing the intervention as much as possible.

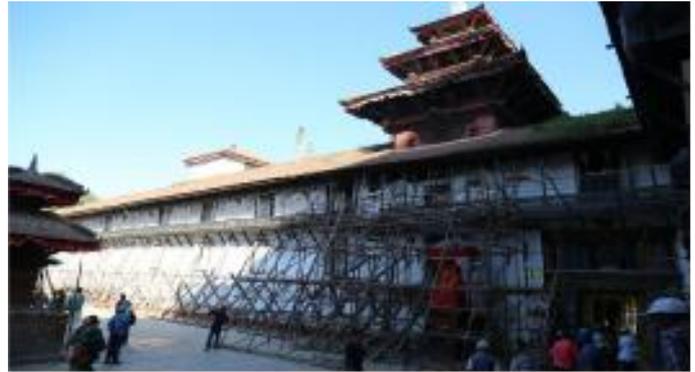
### 4.3 Conservation of Aagan Temple and Western long of the palace

Since the western wing including the main entrance of the palace was largely affected by the earthquake, the over structure of sacred Aagan Temple over the western long was suspected to be effected heavily, National Research Institute for Cultural Properties, Tokyo had had a detail structural investigation of the entire structure with approval and close cooperation of Department of Archaeology and Hanumandhoka Palace Museum Development Committee. The project is approved by Department to be conserved the temple and entire western wing of the palace under JFIT project.

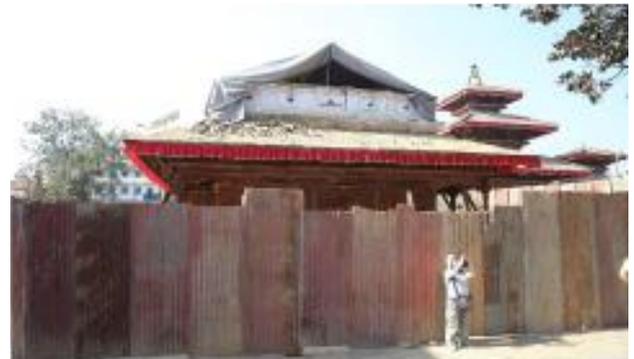
The Kageswor Temple, on the west of Taleju, originally built in 1681 and rebuilt after the earthquake of 1934 and lastly restored by Kathmandu Valley Preservation Trust (KVPT) before 10 years was partially damaged by the 2015 earthquake. As the temple of mixed architecture of multi roof and Shikhara was restored by KVPT before, the responsibility of restoring the temple has taken again by the same INGO, KVPT.

With the approval of DoA, the restoration work is in progress in preliminary stage.

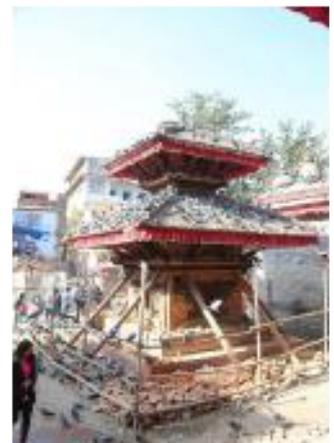
Laxmi Narayan Temple is another small but beautiful multi roof temple in Hanumandhoka palace square partially effected by the earthquake. The temple built by traditional brick, wood and traditional terracotta tile *Jhigati* is in the completion phase of restoration. With the approval and close inspection of DoA, KVPT has taken the responsibility of the work.

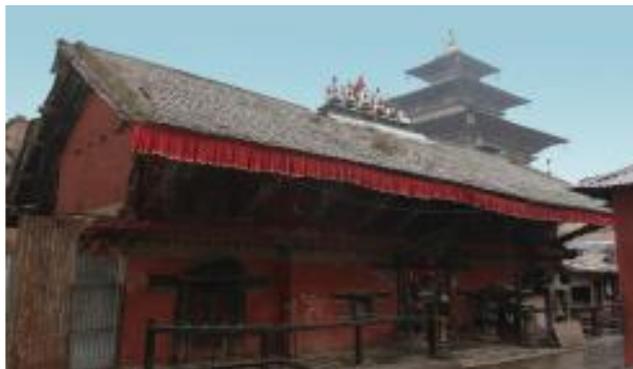
The temple of Tarinidevi, also known as Tarini Bahal, in the Hanumandhoka protected monument zone, outside the palace premises is in the last phase of completion of conservation work. The temple is conserved in initiative of local community with the mutual fund of municipality and community under the close inspection of the Department of Archaeology.

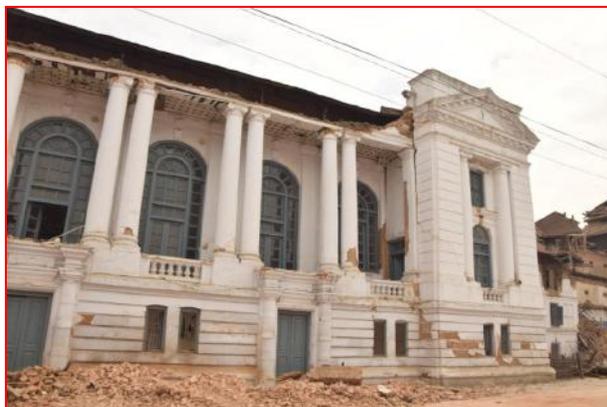
MoU between Government of Nepal and Miyamoto Global Disaster Relief, Nepal was done for the conservation of Gaddi Baithak, one of the significant part of Hanumandhoka Palace,

which is an important Neo-classical building and in vulnerable condition due to the earthquake 2015. Miyamoto has been in the process for the completion of its first phase that it has prepared the detail assessment and is on the process of reviewing by the technical committee for the approval by government and project has targeted for completion within next two years in the usual and general context.

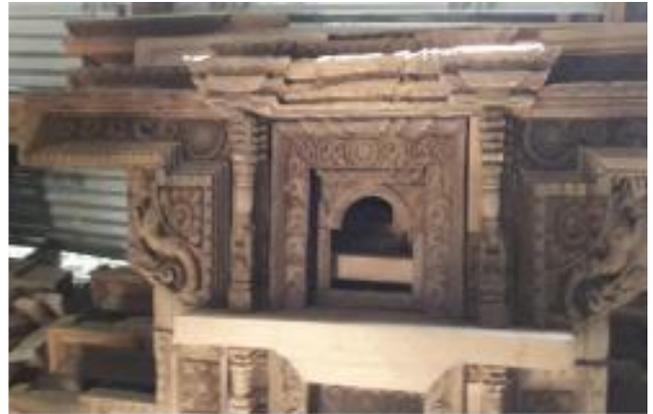
Door of Char Narayan Temple after maintenance

has been actively involved in the total activity of erecting the temple as its original state. All the damaged wooden carved elements such as columns, windows, door, Carnes etc. are salvaged and well documented with detail inventory. Central workshop is established in Patan Durbar premises employing skilful artesian to work on wood and stone planning to reuse the elements of the collapsed temple as much as possible.

The detail drawing and cost estimate proposed by KVPT is already approved by Department of Archaeology; and the restoration work of the temple is started under the close cooperation and inspection of the Department.

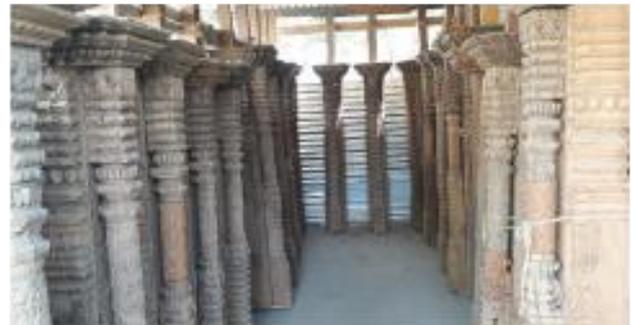
Columns of Char Narayan Temple after maintenance

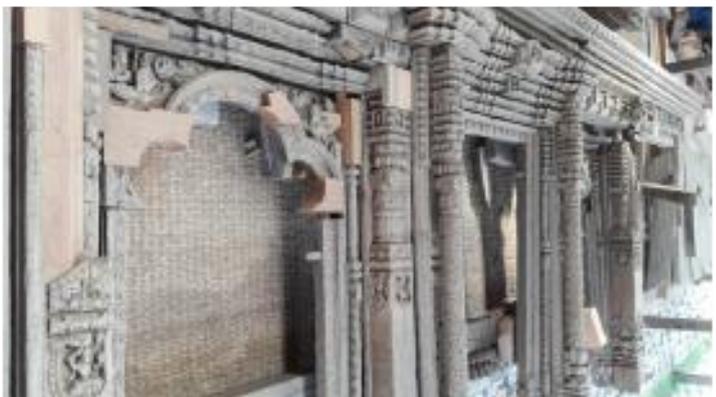
The Hari-Shankhar Temple devoted to lord Vishnu and Shiva, in Patan Durbar Square, near to collapsed Char-Narayan temple and just beside the Narasimha temple also was destroyed completely above the plinth level by devastating earthquake. All the damaged wooden carved elements of the two roofed temple with extraordinary wooden art and architecture is well

salvaged with detail documentation. Almost all columns, windows, door, Carnes, tympanum, door wings, struts etc. are identified and inventoried to be reused in the restoration of the temple.

Door of Hari-Shankhar Temple after maintenance

As the foundation of the temple was found intact and strong enough in the rescue archaeological investigation, it is planned to restore the temple keeping the original foundation intact. The detail drawing and cost estimate proposed by KVPT is already approved by Department of Archaeology; and the restoration work of the temple is started under the close cooperation and inspection of the Department.

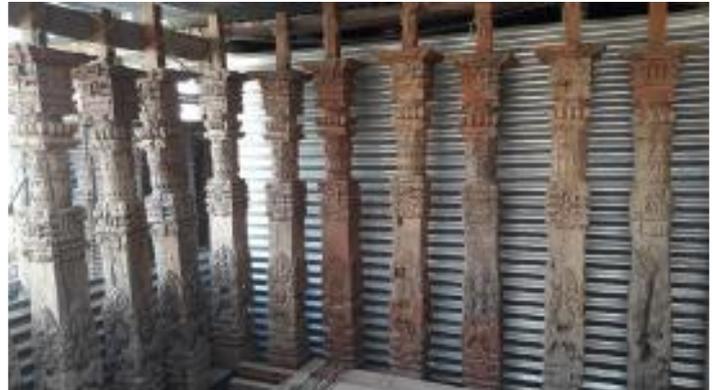
The Manimandap, a public rest shelter, in front of Mangahiti, water spout, was completely collapsed above the plinth level by the earthquake. Almost all columns, brackets, struts are identified and inventoried to be reused in the restoration of the structure. As all the wooden elements are ready for installation

Columns of Manimandap after maintenance

with the maintenance, the restoration work is started after the detail investigation digging out about 3 feet for tracing the foundation condition of right one of Manimandap.

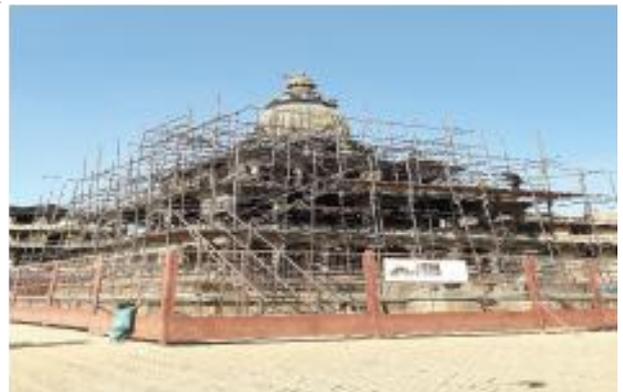
One of the most famous monuments of Patan, the Krishna Temple, built by Siddhinar Singh Malla in 1636 A.D was also partially but severally damaged, especially upper second stories. Immediately after the earthquake the rescue shoring was given to the structure to prevent the further damage. As the total responsibility of conservation is taken by KVPT, with the approval of DoA, proper

Krishna Temple under Conservation

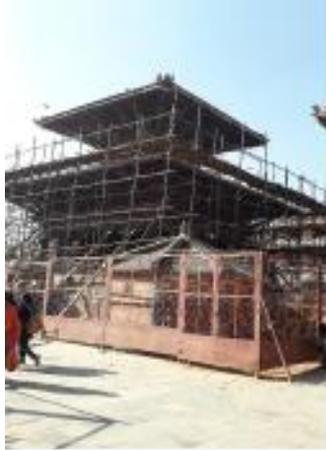
The Bishwanath Temple, near to Krishna temple, is also partially but severally affected especially in upper second stories. Immediately after the earthquake the rescue shoring was given to the structure to prevent the further damage. The temple is also decided to be conserved by KVPT and approval is already given. Installing the safe and proper scaffolding the conservation work is started. On the process of conservation, all the surrounding wooden tympanums (torans) are removed and stored inside the SundariChowk. The roof tiles also removed to decrease the load of temple.

Biswanath Temple under Conservation

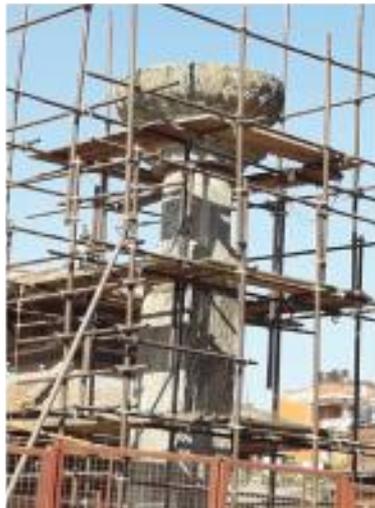
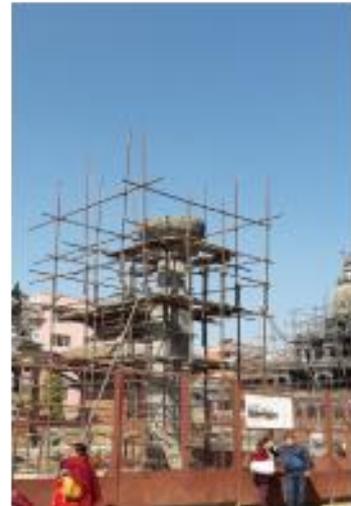
The huge stone column with the statue of King Yognarendra Malla was also largely affected, as the column was broken into three above the stone lotus part including bronze statues of the king was felled down by devastating earthquake.

In the initiation of KVPT with close coordination with DoA, the Austrian expert team had inspected and contributed for the installation of three big pieces of stone. Remaining bronze statues are in maintenance process.

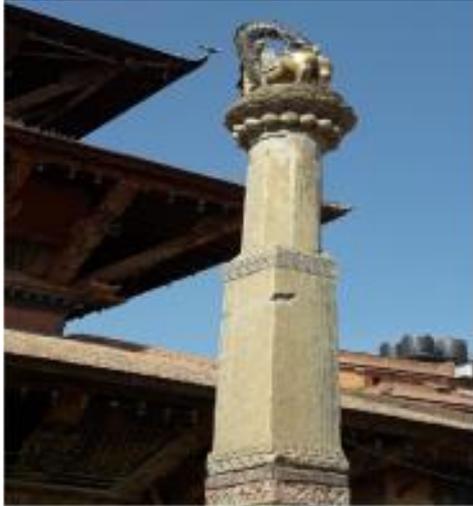
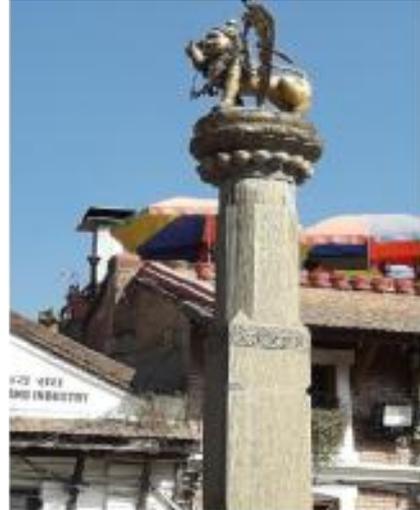
### **1.7 Conservation of the Lion statue column**

The Lion Statue Stone Column in front of Bhimsen Temple was also broken in two pieces by the earthquake. By the technical help of the Austrian expert team it was inspected and joined by inserting stainless steel rod. The column is successfully installed. KVPT is credited to take the initiation to have the expertise of the Austrian stone conservator.

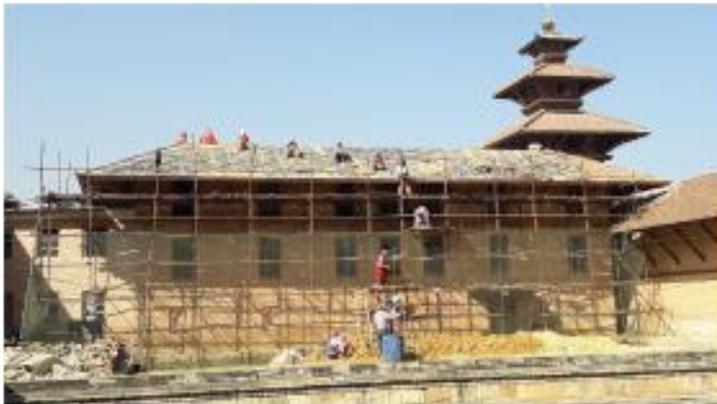
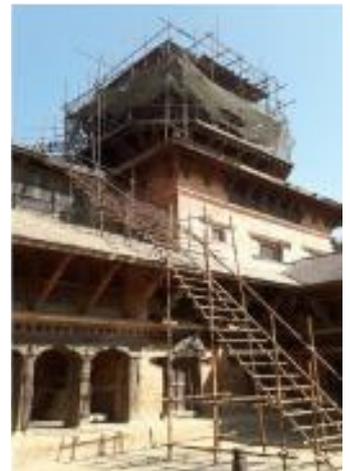
Conservation of Mul Chowk and Sundari Chowk is a continue work of previous years. KVPT has got the approval from the Department to work on those monuments before earthquake. The Southern Taleju temple conservation work had already finished whereas Northern Taleju Temple is going on conservation process. The roof work of eastern lung of Sundari courtyard has just completed.

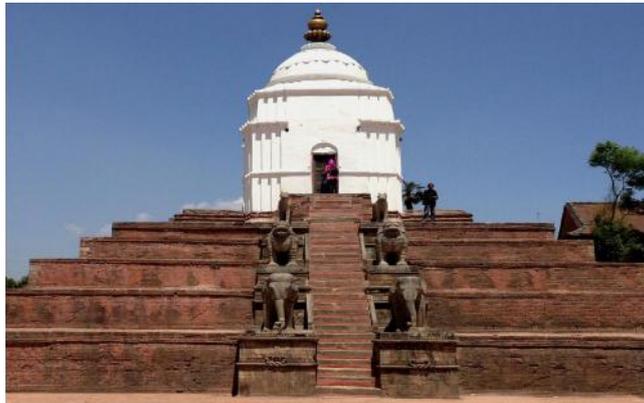
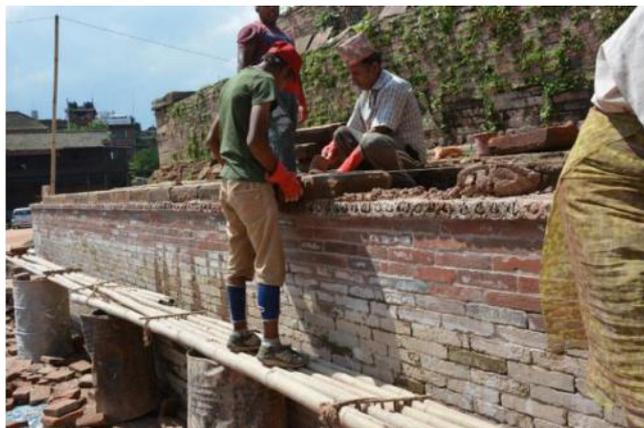
Silu Mahadev , temple dedicated to lord Shiva is situated at western part of Bhaktapur Durbar Square complex. This is one of the tallest temples in the second part of Bhaktapur Durbar Square. The temple is standing on a six steps plinth with animal guardians in each step namely elephants, lion and bull (bottom to top). This temple was damaged by 1935 earthquake and rebuilt in dome shape different than the previous original form.

Repair of the lowest plinth (fifth level) has been completed, while fourth and third plinth is undergoing repair works. For the repair works, the outer shell of the mud mortar plinth, 2 feet width is carefully removed and replaced by Lime Surkhi brick-wall, without disturbing the inner core. The foundation of lowest plinth was taken down to 2 feet.

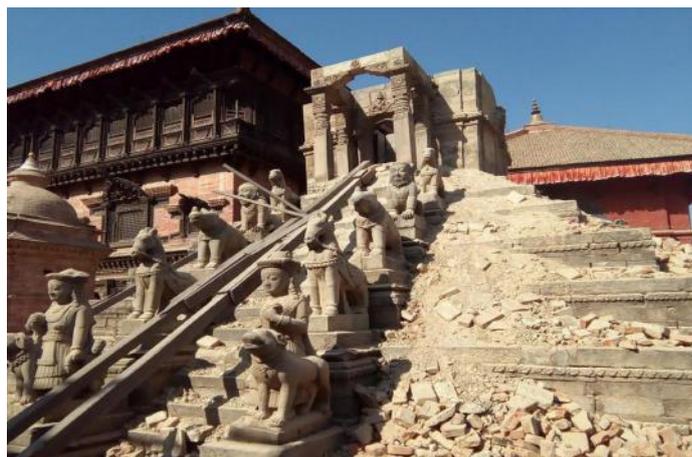
## 1.2 Siddhi Laxmi Temple restoration

April 25th Earthquake damaged the Temple with major cracks at South. Considering the possibility of future collapse of the monuments, measured detail drawings were prepared for the reconstruction of Siddhi Laxmi. The contract for the restoration is already awarded.

Careful dismantling with carefully marking each stone of the the temple is completed; and stored it near the temple complex. The project is estimated to be completed in Poush 2074. The temple is demolished up to Plinth keeping the foundation intact.

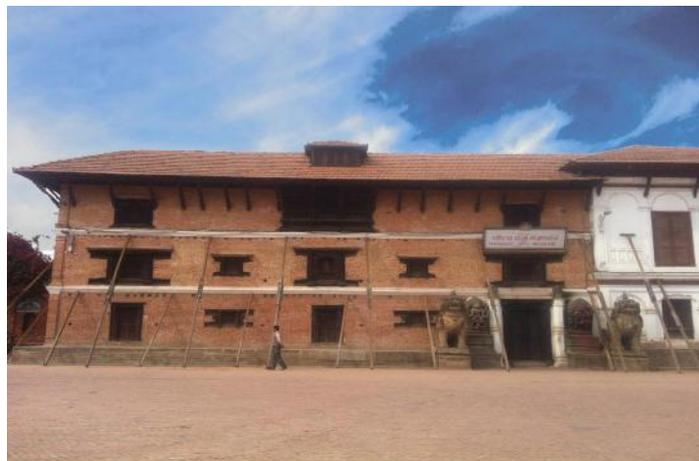
The western end of the Bhaktapur palace was converted into National Art gallery established by Government of Nepal, Department of Archaeology in 1960 A.D. which contains numerous paintings, manuscripts and stone sculptures. Previously, This building was part of Malati chowk built by King Bhupatendra Malla in 1707 A.D.

The building was largely affected by the Gorkha Earthquake. Wooden shoring was provided to avoid the further damage of the building funded by GIZ and DOA in cooperation with UNESCO. Restoration of Singha Dhoka building complex of Bhaktapur royal palace is going to be carried out under the budget of DOA, while the Lal Durbar wing will be reconstructed by Bhaktapur municipality in collaboration with KFW.

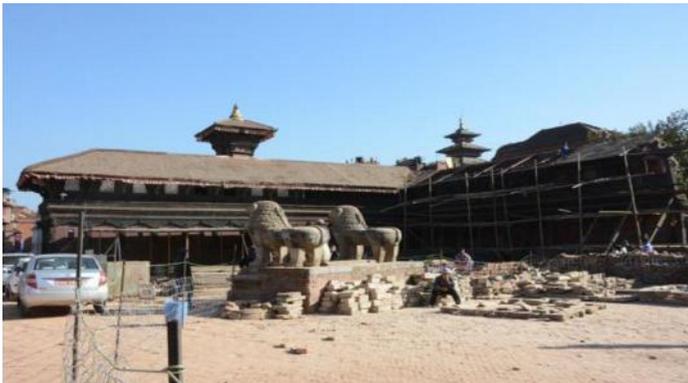
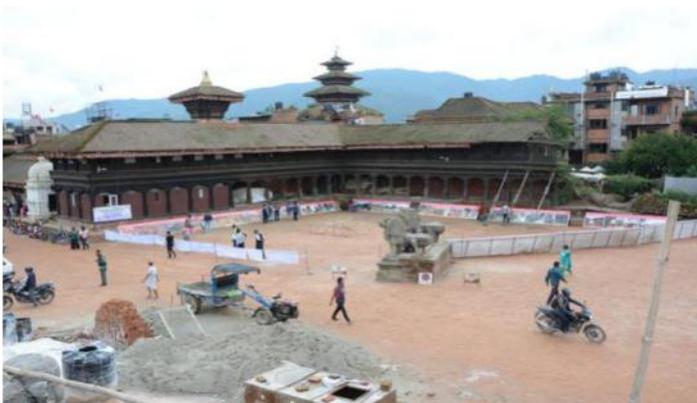
Taba Sattal also known as Taha Pha is located at the west corner of Bhaktapur Durbar Square. The middle portion of the Southwestern wing of the building was completely collapsed by the earthquake. Similarly, the upper portion of the northeast wing was damaged, and numerous cracks were observed. The northeast corner of the Building is currently used as office space of Bhaktapur Monument office. Hence, temporary office space is created at the ground floor of the building. Wooden shoring was provided to avoid the further damage of the building. Budget is allocated for the restoration of the structure.

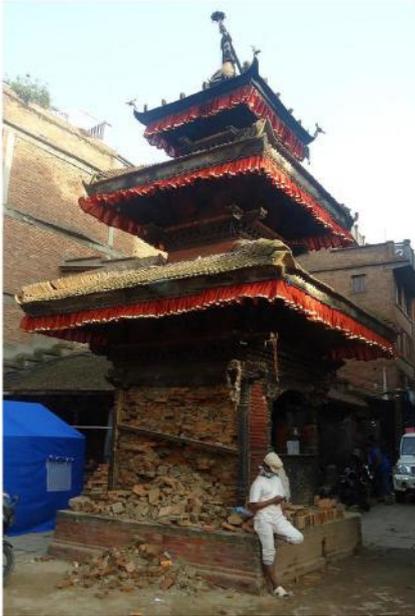
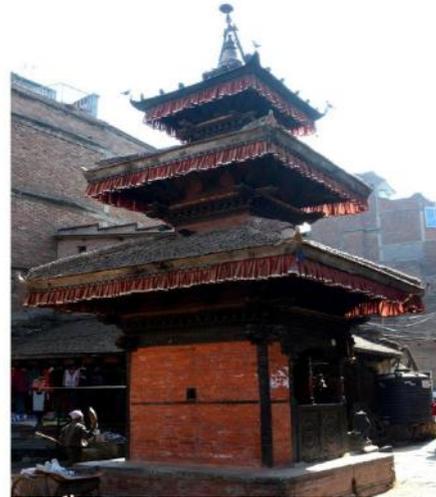
#### **1.5 Conservation of Golmadi Ganesh**

The conservation of Golmadi Ganesh temple is completed. Northern wall of the temple was heavily damaged by the earthquake. Emergency wooden shoring was placed just after the earthquake to prevent the temple from further damage. Repair of the damaged wall and roof work was carried out using emergency budget of DoA.

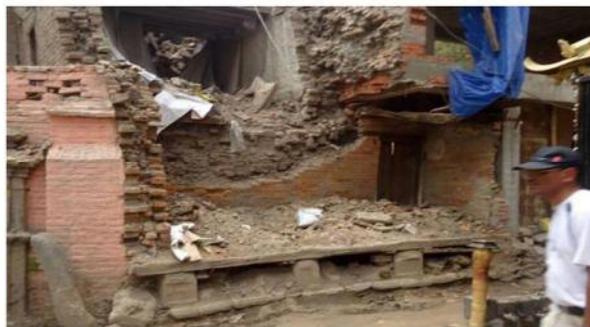
Damage Balakhu pati by Earthquake.

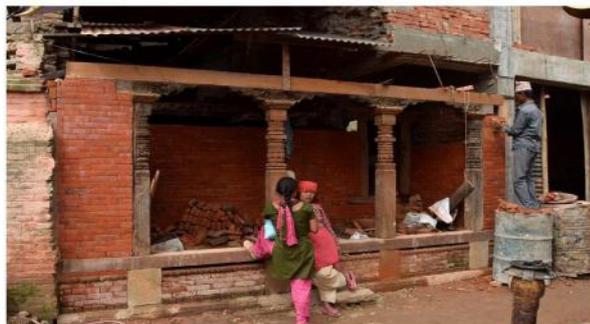
Balakhu pati during Conservation.

These are two Sattal beside Balakhu Ganesh Temple, situated next to Jana Jyoti Pustakalaya (library). Restoration process of these Sattal was planned before earthquake, whereas the earthquake had damaged the structure more; and both of these Sattals were reconstructed using DoA regular fund.

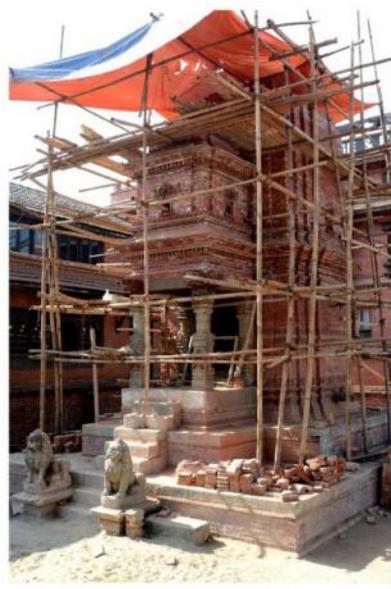
Badri Narayan Temple is a small temple located west of the Gopi Nath Temple locally dedicated to Vishnu or Narayan. This terracotta built Shikhara temple is one of the four Dham built by Yakshya Mall and dates back to 17<sup>th</sup> century.

Restoration work of Badri Narayan started before earthquake under DOA regular Budget; and halted for few months caused by the earthquake. However the restoration process of Badri Narayan is completed and has become the first restoration project completed after earthquake.

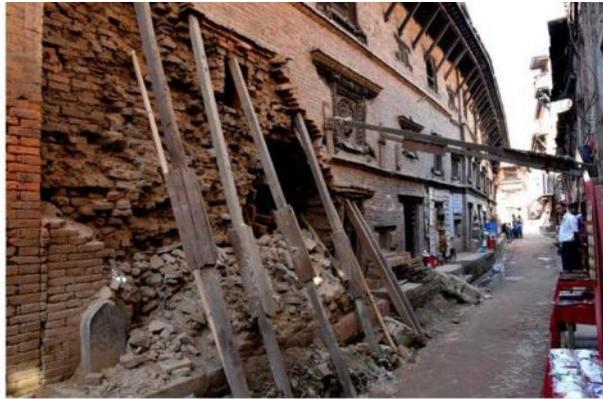
Emergency Shoring after earthquake at Pujarimath.

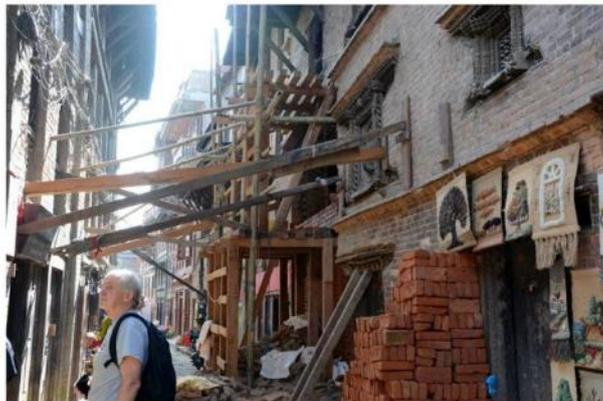
Shoring During Conservation at Pujarimath.

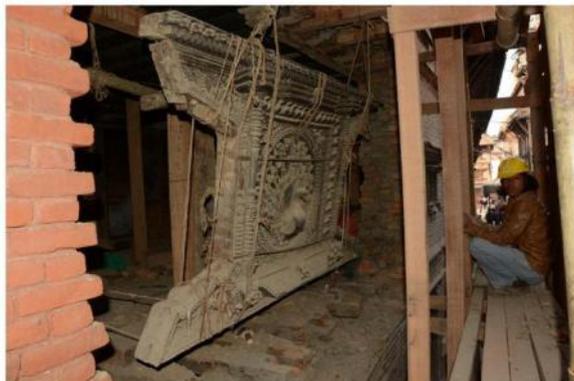
Removal of window for Restoration.

The 16th century Pujari Math is one of the seven Math surrounding Dattatraya temple built by king Yaksha Malla and is situated to the right of the Dattatraya Temple. Presently Pujari Math is converted into wood and crafts museum. Shoring work was done immediately after Earthquake to prevent further damage and restoration of *Mayur Jhyal* Peacock window is completed.

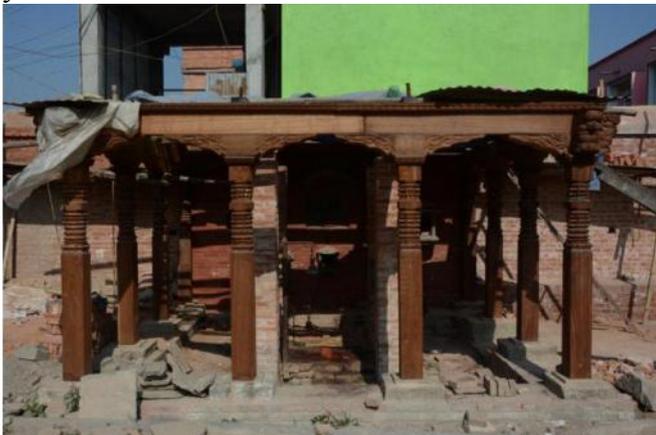
Duimaju Temple is situated at Duimaju Chowk of Bhaktapur Durbar square .Restoration of Duimaju was started before earthquake and estimated to be complete by end of this fiscal year.

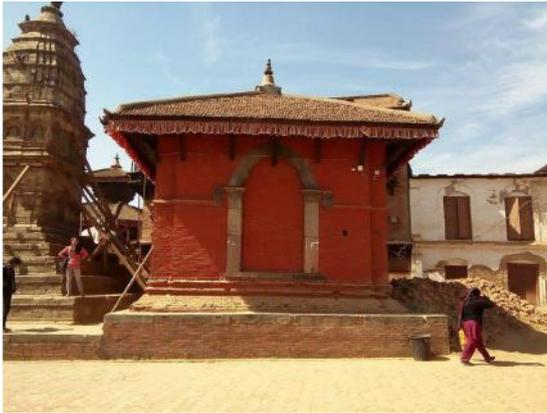
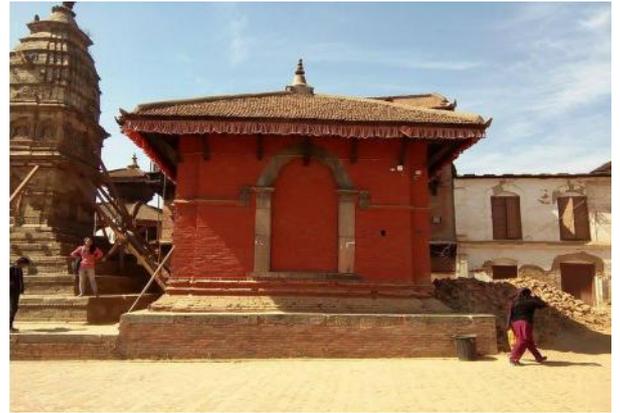
One storey Nepalese Style Vatsala Temple is located at eastern part of Bhaktapur Durbar Square beside Siddhi Laxmi Temple. The conservation work was carried out which included skinning work and repair of the Roof under emergency budget of DoA.

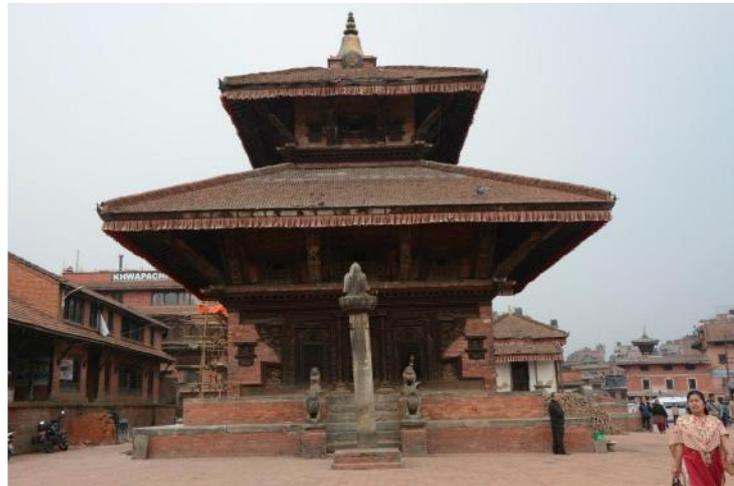
Two roofed pagoda style Gopi Nath Temple is located at western corner of durbar square. Gopi Nath is one of the forms of Vishnu. The temple is also known as Dwarika and Krishna Temple as well, houses three deities, left to right, respectively: Satyabhama, Krishna and Radha.

The inner walls of the sanctum were damaged by recent earthquake and shoring work is done inside temple by using DOA emergency fund. With detail drawing documentation the work of conservation is started.

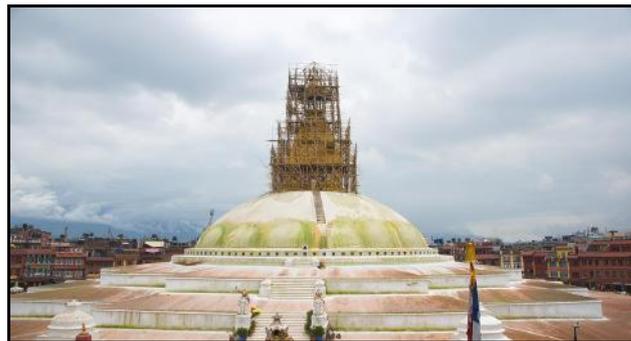
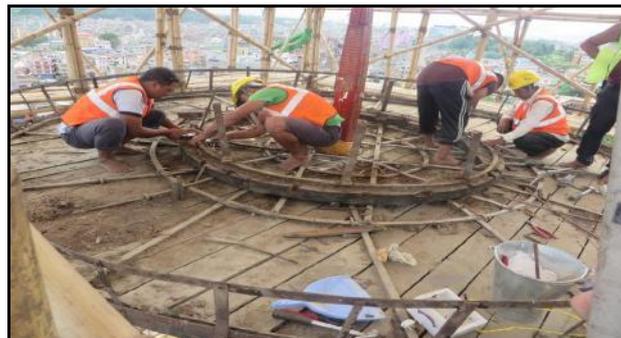
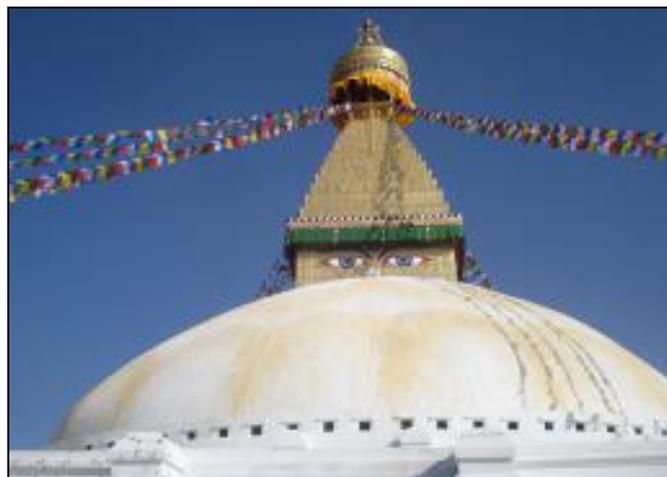
At first, the effect of the earthquake was appeared on the topmost 3 steps of Bhuwanas with cracks and dislocation of the bricks breaking the outer metal cover. Finally the effect of the earthquake found to the entire super structure of the Stupa over the dome.

In the initiative of Bouddha Area Development Committee, with the approval and close inspection of DoA, deputing an engineer and archaeological officer for entire progress, the work of careful dismantling with detail documentation and the conservation of the stupa with the use of traditional method and material is recently completed within 16 months.

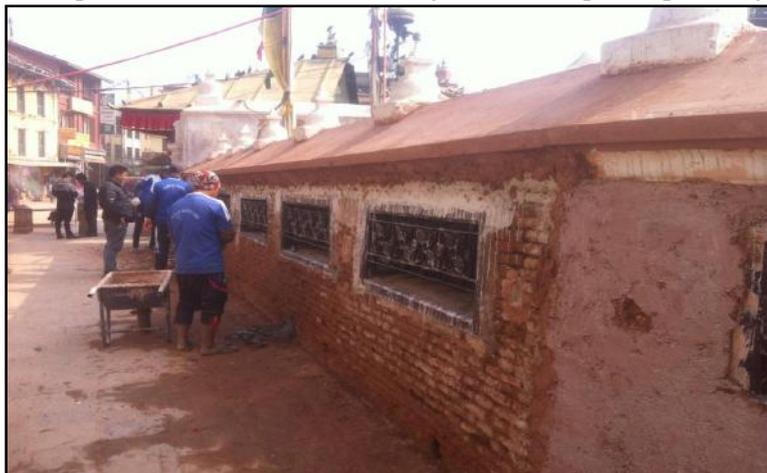
The Mane Wall conservation is completed as it was affected by the earthquake partially. However, as reported in previous report, the entire Mane Wall was conserved replastering it with the Bajra mortar, mixture of Lime, sand, brick powder, black lentil powder and molasses with water replacing the original Liun plaster, it was partially affected by the earthquake and conserved in the initiation of Baudhanath Area Development Committee under the direct supervision of DoA.

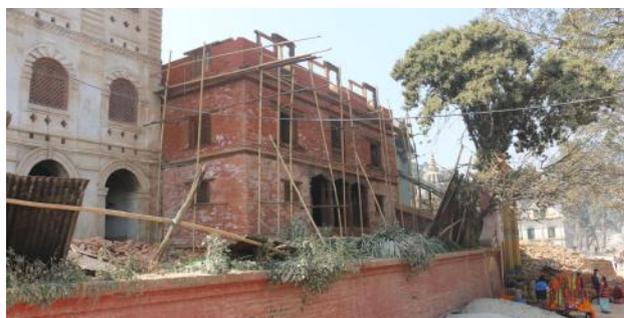
Guheswari Sattal is another conservation project in Pashupati Protected Monument Zone. With the approval of DoA northern wing of the Sattal was tendered last year. Since the upper story of his building is seen latterly added and with no such important elements, the restoration work is in progress at second floor

level with the plan to remove the later added upper floor which also helps Guheshwari temple to be more exposed from north side. And in the same way the progress of North West sattal is above the foundation level. Latter added height of this Sattal is also reduced by one story.

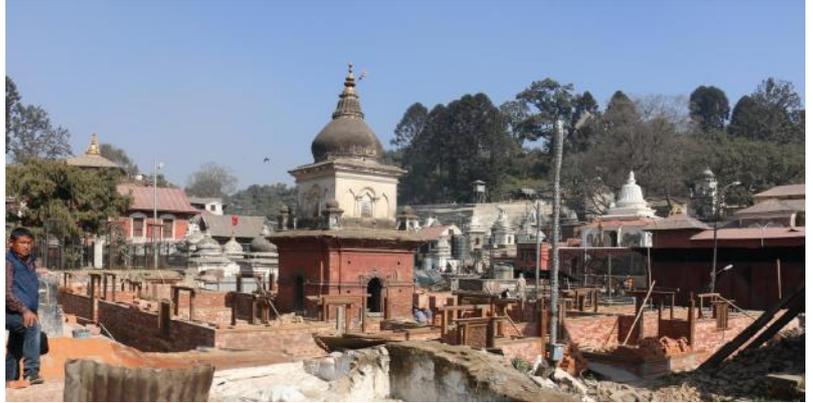
Chaughera Sattal (courtyard rest house) in Bhasmeshwar Cremation area is under conservation with the approval and close inspection already granted from Department of Archaeology to Pashupati Area Development Trust (PADT). The entire financial part has been managed by PADT.

It's a Sattal with two courtyards among them southern one is nearly two

times of north one. North one contains one Shivalaya, the temple devoted to Shiva, called Pranmukteshwar where as southern courtyard contains two shivalayas Amarkanteshwar & Sureshkanteshwar. Conservation of Sattal around northern courtyard is being in progress. In ground floor all doors and windows are placed in position and wall is at the mid of the window level.

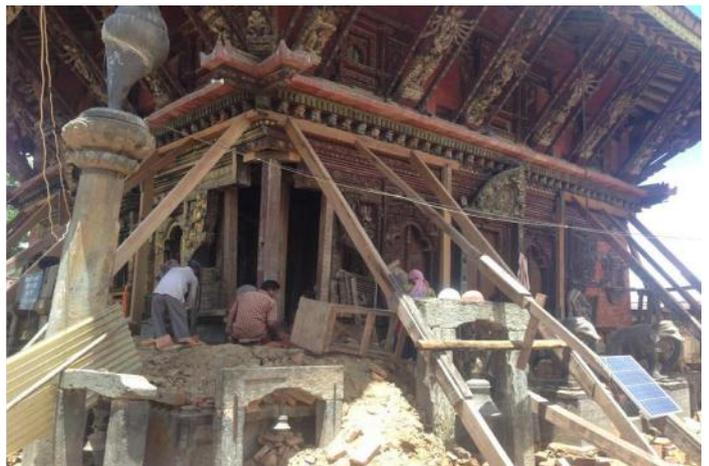
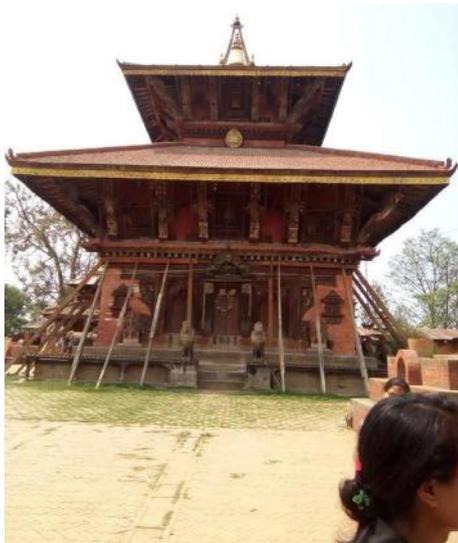
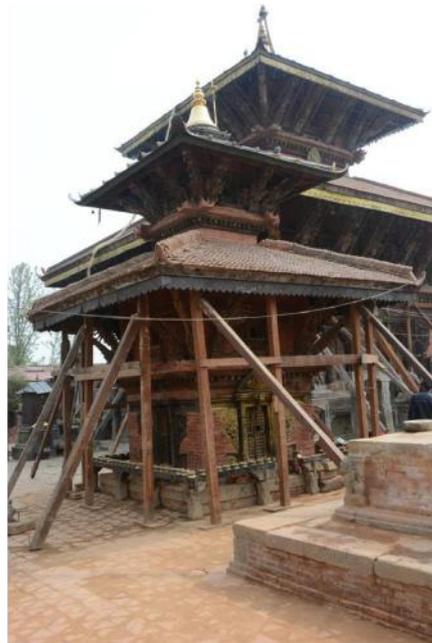
DOA is responsible for renovation of Changu Narayan temple, while renovation of Kileswor Mahadev and temple periphery is carried out by Jhon Sanday and Associates. Shoring work and repair of four corners was done immediately after earthquake to prevent future damage using DoA emergency fund.

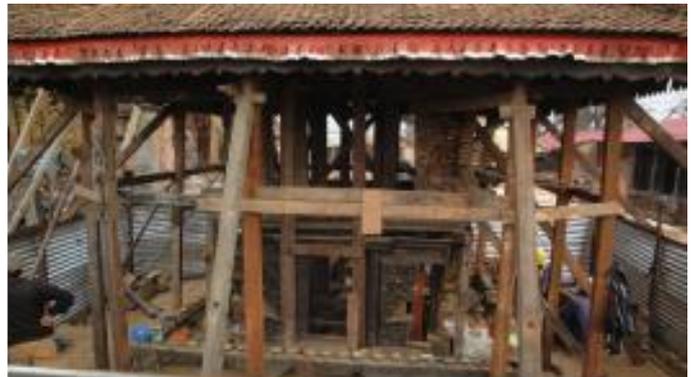
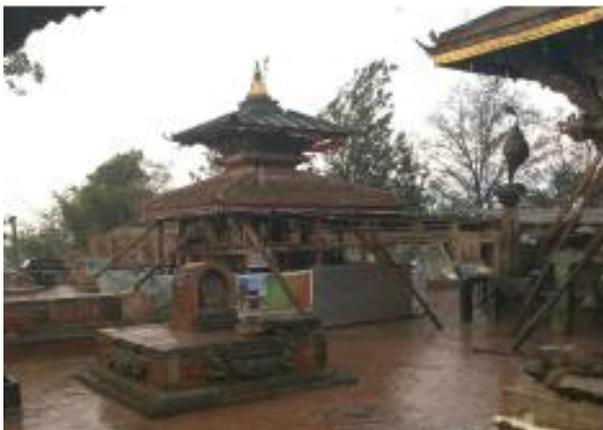
As per the MoU, it has been working the site and the first completion of conservation work during these post-earthquake activities is the completion of Kileshwor Temple just in front of Changu Narayan main temple. Now, HECFN is working on the restoration of Laxmi Narayan Temple and the Chaughera Sattal as well as on other monuments.
