PAKISTAN

Historic Monuments of Thatta

II.1 Introduction

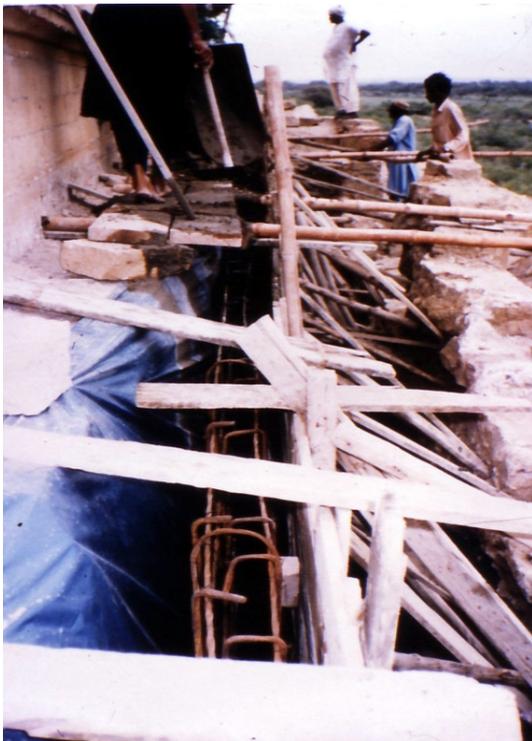
Restoration works at Thatta

- The Dept. has prepared plans for the conservation of the property particularly with reference to weathering.

- "For proper management and monitoring of the site it is necessary that enough staff should be deputed to the site, including a site director, who will be responsible for its upkeep".
- The Government has prepared a comprehensive plan for the conservation of Thatta, for implementation in 2003-2004.
- Both financial and technical assistance is required from the World Heritage Fund.
