Report on the ICOMOS Advisory Mission to City of Quito (C 2)

7 to 10 December 2016

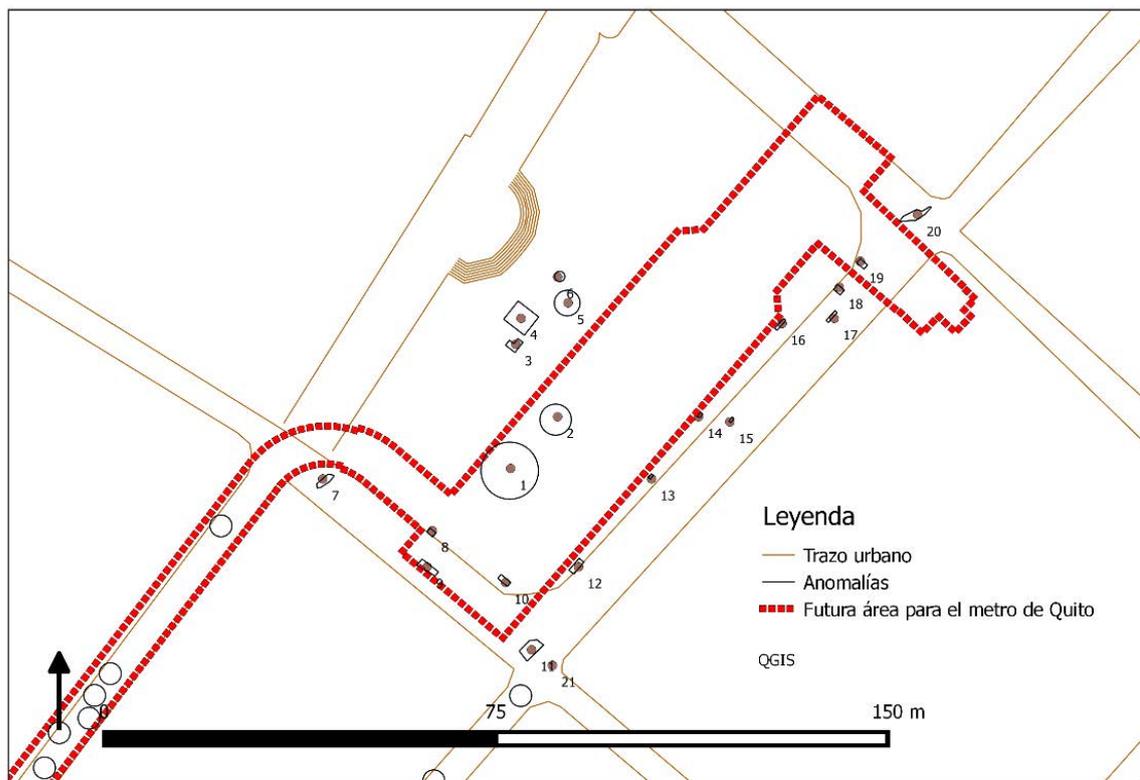
The distribution of the anomalies in the Plaza, only in the area that would be affected by the construction of the Station, can be seen in Graph 5:

Graph 5. Location of the anomalies at Plaza San Francisco (taken from Delgado & Vásquez streets, 2015)

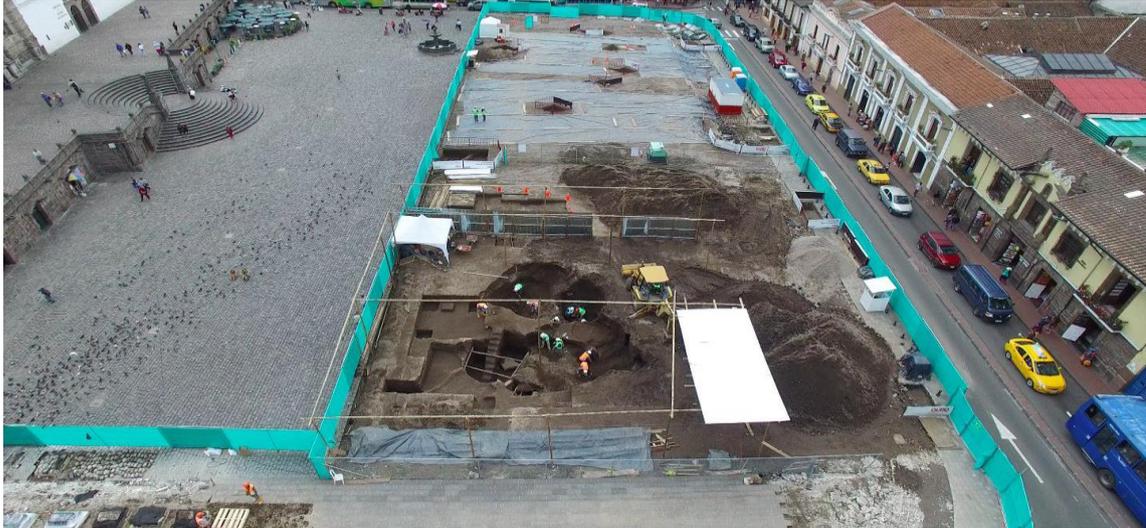
Image1. Field work. Archaeological Rescue, 2016

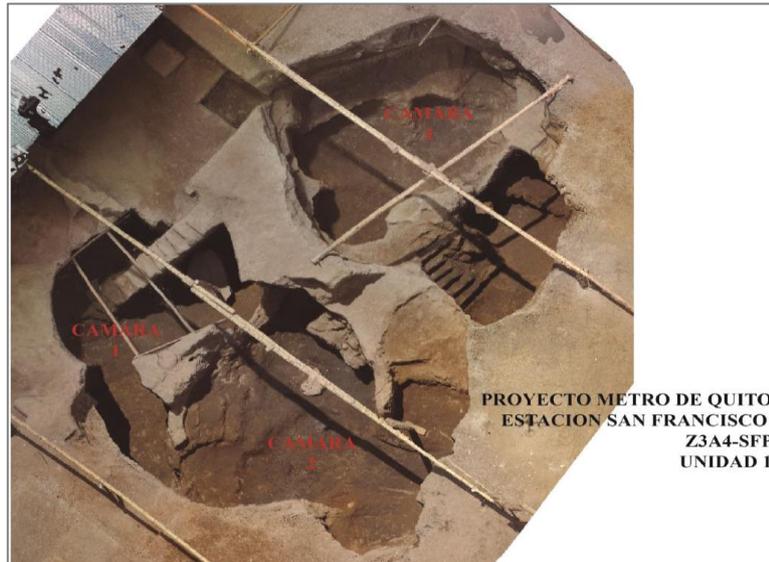
Chamber 3 presents a shape similar to an eight (8), orientated from east to west, structured in two divisions built to unevenness. The constructive typology of this structure would seem to correspond to different temporalities, i.e. it is older than the two previous chambers.

Image 1. Anomaly 1

- It is recommended that Anomaly 1 *in situ* be preserved and put into value, accompanied by its respective interpretation property;
- It is recommended to implement the recommendations of the 2017 Heritage Impact Assessment (HIA) report, in order to ensure verification of its assertions regarding the evaluation of the construction of the MQ and its coming into operation; a process that would show the State Party's interest to demonstrate the governance of the World Heritage property;

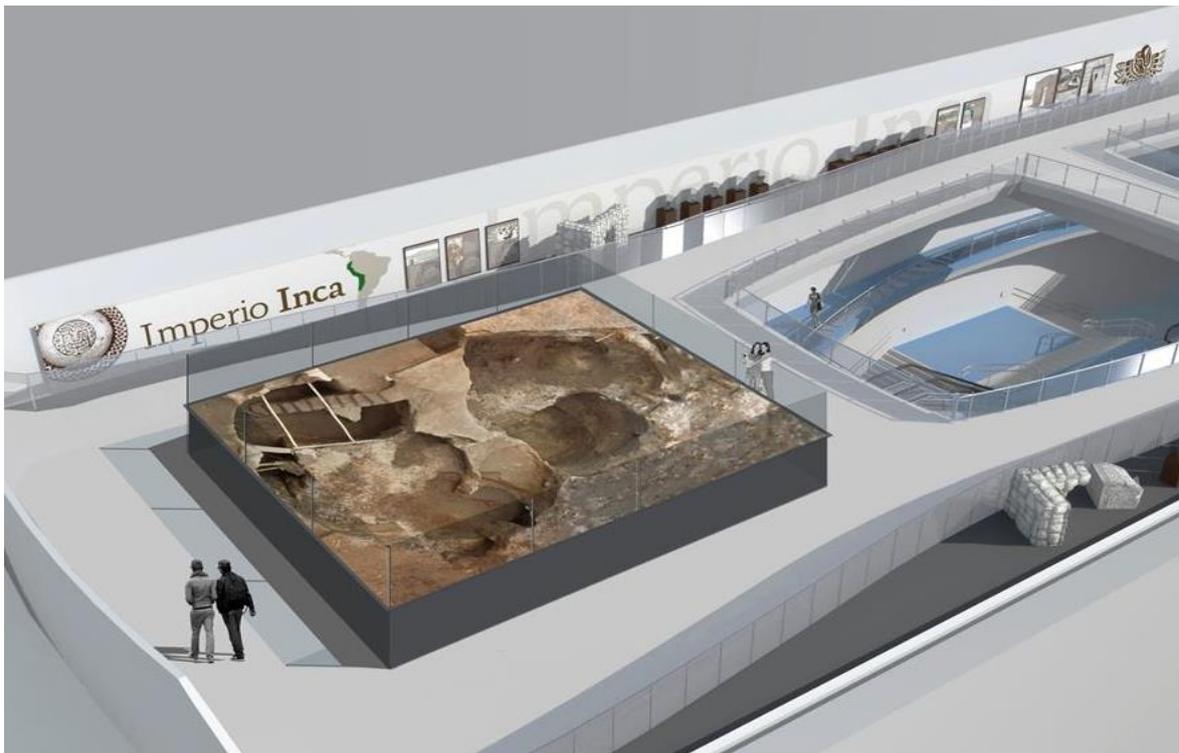
Graph 6. View in Plant of Structure – Situation: Proposal to Put in Value. Final Project Archaeological Rescue Report

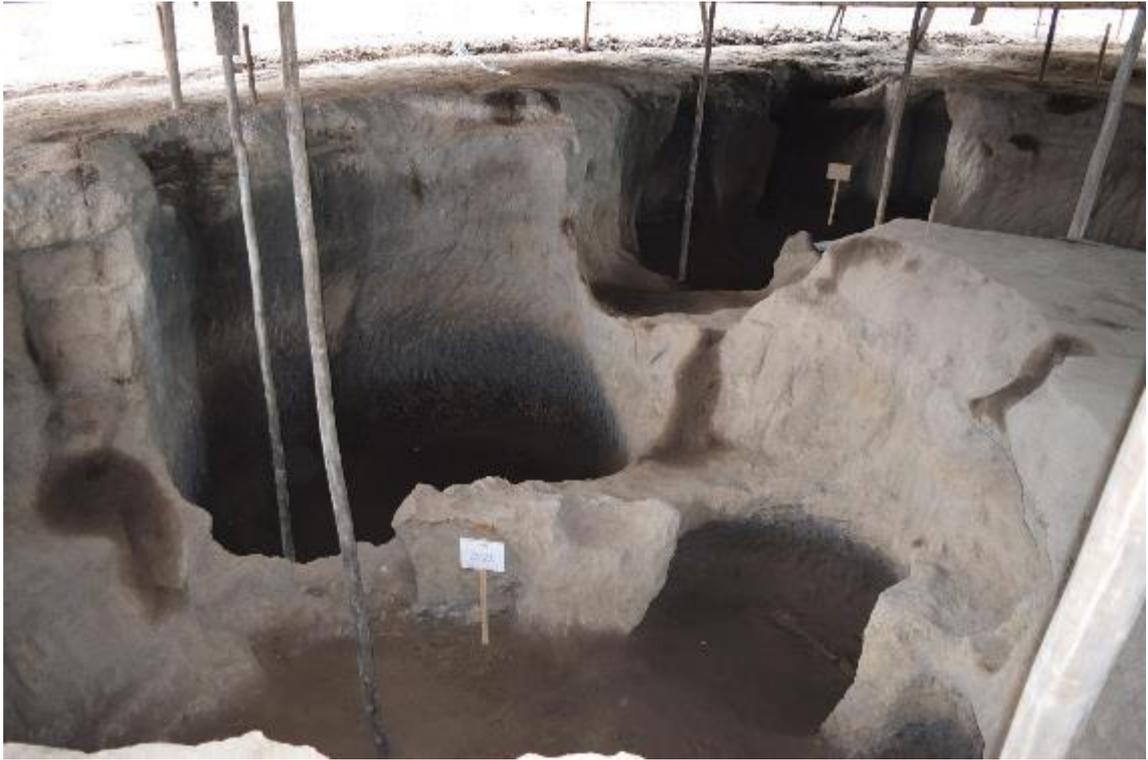
Fortunately, for the excavation of the Plaza San Francisco station, the Cangahua Formation can support almost vertical faces, as can be seen in the excavated archaeological site visited during the Mission (Figure 3). As the soil is relatively rigid and low in permeability, the construction of subsoil structures can handle groundwater and soil movements relatively efficiently. It should be noted that in the excavation at the CHQ, it is necessary to manage and control the risk of damage in the patrimonial structures –structures that maintain the economic center, the tourist attraction, and the cultural existence of the CHQ-. Therefore, the program of geotechnical and structural instrumentation and monitoring is critical for the result of the construction of the Plaza San Francisco station.

Image3. Archaeological excavation on the geophysical anomaly in Plaza San Francisco, 2016

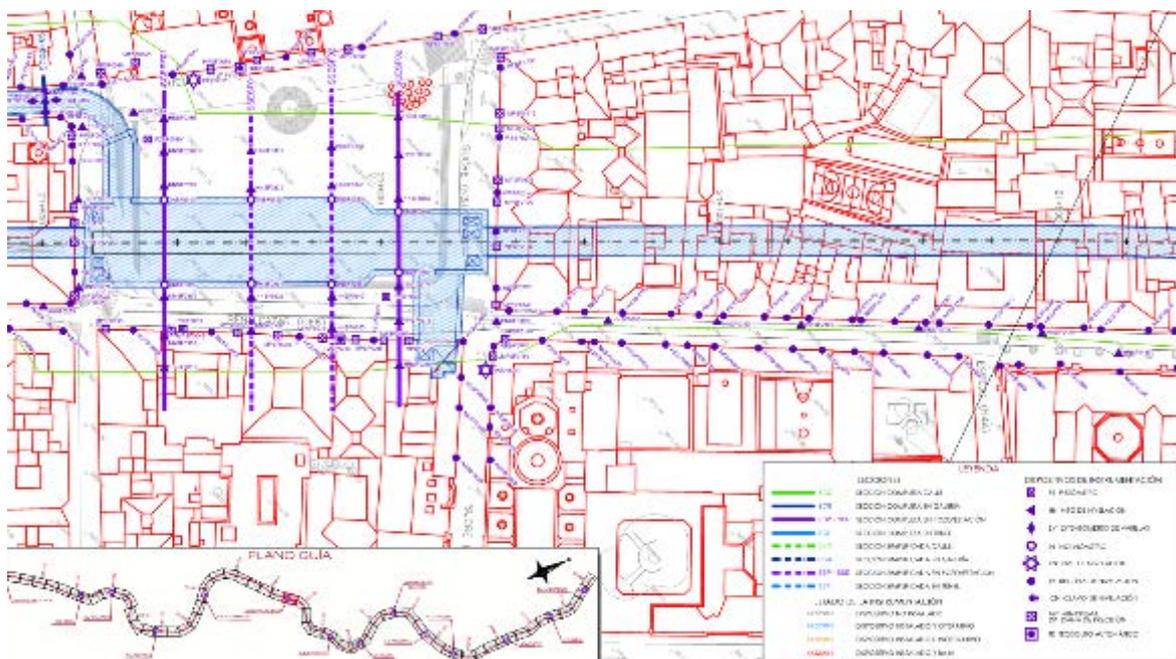
During the Advisory Mission drawings were received from Metro Quito, showing the sequence for the construction of the station and the planned instrumentation¹² program [Graph 7]. Neither additional plans nor calculations were furnished on the anticipated soil deformations (i.e. models for the interaction of soil-structure, numerical models, bi dimensional or tridimensional). In general terms, the execution plan to execute the station at Plaza San Francisco is reasonably consistent with international practice, and the total automated stations will provide frequent monitoring on the displacement of the survey points.

Graph 7. Execution plane image showing piezometer, leveling milestone, strain gauges, inclinometers, leveling base, mini-prism, and theodolite, MQ

- It is recommended to implement a system of geotechnical instrumentation and movement control, at the station to be built immediately before Plaza San Francisco, to measure and compare structural movements. The results of this study should be shared with the World Heritage Centre before starting the construction of the Plaza San Francisco station.

- It is suggested to take into account the recommendations made regarding control of soil displacement criteria, the addition of monitoring along the alignment of the tunneling machine and in the significant buildings of the area, as well as the action plan for seismic or construction eventualities.
-

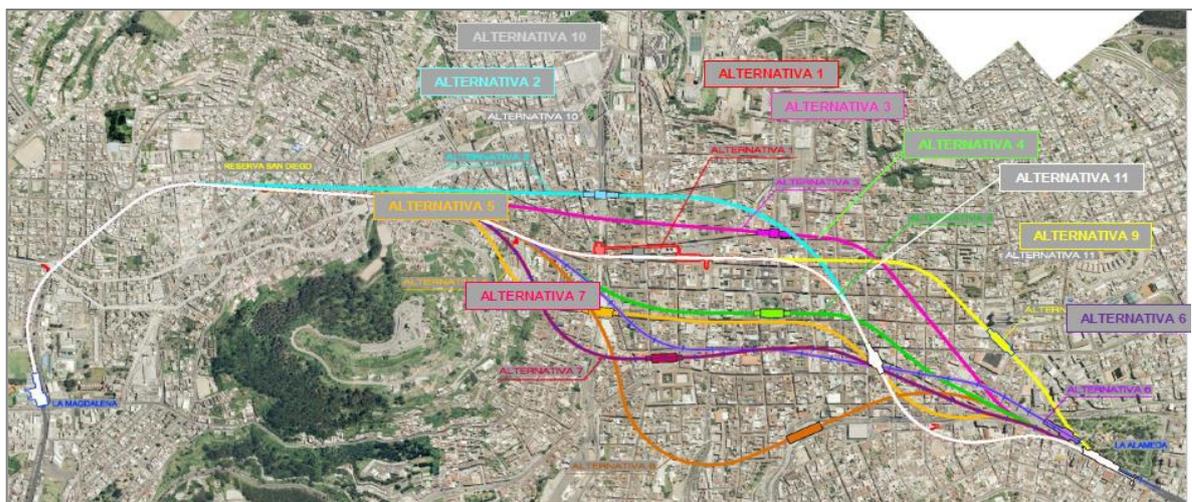
- Intersection between Av. 24 de Mayo e Imbabura
- Santa Clara Square
- Plaza de la Merced

Graph 8. Alternative courses for Line 1 of the MQ through the CHQCHQ. MQ

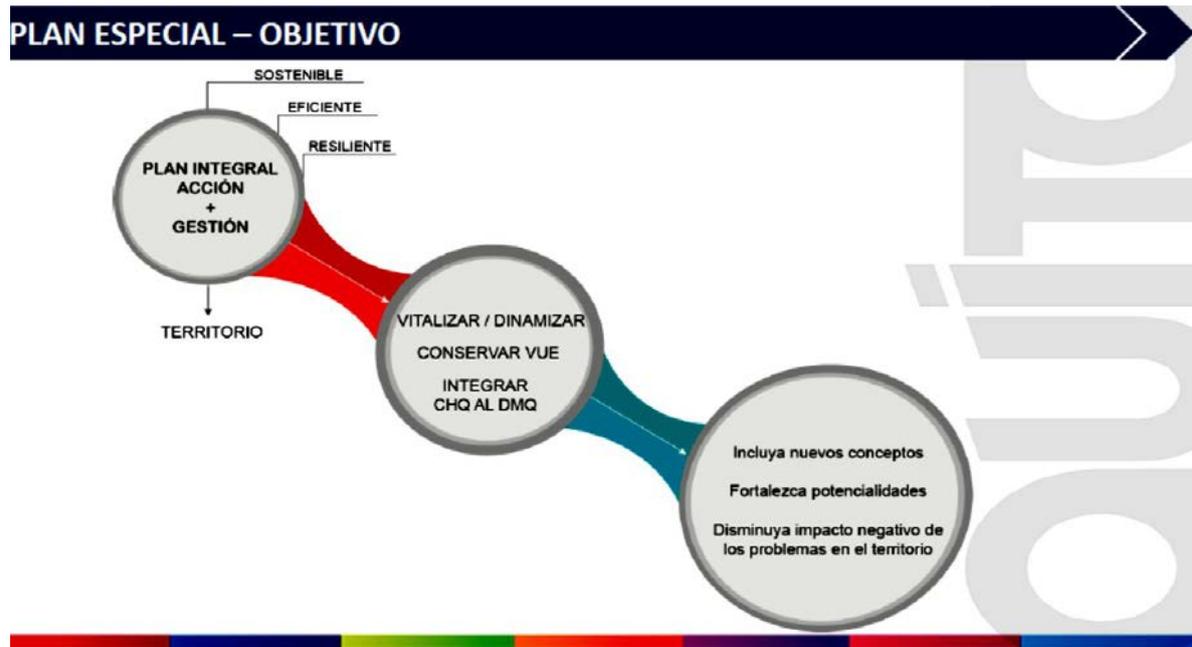
Graph 14. Objectives of the Special Plan. IMPQ

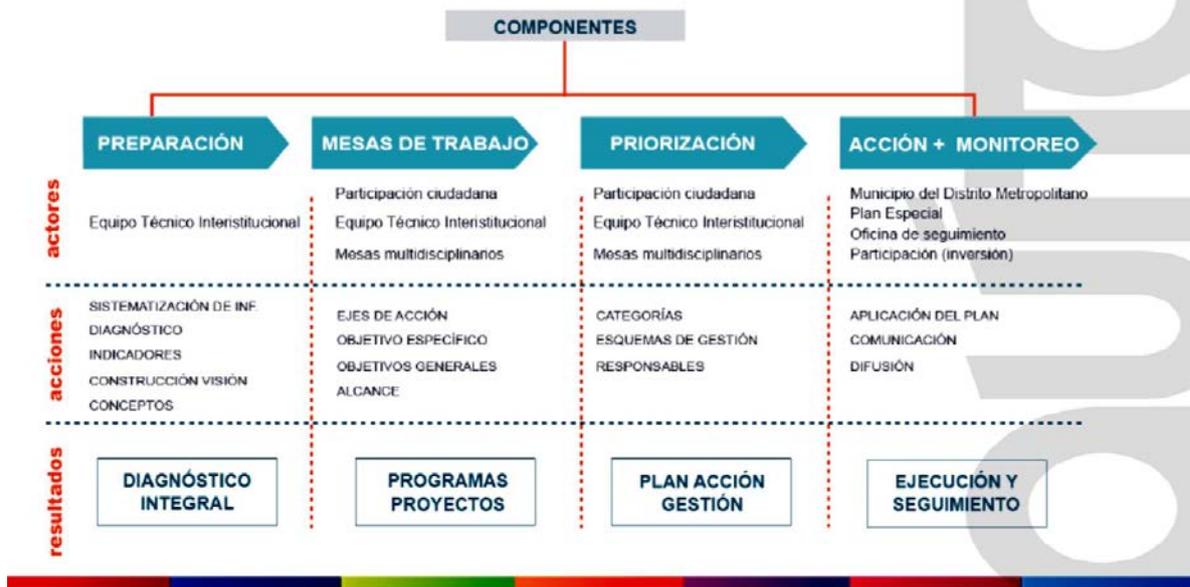
The methodology to be applied to develop each stage is as follows [Graph 12]:

Graph 12. Methodology of the Special Plan. IMPQ

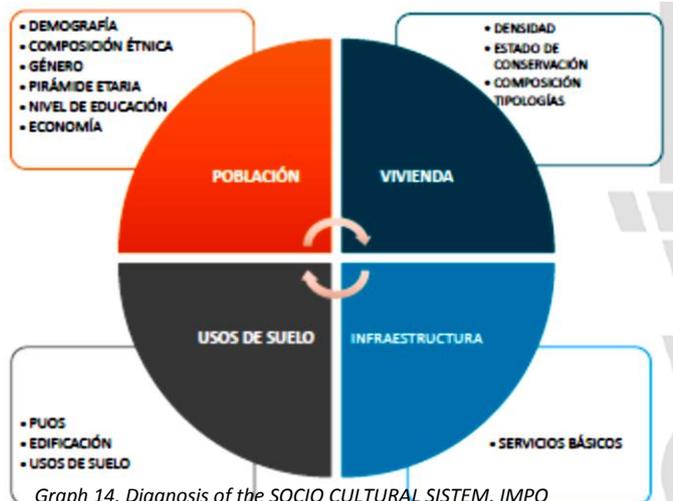
The depopulation is attributed to the poor conditions of conservation of buildings and the transfer of educational institutions and intuitions outside the area.

Graph 14. Diagnosis of the SOCIO CULTURAL SYSTEM, IMPQ

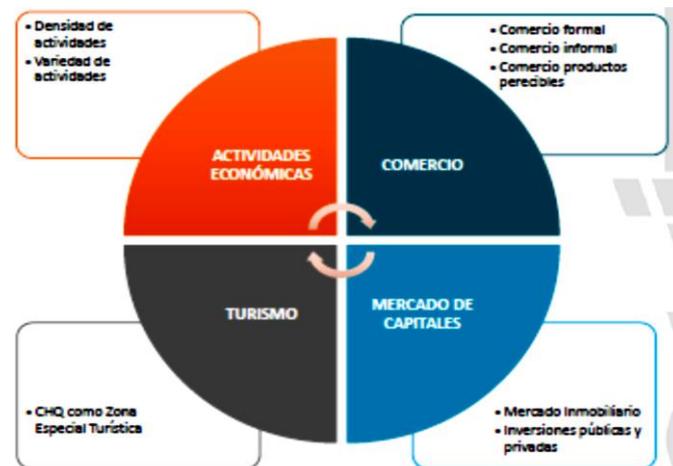
For the ECONOMIC SYSTEM, the analysis of the variables indicates the diversity of activities and their density in the ground floor, superimposed with the informal commerce in the public streets, which defines the axes of greater demand [Graph 15].

Graph 15. Diagnosis of the ECONOMIC SYSTEM, IMPQ

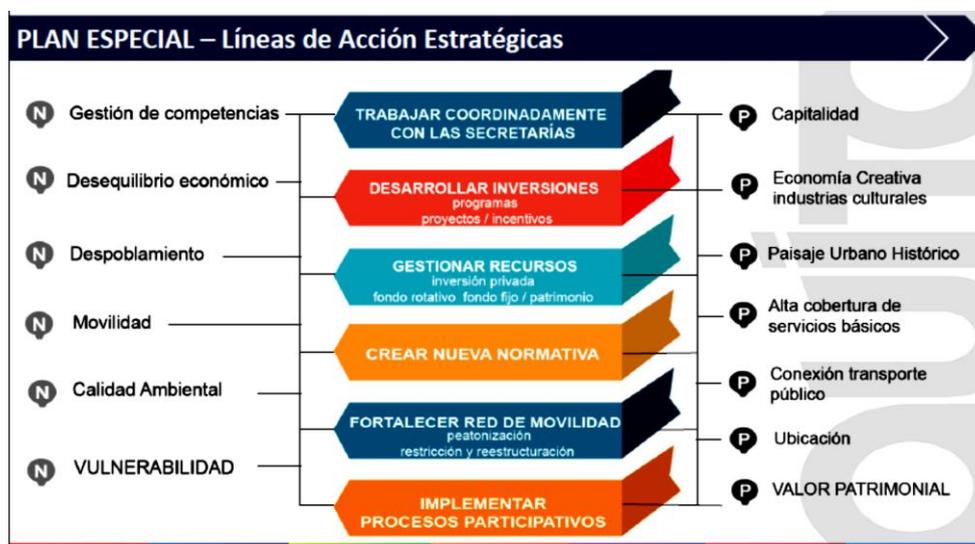
From the above the main vulnerabilities of the property arise, which generate the strategic lines of action to revert them [Graph 17]:

Graph 17. Strategic Action Lines for the Special Plan, IMPQ

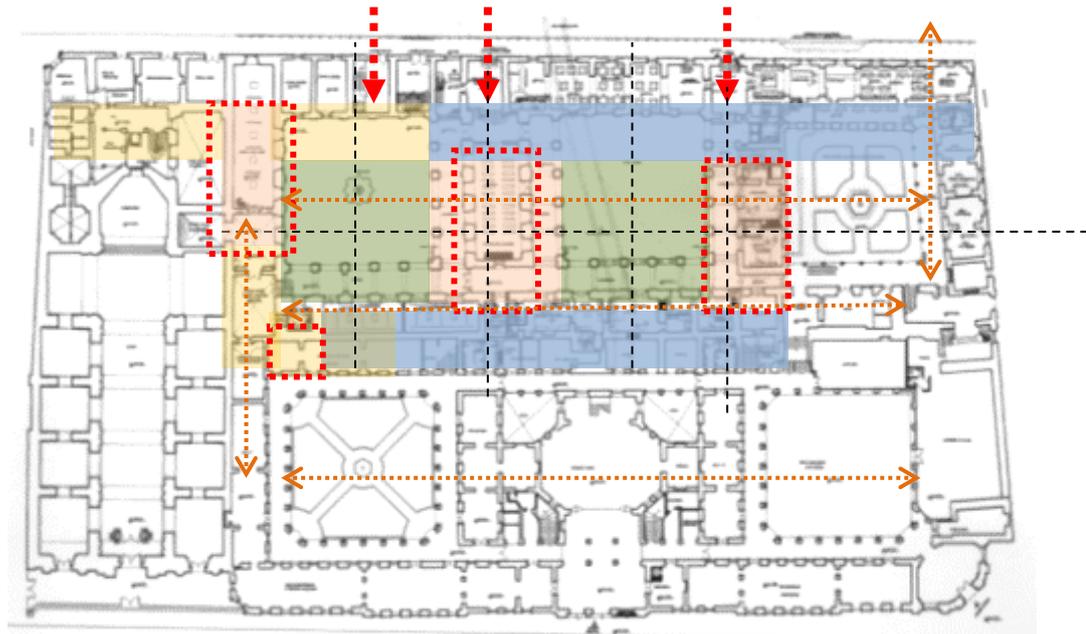
At present, the historical unit is structured through courtyards, two of which form part of the proposal. The gangway parallel to the street contains specific activities, such as offices, classrooms and rooms, mostly unused. The transversal ones are occupied by large spaces of religious and social use such as the Chapel of San José, the Chapel of the Miracle in the ground floor and multipurpose hall in the top floor, and the Auditorium in ground floor and respectively in each of the three wings [Graph 21].

Graph 21. Analysis of significant spaces

- It is recommended to include archaeological control in both Patios during the work so as to, in addition to complying with current legislation, contribute to the interpretation of the Compañía de Jesús Complex and the World Heritage property;

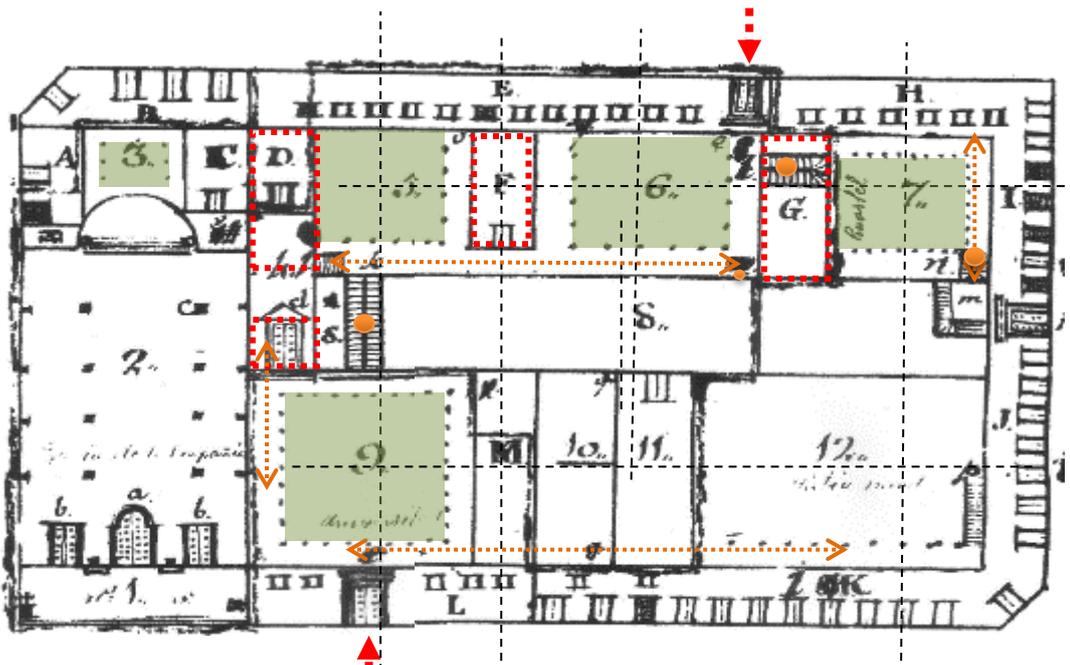
Institutional agreements have made it possible to recover the visual relationship between the side-yard units of the Church, that correspond to the Museum of the Compañía and to the Metropolitan Cultural Center, which facilitate the perception of the longitudinal visuals that characterized the order's ensembles and which have been maintained from the original building until today. In this way, in spite of the change of uses and of the different legal domains, the unit will benefit in the interpretation of its spatial and functional architectural typology. [Annex X].

Graph 22. Cloister and visuals scheme on "Plan of the lower part of the building of the main college that with the name of Maximum had the Jesuits", Quito, 1783? 1830?

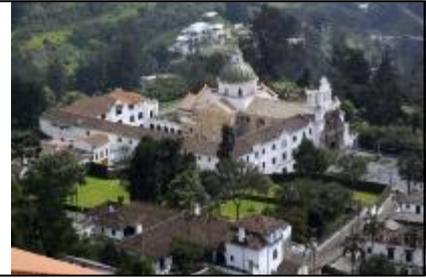
Work: Integral Plan for Guápulo,
IMPQ- EPMMP, 2015

The Integral Plan of Guápulo addresses road, public infrastructure and mobility interventions for this neighborhood in order to recover the quality of urban spaces and the quality of life of its inhabitants, reducing the vehicle load of the sector that can reach 21 000 cars on the Orellana road.

The closing of the Germánico Salgado Street has the objective of preserving the heritage buildings, as well as the works of road improvement, sidewalks, curbs and signposts in Compte and Rafael León Larrea Streets, imposing a maximum speed of 30 km / h.

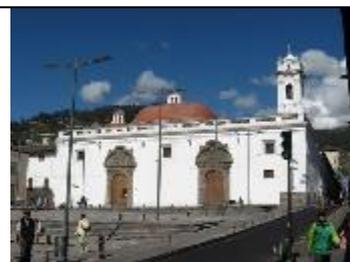
VI.1. Church and Convent of Santa Clara
Cuenca y Rocafuerte
Midcentury XVII
Restored between 1990-2000, FONSAL
Affected by earthquakes of 2016: convent and church

Over the centuries the building has received reinforcements to face earthquakes, as evidenced by the buttresses of the west side of the church. In 2016 the earthquakes affected part of the perimeter wall of the orchard, the novitiate, sectors near the first courtyard and the tower.

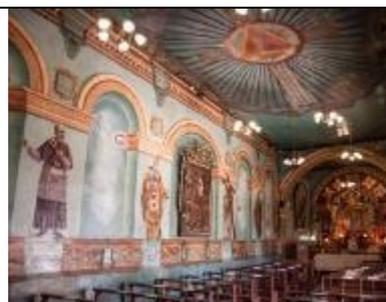
VI.2. Chapel Los Milagros
Rocafuerte y Fernández Madrid N1-113
1680
Restored between 1989-90 M-2000, FONSAL
Affected by earthquakes of 2016: chapel

In the chapel the seismic movement affected the sector of the high choir, with the detachment of the plaster over the wall of the ceiling. Also affected are the paintings of the ceiling of the nave, on which the consolidation prior to the intervention has been applied.

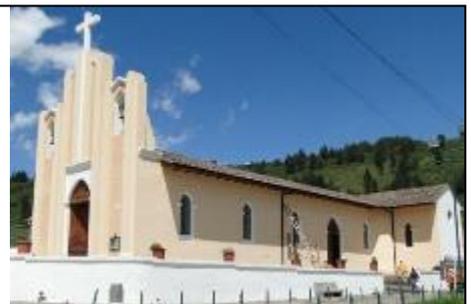
VI.5. Iglesia de Nono
Parroquia Nono, Noroccidente DMQ
Siglo XVI en adelante
Affected by earthquakes of 2016 church

The chapel has a structure that corresponds to the original building in the nave and lateral dependencies, while the current facade is a wall built later parallel to the existing one.

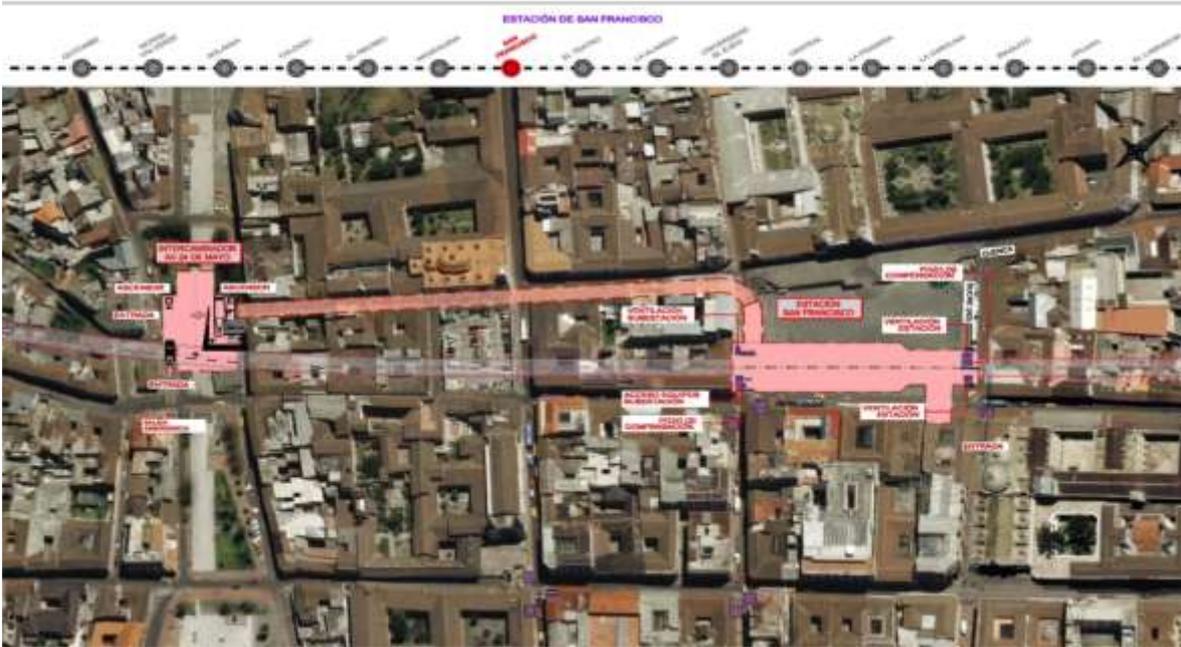
- Ventilation and EPB extraction well in San Diego
- 24 de Mayo exchanger
- Ventilation and EPB extraction well in Theater Square
- Auxiliary well next to Santa Clara Square, from which to undertake the connecting tunnel between 24 de Mayo and San Francisco.

It is stated that the proposed changes would “obviate extract EPBs wells in San Diego and Plaza del Teatro. Thus, although these wells would be built for another purpose (ventilation, pumping, emergency exit), deadline does not depend on the tunnels and surface alteration would be much simpler in terms of effort and time. In fact, since the EPB would no longer be drilled out of these wells, a new location would be analyzed, looking for a less sensitive location (especially in the Plaza del Teatro)”.

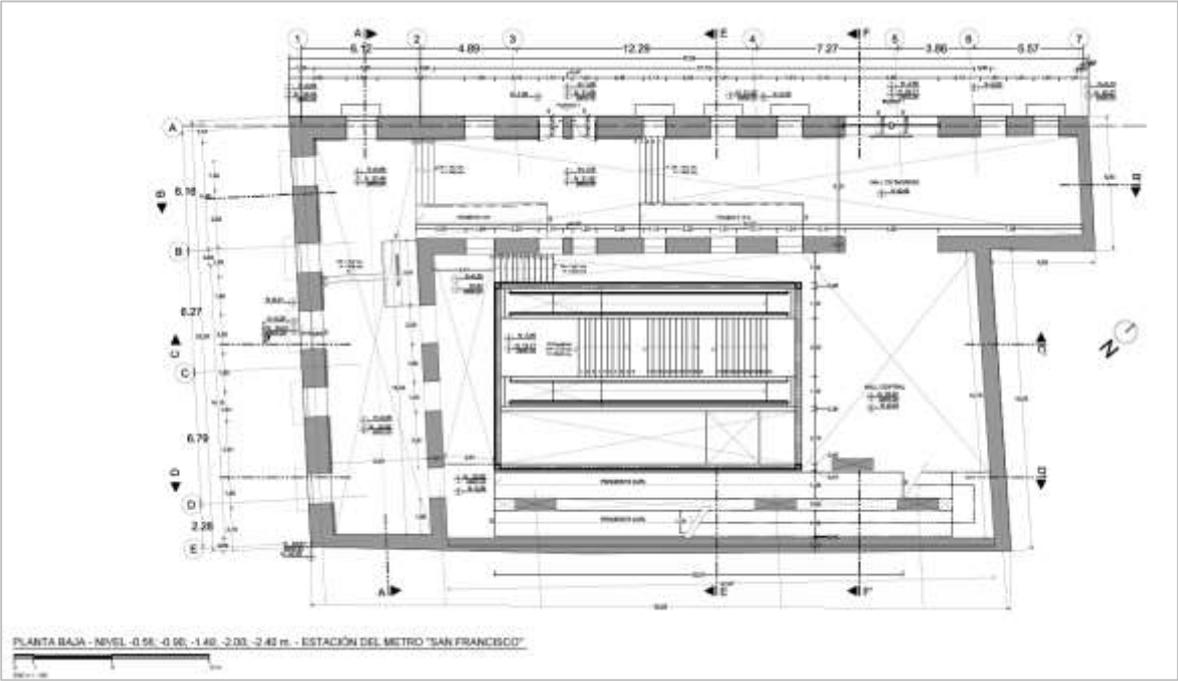
- The optimized San Francisco Station consists of:
 - A box station of about 72,000 m3, located in the east of the square, with 3 levels, inside of which are located all the stairs and elevators that connect over the different levels plus technical spaces, executed as the other stations, under shelter of screens by the ‘up & down’ construction method.
 - An integrated pedestrian access integrated within the building at the crossing of Sucre and Benalcázar streets, so as to avoid any impact or insertion into the square.
 - An exchanger located at Av. 24 de Mayo, which benefits from the avenue’s vehicular underpass to locate an additional bus stop, linking by underground means to the lobby of the San Francisco Station, by moving walkways”.
 - An emergency exit of this exchanger in Santa Clara Square.

In the proposed dimensions, the station occupies the entire length of the San Francisco Square. The dimensions appear to meet the required safety standards, both in the construction work process and in its future operation. Architectural drawings of the station have been incorporated, but no design is provided for the emergency exit of Santa Clara Square (Drawing No. 10.7.1.4), or vents in San Francisco Square (Drawings No. 10.7.1.2 and 10.7.1.3), in relation to the space of the square and the surrounding buildings.

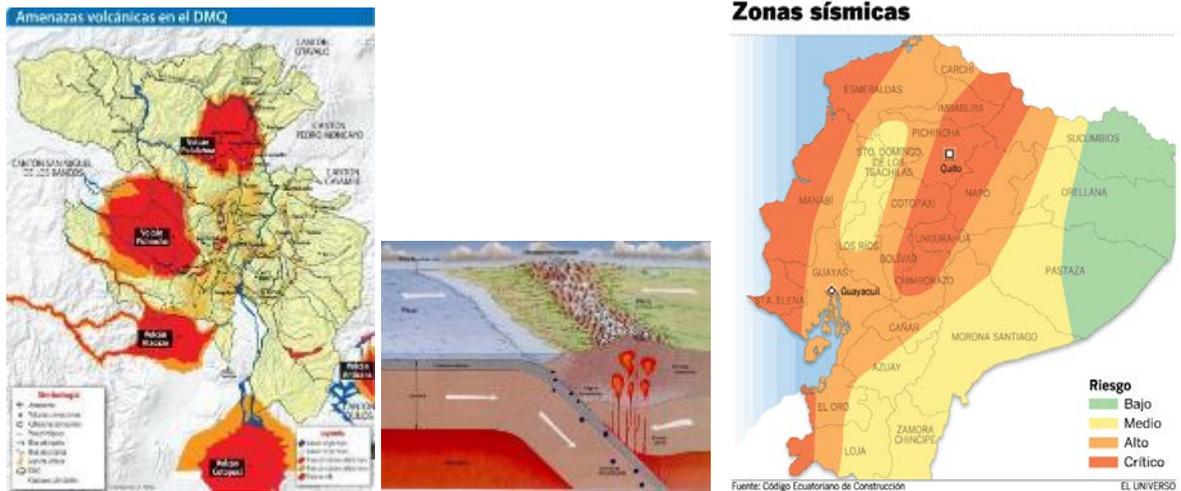
Graph V. 2. Volcanic threatens on the territory of Quito's Metropolitan District and seismic zonings in the Ecuadorian Construction Code

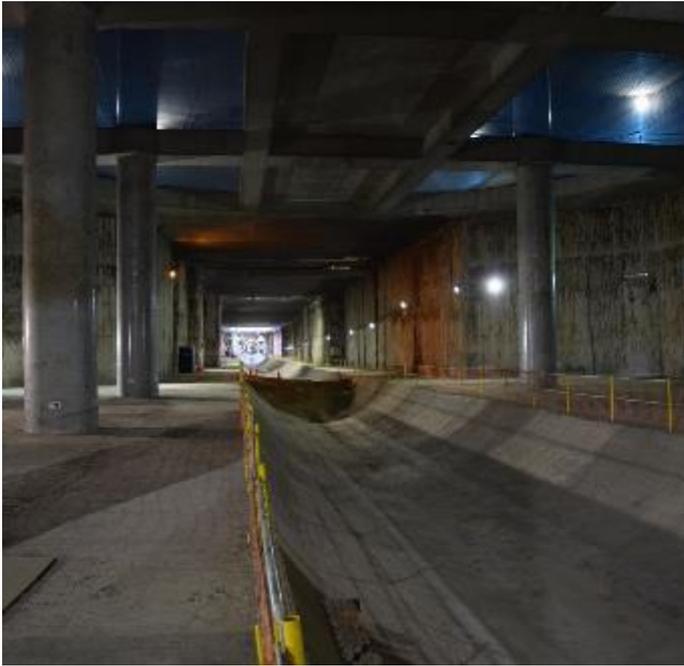
Imagen IX.1. Slurry walls constructed at the El Labrador Station, mezzanine level.

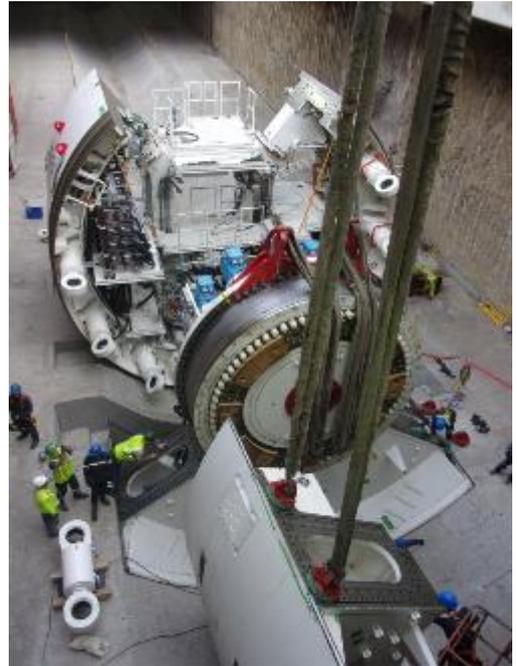
Imagen IX.2. Quito Metro tunnel boring machine being assembled

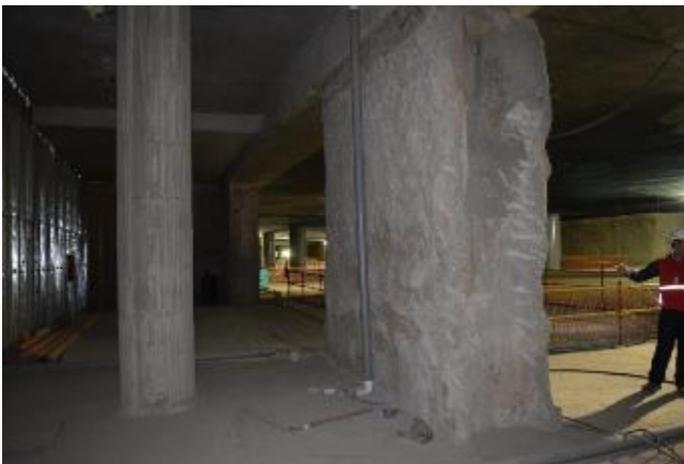
Imagen IX.3. Track level of the El Labrador Station, with TBM (tuneladora) cradle and in the distance, the TBM assembly area.

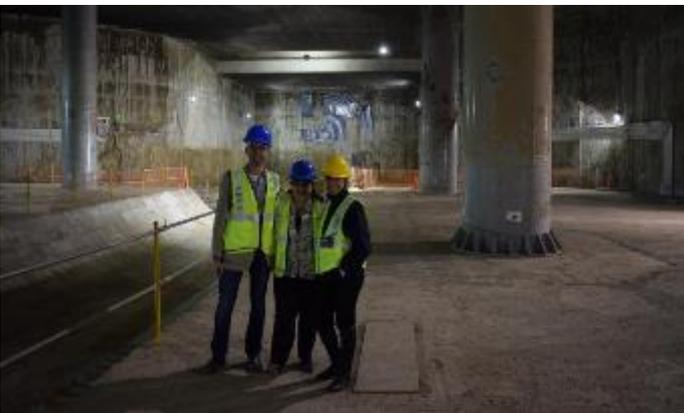
Imagen IX.4. ICOMOS team with IMPQ representative shown for scale at El Labrador Station with station box break-out wall behind.

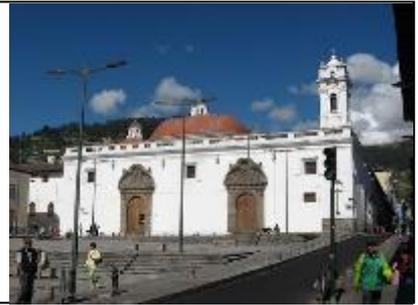
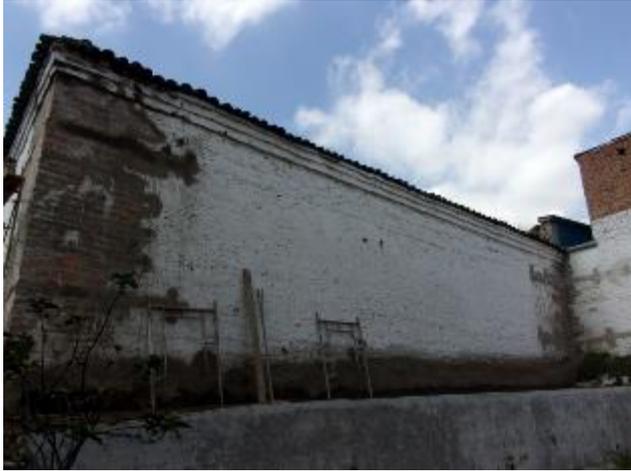
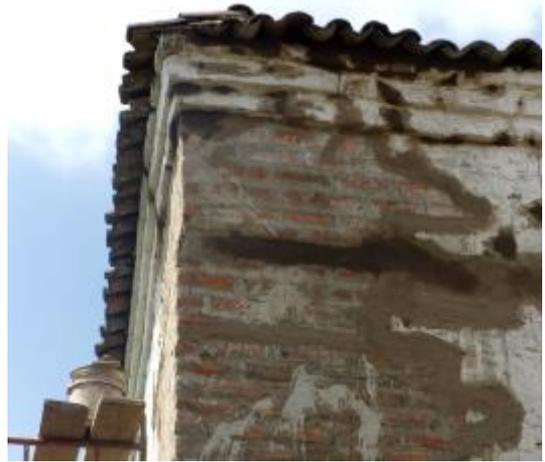
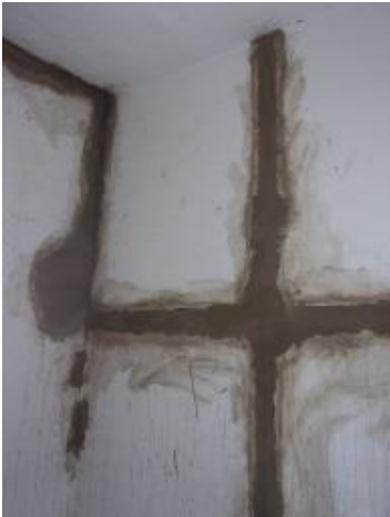
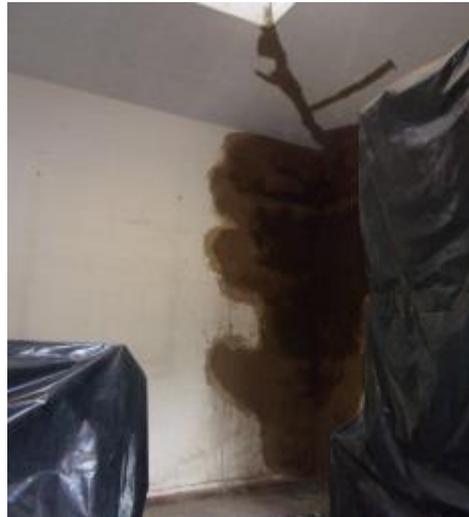
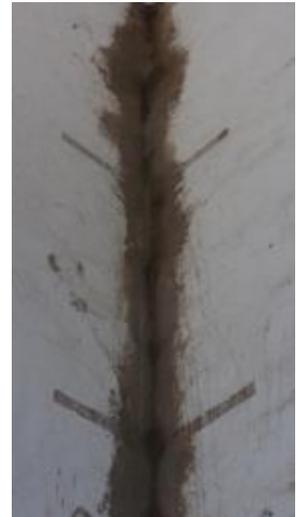
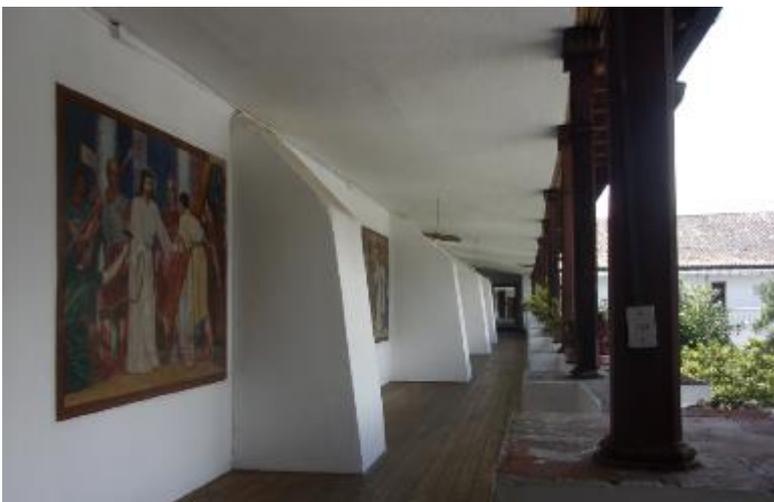
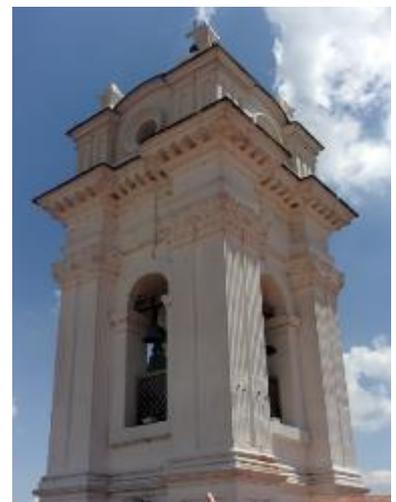
XII.1 Church and Convent of Santa Clara
Cuenca and Rocafuerte
About the middle of the 17th century
Restored between 1990-2000, FONSAI
Affected by the 2016 earthquakes: convent and church

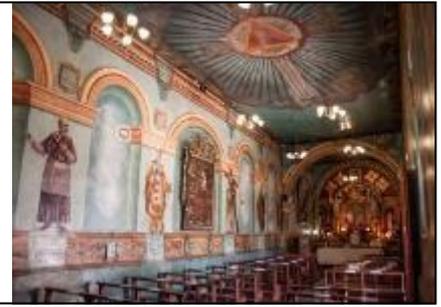
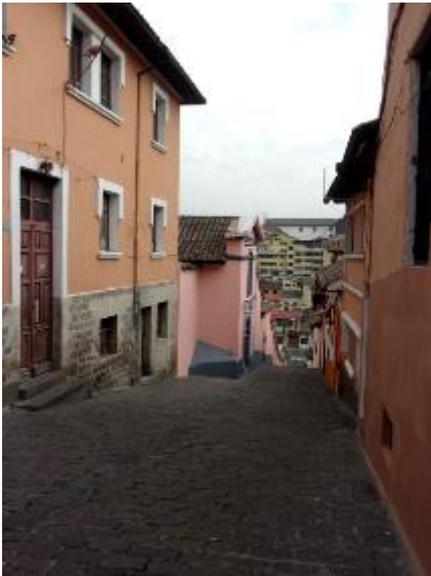
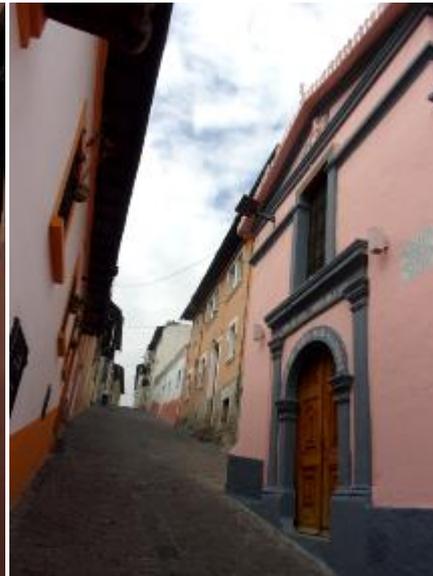
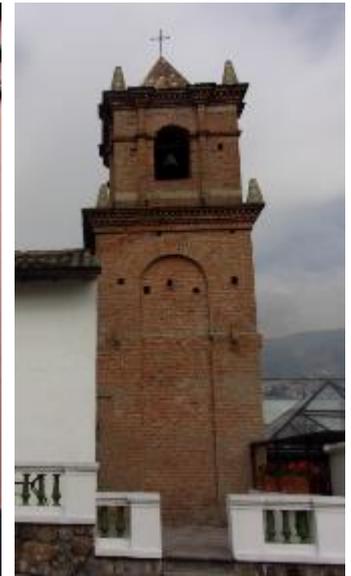
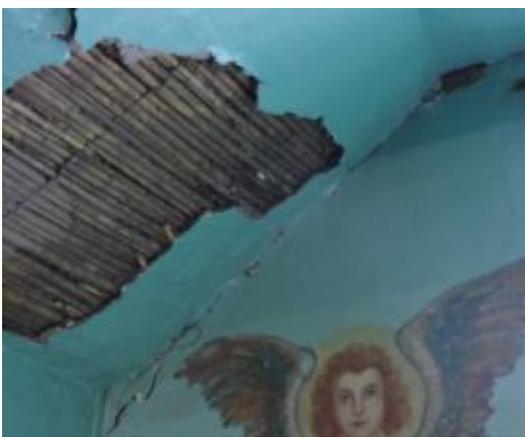
XII.2. Chapel de Los Milagros
Rocafuerte and Fernández Madrid N1-113
1680
Restored between 1989-90 M-2000, FONSAL
Affected by 2016 earthquakes: chapel

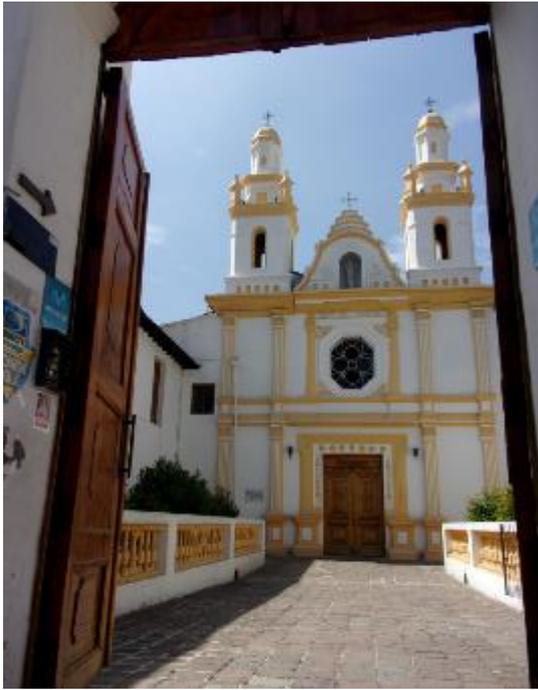
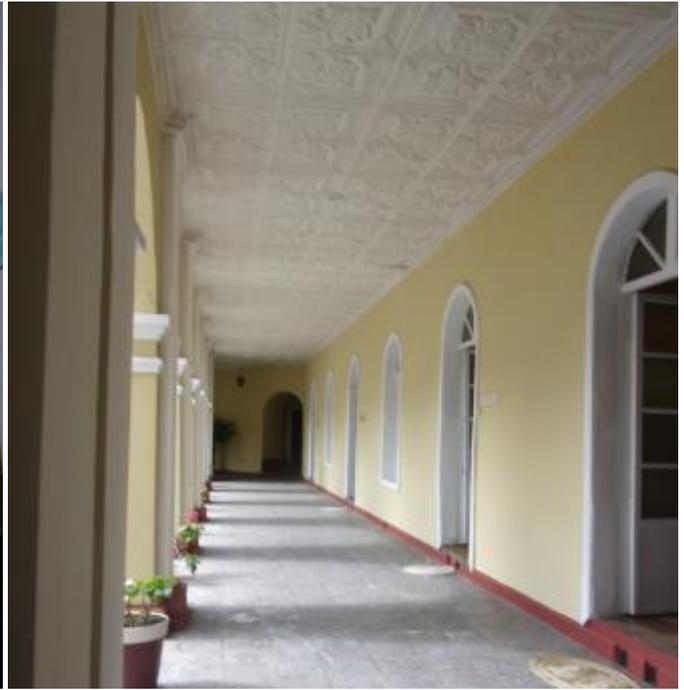
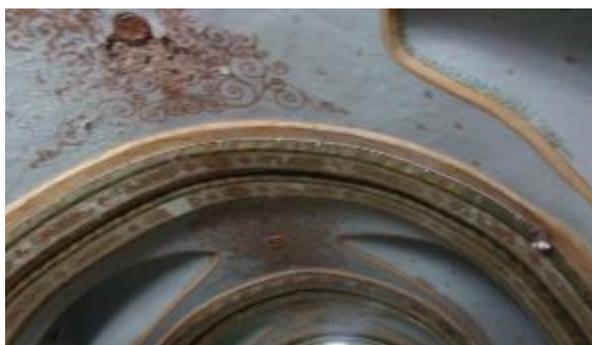
**XII.3. Convent del Buen Pastor,
Old Recoleta de la Peña de Francia**
La Recoleta
1600, 1770 church, modifications 1871-1912
Restored between 1993-2000, FONSA
Affected by 2016 earthquakes: convent and church

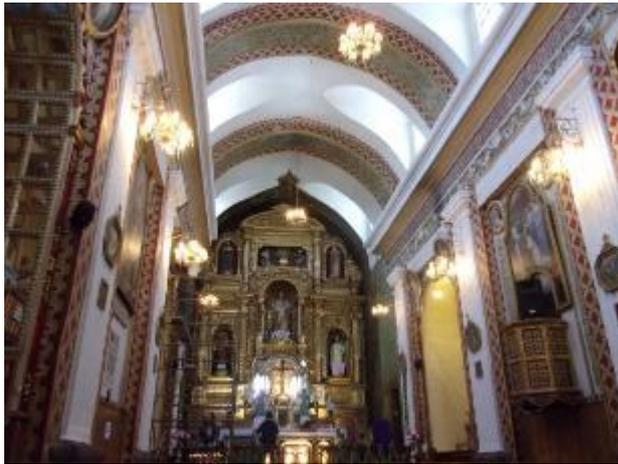
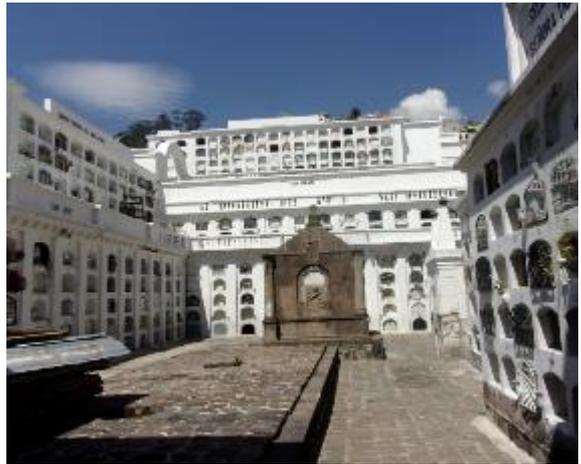
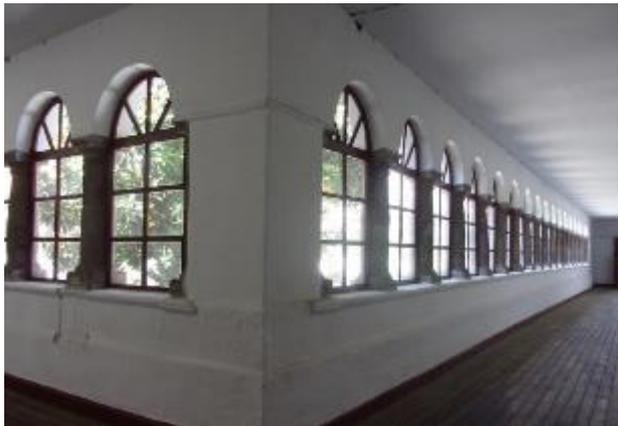
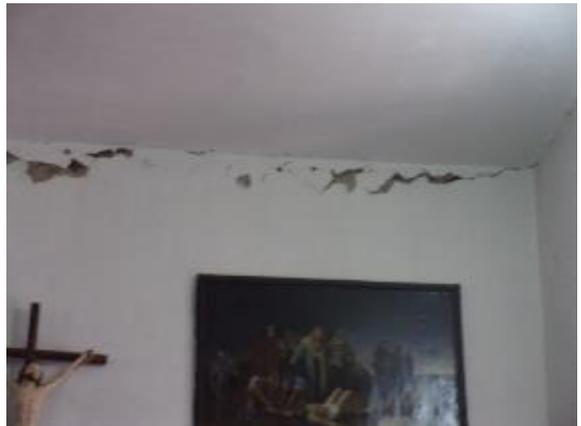
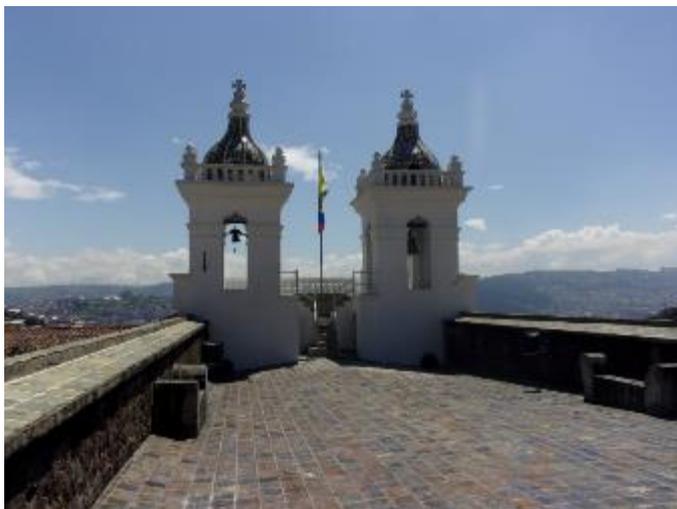
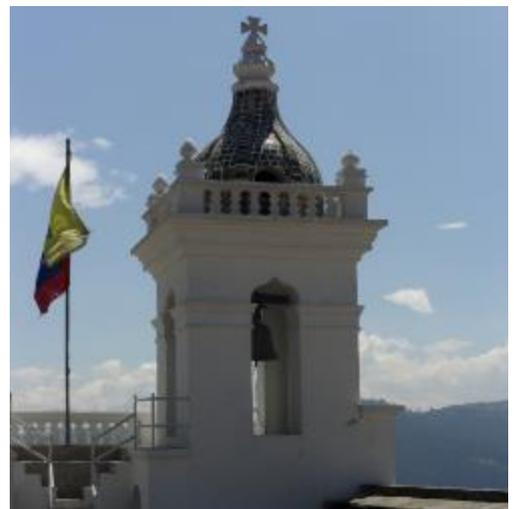
XII.4. Church and Convent Mercedario de El Tejar
El Retiro N5-153, La Merced
1750
Affected by 2016 earthquakes: convent and church
