Report on the ICOMOS Advisory Mission to City of Quito (C 2)

7 to 10 December 2016

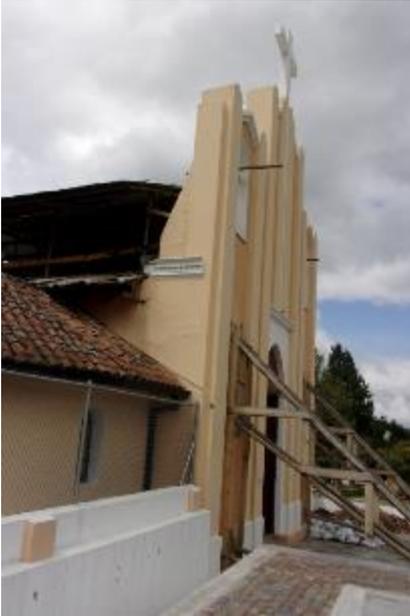
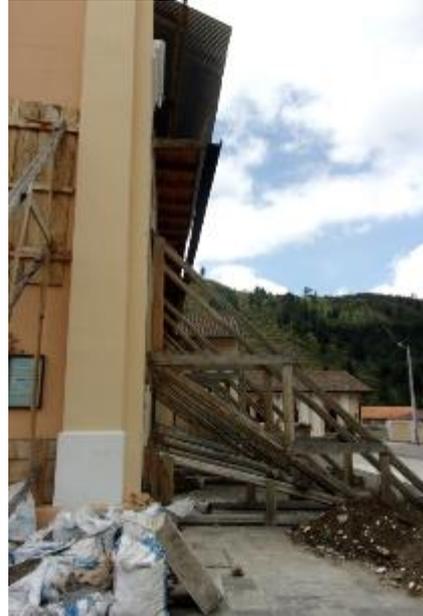
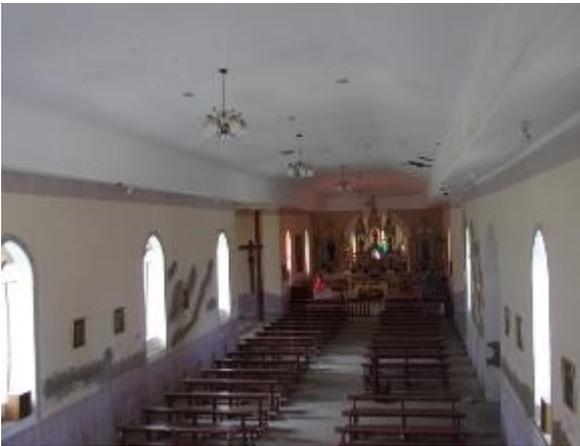
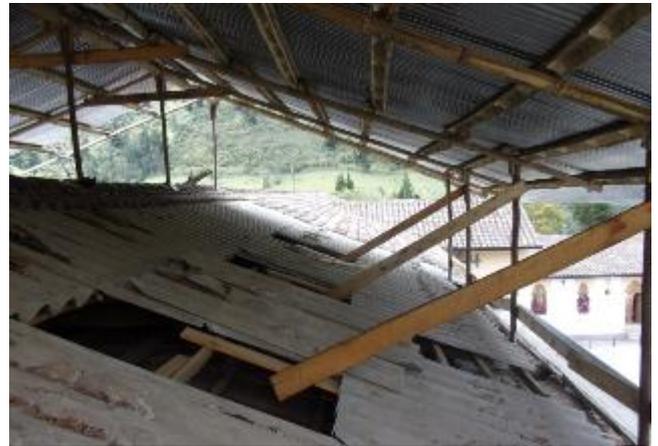
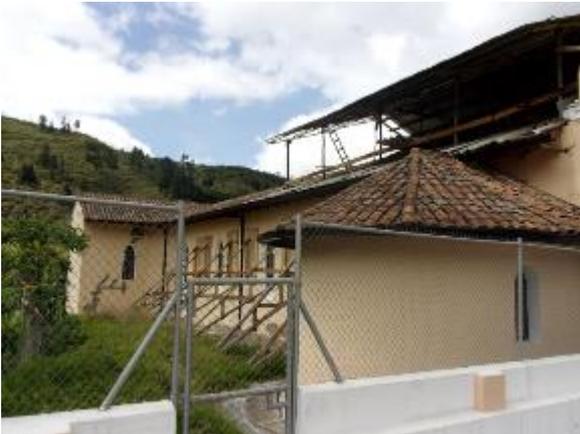
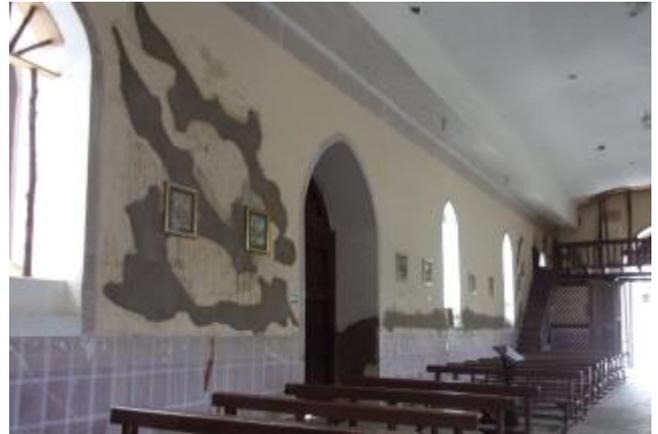
VI.5. Church of Nono
Nono Parrish, NW DMQ
16th century and on
Affected by 2016 earthquakes: church
