Subject: Submission of SoC Report on Kathmandu Valley World Heritage Property, (Nepal) (C121).

KATHMANDU VALLEY WORLD HERITAGE SITE
(Nepal) (C 121 bis)
1 FEBRUARY 2018

Submitted by:
Government of Nepal
Ministry of Culture, Tourism and Civil Aviation
DEPARTMENT OF ARCHAEOLOGY
Ramshah Path, Kathmandu, Nepal
Telephone: +977 1 4250683
Facsimile: +977 1 4262856
E-mail: info@doa.gov.np

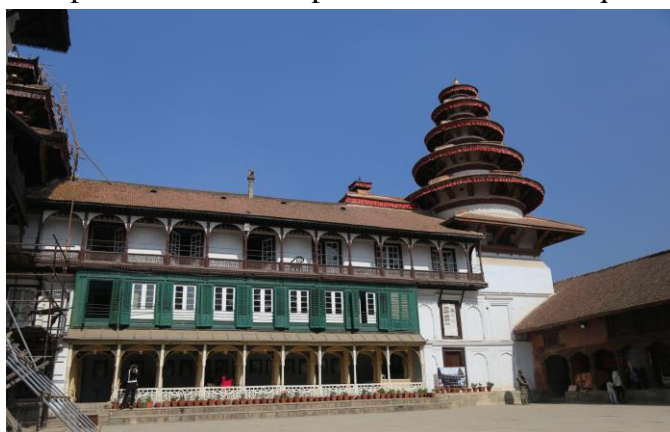
The conservation work of Panchamukhi Hanuman Temple, a prominent multi roofed temple in the palace premises is completed as first completion after the earthquake.

The southern wing of the Mohankali chowk is also conserved as well within the same project budget. However, the project was started before the earthquake, but due to the earthquake it was obstructed for some months. The project was under taken by the joint fund of Hanuman Dhoka Museum Development Committee and

American Ambassadors fund for Culture Preservation; in the supervision and monitoring by the Department of Archaeology. The Temple and southern wing of this complex was more damaged by devastating earthquake on 25th April, 2015 as well. The conservation work was carried out using traditional material, technology and craftsmanship.

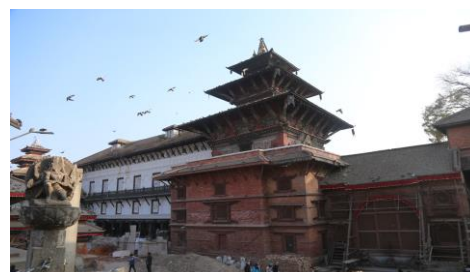
The conservation work of Degu Talezu is completed recently. This temple was under consideration for renovation and the bidding process had already completed before the earthquake; and the devastating earthquake had increased the damage portion of outer

part of bulged wall of the temple.

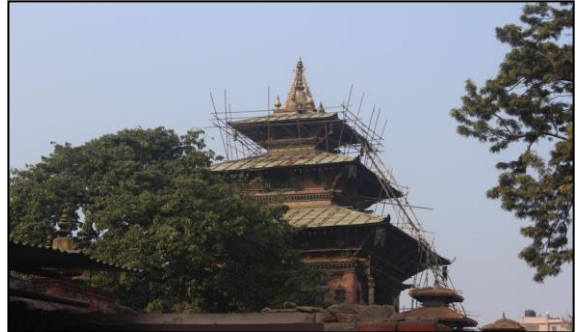
The renovation of Taleju temple is completed recently. Talegu Temple is biggest monument and landmark of Kathmandu Durbar Square. Talezu is a tutelary deity of Malla Kings. The temple also was affected by the earthquake; especially in top and second roof.

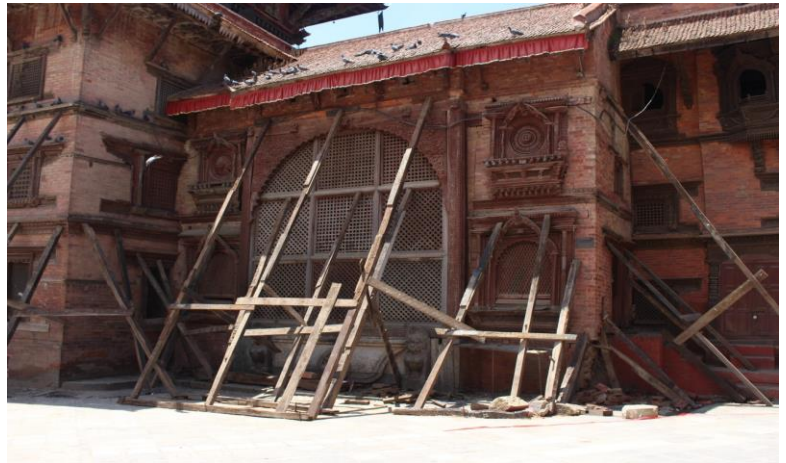
Conservation of the Sweta Vairab Temple attached to Degutaleju is already completed. The recently restored temple of Vairab was partially affected by the earthquake and well shored just after the quake to protect from the further destruction.

Hanumandhoka
Palace Museum
Development
Committee had taken
total responsibility of
the conservation
under the close
inspection of DoA.

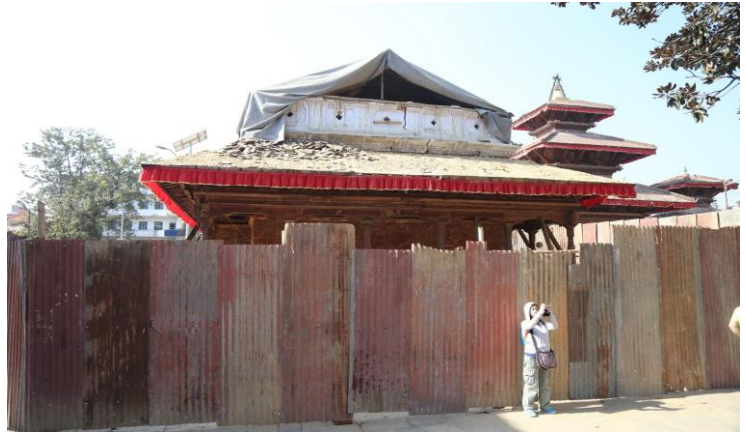
The kageswor Temple, on the west of Taleju, originally built in 1681 and rebuilt after the earthquake of 1934 and lastly restored by Kathmandu Valley Preservation Trust (KVPT) before 10 years was partially collapsed by the 2015 earthquake. The temple is under completion of

restoration. Almost all the structural work is completed. It is only to place the pinnacle and to plaster the outer wall of the structure. The total responsibility of conserving this temple is taken by Kathmandu Valley Preservation Trust (KVPT). The temple is conserved with traditional method and material as it was built before.

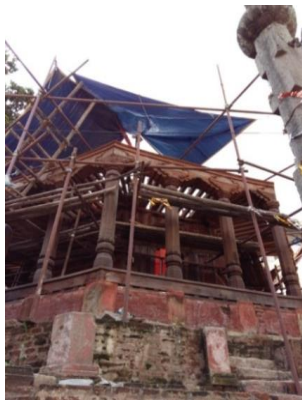
3.1 Chyasin Dega Reconstruction

The renovation work of Bal Gopaleswar temple also called Chyasing Dega is also called Chyasin Dega is in rapid progress. The first floor of the temple is already planked and work of second storey is under progress. This temple is a prominent multi roof temple in octagonal shape, devoted to lord Krishna was completely damaged by the earthquake. The temple is under restoration under the multiyear restoration project of Department of Archaeology. As the temple was built by the massive use of traditional brick, wood and terracotta tiles, full consideration is paid to restore the temple with the use of traditional technique and materials reusing the old wooden and other elements as much as possible. Since the 'Surkhi mortar', the mixture of lime, sand and brick powder, is accepted as a traditional construction material, Surkhi mortar is used in restoration of the temple instead of mud mortar.

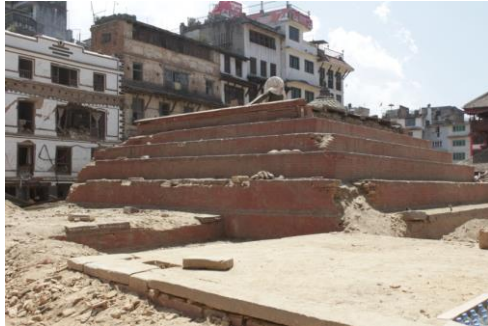
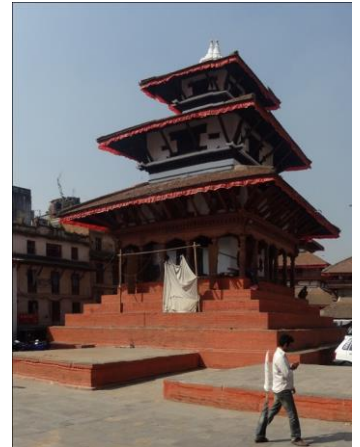
3.2. **Restoration of Trailokya Mohan Narayan Temple**

The Restoration Work of Trailokya Mohan temple is ongoing. The Trailokya Mohan Narayan Temple also known as Dasavatar temple on north-west side of Kumari Temple was built in early 18th century. The over structure of the three tiered multi roof temple was completely destroyed by the earthquake. After the detail investigation with emergency archaeological excavation, the restoration work was already started

with the concept of utilize almost wooden artistic and

other remaining material of the same temple replacing the damaged by new one.

The already separated and inventoried wooden elements are being reassembled and conserved for reuse. Other necessary new wooden elements also are being prepared as well.

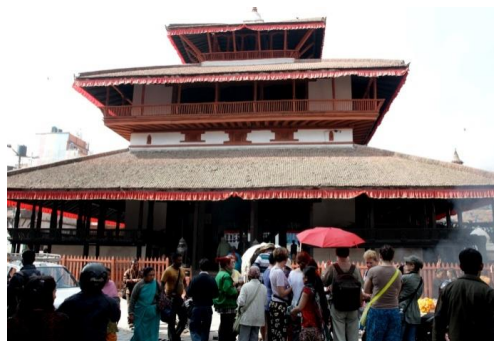
Kasthamandap also known as Maru Sattal; literally "Wooden Shelter" is a three-storied public resting shelter that enshrined Gorakshanath, situated in Hanumandhoka Protected monument Zone in the Southwestern corner of Palace Square was completely destroyed by the by the 2015 earthquake.

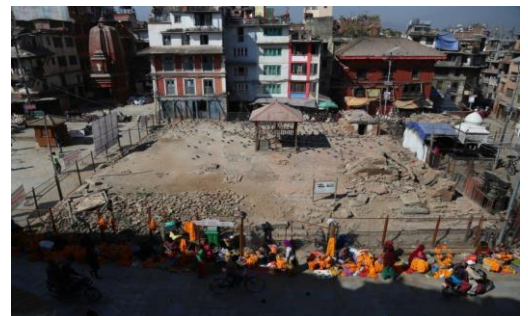
aftermath of the earthquake have suggested that the Kasthamandap may have been built in the 7th century during the Lichhavi era. Before this, it was assumed that the Kasthamandap was built in around the 12th century.

A team of national and international experts from the Department of Archaeology (DoA), Government of Nepal and Durham University with the financial support of UNESCO, had conducted a research excavation in the area of destroyed area.

Regarding the restoration of Kasthamandap, Kathmandu Municipality has taken the responsibility; and detail approved drawing with detail documentation and conservation note is already handed over to Municipality.

Under the project funded by UNESCO, all the remaining wooden and other materials of the temple are salvaged and well documented. On the restoration of the temple, all those salvaged reusable elements of the structure will be reused.

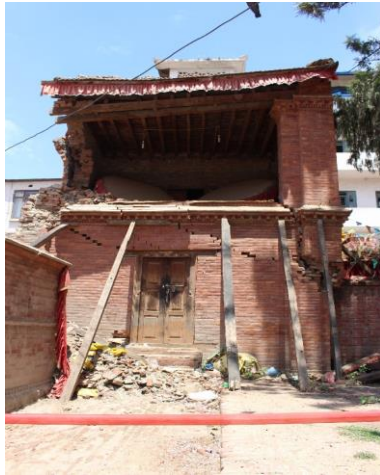
4.2 Restoration of Nagaraghar

The Naghara Ghar, big Drum house, built in early 20th Century, situated west of Degutale temple in Hanumandhoka Palace Square is a monument of

cultural and historical significance.

the renovation from KMC was approved by DoA before the earthquake; and the devastating earthquake had badly damaged the house. The Conservation work of this structure is completed now. Replacing the mud mortar by lime mortar the house is conserved with traditional method and material as it was built before. Kathmandu Metropolitan City had taken the total responsibility of the conservation under the close inspection of Department of Archaeology.

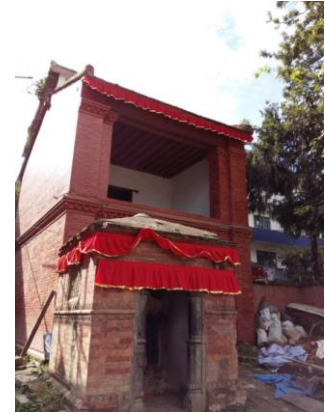
This structure was under consideration for renovation and the proposal for

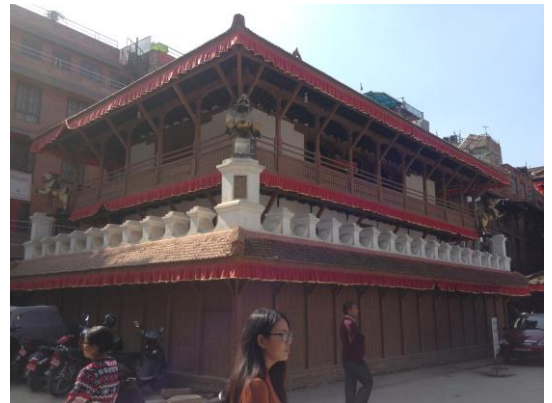
4.3 Renovation of Singha Sattal

The Restoration of Singha Sattal, popularly known as Silyan Sattal (Traditional Rest House) is completed. The Sattal with a shrine of Natyeswar (god of dance) inside it was in dilapidated condition for a long time. Under the direct inspection of DoA, with detail documentation, it is conserved by KMC and Guthi Sansthan. Traditional types of bricks, *Jhigati* roof tile and timber are the major construction material as it was used before.

Since the construction of the structure is traditionally and mythically connected with Kasthamandap, it was believed to be built in the 12th century; since the recent archaeological investigation has proven the Kasthamandapa older than that period, while restoring this monument, the architect and archaeologist involved have paid very careful attention.

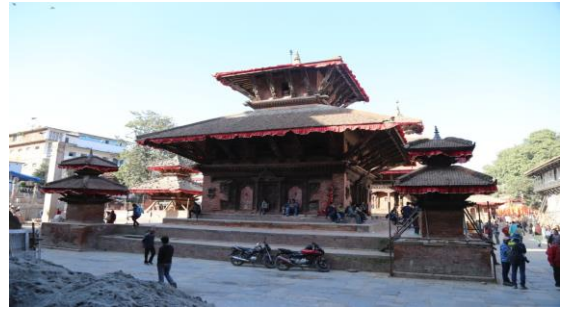
5.1 Jagannath Temple

Jagannath temple in front of main entrance of the palace is under conservation. The temple is being conserved under the UNESCO-JFIT project. The detail structural assessment and architectural study of the temple is completed. Since the temple is targeted to strengthen without dismantling entire structure, the modality of strengthening the temple will shortly be identified.

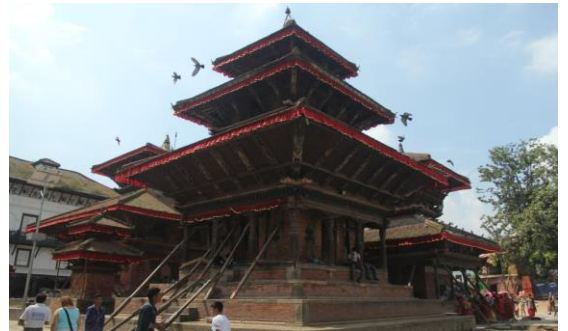
5.2 Conservation of Shree Krishna Maha Vishnu Temple

Among the two monuments to be conserved under UNESCO-JFIT Project, Shree Krishna Maha Vishnu Temple, also known as Gopinath, is another one. The temple also was partially affected by the earthquake. After the detail structural assessment of the Jagannath temple, the expert team had worked for the structural assessment of Gopinath temple. After the completion of the assessment it is assumed to be strengthening the structure minimizing the intervention as much as possible. Since almost structural and architectural study and the assessment of the temple is completed, DoA and Unesco is going find the proper modality of strengthening soon.

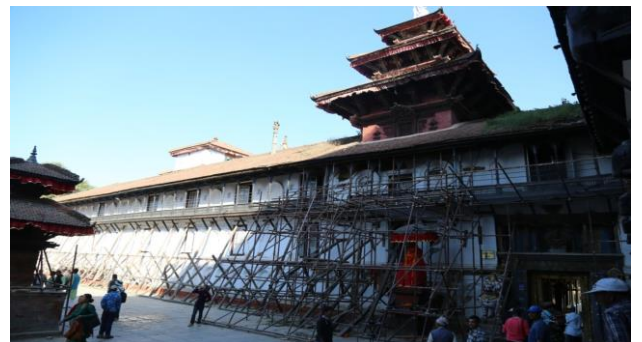
5.3 Conservation of Aagam Chhen and Western long of the palace

Since the western wing including the main entrance of the palace was largely affected by the earthquake, the over structure of sacred Aagam Temple over the western long was suspected to be effected heavily, National Research Institute for Cultural Properties, Tokyo had had a detail structural investigation of the entire structure with approval and close cooperation of Department of Archaeology and Hanumandhoka Palace Museum Development Committee. The project is approved by Department. The Aagam Chhen is going to conserve by the Department of Archaeology through the support of Government of Japan.

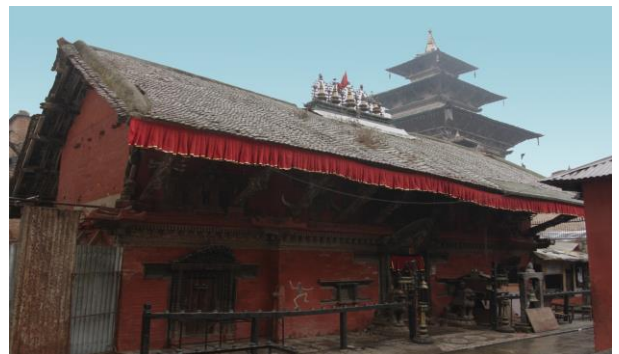
8.1 Conservation of Tarini Devi Temple.

The Tarinidevi temple conservation work is completed. The temple of Tarinidevi, also known as Tarini Bahal, in the Hanumandhoka protected monument zone, outside the palace premises. The temple is conserved in initiative of local community with the mutual fund of municipality and community under the close inspection of the Department of Archaeology.

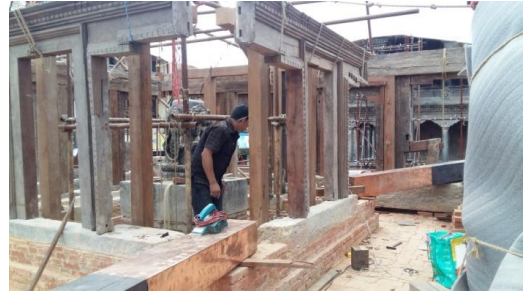
The restoration work of Char-Narayan Temple is under progress in preliminary phase.

The Char-Narayan Temple, devoted to lord Vishnu, enshrined a cylindrical four faced beautiful stone image of Vishnu, representing the art and architecture of 17th century was completely collapsed above the plinth level by devastating 2015 earthquake.

From the very beginning after the earthquake, Kathmandu Valley Preservation Trust (KVPT) has been actively involved in the total activity of restoring the temple in its original state. All the damaged wooden carved elements such as columns, windows, door, Carnes etc. which were salvaged and well documented with detail inventory are being properly used with necessary conservation in present restoration work. Since the foundation of the temple was found unaffected and strong enough in examination, the temple is being erected over the previous plinth without disturbing original foundation and plinth.

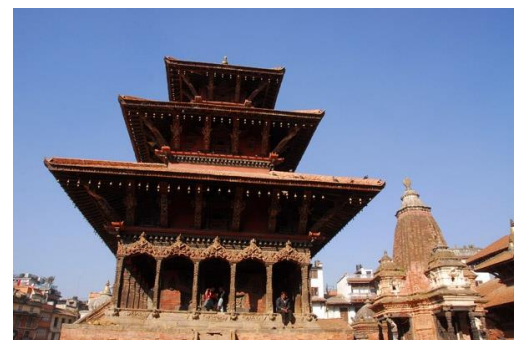
The Hari-Shankhar Temple devoted to lord Vishnu and Shiva, in Patan Durbar Square, near to collapsed Char-Narayan temple and just beside the Narasimha temple also was destroyed completely above the plinth level by devastating earthquake. As reported in previous report, all the damaged wooden carved elements of the three roofed temple with extraordinary wooden art and architecture was well salvaged with detail documentation. Almost all identified

columns, windows, door, Carnes, tympanum, door wings, struts etc. were inventoried and being reused in present restoration of the temple.

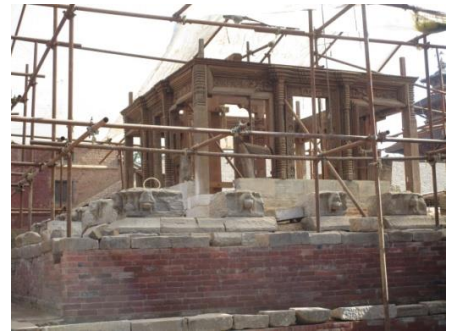
As the foundation of the temple was found intact and strong enough in the rescue archaeological investigation, the temple is being restored keeping the original foundation intact.

Since the restoration work is in beginning phase, brick work is not started in super structure yet. All four doorways is fixed and nain sanctum is covered with doorways from all four direction. All the carved wood being used are from the original temple with minimum intervention if necessary.

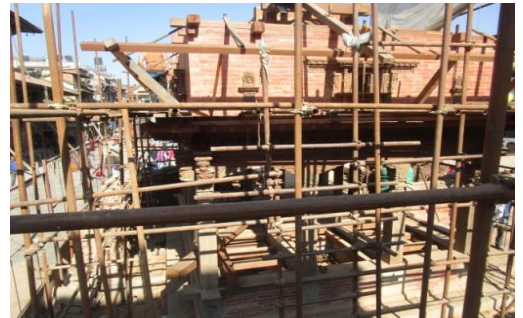
1.3 Restoration of Manimandaps

The restoration work of Manimandap is in rapid progress and almost 70 percent work is completed.

The Manimandap, the twin public rest shelter, in front of Mangahiti, water spout, was completely collapsed above the plinth level by the earthquake. As reported in previous report almost all columns, brackets, struts were identified and inventoried; and those all are reused in the present restoration of the structure. As there are two structures of rest house, the northern one is almost completed.

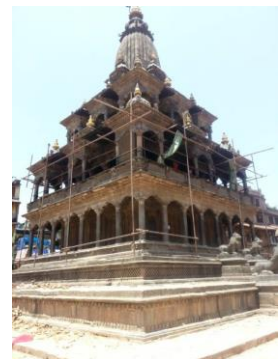
1.4 Conservation of Krishna Temple:

The conservation of Krishna Temple is in progress.

One of the most famous monuments of Patan, the Krishna Temple, built by Siddhinar Singh Malla in 1636 A.D was also partially but severally damaged, especially upper second stories. Immediately after the earthquake the rescue shoring was given to the structure to prevent the further damage. As the total responsibility of conservation is taken by KVPT, with the approval of DoA,.

In present conservation the damaged threshold stone at northwest corner of innermost sanctum (garbhagriha) is replaced and the base stones at the Second floor level which is the main Component of the structure are changed with new stone carving as in original one.

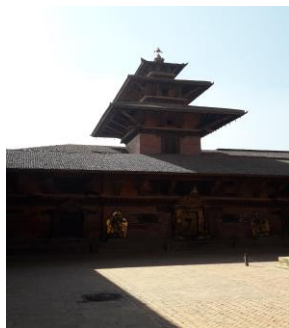
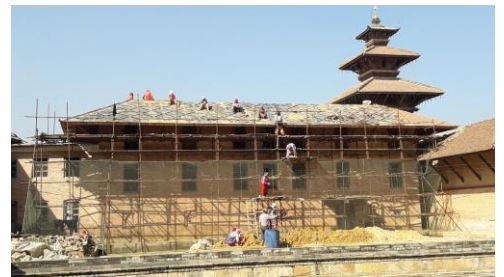
1.8 Conservation of Mul Chowk and Sundari Chowk

Conservation of Mul Chowk and Sundari Chowk is a continue work of previous years. KVPT has got the approval from the

Department to work on those monuments before earthquake. The Southern Taleju temple conservation work had already

finished whereas in the Northern Taleju the pinnacle of the temple is to install which is in the completion phase of conservation. The roof work of eastern lung of Sundari courtyard also has already completed.

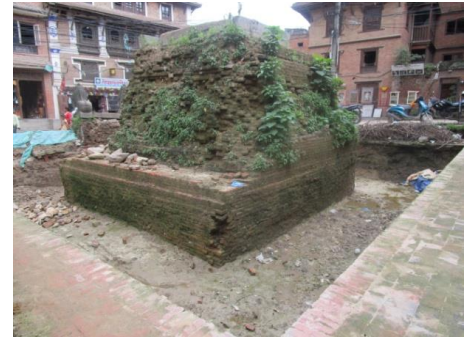
Radhakrishna temple situated in Swatha Tole in northern side outside of Patan Durbar complex was completely collapsed by the earthquake. All the wooden and stone elements of the temple were immediately salvaged and secured inside palace complex.

The temple is planned to restore form the very foundation and excavated the foundation; however the main sanctum of the temple is preserved in original form. Since the surrounding plinth and circumambulatory area is excavated 5"-0" depth preserving the central Grabhagriha area, stone in lime, Surkhi and sand mortar is used for making the mat of foundation. The restoration work is in preliminary phase.

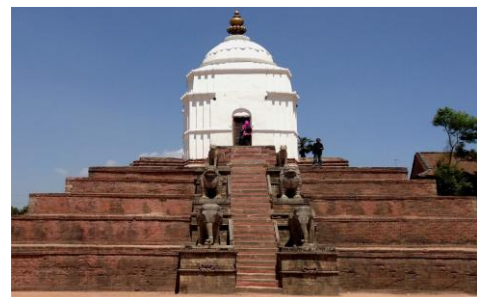
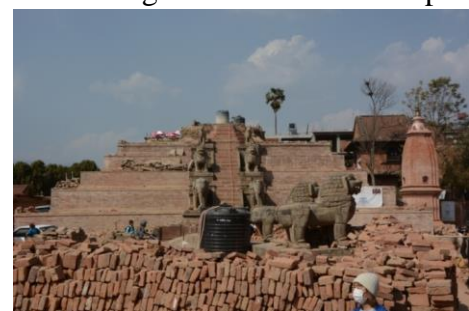
Repair of the plinth level has been completed. For the repair works, the outer shell of the mud mortar plinth of 2 feet width is carefully removed and replaced by Lime

Surkhi brick-wall, without disturbing the inner core. The foundation of lowest plinth was taken down to 2 feet.

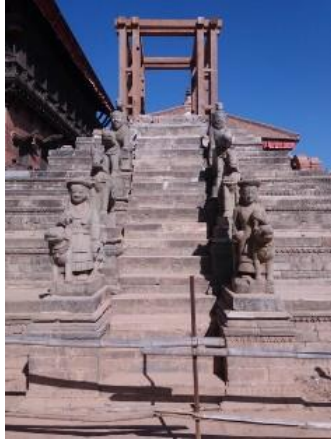
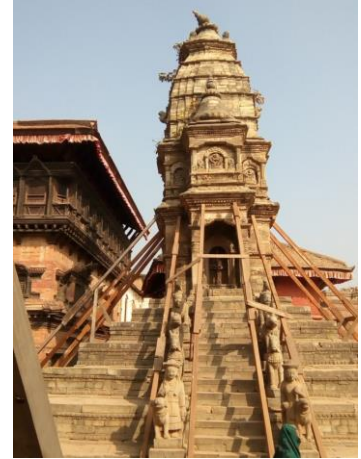
The Siddhi Laxmi Temple is a 17th century Shikhara style stone temple, dedicated to goddess Siddhi Laxmi located at south eastern corner of the 55 windows. Earthquake had damaged the Temple with major cracks at South side. Considering the possibility of future collapse of the monuments, measured detail drawings were prepared and the structure was carefully dismantled.

Now the restoration of the temple is in progress. All the stone of the temple are being reused but all the wood is replaced by new strong Sal wood. Conservation of the plinth level is completed and present work is progressing in main sanctum level erecting required all wooden pillars.

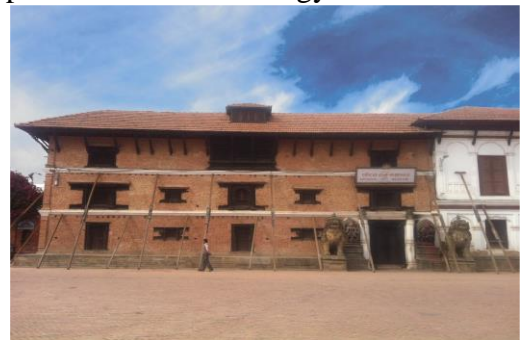
The building was largely affected by the Gorkha Earthquake. Wooden shoring was provided to avoid the further damage of the building funded by GIZ and DOA in cooperation with UNESCO. Restoration

Details Structural analysis is completed recently by the expert team; outcome of the analysis is yet to be published.

Northwest wing of the Singh Dhoka complex is planned to be restored during the first Phase of intervention. This wing will be restored in the original form with two storey tiered Burja crowing the structure.

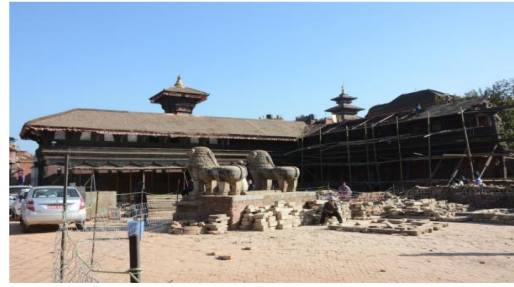
1.4 Restoration of Taba Sattal

Taba Sattal also known as Taha Pha is located at the west corner of Bhaktapur Durbar Square. The middle portion of Southwestern wing of the building was completely collapsed by the earthquake. Similarly, the upper portion of the northeast wing was damaged, and numerous cracks were observed.

Since the budget was allocated in last fiscal year as multiyear project, the restoration work of the Sattal is under progress in preliminary phase. The work of foundation level is completed and erection of wall for the ground floor is in progress

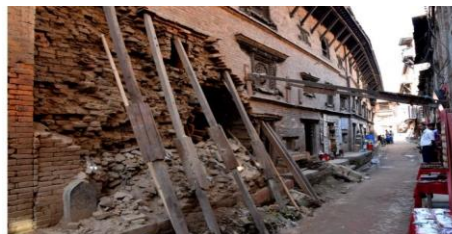
Emergency Shoring after earthquake at Pujarimath.

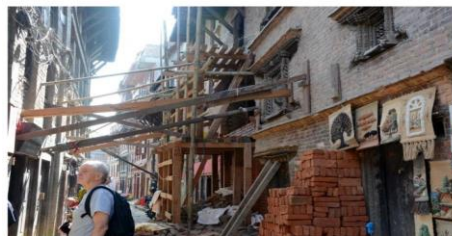
Shoring During Conservation at Pujarimath.

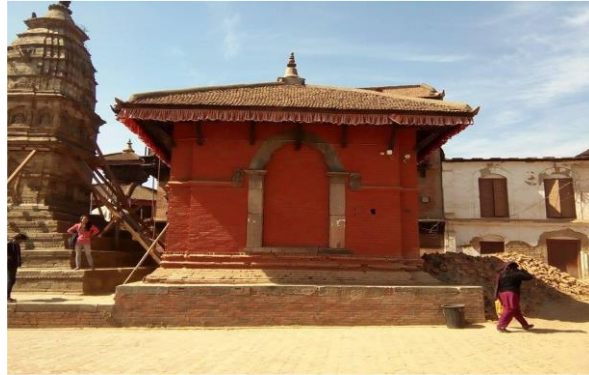
1.11 Conservation of Yantra Vatsala

One storey Nepalese Style Vatsala Temple is located at eastern part of Bhaktapur Durbar Square beside Siddhi Laxmi Temple. The conservation work was carried out which included skinning work and repair of the Roof under emergency budget of DOA. Conservation of this temple became first monument to be completed after the earthquake.

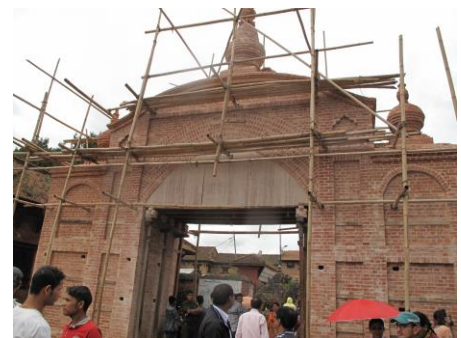
2.1 Khauma gate

Khauma Gate is the main western gate of Bhaktapur Durbar Square. The southern portion of the gate was collapsed by the earthquake. Similarly, the upper portion of the gate has been damaged, and numerous cracks were observed. The entire damage portion is carefully demolished up to foundation. The gate is already restoration in its original form in traditional technique and materials. The structure is restored stronger than the previous one using sufficient wooden tie-up and posts of strong Sal wood.

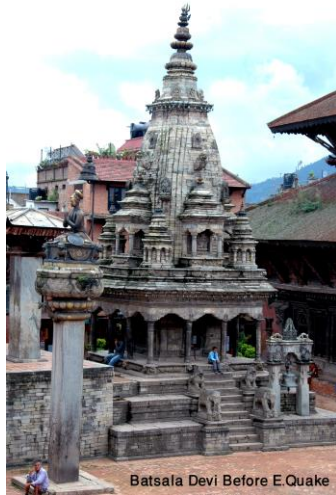
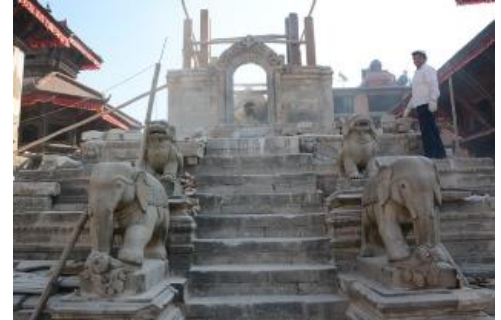
2.2 Vatshala Temple

Directly in front of the palace and beside the statue of king Bhupatendra Malla and next to the Big Bell is the Vatshala Devi Temple. This

Shikhar style temple was entirely constructed in sandstone and is built upon a three-stage plinth, and has similarities to the Krishna

temple of Patan. It is dedicated to Vatsala Devi, a form of the goddess Durga. The temple was originally built by King Jitmitra Malla in 1696 A.D. The structure that

The Vatshala temple was completely collapsed by the earthquake. The foundation of the temple was examined through rescue archaeological excavation executed by DoA with the support of UNESCO Kathmandu office and Durham University, London. Since the foundation of the temple was found strong enough, the temple is being restored over the original foundation. Total responsibility of the restoration is taken by Bhaktapur Municipality with close coordination of Department.

The restoration work of Vatsala temple is in rapid progress.

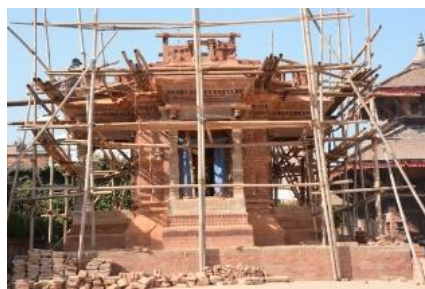
2.3 Kedar Nath Temple

The Kedarnath Temple located in front of National Art

Museum in Bhaktapur Durbar Square is a significant Shikhara style temple dedicated to lord Shiva. The middle portion of the Southwestern part of the temple was

collapsed by the earthquake. Similarly, the upper portion of the northeast part also was damaged, and numerous cracks were observed in the entire structure.

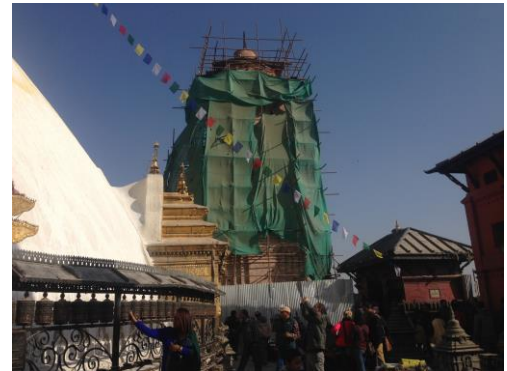
1.1 Restoration of Anantapur temple

The restoration work of Anantapur temple is in the phase of completion. Anantapur, Shikhara Style temple, situated in the Southeastern corner of Swayambhu hill, built in 1654, is one of many contributions of King Pratap Malla in Swayambhu zone. The temple built of traditional Ma-apa in mud mortar, wood, Vajra was collapsed by the earthquake 2015 almost over the Cornish level also creating several cracks in down parts. Department of Archaeology

is directly involved in the restoration project allocating the budget under Post Earthquake Reconstruction Fund (PDRF) of Government of Nepal. Federation of Swayambhu Management and Conservation (FSMC) has an important role for coordination and management with priests to perform required religious and cultural procedure and activities on the process of restoration. The restoration work started in fiscal year 2072-73 is almost completed expect installing the pinnacle and lime plaster on outer surface.

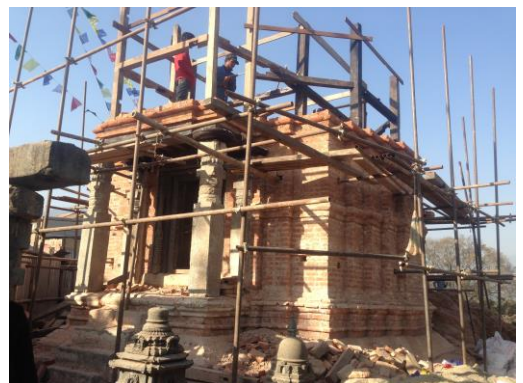
1.2 Restoration of Pratappur temple

The Restoration work of Pratappur temple is being progressed rapidly. Pratapur temple, another famous monument, situated parallel to Anantapur in Northeastern corner of the Swayambhu hill was built by King pratap Malla in 1654 AD. This temple was not destroyed but affected severely by the earthquake and was in vulnerable condition. Assessing the hazard of the temple in vulnerable state, it was decided to restore dismantling the damaged temple structure. Pratappur was damaged by fire in 2008; and the restored structure was also again destroyed by thunder in 2011. The newly restored structure was again severely victimized by the earthquake.

The project for reconstruction of Pratappur temple was approved in fiscal year 2073-74 as multiyear project and the work was started from early June 2017. The dismantling of damaged structure, careful opening of plinth and the rescue

Before starting the restoration work the condition of the foundation was studied through rescue archaeological excavation laying the trenches on northeast and north side of the temple outside adjacent to the foundation wall. Since the foundation was found good in condition, the restoration work is being done without disturbing the original foundation of 17th Century. With necessary conservation all four stone pillars are erected and the restoration work is being progressed by its second floor in present.

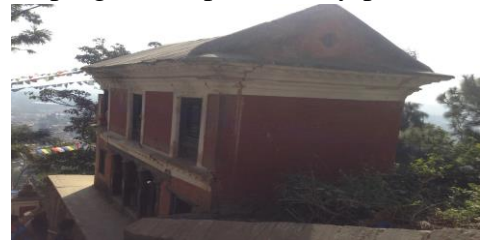
1.3 Restoration of Seto (White) Sattal

The restoration work of the Seto Sattal is under progress in preliminary phase. The traditional rest house built in early 20th Century situated in southern slope of Manjushree shrine in Manjushree hill of Swayambhu Protected Monument Zone was severely damaged by the earthquake. Under the Government budget allocated for running fiscal year 2074-75 the damaged structure is recently dismantled with detail drawing and documentation; and the restoration work is started.

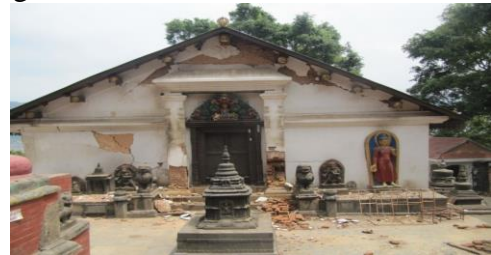
2.1 Conservation of Santipur temple

The Conservation work of Santipur, a sacred temple on the northern most part of Swayambhu hillock is under rapid progress. The conservation work has been conducted by Federation of Swayambhu Management and Conservation (FSMC) with close cooperation and inspection of Department of Archaeology.

The temple was severely affected by earthquake even destroying almost half part of precious mural painting and affecting the rest half severely. Under the project funded by UNESCO, the remaining mural painting was securely detached from the wall and salvaged with detail documentation in close collaboration between DoA and FSMC.

In Santipur temple only the effected parts is being conserved very carefully preserving the rest not affected parts. It is being conserved with traditional technique and material to retrieve its original value back.

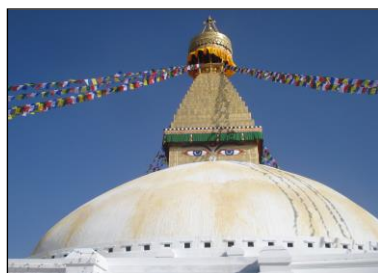
with cracks and dislocation of the bricks breaking the outer metal cover. Finally the effect of the earthquake found to the entire super structure of the Stupa over the dome.

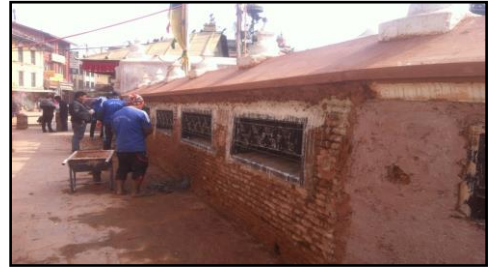
1.2 Conservation of Mane Wall

The Mane Wall conservation is completed as it was affected by the earthquake partially. However, as reported in previous report, the entire Mane Wall was conserved re-plastering it with the Bajra mortar , mixture of Lime, sand, brick powder, black lentil powder and molasses with water replacing the original Liun plaster, it was partially affected by the earthquake and conserved in the initiation of Baudhanath Area Development Committee under the direct supervision of DoA.

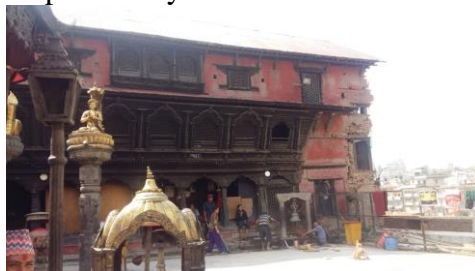
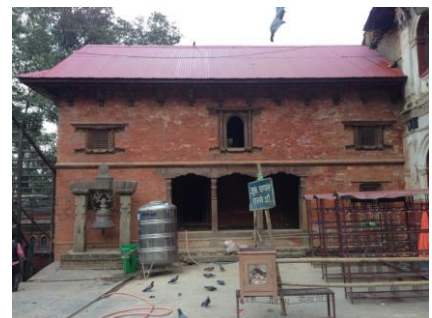
1.1 Restoration of Sattals in Guheswari Complex

In Guheswari temple complex in Pashupati Protected Monument Zone three Sattal structures are under restoration project with the approval of DoA; and all the responsibility of restoration is taken by Pashupati Area Development Trust (PADT).

Among those three Sattals under restoration the northeastern Sattal is completed.

The Sattal is restored in its original structure

but using almost all new wood and brick, as very few old wooden elements were found reusable while dismantling the old structure which was badly affected by the earthquake.

The Sattal of the north side is under restoration. This wing of the Sattal was started to restore last year. Two of the three storey of the Sattal is completed. As reported last year, the Sattal is planned to built removing the latter added upper floor which also helps Guheshwari temple to be more exposed from north side.

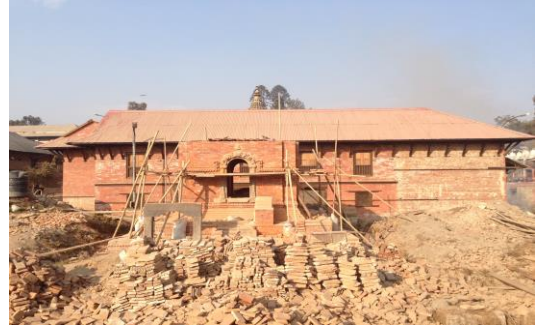
1.2 Bhasmeshwar Sattal Conservation

The restoration of Bhasmeshwar Chaughera Sattal (courtyard rest house) in Bhasmeshwar Cremation area is completed. It was conserved with the approval and close inspection of Department of Archaeology and entire financial responsibility was taken by Pashupati Area Development Trust (PADT). The Sattal is restored in its original style.

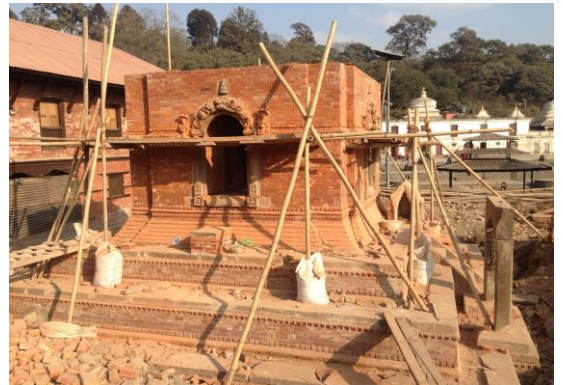
1.3 Amarkanteswar, Sureskanteswar and Pranmukteswar Temple

The three temples Amarkanteswar, Sureskanteswar and Pranmukteswar situated inside Bhasmeshwar Courtyard Sattal in Bhasmeshwar area were badly affected by the earthquake. Pranmukteswar is in the courtyard of northern Sattal and rest two is in the courtyard of southern Sattal of Bhasmeshwar. Among three temples Amarkanteswar and Sureskanteswar had some problems before earthquake and were affected more by the earthquake. All these three temples are in Mughal style with dome on top. All are built in All three temples were built in Shah period in early 19th century.

With the Governmental approval from Department of Archaeology Amarkanteswar and Sureskanteswar temple are under conservation. Pashupati Area Development Trust (PADT) is directly involved in restoration of these temples and DoA is involved for required technical support. The approval for the restoration is given with the condition to prepare detail documentation of dismantling and reconstruction process and submit DoA as final completion report.

Restoration work of Amarkanteswar is in rapid progress. Before starting the restoration the foundation of the temple was examined and as it was found intact and not affected by the earthquake, the over structure is being built leaving the original foundation intact. Maintaining the plinth the over structure is being raised with proper use of wooden tie-up and pillar. All the four stone doors are set and the restoration work is being progress by its first floor.

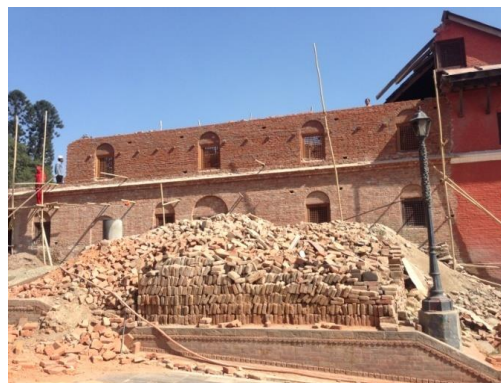
1.4 Kulananda Jha, Sankarnarayan and Gurju Sattals:

All three, **Kulananda Jha Sattal, Sankarnarayan Sattal and Gurju Sattal** situated towards the west side of western gate of Pashupati temple were not collapse but badly damaged by the earthquake. Kulananda Jha Sattal, the biggest courtyard Sattal among three is situated in front of Sankaracharya (Bhuteswar) Temple. The Sankarnarayan Sattal is joint with Mahasnanghar in its east side and the Gurju Sattal is situated just in front of Mahasnanghar.

Though no one Sattals mentioned above were collapsed but severely damaged by the earthquake. Southern upper portion of Kulananda Jha Sattal was fallen. The front wall was bulged out. Many cracks were observed all over the structure.

There were many vertical cracks in Gurju Sattal. The entire structure was tilted toward front busy road to Pashupati. The eastern wall was almost fallen.

Kulananda Jha Sattal is under restoration by its second floor; the work of foundation is started for Sankarnarayan and the work of Gurju Sattal is yet to start. However a detail rescue archaeological excavation is completed in the foundation of Gurju Sattal. All three Sattals are planned to build their original style with traditional technique and materials replacing mid mortar with lime mortar.

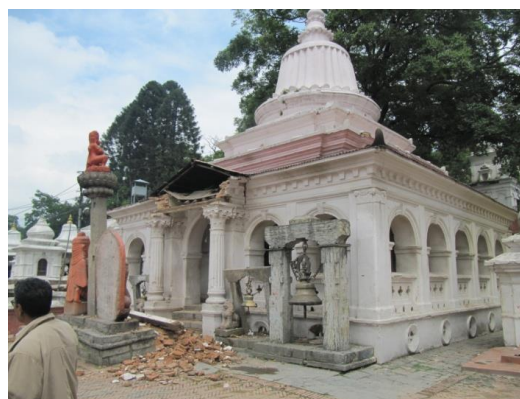
Comparatively there was less damage in Rammandir. The upper part of the portico in front was damaged and fallen. The arched front entrance of the temple was cracked. There were some vertical cracks observed on northern wall.

In the initiation of Pashupati Area Development Trust (PADT) the temple was conserved with donation of some donors. In some extent Guthi Sansthan is also one of the related organizations in the process of conservation. DoA had a role of approving the proposal and required technical support. Now Rammandir is already repaired in its original form using same types of materials used before.

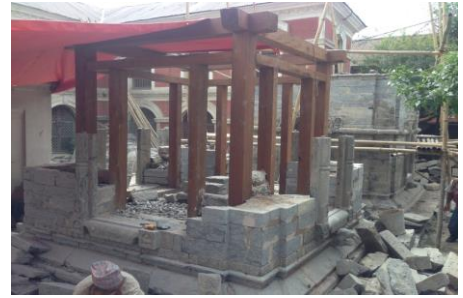
1.6 Restoration of Chautariya Sivalaya Temple

The Chautariya Sivalaya temple located in southern side of Pashupati temple complex, just outside the southern gate, in the western side of Bhasmeswar was partially collapsed by the earthquake.

The remaining vulnerable structure of the damaged Chautariya Sivalaya was dismantled with the help of Nepali Army and Armed

Police in the initiation of Pashupati Area Development Trust (PADT). Department of Archaeology had inventoried the objects of archaeological importance.

As per the proposal of PADT, approval for the restoration of the Shivalayas was provided by Department in June 2017. The total restoration work, except placing the pinnacle, is completed.

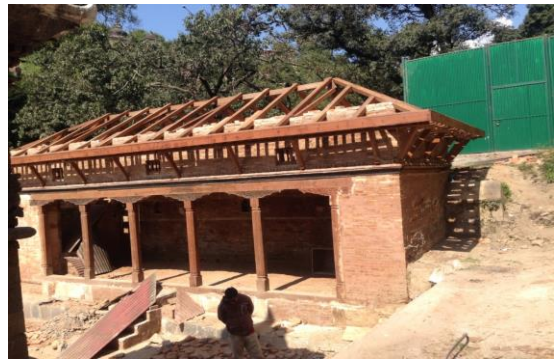
The Pandra (fifteen) Sivalaya Sattal was generally affected by the 2015 earthquake. But roof of the Sattal was already in the state to be conserved before the earthquake.

Though the purpose of building of this Sattal is not clear; however, since the name is given 'Pandra Sivalaya Sattal', it must be built as a priest residence of the Pandra Sivalaya just in front of this Sattal. As per the proposal of Pashupati Area Development Trust (PADT) Department of Archaeology had given the approval for its conservation

Now the conservation of the Sattal is in completion phase. Except roofing by Zink Sheet, the entire work is completed.

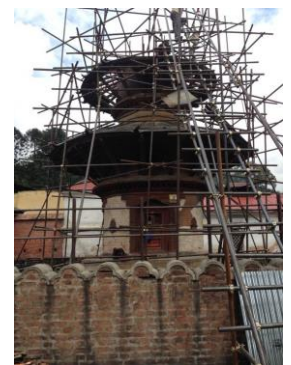
1.8 Restoration of Kotilingeswar Temple

The Kotilingeswar temple located inside the Pashupati complex just outside the main courtyard towards south in the Chausatthi Sivalinga premises was partially damaged by the earthquake. Kotilingeswar temple is one of the oldest and important monuments of Pashupati area which was built by King Pratap Mall in second half of 17th century AD. It is one of very few multi roof temples of Pashupati having circular plan with three circular metal roofs.

After the approval from DoA for its entire restoration, as per the proposal of PADT with detail drawing and cost estimate, the temple is dismantled now. While dismantling all the wooden elements of the temple are well documented but almost all the wooden elements of the temple are rotten and damaged and only very few of them can be reused.

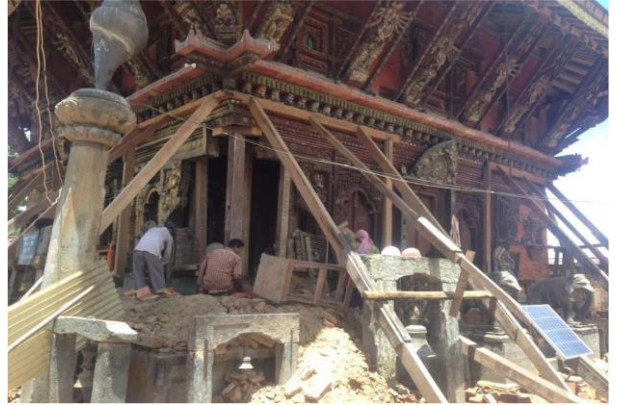
Changu Narayan Temple was not collapsed but affected largely by the earthquake.

The conservation of the temple is completed recently. The conservation work was carried out from Department of Archaeology employing highly skillful manpower, since the temple was conserved very carefully without dismantling the structure. All the rotten wooden inner posts and bands are replaced by new strong Sal wood timber. The temple is conserved in traditional technique and material replacing the mud mortar by lime mortar.

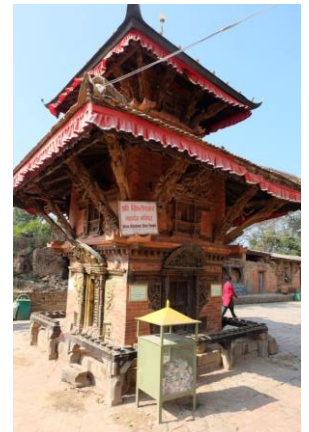
2.1 Kileshwor Mahadev Temple

The beautiful small multi roof temple in the southwestern corner of Changu Narayan temple in Changunarayan temple complex is known as Kileshwor. The Kileshwor temple is the only *Shaivite* shrine in the Changu Narayan temple complex. The temple is dedicated to Shiva as Lord Pashupati, and houses a *Chaturmukha* Lingam with human faces looking towards the four cardinal directions and one to the heavens. This temple has an outstanding collection carved wooden struts supporting its double roofs depicting incarnations of Shiva and some interesting erotic images. Each of the four doors is modeled on those of the main temple with the main entrance made in gilded metal and the other three are carved in wood.

Like many of the smaller shrines Kileshwor Mahadev had also suffered damage from the earthquake, but it was not collapsed. The worst damage is at the base of the temple structure and the original brickwork has been disturbed. The hidden timber frame structure has however stood firm and will require minor repairs to restore its structural integrity. The remaining structure appears in reasonable condition, but will require careful checking once scaffolding is built to provide access. The roof structures were disturbed by the earthquake, and will need to be checked for alignment. The magnificent carved doors and struts are in poor condition, and desiccated.

Since the MoU was done between Department of Archaeology and Heritage and Environment Conservation Foundation Nepal for the conservation of some monuments in Changu Narayan temple complex, the Kileshwor Temple is conserved by an HECFN with close coordination with Department of Archaeology.

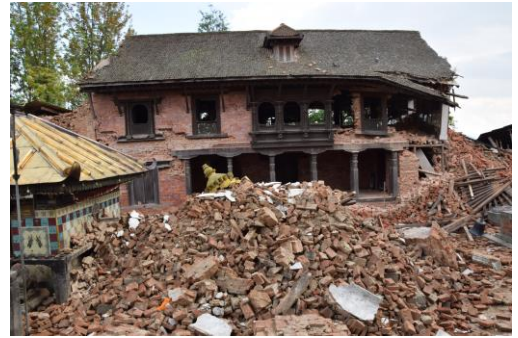
2.2 Amatya Sattal

The *sattal* enclosing the Changu Narayan courtyard consists of two principle units—the Chaughera *Sattal* and the Amatya Sattal, which were of simple design and basic construction. These structures were formerly living spaces for the officiating priests (*pujari*) and pilgrims attending the many festivals that take place at Changu Narayan.

The Chaughera Sattal, occupying the east, north and west sections of the courtyard, was formerly a pilgrimage rest house and, prior to the 2015 earthquakes, was used by the local community for various activities, mostly on the lower level. Three priests (*pujaris*) responsible for daily worship were provided accommodation in these structures as well.

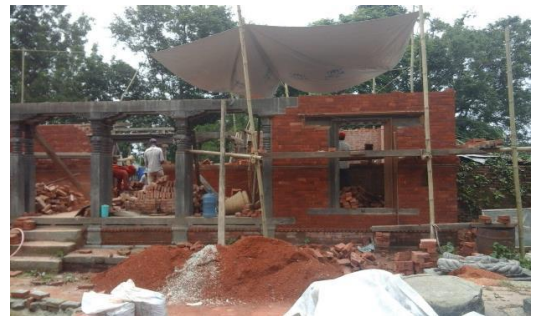
The Amatya *Sattal*, which occupies the southern side of the courtyard, was, prior to the earthquake, used by the Living Traditions Museum. Previously this *sattal* had been restored by the Department of Archaeology several years ago and the structure was upgraded by the LTM to suit their purposes.

The rest houses (*sattals*) enclosing the courtyard either collapsed or seriously damaged during the recent earthquake in April/May 2015. The upper floors and roofs were considered dangerous and The military moved in and demolished all the remaining standing sections of the upper

floors and roofs of the *sattals*. There remains only the ground/lower floor.
