UNESCO Documentation and Advisory Services (UDAS) Project
Fourth Consultation Workshop for the Conservation Works of the Baalbak Jupiter Colonnade
26-29 March 2018

EXPERT REPORT

Stephen J. Kelley, FAIA, SE, FUS/ICOMOS
Secretary-General, Iscarsah

14 May 2018

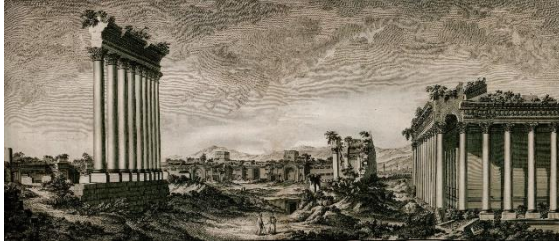
Figure 4 – Sketch of the Baalbek site as viewed from the west by Robert Wood, circa 1751. The Jupiter Colonnade is depicted with nine columns. Three of the columns, those to the west, collapsed during the 1759 earthquake as well as that portion of the stone lintel that they supported.

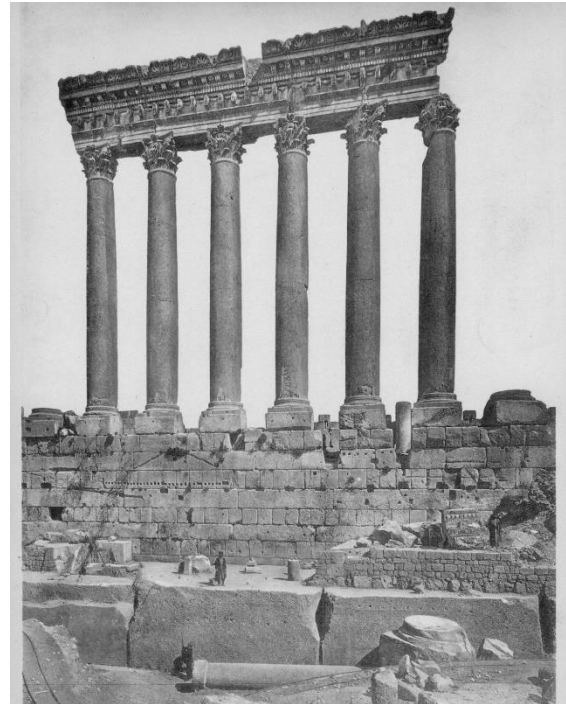
Figure 7 – View of the Jupiter Colonnade as seen from the south. Characteristic damage of the frieze in the middle of the stone lintel can be seen. The eastern portion of the stone lintel (right) extends no further than the centerline of the column. Photograph taken during the German mission, circa 1900.

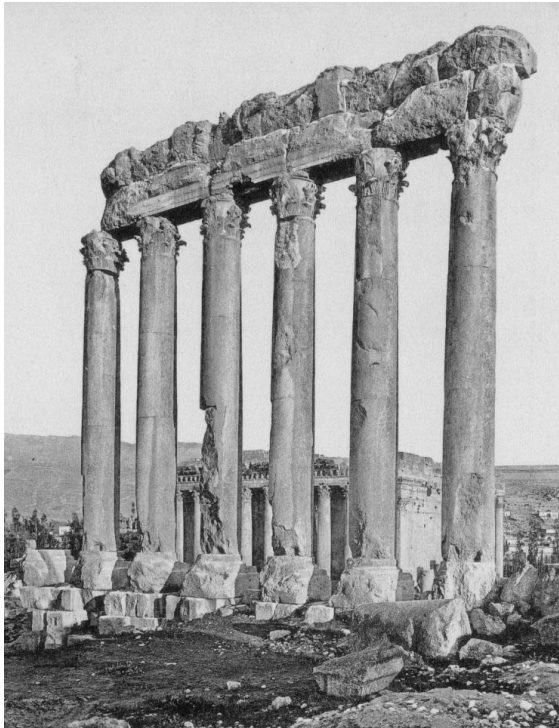
Figure 8 – View of the Jupiter Colonnade as seen from the north. The unconsolidated stone lintel reveals the extensive amount of stone loss and the tenuous nature of the stone lintel bearing on the easternmost column (left). In addition extensive damage can be seen emanating from the base of several of the columns which is most likely resultant from the rocking of these columns during seismic actions. Photograph taken during the German mission, circa 1900.

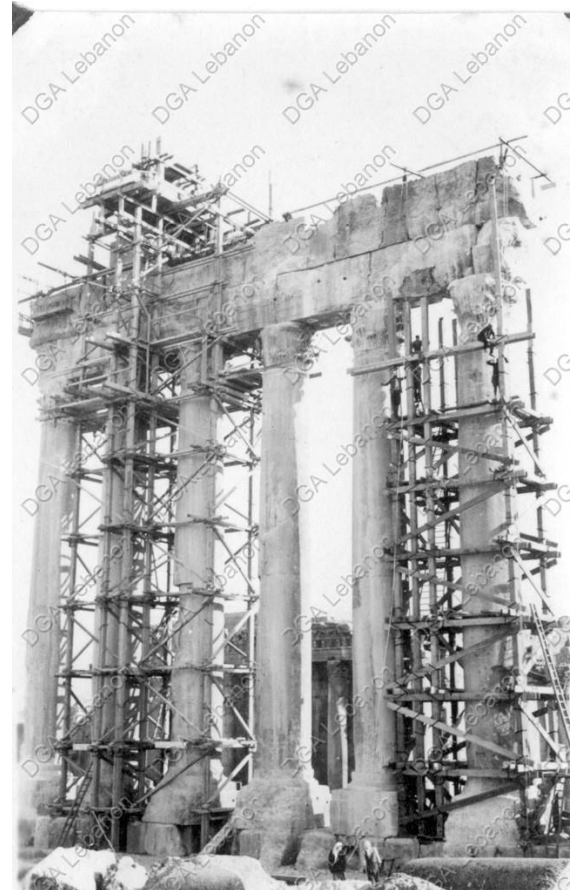
Figure 10 – View of the Jupiter Colonnade as seen from the north with wooden scaffolding in place. The wooden scaffolding was localized and moved rather than covering the entire Colonnade.

Photograph taken during the French Mission, circa 1930s.

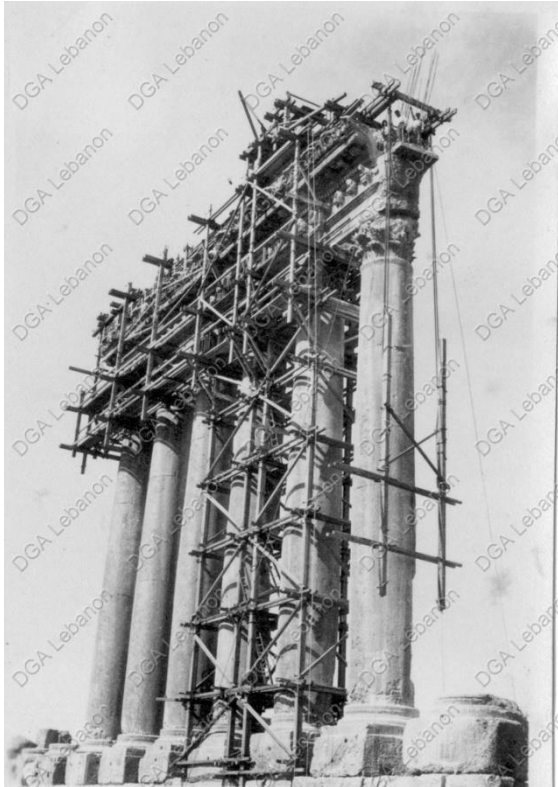
Figure 11 – View of the Jupiter Colonnade as seen from the southeast with wooden scaffolding in place. A suspended wooden scaffolding hangs from the top of the stone lintel to facilitate work on the architrave and frieze. Photograph taken during the French Mission, circa 1930s.

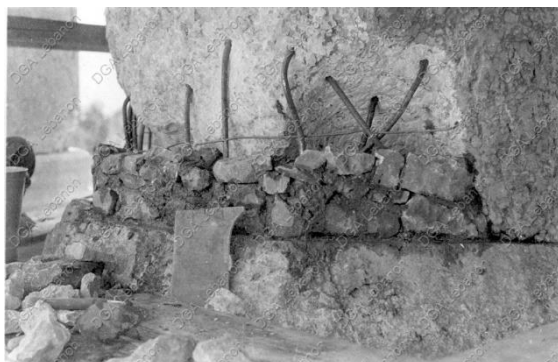
Figure 12 – Work in progress at the base of one of the damaged columns. Ferrous metal rods have been set in drilled holes in the column stone, and the exterior face is filled with limestone laden mortar. The cavity behind the face is believed to be filled with concrete. Photograph taken during the French Mission, circa 1930s.

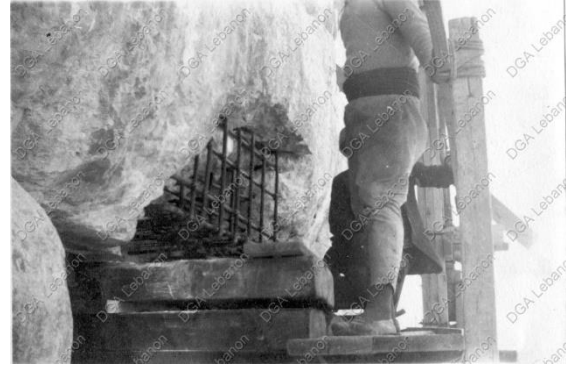
Figure 13 – View of the underside of the stone lintel on the north side where extent extensive stone loss is being replaced with reinforced concrete. Photograph taken during the French Mission, circa 1930s.

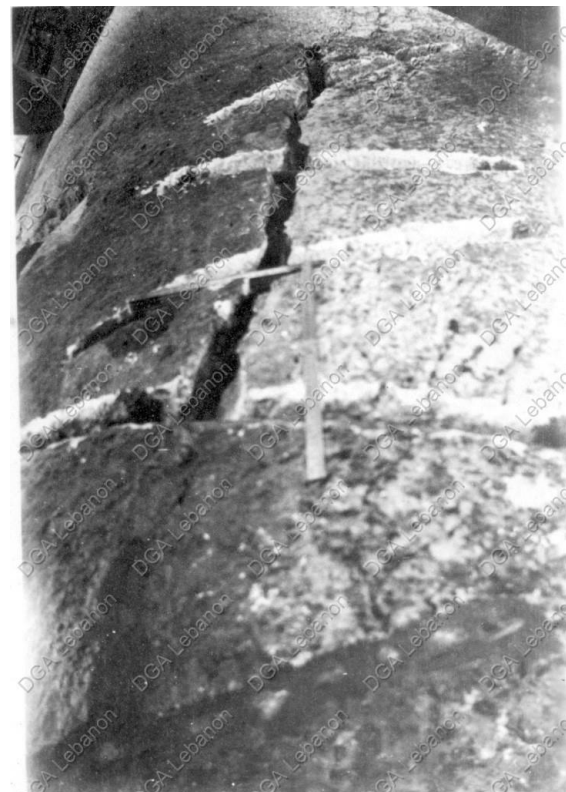
Figure 14 – Staple shaped ferrous anchors embedded in slots that span a vertical crack on the south side of one of the columns. Photograph taken during the French Mission, circa 1930s.

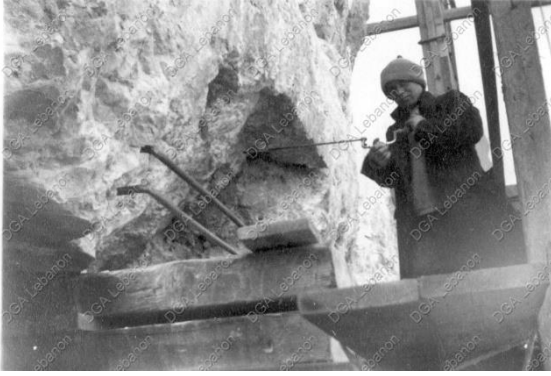
Figure 15 – Holes to receive ferrous metal rods in the stone lintel are being drilled by hand. Photograph taken during the French Mission, circa 1930s.

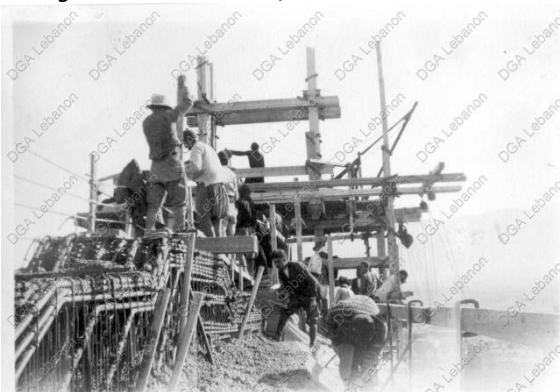
Figure 17 – The reinforcing for the concrete cap is in place. The concrete over the westernmost span is thickened probably to add additional strength to support the broken stone lintel below. Photograph taken during the French Mission, circa 1930s.

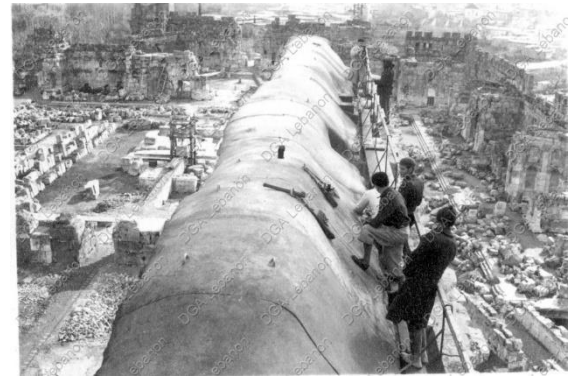
Figure 19 – View of the reinforced concrete after it has been poured as seen from the west. Control joints in the concrete cap mimic the joints between the stones of the frieze upon which it has been cast. The concrete cap was finished by hand without formwork so that it would shed water. Metallic anchors protrude from the top to assist in access and repair work that may be planned in the future. Photograph taken during the French Mission, circa 1930s.

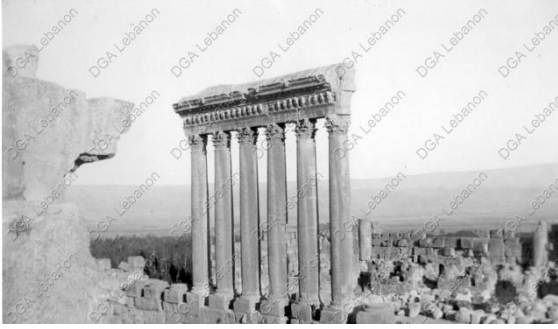
Figure 20 – View of the newly consolidated Jupiter Colonnade after the scaffolding has been removed as shown from the southeast. The concrete cap with its thickened portion and the westernmost span can be seen as well as the building up of the stone lintel on the east (right) to further consolidate the bearing of the stone lintel on the easternmost column. Photograph taken during the French Mission, circa 1930s.

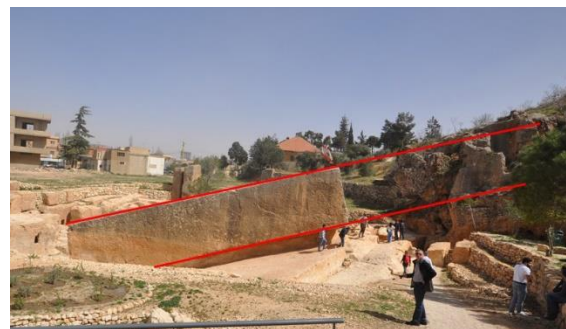
Figure 23 – The large stone at the quarry that was hewn and never moved reveals that the stone was hewn between weakened strata and the surrounding deposit. The workers in the quarry were cognizant of natural weaknesses in the limestone.

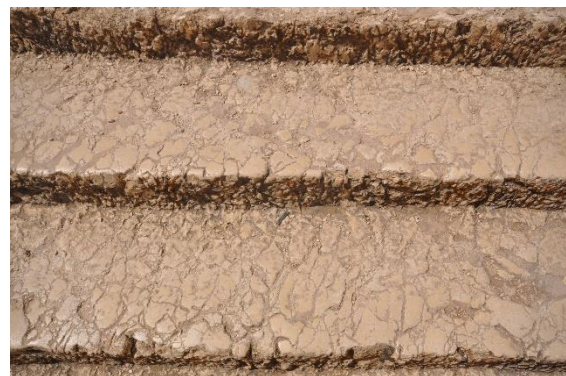
Figure 24 – Disaggregation of the limestone as seen on the steps leading up to the temple of Bacchus.

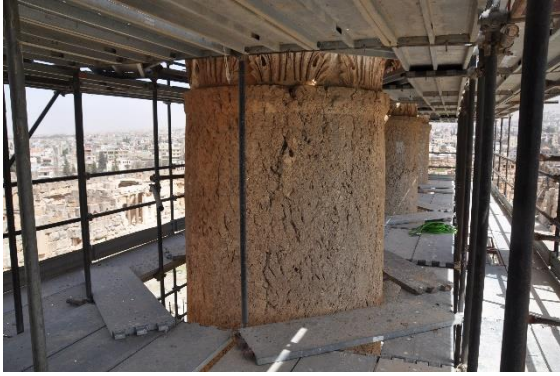
Figure 25 – Alveolarization of the limestone on the face of the column shaft just below the capital.

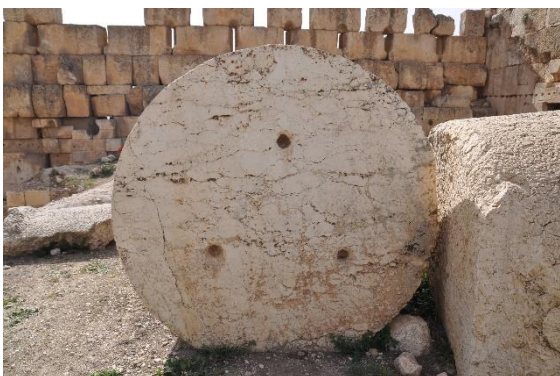
Figure 26 – View of one of the ends of one of the fallen column shaft stones. The three drilled holes would have received metallic anchors to secure one stone top of the other. The metallic anchors would have been set in molten lead.

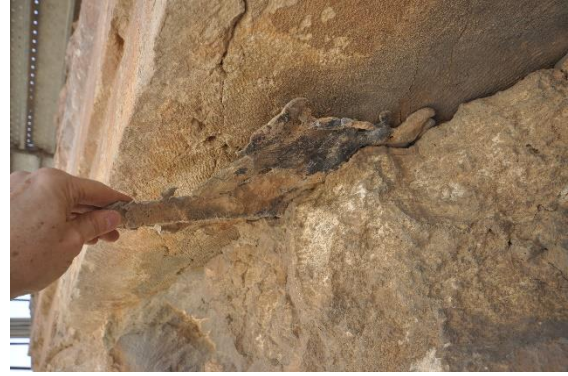
Figure 27 – Some of the molten lead within the stone lintel (between architrave and freeze stone units). Has been exposed on the north side.

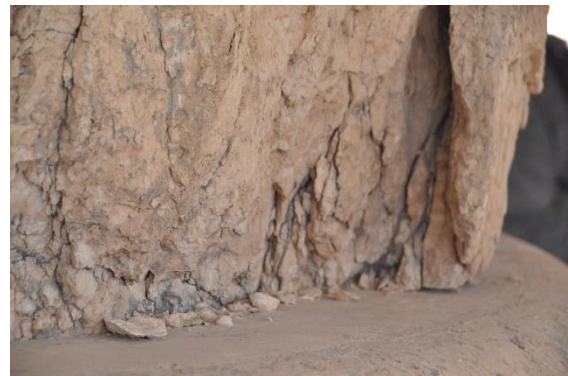
Figure 28 – Close up view of the north side of one of the column shafts where it rests on the base. This is an area where the stones have been damaged possibly due to rocking during seismic actions. It appears that this damage may be exacerbated by freeze thaw decay.

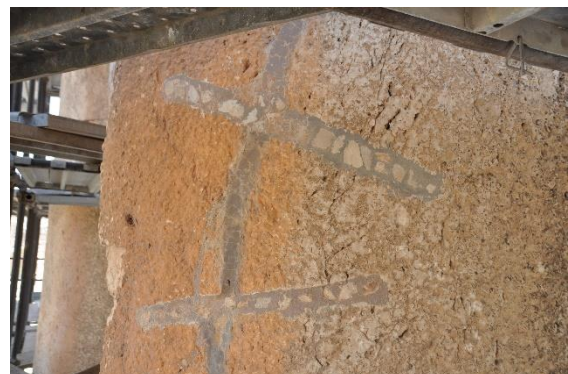
Figure 29 – Area where staple shaped metallic anchors were embedded spanning a vertical crack in one of the capitals.

1. The present strategy of painting these pins where they are exposed will not be effective. Anchors corrode on embedded surfaces and will not corrode on exposed surfaces. From experience I can attest the following:

steel corrodes much more readily where it is buried in mortar or stone in comparison to where it is exposed; and the corrosive expansion of carbon steel anchors will destroy the stone into which it is embedded. I strongly recommend that consideration be given to removing these pins in the column shafts in all cases where this can be performed without causing significant damage. Once removed the pins can be replaced with stainless steel, nonferrous, or nonmetallic anchors of similar size and profile. I agree that extraction of these pins at the column capitals would be too damaging and should probably not be attempted at this time.

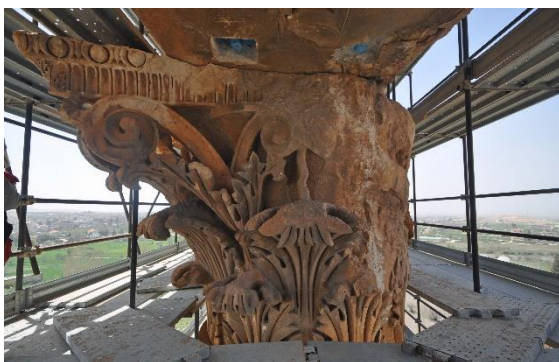
Figure 31 – One of the Corinthian capitals as seen looking westward. Carving is highly ornate but is only present on the south side of the Capital.

The Corinthian capitals are each composed of a single stone, and it is believed that they were partially carved after they were set atop the column shafts (Figure 31). The six capitals have ornate carving on the south side only (exterior side) and not on the north (interior side). I will not speculate on the reasons because it is beyond the scope of my peer review. There were numerous repairs using metallic pins evident to the capitals there were added during the 1930s work (Figure 32). In my opinion at least one of these pins, composed of wrought iron, is original, and was a repair done by the builders during initial construction (Figure 33). This is not unusual and is still common practice for builders on a structure to perform minor repairs on the scaffolding.

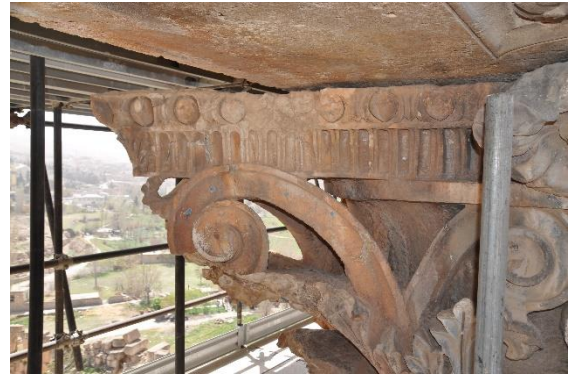
Figure 32 – Close up view of one of the Corinthian capital scrolls revealing its delicate nature and deep carving. Metallic anchors added by the French Mission can easily be seen because they have been painted with blue paint.

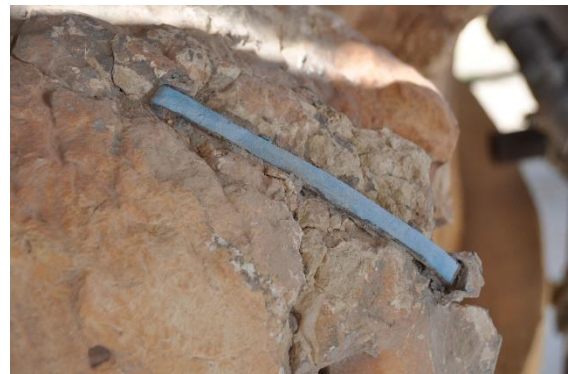
Figure 33 – Close up view of metallic anchor which appears to be wrought iron and square in profile, and not the carbon steel and circular in profile of which the French Mission anchors are composed. This anchor is believed to be from the Roman era and installed as a repair during the initial construction of the temple.

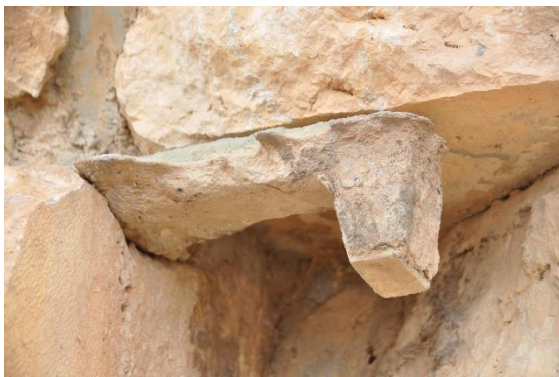
Figure 35 – Roman era cast bronze anchor set in lead that has been exposed due to previous damage on the north side of the stone lintel in the horizontal joint between the architrave and frieze stones.

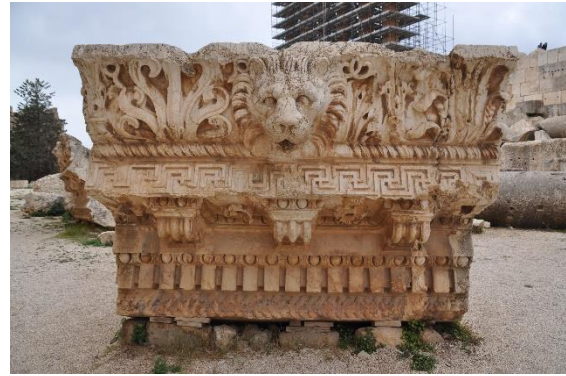
Figure 36 – A unit of the frieze that has fallen to the ground. Note the high degree of ornamental carving, much of which was put in place after the stone was set atop the Colonnade.

Inspection of portions of the stone lintel that are on the ground reveal intricate nature of carving as well as the manner in which the frieze stone units interlocked on the backside (Figures 36 and 37). Also evident that the stones of the architrave and frieze were ornately carved on the south side (exterior) only much like the capitals below. In addition, there is much stone loss on the north side that was consolidated with stonework backed up by concrete and tied to the stone with steel reinforcing. In addition a large portion of the entire stone lintel at the east side was also replaced with stonework and concrete.

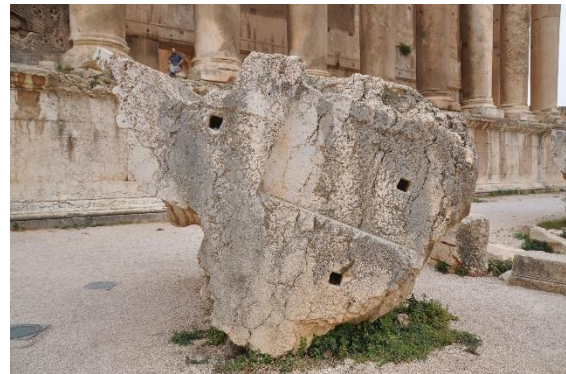
Figure 37 – Side view of the frieze unit showing the tothing of one stone to the other. Small square holes either used to receive metal towels, to hoist the stone into place, or both.

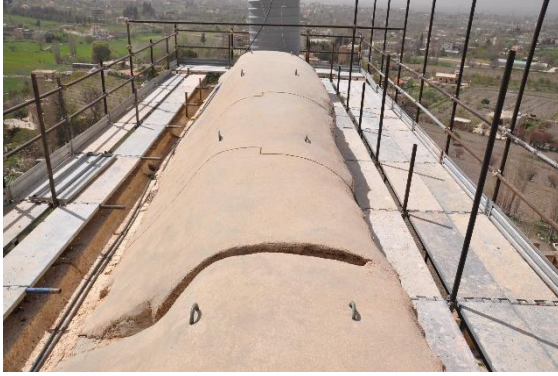
Figure 38 – View of the concrete cap looking eastward. The concrete is smooth and rounded in order to shed water to the original guttering system on the south and off of the stone lintel on the north.

2. The concrete cap on the stone lintel should be made waterproof. Open cracks, joints, voids and the like on all faces of the architrave should be filled to mitigate infiltration of water. Corrosion of ferrous pins occurs in the presence of water in the architrave can serve as a protective canopy for many of these pins in the capitals directly below.

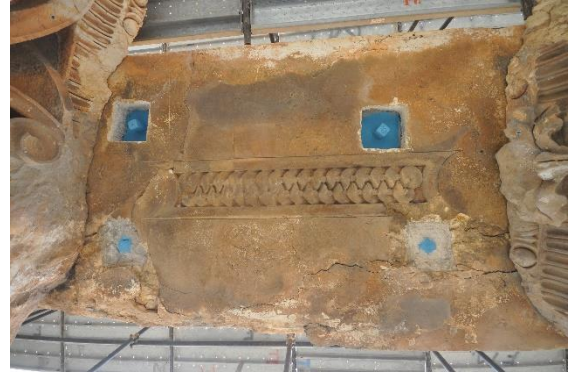
Figure 41 – View of the underside of another one of the architrave stones that has been suspended from the reinforced concrete cap above.

Atop the stone lintel is the concrete grade beam which was installed by the French Mission (Figure 38). A curious aspect of this grade beam is its precise effect on the long term behavior of the Jupiter Colonnade. We know that this beam is structural and that three compromised architrave stone units have been suspended from it via metallic anchors with end plates (Figures 39 through 41). We also know that the concrete was meant to form a waterproof cap that would successfully shed water off the top of the stone lintel (Figures 42 and 43).

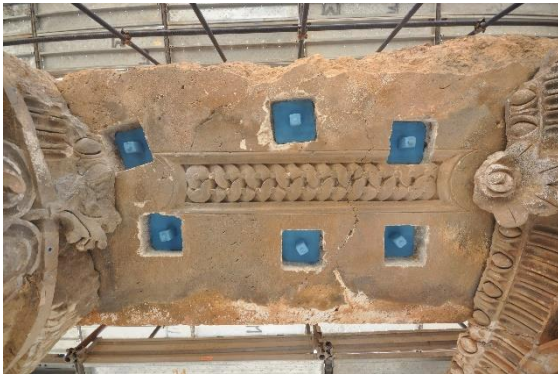
Figure 39 – View of the underside of one of the architrave stones that has been suspended from the reinforced concrete cap above. Through plates, recently painted blue, were inset into the stone and then covered with mortar.

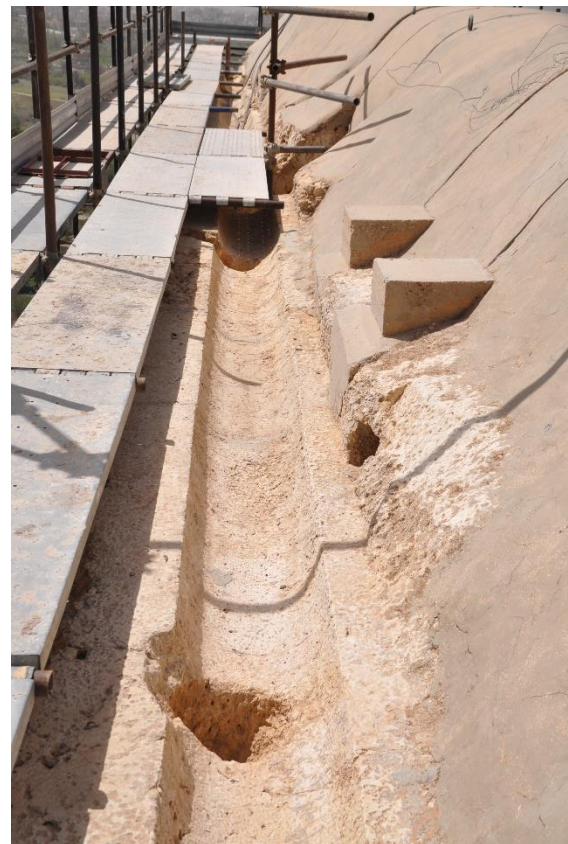
Figure 42 – The original guttering system within the stone frieze. The concrete cap allows water to drain into this guttering system which has downspouts that lead to the mouths of carved lions in the south side of the frieze.

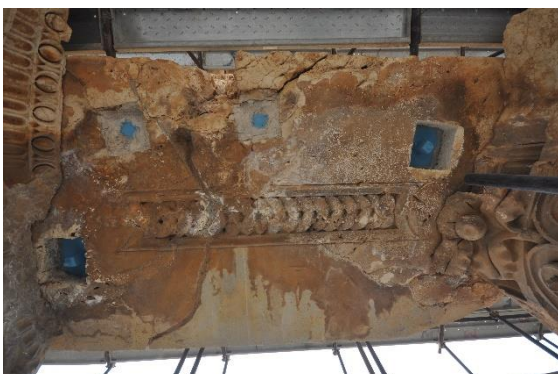
Figure 40 – View of the underside of the westernmost architrave stone which had been compromised by a large crack.

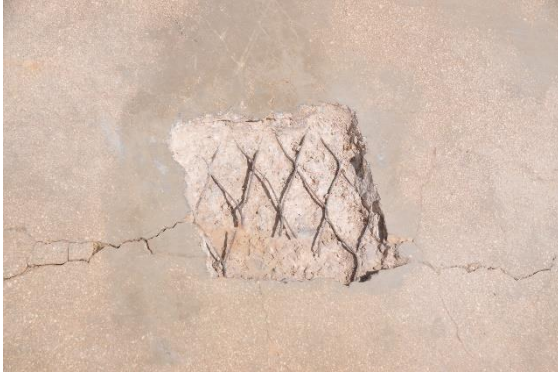
Figure 43 – Welded wire fabric was placed in the concrete cap near the surface to control shrinkage cracks in the concrete and increase its water shedding abilities.

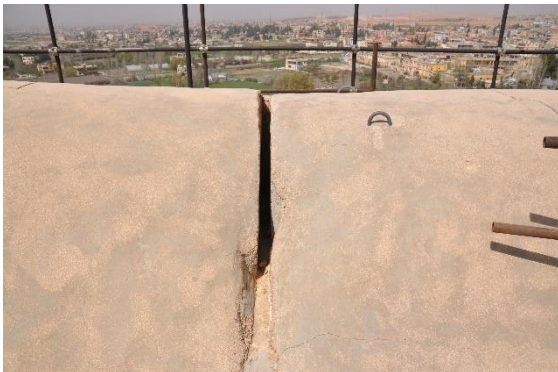
Figure 44 – Formed break in the concrete cap towards the west end of the cap. Little is known about the steel reinforcing within the concrete other than it must be present above the architrave stones that are suspended and is discontinuous at this break.

1. Perform metallurgical studies on the ferrous metal pins to verify that they are indeed carbon steel.
2. Perform further accelerated weathering tests on the stone and the concrete to determine if the reduction of strength is a trend.
3. Not enough is known about the metal reinforcing in the concrete beam atop the stone lintel other than the thickened area above the cracked stone architrave unit. It can be assumed that there is metal reinforcing above the other architrave stones that have been reinforced. However, the formed separation in the concrete cap

indicates that the beam was not meant to form a continuous tie across the top of the lintel. Further intrusive inspection is warranted in this contemporary element to determine the sizes, numbers and conditions of the reinforcing steel in areas where little is known about the reinforcing steel. Such an inspection would include selective removal of concrete, would not affect the authentic portions of the monument, and could be easily repaired.
