State Of Conservation Report

Um er-Rasas

(Kastrom Mefa'a)

Jordan

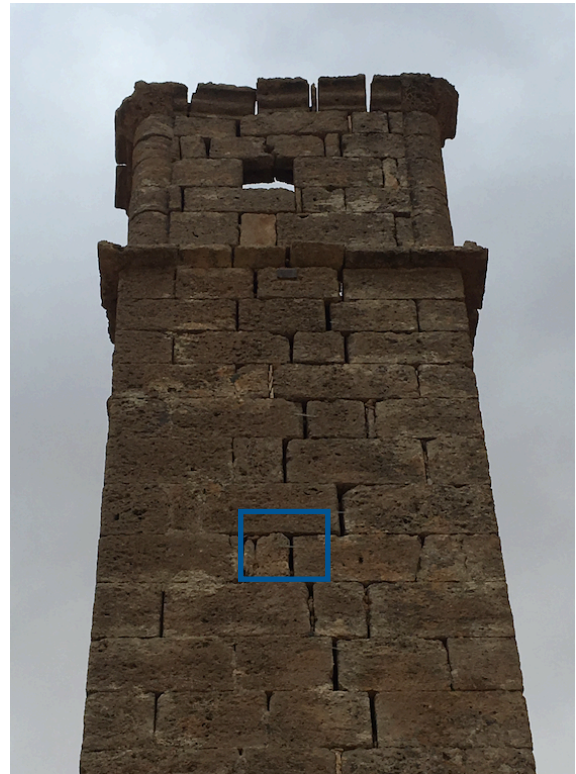
The current strategy in use regarding the Stylite Tower is constant monitoring and preventive actions using glass panels fixated on the tower since 2006. Last monitoring mission to the site from the Department of Antiquities (DoA) staff was in December 2018.

Figure 1: An example of the glass panels
Source: DoA

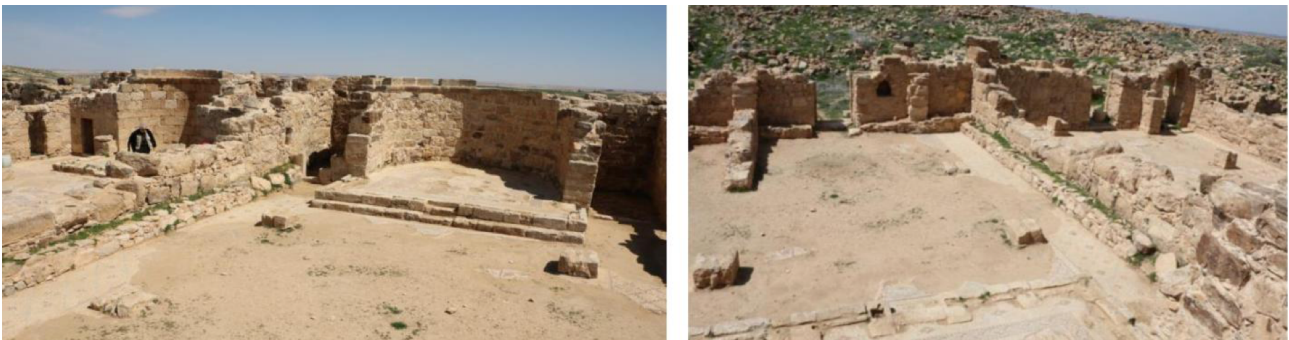
The state of conservation of the Castrum Fortification is also monitored on a constant bases, with restoration, maintenance and consolidation of the Twins Churches led by the European Centre for Byzantine and Post Byzantine Studies (EKBMM).

Figure 3 : The Twins Churches

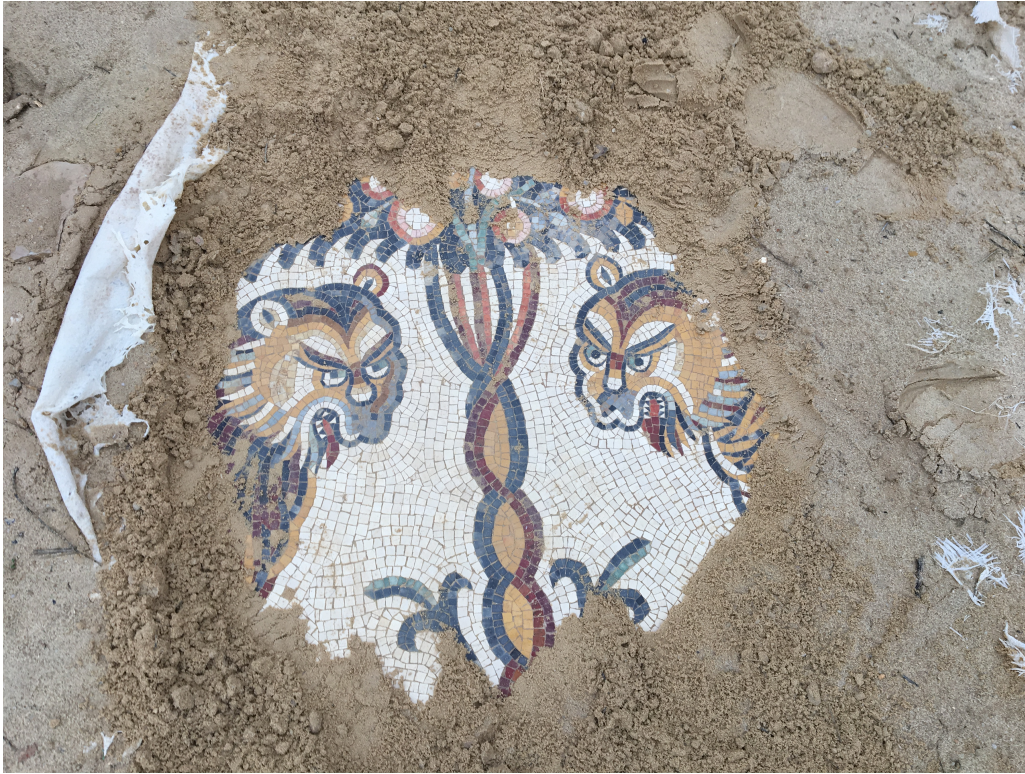
Various projects to cover the mosaic floors of several churches were conducted utilising the Geotextile method, such as in the Lion Church and the Twin Churches, with constant monitoring and reconditions when necessary.

Figure 7: Geotextile in the Lion Church

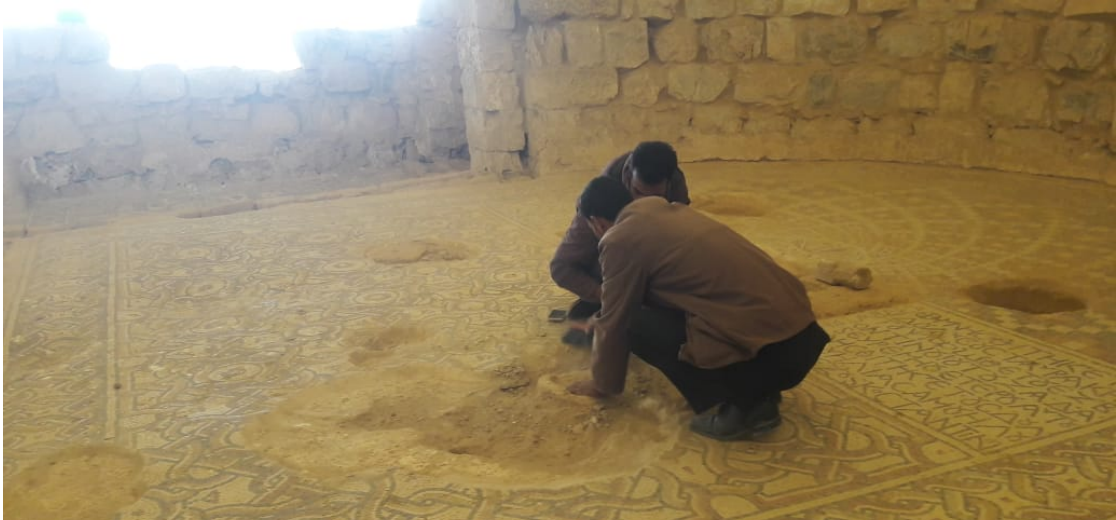
During the periodic monitoring, and by referring back to the periodic reports of the site, occasionally the site staff notice that some of the mosaic floors are affected by the weathering conditions, visitors and some animals that wonder around the site at night, therefore, the Department of Antiquities have implemented direct consolidation procedures especially in St. Stephan Church, such as the consolidation of the floors' edges by specialised conservators from the local community in consultation with the Madaba Mosaic School. It is worth mentioning that the conservators were trained in a specialised workshop in cooperation with the EKBMM and The Architectural Conservation Laboratory of the University of Attica (ACL-UNIWA). Moreover, the site staff are regularly cleaning the mosaic floors from the birds' droppings.

Figure 8: Conservators working on consolidating St. Stephen Church

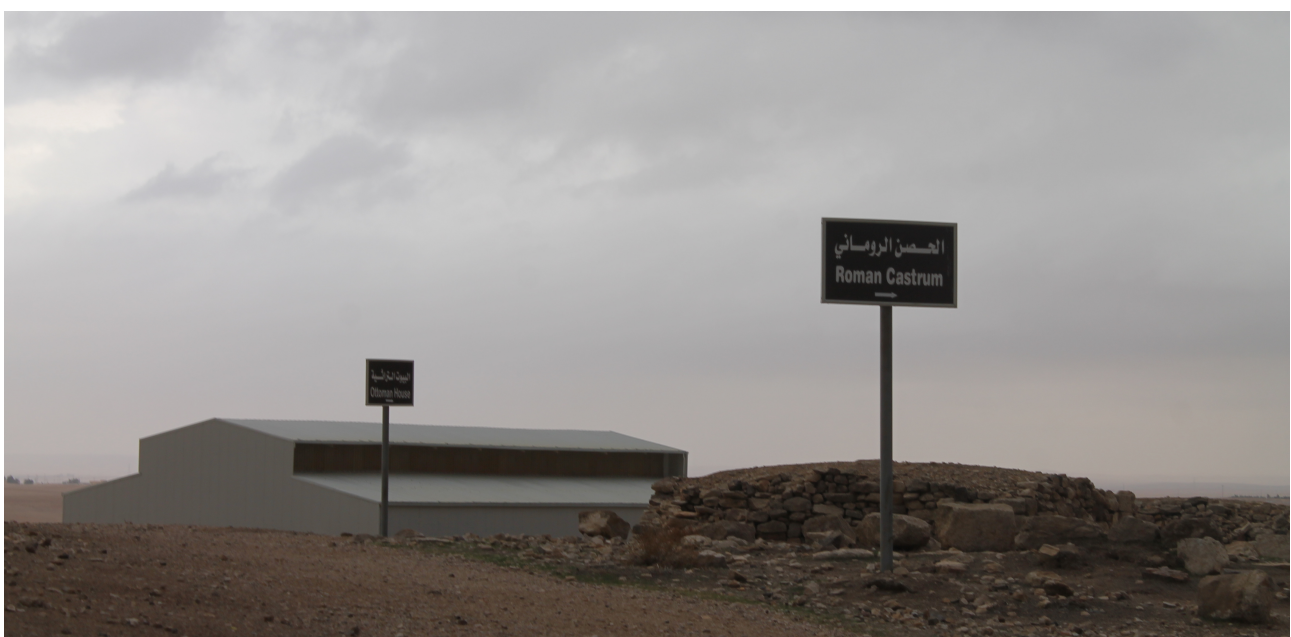
Figure 9: Newly installed panels

New panels were installed in June, 2018 showing the locations of the main archaeological features of the property.

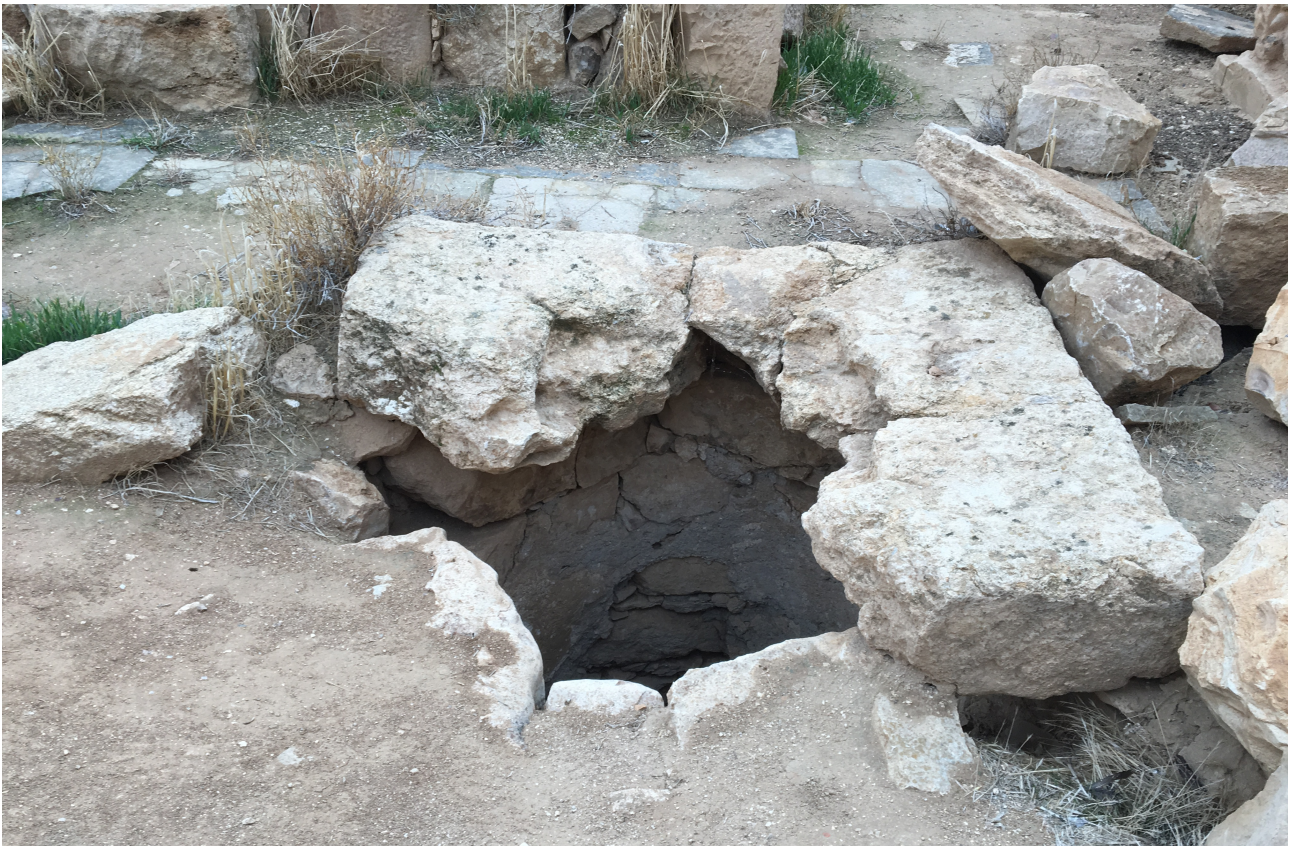
Hitherto, 143 wells have been discovered. Although the majority of them are far away from the touristic trail, a few are somehow close and needs to be covered to insure the safety of the visitors, therefore the DoA is planning on designing proper protections promptly.

Figure 10: A well near the visitors' trail
