KATHMANDU VALLEY WORLD HERITAGE SITE
(Nepal) (C 121 bis)
1 FEBRUARY 2019

Submitted by:
Government of Nepal
Ministry of Culture, Tourism and Civil Aviation
DEPARTMENT OF ARCHAEOLOGY
Ramshah Path, Kathmandu, Nepal
Telephone: +977 1 4250683
Facsimile: +977 1 4262856
E-mail: info@doa.gov.np

STATE OF CONSERVATION REPORTS FROM INDIVIDUAL MONUMENT ZONES

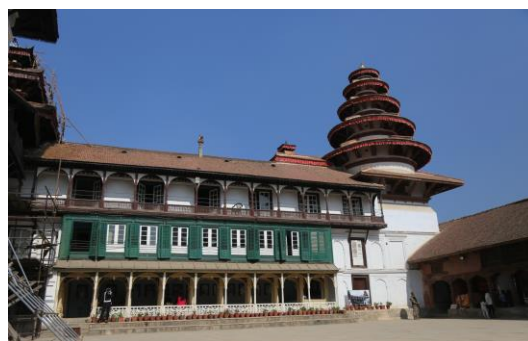
The conservation work of Panchamukhi Hanuman Temple, a prominent multi roofed temple in the palace premises is completed as first completion after the earthquake. The southern wing of the Mohankali chowk is also conserved as well within the same project budget. However, the project was started before the earthquake, but due to the earthquake it was obstructed for some months. The project was under taken by the joint fund of Hanuman Dhoka Museum Development Committee and American Ambassadors fund for Culture Preservation; in the supervision and monitoring by the Department of Archaeology. The conservation work carried out using traditional material, technology and craftsmanship.

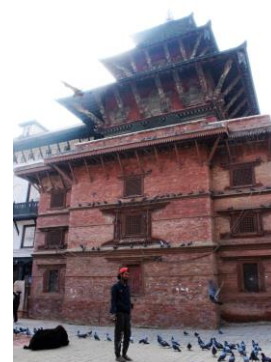
The Degu Taleju is tutelary deity of Malla Kings. This temple was built by King Shiva Simha Dev in 17th Century. This is one of the important monuments situated within Hanumandhoka durbar complex. The conservation work of this temple is completed with traditional material

and technology.

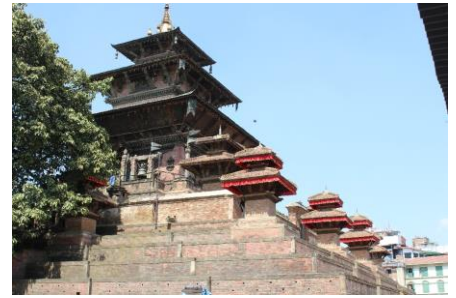
1.3 Conservation of Taleju Temple

The conservation of Taleju temple is completed. Taleju Temple is biggest monument and landmark of Kathmandu Durbar Square. Taleju is a tutelary deity of Malla Kings. The temple was affected by the earthquake; especially in top and second roof and all the small 12 temples on the plinth as well. The conservation work of main temple is completed and the small temple structures (Kachhadega – 12 in numbers) built on the plinth of the temple has also completed recently.

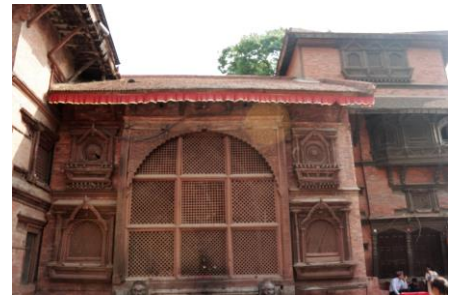
1.4 Conservation of Sweta Vairab Temple

Conservation of the Sweta Bhairav Temple attached to Degutaleju is already completed. The recently restored temple of Bhairav was partially affected by the earthquake and well shored just after the quake to protect from the further destruction. Hanumandhoka Palace Museum Development Committee had taken total responsibility of the conservation under the close inspection of DoA.

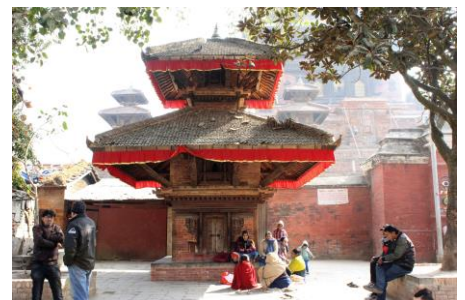
2.1 Conservation of Shiva Temple

Conservation of the Shiva temple just outside of main gate of Taleju temple is completed. One of two Shiva temples in front of Taleju gate was collapsed and the northern one was badly affected by the earthquake. The total responsibility of conserving the small but beautiful two roofed temple of the right side of the gate which was not collapsed but badly affected was taken by Kathmandu Valley Preservation Trust. Applying the mud mortar the temple is conserved with traditional method and material as it was built before.

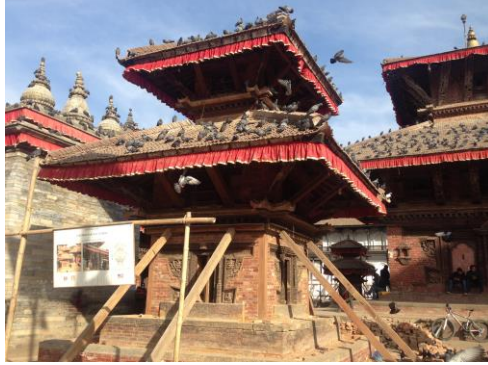
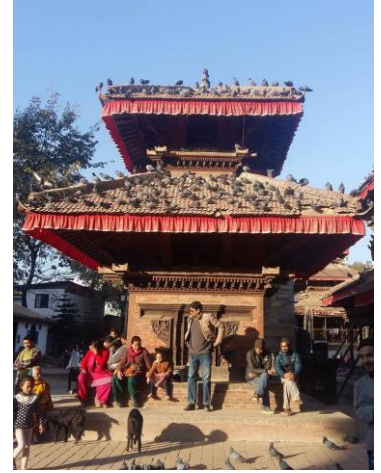
2.2 Conservation of Laxmi Narayan Temple

Conservation of the Laxmi Narayan temple just backside of Kalbhairab in Hanumadhoka which was badly affected by the earthquake is completed. The total responsibility of conserving this small but beautiful two roofed temple was taken by Kathmandu Valley Preservation Trust. Applying the mud mortar the temple is conserved with traditional method and material as it was built before. Adding few necessary wood, all the wooden members from the temple is reused in conservation.

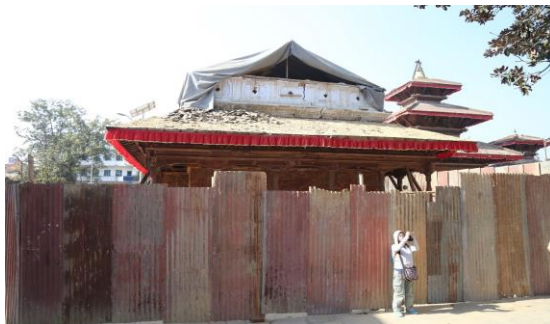
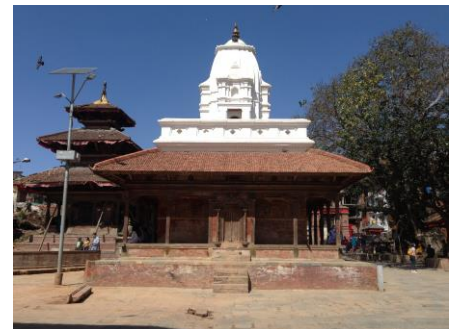
2.3 Conservation of Kageswar Temple

The Kageswar Temple, on the west of Taleju, originally built in 1681 and rebuilt after the earthquake of 1934 and lastly restored by Kathmandu Valley Preservation Trust (KVPT) before 10 years was partially collapsed by the 2015 earthquake. The after earthquake restoration of the temple is completion. The total responsibility of conserving this temple is taken by Kathmandu Valley Preservation Trust (KVPT). The temple is conserved with traditional method and material as it was built before.

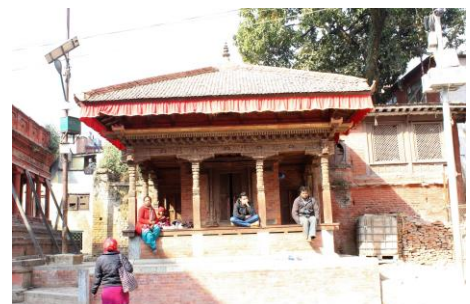
2.4 Saraswati Temple

The one storey Nepali style temple dedicated to Goddess Saraswati located on the just south of Bamsagopal temple in Hanumandhoka Palace Square is completed. The temple was not collapsed but affected by the 2015 earthquake. The temple is conserved over the plinth level preserving the original foundation and plinth as it is; and conserved the over structure with minimum intervention reusing

all the useable elements of the original temple. The total responsibility of conserving this temple is taken by Kathmandu Valley Preservation Trust (KVPT). The temple is conserved with traditional method and material as it was built before.

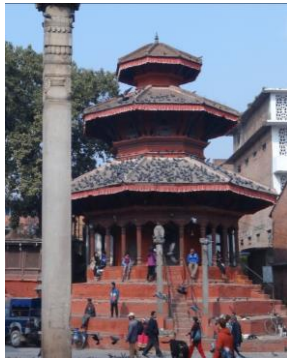
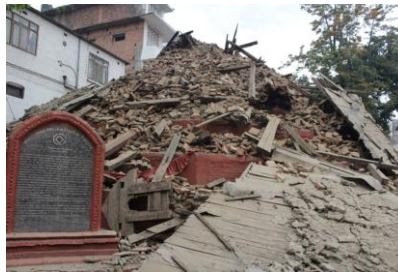
3.1 Bamsa Gopal Temple (Chyasin Dega) Restoration

The renovation work of Bal Gopal temple also called Chyasing Dega is completed. This temple is a prominent multi roof temple in octagonal shape, devoted to lord Krishna was completely damaged by the earthquake. The temple is restored by Department of Archaeology. As the temple was built by the massive use of traditional brick, wood and terracotta tiles, full consideration is paid to restore the temple with the use of traditional technique and materials reusing the old wooden and other elements as much as possible. Since the 'Surkhi mortar', the mixture of lime, sand and brick powder, is accepted as a traditional construction material, Surkhi mortar is used in restoration of the temple instead of mud mortar.

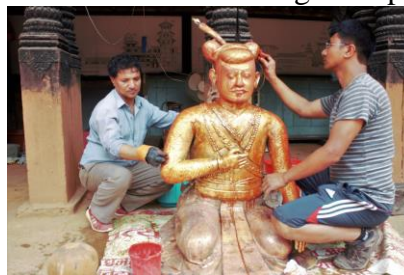
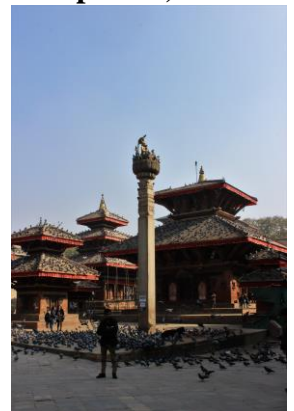
3.2 Pratap Stambha (The Stone Pillar with the Statue of King Pratap Malla)

The Stone Pillar with the metal statue of King Pratap Malla in front of Degu Taleju temple in Hanumandhoka was partially collapsed by the earthquake. The metal statue was fallen with its stone capital part. The statue of King Pratap Malla with his two queens and four sons were badly damaged.

It had taken considerable time of skilled artists for the conservation of the damaged metal statue. The huge stone capital of the pillar was lifted using traditional knowledge and technique to set the statue over it. Now the Pratap Stone Pillar is well restored in its original condition.

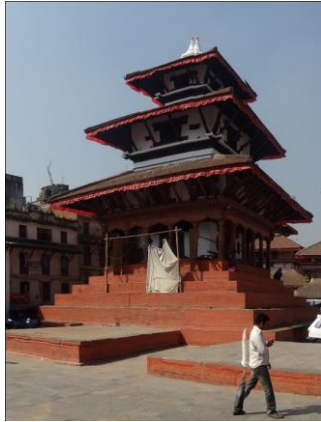
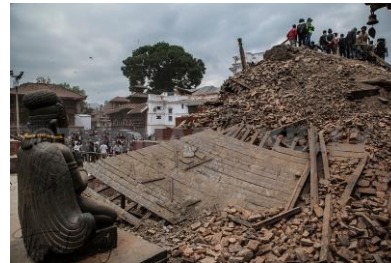
3.3 Restoration of Trailokya Mohan Narayan Temple

The Restoration Work of Trailokya Mohan temple is ongoing. The Trailokya Mohan Narayan Temple is also known as Dasavatar temple on north-west side of Kumari Temple, was built in early 18th century. The super structure of the three tiered multi roof temple was completely destroyed by the earthquake. After the detail

investigation with emergency archaeological excavation, the restoration work was already started with the concept of utilizing almost wooden artistic and other remaining material of the same temple replacing the damaged by new one. The already separated and inventoried wooden elements are being reassembled and conserved for reuse. Other necessary new wooden elements also are being prepared as well.

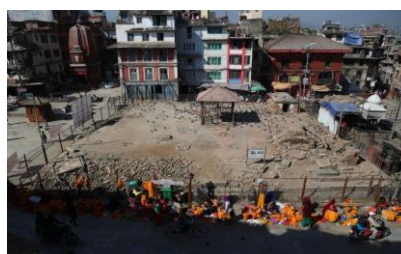
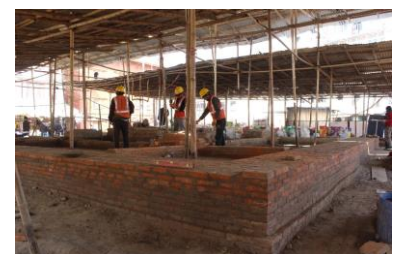
4.1 Restoration of Kasthamandap

being restored by the local community led by "Kastamandap Punanirman Committee" with the fund provided by Kathmandu Metropolitan City office.

Under the project funded by UNESCO, all the remaining wooden and other materials of the temple are salvaged and well documented. On the restoration of the temple, all those salvaged reusable elements of the structure are being reused.

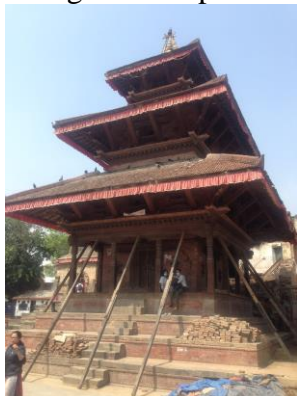
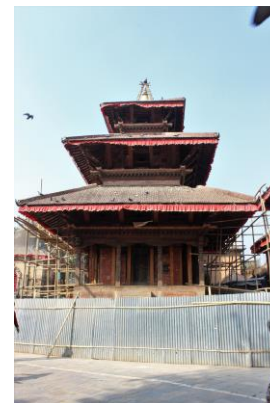
4.2 Mahavisnu Temple

The temple of Vishnu known as Mahavisnu temple is located on the northwestern corner of Hanumandhoka Durbar Square. The temple was partially affected by the earthquake. However, as the temple was restored few years before the earthquake, a building west of the temple was collapsed and fallen over the Mahavisnu temple damaging the temple structure partially. The western portion of the first roof was more affected and also the brick walls in the ground floor were cracked.

The conservation work of the temple is ongoing. Presently the first floor conservation is completed. The total responsibility of the temple conservation was taken by Kathmandu Metropolitan City Office. For strengthening the structural strength of temple the use of wooden elements is increase in considerable number.

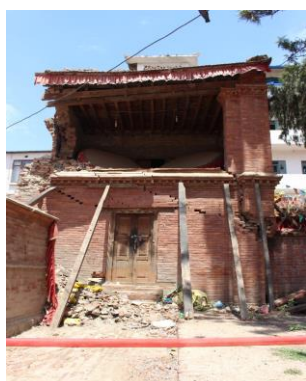
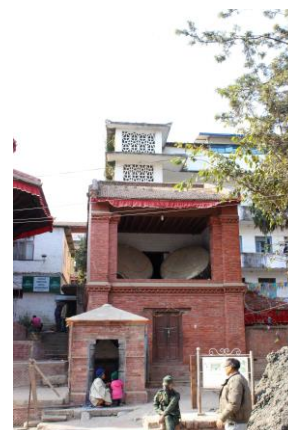
4.3 Restoration of Nagaraghar

The Naghara Ghar, big Drum house, built in early 20th Century, situated west of Degutale temple in Hanumandhoka Palace Square is a monument of cultural and historical significance. The Conservation work of this structure is completed within a year of earthquake. Replacing the mud mortar by lime mortar the house is conserved with traditional method and material as it was built before. Kathmandu Metropolitan City had taken the total responsibility of the conservation under the close inspection of Department of Archaeology.

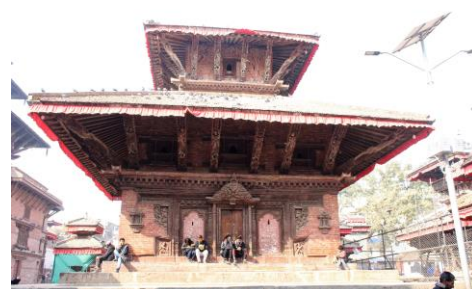
5.1 Jagannath Temple

Jagannath temple in front of main entrance of the palace is under conservation. The temple is being conserved under the UNESCO- Hainan project. The detail structural assessment and architectural study of the temple is completed. Since the temple is targeted to strengthen without dismantling entire structure; the modality of strengthening the temple is also identified by series of meeting with experts and local stakeholders with close coordination of Department of archaeology.

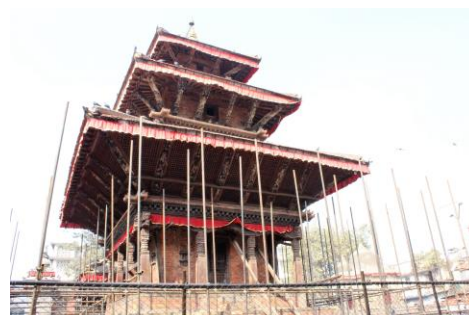
5.2 Conservation of Shree Krishna Maha Vishnu (Gopinath) Temple

Among the two monuments to be conserved under UNESCO- Hainan Project, Shree Krishna Maha Vishnu Temple, also known as Gopinath, is another one. The temple also was partially affected by the earthquake. The detail structural assessment of Gopinath temple is already completed; and finalized the modality of strengthening of the temple without dismantling entire structure. After presenting the detail of the modality and the procedure of the local stakeholder conservation work of the temple is already started.

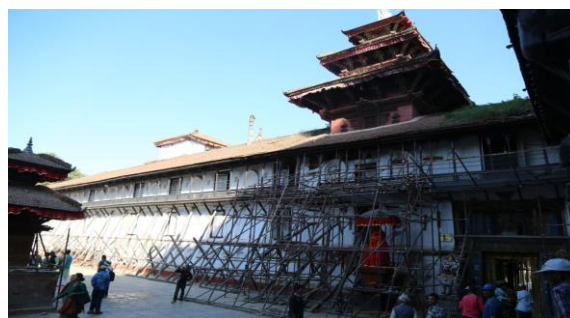
5.3 Conservation of Aagamchhen and Western wing of the palace

Since the western wing including the main entrance of the palace was largely affected by the earthquake, the over structure of sacred Aagamchhen over the western long was suspected to be effected heavily, National Research Institute for Cultural Properties, Tokyo had had a detail structural investigation of the entire structure with approval and close cooperation of Department of Archaeology and

Hanumandhoka Palace Museum Development Committee. The project is approved by Department of Archaeology. The Agamchhen and the western wing of the palace is going to be conserved by Department of Archaeology through the support of Government of Japan.

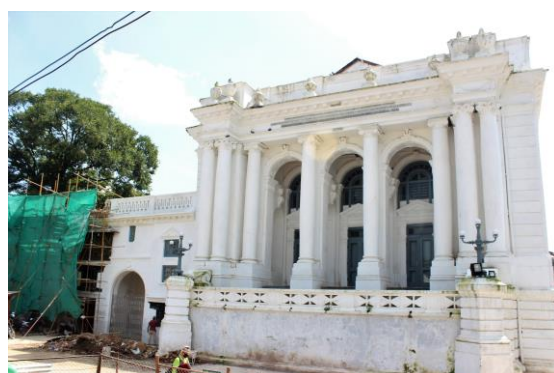
5.5 Conservation of Gaddi Baithak

Since the first phase of strengthening work of Gaddi Bhithak is completed with the completion of the main building of Gaddi Baithk, the second phase is started with interior upgrading and structural strengthening work of adjacent building including main entrance of the Gaddi Baithak.

The Gaddi Baithak situated in Hanumandhoka Protected Monument Zone, in front of Kumari Ghar, is a neo-classical monument building built in 1908 AD by Prime Minister Chandra Samsher Rana. This monument was heavily damaged by the earthquake. Miyamoto Global Disaster Relief has undertaken the total responsibility of repair and structural upgrade of the building with a grant provided by the US Ambassador's Fund of Cultural Preservation. The project is being executed under the signed MoU between Department of Archaeology, Government of Nepal and Miyamoto Global Disaster Relief.

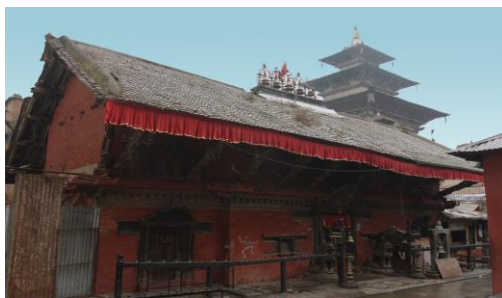
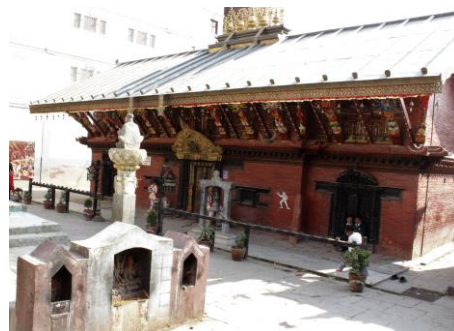
The Tarinidevi temple conservation work is completed. The temple of Tarinidevi, also known as Tarini Bahal, in Hanumandhoka protected monument zone, is located outside the palace premises. The temple was targeted to conserve before the earthquake and was more

damaged by the earthquake. The temple is conserved in initiative of local community with the mutual fund of municipality and community under the close inspection of the Department of Archaeology.

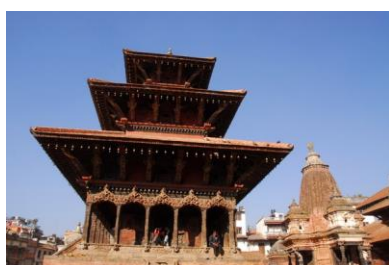
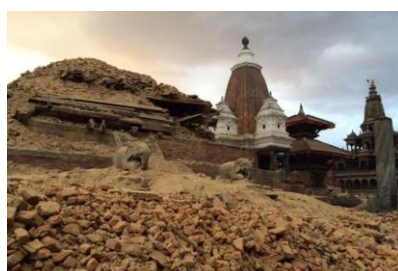
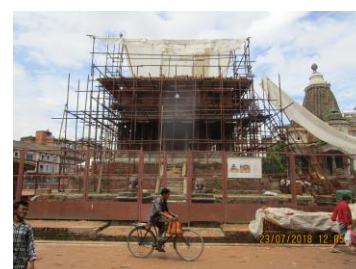
The Hari-Shankar Temple devoted to lord Vishnu and Shiva, in Patan Durbar Square, near to collapsed Char-Narayan temple and just beside the Narasimha temple also was destroyed completely above the plinth level by devastating earthquake. As reported in previous report, all the damaged wooden carved elements of the three roofed temple with extraordinary wooden art and architecture was well salvaged with detail documentation. Almost all identified columns, windows, door, Carves, tympanum, door wings, struts etc. were inventoried and being reused in present restoration of the temple.

As the foundation of the temple was found intact and strong enough in the rescue archaeological investigation, the temple is being restored keeping the original foundation intact.

All the base stones of the doorframe, all four doorways, carved tympanums, struts of the temple have been reused and fixed as it was in existing position. All the wooden emblems are installed with maintenance of original adding some new wood for missing portions. Fine yellow clay is being used as mortar in the wall as its original state. Sufficiently wooden pillar and tie-up beam is given. All the new wood used for the temple is Sala Wood.

In Hari Shankar temple some new intervention is also carried out particularly in the outer plinth. Strong Ma-apa (brick) foundation is erected replacing the loose soil and brickbats filling. All the work is being done under the close inspection of Department of Archaeology.

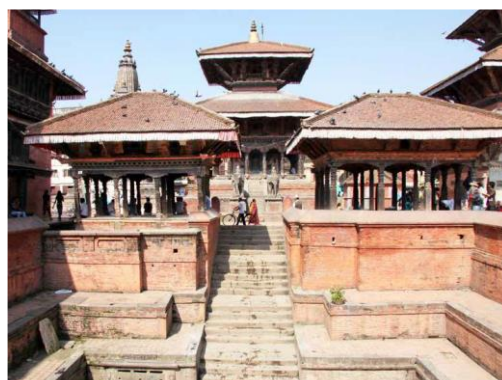
1.3 Restoration of Manimandaps

The restoration work of Manimandap is completed.

The Manimandap, the twin public rest shelter, in front of Mangahiti, water spout, was completely collapsed above the plinth level by the earthquake. As reported in previous report almost all columns, brackets, struts were identified and inventoried; and those all are reused in the present restoration of the structure. As there are two structures of rest house, both of the structures are completed.

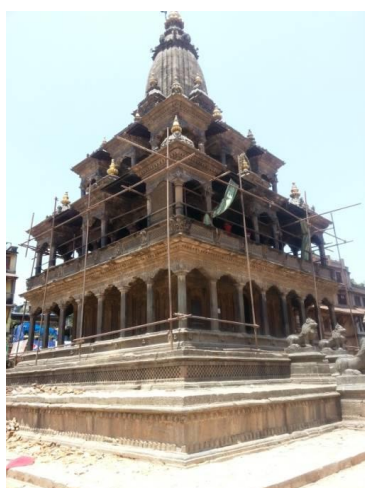
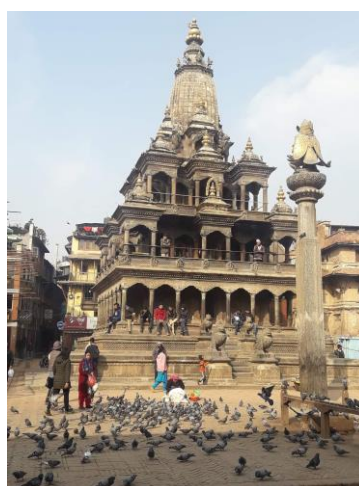
One of the most famous monuments of Patan, the Krishna Temple, built by Siddhinarasingh Malla in 1636 A.D was also partially but severally damaged, especially upper second stories. Immediately after the earthquake the rescue shoring was given to the structure to prevent the further damage. The total responsibility of conservation is taken by KVPT, with close coordination with Department of Archaeology.

In present conservation the damaged threshold stone at northwest corner of innermost sanctum (garbhagriha) is replaced and the base stones at the Second floor level which is the main component of the structure are changed with new stone carving as in original one. Various water seepage problems are solved with careful conservation of dislocated stones. Some outer stone pillars also are conserved. 19 pinnacles out of 19 were taken out and reinstalled conserving it with gold gilding. The conservation work is completed few months before.

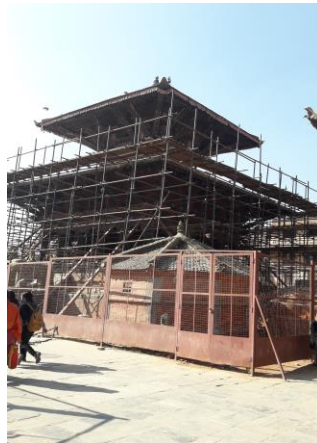
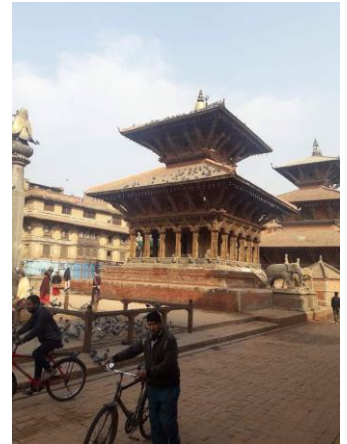
1.5 Conservation of Bishwonath Temple

As reported in previous report the Bishwanath Temple, near to Krishna temple, was also partially but severally affected. Immediately after the earthquake the rescue shoring was given to the structure to prevent the further damage. The temple is also being conserved by KVPT.

By the detail structural study it was found that the Vishwonath temple was damaged by earthquake but due to lack of periodic conservation as well. Many inner wooden members were found rotten and damaged by damp. In the present conservation all those damaged wooden members are replaced with new timbers. Few new interventions also is introduced in the conservation wrapping the wooden pillars, which is directly contacted with brick wall, by copper plate. The basic damage was found in ground floor which is almost finished the conservation work. In the Bishwonath Temple, some new intervention is carried out in the outer plinth also. Strong Ma-apa (brick) foundation is erected replacing the loose soil and brickbats filling. Since 95 percent work is completed, it is targeted to complete the work within March 2019.

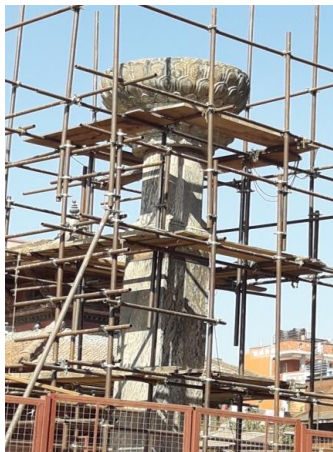
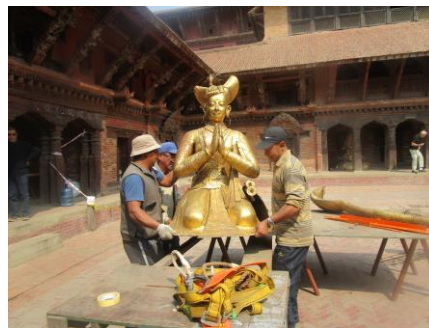
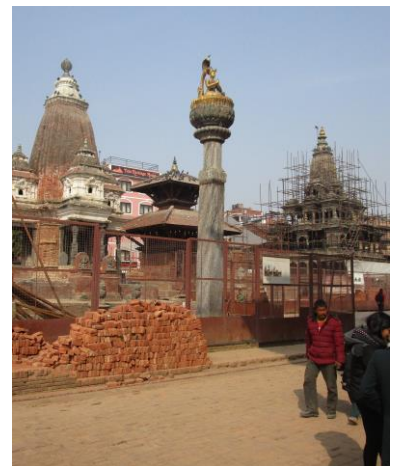
The huge stone column with the statue of King Yognarendra Malla was also largely affected, as the column was broken into three above the stone lotus part including bronze statues of the king was felled down by devastating earthquake.

In the initiation of KVPT with close coordination with DoA, the Austrian expert team had inspected and contributed for the installation of three big pieces of stone. Remaining bronze statues are maintained and installed in original state.

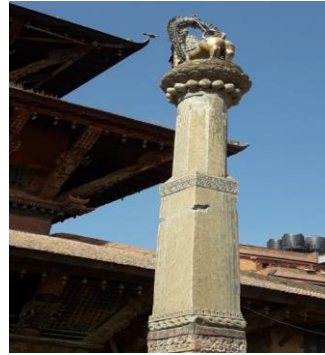
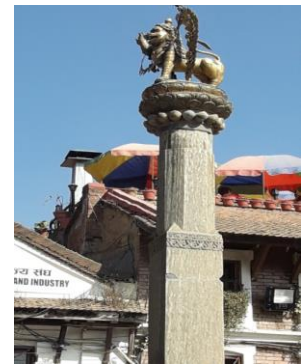
1.7 Conservation of the Lion statue column

The Lion Statue Stone Column in front of Bhimsen Temple was also broken in two pieces by the earthquake. By the technical help of the Austrian expert team it was inspected and joined by inserting stainless steel rod. The column is successfully installed. KVPT is credited to take the initiation to have the expertise of the Austrian stone conservator.

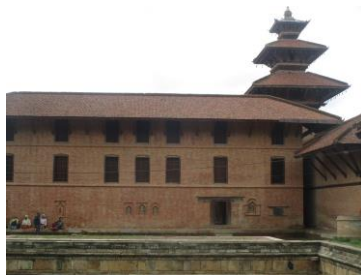
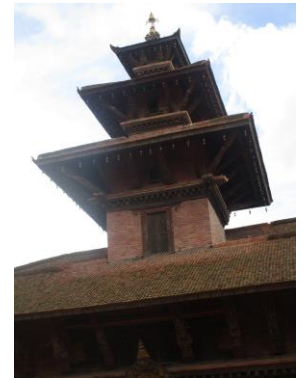
The Southern Taleju temple conservation work was completed already in May 2016 and whereas the Northern Taleju temple is completed in April 2018.

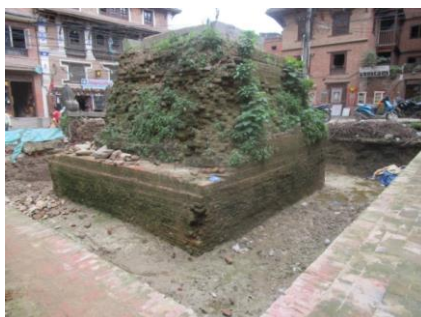
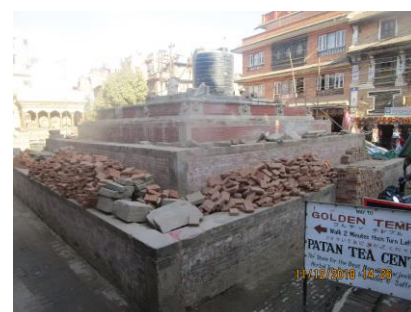
Radhakrishna temple situated in Swatha Tole in northern side outside of Patan Durbar complex was completely collapsed by the earthquake. All the wooden and stone elements of the temple were immediately salvaged and secured inside palace complex.

The temple is planned to restore from the very foundation and excavated the foundation; however the main sanctum of the temple is preserved in original form. Since the surrounding plinth and circumambulatory area is excavated 5'-0" depth preserving the central Grabhagriha area, stone in lime, Surkhi and sand mortar is used for making the mat of foundation. Because of some technical problems the restoration work is still in preliminary phase and under progress over the plinth level.

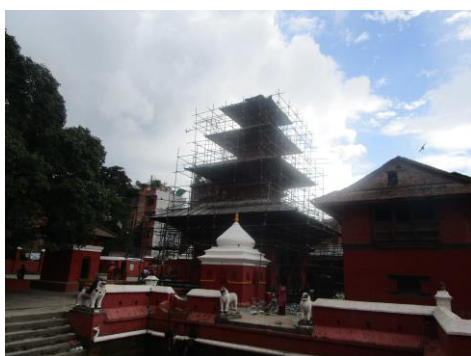
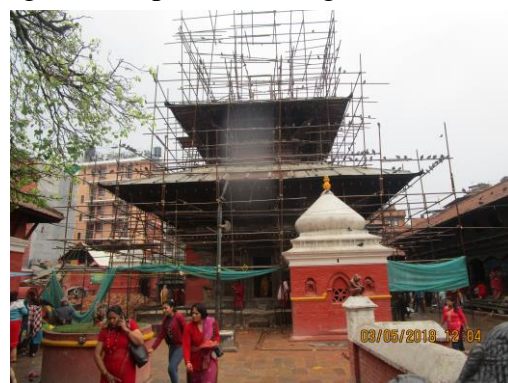
2.3 Conservation of Kumbheswor Temple

The Kumbheswor temple, a five story temple devoted to Lord Shiva, in the Lalitpur Durbar Protected Monument Zone is another temple which also was badly damaged especially upper two-three stories. Allocating the budget by government, Department of Archaeology has taken the total responsibility to conserve the temple. Since the first and second storey was found strong enough and not found big damage by the earthquake, only the upper three storeys are dismantled and the brick work is already started. The wood work is also in progress. All the elements of dismantled temple are well stored in temple premises. Almost all artistic wooden elements acquire from the original temple are being reused with necessary conservation.

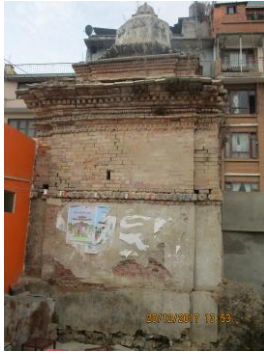
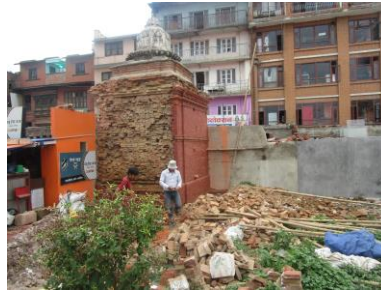
2.4 Conservation of Garud Narayan Temple

Garud Narayan temple, a small Gumbaj style temple built in Shah Period, located outside of Patan Durbar Square beside the road to Jawalekhel was partially damaged by the earthquake 2015. The temple is built of brick in mud mortar and the upper portion of Gumbaj is built with brick in Vajra mortar. One part of the brick wall was almost collapsed in the earthquake. The temple is conserved safely without dismantling. Conservation of the temple is completed recently.

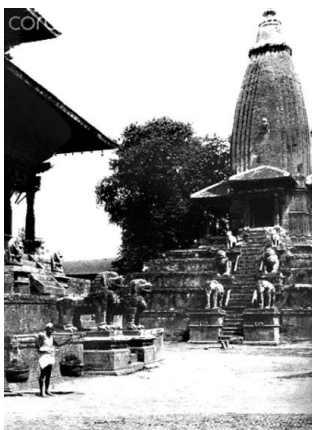
Now the repair of the plinth level has been

completed. For the repair works, the outer shell of the mud mortar plinth of 2 feet width is carefully removed and replaced by Lime Surkhi brick-wall, without disturbing the inner core. The foundation of lowest plinth was taken down to 2 feet. Recently the work is in rapid progress in main sanctum level.

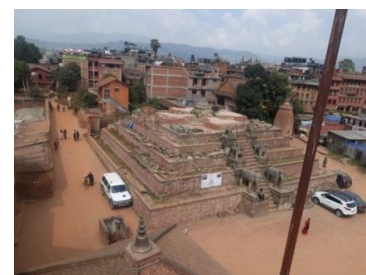
Since the necessity of more detail structural study of the proposed structure was felt, the restoration work was halted for some months for the study; and as the study is completed, following the recommendation of the structural study the restoration work is continued.

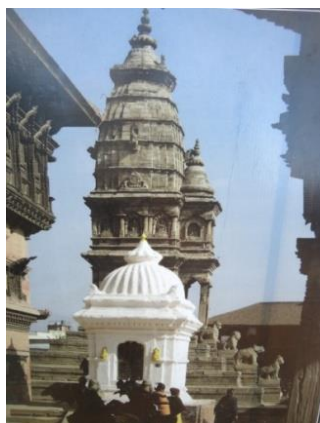
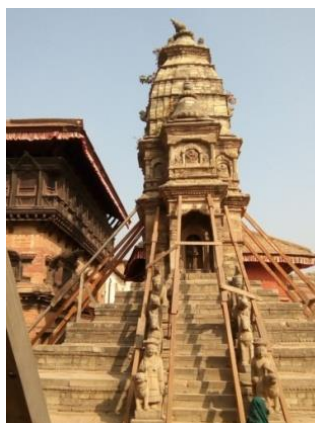
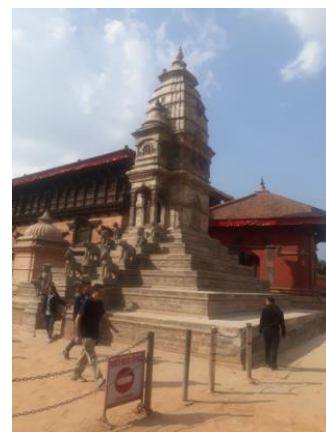
1.2 Siddhi Laxmi Temple Restoration

The Siddhi Laxmi Temple is a 17th century Shikhara style stone temple, dedicated to goddess Siddhi Laxmi located at south eastern corner of the 55 windows. Earthquake had damaged the Temple with major cracks at South side. Considering the possibility of future collapse of the monuments, measured detail drawings were prepared and the structure was carefully dismantled.

In the present restoration process all the stone of the temple are reused but all the wood is replaced by new strong Sal wood. The pinnacle of the temple also conserved with gold gilding.

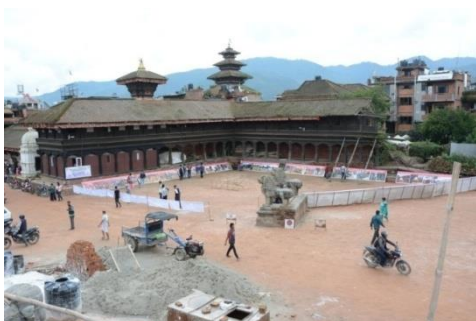
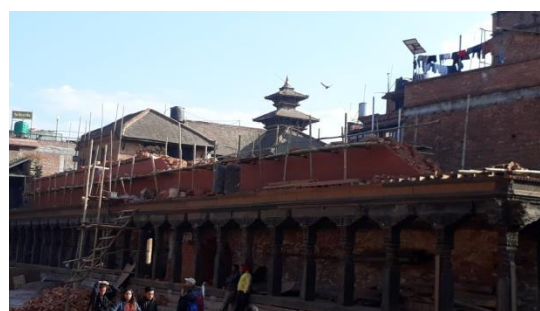
The restoration work of Taba Sattal is in rapid progress; and 60 percent work is completed. Taba Sattal also known as Taha Pha is located at the west corner of Bhaktapur Durbar Square. The middle portion of the Southwestern wing of the building was completely collapsed by the earthquake. Similarly, the upper portion of the northeast wing was damaged, and numerous cracks were observed.

Since the budget was allocated in last fiscal year as multiyear project, the restoration work of the Sattal is continued this year too. Almost wooden elements are being reused in present restoration work with necessary repair and conservation. All the lattice windows are well preserved and is planned to reuse. As the work is progressing over first floor, it is targeted to complete within April 2019.

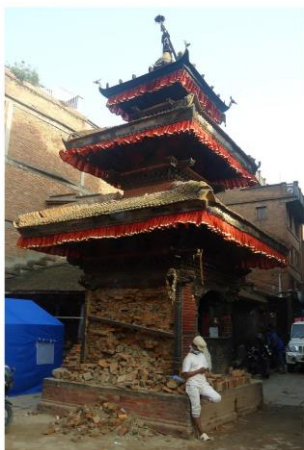
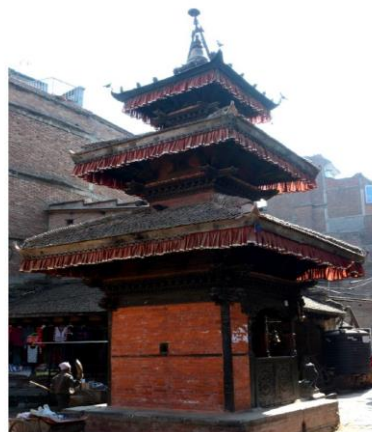
1.4 Conservation of Golmadi Ganesh

The conservation of Golmadi Ganesh temple was completed within the year of earthquake. Northern wall of the temple was heavily damaged by the earthquake. Emergency wooden shoring was placed just after the earthquake to prevent the temple from further damage. Repair of the damaged wall and roof work was carried out using emergency budget of DOA.

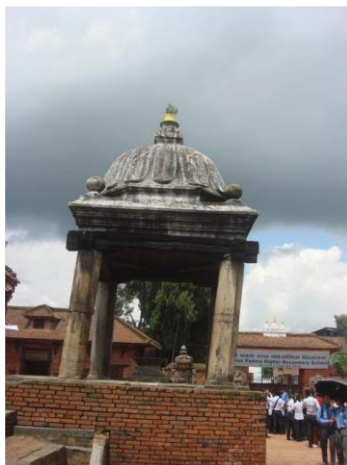
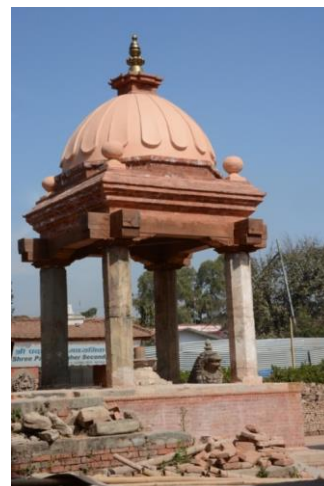
1.7 Restoration of Rameswor temple

Rameswor Temple, one of the Char Dham of Bhaktapur built by Yakshya Malla is located at the western end of the Durbar square. This free standing open shrine topped by *Gumbaj* is a temple dedicated to god Shiva. The reconstruction work was carried before earthquake; and halted for few months caused by earthquake. The restoration of the temple is already completed.

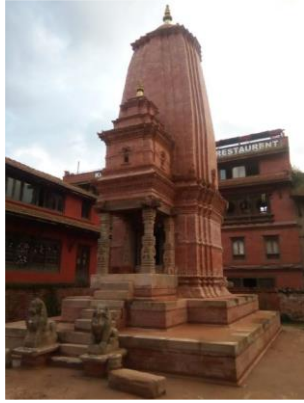
1.8 Restoration of Badri Narayan Temple

Badri Narayan Temple is a small temple located west of the Gopi Nath Temple locally dedicated to Vishnu or Narayan. This terracotta built Shikhara temple is one of the four Dham built by Yakshya Mall and dates back to 17th century.

Restoration work of Badri Narayan started before earthquake under DOA regular Budget; and halted for few months caused by the earthquake. However the restoration process of Badri Narayan is completed and has become the first restoration project completed after earthquake.

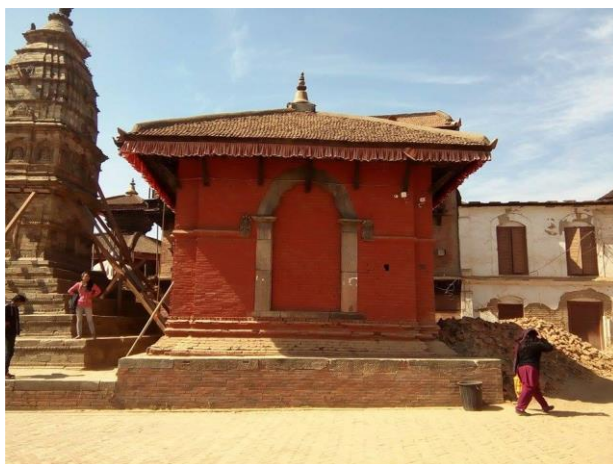
1.12 Conservation of Yantra Vatsala

One storey Nepalese Style Vatsala Temple is located at eastern part of Bhaktapur Durbar Square beside Siddhi Laxmi Temple. The conservation work was carried out which included skinning work and repair of the Roof under emergency budget of DOA. Conservation of this temple became first monument to be completed after the earthquake.

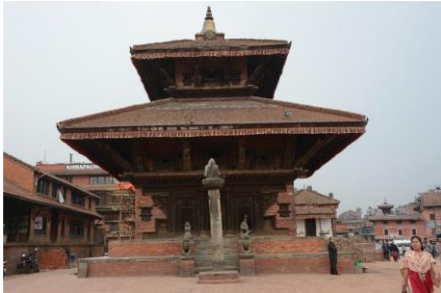
The temple conservation work is completed with minimum intervention. In the present conservation all the rotten wooden members of the ground floor are replaced with new strong Sal wood. Also the mud mortar is replaced with Lime mortar.

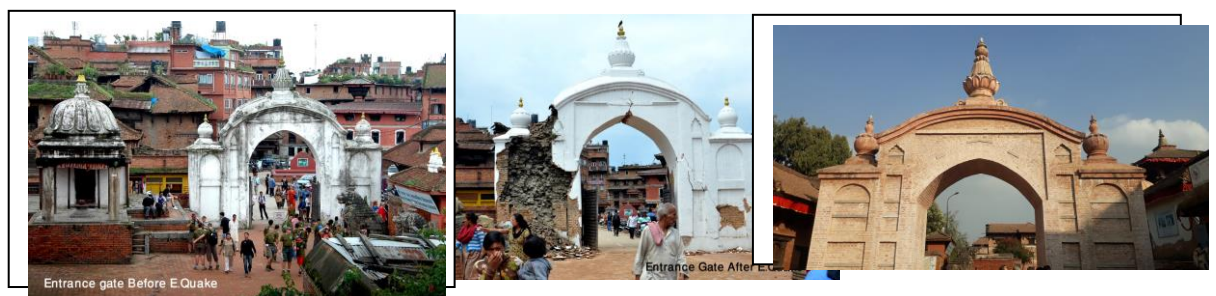
1.14 Khauma Gate

Khauma Gate is the main western gate of Bhaktapur Durbar Square. The southern portion of the gate was collapsed by the earthquake. Similarly, the upper portion of the gate has been damaged, and numerous cracks were observed. The entire damage portion is carefully demolished up to foundation. The gate is already restored in its original form in traditional technique and materials. The structure is restored stronger than the previous one using sufficient wooden tie-up and posts of strong Sal wood.

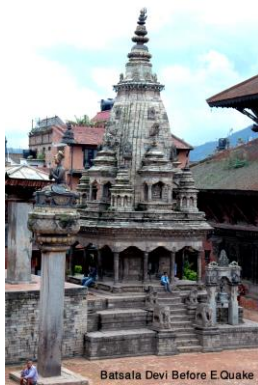
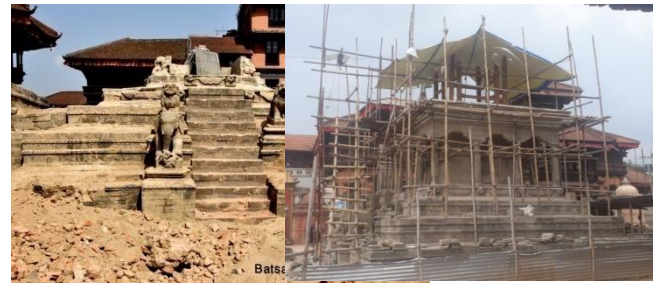
The Vatshala temple was completely collapsed by the earthquake. The foundation of the temple was examined through rescue archaeological excavation executed by DoA with the support of UNESCO Kathmandu office and Durham University, London. Since the

foundation of the temple was found strong enough, the temple is being restored over the original foundation. Total responsibility of the restoration is taken by Bhaktapur Municipality with close coordination of Department.

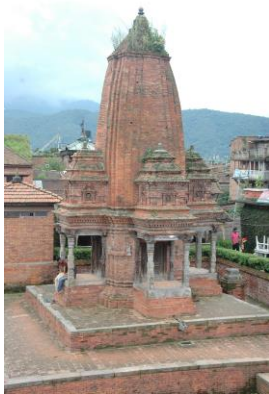
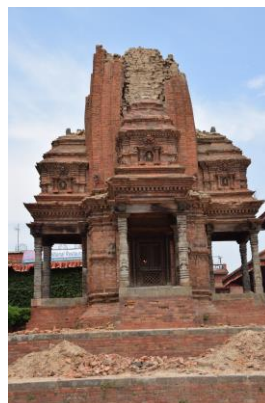
1.16 Kedarnath Temple

The Kedarnath Temple located in front of National Art Museum in Bhaktapur Durbar Square is a significant Shikhara style temple dedicated to lord Shiva. The middle portion of the Southwestern part of the temple was collapsed by the earthquake. Similarly, the upper portion of the northeast part also was damaged, and numerous cracks were observed in the entire structure.

The restoration work of Kedarnath temple is completed. The total fund of the restoration work was bear by Bhaktapur Municipality and the responsibility of restoration was given to local user committee. The temple is restored in its original form with traditional technique and materials replacing mud mortar by lime mortar.

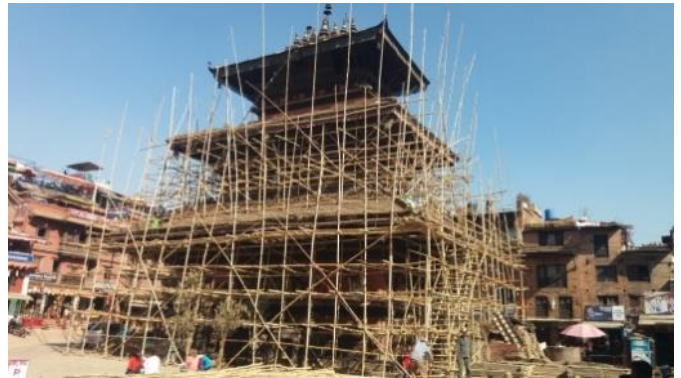
This temple was first built as a one-storey pagoda but was later changed into a three storey temple in 1718 AD by King Bhupatindra Malla. The local elderly people say that the roof of Five-Storey Temple in the same

Taumadi Square got damaged where as the Bhairabnath temple was completely collapsed in the disastrous earthquake of 1934 AD. The present temple was rebuilt after 1934 AD.

As the temple was conserved just before the 2015 earthquake, the Temple was not affected badly but there was some damage on the top story and some cracks in some walls of the temple. After series of meeting with experts and stakeholder the modality of conservation was finalized. In the involvement of professor and student of Khwapa Engineering Collage the detail structural and architectural study and analyses was carried out before finalizing the conservation modality. With the minimum intervention principle, without dismantling the entire structure, the temple is being conserved with traditional technique using all the traditional construction materials.

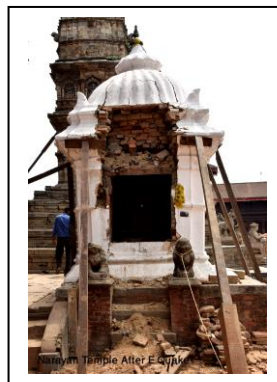
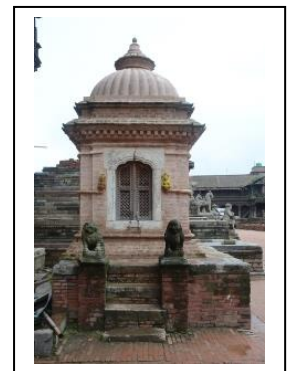
Sankar Narayan Temple located in the eastern end of Fifty-five Window Palace and just on the west of Siddilaxmi temple, was partially collapsed by the 2015 earthquake. The one storey small temple enshrined the image of Sankarnarayan, duet form of Lord Shiva and Vishnu, is already restored in its original form.

The work was initiated by Bhaktapur Municipality with close coordination with Conservation and Durbar Management office, Bhaktapur; and the restoration work was undertaken by Local User Committee with the fund provided by Municipal office.

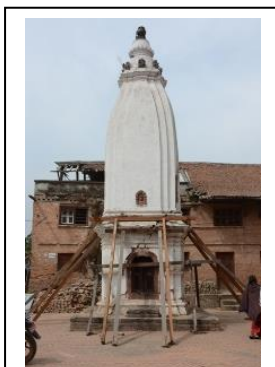
1.20 Tribikram Narayan Temple

The temple of Tribikram Narayan located just south of Yaksheswar temple in Bhaktapur Palace Square was not collapsed but damaged with several cracks. The small but beautiful temple of lord Vishnu built in Shikhara style is already restored dismantling the damaged structure. The temple is restored in its original style replacing rotten wooden elements with

new and mud mortar with Lime mortar. Bhaktapur Municipal office had taken all the responsibilities of restoring Tribikram Narayan temple.

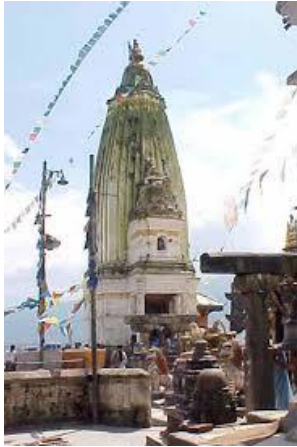
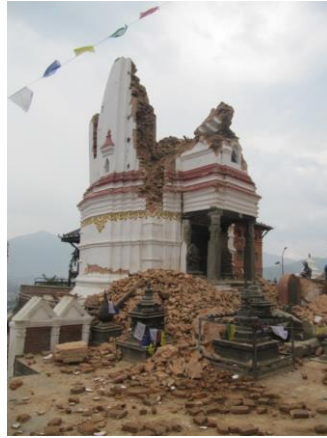
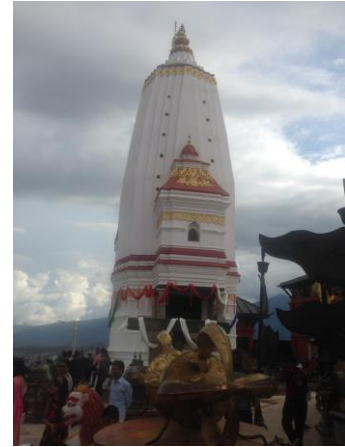
The temple built of traditional Ma-apa in mud mortar, wood, Vajra was collapsed by the earthquake 2015 almost over the Cornish level also creating several cracks in down parts. Department of Archaeology is directly involved in the restoration project allocating the budget under Post Earthquake Reconstruction Fund (PDRF) of Government of Nepal. Federation of Swayambhu Management and Conservation (FSMC) has an important role for coordination and management with priests to perform required religious and cultural procedure and activities on the process of restoration. The restoration work started in fiscal year 2072-73 and completed in fiscal year 2074-75.

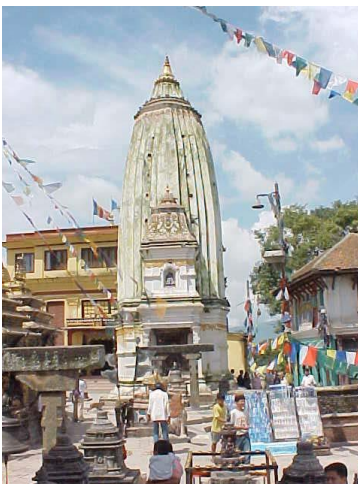
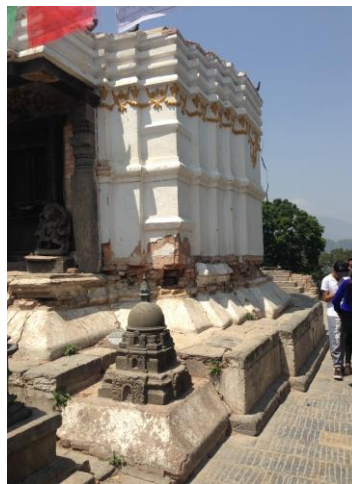
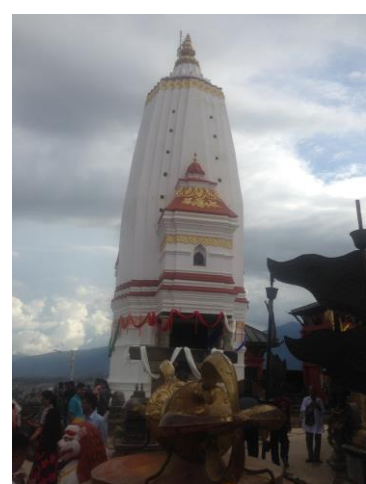
Before starting the restoration work the condition of the foundation was studied through rescue archaeological excavation laying the trenches on northeast and north side of the temple outside adjacent to the foundation wall. Since the foundation was found in good condition, the restoration work was done without disturbing the original foundation of 17th Century. With necessary conservation all four stone pillars are erected and the entire restoration work is completed in its original structure within targeted time frame.

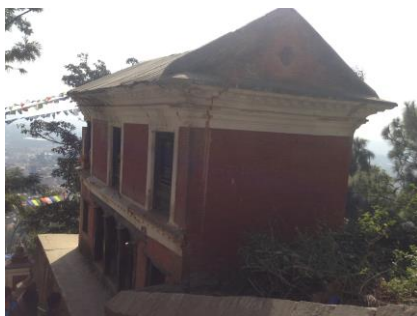
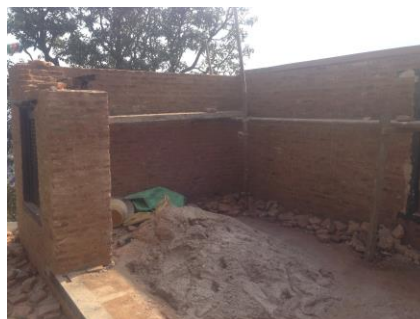
1.3 Restoration of Seto (White) Sattal

The restoration work of the Seto Sattal is under progress and completed 60 percent. The traditional rest house built in early 20th Century situated in southern slope of Manjushree shrine in Manjushree hill of Swayambhu Protected Monument Zone was severely damaged by the earthquake. Under the Government budget allocated as regular budget for running fiscal year 2074-75 the damaged structure was dismantled with detail drawing and documentation; and the restoration work was started. However the conservation work is not completed with allocated budget; and the budget is allocated in running fiscal year 2075-76 to complete the monument.

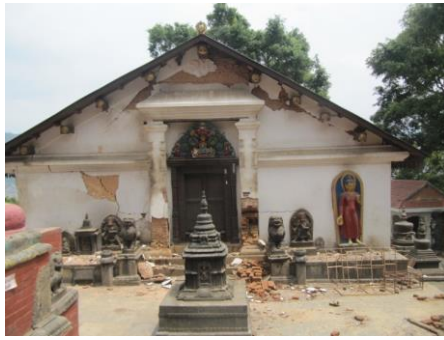
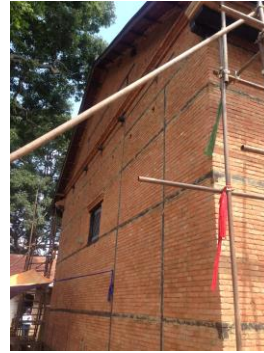
The temple was severely affected by the earthquake even destroying almost half part of precious mural painting and affecting the rest half severely. Under the project funded by UNESCO, the remaining mural painting was securely detached from the wall and salvaged with detail documentation in close collaboration between DoA and FSMC.

In Santipur temple only the effected parts is being conserved very carefully preserving the rest not affected parts. It is being conserved with traditional technique and material to retrieve its original value back. Presently, all the part of the Santipur temple is completed except front face; and the work is going on in the same front façade and targeted to complete entire conservation work within April 2019.

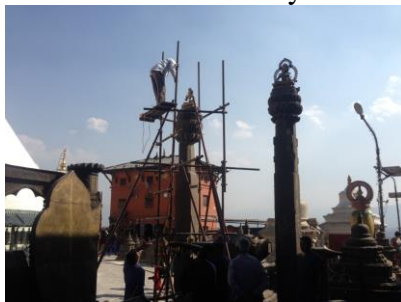
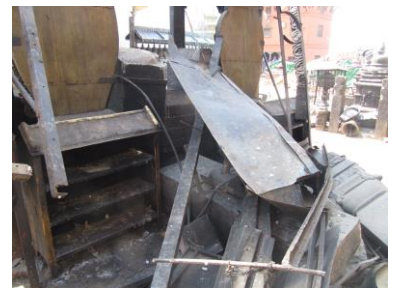
2.3 Conservation and Erection of four Stone Pillar and Big Bell

Four Stone Pillars and one big bell are conserved and erected in the initiation of FSMC. The stone pillar with Sadakshary Lokeshwar, one stone pillar of with Peacock, two stone pillars with Tara image situated on the west of Swayambhu Mahachaitya just in front of Amitav Buddha were affected by the earthquake. The Pillar of Sadakshary Lokeshwar was felled, the Peacock Pillar was broken into three pieces and the capital of the both Tara pillar were felled. The big bell situated in front of Anantapur Temple also was broken. All those monuments are already erected with necessary conservation.

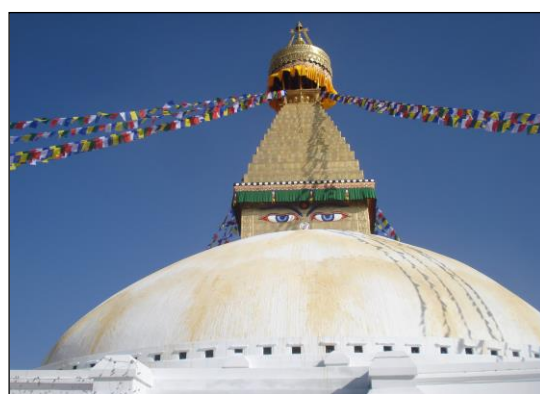
At first, the effect of the earthquake was appeared on the topmost 3 steps of Bhuwanas with cracks and dislocation of the bricks breaking the outer metal cover. Finally the effect of the earthquake found to the entire super structure of the Stupa over the dome.

In the initiative of Bouddha Area Development Committee, with the approval and close inspection of DoA, deputing an engineer and archaeological officer for entire progress, the work of careful dismantling with detail documentation and the conservation of the stupa with the use of traditional method and material is recently completed within 16 months.

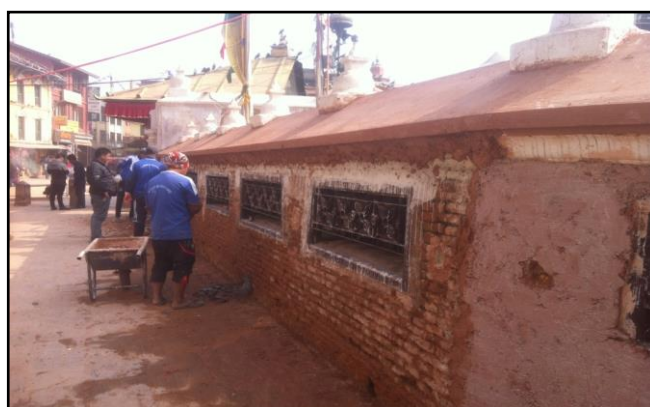
1.2 Conservation of Mane Wall

The Mane Wall conservation is completed as it was affected by the earthquake partially.

However, as reported in previous report, the entire Mane Wall was conserved re-plastering it with the Bajra mortar, mixture of Lime, sand, brick powder, black lentil powder and molasses with water replacing the original Liun plaster, it was partially affected by the earthquake and conserved in the initiation of Baudhanath Area Development Committee under the direct supervision of DoA.

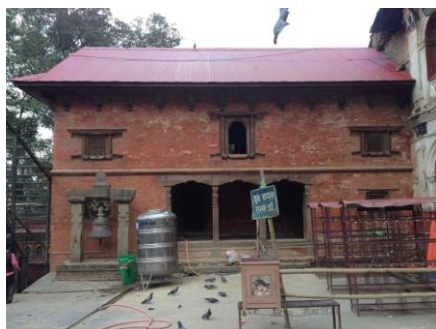
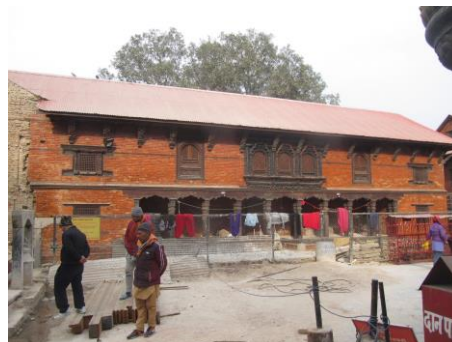
The Sattals are restored in its original structure but using almost all new wood of structural function; however the artistic window and other elements are reused with necessary conservation. In northeastern Sattal very few old wooden elements were found reusable while dismantling the old structure which was badly affected by the earthquake. Whereas from the northern Sattal almost all wooden elements of artistic value were retrieve while dismantling safely. But, same as northeastern Sattal all the structural wooden elements were used new in northern Sattal too.

The restoration work of western wing is just start. The Sattal structure was safely dismantled in presence of officials; and all the wooden elements of the Sattal are inventoried in detail and well stored as well for reuse. This wing also was badly affected by the earthquake and since it is the most artistic part of the complex, it was planned to dismantle the structure very carefully protecting all the wooden elements with full documentation for proper reuse while restoring the Sattal. The restoration work is under progress in preliminary phase.

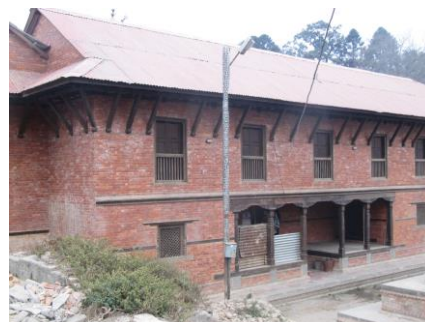
1.2 Bhasmeshwar Sattal Conservation

The restoration of Bhasmeshwar Chaughera Sattal (courtyard rest house) in Bhasmeshwar Cremation area is already completed. It was conserved with the approval and close inspection of Department of Archaeology and entire financial responsibility was taken by Pashupati Area Development Trust (PADT). The Sattal is restored in its original style. Almost wooden elements and brick are used new except few artistic windows and wooden posts.
