KATHMANDU VALLEY WORLD HERITAGE SITE
(Nepal) (C 121 bis)
1 FEBRUARY 2019

Submitted by:
Government of Nepal
Ministry of Culture, Tourism and Civil Aviation
DEPARTMENT OF ARCHAEOLOGY
Ramshah Path, Kathmandu, Nepal
Telephone: +977 1 4250683
Facsimile: +977 1 4262856
E-mail: info@doa.gov.np

STATE OF CONSERVATION REPORTS FROM INDIVIDUAL MONUMENT ZONES

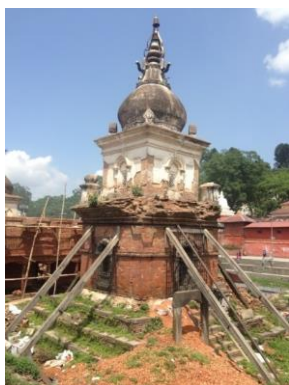
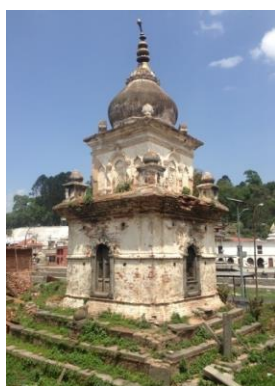
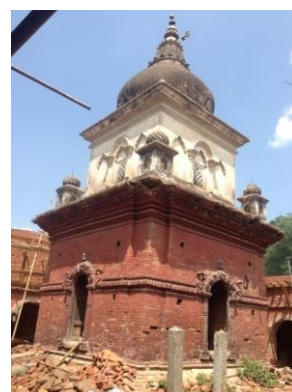
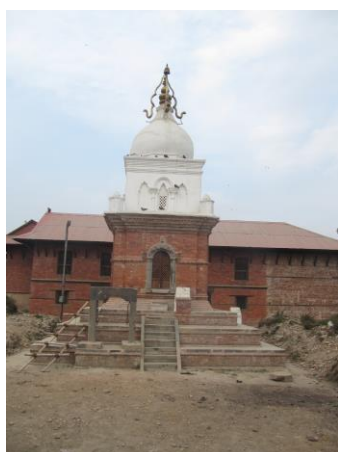
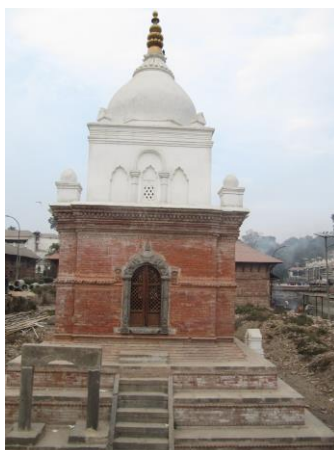
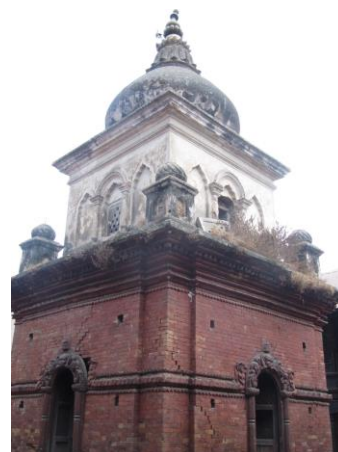
1.3 Amarkanteswar, Sureskanteswar and Pranmukteswar Temple

The three temples Amarkanteswar, Sureskanteswar and Pranmukteswar situated inside Bhasmeshwar Courtyard Sattal in Bhasmeshwar area were badly affected by the earthquake. Pranmukteswar is in the courtyard of northern Sattal and rest two is in the courtyard of southern Sattal of Bhasmeshwar. Among three temples Amarkanteswar and Sureskanteswar had some problems before earthquake and were affected more by the earthquake. All these three temples are in Mugal style with dome on top. All three temples were built in Shah period in early 19th century.

The Restoration of both Amarkanteswar and Sureskanteswar is completed. Both the temples are restored over the original plinth preserving old foundation archaeology. However, before starting the restoration the foundation of the temple was examined in close observation of Archaeological Official from Department of Archaeology; and as it was found intact and not affected by the earthquake, the over structure is built keeping the original foundation intact and maintaining the plinth. The restoration is upgraded with proper use of wooden tie-up and pillars. Since all the wooden elements were found

The Pranmukteswar in the courtyard of completed northern Sattal is yet to conserve, and it is intended to conserve the temple without dismantling; however it is yet to be examined structurally in detail.

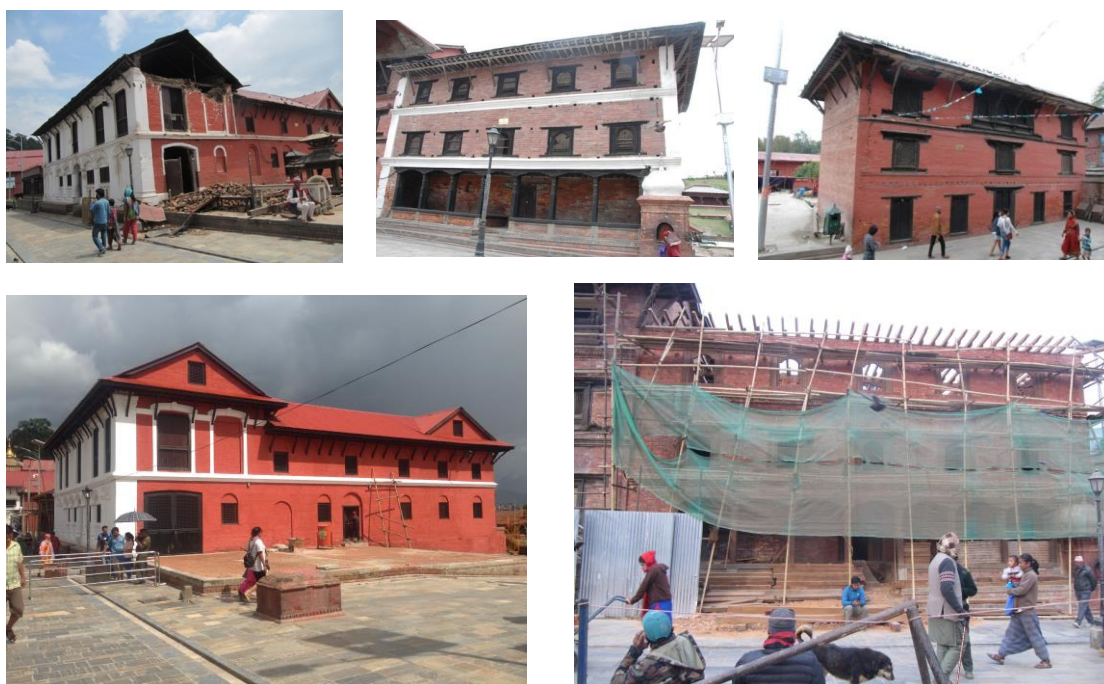
1.4 Kulananda Jha, Sankarnarayan and Gurju Sattals:

Though no one Sattals mentioned above were collapsed but severely damaged by the earthquake. Southern upper portion of Kulananda Jha Sattal was fallen. The front wall was bulged out. Many cracks were observed all over the structure.

There were many vertical cracks in Gurju Sattal. The entire structure was tilted toward front busy road to Pashupati. The eastern wall was almost fallen.

The restoration work of Kulananda Jha Sattal is completed. The Sattal is restored as original. However, except some artistic reusable elements all the wooden elements are replaced by new one and mud mortar is replaced by Lime_Surkhi mortar.

Sankarnarayan Sattal is being restored and 50 percent work is completed. All the reusable wooden elements are secured well and being reused in present restoration work. As in the Kulananda Jha Sattal mud mortar is replaced by Lime mortar in Sankarnarayan Sattal too.

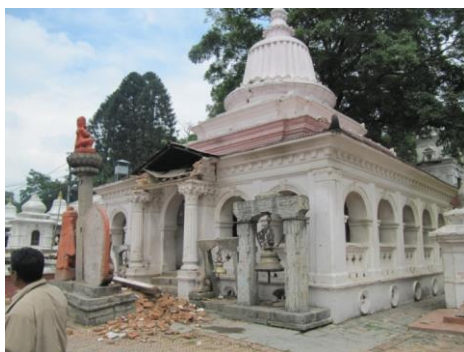
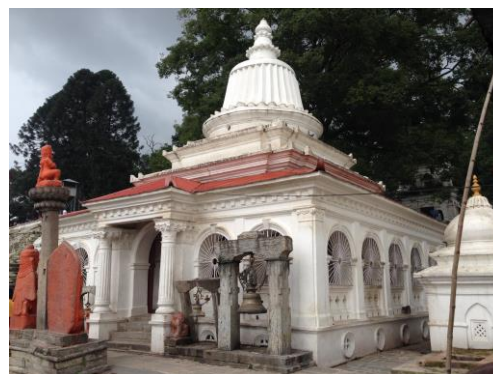
1.5 Conservation of Ram mandir:

Comparatively there was less damage in Rammandir. The upper part of the portico in front was damaged and fallen. The arched front entrance of the temple was cracked. There were some vertical cracks observed on northern wall.

providing required technical support. Now Rammandir is already repaired in its original form using same types of materials used before.

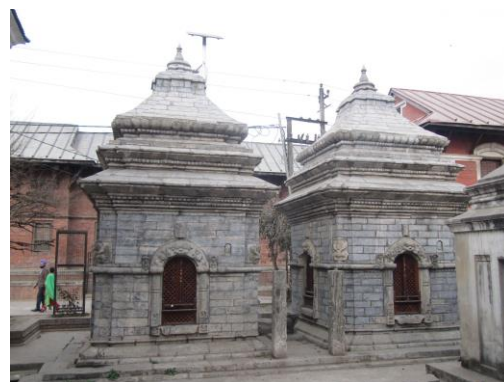
1.6 Restoration of Chautariya Sivalaya Temple

The temple is restored over the original plinth as approved from the DoA. The temple is built in stone masonry in its original style using 90 percent same stone elements replacing all the wood by new quality timber.

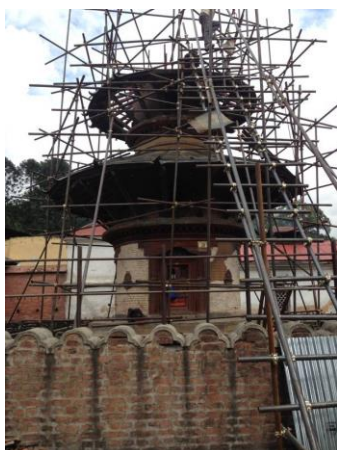
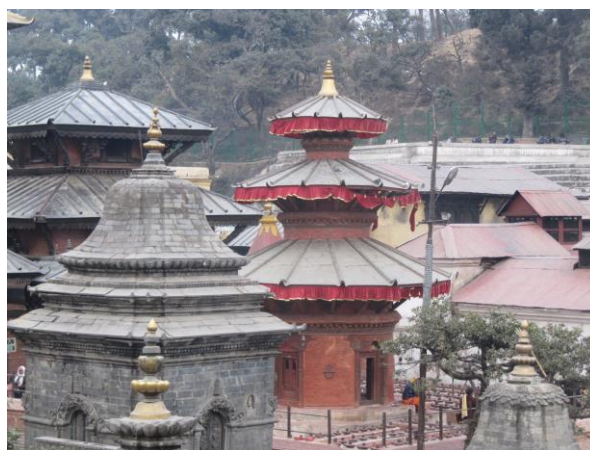
The Kotilingeswar temple located inside the Pashupati complex just outside the main courtyard towards south in the Chausatthi Sivalinga premises was partially damaged by the

earthquake. Kotilingeswar temple is one of the oldest and important monuments of Pashupati area which was built by King Pratap Mall in second half of 17th century AD. It is one of very few multi roof temples of Pashupati having circular plan with three circular metal roofs.

After the approval from DoA for its entire restoration, as per the proposal of PADT with detail drawing and cost estimate, the temple was dismantled safely. While dismantling all the wooden elements of the temple were well documented but almost all the wooden elements of the temple were found rotten and damaged and only very few of them are be reused.

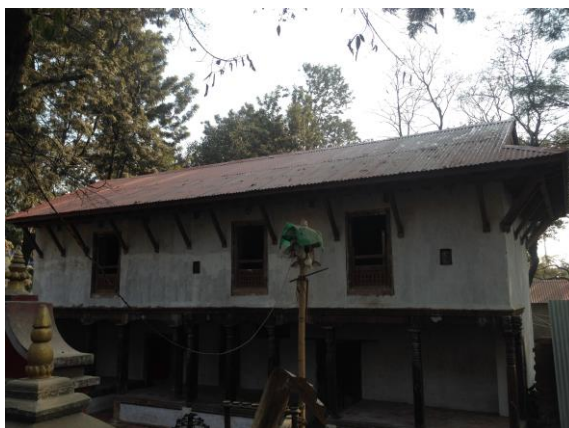
1.9 Bankali Sattal Restoration

Bankali Sattal restoration work is already completed. Bankali is a famous and one of most worshiped goddess shrine of Pashupati. The shrine is located in the southern part of Pashupati Protected Monument Zone. The Sattal built in the Shrine premises to facilitate the devotees in their religious and cultural activities in the Bankali shrine is named Bankali Sattal. The Sattal was partially damaged by the earthquake 2015. The upper part of the western wall was collapsed and other brick walls were cracked in many places.

The Sattal is restored over its original foundation and used almost artistic wooden material of original structure. The ground floor of the Sattal was occupied illegally and also partitioned for residential purpose. After the restoration of the Sattal, it is reopened the Dalan for cultural activities. Replacing the mud mortar the Sattal is restored using Lime mortar. All the responsibility of restoration was taken by PADT.

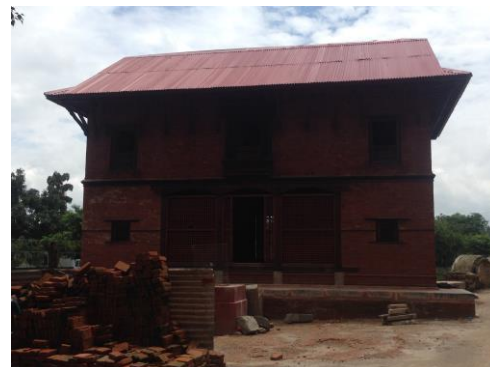
1.10 Restoration of Bagmati River Bank Sattal of Guheswari

In Pashupati Protected Monument Zone, 3 Sattals inside the Guhyeswari complex and one Sattal on the bank of Bagmati River were damaged by the earthquake. However the Rever it was Sattal was not collapsed. But many cracks were observed in the brick wall of the structure. As per the proposal of PADT, DoA provided the approval for the restoration of the Sattal. All the financial responsibility was taken by PADT and DoA provided the necessary technical support.

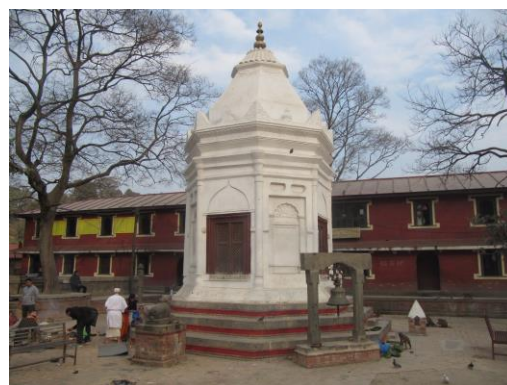
1.12 Taraprakaseswar Temple Restoration

Taraprakaseswar temple inside the Kriyaputri premises was not collapsed but severely damaged by the 2015 earthquake. Since the damage structure was more vulnerable in the very busy Kriyaputri area, the temple was dismantled immediately after the earthquake by PADT with the help of Nepal Army.

All the drawing documentation was prepared by PADT and approved by DoA for the conservation of the temple. All the stone and almost reusable bricks are reused in present restoration work; but all the wood are replaced by new and the mud mortar is replaced by Lime mortar.

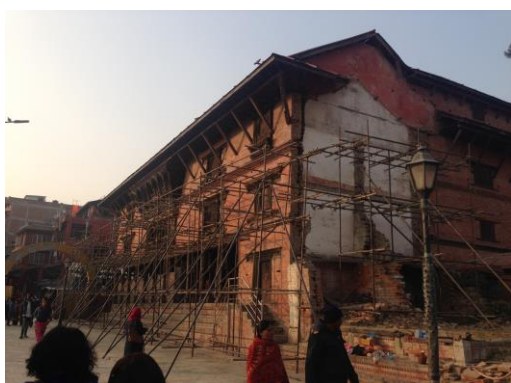
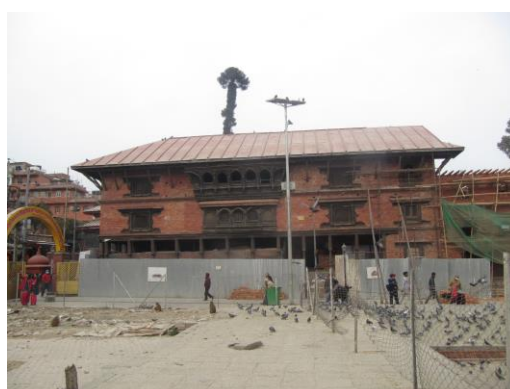
1.13 Mahasnanghar Sattal Conservation

Mahasnanghar is one of the dominating heritage buildings situated in western part of Pashupati area in front of Gurju Sattal. It is a big courtyard Sattal complex built in early 19th century. It was partially damaged by the earthquake. However, the back, northern portion of the building was partially fallen.

Since the Mahasnanghar was recently conserved entirely from Department of Archaeology in 2006, there is less damage occurred in the structure. But the back, northern part was much affected than the front colonnaded side. The northern wall of the building was fallen partially also affecting the western wall in northwestern part. The eastern wall adjacent to Sankaracharya Sattal was cracked. The fissure in the joint of eastern and southern wall was much prominent. However, the building is not tilted.

In the initiation and coordination of Pashupati Area Development Trust, the huge structure of historical, archaeological and cultural importance is being restored by a private company, Nepal Investment Bank Pvt. Ltd. More than 50 percent work is completed.

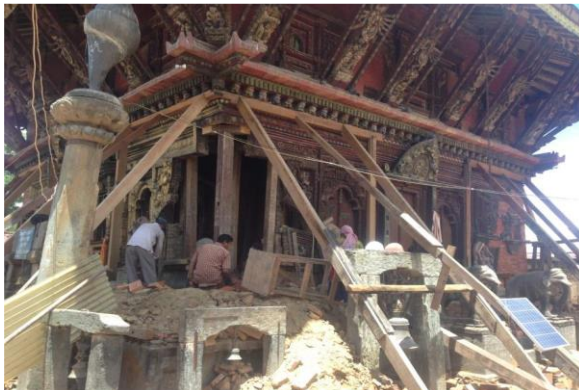
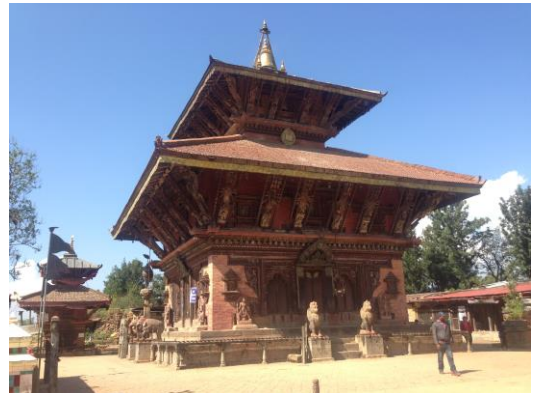
1. Changunarayan Temple Conservation Work

Changu Narayan Temple was not collapsed but affected largely by the earthquake.

The conservation of the temple is already completed. The conservation work was carried out from Department of Archaeology employing highly skillful manpower, since the temple was conserved very carefully without dismantling the structure. All the rotten wooden inner posts and bands are replaced by new strong Sal wood timber. The temple is conserved in traditional technique and material replacing the mud mortar by lime mortar.

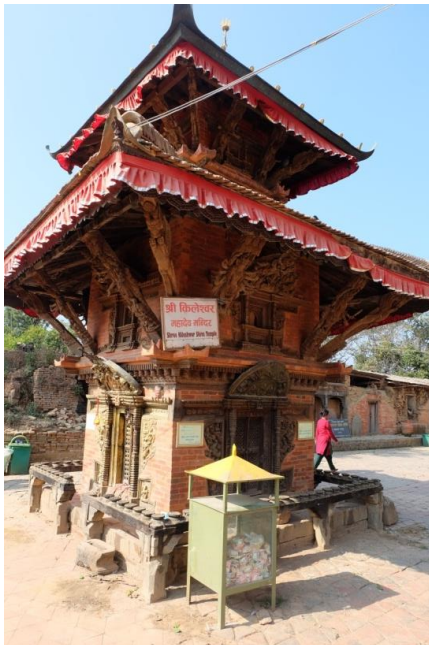
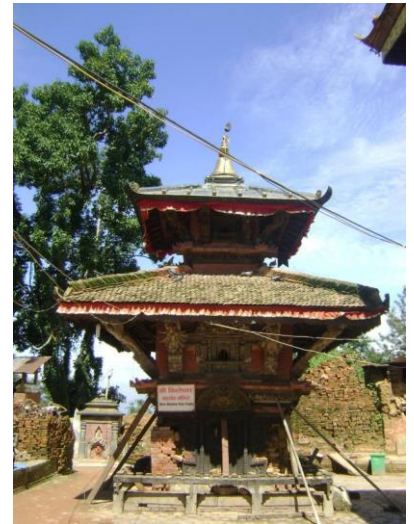
2. Kileshwor Mahadev Temple

however stood firm and will require minor repairs to restore its structural integrity. The remaining structure appears in reasonable condition, but will require careful checking once scaffolding is built to provide access. The roof structures were disturbed by the earthquake, and will need to be checked for alignment. The magnificent carved doors and struts are in poor condition, and desiccated.

Since the MoU was done between Department of Archaeology and Heritage and Environment Conservation Foundation Nepal for the conservation of some monuments in Changu Narayan complex, the Kileshwor Temple is conserved by an HECFN with close coordination with Department of Archaeology.

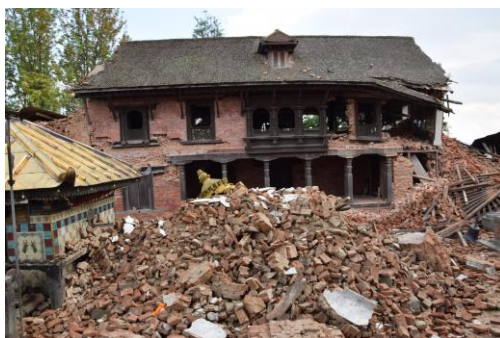
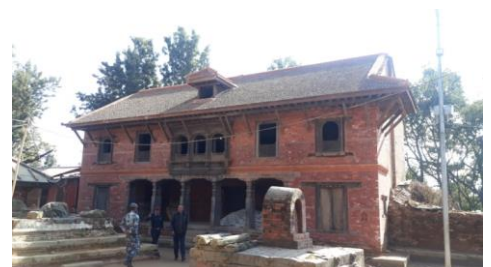
3. Amatya Sattal

The rest houses (*sattals*) enclosing the courtyard either collapsed or seriously damaged during the recent earthquake in April/May 2015. The upper floors and roofs were considered dangerous and The military moved in and demolished all the remaining standing sections of the upper floors and roofs of the *sattals*. There remains only the ground/lower floor.

Restoration of Amatya Sattal is recently completed.

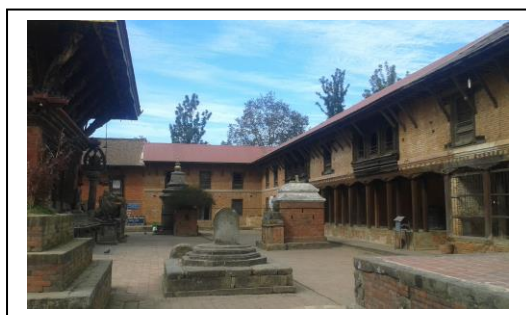
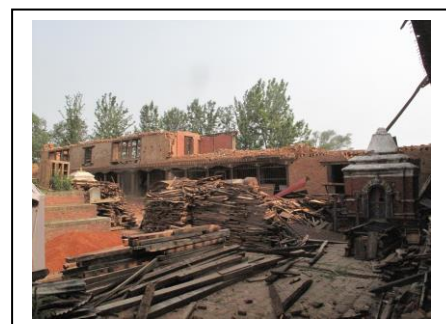
Almost all the Sattal structure was damaged by the 2015 earthquake. The damaged Sattal structure was dismantled safely and stored all material of archaeological importance in Temple premises.

However there was a MoU between DOA, GoN and Heritage and Environment Conservation Foundation Nepal (HECFN), for rehabilitation, reconstruction, conservation and renovation of all the monuments of Changu Narayan temple premises; due to lack of sufficient fund, the INGO could not continue the work as signed MoU. Now DoA has started the conservation work allocating sufficient budget as a multiyear project. All drawing, const estimation and other necessary documents are already prepared; and the work is being started within this month.
