**Subject:** Submission of requested reports regarding the  
*State of Conservation report of "the Persian Qanat" and "Susa" World Heritage Sites*

**Report on the state of conservation of Susa World Heritage Site**

*Tehran 2019*

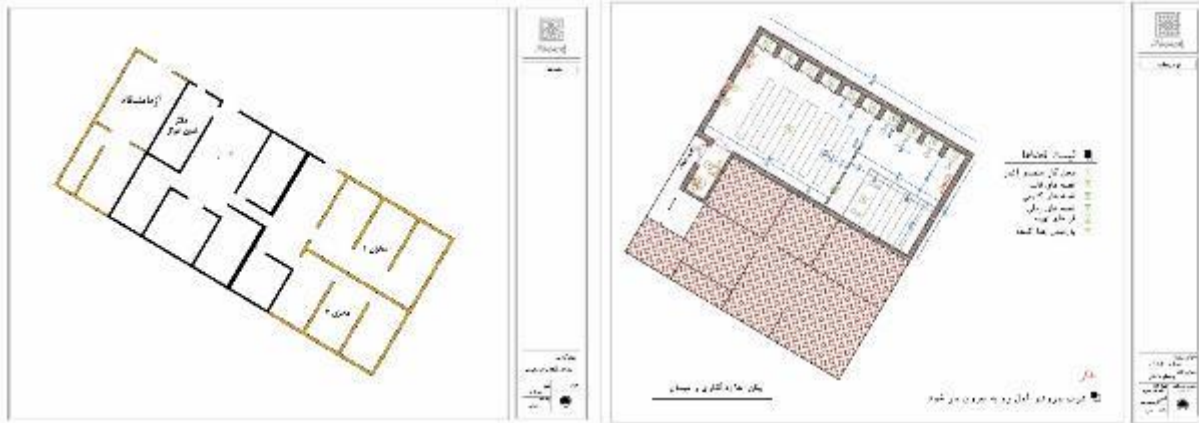
During past few years, a part of building no.1 (non-historic building) was improved and equipped. In this working season, the remaining part of the building will be refurbished and secured.

Figure 9. Plan of storage no. 1 and no. 2

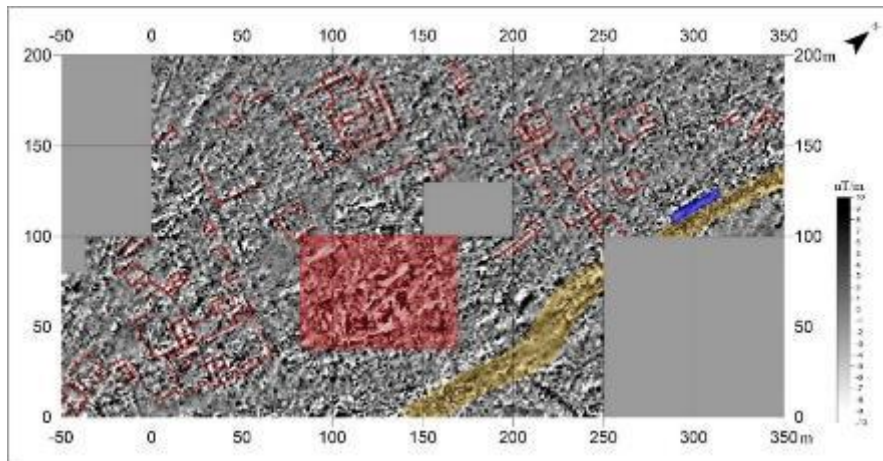
Figure 20. Geophysical map of Sanatgaran City (the zone highlighted in red signifies excavated regions and the red lines refer to anomalies caused by buried brick structures)

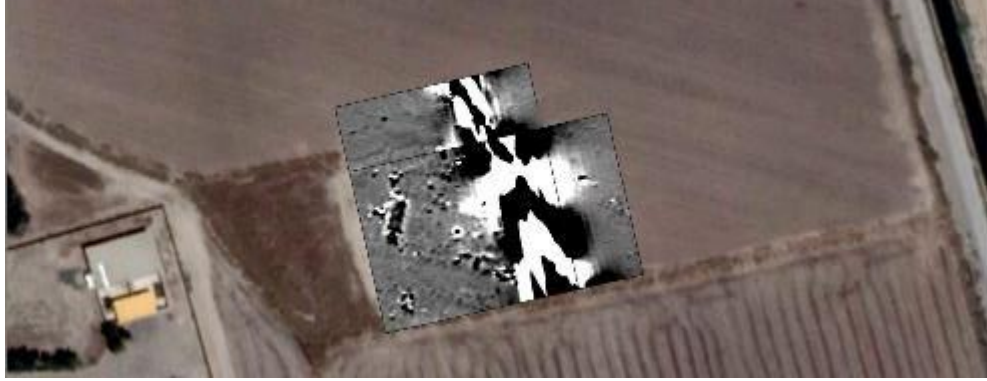
Figure 21. Magnetic Map of Ayadana Hill

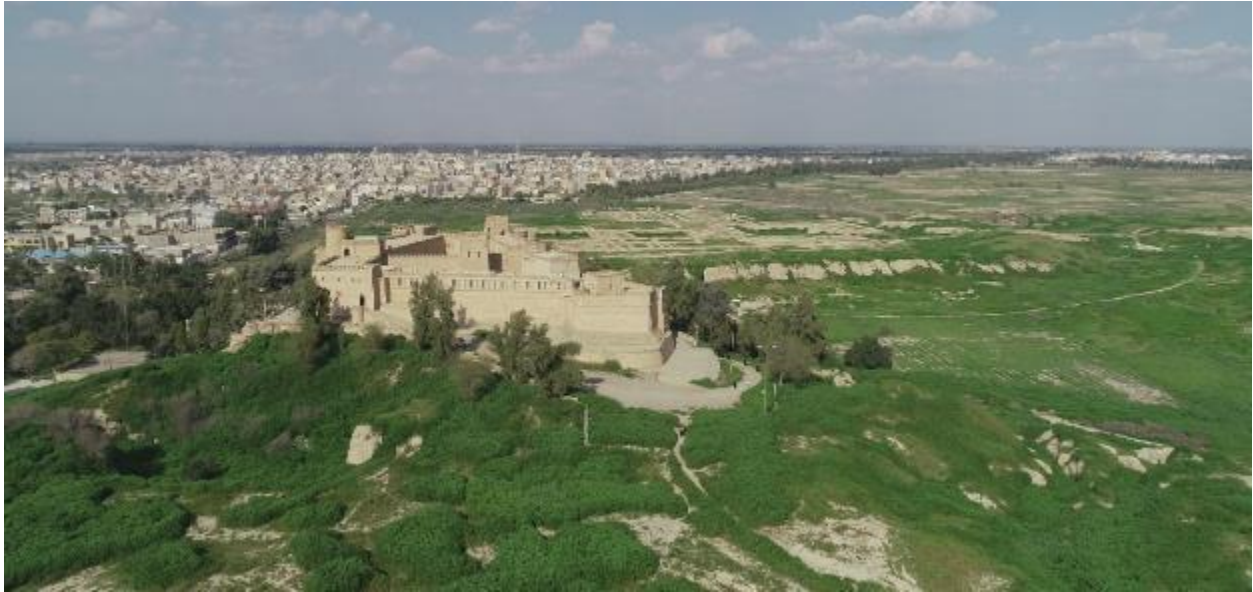
Dealing with vegetation to prevent from damages to architectural structures and archeological layers has been carried out in the past two years, like the years before, within the Ardashir Palace, Apadana Palace, the eastern gate of Apadana Palace, Hadish, the fifteenth city and Achaemenid village. However, the most noticeable case is removing *Prosopis Fracta* trees from large eastern trench of Apadana Palace. In this section, the climatic condition provided the setting for outgrowth of the specie so that some trees grew as high as 7m.

Figure 32. Outgrowth of plants in Susa World Heritage Site

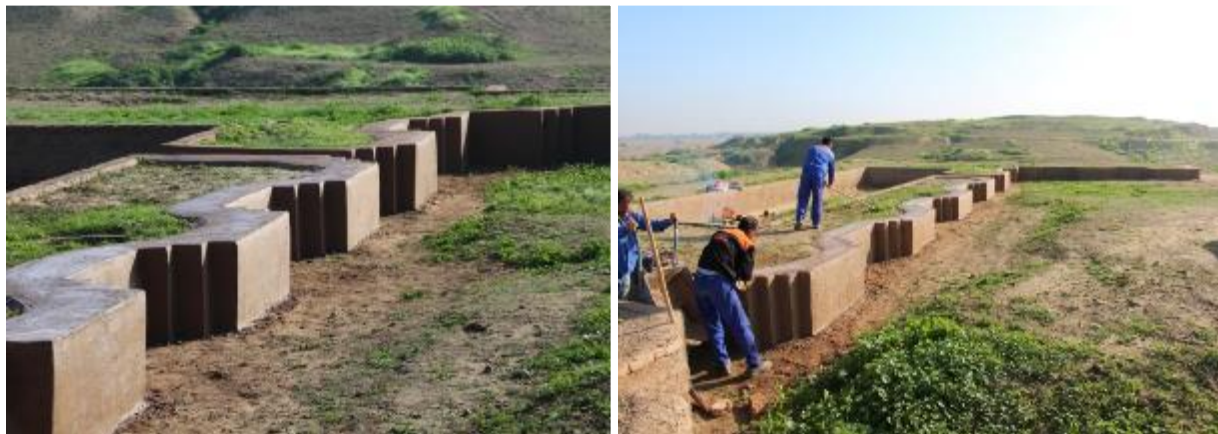
Figure 42. Mud-straw coating of remains of the eastern gate of Apadana

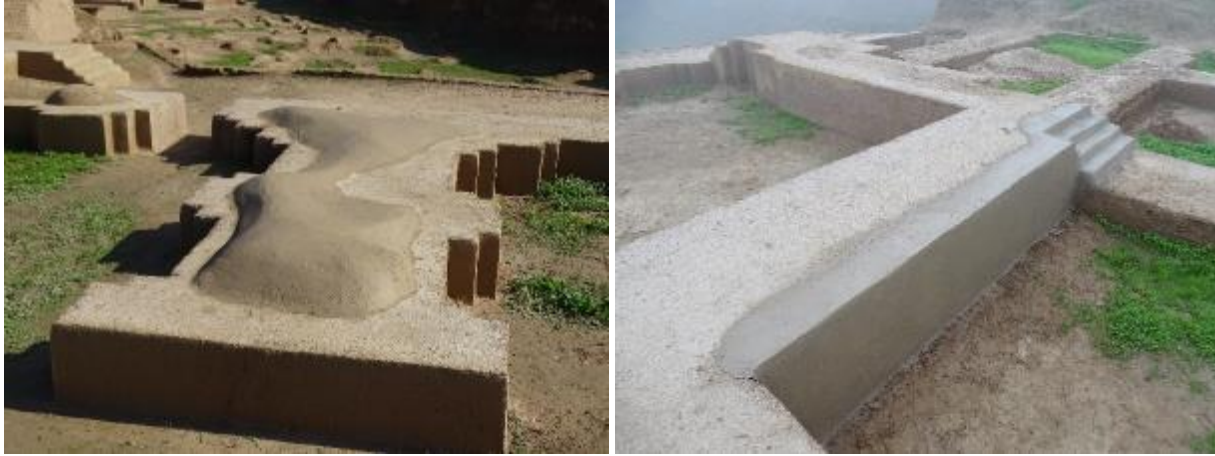
Figure 45. Mud-straw coating of architectural remains of Hadish

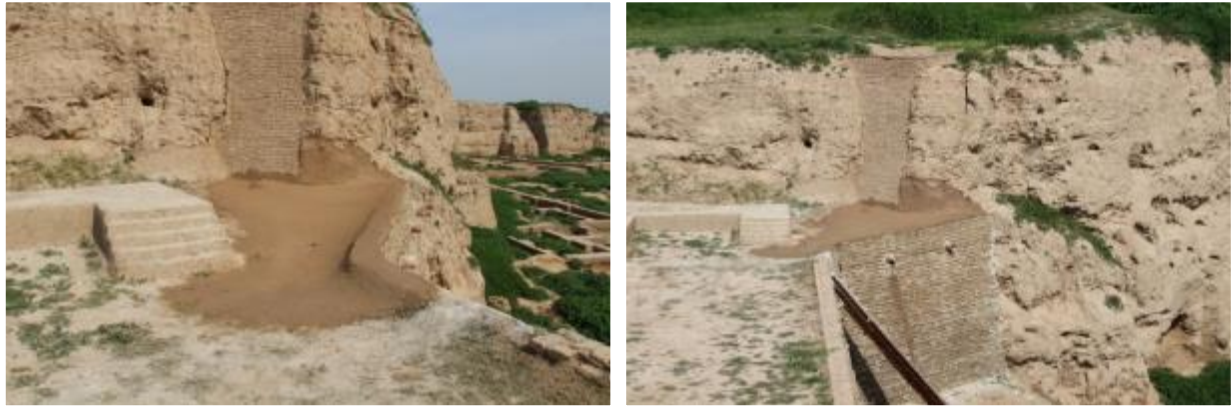
Figure 47. Restoration of water-washed edges of large trench of Shahi City (Fifteenth City)

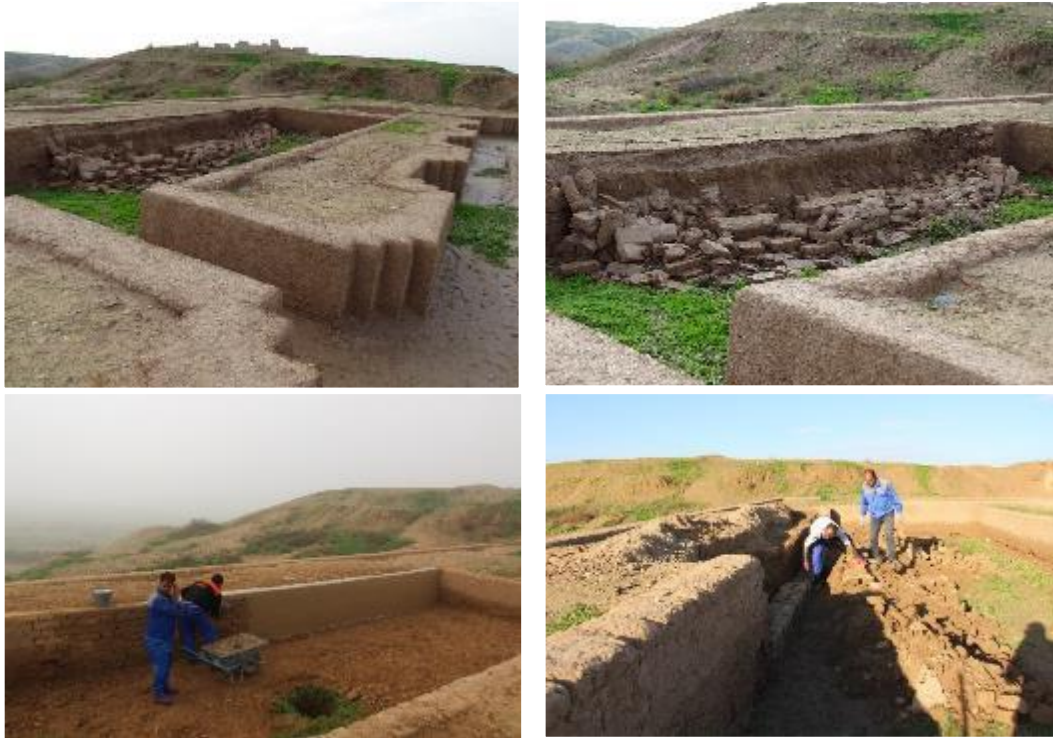
Figure ۴۸. Local restoration of eastern gate of Apadana Palace

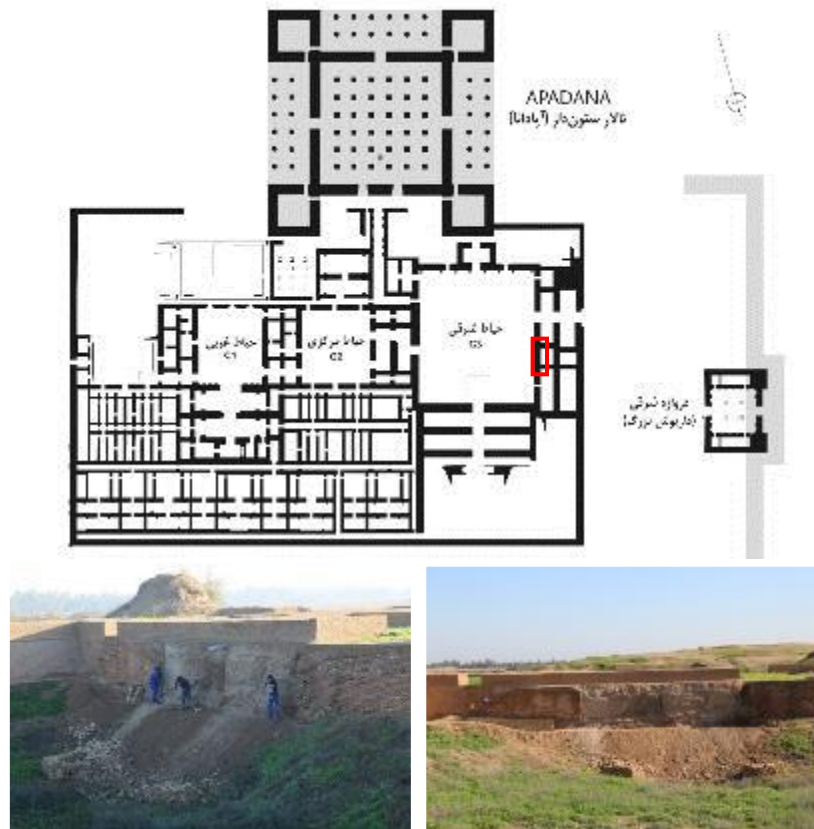
Figure ۴۹. Before restoration (right) and during restoration (left)

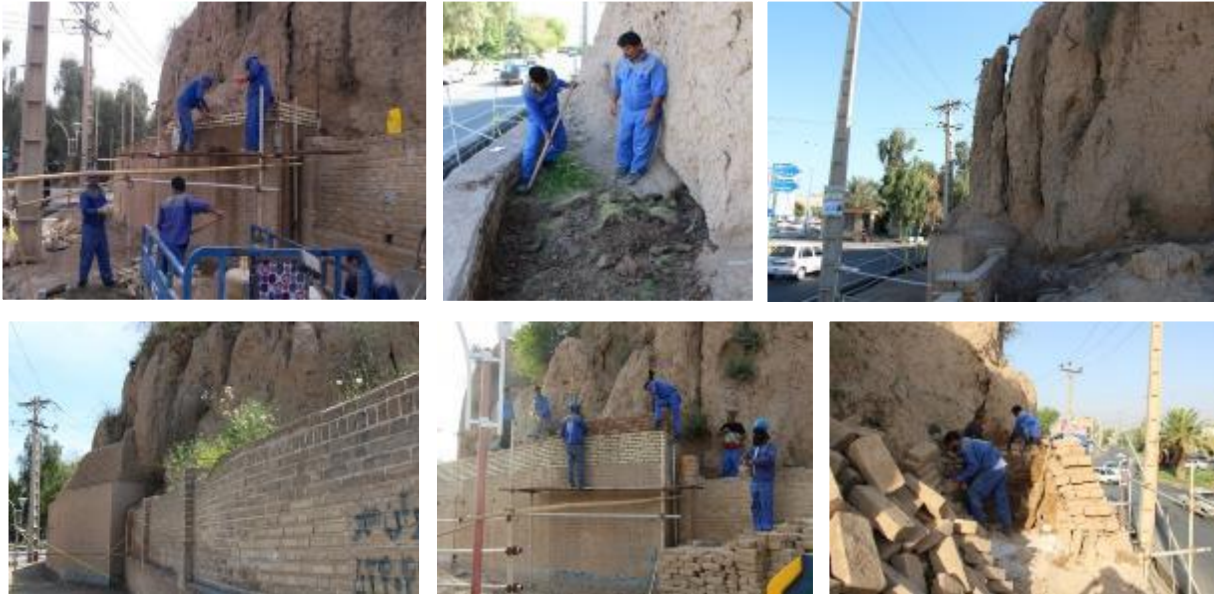
Figure 41 . Protective-restoration Measures on the northwestern tower of Apadana Royal Palace

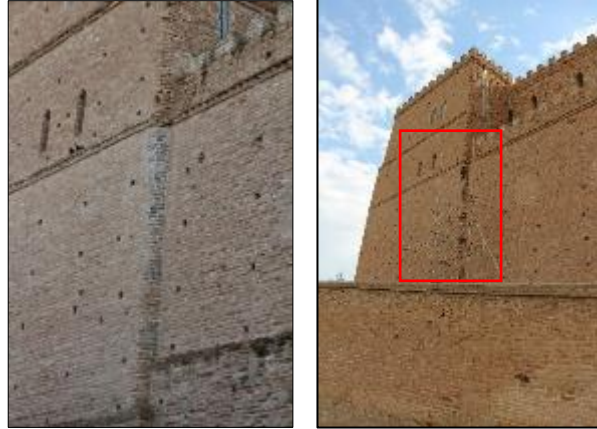
Over the years, certain parts of external wall in western corner of the structure had been damaged which are restored and the vulnerable bricks substituted at heights.

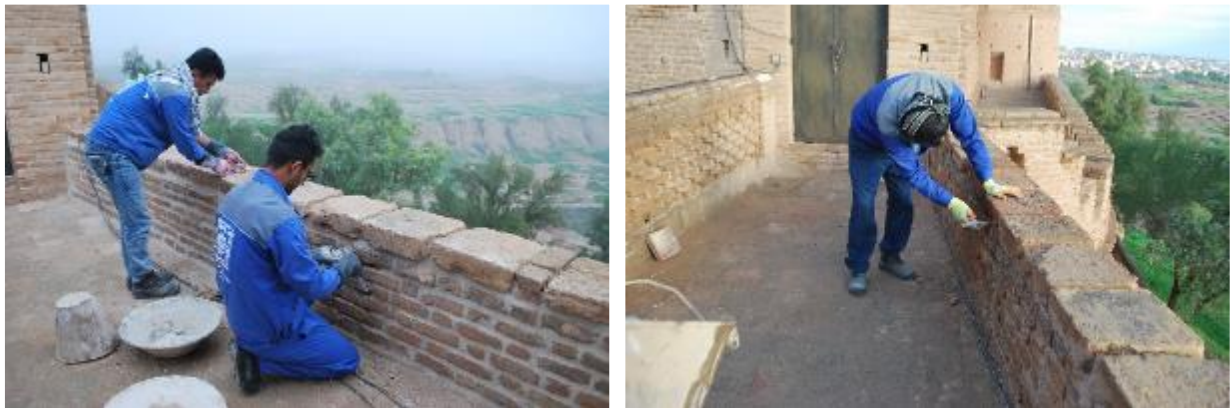
Considering the historic qualities of the castle, the structure evidently required periodic restorations. As a result, restoration team of the Susa World Heritage Base follow daily and weekly measures based on a pre-adopted plan.

*Figure 52. Periodic Restoration of the Castle*

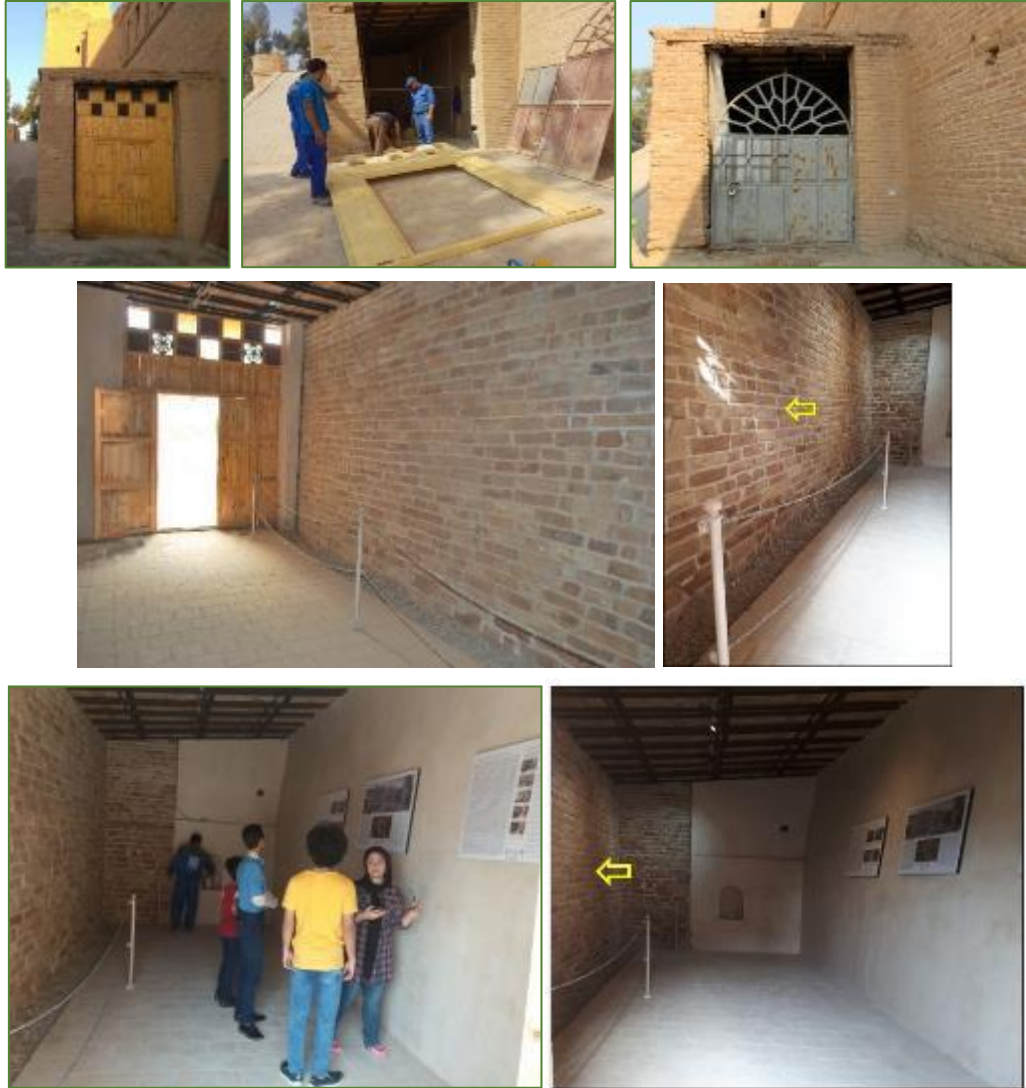
- 1- Evacuation of unnecessary tools and building materials;
- 2- Restoration of the roof;
- 3- Reorganization of the pavement;
- 4- Substitution of the deteriorated door;
- 5- Cleaning and stabilization of inscriptions;
- 6- Substitution and completion of lighting and air conditioning systems;
- 7- Designing and producing presentation signs and their installation.

Figure ٥٢. Current condition of Girshman Garage after restoration

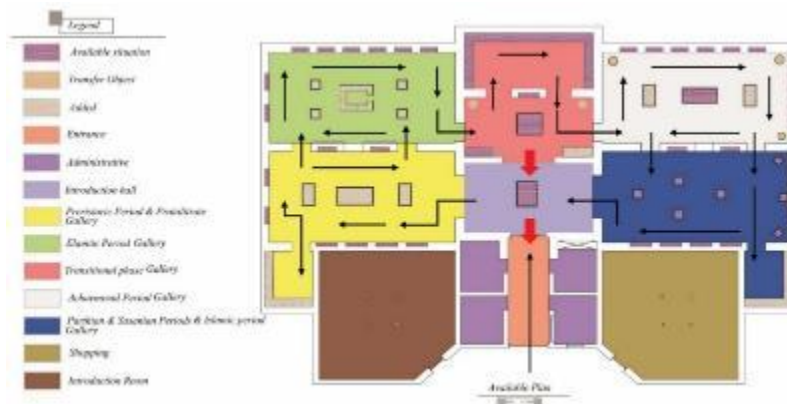
The Museum plan of the Site revised and designed in few steps based on the current condition of halls and in order to provide a clear vision on the evolution of Susa throughout the centuries, its expansion and survival in a 600-year period, namely from prehistoric era of 5<sup>th</sup> century B.C. to 13<sup>th</sup> century A.D.

Figure 57. Plan of current condition of Susa Archeological Museum
