STATE PARTY REPORT

On The State of Conservation of The

Syrian Cultural Heritage Sites (Syrian Arab Republic)

Name of World Heritage property: CRAC DES CHEVALIERS & QAL'AT SALAH EL-DIN Date of inscription on World Heritage List: 2006

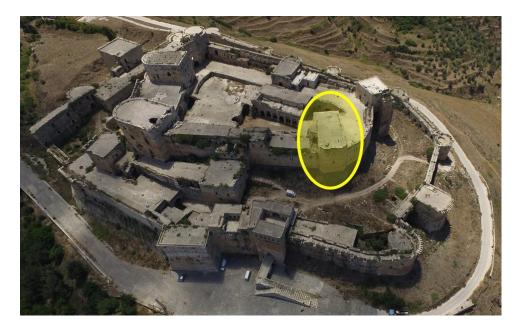
The team started from the church tower (No. 20) in the inner castle, because its surface had been isolated in 2017 by the joint Syrian-Hungarian mission, many excavations and diggings (necessary for study) were conducted on a surface the tower and its interior and the surrounding area.

Aerial photo of the Crac des Chevaliers with the church indicated with yellow. (B. Takáts)

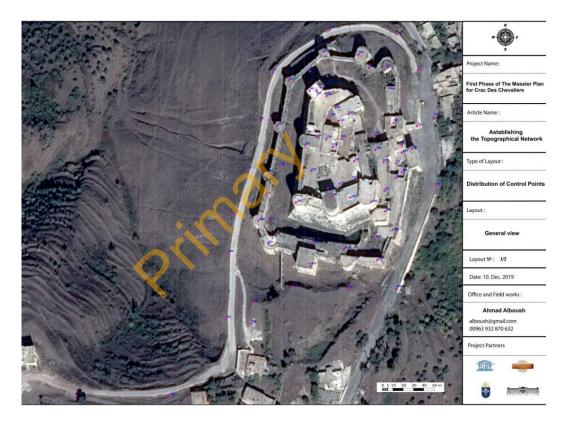
The team Created a network of topographical points to be used in measurements and surveying work in the castle, these references points will be compatible with the local coordinates system and cover all the area of the castle.

Establishing the topographical network

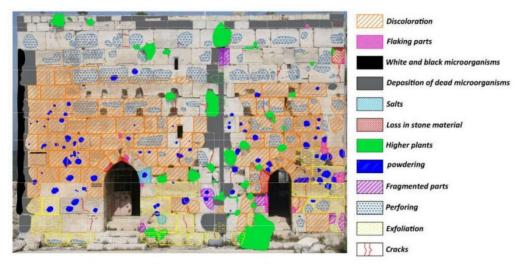
Figure 8 deterioration mapping of the external southern east façade of king's daughter tower

The work was continued during August and September 2019 with an "In situ" stone decay diagnosis. That work involved mapping of stone deterioration to four facades in different directions. As well as, evaluation of decayed surface by using Rilem Tube as a non-destructive technique.

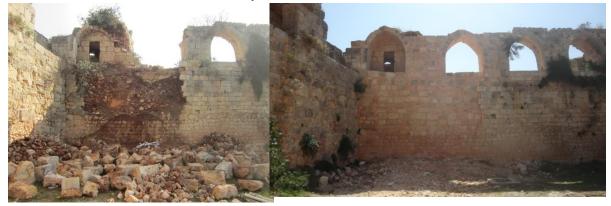
- On 2019, a collapse of part of the byzantine wall on the southeastern side of the castle, which rises 50 meters from the surrounding street. On 2017, the cross vault on the second floor of the byzantine tower collapsed, which deteriorated the structural state of the walls of the tower placed on a rocky slop.
- Other masonries in the castle are exposed to severe cracks such as the Royal Tower (Donggun), stables, water tank, walls, towers, and the lower town.

The collapsed part of the byzantine wall on the southeastern side of the castle - before

The byzantine wall on the southeastern side of the castle – after

- The DGAM implemented emergency interventions to support the collapsed eastern wall and the defense towers of the lower town in the castle.
- With funding from the Ministry of Tourism, a project for preparing tourist routes and facilities will start this year in the safe areas of the castle.

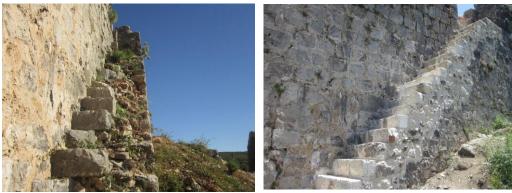
The stone step before restoration

The stone step after restoration

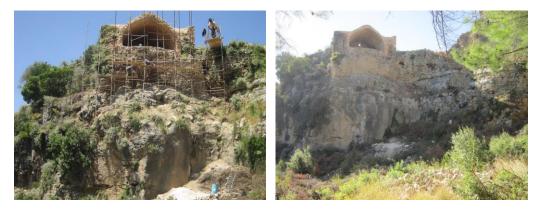
The damaged tower before retoration

The damaged tower after retoration

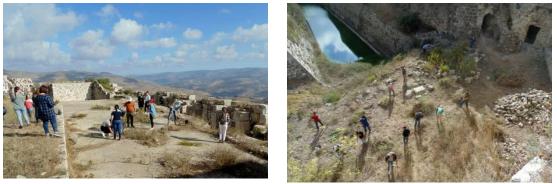
Al-Hawash Private University in Wadi Al-Nadara, in cooperation with the Governorate of Homs and the Directorate General of Antiquities and Museums, launched an initiative to weed and exterminate trees and herbs in Crac des chevaliers, with the participation of 400 volunteers. The work started in cleaning and weeding at the tourist line, the outer castle wall, and the space between the western walls of the inner and outer fortress. The importance of this initiative, is the emphasizes the role of the local community in preserving historical and archaeological monuments and support the protection the castle from fires and the negative effects of the growth of herbs and trees in it, especially with the presence of giant trees of figs and pomegranates in the ceiling of the Knights Hall, which poses a great danger to it. This cooperation include also, a survey the entire castle to create a digital maps.

An initiative to weed and exterminate trees and herbs in Crac des chevaliers, with the participation of 400 volunteers

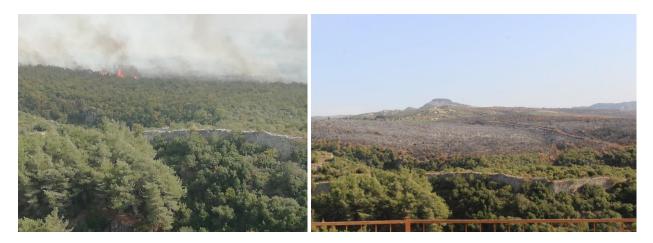
Huge deliberate Fires broke out early in the morning on Friday, October 9, in several areas in Lattakia countryside. These fires swept through large areas of land and forests, reaching the buffer zone in the Qal'at. The images show massive destruction of mountain forests and the erosion of vast green areas.

The south buffer-zone during the fire

The south buffer-zone after the fire

Preventive masseurs were started with the M of agriculture to minimize the negative impacts of fire by constructing breaking lines around the castle to avoid spreading the fires to the Qal'at building.

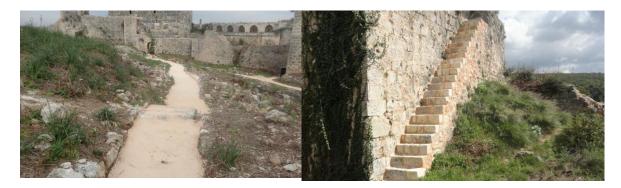
A comprehensive visitor plan is being developed for the site, within the framework of the agreement signed with the Ministry of Culture and Ministry of Tourism including the development of sustainable tourism for the ever-growing number of visitors to the site. This will include visitors' paths, an information center, explanation sign boards and visitor leaflets, proper facilities, and proper fencing and protection of the site to protect it from unauthorized visitors and illegal archaeological digs. His year a short visitor route was rehabilitated in addition to the tourism information center.

Rehabilitation works to the short visitor route.
