**STATE OF CONSERVATION REPORT FOR THE ISIMANGALISO WETLAND PARK WORLD
HERITAGE SITE (N914)**

DECEMBER 2019

Name of property: iSimangaliso Wetland Park

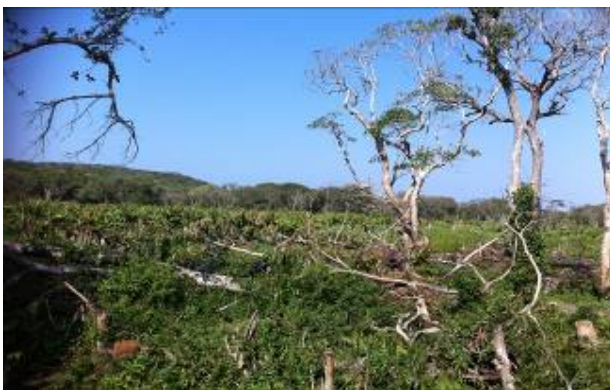
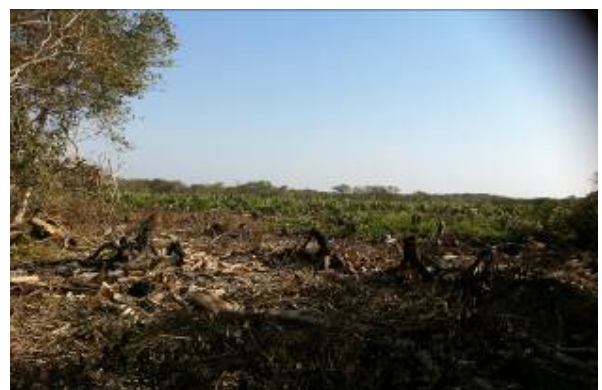
Aerial Imagery 1: Swamp forest destruction imagery received from UNESCO in August 2020. The site looks fairly new and shows recent cultivation activities.

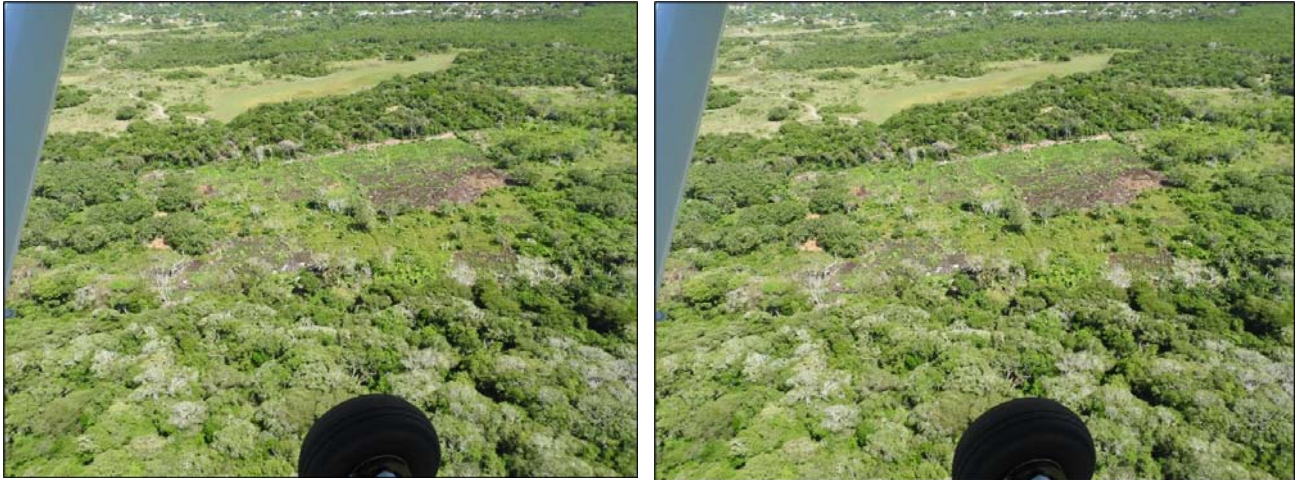
Aerial Imagery 2 – taken December 2020 showing Mgobozeleni swamp forest at same position as imagery 1

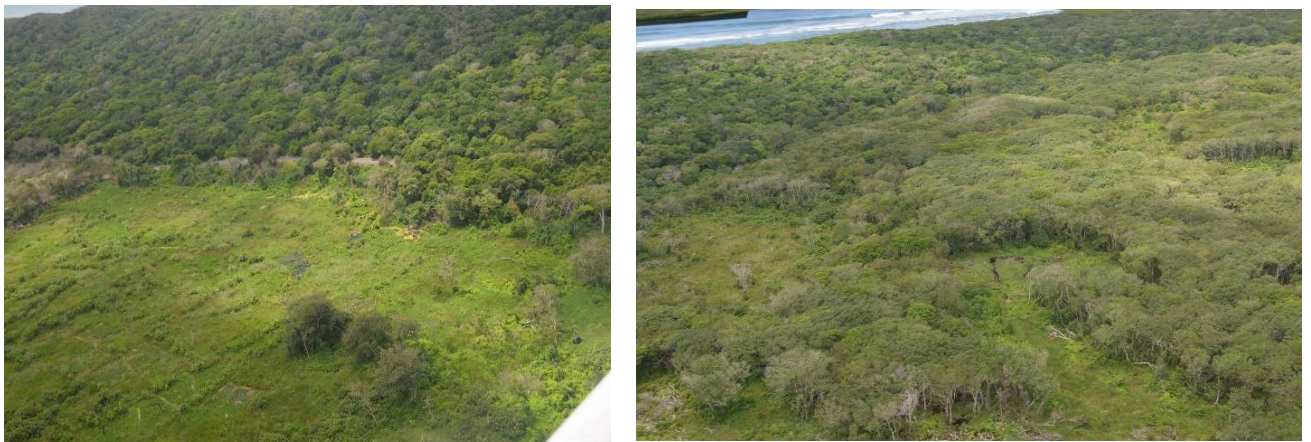
Aerial Imagery 3 – taken 17 February 2021: showing Mgobozeleni swamp forest at same position as imagery 1

The above photographs (aerial image 3) are new aerial images taken from the same Mgobozeleni swamp forest.

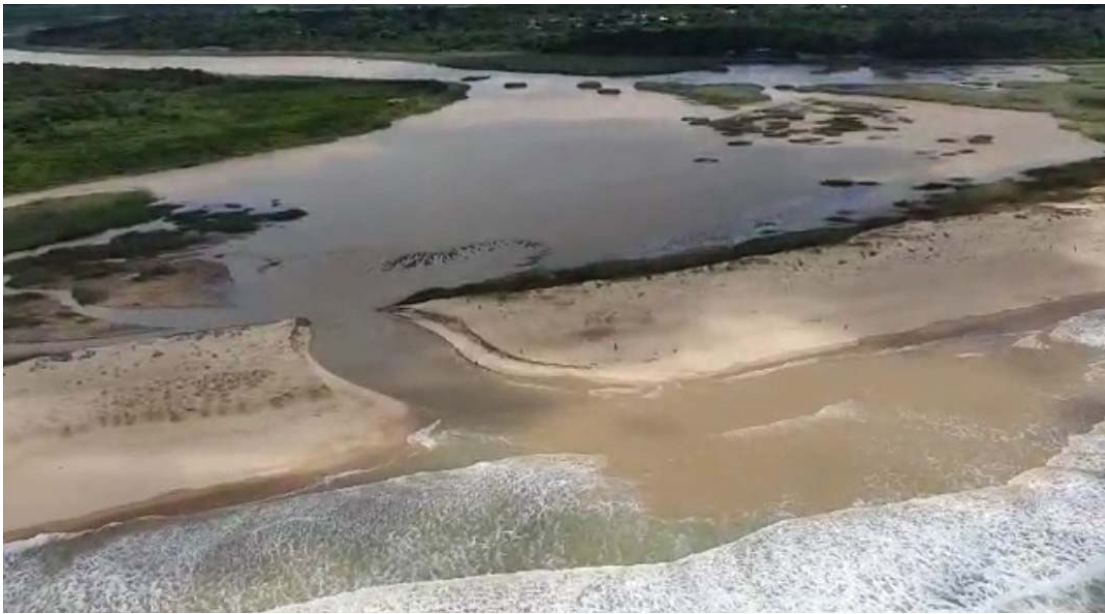
Figure 1b: showing point of channel excavation linking to the sea – after assisted breach.

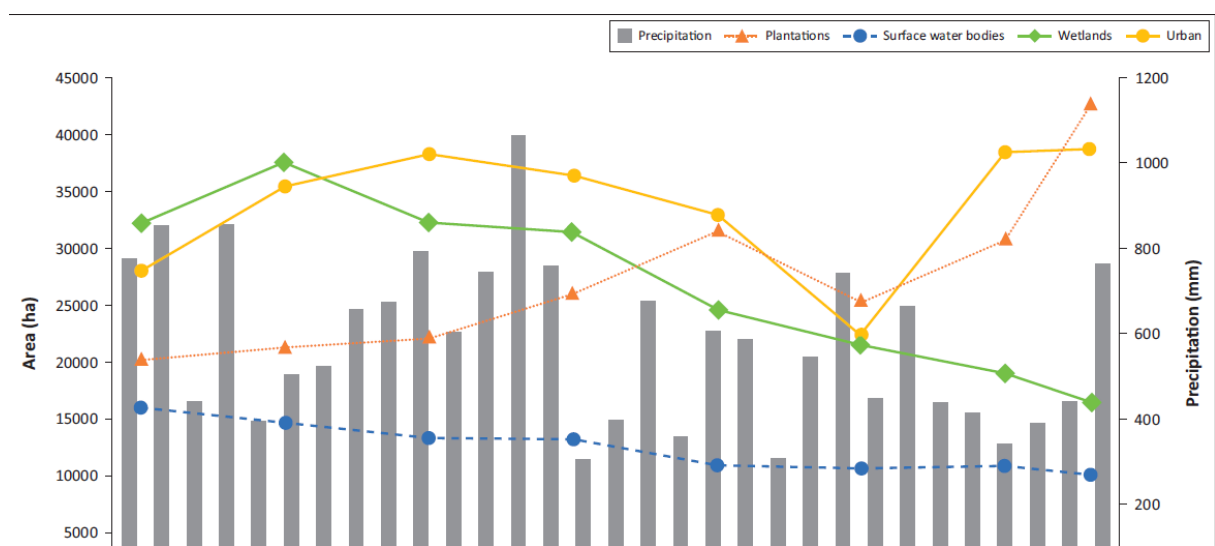
Figure 3: showing area covered by plantations, water bodies and wetlands, as well as annual precipitation.
