**State of Conservation report of Meidan Emam, Esfahan
World Heritage Site**

Tehran 2020

The report entitled “Disaster Risk Management Plan (DRMP) for the World Heritage Site of Emam Square, including mitigation Measures in the event of an earthquake for Ali Qapu pavilion and Other Built Structures of the square” is attached.

MEIDAN EMAM WORLD HERITAGE SITE DRAFT MANAGEMENT PLAN

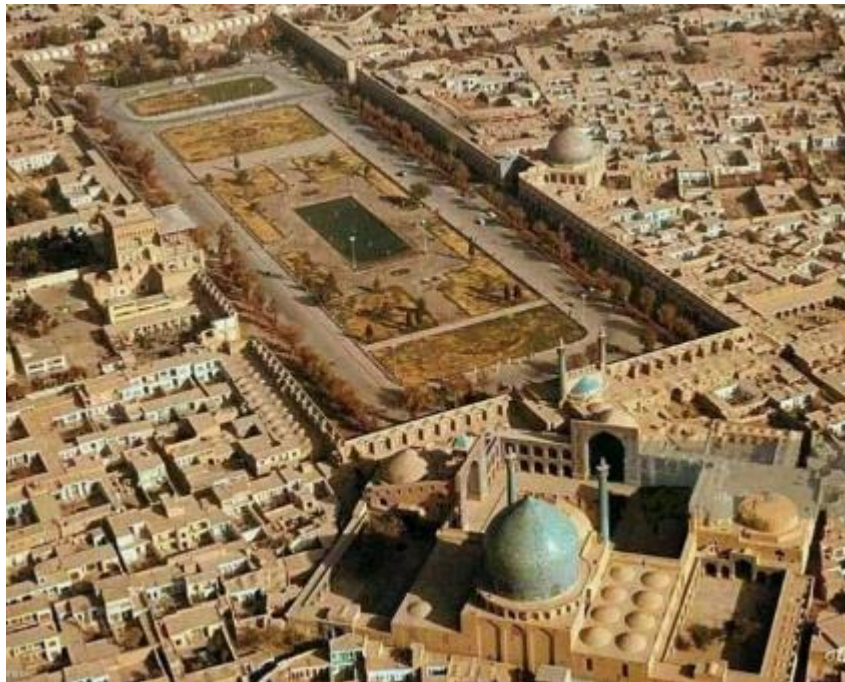
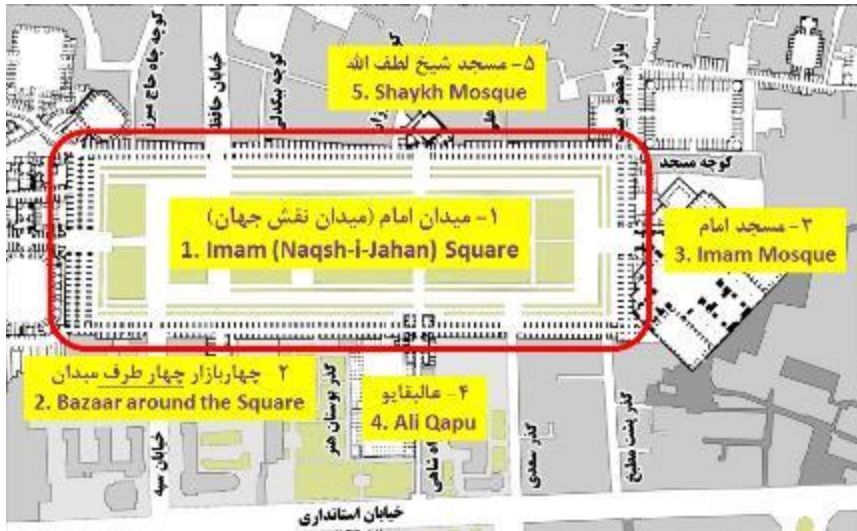
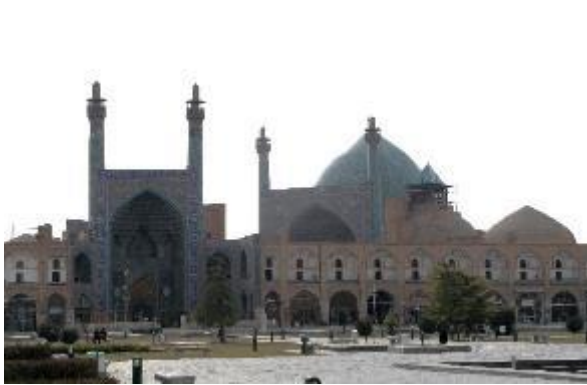
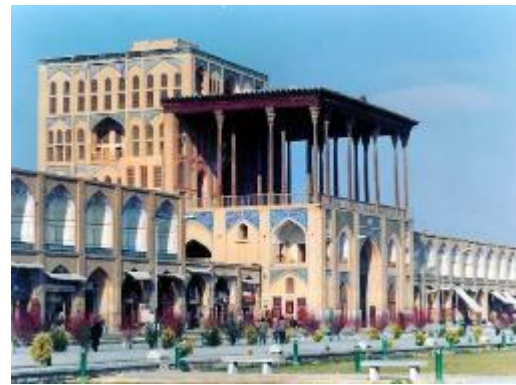
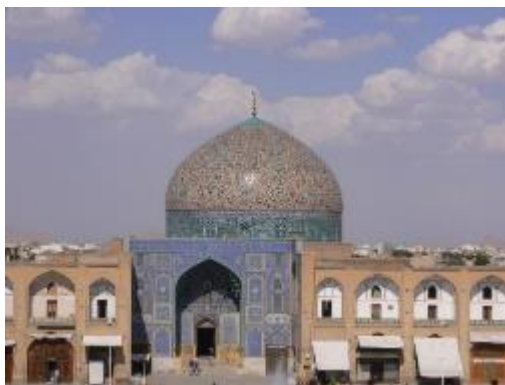
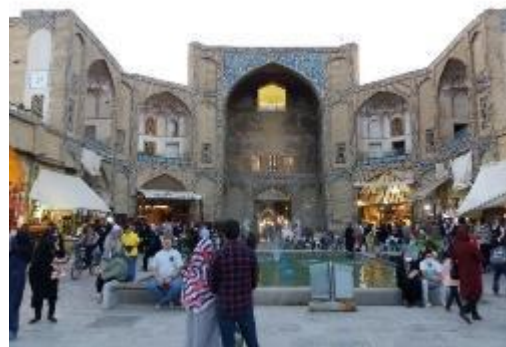
The area of the World Heritage Site of the Emam square for which a disaster risk management plan is being developed, is shown in Figure 1 with a rectangle. It consists of the square (No. 1), Abbassi Jami mosque (Emam mosque, No. 3), Shaykh-Lutf-Allah mosque (No. 5), Ali Qapu edifice (No. 4), and the bazaar around the square (No. 2).

Figure 1. The World Heritage Site of the Imam square: a) view from the south, b) the area for which the DRMP is prepared, c) Imam mosque (1612-38 A.D.), d) Ali Qapu edifice (1597-1668 A.D.), e) Shaykh-Lutf-Allah mosque (1601-28 A.D.), f) Qaysariyah gateway

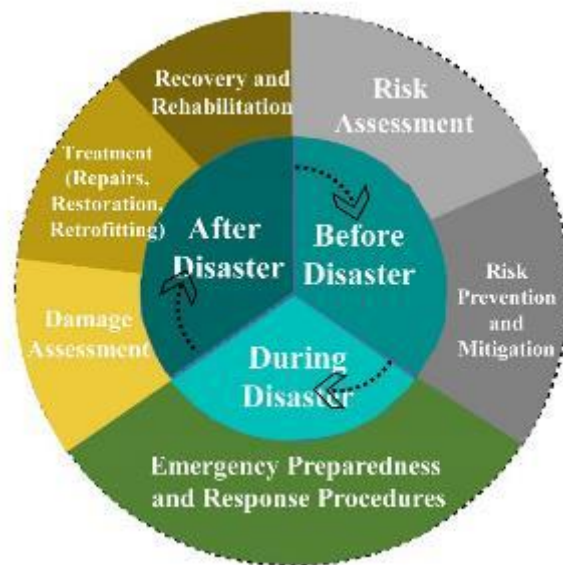
Figure 2. Three phases of disaster risk management: before, during and after disaster [20].

Disaster risk management activities can be classified into three phases: before disaster, during disaster and after disaster (Figure 3).

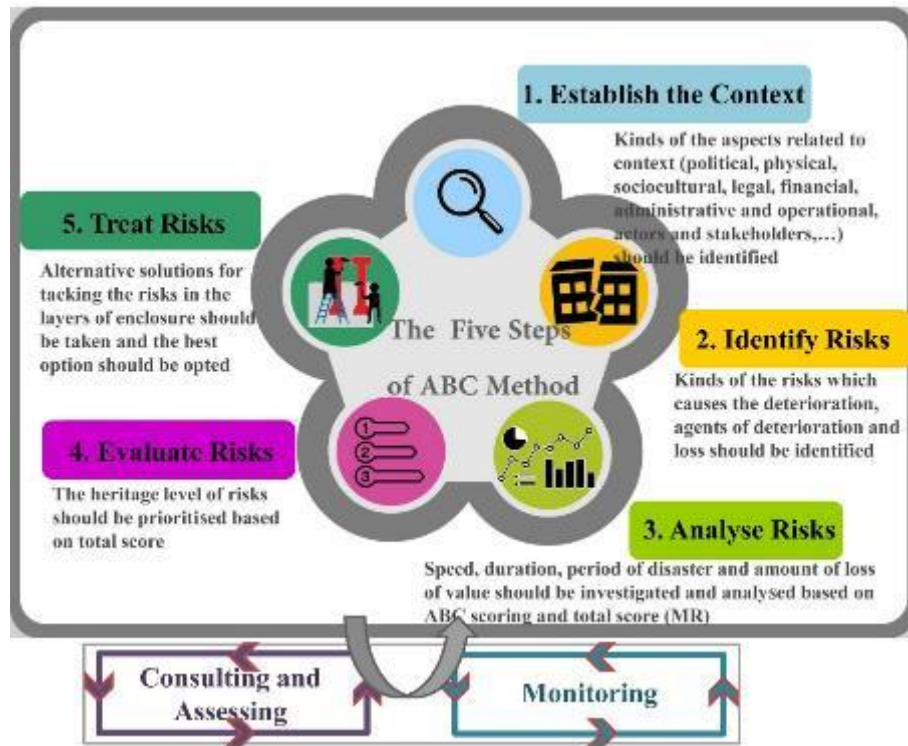
Figure 3. The ABC method

After reviewing the various methods of disaster risk management tested, the disaster risk management plan based on the ABC method was selected to carry out this project.

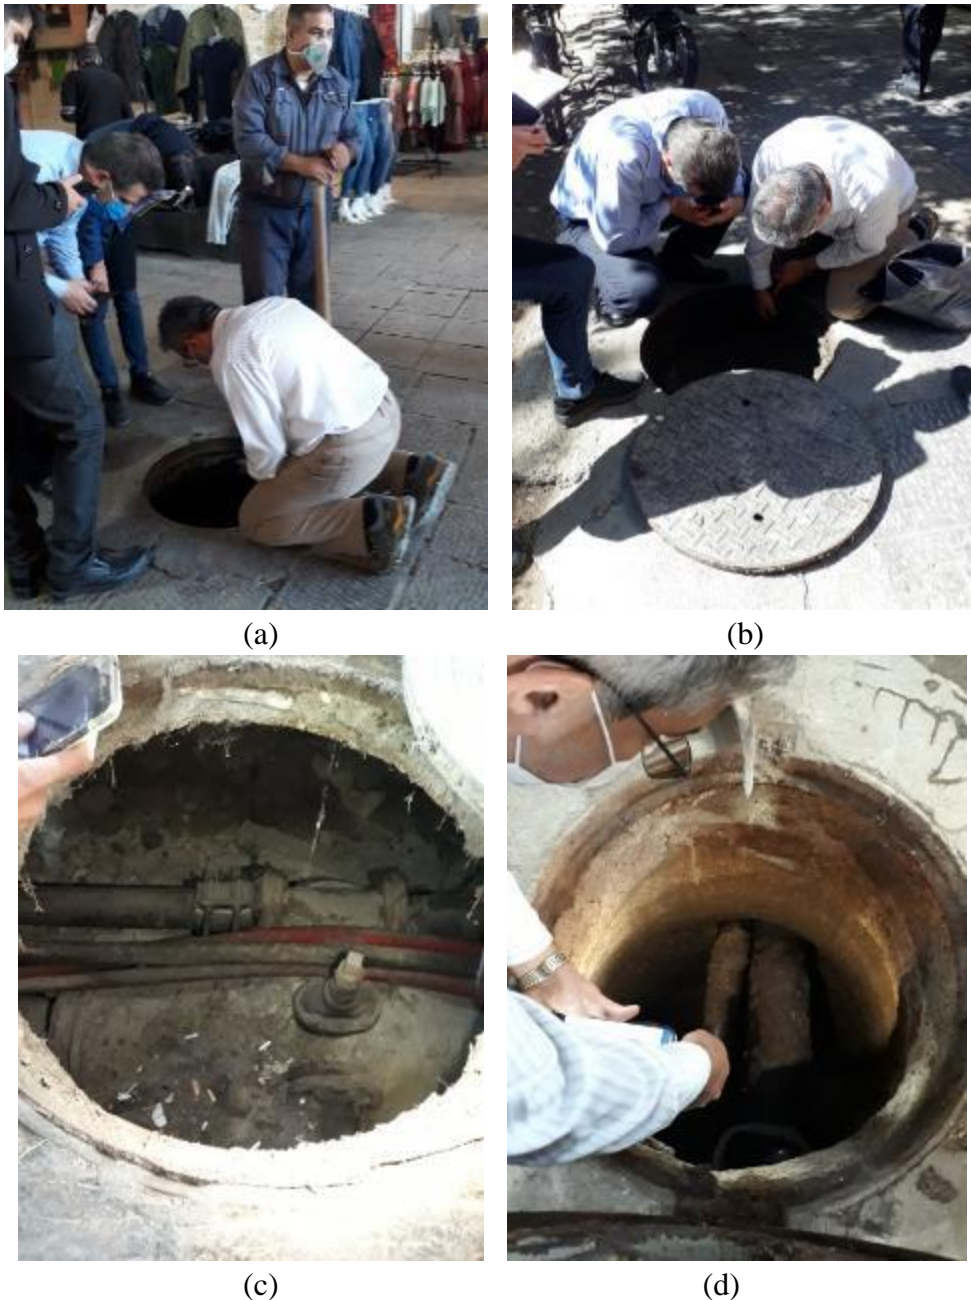
Figure 7. Investigation of manholes in the area of the Emam square, point: a) 5, b) 7, c) 4, d) 6 in Figure 1

The situation of manholes in the bazaar around the Emam square was also examined (Figure 7). Studies show that the depth of manholes is not constant and varies from less than 1 m to more than 3 m and in them other facilities such as water pipelines has also observed. Examination of these manholes will be useful for monitoring the sewage passage, possible clogging of the sewage pipeline and their maintenance. It is also possible to determine the slope of the sewage pipeline between the manholes by measuring the depth of the sewage pipes inside the manholes and to ensure the correct operation of the sewage pipes. Examination of the existing manholes shows the effects of the presence of vermin inside the manholes. Corrosion of sewage pipes can also be seen inside the manholes. Also, the slope of the sewage pipeline is not the same in the whole network.

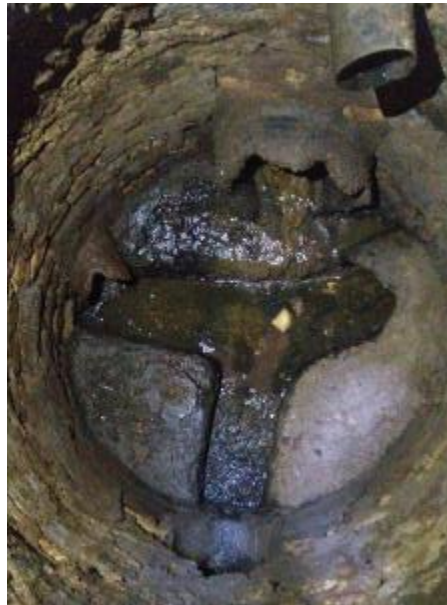
Figure 9. Destruction and decay of the sewage pipe in the area of the Emam square, point 1 in Figure 1

Studies show that there is a slight leakage of sewage from pipes and canals due to their decay and destruction (Figure 6). The main sewage pipes, between the manholes, are made of

concrete with asbestos with a diameter of 25 cm and more. The pipes of the sewage sub-lines in some alleys and dead ends, which are connected to the buildings, are made of PVC or possibly cast iron (in some areas) with a diameter of 11 cm.

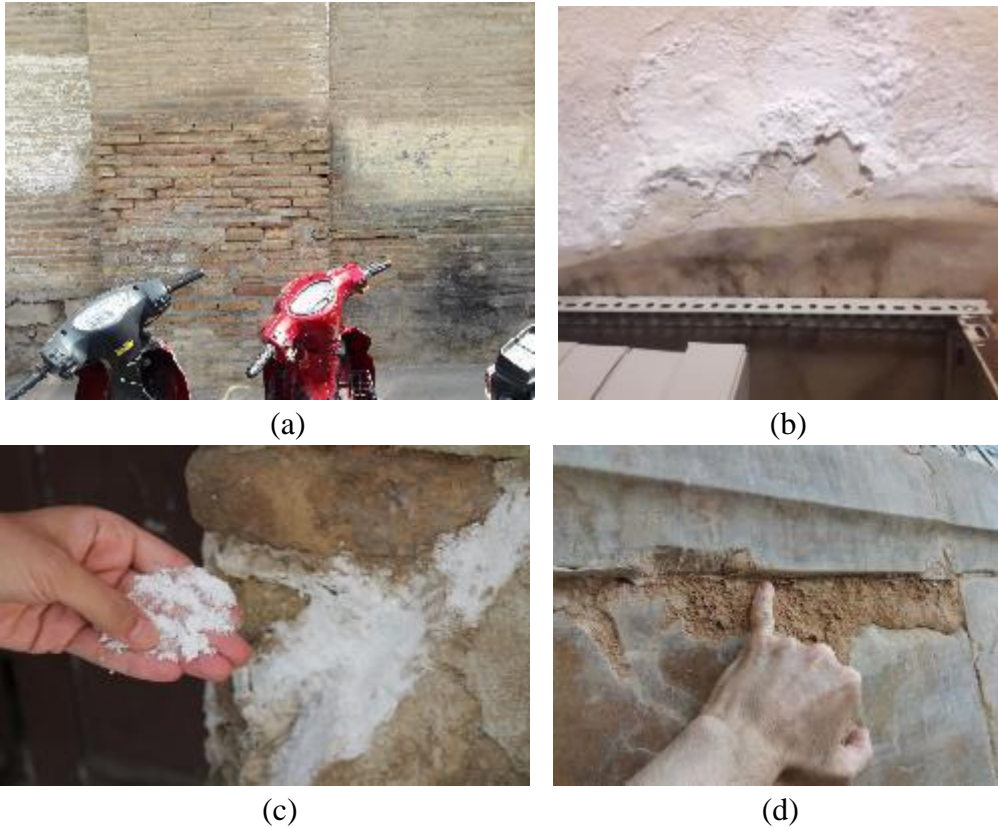
Figure 10. Leakage effects from sewage pipes, point a) 9, b) 10, c) 3, d) 11 in Figure 1

The effects of leakage can be seen in the dampness and the presence of dandruff on the walls inside the bazaar round the Emam square. (Figure 7).

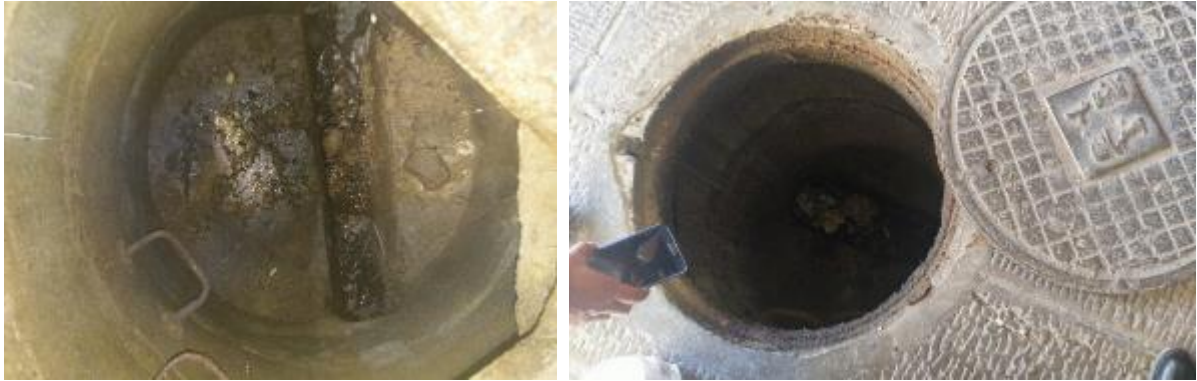
Figure 11. Existence of plastic containers in the sewage path and the low slope of the sewage pipeline, point 9 in Figure 1

The variable slope of sewage pipes and canals and in some areas, their low slope and the presence of solid parts such as plastic containers may cause blockage (Figure 8).

In addition, it should be borne in mind that soil subsidise due to sewage leakage in man-made fine soil and clay might be likely.

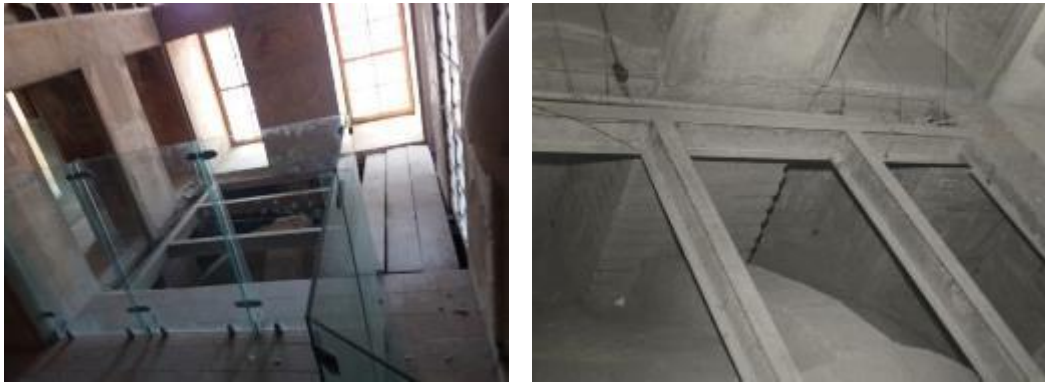
Figure 12. Ali Qapu edifice, lightening the roofs at sixth floor, 1965-1970

1. Supporting the damaged or cracked parts of the building;
2. Repairing the most critical damages in the building by using the same traditional materials;
3. Lightening the roofs and elements under thrust from excess loads (Figure 1);
4. Connecting the different parts of the building by using continuous spreaders in order to distribute the loads (Figure 2);
5. Creating a horizontal circumferential frame in the whole building in order to prevent the external parts from detaching (Figure 3).

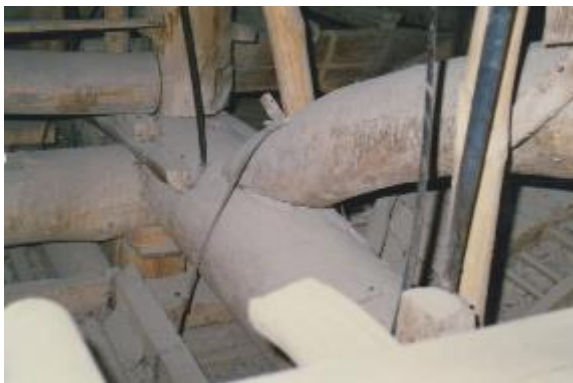
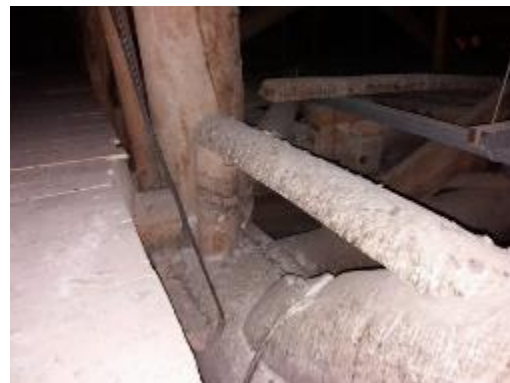
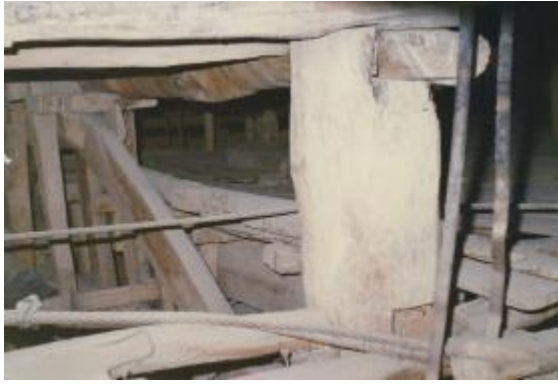
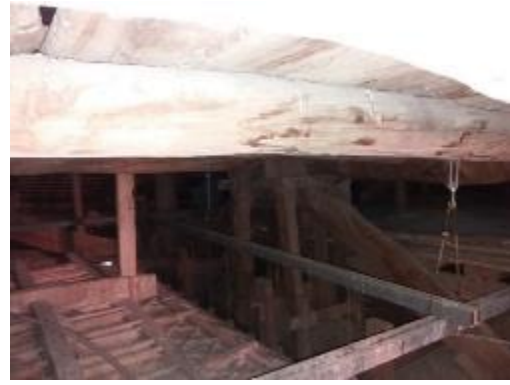
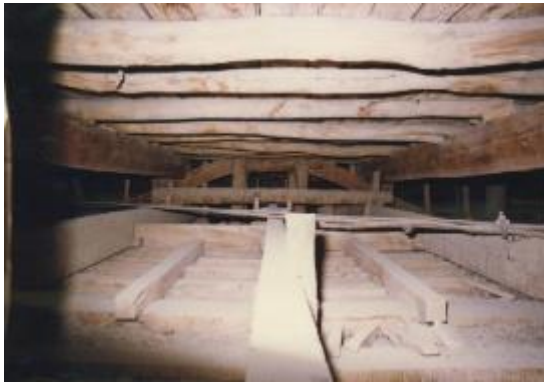
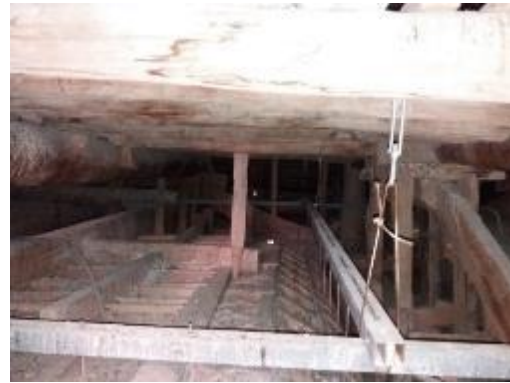
Figure 17. Ali Qapu edifice, wooden columnar structure: a) and b) wooden main and secondary beams in two directions (1990 and 2020), c) and d) a wooden truss (1990 and 2020), e) and f) wooden roof over the pond (1990 and 2020)

The second restoration of Ali Qapu was undergone from 2005 to 2017 and it was concentrated on the wooden columnar structure and its supporting veranda. The main purpose of the work was to repair the damaged wooden part as well as the structural rehabilitation of the wooden structure.

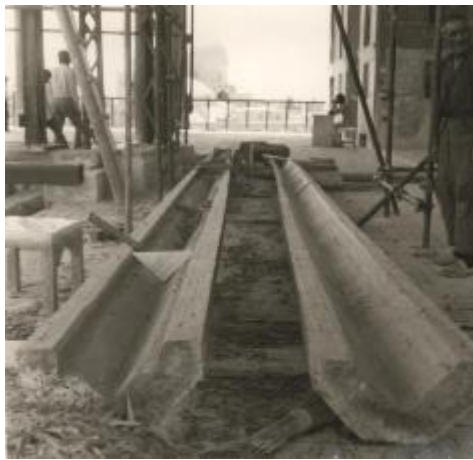
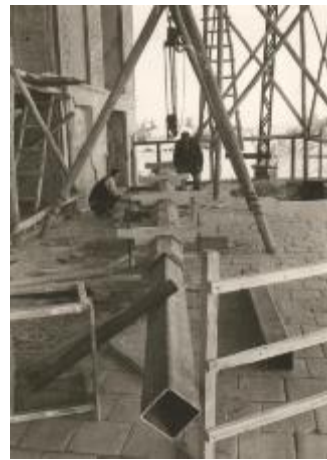
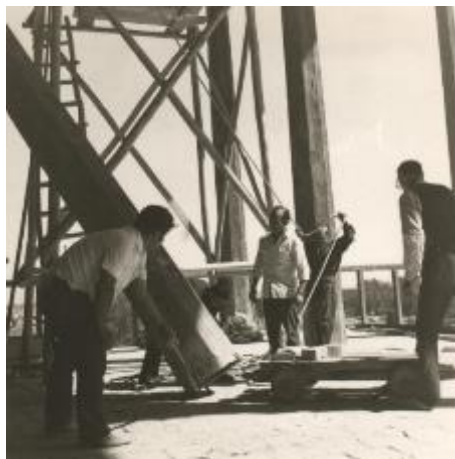
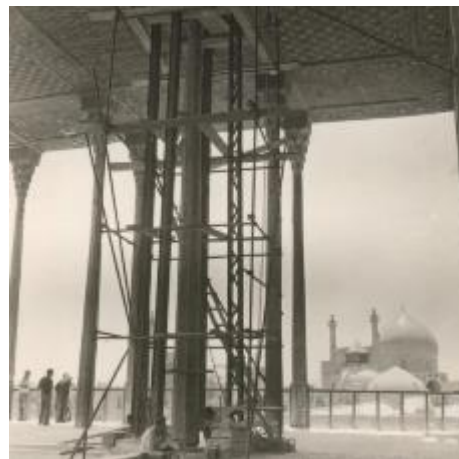
Figure 18. Ali Qapu edifice, method of strengthening of wooden columns: a) schematics of the method, b) to e) the method (1960s and 1970s)

During 1967 to 1968 and 1972 to 1975, six columns α' to ζ') were stabilized by cutting the wooden column into two parts, then emptying the central section of the two parts and putting a \square -shape steel profile between them and re-erecting the wood/steel column (Figure 7). The spreader under the columns was also stabilized by I-shape steel profiles.

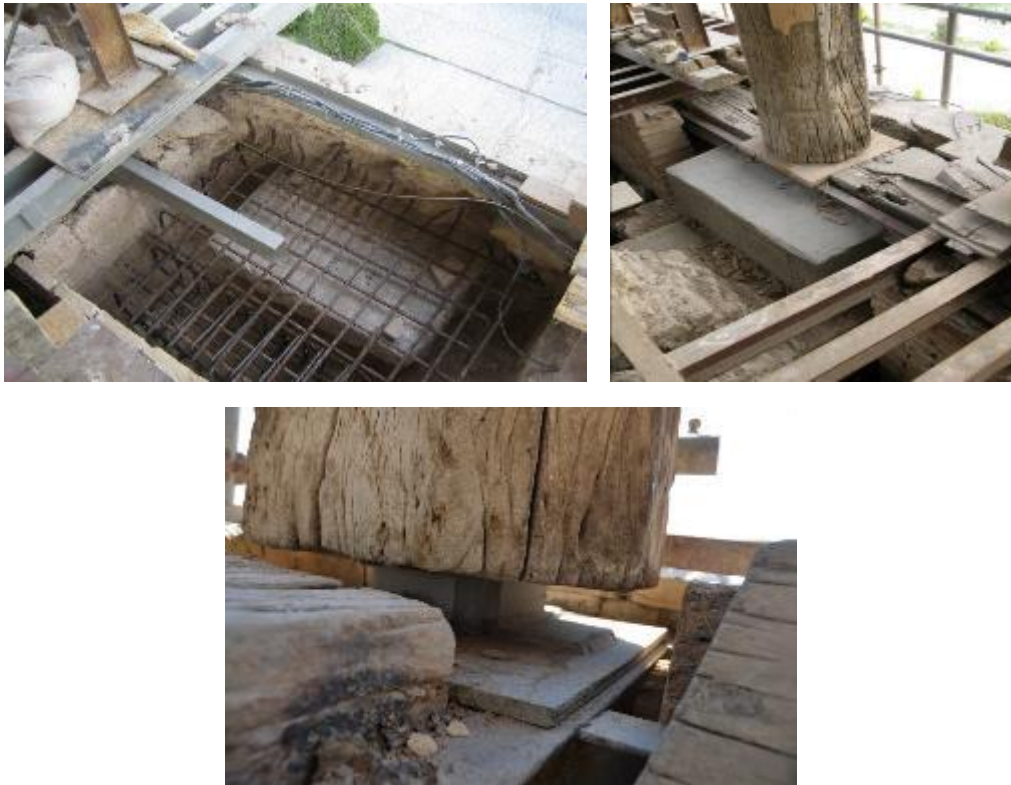
Figure 20. Ali Qapu edifice, strengthening the supports of the columns (2005 to 2017)

For strengthening the connection between the steel profile inside the column and its support, a reinforced concrete foundation was constructed under each column and the connection was stabilized by welded steel stiffeners (Figure 9).

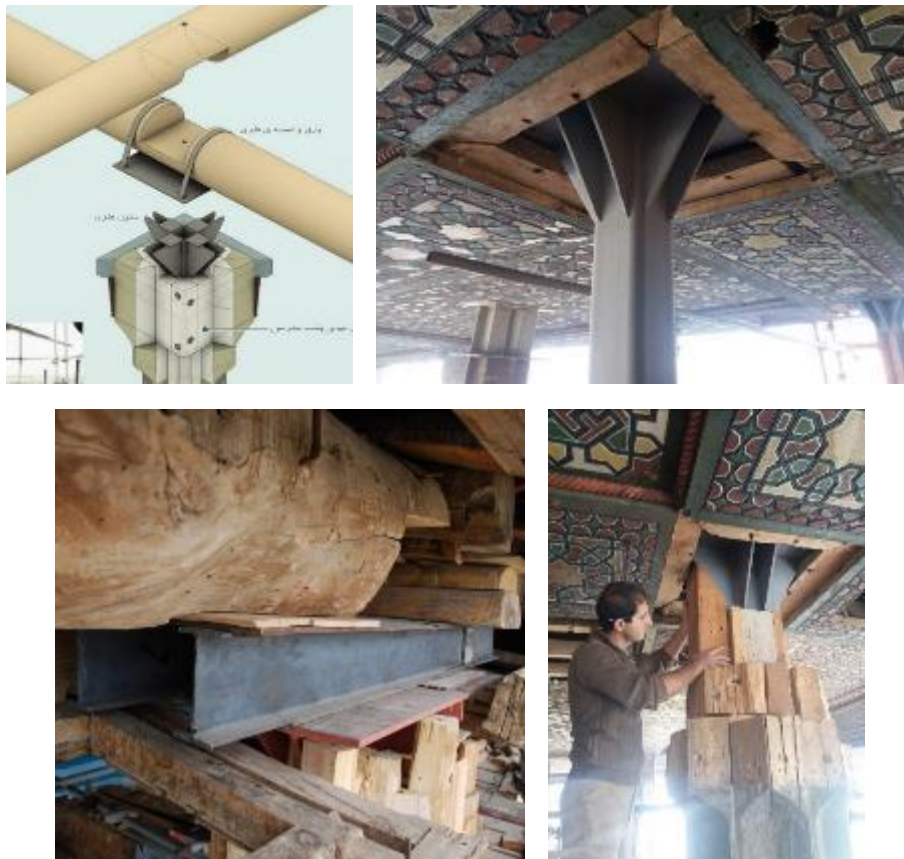
Figure 21. Ali Qapu edifice, strengthening the connections of the columns to top beams (2005 to 2017)

For the top of the column, a steel plate was connected to the beam above and the top of the steel profile was connected to the steel plate using welded steel stiffeners (Figure 10).

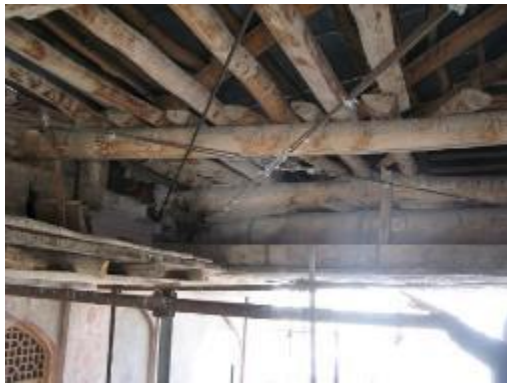
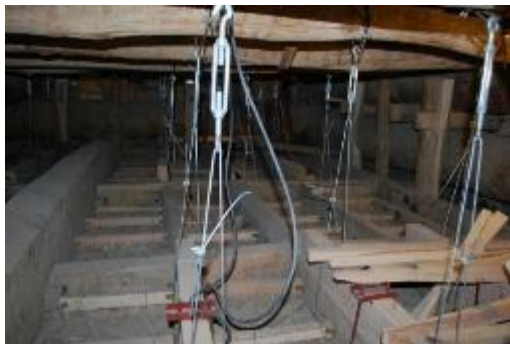
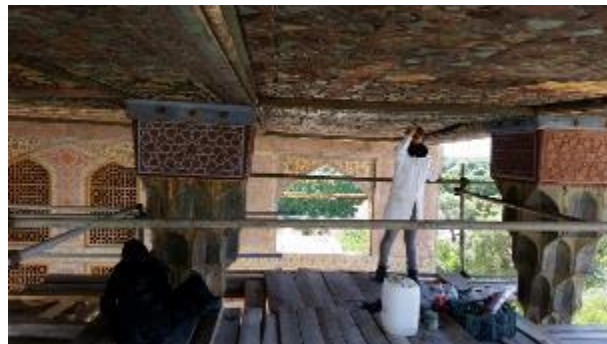
The decorated wooden ceiling is hanging and its weight is transmitted to the beams inside the roof by wooden connection and original iron strips. In the restoration work additional steel hangers were used to give additional strengthened the route of weight load from the ceiling to the upper beams (Figures 11 (c) and (d)).
