**REPORT ON THE JOINT WORLD HERITAGE CENTRE / ICOMOS / ICCROM
REACTIVE MONITORING MISSION**

BAHLA FORT (OMAN)

6th – 10th March 2017

REPORT ON THE REACTIVE MONITORING MISSION TO BAHLA FORT (OMAN)

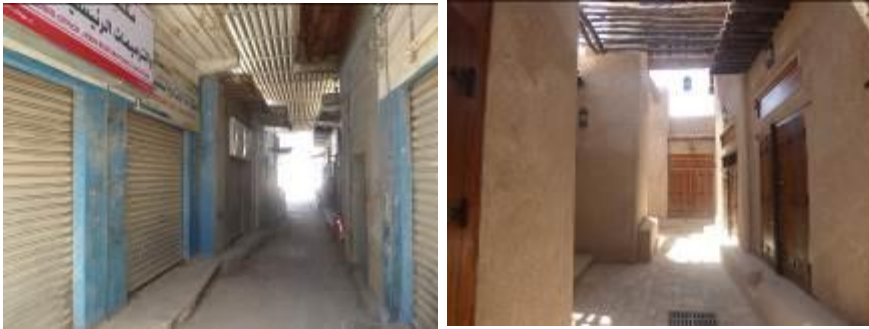
Figs. 56 & 50 – Before and after intervention (photos taken on March 8th, 2017)

Phase 1 of the project developed for Bahla Market (Souq) has almost been completed. It respects the ancient interior typology of each shop, in spite of complaints from the owners of

the shops about the need for more space inside each unit. There was a concern expressed by the Souq project team that they were trying to retain spatial authenticity.

Regarding the material authenticity, it looks like traditional construction practices with stone masonry have been followed (fig.59), except for the use of white cement (fig.64), also confirmed by the local building team. White cement changes the colour of the mortar, but still has the same properties as grey cement. Regarding the original souq, many concrete and metal additions to the original adobe walls were observed (see fig. 56). However, the little that remained of original adobe construction from the ancient souq (e.g. fig. 57) should still be protected and not replaced. The new project brings a renovated contemporary image, following a traditional construction approach with stone masonry (fig.60), earthen plaster and wooden elements. Only a limited use of adobe construction was observed, though it could have been an excellent opportunity to contribute to the original construction culture and raise awareness.

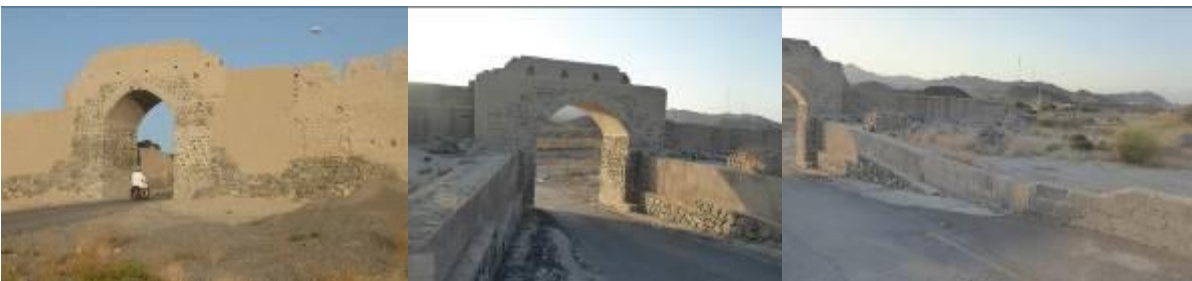
Figs. 17, 18, 19 – Current state of Sabah Salem gate reconstruction (photos taken on March 8th, 2017)

The intervention that took place at the Sabah Salem Gate was the reconstruction of a gate that fell 60 years ago. The State Party in its report dated from March 2017 (see annexe 7.7, p.8) mentions “restoration and consolidation works”. The mission team did not identify any existing documentation regarding the wall record, before the intervention. The only available information was one poster presented at the exhibition in Nizwa Cultural Centre (see figs. 148, 149, 150 - see Annexe 7.6). The poster outlines the process of the gate’s reconstruction. With limited access to information, it is impossible to assess whether rigorous methods of reconstruction based on historical and scientific evidence were followed.

It is relevant to note a lack of material connection between the adobe and stone masonry gate and the side road concrete blocks, covered with earth plaster. This discloses a lack of concern over materials and a lack of local traditional practices that are quickly disappearing, but in particular gives a negative image to local populations that have the same attitude. This is of high concern, as it reveals the possibility for similar practices throughout the property.

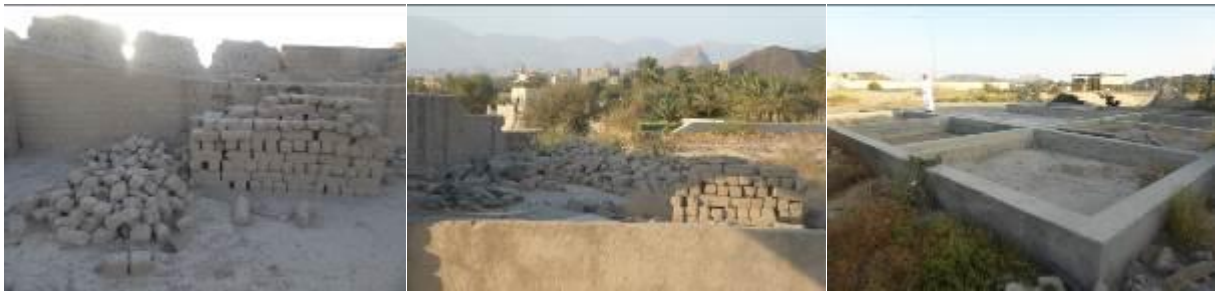
Figs. 22, 23, 24 – Adobe workshop no longer in use at Sabah Salem gate (photos taken on March 8th, 2017)

Located at Sabah Salem Gate is the workshop that provided the adobes that were used during this Gate's reconstruction. The adobes were produced for specific interventions along the surrounding wall [also mentioned in the *2016 State of Conservation Report (C433)*, additional information provided on 1 March 2016].

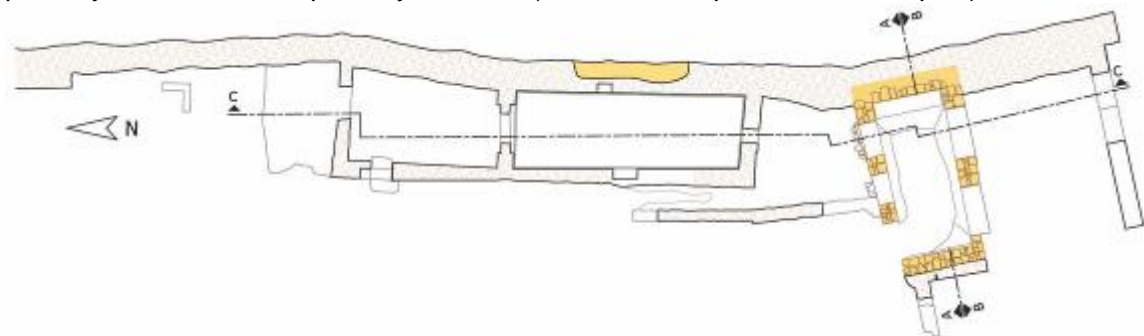
Fig. A – Intervention proposal (image provided by the State Party, on March 12th, 2017)

The restoration of the Shaikh Bin Baraka_Mausoleum and of the Alkhair Mosque has been concluded. According to the site visit, the restoration plan presented below, and the report in Annexe 7.7. (p.8), intervention was addressed using stone masonry. The original building was partially in earthen and partially in stone (Annexe 7.7., p.11 and 204 report).

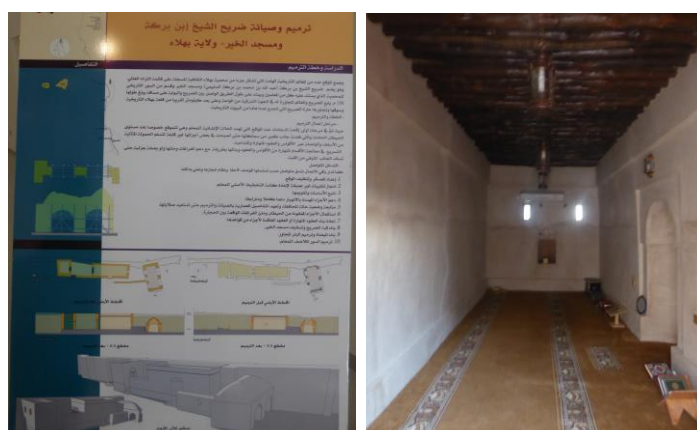
Figs. 145 & 32 – Intervention proposal poster presented at Nizwa Cultural Centre exhibition; and image of the mosque interior (photos taken on March 8th, 2017)

Considering the report in annexe 7.7, a restoration intervention took place at the mosque with "a detailed documentation" of the entire process. However, no documentation concerning the state of conservation before intervention was presented to the mission experts (just a brief description was presented within the 2016 state of conservation report with a longer description in the 2014 state of conservation report). When visiting the Nizwa exhibition, the expert mission members identified a poster with a general intervention plan (see fig.145). Therefore, it was impossible to specifically determine the recent intervention's potential impact on authenticity. However, when comparing previous photos with the current state, the form of the mausoleum has definitely changed (see 2016 Report, p.21).

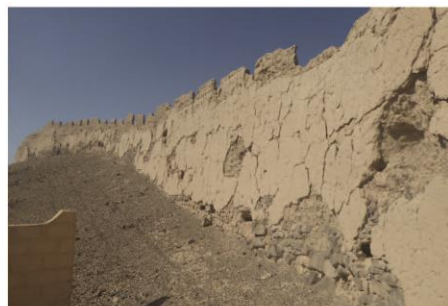
10_Surrounding original wall_In decay.jpg

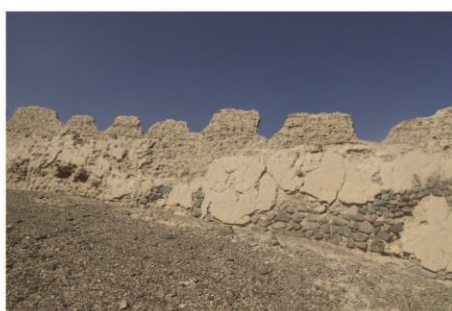
11_Surrounding original wall_In decay_Remains of past consolidation efforts.jpg

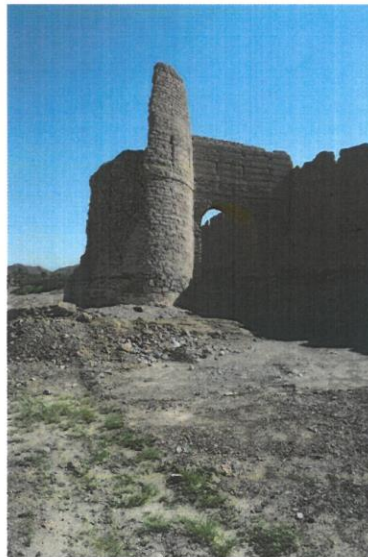
Part of Bahla wall and remain of one of the defensive towers

The walls cross many valleys and surrounds many important quarters, its height varies from side to side according to the natural terrain, it measures near mountains and hills around 3 meters, and in valleys around 5 to 6 meters. The

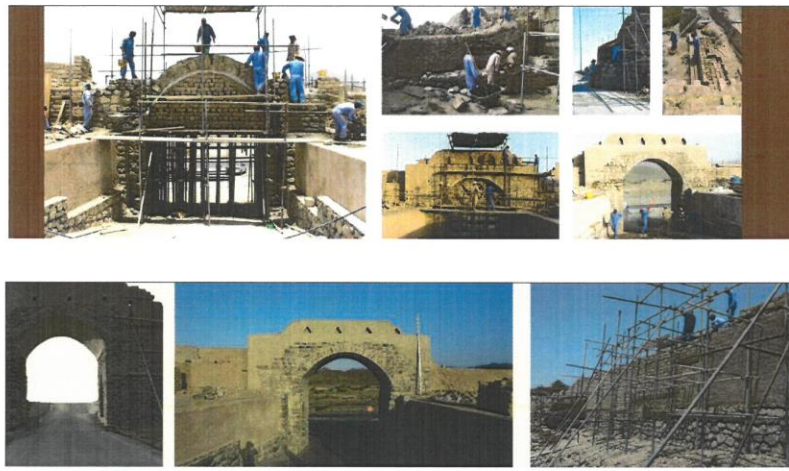
Sabah Salem Gate is located at one of the most vital entrances to the Oasis of Bahla and is used on daily basis by the inhabitants, and since parts of the gate were damaged by rain, it became a priority for the Ministry to initiate the restoration and consolidation works, to enable the inhabitants pass through the gate.

Photos during and after restoration works at the Sabah Salem Gate

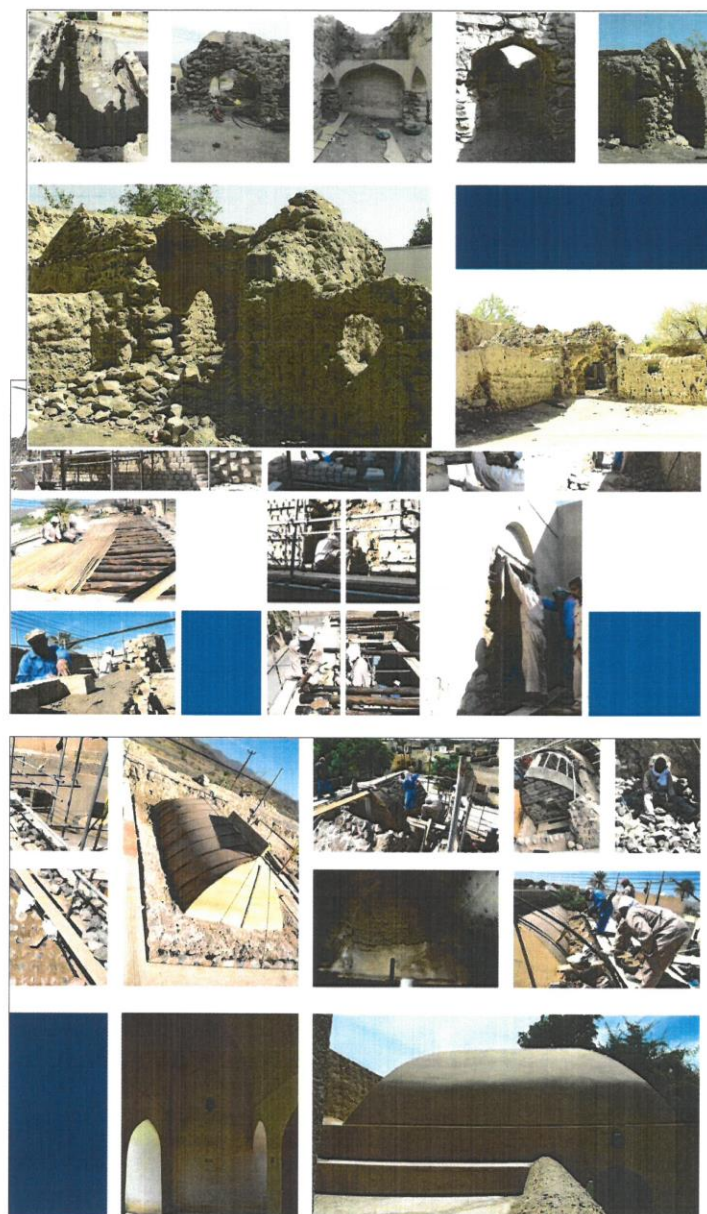
Photos of the mausoleum before, during and after restoration works

In conclusion, this brief demonstration is a reliable and probable approach to definitively come to a decision regarding the shape and the general form of the dome of the Sheikh Ibn-Baraka mausoleum.

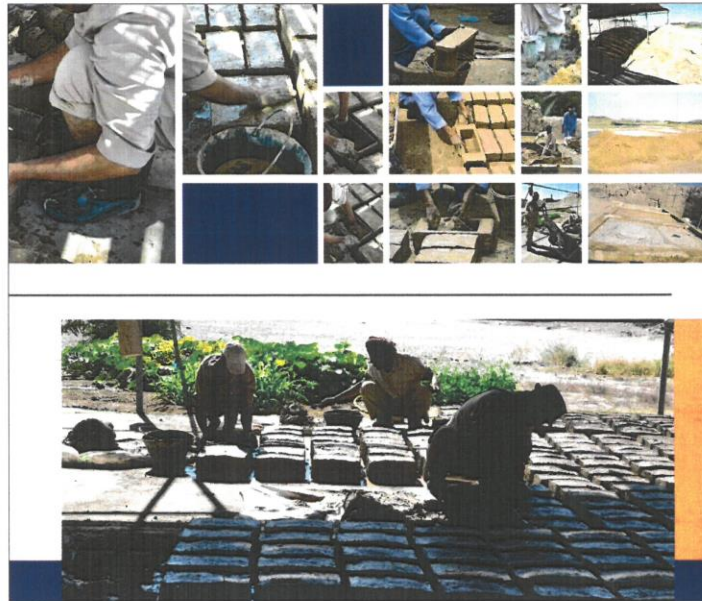
- 5- At a later stage the bricks are removed from the molds to be air dried, and flipped from side to side to reassure the drying of all sides, the drying period varies depending on the season and other factors, as it takes approximately a week to dry in the summer and more than two weeks in winter. Cracking in the bricks may occur if mixing the soil and hay is not enough where air bubbles form in the mix, and if the hay amount is not enough, that is why the mixing and compacting are very important in the fabrication process.

Fabrication of Adobe bricks at the workshop

It is highly important to mention that the adobe bricks prepared by the workshop and constructed in the pilot project area have not shown any deterioration or degradation since their installation, even when exposed to natural effects impact.

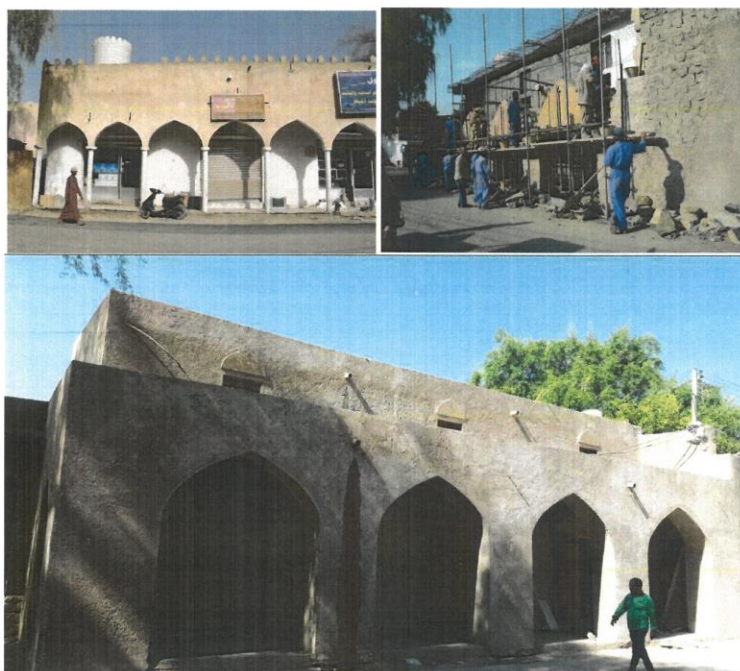
Although the restoration methodology in the pilot project have been extensively explained in many previous reports sent to the Committee, we find it necessary to confirm that any accomplished work have definitely depended on the restoration guide lines in the Management Plan, and to all decisions by the Committee made on the subject. In addition to the fact that the pilot project was initially focused on the most demolished and deteriorated part of the Souk, where emergency measures had to take place to save the structures in this part where possible, many of the structures were already destructed and had to be rebuilt using the same traditional materials and techniques, while other structures had to undergo restoration and consolidation works also using traditional materials and techniques, Unquestionably, all finishing works were made according to the same traditional materials and techniques such as wooden doors and final coating layers.

Photos of the souk before and after restoration works

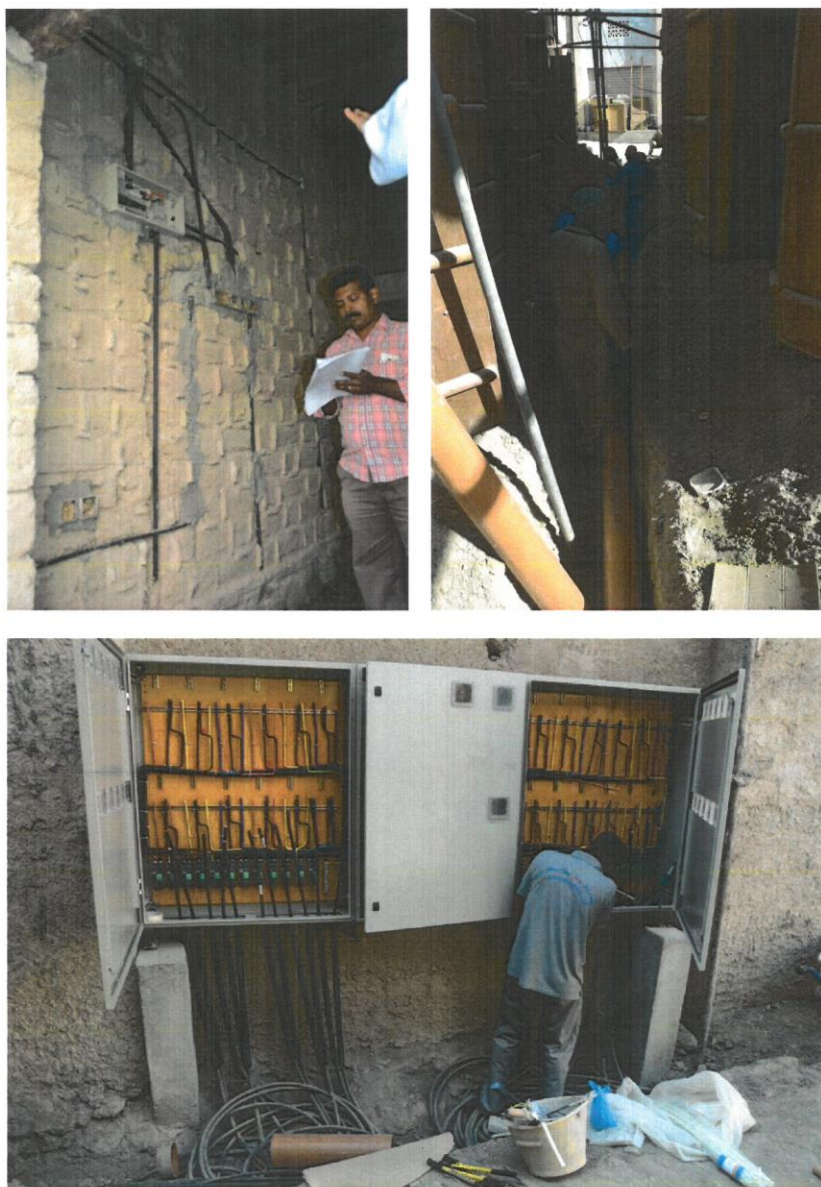
Installation of electrical wiring

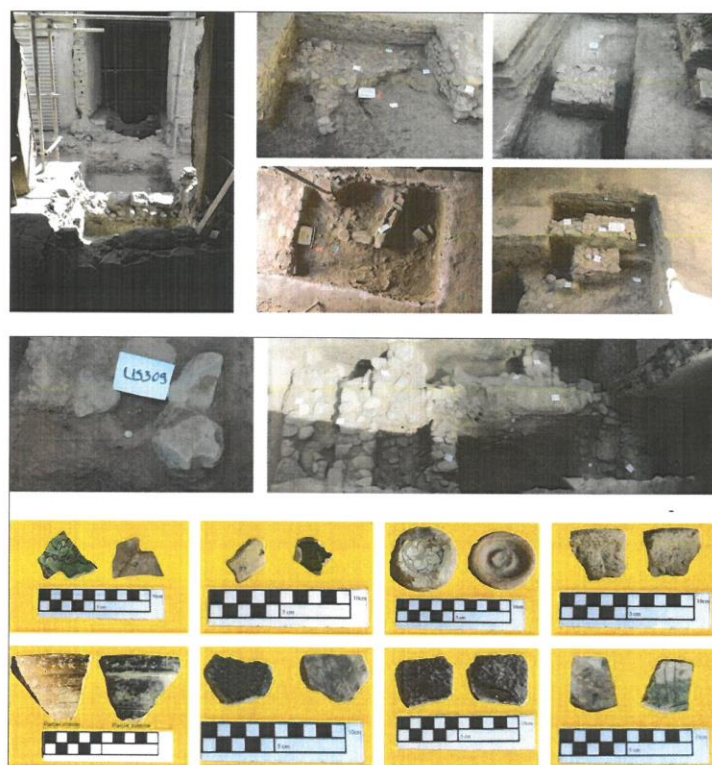
operating program. These archaeological surveys also permitted to learn about the conservation status of foundations and construction technique, it had also shown an infrastructure unable to continue to support the loads from the superstructure allocated in some areas, so consolidation works for foundations is urgently needed and sometimes reconstruction in case of total absence had been systematically engaged in order to overcome and correct this delicate deficiency.

Photos for the surveys and part of the findings
