Kathmandu Valley (Nepal) (C 121bis)  
Vallée de Kathmandu (Népal) (C 121bis)

# Report on the Joint World Heritage Centre/ICOMOS/ICCROM Reactive Monitoring Mission to the World Heritage Property of the Kathmandu Valley (Nepal, C 121bis)

16–21 October 2019

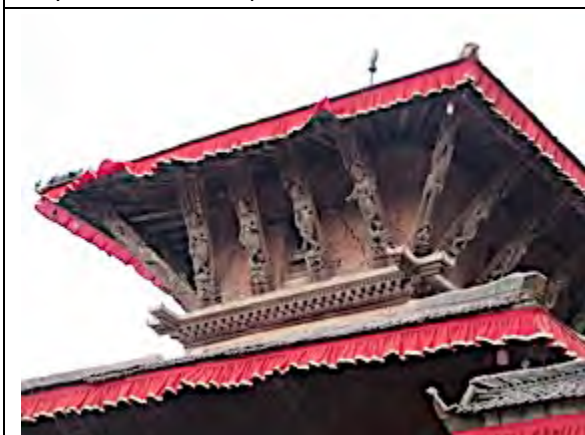
Jagannath Temple has loose bricks in upper storey, but people are still occupying area beneath as safety barriers have been removed

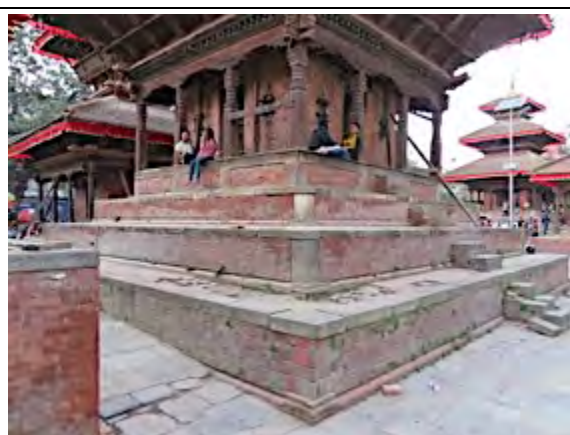
Loose bricks in upper storey of Jagannath Temple

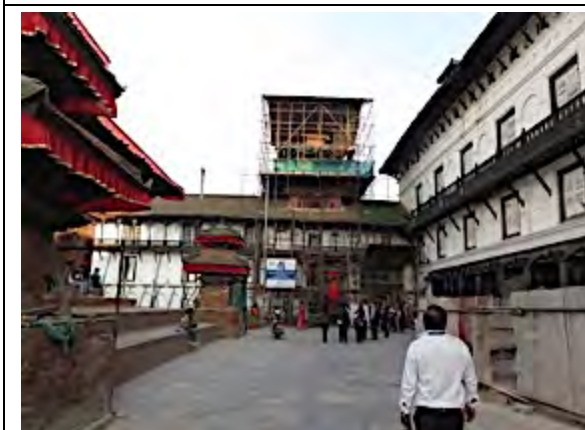
Temporary stabilisation and safety barriers removed from Shree Krishna Mahavishnu Temple, which has damage to its lower structure

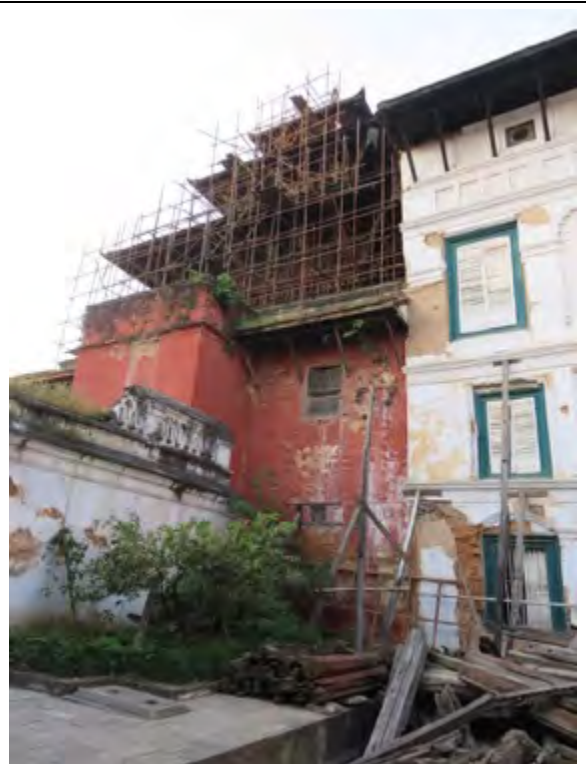
Falling damp affecting palace and Degutale Temple as palace wing has not been repaired as yet

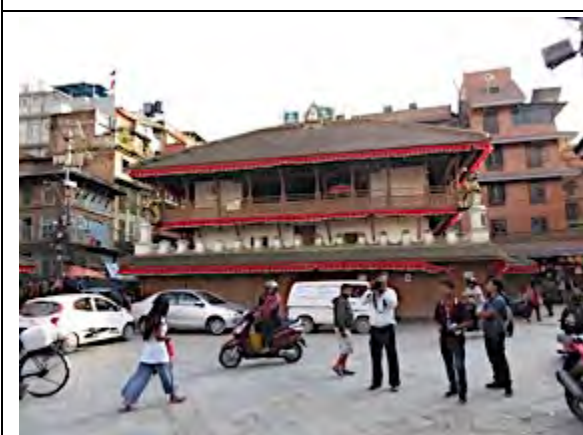
Garud Narayan Temple did not suffer severe damage during the earthquake, but is showing signs of neglect with roof desperately needing repair

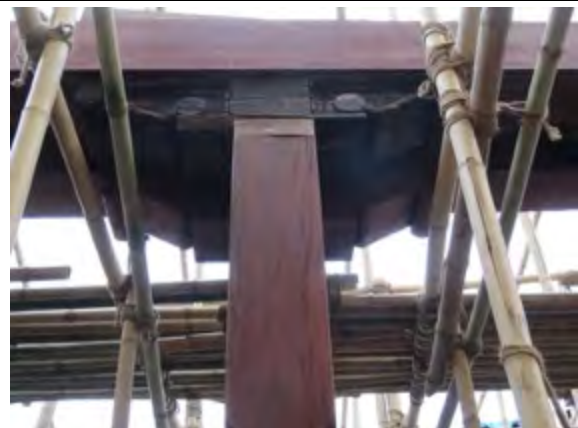
Some stone footings have been retained and others have been replaced. Copper shoes have been used to damp proof the base of the posts.

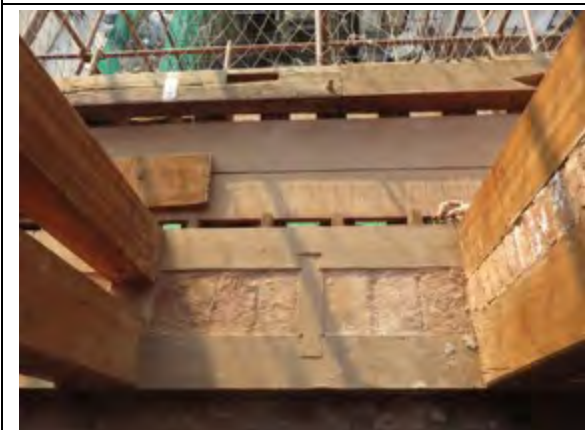
Reconstructing outer ledge of Basantapur Bhawan using traditional techniques

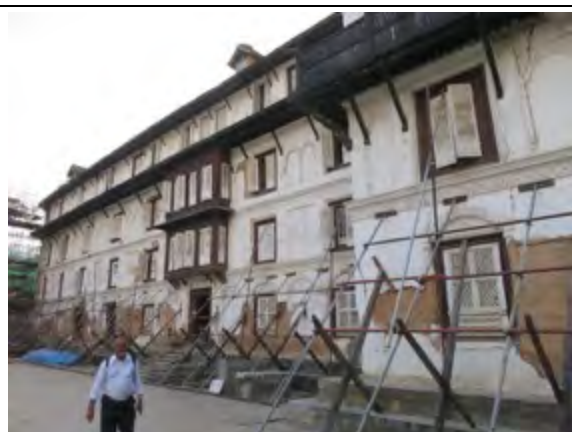
Southern wing of palace (left, scaffolded) has been substantially demolished as a result of the earthquake damage and decay resulting from ongoing exposure to the weather – to be rebuilt.

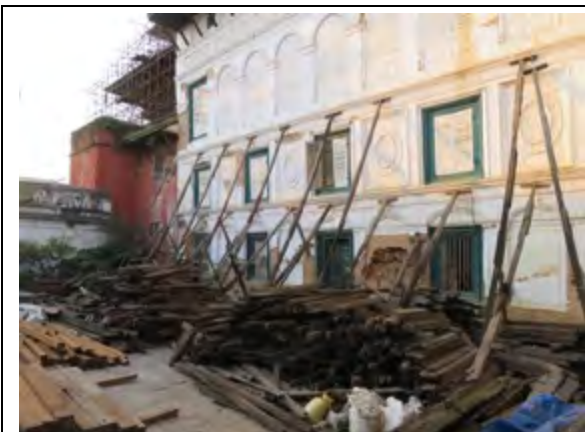
Central portion of palace is yet to be repaired (facing Nasal Chowk)

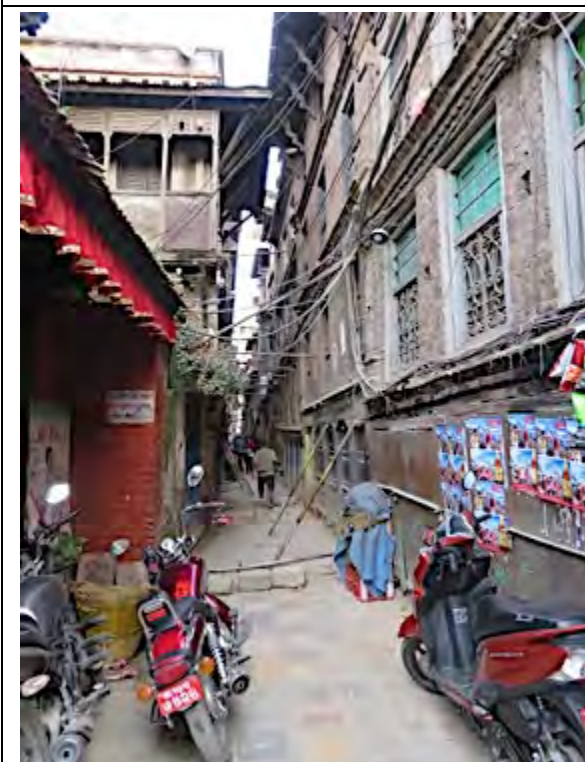
Section of palace that has collapsed since the 2017 RMM due to exposure of walls to the weather

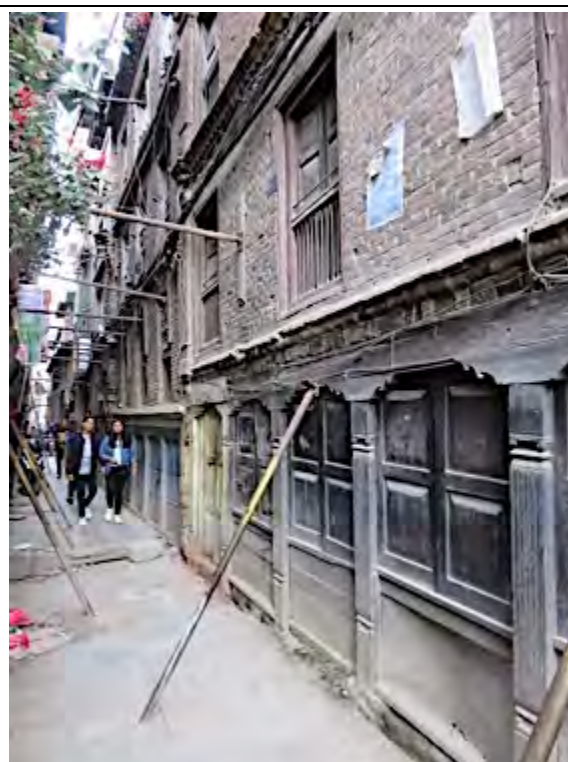
Housing and other structures (including part of Kumari Bahal) on the southern boundary of the Hanuman Dhoka Durbar Square Monument Zone have not been repaired as yet

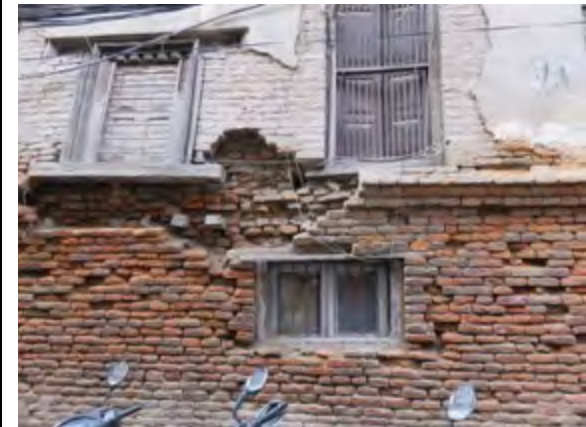
| <p>Rear of buildings facing Basantapur Square within Hanuman Dhoka Durbar Square Monument Zone</p> | <p>Failure of rear wall of building facing Basantapur Square</p> |

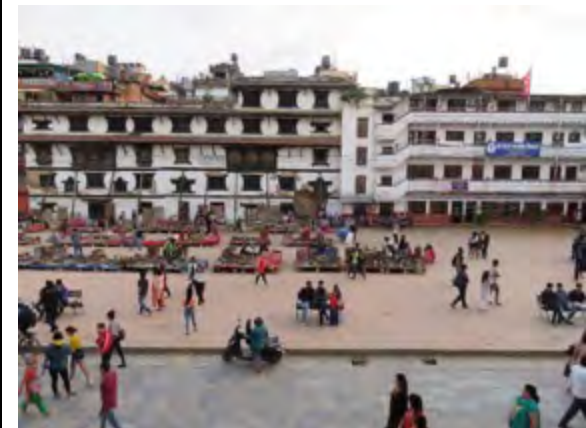
| <p>Building on southern boundary of Basantapur Square is yet to be fully stabilised and repaired. Kumari Bahal is at the western end of the square and Gaddi Baithak on right.</p> | <p>Front of buildings along southern boundary of Basantapur Square – yet to be fully stabilised and repaired.</p> |

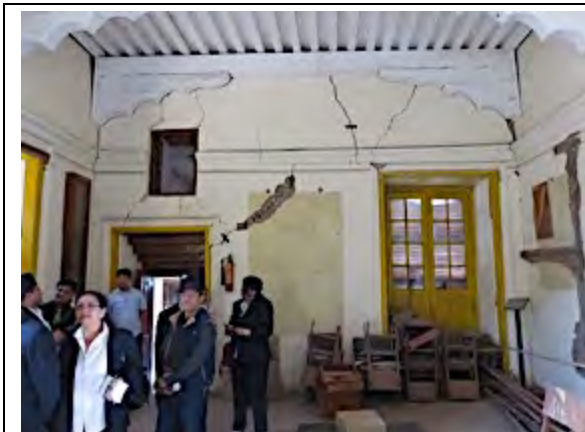
Damage to Lal Baithak is being monitored, but repairs have not been undertaken.

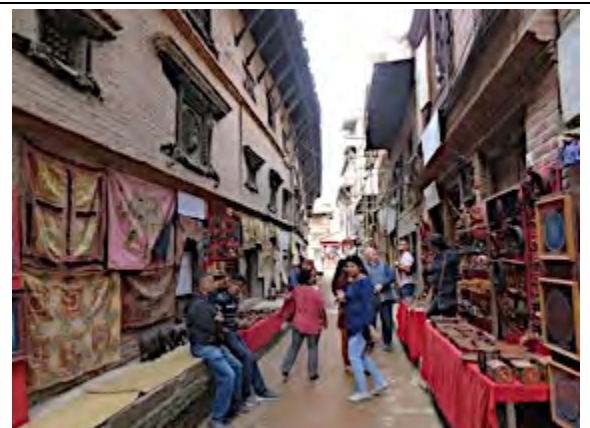
Peacock window in wall of museum reinstated (left), but wall still bulging and needing further work.

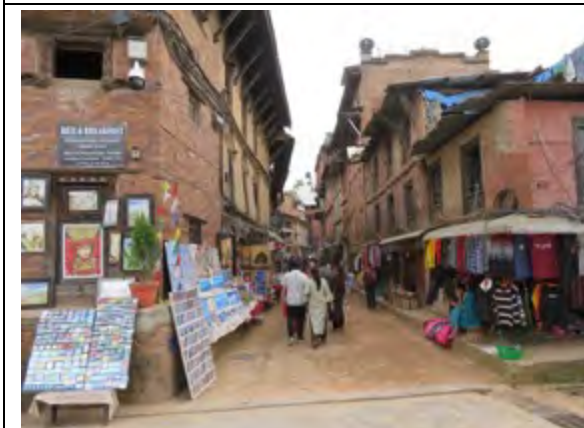
Earthquake damaged traditional houses near Dattatreya Square remain unrepaired (right)

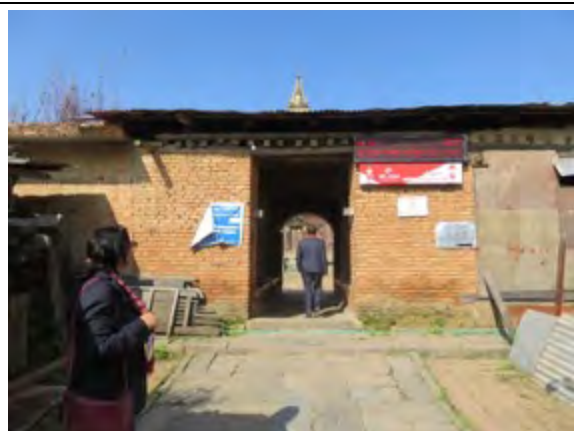
Eastern entrance to temple complex – brickwork has been repaired, but is missing its original detail; upper floor of sattal is still missing; new electronic signage has been mounted on the wall adjacent to the entrance and is intrusive to the temple context

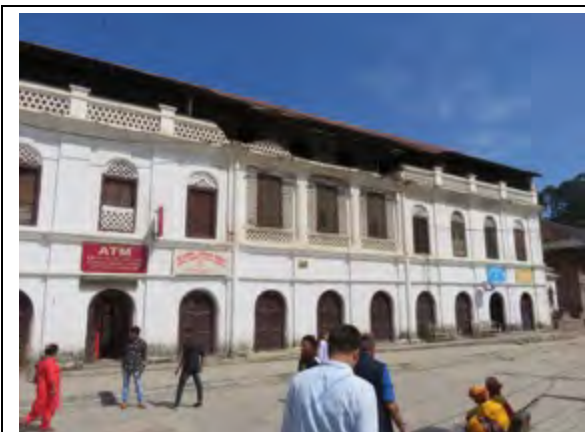
Damage to this early twentieth century building, located adjacent to the main path down to the river, has not been repaired as yet.

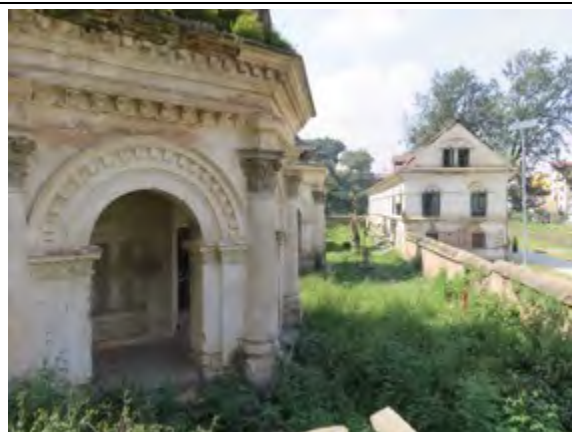
Temples near Bagmati River. It is intended to adapt the rectangular building as a museum.
