Republic of Iraq
Ministry of Culture, Tourism and Antiquities
State Board of Antiquities & Heritage
International Organizations Department
State of Conservation report
Ashur (Qal'at Sherqat)
In response to the extended 44th session of the World
Heritage Committee, Fuzhou, China 2021
Decision 44 COM 7A.7

Property name: Ashur (Qal'at Sherqat)

6. Ashur (Qal'at Sherqat) (Iraq) (C 1130)

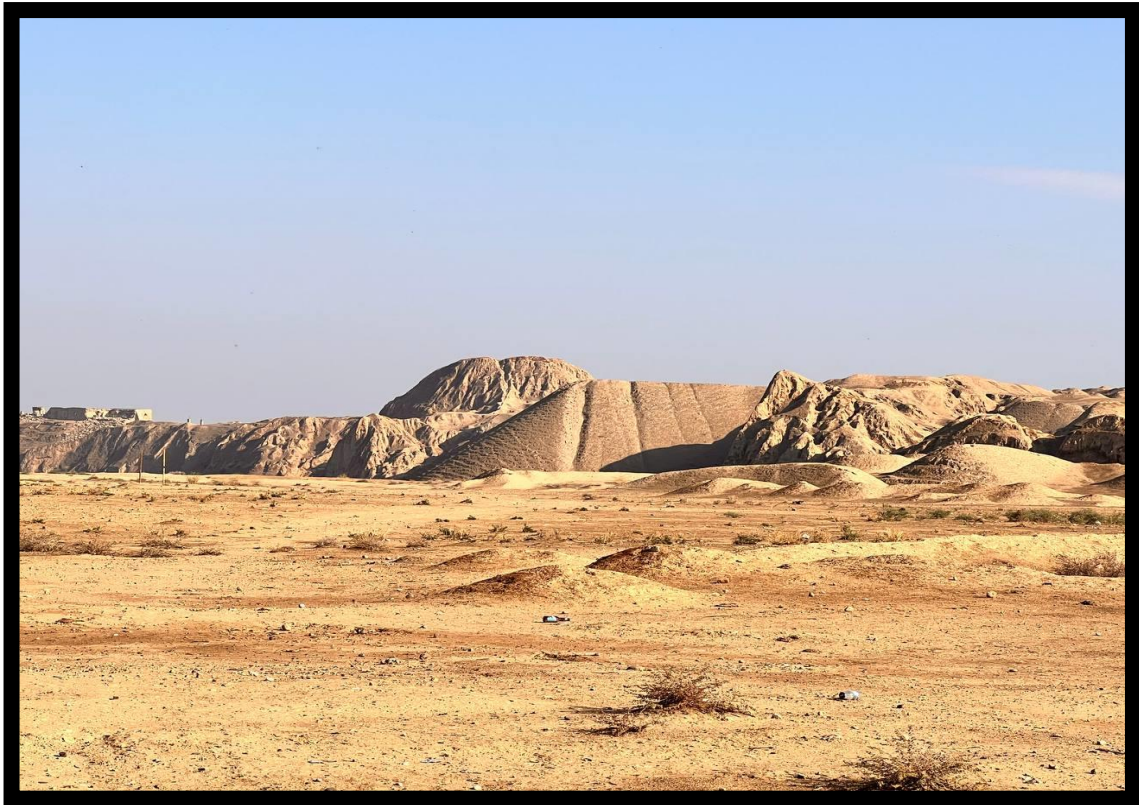
(Figure No. 4)

The city of Assur (Ashur) / the northern side / the cavernous area of the wall

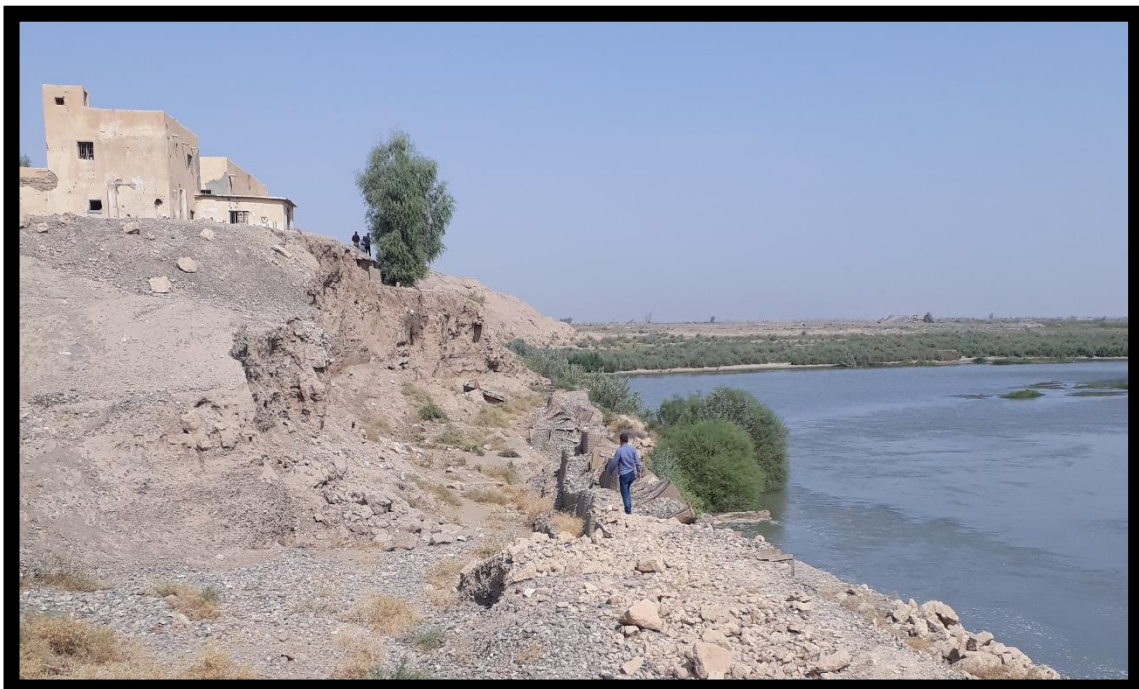
(Figure No. 5)

Within a few years, the river entered from the weak areas between the expedition residence and the estuary of the nearby valley in the south, then it entered to the city for a distance of 30 meters, and the distance is still increased. Therefore, the cliff is collapsing and the city is under threat, because the demolition takes hundreds of the archeological parts. So, the solution is to conserve and rebuild the Masnah (buttress) at a distance (73 meters) with the parts that preserved their foundations.

/ Al-Masnah / the cliff of the river / the danger is visible on Walter Andrae palace

1. The tributary is dried in the summer to search the path of the Masnah (buttress) foundations that buried in the dried-up river bed.
2. Working to find the original parts of the Masnah (buttress) and try to return them to their original places.
3. Rearranging the regulator nearby the Tigris Gate.

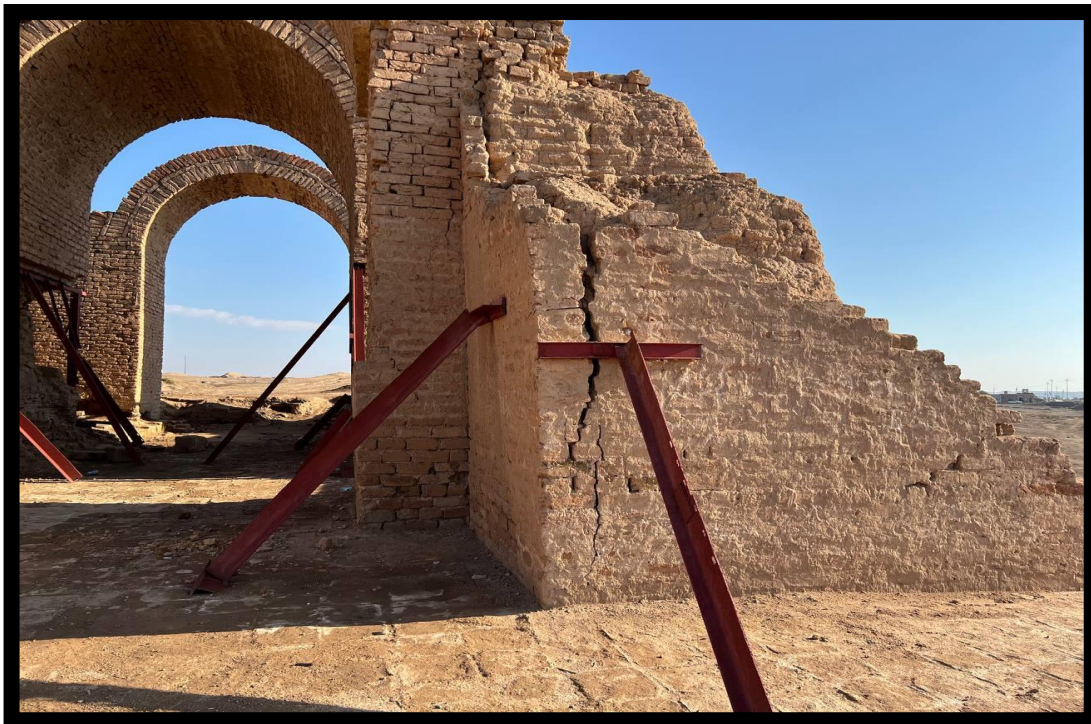
(Figure no.7)
Tabera Gate / Supporter elements

The supporter elements holding the arches have been damaged in a way that make us urged to accelerate their restoration and conservation before too late.

The bricks covering both supporters have collapsed significantly, and there is a serious damage to the stability of the arch. More than half of the northern supporter elements from the west collapsed. This forms an alarm sound of the possibility of the arch collapsing.

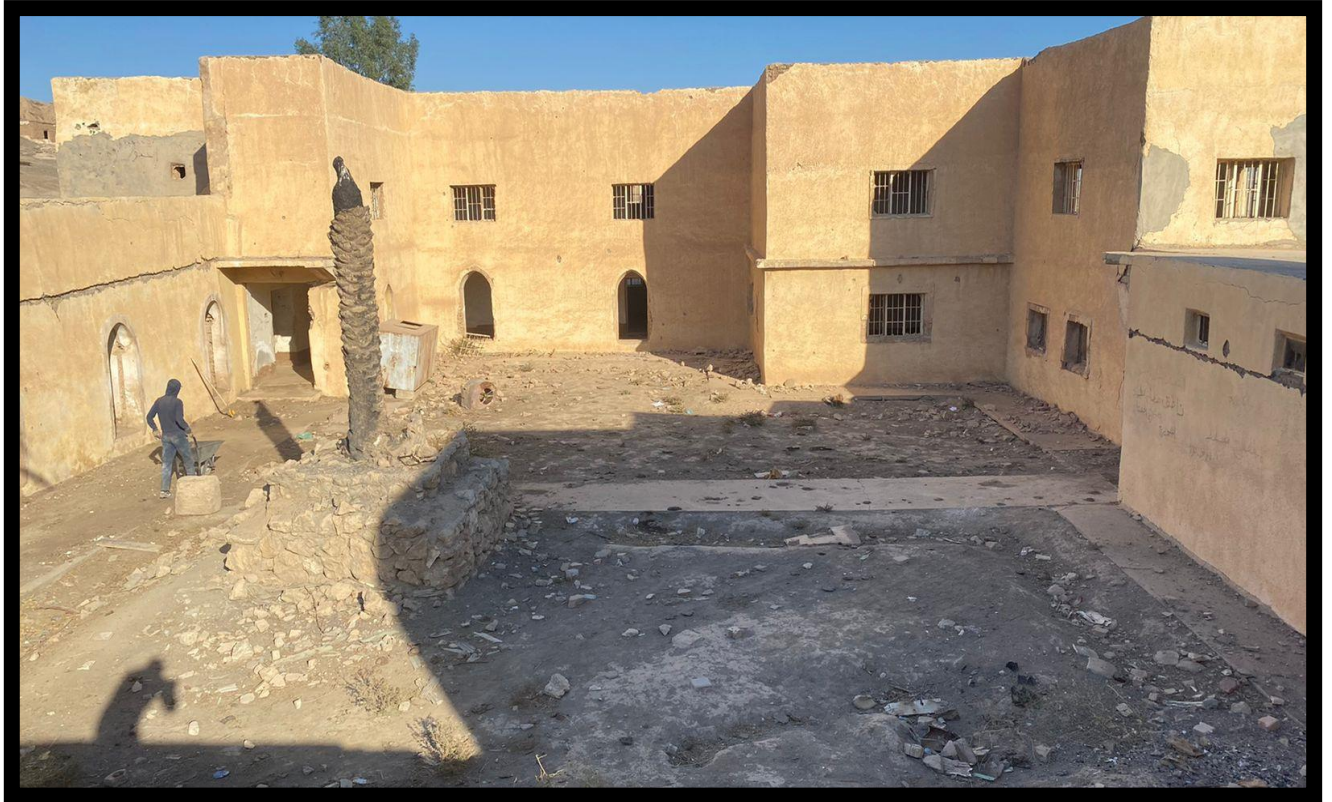
Figure no. 9

Walter Andrae Palace before cleaning

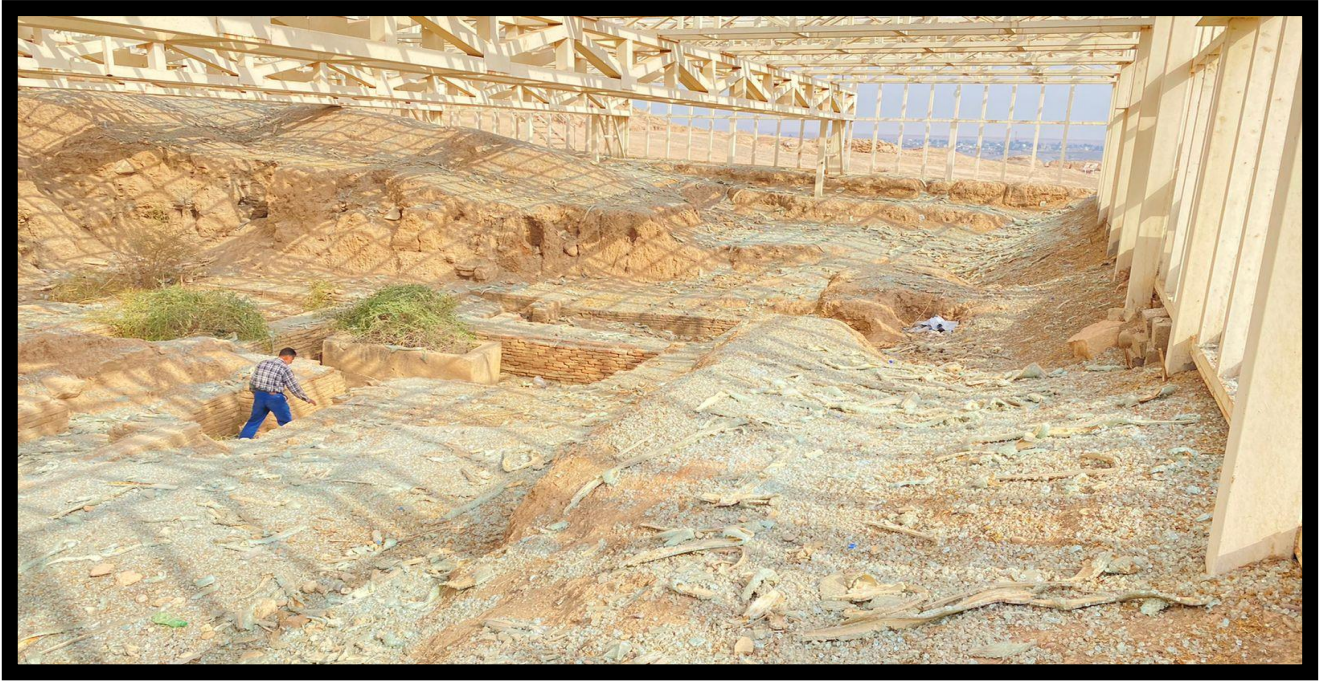
The vandalism of the cemetery by ISIS and due to the variance in time dilation, in addition to the natural factors of rain, wind and others, all these factors had a great impact on its walls which were conserved in the eighties of the last century. We renovated the old conservation by following a method based on the principle of minimal intervention after cleaning the cemetery and removing the natural plant that some of which had rooted between the wall bricks, to prepare them for conservation. It is noteworthy that conserving the walls protects the cemetery from water leakage from its sides during the rainy seasons, knowing that it was originally hidden underground since the time of Assyria, and it is

Figure 13 Royal Cemetry before cleaning

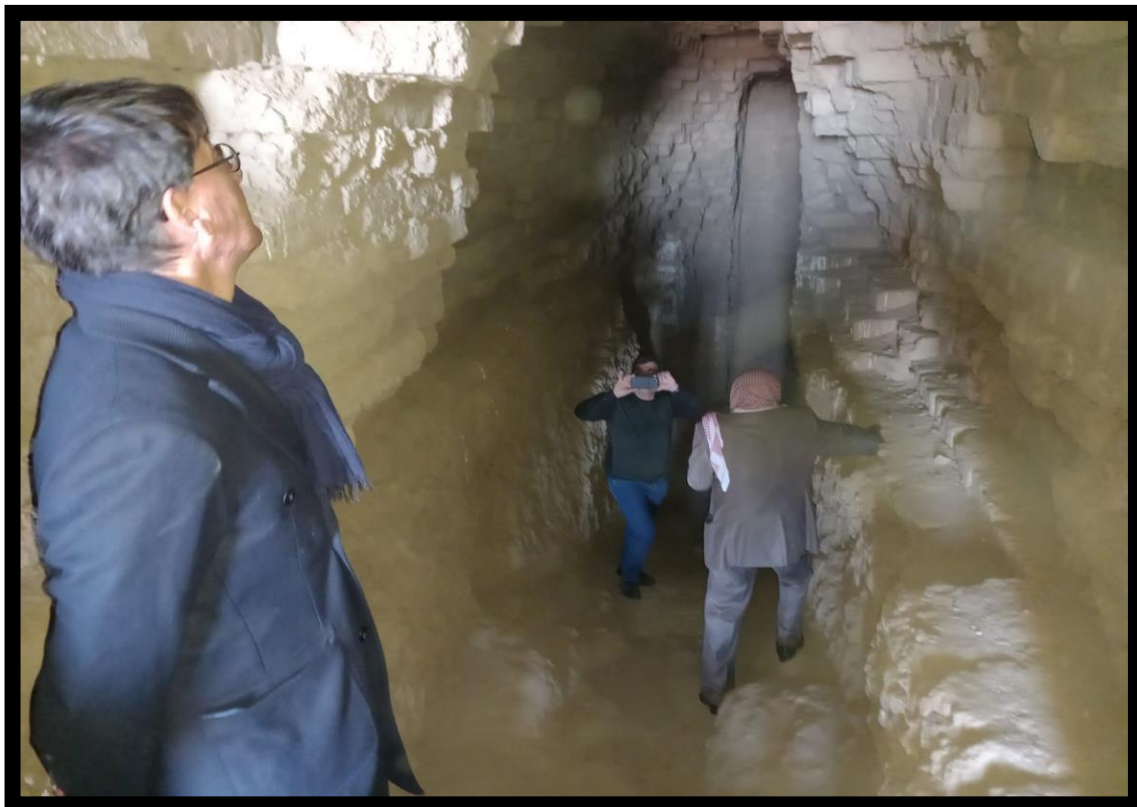
(Figure No. 19)

In 2018, in the winter, sound the alarm from inside Hormuzd Rassam tunnel, which refers to the existence of moisture in the south section of the tunnel and the moisture comes from the hole located in the back of the (top) of the Ziggurat from the outside, measuring (a square of side length 4 meters) and a depth of 8 meters, and the reason is the decayed adobe bricks in that hole where water and mud were accumulated. The solution is to patch this large hole in the body of the Ziggurat. Patching process is by removing the decay, uncovering the adobe bricks joints, and constructing the square hole (a scientific-practical construction).

The tunnel in the body of the ziggurat on its western side

It is noteworthy that the danger still exists despite the backfilling of the trench. As the decayed pocket remains at the top of the Ziggurat, the decay is still expanding, and the administration of the site constantly watch that alarm, which is still sounding. From our perspective that the moisture does not dry due to its source which is a deep decayed hole at the top of the Ziggurat. The solution is to clean the hole first and then build it with adobe bricks and mud, that will cut off the source of

moisture permanently, and as a precaution for the future, we see that the Hormuzd Rassam tunnel needs to be built with adobe bricks, starting from the center. There are other solutions to ensure that no tunnel or hole left, which should be implemented as soon as possible.

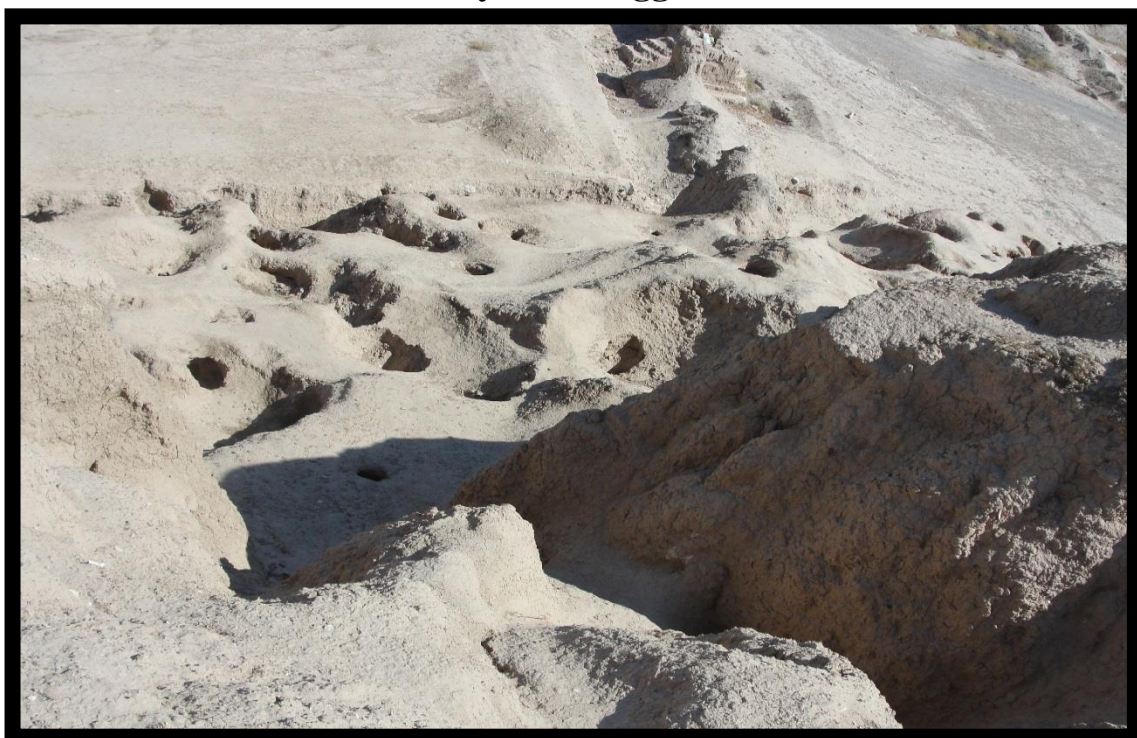
(Figure no. 20)

The opening in the southern side of the ziggurat

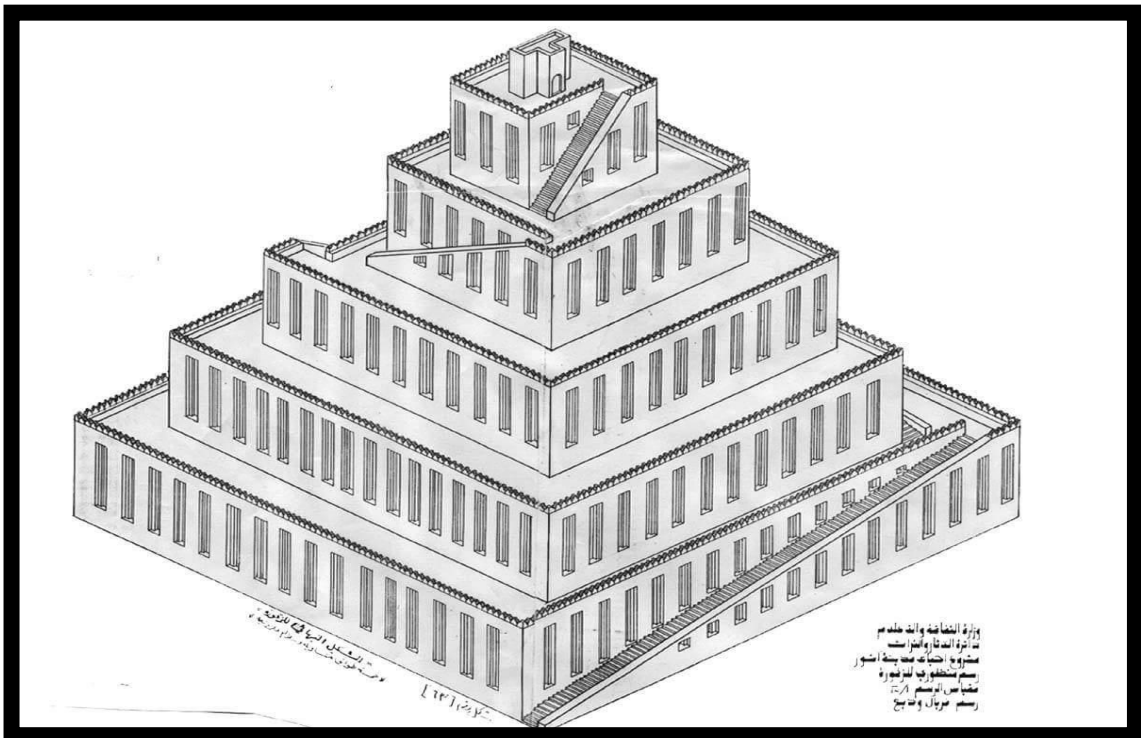
(Figure no. 22)

(Layers of the ziggurat of Assur (Ashur))

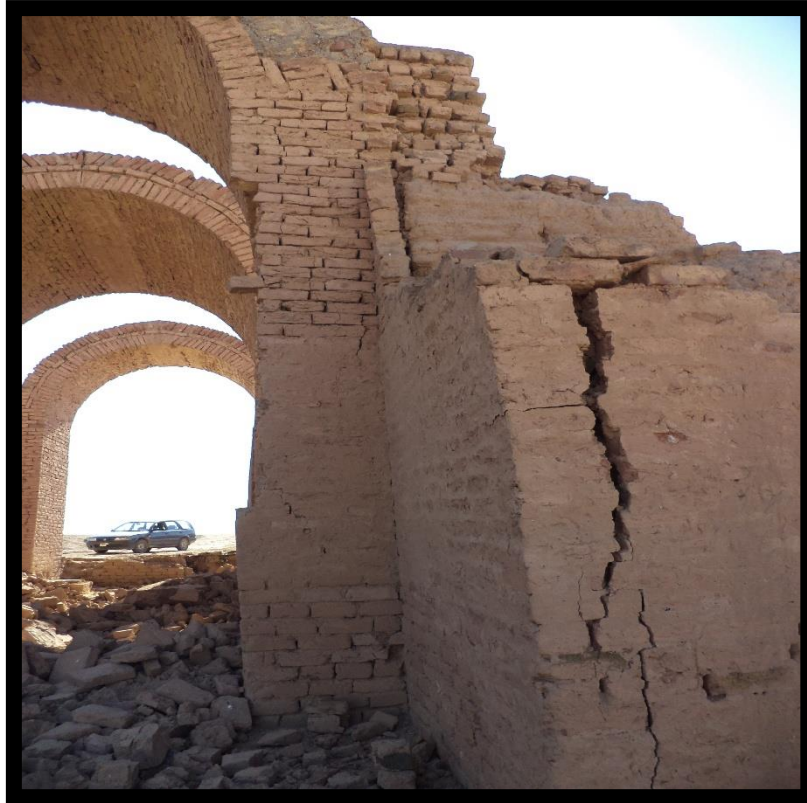
(Figure no.23)

Tabera was subjected to destruction, and a number of gunpowder barrels exploded inside. Its entire body was affected; as the covers of the brick walls fell and the brick cover fell from the inside also. Even the north tower (outer) had a severe crack that could lead to its collapse if not conserved. The supporting elements are the most damaged and its shape warns of danger and calls for urgent restoration, otherwise all the brick covering the walls will fall off.

Cracks in the body of the Tabera Gate after it was blown up

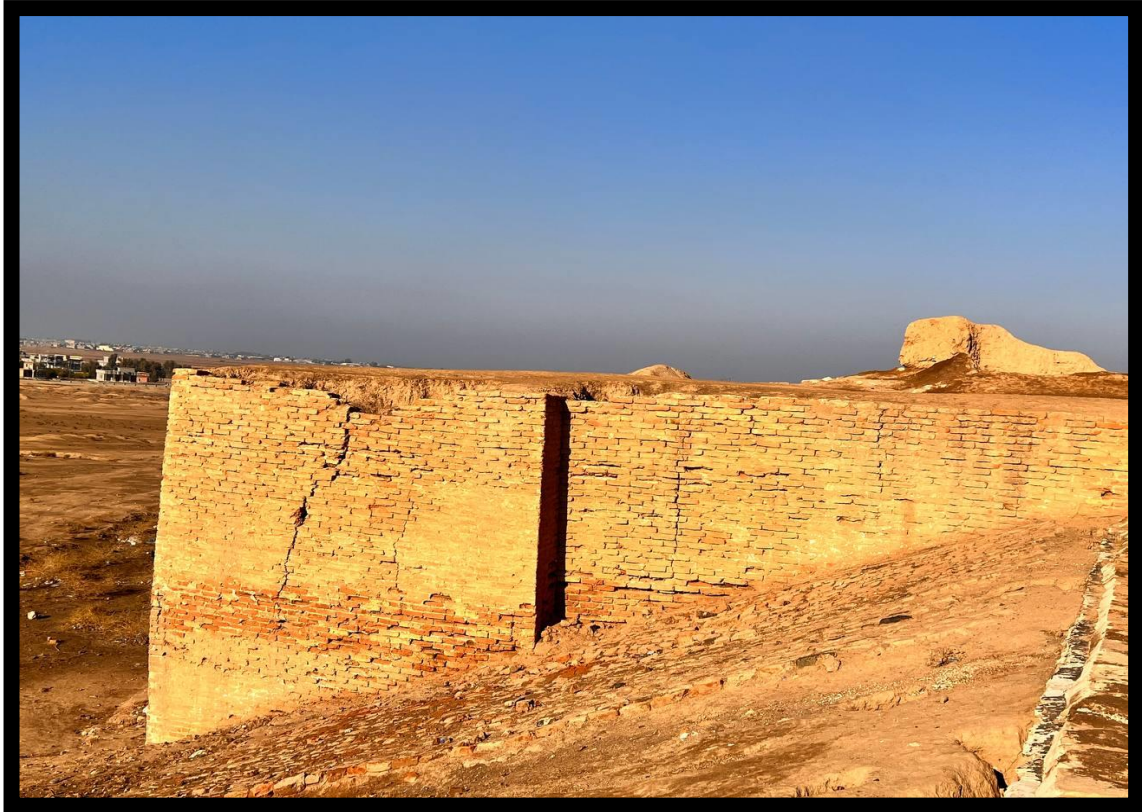
(Figure no.24)
Tabera Gate / North Tower / Effects of the bombing

This tower was not collapsed, but it was cracked vertically. The affected parts must be treated and reconstructed when the gate completed.

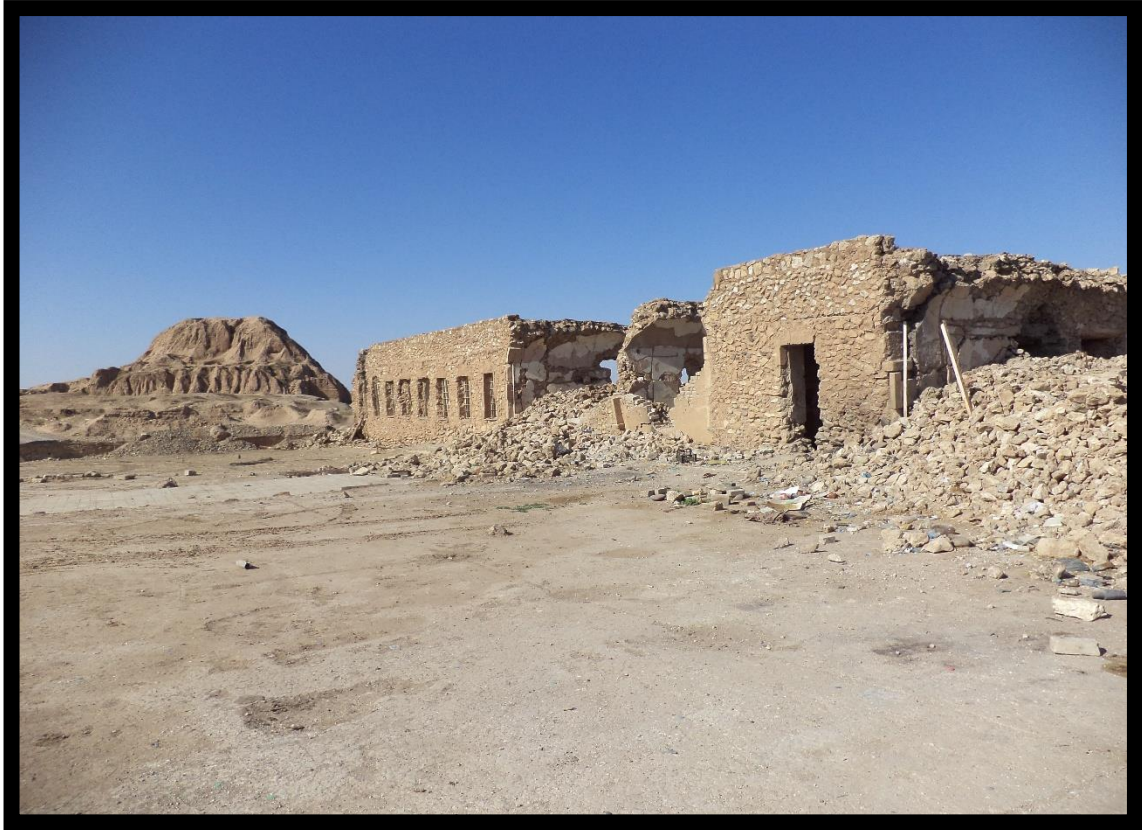
Farhan Pasha Palace was completely destroyed by ISIS. It was completely damaged and is included in the reconstruction. Sherqat site Administration-Saladin Inspectorate of Antiquities, are waiting for the decision of the UNESCO and the State Board of Antiquities and Heritage, which will be the first one in regards to the conservation of Farhan Pasha Palace or the temple of the deity Assur.

(Figure no.30)
Farhan Pasha Palace after the bombing

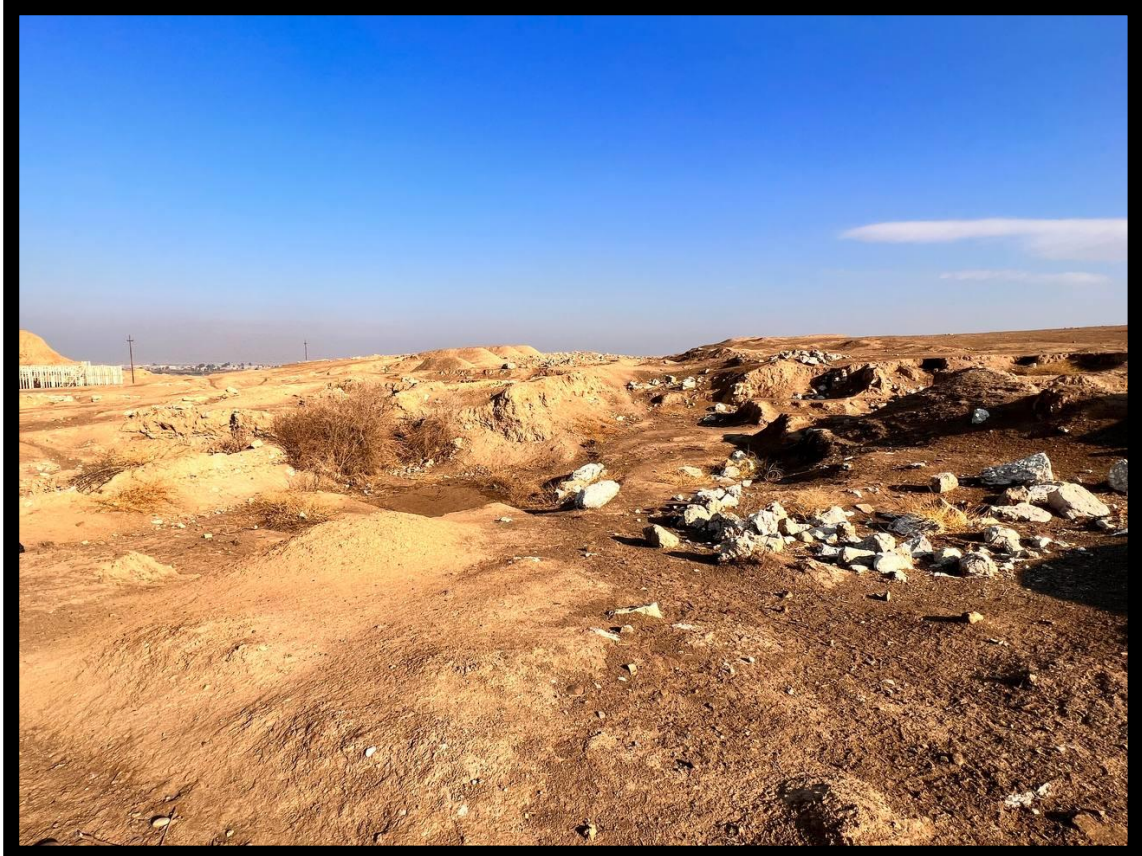
for the adjacent temple (**Sin – Shamash**), it is only an old hole in which there are fragments of limestone from which we do not understand anything other than that it was the foundations of the temple, but we are sure that the temple **Sin – Shamash** was here in this place.

The remains of the temple of Sin-Shamash
