Subject: **State of conservation report for the World Heritage Property 'Gelati Monastery'**

STATE OF CONSERVATION REPORT BY THE STATE PARTY

Gelati Monastery (Georgia) (C 710bis)

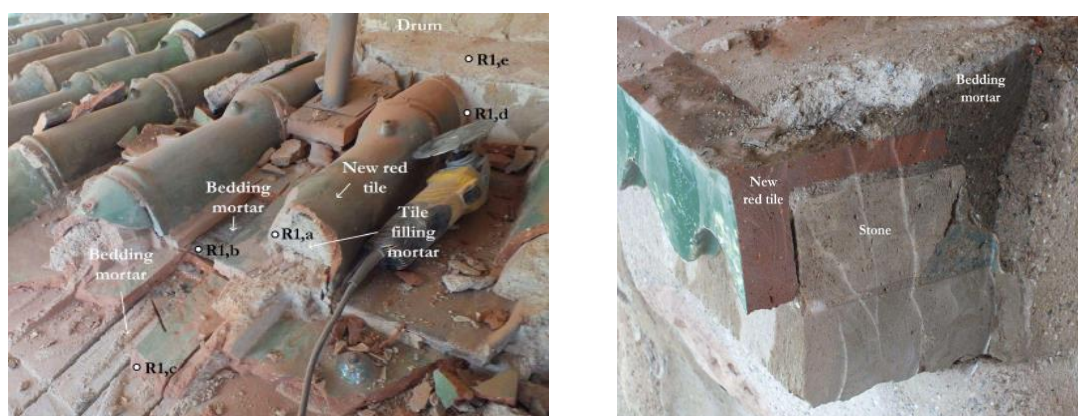
Sondage R1

The investigation revealed nine typologies of a new under-roofing filling implemented in the pitches of the Main Church. All the pitches of St. George’s Church are arranged based on one solution among the nine typologies employed in the Main Church. According to the investigation, the Church of St. George presents similar problems to those of the Main Church, although less serious regarding the situation with roofing. Thus, the final solution on the covering of the Main Church is also extendable to St. George’s Church.

In December 2021, ISPC-Cnr¹ and ReStruere LTD delivered the results of the tests on materials (see Annex 3: “Test on material samples taken on-site. Scientific report explaining the results of the tests”). In the meantime, the Georgian team, operating under the supervision of ReStruere LTD, carried out further investigations and sondages on some pitches of the Main Church (see Annex 4: “Technical Report with Photo and Graphic Documentation Regarding the New Sondages”). Following the sondages on the pitches and the results of the tests on the materials, the reason for the infiltrations became clear. The external covering of glazed tiles supported by an under-roof filling composed of various materials through a thick layer of lime mortar favoured the water infiltration. The adopted strategy of filling the under-roofs, the material of the glazed tiles, the building techniques employed and the shape of the new roofing system are inappropriate and insufficient for protecting the property.

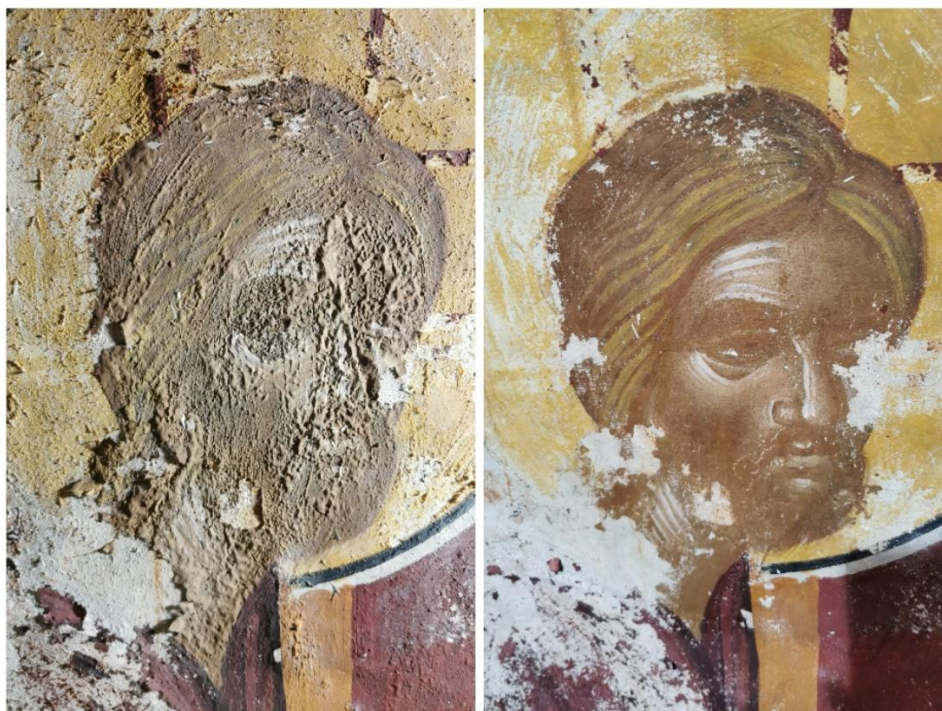
Before consolidation

After consolidation

Between 16 and 21 September 2021, the State Party organized the **Second Emergency Mission**, led by the Italian conservator-restorer Vincenzo Centanni with the involvement of the group of Georgian conservator-restorers to monitor the state of conservation of the wall paintings in the Main Church and to compare it with what was previously detected in June 2021. Following the monitoring, the restorers provided immediate consolidation of the layers of plaster and the pictorial film, according to previously verified methodology, in all points, where a danger of imminent fall of the portions of the painted plaster and the pictorial film was exposed (see Annex 9: “Article on the emergency conservation-restoration intervention of the Frescoes of the Church of the Nativity Gelati Monastery” by Vincenzo Centanni, Marco Pulieri).

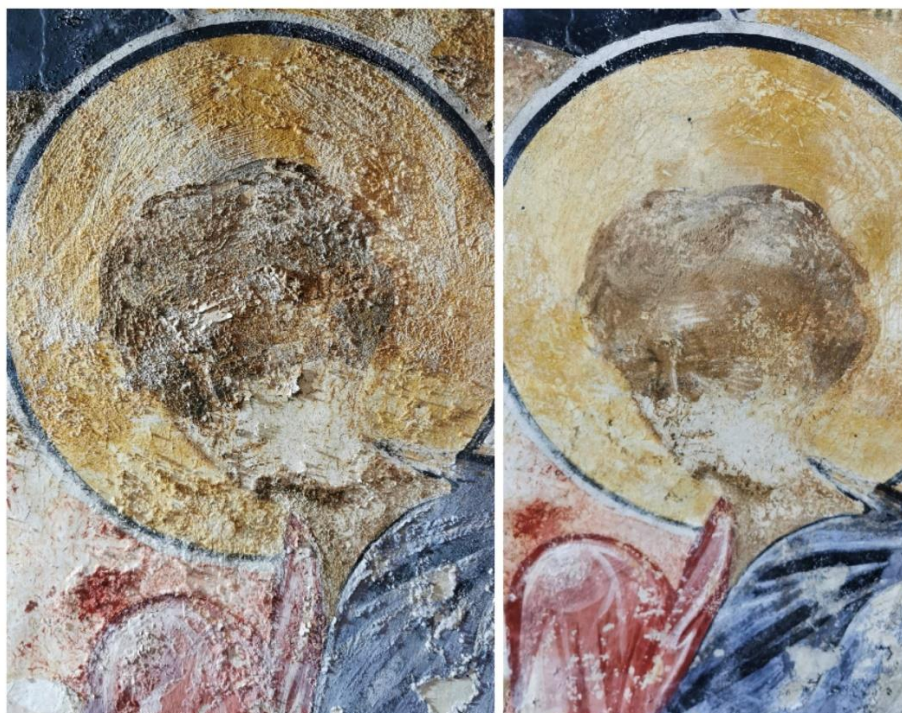
Before consolidation

After consolidation

From 05 to 12 November 2021, the State Party arranged the **Third Supervision Mission** led by the restorer Marco Pulieri to monitor the state of conservation of the pictorial film by comparing it with that found in the two previous interventions. Following the monitoring, the adopted methodology proved to be perfectly suitable for the degraded situation. Thus, for the safety of every critical point of the pictorial cycle of the West arm, the Mission launched a color and capillary plaster consolidation campaign that was completed at the beginning of December by the team of Georgian restorers under the supervision of the Giovanni Secco Suardo Association. The Missions also served as a capacity-building activity for the Georgian restorers involved in the restoration process undertaken by the international experts concerning the methodology developed and materials to be used in the conservation intervention.

At the moment, the stability and safety of the entire surface of the wall paintings of the West arm is secured (see Annex 10: “Report on the State of Conservation of the Gelati Monastery World Heritage Property, Georgia. Mission of 05-12 November 2021” by conservation specialist of wall paintings: Marco Pulieri).
