STATE OF CONSERVATION REPORT

OKAVANGO DELTA WORLD HERITAGE SITE

**Annexure 1: Audit Report for Construction of Bridge Over
Okavango River at Mohembo**

Report on Audit of 18 – 19 August 2021

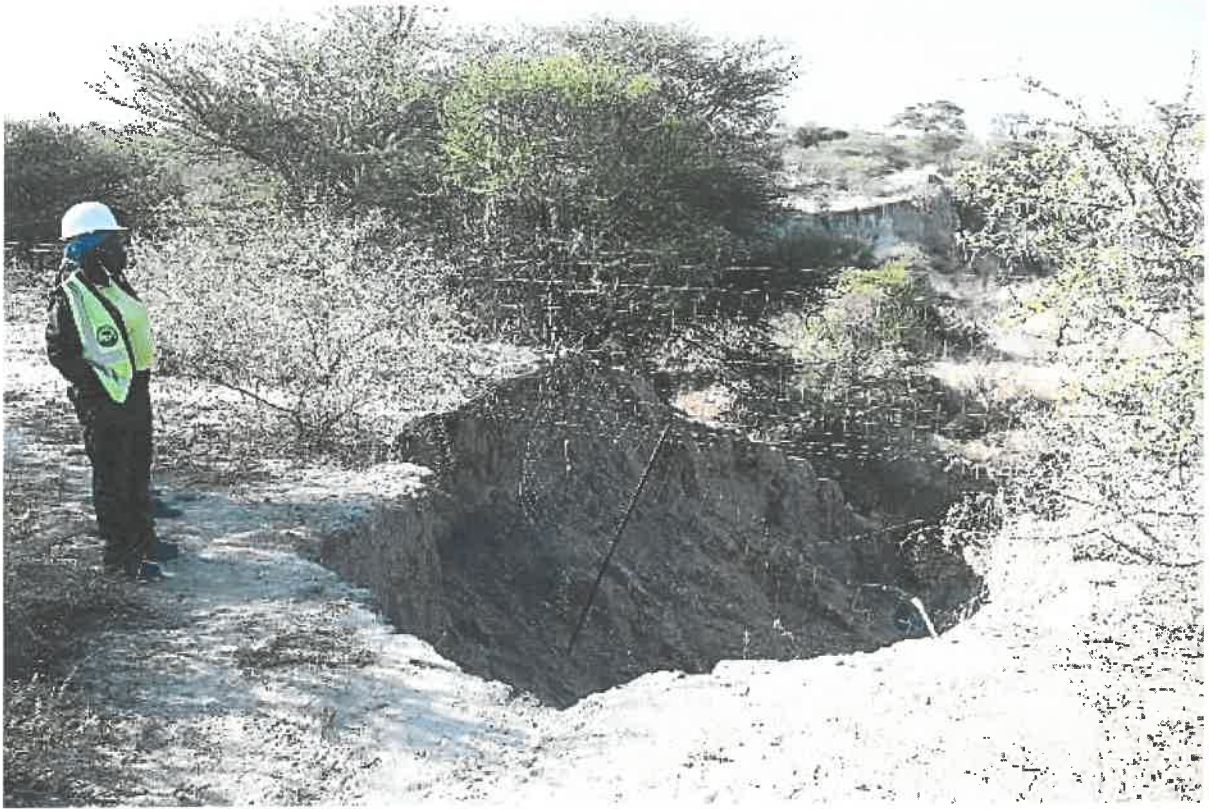
Figure 1. Gully encroaching into fence at Samochima Burrow Pit

The Shakawe and Samochima burrow pits were fenced using a 1.5m grid fence. This was considered a commendable standard as it was largely animal proof. Given that these burrow pits were in the centres of livestock/wildlife area, the provided fences were deemed to be reasonably useful. The integrity of the fence needs attention/maintenance. Access, livestock which would lead to conflict with neighbouring land users. No fence was observed around the Shadikekete Burrow Pit.

Summary Finding	Rating
Where available, fencing was of commendable standard, although maintenance required.	Partially compliant

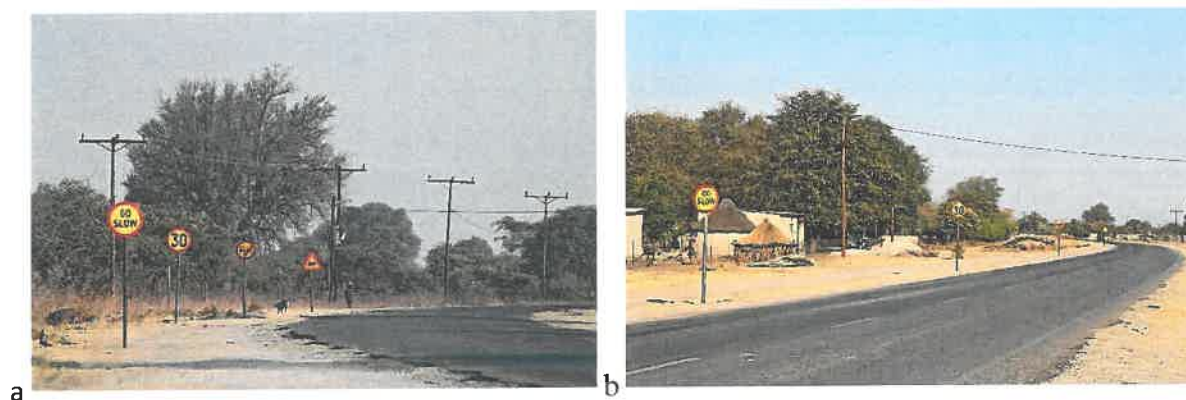
Figure 2 Signage near Shakawe Burrow Pit

Signage was reportedly confined to times when there were activities as signs were reportedly frequently stolen. During the audit, signage was available along the tarred road closest to Shakawe Burrow Pit (see Figs 5).

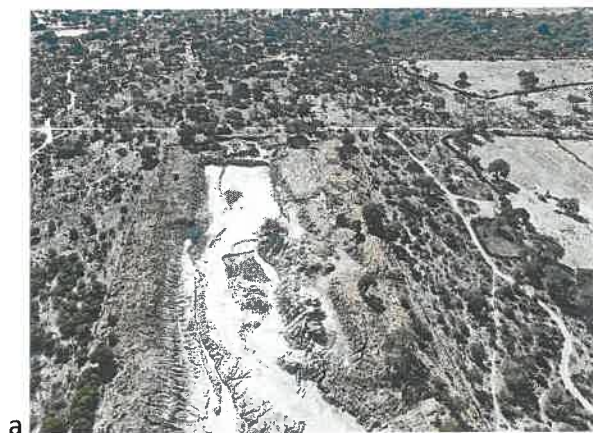
Figure 3 Aerial view of Burrow Pits at Samochima

- At Samochima, the banks were steep and unrehabilitated. Given the excavated depths, the servitudes were likely inadequate for rehabilitation.

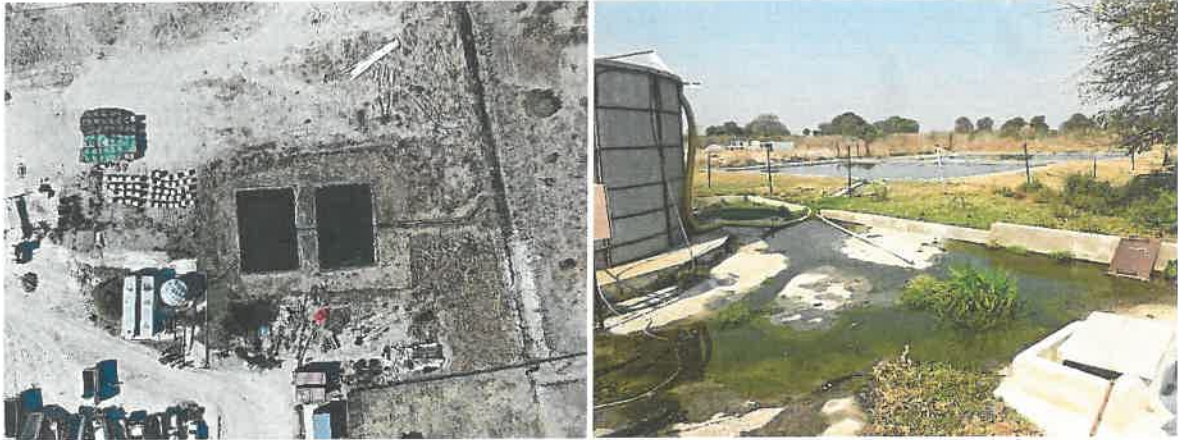
Figure 5 Aerial view of the Wastewater Treatment Plant

Sewage from the contractor's camp was treated using an onsite WTP. Details of the design were not known to the environmentalists. The facility is not licensed in spite of requirements of the Waste Management Act and recommendations of the previous environmental audit.

Finding	Rating
The facility is not licensed	Partially compliant

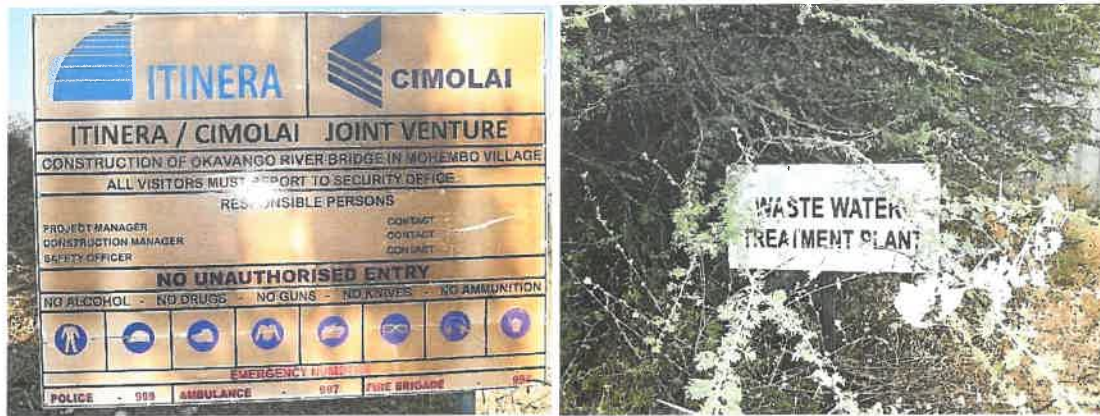
Figure 8. Signage at WTP

No signage at chemical storage facility, no demarcation, no access control. Poor signage (

Finding	Rating
No signage at some points	Partially compliant

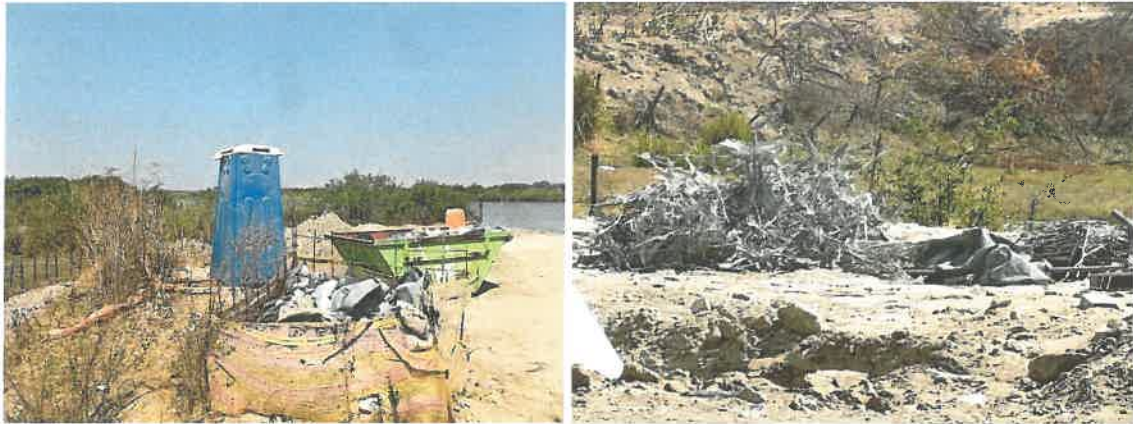
Waste management is commendable and complying to EMP.

Finding	Rating
Waste management is commendable and complying to EMP.	compliant

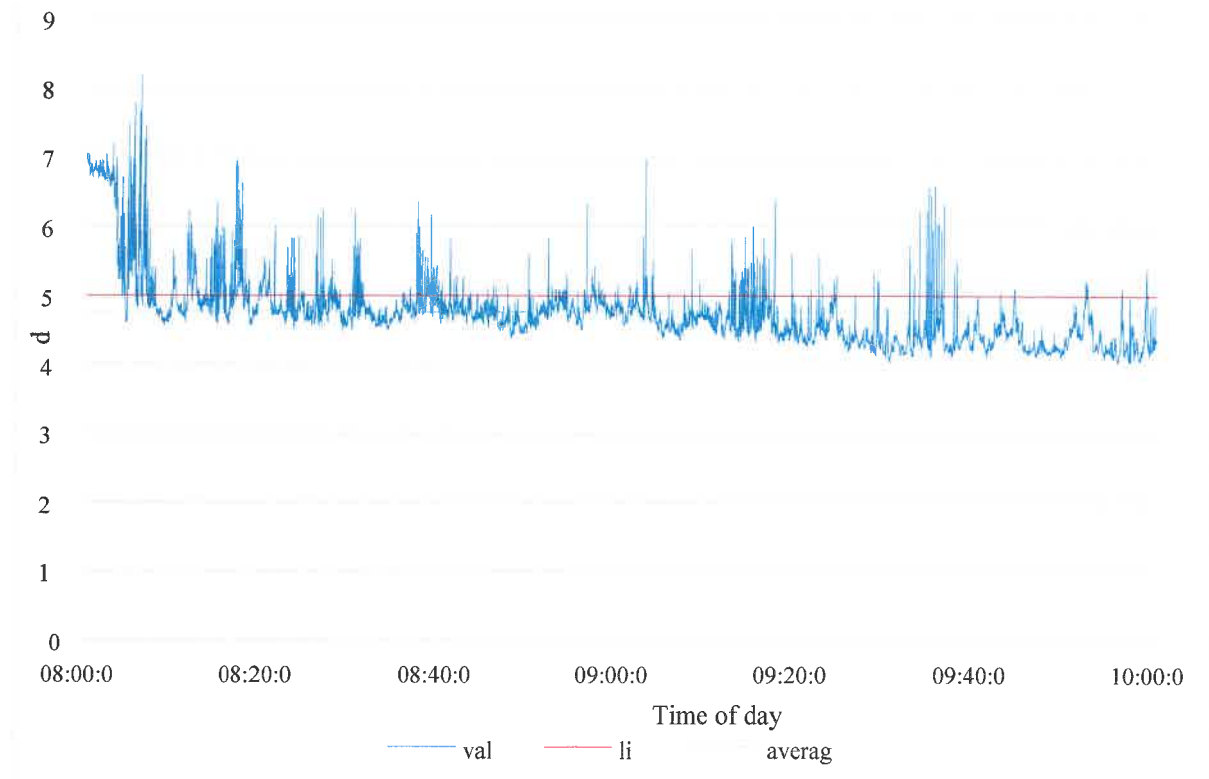
Figur 1 Noise monitoring results

Independent noise sampling was done on the morning of the 19th August 2021. Monitoring was done from 18°17'14.4"S 21°47'17.4"E, which is a residential area lying 200m from the contractor's camp at a bearing of 280°. Monitoring was done for a period of 2 hours, being 0800-1000hrs. Measurement was done on a MT975 noise meter, erected at a height of 1.5m. Deployment was inside a reed shelter with the only opening being a door, which was left wide open. The weather for the morning was calm, with a low breeze in the south westerly direction. No precipitation was noted.

The observation was that the readings for the morning ranged from 38 to 53 dB, with an average of 48 dBA. Although this was below the legal threshold, the proximity was only within 2dB of the threshold - suggesting that exceedances were likely as can be observed in Fig 11.

Finding	Rating
	compliant

Satisfactory compliance to BOBS standards (below 50 dBA). Recommendation for use of monitoring protocols as prescribed in BOS 575:2013 standards.

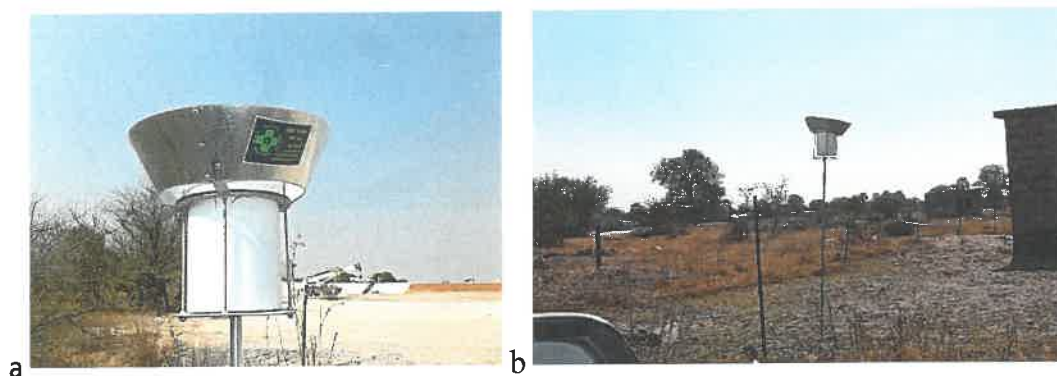
Figure 12. some of the dust buckets observed

Finding	Rating
Dust monitoring at Bridge and contractor's camp	compliant

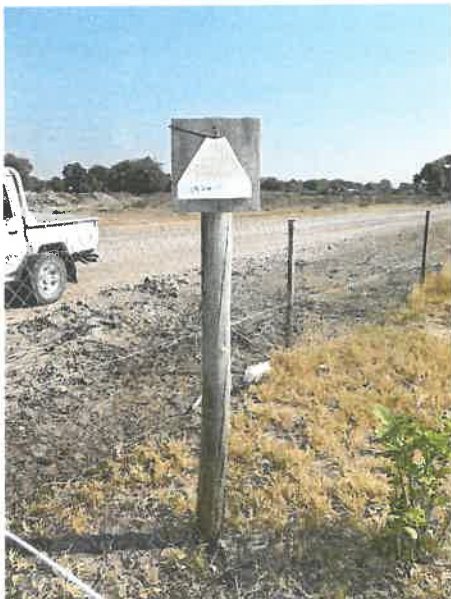
Figure 13 Air quality monitoring station at the cement batching plant

There was an active programme for monitoring the quality of ambient air, as proven by the monitoring records as well as the monitoring stations at the cement batching plant.

Parameters included BTEX, PM₁₀

Finding	Rating
Evidence of air quality monitoring station at cement batching plant	compliant
