#### **State of Conservation Report**

## Gusuku Sites and Related Properties of the Kingdom of Ryukyu (Japan) (C972)

## 1. Executive Summary of the Report

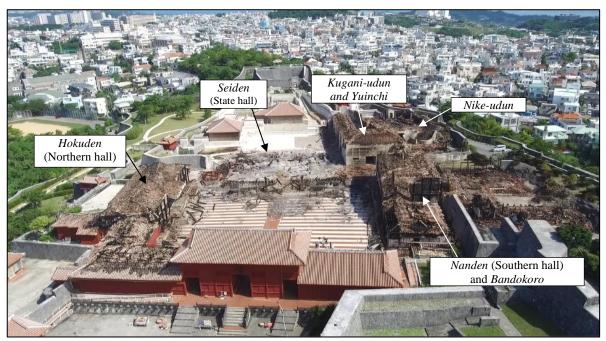
Shuri-jô site after the fire (November 2019)

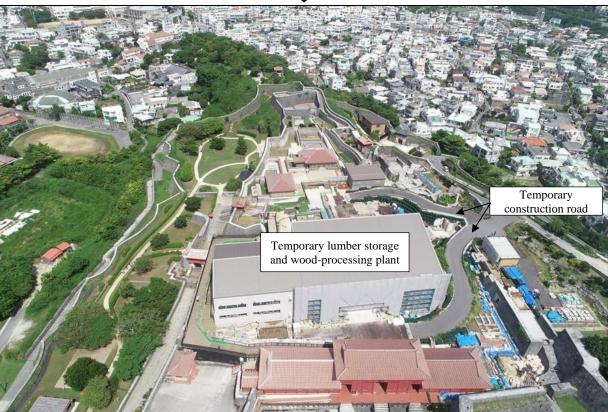
Up-to-date view of Shuri-jô site (August 2022)
