REPORT
of the Joint World Heritage Centre/ICOMOS/ICCROM
Advisory mission
to the World Heritage property “Gelati Monastery” (Georgia)
28 November – 2 December 2022

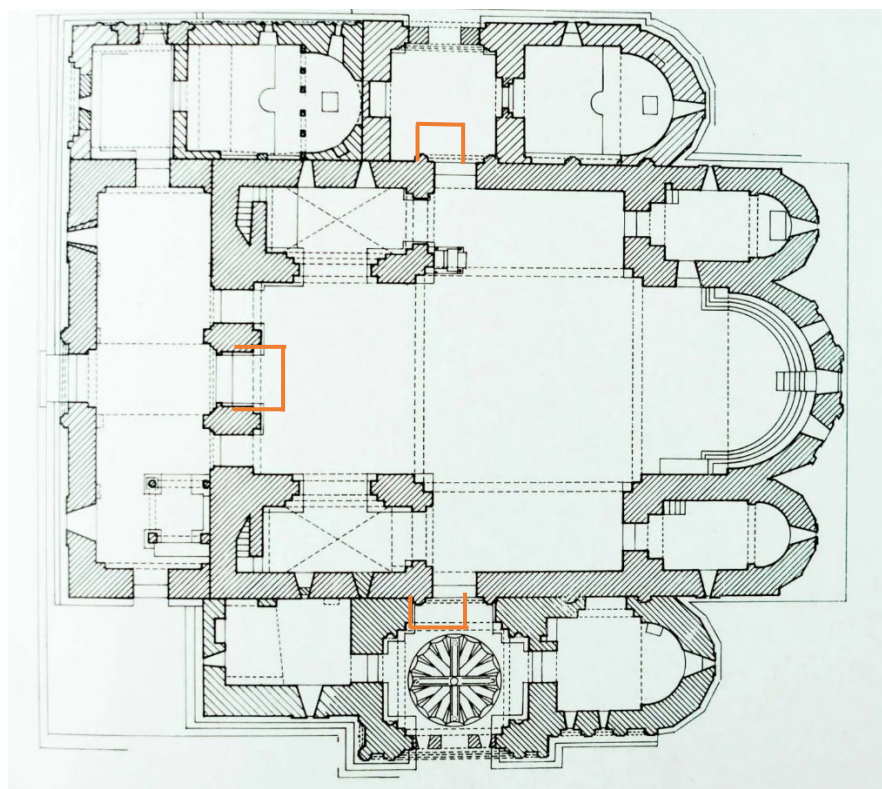
Fig. 2. Church of the Nativity of the Virgin ground plan (with indications of the places of the proposed temporary additional anti-wind doors)

16. Installation of additional temporary double wooden doors (wind barriers) at the three entrances to the naos is recommended, as well as closing of some of the open windows to reduce wind-driven moisture ingress, depending on the monitoring process results.

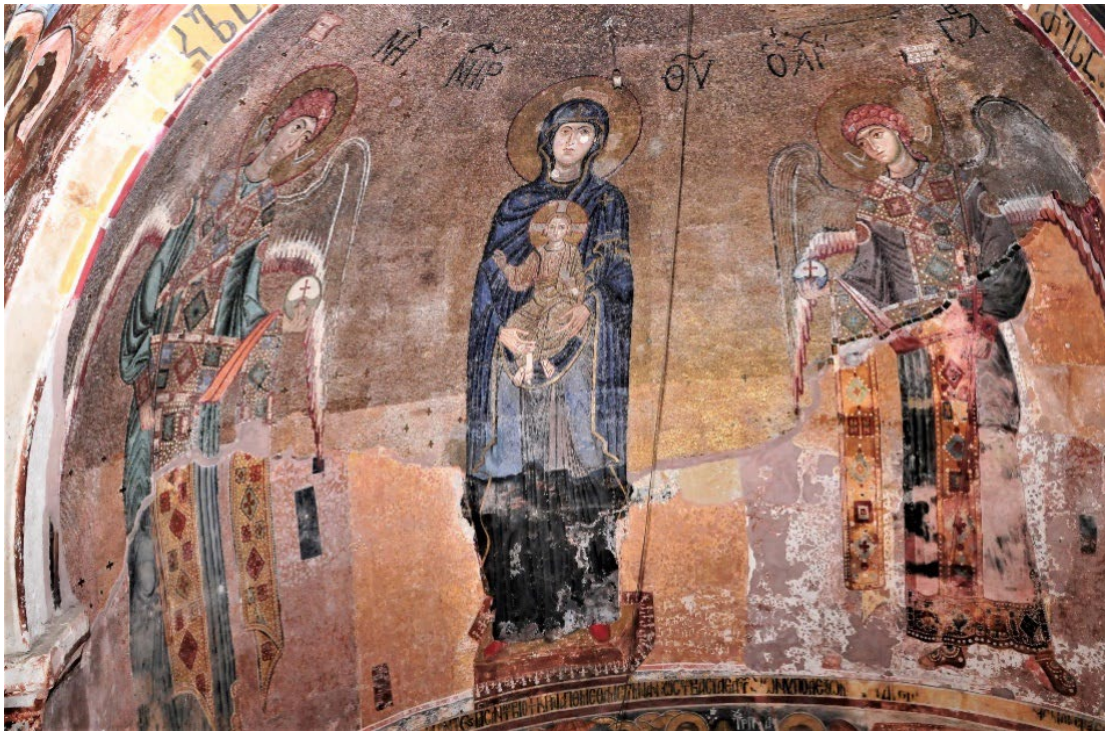
Fig. 3. The central part of the altar apsis with the mosaics

The Main Church of the Gelati Monastery is the only Medieval monument in the larger historic region of Eastern Asia Minor and the Caucasus that still has well-preserved mosaic decoration, comparable with the best Byzantine mosaics, as well as having the largest ensemble of paintings of the middle Byzantine, late Byzantine, and post-Byzantine periods in Georgia, including more than 40 portraits of kings, queens, and high clerics and the earliest depiction of the seven Ecumenical Councils (fig. 3).

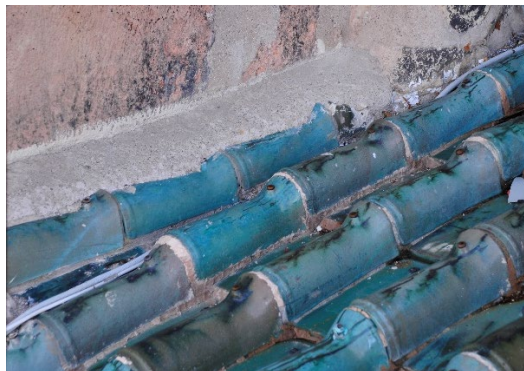
Fig. 7. New roof covering on the northern side

- Roof typologies: Nine typologies, different or in combination, of new roofing with under-roofing filling have been implemented over time (fig. 4-6).
- Defective materials: Glazed tiles (both white and red type): the tests carried out at the *Consiglio Nazionale delle Ricerche - Istituto di Scienze del Patrimonio Culturale* showed that the tiles used could not guarantee effective protection from water infiltration due to their composition and inadequate baking. The new glazed tiles exhibit a porosity value greater than the average value for comparable medieval tiles (fig. 7).

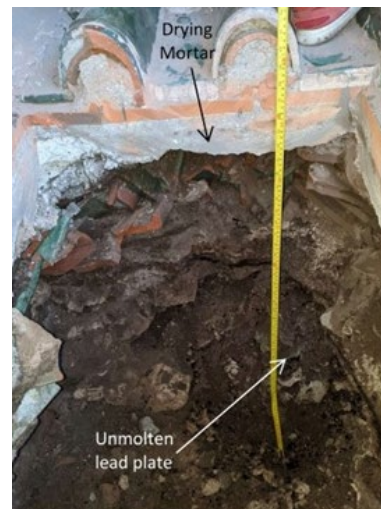
Fig. 8. Survey N1, on the north slope of the west arm and at the edge of the wall of the drum base (pitch N2) – section, view from the west (Georgian team report, 1/2022)

Fig. 9. Survey N1, view from the north: moisture found in the mortar and in the other filling materials (Georgian team report, 1/2022)

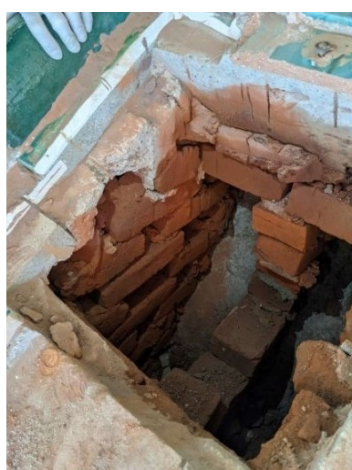
Fig. 10. Survey N3 on the east slope of the apsis roof (pitch N13), view from the north-east: plenty of moisture under the glazed tiles (Georgian team report, 1/2022)

Fig. 11. Survey N3, section, view from the north (Georgian team report, 1/2022)

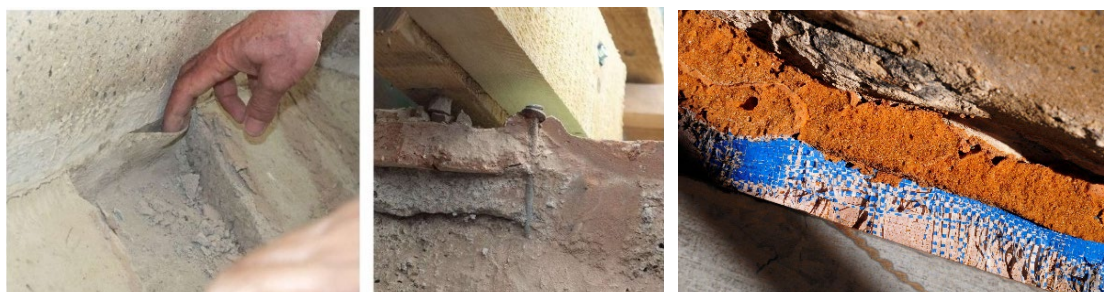
- Incorrect installation technique: A thick layer of porous lime mortar, capable of absorbing a lot of water was installed as fill under the tiles. In some pitches no water/moisture insulation layer is installed. Even where some kind of water/moisture insulation is present, both the material (quantity and thickness) and the installation are defective. The large quantity of the filling material under the tiled roofs absorbed the water transferred from the tiles layer and constituted a reservoir of humidity (fig. 8-11). The nails used were rusty, while the thickness of the mortar between the insulating layer and the tiles was not sufficient to ensure that the nails fixing the tiles do not pierce the water insulating layer, making the latter ineffective (fig. 12-13). Special tiles, used for meeting the geometry of the curved shape on the domes covering the Churches of the Virgin and Saint George, are not present in the apses, where the tiles are simply doubled by juxtaposition (fig. 14-15).

Fig. 12. Incorrect installation technique: a short strip of insulating material / nails penetrating the liquid insulated mortar (by ReStruere)

Fig. 13. Insulation coating layers added more lately (2022 Joint WHC/ICOMOS/ICCROM mission)

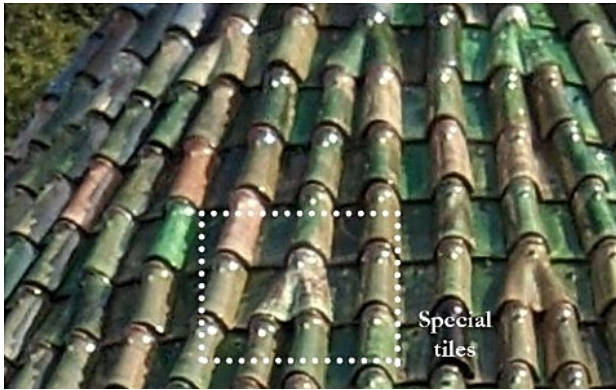
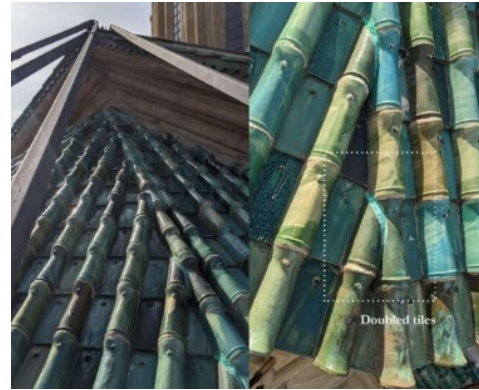
Fig. 14. St. George's dome. The special tiles are clearly visible (photo provided)

Fig. 15. Doubling of tiles obtained by juxtaposition on the apses (photo provided)

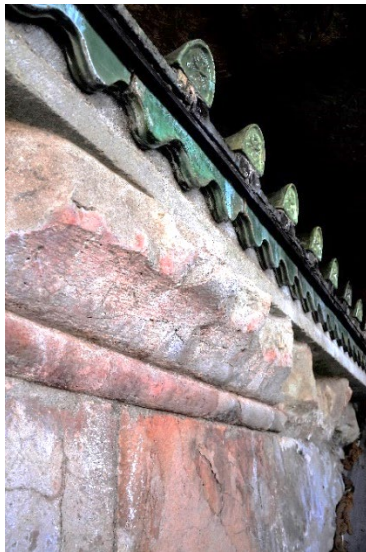
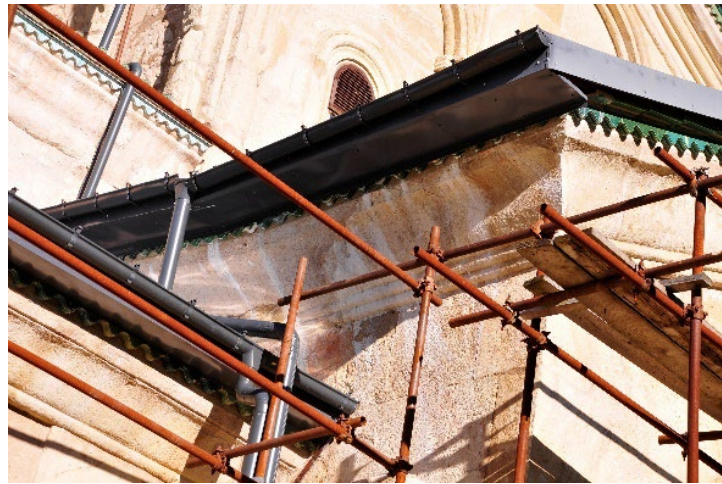
- Un-functional design solution: The roofing of the pitches does not have sufficient overhangs to guarantee the protection of the cornices and other parts of the stonewall (fig. 16-17). There are no specific protection devices (such as flashings) on the intersection surfaces between the pitches and the vertical walls or in coincidence with the impluvium where the risk of infiltration is greater (fig. 18-19). The above is compounded by the absence of devices useful for the collection and channelling of rainwater (gutter and downpipes).

Fig. 16. Base of the cupola drum: the original stone protrudes even more than the new addition

Fig. 17. Washout results on the carved cornices due to the absence of overhang of the new roofing pitches

- e. Approval of the creation of roof overhangs above the cornices. It is advisable to restore the cornice shape according to the authentic cornice, which should prevent damage to the walls from precipitation and to the church structure from water infiltration.
- f. The roofing tiles should be changed over the dome of the Main Church and the other buildings of the monastery complex where the same glazed tiles have been used.

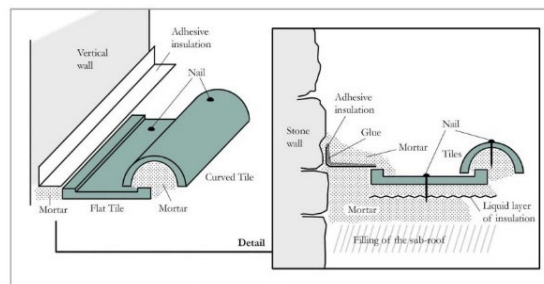
Fig. 18. Scheme of the sontage R2 - Incorrect installation technique (by ReStruere)

Fig. 19. Scheme of the sontage R3 - Incorrect installation technique (by ReStruere)

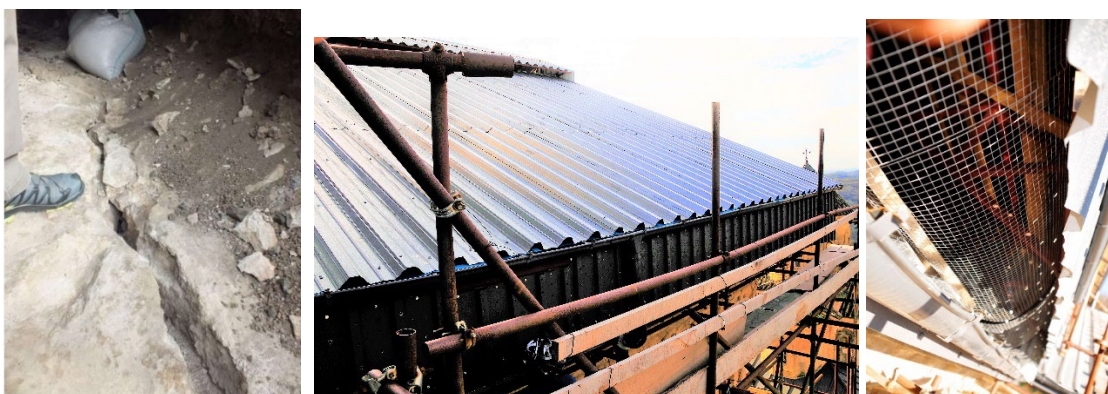
- The west arm covering was removed, including the glazed tile roofing and the temporary metal cover. The removal of the layer of the new filling (new intervention and the old – collapsed and incoherent) on the south side of the west arm revealed a longitudinal crack, affecting the top of the wall (fig. 20). Inspection of the external south facade of the west arm revealed findings of fractures in cornices and arches, evidence of the

Fig. 20. Southern wall of west arm. Longitudinal crack on the top of the wall (by ReStruere)

Fig. 21. West arm, new temporary roofing

Fig. 22. Openings allowing air to circulate and facilitating moisture evaporation outside the extrados of the west arm

- Provisional consolidation of the crack by using “staples” and levelling of the anchorage surface, avoiding using cement, but using instead a special pozzolana mortar (MasterEmaco 285 Tix).
- Installation of a temporary emergency cover protecting the west arm from the ingress of rain. The new temporary roof is placed on an iron truss system, which is supported by reinforced truss piers, fixed along a concrete base, on the insulated substrate protecting the longitudinal cracks. It is raised at a high of approximately 1,20 m over the lower level, giving the possibility to work under it and allowing the movement of air (fig. 21-24).
- Removal of the under-roof filling: only the layer of the new filling (new intervention) and the layer of the old lime-based conglomerate, and only when it is already collapsed and incoherent; work done under the supervision of an archaeologist.

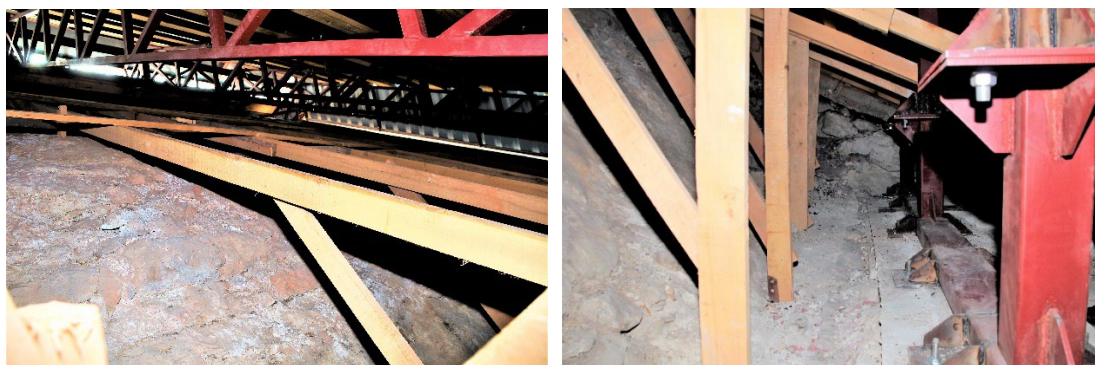
Fig. 23. The iron truss system supporting the new temporary roof covering the extrados of the west arm

Fig. 24. The reinforced truss piers supporting the iron truss system, fixed along a concrete base, on the insulated substrate protecting the longitudinal cracks

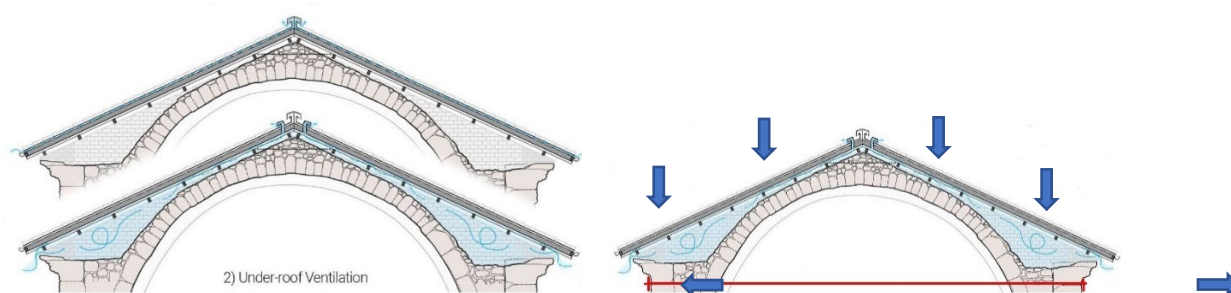
Fig. 25. Proposal for a new roof construction based on two separate circuits for the airflow to obtain an optimal roof ventilation system (by ReStruere)

Fig. 26. Potential intervention against failure risks under strong future seismic stress (2022 Joint WHC/ICOMOS/ICCROM mission)

- d. Adoption of a double roof ventilation system without, however, removing the old mortar if it appears to be solid/rigid (fig. 25). The new roofing system should permit the evaporation of humidity to the outside through the ventilation capable of aeration the under roof/vault extrados. This space will be partially empty to facilitate transpiration and ventilation and, in addition, to reduce overhead load on the building. When choosing the materials to be used, preparing the design of the roof and its details, as well as their specifications/indicators, the meteoric factors affecting the durability of the

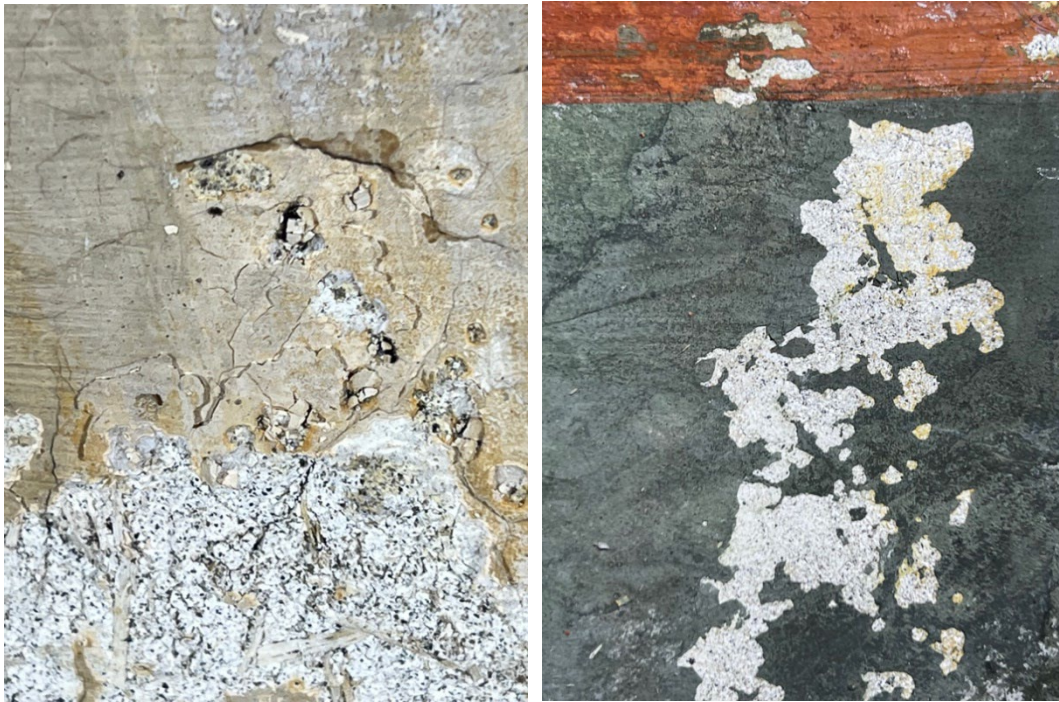
Fig. 27, 28. Subflorences and paint layer detachment in the southern wall of the west wing

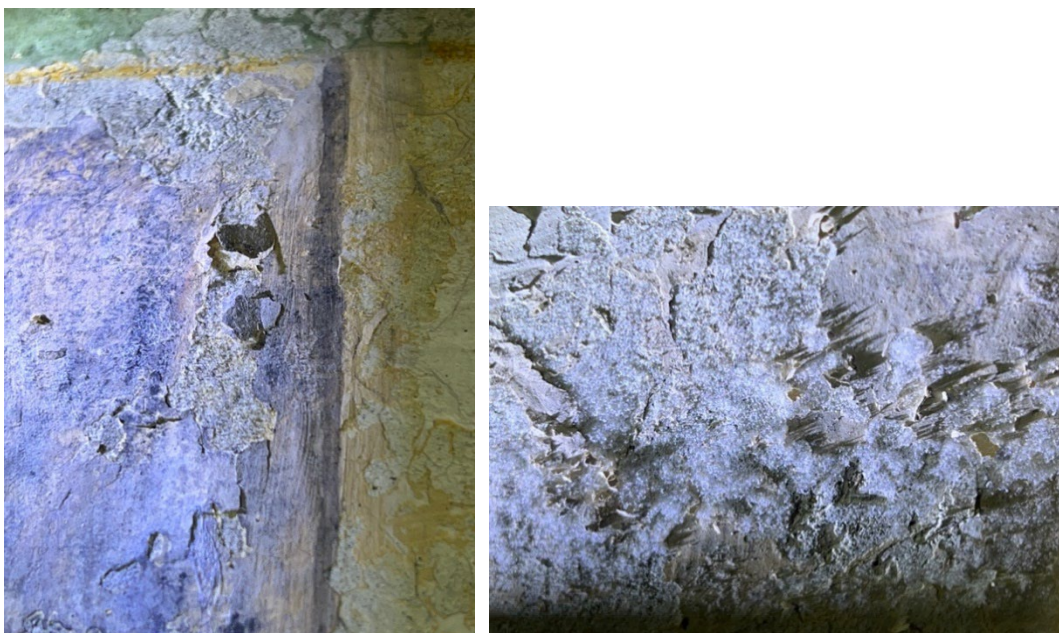
Fig. 29, 30. Detachment of paint layer and salt efflorescences in the northern wall of the west wing

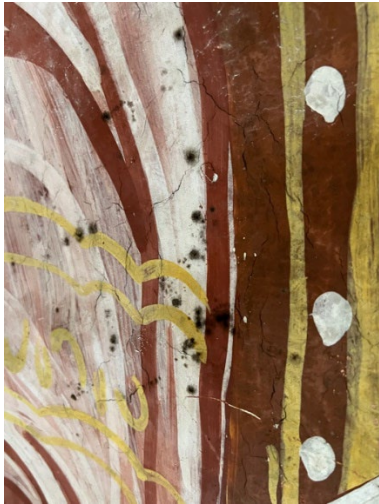
- Treatment of biological decay: while quaternary ammonium salts (2% in deionised water) have been used for a long time, with good results, there are now fewer toxic materials which could also be considered for Gelati, such as essential oils. These materials have been tested on mural paintings and on stone with good results. The use

of these non-toxic materials may be useful, particularly if the relative humidity inside the church continues to have high levels over a prolonged time (fig. 31).

Fig. 31. Biological growth is still present in some areas of the mural paintings

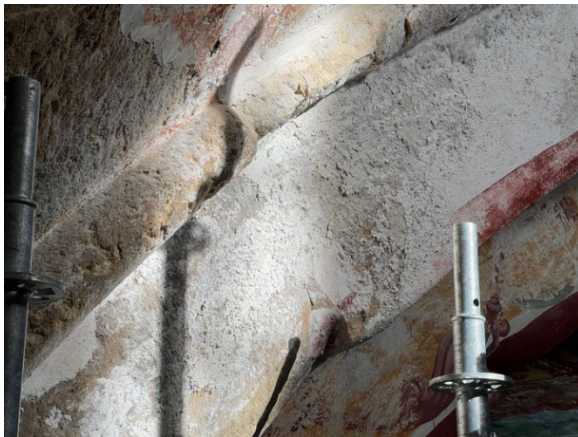
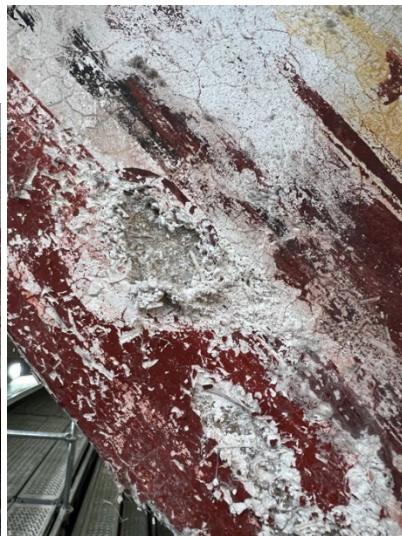
Fig. 32,33. Areas with severe plaster decay under the northwest pendentive

- Consolidation of decayed plaster: the use of ammonium oxalate could be an interesting possibility for salt-laden plaster. However, at an emergency stage, only severely decayed areas should be consolidated, and the results should be monitored over a more extended period of time, to verify its effectiveness with the continued presence of soluble salts (fig. 32-33).

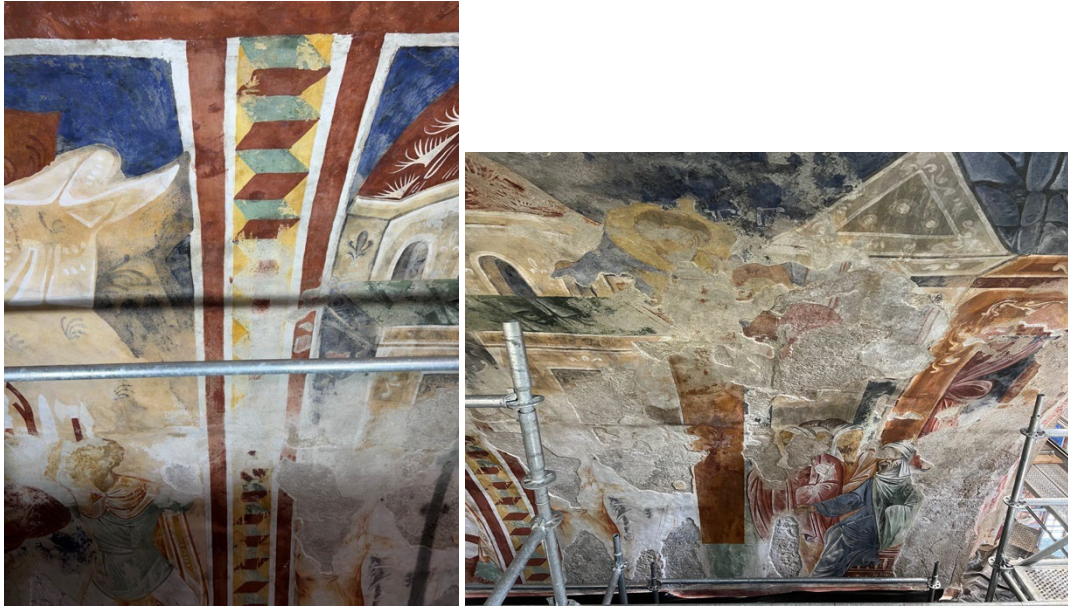
Fig. 34,35. Colour integration in the northern wall of the west wing

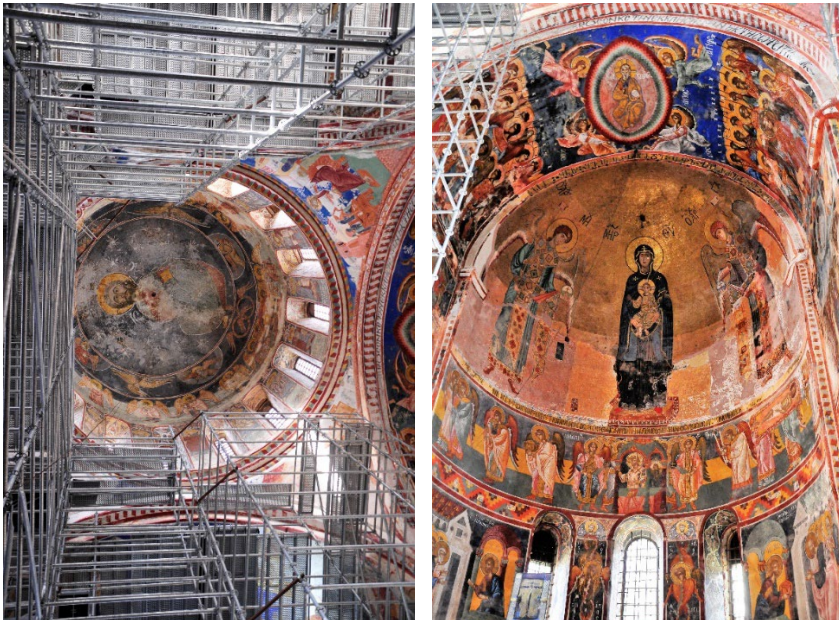
Fig. 36, 37. The scaffolding in the interior of the church: view to the cupola and to the altar

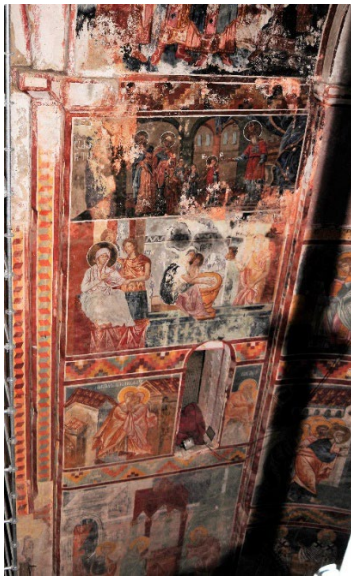
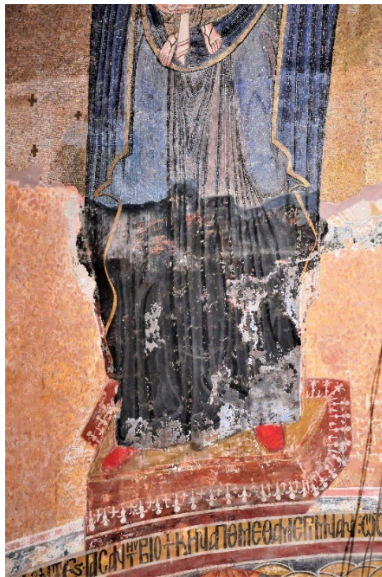
Fig. 38. Left part of the "triumphal arch" to the altar

Fig. 39. Lower part of the *himation* of Mother of God representation

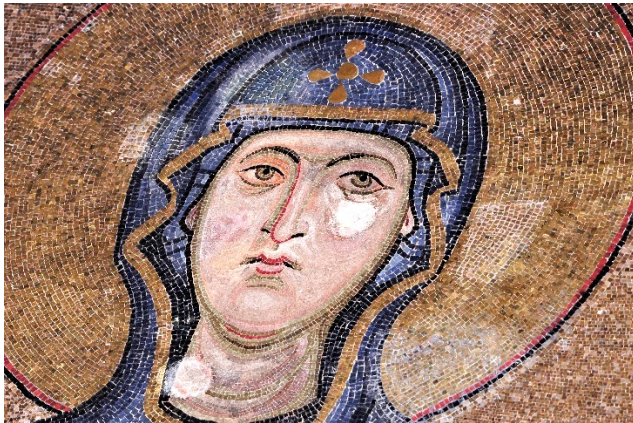
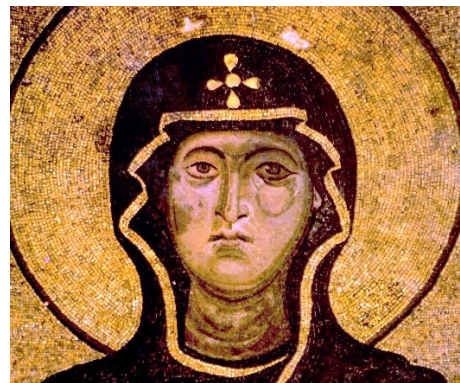
Fig. 40. Mother of God – detail of the head

Fig. 41. Mother of God – detail of the head, as in 1982 (bibliographical research)

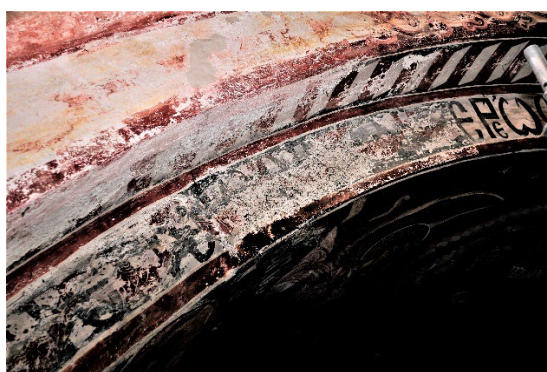
Fig. 42. Head of archangel Gabriel, detail

Fig. 43. Condition of the inscription on the frontal part of the "triumphal arch"

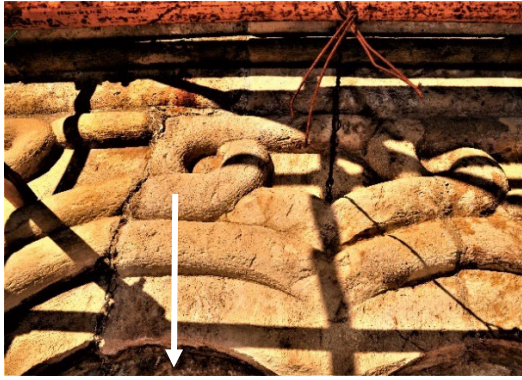
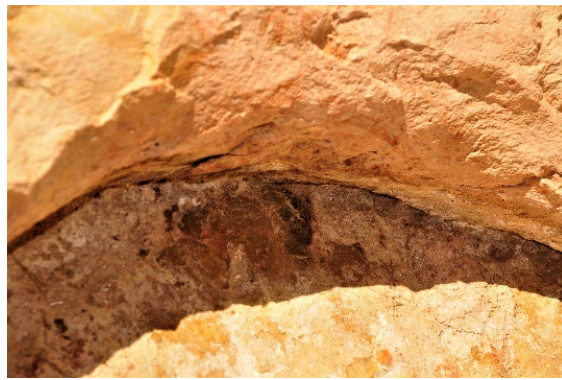
Fig. 44. West arm – south façade: Shifting of structural – decorated ashlars

Fig. 45. West arm – south façade: Permanent humidity, extraction of salts and exfoliation of decorative elements

15. Implement a project for thorough filling of joints and completion of broken/missing sections of structural ashlar on the church facades. It is advised to use a repair natural hydraulic lime mortar satisfying the issue of compatibility (ensuring breathability and avoiding percolation of salt solutions to the original building stones), and the issue of the restoration of the mortars' mechanical performance (strength and porosity) to achieve sustainability.

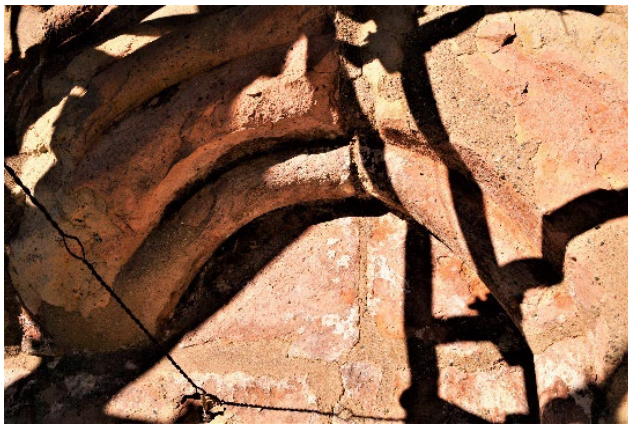
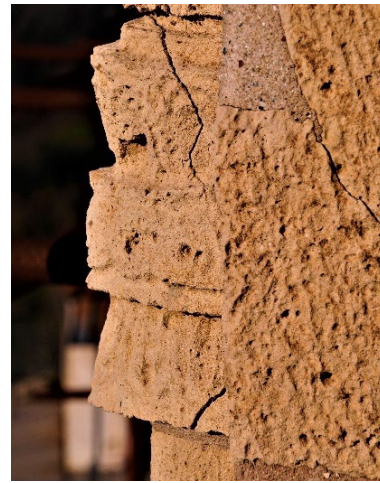
Fig. 46. West arm – south façade: Salt presence on the joints

Fig. 47. West arm – W-S corner: Fractures of structural and decorative elements

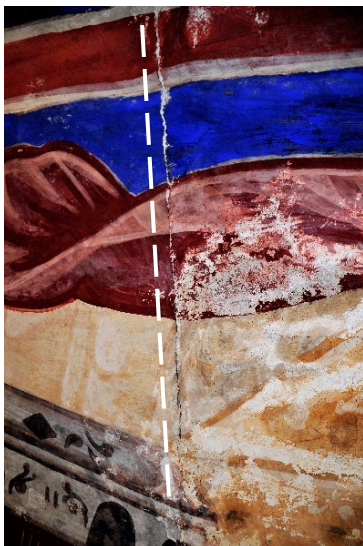
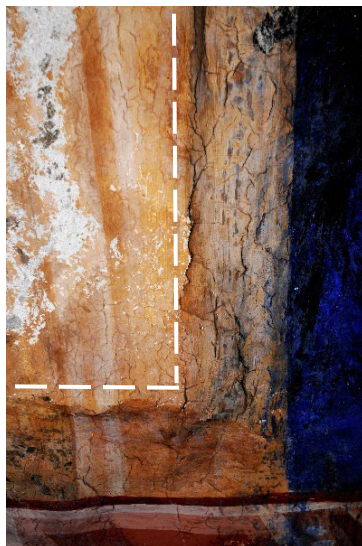
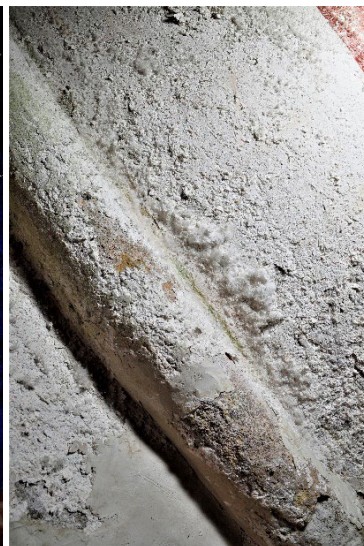
Fig. 48, 49. North arm – west wall: shifting of the building ashlars

Fig. 50. North arm – frontal arch: intensive presence of nitrates on the arch surface

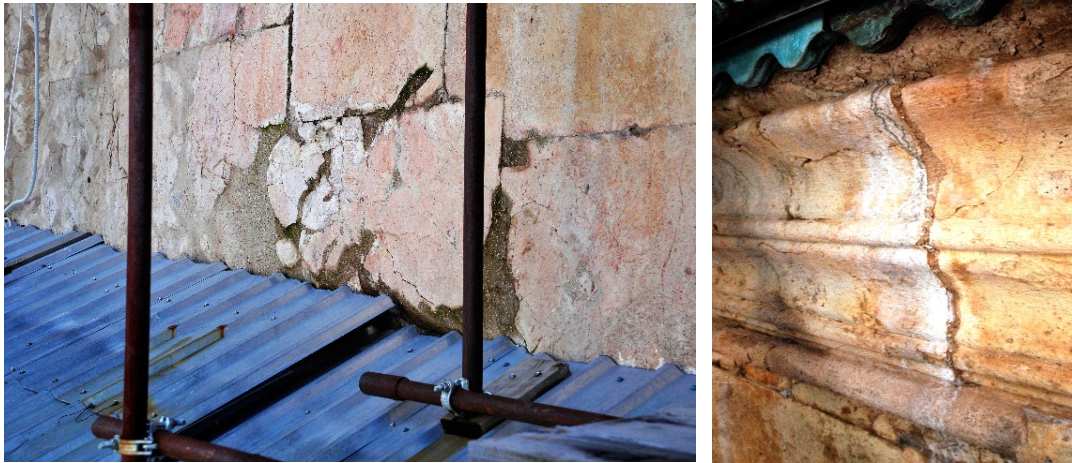
Fig. 51, 52. Condition of the north façade near to north arm – recent humidity on the joints' mortar and salt crystallization

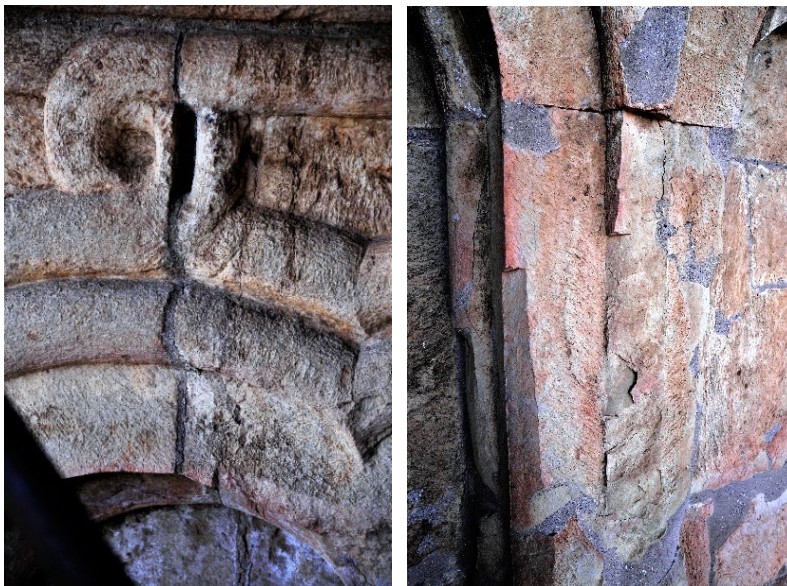
Fig. 53, 54. North arm – west façade: open joint cracks, fabric detachment and salt crystallization

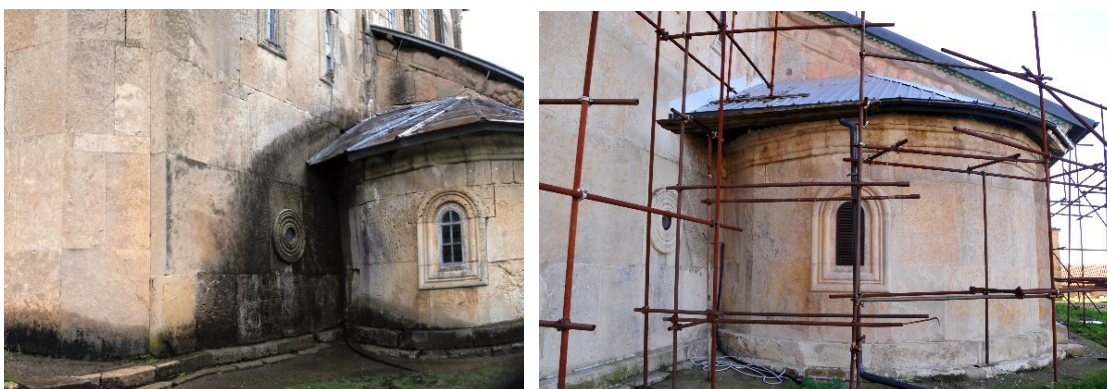
Fig. 55. The N-E apsis of the church to the conjunction with the northern parekklesion (2010 Joint World Heritage Centre/ICOMOS/ICCROM Advisory mission)

Fig. 56. The same area during the 2022 Joint WHC/ICOMOS/ICCROM mission

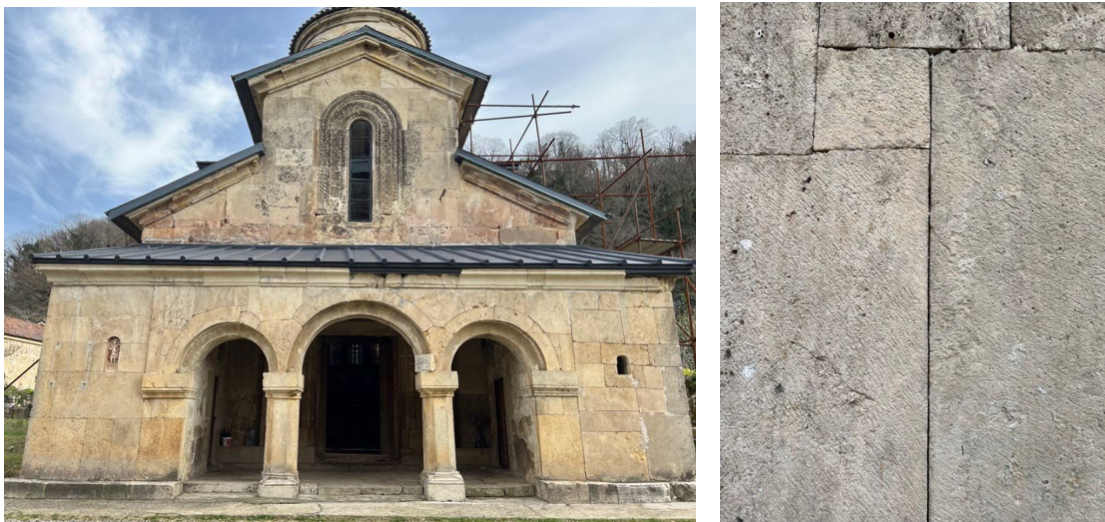
Fig. 58, 59. View of the façade of the Church of Saint George: need for infills in external stone joints, to avoid water penetration

20. Regarding the Church of Saint George, there is an immediate need to work on external joints between stone blocks to ensure there is no water infiltration from the external walls, taking into consideration the suggestion in Recommendation 15 regarding the compatibility and sustainability of repair mortars.

There is an immediate need to work on external joints and cracks between stone blocks to ensure there is no water infiltration from the external walls (fig. 59), following the recommendations above for a similar issue in the Main Church.

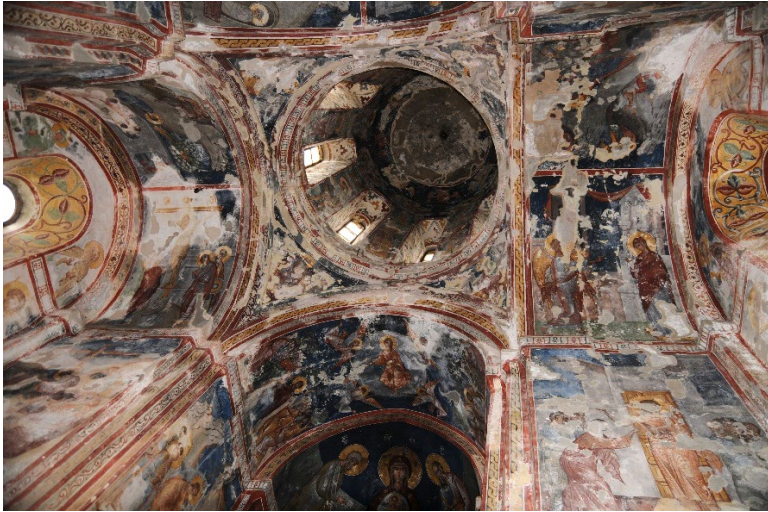
Fig. 60. Interior view to the cupola

Saint George Church presents humidity problems similar to those of the Main Church, although less serious. However, its wall paintings (16th c.) are overall in a worse condition and therefore, the need for intervention is high (fig. 58, 60). Pumice irregular blocks were used to fill the uneven surface, which was covered with a dense mortar layer. Externally, the church faces an evident problem related to the rising damp: the north side is the most affected (fig. 61), followed by the east and south-west sides. A sewage network outward with sewer manholes is absent,

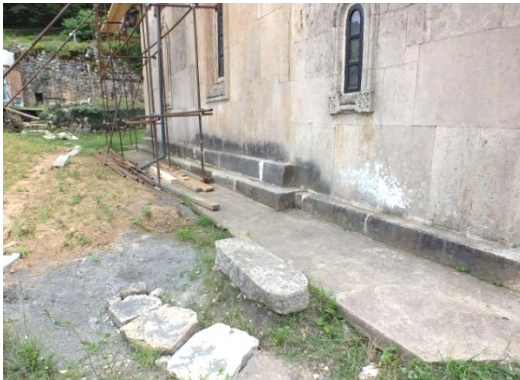
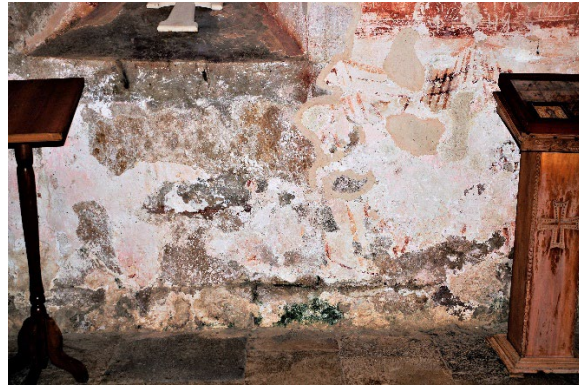
Fig. 61. St. George: exterior view, north side. Detail of the visible rising damp (by ReStruere)

Fig. 62. St. George: interior view, north side. Detail of the visible rising damp
