Butrint National Park

Integrated Management Plan (2020-2030)

FINAL ISSUE April 2020

PRINCE+PEARCE

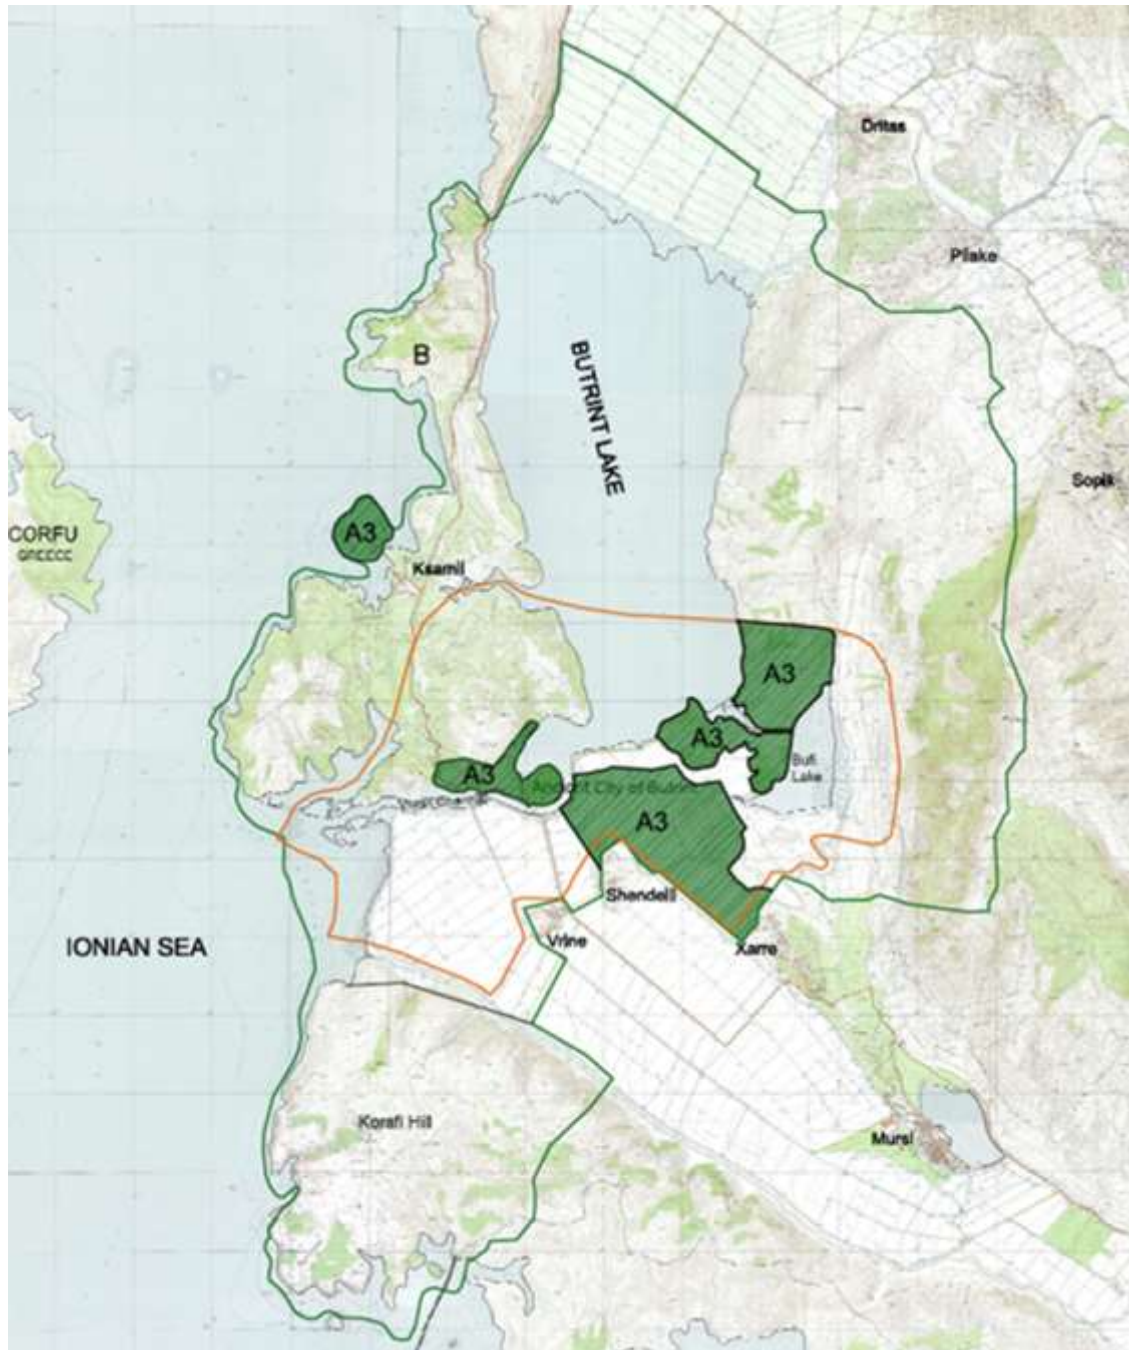
Figure 1: The map shows the current status of the protected areas in and around the World Heritage Site with regard to (a) the National Park (green), (b) the World Heritage Site Core Zone (brown) and (c) its component A3 Sub-Zone (hatched green).

The Ancient City of Butrint was designated a World Heritage Site in 1992 under Decision # 570 of UNESCO's World Heritage Committee (Figure 1). It comprised just 16 hectares of the central peninsular with its standing Classical and later remains. The map below shows the current status of the protected areas in and around the World Heritage Site with regard to (a) the National Park (green), (b) the World Heritage Site (brown) and (c) its component A3 Sub-Zone (hatched green). (See Annex B for the complete map progression).

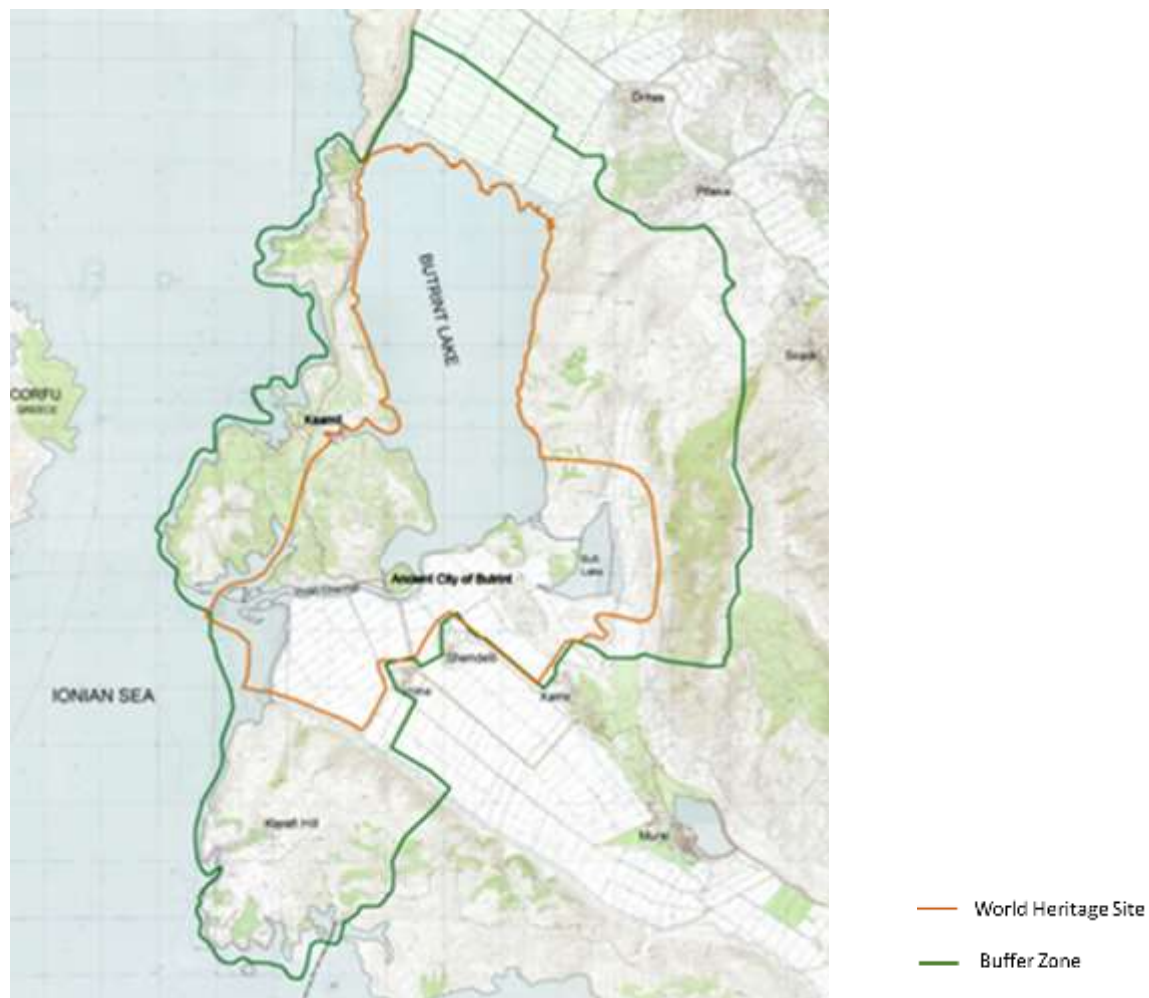
Figure 4: Possible expansion of the WHS to cover the whole of Lake Butrint

Thus, the extension of the World Heritage Site boundary as shown below and in Annex B would ensure both an equal treatment of the surface of the Lake Butrint, and would thus entail a more rigorous regime of protection as far as the World Heritage Site is concerned.

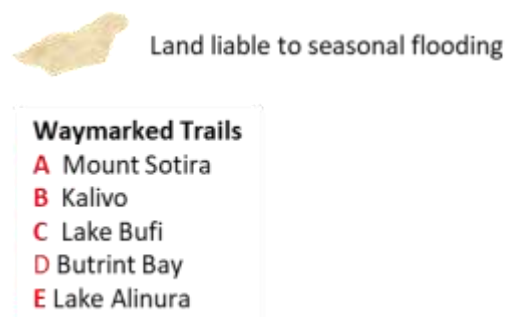
Figure 14: Possible walking trails

For illustrative purposes only these trails are indicated on the following site map:

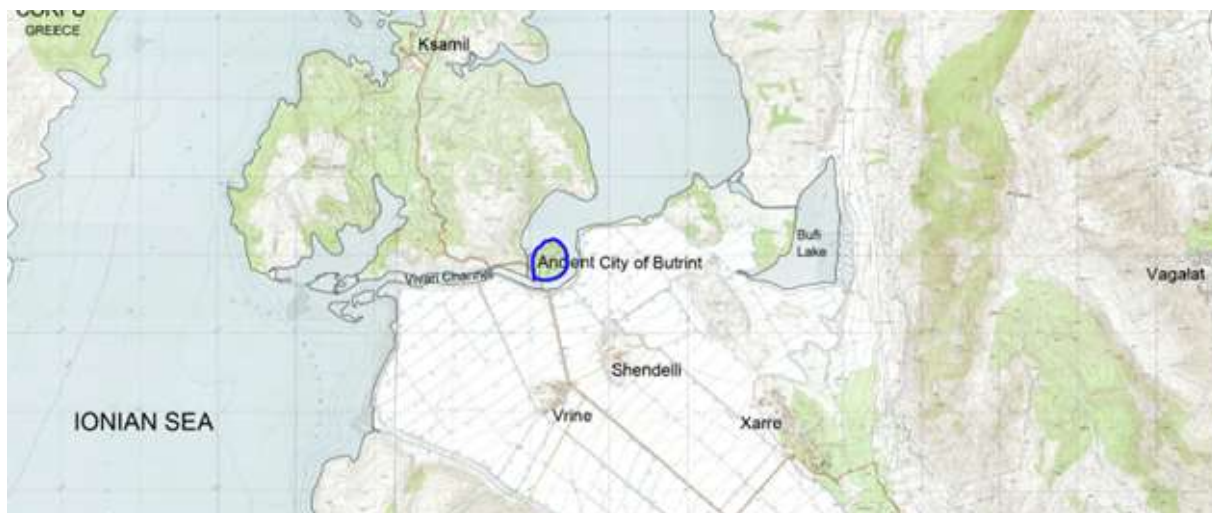
The Ancient City of Butrint was designated a World Heritage Site in 1992 under Decision # 570 of UNESCO's World Heritage Committee (Figure 20). At just 16 hectares it measured over the central peninsular with its standing Classical and later remains:

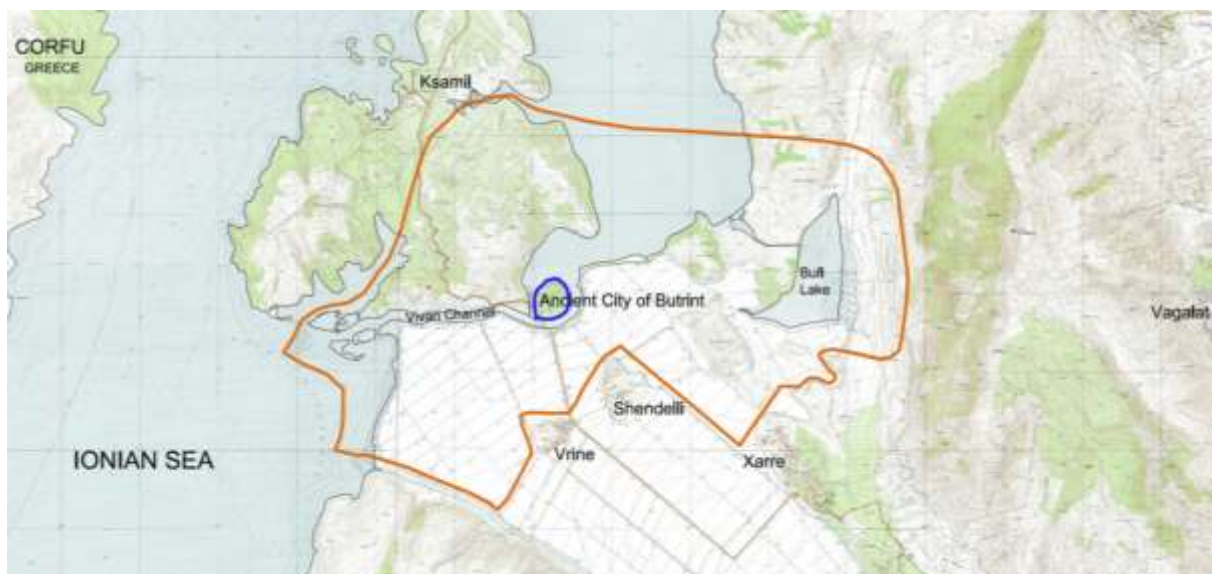
In 1999 the State suggested an extension of the World Heritage Site from 16 hectares to 2,500 hectares⁵⁵ by including the Virari Channel, part of the Vrina Plain, Lake Buti, the southern part of Lake Butrint and land surrounding Mount Sotira up to the village of Ksamili.

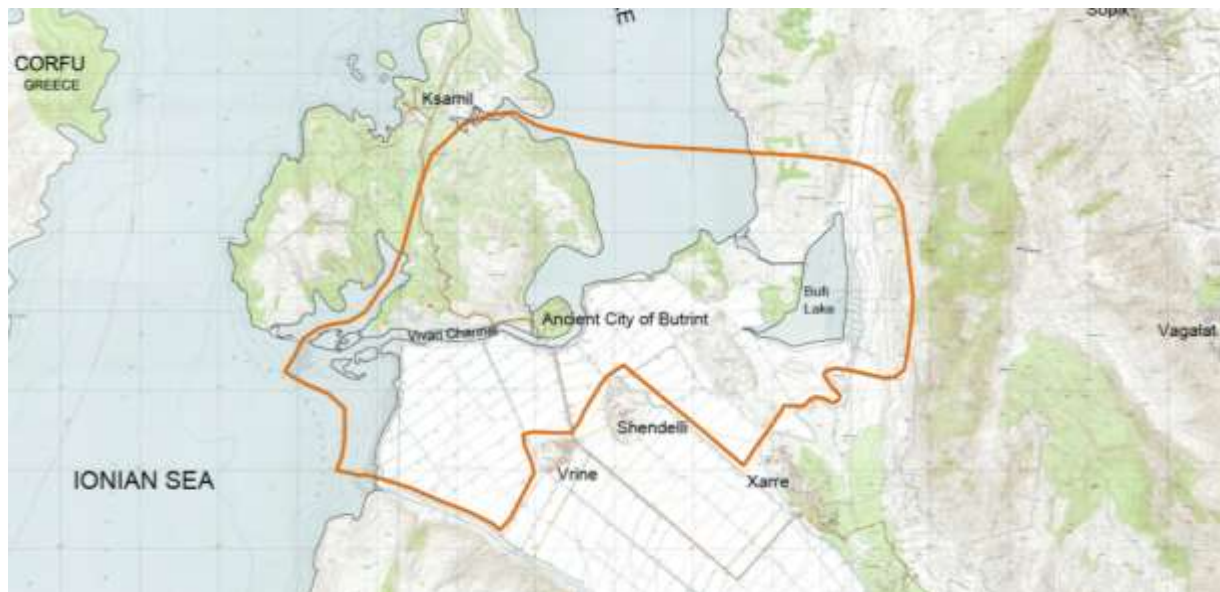
In 2000, this same area of land was designated as the Butrint National Park under Council of Ministers' Decision # 82, dated 2 March 2000.

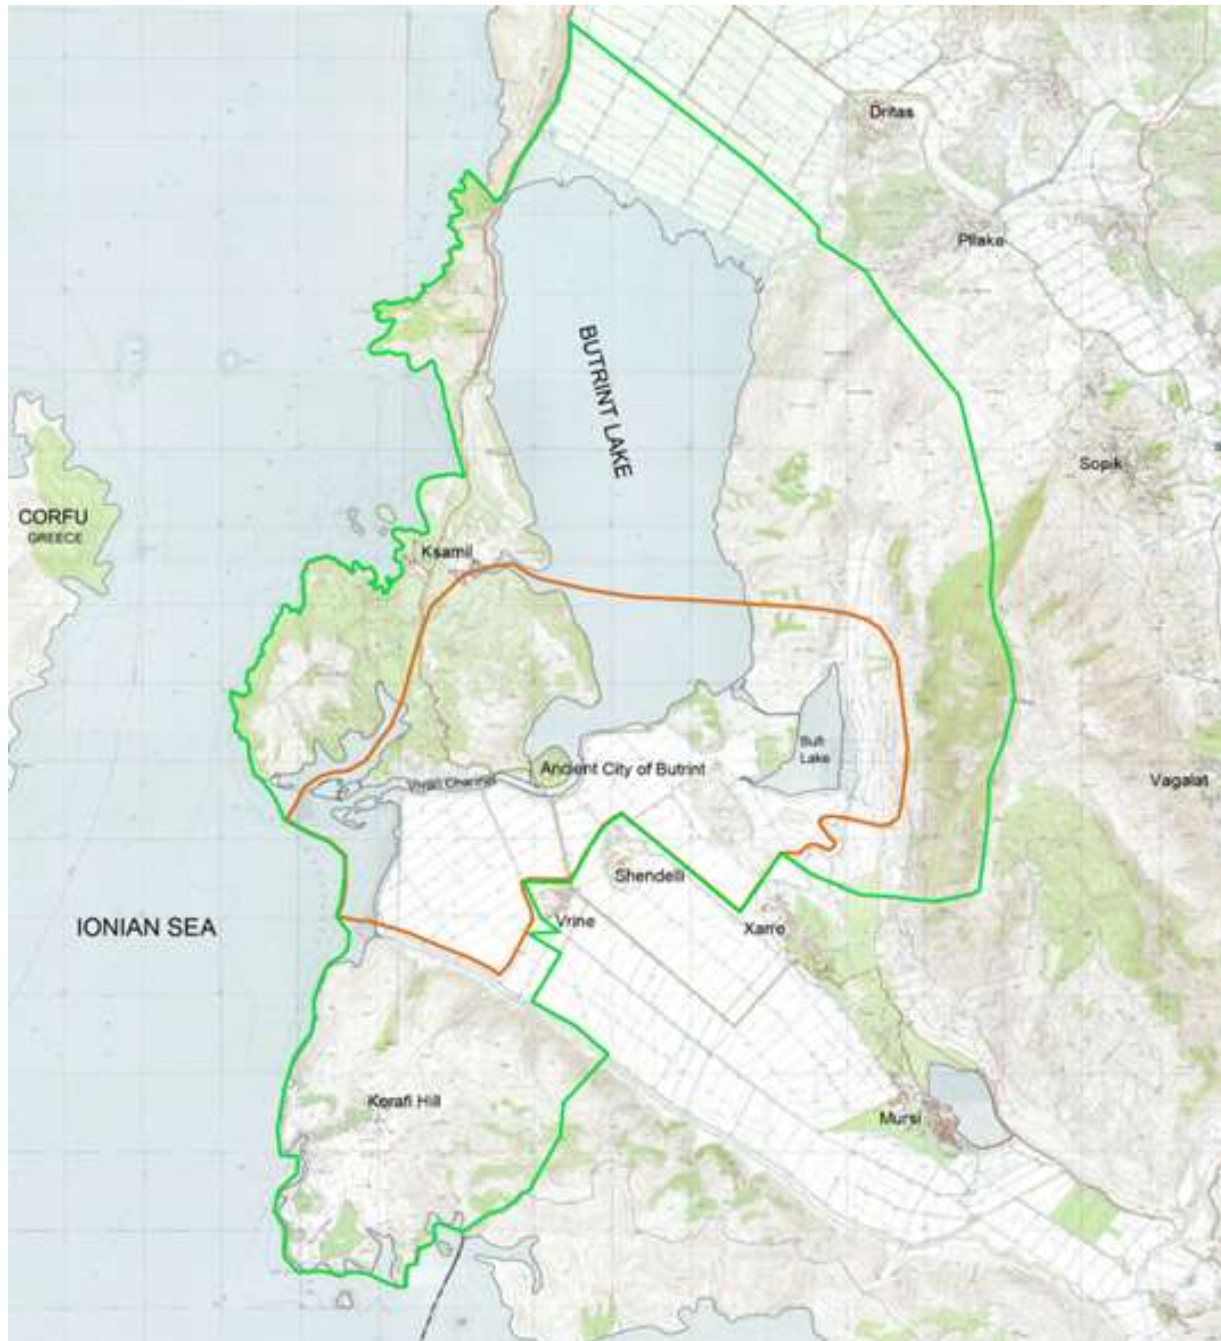
In 2007, at the 31st session of the World Heritage Committee in Christchurch, New Zealand, held between 23 June and 2 July, the 8,591.2 ha boundary of the Butrint National Park became the Buffer Zone for the World Heritage Site Core area of 2,500 hectares; the latter being both the 2000 World Heritage Site and National Park boundaries.

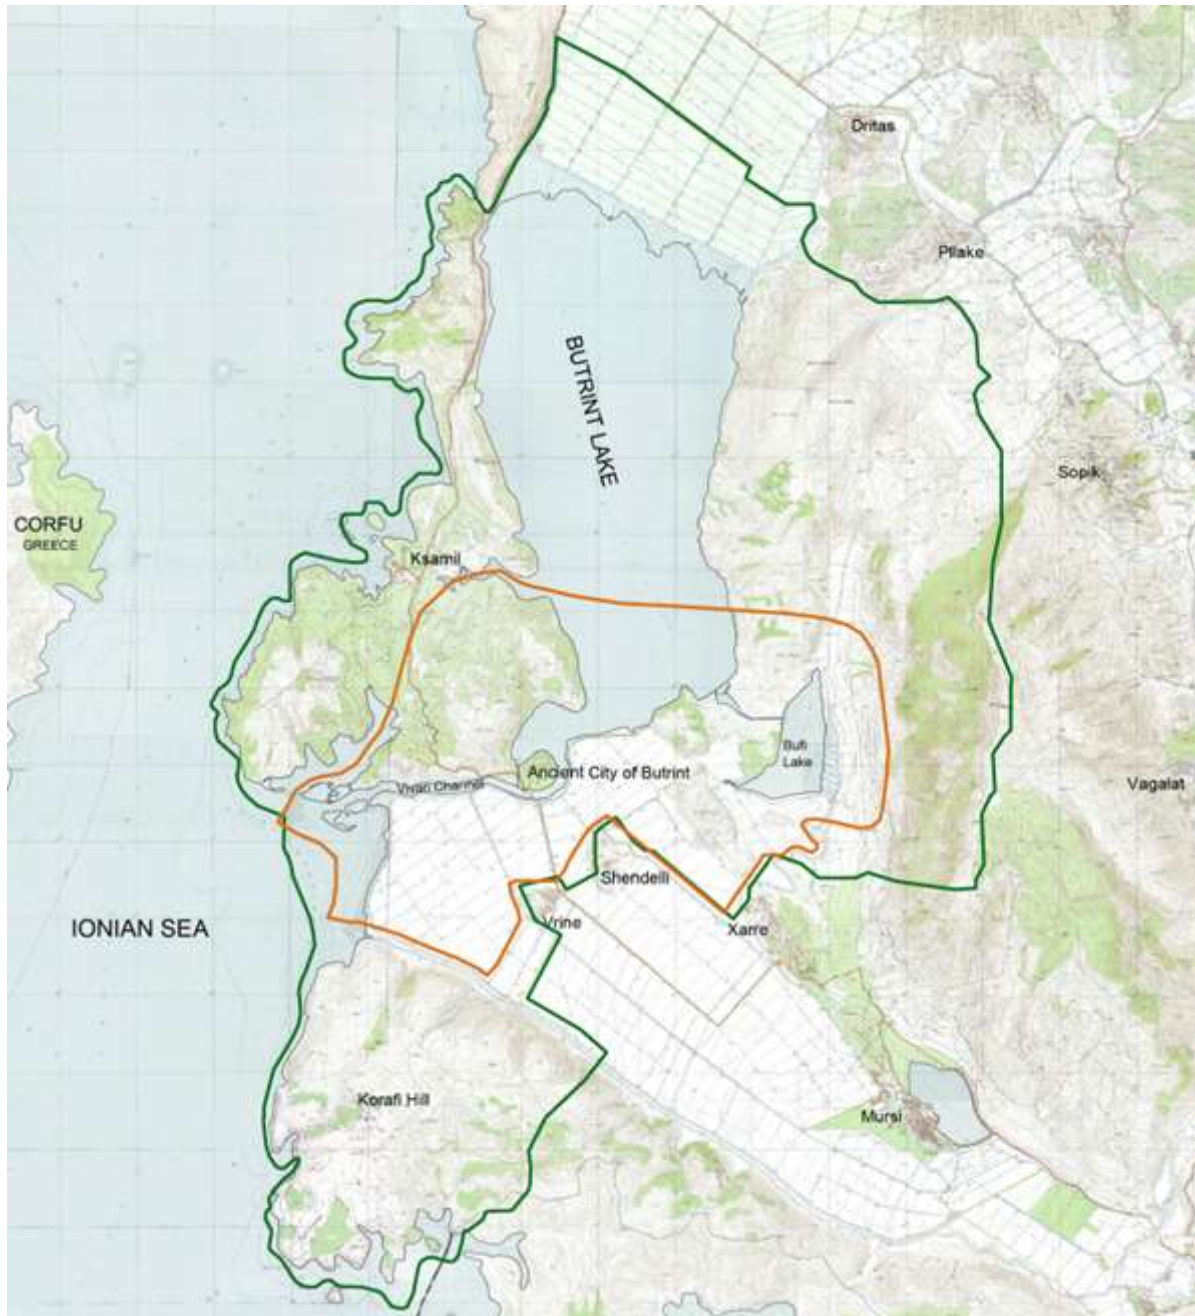
In 2013, the boundary of the National Park was expanded from 8,900 ha to 9,424.2 ha under Council of Ministers' Decision # 134, dated 20 February 2013, thus updating Decision # 693.

Importantly, this updating expanded the Park's protected area seawards by roughly 1.5 kilometres to include, for example, the islands immediately offshore of Ksamil as well as the rest of the coastline south of Gjiri Hartes to the border with Greece, thus bringing it more in-line with the borders of the Ramsar site (Figure 7).

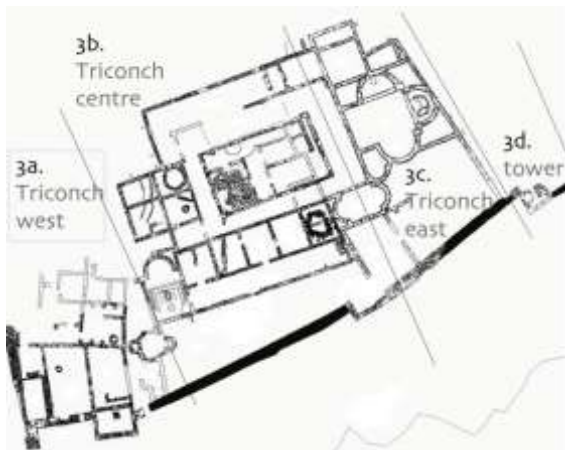
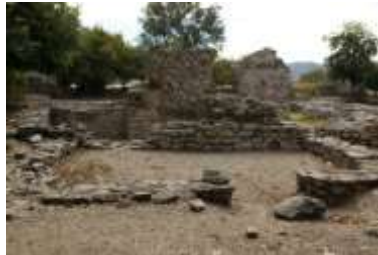
<p>Brief description: The first phase of the complex dates to the late 4th century AD. Remains of this phase can be seen close to the Channel. The triconch palace was constructed in the latter part of the 5th century AD. It was built over the garden area of the earlier palace and over at least four earlier buildings, parts of which were incorporated into it. The triconch palace is laid out around a large courtyard. To the east of the courtyard there is a trefoil dining room (<i>triclinium</i>), with the foundations for a couch still visible in the central apse. To the south is a reception room which looks out onto the Vivari Channel (possibly with a private marina)</p> <p>By the early 6th century AD direct access from the triconch palace to the Vivari Channel had been blocked off by the city's new circuit-wall (wall 3) and the rooms were being used for small-scale industrial activity. By the mid 7th century AD the building had been abandoned.' (<i>Neritan Ceka ibid p44/45</i>)</p>

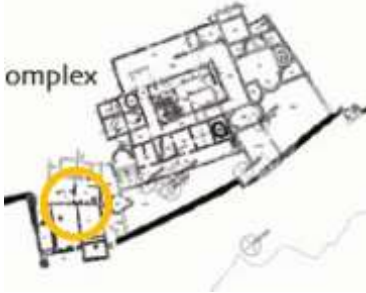
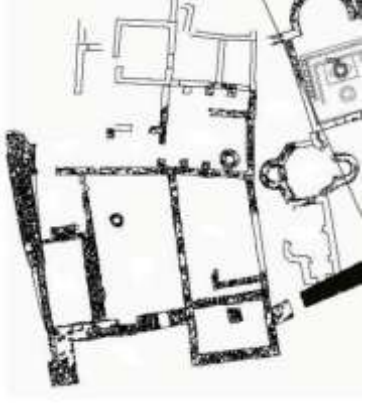
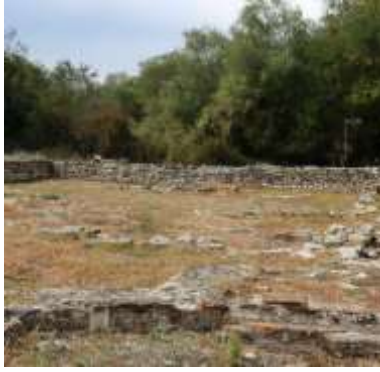
<p>Brief description: The western section of the Triconch area is does not form part of the triconch palace and consists of a series of low walls and spaces bounded by the channel-circuit wall (wall 2). A well is visible in the centre of one of the enclosed spaces. This may have been the site of a medieval 'merchant's house'</p> <p>Conservation interventions: None on the walls of the complex were conserved; beside the conservation undertaken in 2008 on fortification walls; and conservation undertaken on the mosaics.</p> <p>Current condition: However in the condition survey it is noted that little can be done with the surviving walls, since the entire triconch complex is subject to seasonal flooding; while The remaining walls are constructed entirely from rough hewn limestone blocks with the occasional use of brick and tile spolia. Some walls are laid with lime mortar, others are rougher, earth constructions; Especially the walls of earth construction cannot be protected against the water influence; This has caused movement of some of the wall sections (evident inclinations); The mortar is weakened; while stone and brick pieces fall out of structure</p> <p>Recommendations/Actions: Recommendation from 2009 which was not completed is still valuable:</p> <ul style="list-style-type: none"> - Using spoil from the outside of the Channel-circuit wall backfill this area to 10 cm above high water level. By taking the spoil from the outside of the Channel-circuit wall it is hoped that the action will have the dual effect of accentuating the visual impact of the wall and also improving access to the channel side of the wall for future maintenance. Allow the backfill to create a 'green carpet' of plants that can be easily maintained. - Walls remaining above backfill level should be consolidated (Wall toppings and joints) - Changing the drawbridge placed for visitors, since its entirely rotten - Regular monitoring of mosaics

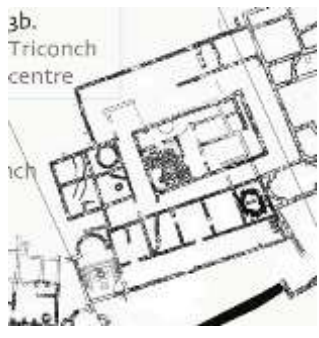
<p>Brief description: The same as for Triconch complex</p> <p>Conservation interventions: None on the walls of the complex were conserved; beside the conservation undertaken in 2008 on fortification walls; and conservation undertaken on the mosaics.</p> <p>Current condition: However in the condition survey it is noted that little can be done with the surviving walls, since the entire triconch complex is subject to seasonal flooding; while The remaining walls are constructed entirely from rough hewn limestone blocks with the occasional use of brick and tile spolia. Some walls are laid with lime mortar, others are rougher, earth constructions; Especially the walls of earth construction cannot be protected against the water influence; This has caused movement of some of the wall sections (evident inclinations); The mortar is weakened; while stone and brick pieces fall out of structure</p> <p>Recommendations/Actions:</p> <ul style="list-style-type: none"> - Walls remaining above backfill level should be consolidated (Wall toppings and joints) - Regular monitoring of mosaics

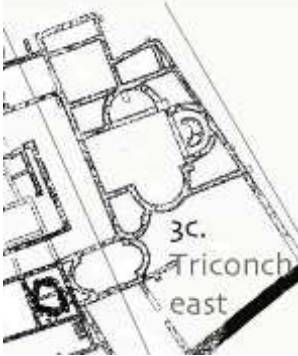
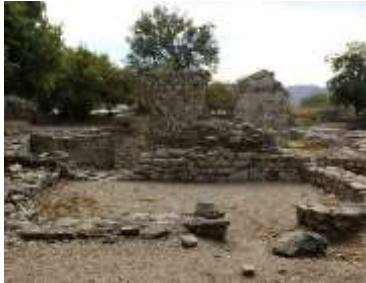
<p>Brief description: The triconch palace was constructed in the latter part of the 5th century AD. It was built over the garden area of the earlier palace and over at least four earlier buildings, parts of which were incorporated into it. The triconch palace is laid out around a large courtyard. To the east of the courtyard there is a trefoil dining room (<i>triclinium</i>), with the foundations for a couch still visible in the central apse. To the south is a reception room which looks out onto the Vivari Channel (possibly with a private marina)</p> <p>By the early 6th century AD direct access from the triconch palace to the Vivari Channel had been blocked off by the city's new circuit-wall (wall 3) and the rooms were being used for small-scale industrial activity. By the mid 7th century AD the building had been abandoned.' (<i>Neritan Ceka ibid p44/45</i>)</p> <p>Conservation interventions: Mosaics of the Triconch Palace have been conserved in 2003; 2010/2011; After condition survey, partial conservation and documentation, the surfaces were backfilled.</p> <p>Current condition: The wall masonry is loose, and it needs conservation. The brick tiles in the masonry are somewhat stable. The vegetation is maintained.</p> <p>Recommendations/Actions:</p> <ul style="list-style-type: none"> - Walls remaining above backfill level should be consolidated (Wall toppings and joints) - Regular monitoring of mosaics

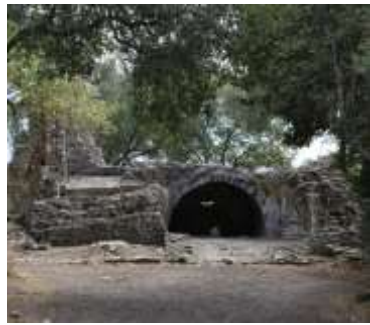
Venetian House - suggested period: 16th century		
Position	plan	Photo 2018

<p>Brief description: A large vaulted structure abuts the city wall. This building was thought by Ugolini to be a church but is now interpreted as a Venetian house (although its precise function is little understood). A vaulted cruciform-shaped undercroft is approached from the south through a barrel vaulted undercroft (of which only a small section survives). Above these undercrofts are traces of the upper floor which would have formed the main part of the working or living quarters. On the eastern side of the house is a tower, only part of which survives, which could be accessed at ground level and first floor level.' (<i>Neritan Ceka ibid p 48</i>)</p> <p>Conservation interventions: Conservation conducted in 2000 and earlier show cases the usage of inappropriate materials; Full conservation and consolidation have been conducted in 2007 through a Summer school training project; in 2008 more significant conservation was undertaken: vegetation was removed; joints were restored and the wall toppings were made on the central vault. In 2009, the wall opening which was created in years up to 2000 in order to allow visitors to follow the coastal trail and was endangering the stability of walls was closed.</p> <p>Current condition: Being nearby water, the monument is in a constant condition of humidity. The interior plastered surfaces were suffering from water penetrating from the exposed vault. Due to lack of maintenance, the plaster toppings are damaged and are allowing further water penetration; some of the upper wall masonry parts are loose and stone has fell off from its original position.</p> <p>Recommendations/Actions:</p> <ul style="list-style-type: none"> - Plaster repairs in the interior (edge consolidation); filling the cracks; re-topping the vault and masonry; cleaning of lichens and moss; followed by conservation of joints - Vegetation needs to be maintained and kept min 4m away from the structure - Systemizing stones around the monument

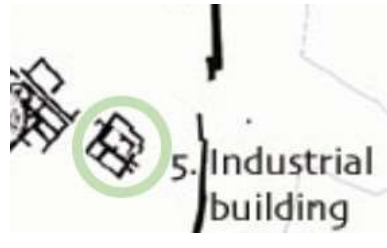
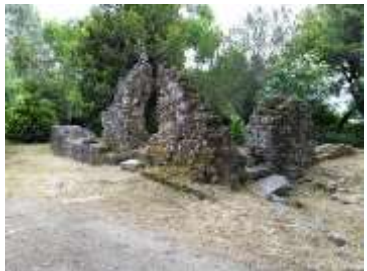
<p>Brief description: This building has been known as the 'Byzantine' or 'Industrial' building, the latter according to Andrew Crowson 'heavily water-worn, appears to have had an industrial function, and may have worked as a mill' (<i>Venetian Butrint p. 61</i>). The ruins south of the baptistery probably date to the Byzantine period, and overlie a Roman building (possibly another part of the bath-house complex that is beneath the baptistery). The function of this building is not known.' (<i>Neritan Ceka ibid p.48</i>). A building of two major phases, uses during both unclear. The early walls are roughly coursed stone and brick, the stones varying from small to large roughly squared blocks and stand to around 0.5m high apart from in the north east corner. Features of note include the rectangular putlog holes at low level on the north east and east sides, the decorative framing of every stone with brick on the surviving tall section of wall (1.2m high) on the northeast corner, and the remains of a hypocaust floor in the north west room. The later building has generally thinner walls, standing higher on the north and west sides, of rubble masonry with occasional tile infill and tile work at the survival of the window on the north side.' (<i>from the 2001 Condition Survey</i>)</p> <p>Conservation interventions: No data on conservation.</p> <p>Current condition: The walls seem stable, although the inner core of the masonry is exposed to elements and the ever present humidity allows for damp conditions in which moss is created over the wall structures.</p> <p>Recommendations/Actions:</p> <ul style="list-style-type: none"> - Minor consolidations; filling the cracks; cleaning of lichens and moss followed by conservation of joints; re-positioning loose or fallen stones - Vegetation needs to be maintained and kept min 4m away from the structure - Systemizing stones around the monument

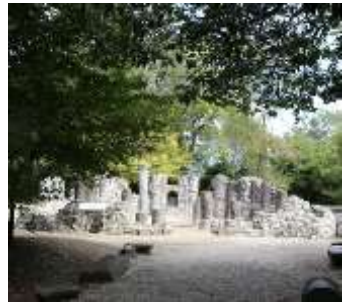
Baptistery and adjacent buildings - Baptistery suggested period: 6th century		
Position	plan	Photo 2018

<p>Brief description: The baptistery at Butrint is probably the largest east of the Adriatic (leaving aside that of Hagia Sofia in Constantinople). It was built in the second quarter of the 6th century AD, on the site of a late Roman public baths (which may itself have been used for baptisms), incorporating part of the earlier structure to create the square exterior in which the circular interior was constructed. In terms of its size and its isolation from the Episcopalian basilica to the north, it is strongly reminiscent of contemporary baptisteries in southern Italy. Every aspect of the building is rich in the symbolism of early Christian baptism.' (<i>Neritan Ceka: ibid</i>)</p> <p>Conservation interventions: The baptistery has been subject to programmes of conservation since excavation by Ugolini. The mosaic pavement was conserved and restored when first excavated and has been the subject to several interventions with varying degrees of success (and failure). It was recorded, monitored and consolidated by Jacques Neguer in July 2007; In 2008 the baptizing well was restored; in 2013 when mosaic was re-opened and the tesserae which were separated from the surface were repositioned; In 2017 small consolidations and re-positioning of the loose stones were conducted by the staff of the park.</p> <p>The building was conjecturally reconstructed by Ugolini who erected the columns where they are now to be seen. Facework and exposed core and walltops have all been consolidated with cementitious mortars during various periods of conservation.</p> <p>Current condition: The structure is stable; lichens and moss are covering most parts of the walls and the columns. However, to the outside face of the building there are areas of exposed and unconsolidated corework to the upstanding masonry to the north west and southeast of the arched fountain. The brick columns of the hypocaust to the east appear fragile and careful cleaning should precede consolidation. There are areas of lost pointing throughout the building. Much of the modern interventions have used portland cement in the mortars and this needs careful monitoring to ascertain whether or not it is accelerating decay in adjacent and tiles. The marble cladding in the font is broken in places and some is lost. A careful cleaning away of the algal scum is needed in order to sift through the debris at the bottom to see if any fragments of cladding remain (from 2009 report)</p> <p>Recommendations/Actions:</p> <ul style="list-style-type: none"> - Developing a full conservation report for the monument and the structures around it (from 2009 report) - The hypocaust to the rear of the fountain should be carefully cleaned to ascertain the need for any urgent consolidation(from 2009 report) - Minor works relating to cleaning of algae remains after water dries out - Maintaining vegetation - Re-opening mosaic every year to check on its condition - Systemizing stones around the monument

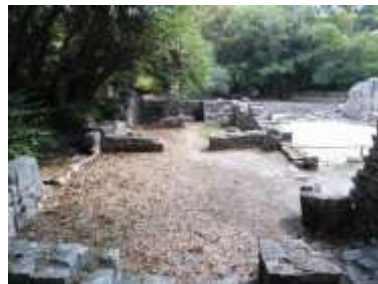
Baptistery and adjacent buildings - The small church suggested period: 14th century		
Position	plan	Photo 2018

<p>Brief description: The ruins of a small medieval church, comprising a simple nave, narthex and bell-tower, can be seen to the north of the baptistery. It overlies the northernmost room of the baptistery complex, part of the door of which is visible in the exterior face of the south wall of the church. The church was probably built in the 14th century AD. At least one apse of an earlier and larger church underlies the apse of this later church.' (<i>Neritan Ceka; ibid</i>)</p> <p>Conservation interventions: From 2007 walltops have been conserved, and the church was part of the programs of vegetation cleaning.</p> <p>Current condition: The structure is stable; lichens and moss are covering some parts of the walls construction.</p> <p>Recommendations/Actions:</p> <ul style="list-style-type: none"> - Monitoring vegetation inside and outside the buildings' walls - Conservation and edge consolidation of remaining plastered surfaces - Monitoring trees in the vicinity of the structure, and especially the one over the remains of the belfri - Cleaning lichens and moss followed by consolidation of joints - Re-positiononing loosen stones -

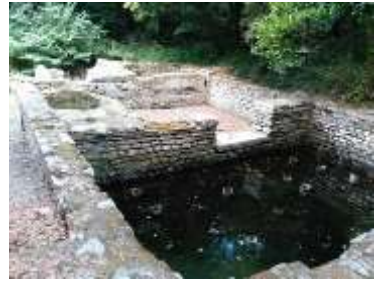
Baptistery and adjacent buildings - The bath house suggested period: 2nd century		
Position	plan	Photo 2018

<p>Brief description: This bath-house is dated to the 2nd century AD by the extensive use of opus testaceum. Only a small section has been excavated, but the calderium, with traces of the hypocaust, can be seen. To the west, in the apse, there was a semicircular heated plunge pool with an adjacent rectangular plunge pool. The bath-house would have been supplied with water by the aqueduct which ran slightly upslope, to the north. The capacity of this small bath-house is estimated to have been 15 people. It is probable that the bath-house beneath the baptistery and the bath-house beneath the Byzantine ruin to the south of the baptistery were in fact connected in some way to the calderium and that they formed a single, large bath-house complex.' (<i>Neritan Ceka. ibid p49</i>)</p> <p>Conservation interventions: In 2013 and 2016, a full cleaning and a conservation of southern part of the structure was undertaken.</p> <p>Current condition: All the floor surfaces of the bath-house are seasonally flooded with a rise of up to 40cm, some, to the north-east, remain flooded throughout the year. This cycle of wetting and drying seems to cause no actual damage to masonry or mortar- there are few bricks or tiles at this level. This exception to this is in the brick arch at low level at the north-east end. The bricks here are deteriorating. The only noticeable effect is a discolouration of the masonry by grey/black algae in this zone.</p> <p>Recommendations/Actions:</p> <ul style="list-style-type: none"> - Monitoring vegetation outside the buildings' walls; especially trees - Cleaning lichens and moss followed by consolidation of joints - Consolidation of parts of structures of brick - After consolidation, backfilling the monument to 10cm above the high water mark using a graded spoil backfill laid over mesh. At low level the backfill should consist of stone, then tile and then gravel.

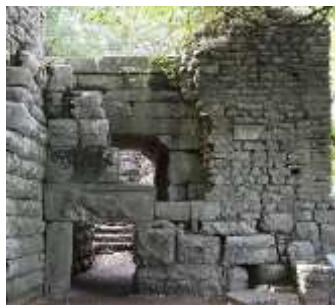
Lion's gate - suggested period: 4 th century BC		
Position	plan	Photo 2018

<p>Brief description: The Lion gate is named after the large relief depicting a lion attacking a bull which was placed on the lintel some time in the 6th century AD. It has been rebuilt several times. The original gate (the entrance of which can still be seen behind the lion relief) was simple in plan, like the Lake gate. However, unlike the Lake gate, the Lion gate was constructed between two parallel walls and was thus invisible from the lake. In the late antique period the gate was re fortified and a lion relief was added. The lion relief was originally from a temple, possibly from the acropolis. The insertion of the relief greatly reduced the size of the gateway. Later still access to the city became even more restricted when a tower (now completely collapsed) was constructed on the external side of the gateway.' (<i>Neritan Ceka: ibid</i>)</p> <p>Conservation interventions: 1962 The massive masonry of the interior of the passageway has been rebuilt, by the Institute of Monuments. The evidence for this is in the iron cramps which are visibly corroding within the masonry. The extent to which the gateway was dismantled and subsequently rebuilt is unknown. No further conservation was undertaken</p> <p>Current condition: Iron cramps are visibly corroding within the masonry. Corroding is causing swelling which is causing the local stonework to fragment. This can clearly be seen on the inner face of the gateway both on and above the lintel. There is a large vertical crack in the masonry; and infill mortar is washed off on the majority of the surface</p> <p>Recommendations/Actions (from report 2009; fully adopted by report 2018 from ZAKB) :</p> <ul style="list-style-type: none"> - Early examination by suitably qualified and experienced structural engineer familiar with this style of masonry - Removal of all vegetation from wall tops followed by consolidation. - Consolidation of medieval masonry- crack filling and replacement of deeply missing mortar. - Stone steps and paved area immediately within the gateway should be examined for loose stones, which should be re-bedded to prevent visitor accidents.

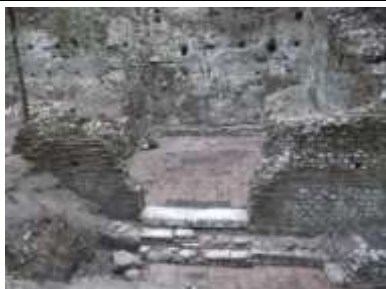
<p>Brief description: Following the complex of Roman forum on the north-east side, on the hillside of acropolis there is a Roman structure with two rooms. The function of this space might have been public. This building was never exposed to visitors. This monument have been excavated by Ugolini in 1939; but no written traces about this buildg are found. From analogical comparison to similar structures, especially the ones found on the east side of the Forum, we can date this building to 1st century.</p> <p>Conservation interventions: In 2015 the building was cleaned of vegetation; no conservation was undertaken</p> <p>Current condition: The upper sections of the wall are in poor condition; it suffers distabilization due to tree roots and cracks are visible on the length of the masonry. Th ebrick sections are lost due to being washed off by water leaks from the hillside. Since it was covered for a long time, the building is covered with lichens and moss; while the joints are deteriorated; the soil on top and behind the walls is creating a significant pressure due to uncontrolled vegetation.</p> <p>Recommendations/Actions:</p> <ul style="list-style-type: none"> - Vegetation management and cleaning in particular across the masonry; cleaning lichens; removing roots; creating a buffer by removing vegetation min 2 m from the masonry; Removing trees on the north side of the monument and within its interior. - Consolidating all cracks and re-fitting moving stones and bricks - Archaeological investigation as to understand the functioning and the role this structure might had - Full documentation of the building - Interpretation of the structure

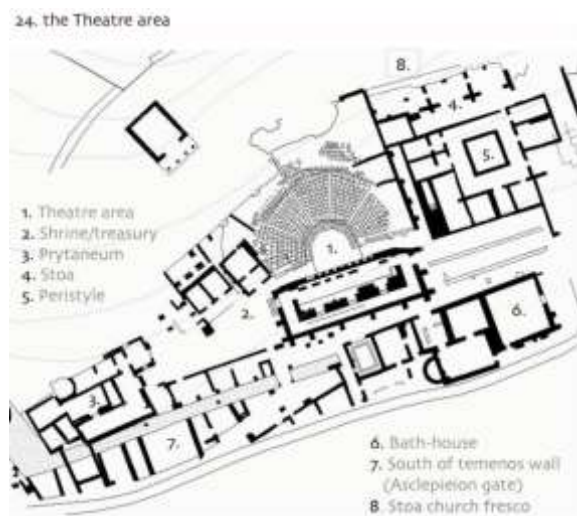
Theater with Theater area; Shrine/treasury; Prytaneum; Stoa; Peristyle; Bath House; South of temenos wall (Asklepion gate); Stoa church fresco

The theatre was excavated in the late 1930's by the Italian Archeological Mission. The excavation uncovered an impressive array of statues from the area immediately in front of the stage. When buildings such as theatres are abandoned the statuary and fine marbles are usually stripped and reused elsewhere, or broken up for the making of lime, so the discovery of this fine statuary *in-situ* is extremely unusual. One hypothesis for this is that the theatre might

Current condition: (From 2009 report) The theatre seating is uneven, but this is no defect that can be easily remedied or indeed that is causing problems. The previous repairs of the steps are toning down and will become more acceptable than they appeared originally; they show eloquently the difficulty of rebuilding architectural elements when the original line has been lost through movement. It is not appropriate that remaining stones from this repair programme are left abandoned in this area. Decay on the bottom step should be watched: there are a number of cracks here and some bits of stone are loose and may be pushed off into the water.

Some of the freestanding upper lines of seating are being undermined, and support of earth concrete or similar should be built here to prevent this going further. A total of 8m run, approx 600mm high is needed, and it is important that this should not appear as a wall, but as a stabilised bank.' (*from the 2001 Condition Survey*)

Recommendations/Actions (From 2009 report endorsed by report done by ZAKB staff in 2018)

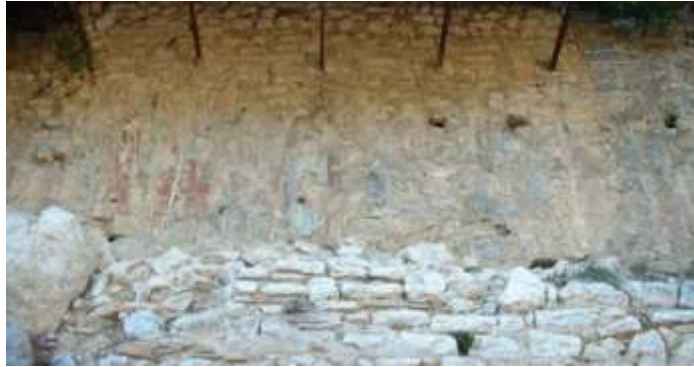
Brief description: 'The remains of a further church are visible to the east of the Theatre, where the remains of wall paintings can be seen on a wall above the Hellenistic structure thought to be a stoa. The church was a small building, little more than a chapel. Its north wall was c. 4.75m long. The position of the western entrance wall is marked by projecting blocks and a vertical scar running up the wall, while the approximate position of the apse can be determined from the roughly vertical termination of the plaster that covered the wall.

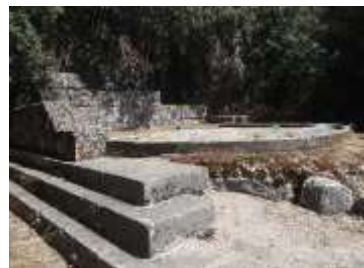
<p>Brief description: The upper temple, behind the theatre, was constructed in the 3rd century BC. It had a portico supported by two columns and two pilasters (no longer present). The naos was constructed of large blocks, plastered over and then white-washed. At the back of the temple is the base of an altar. It is not known to whom the temple is dedicated, although it is thought to have been Asclepius. Access to the temple was probably along a terraced roadway leading up the hillside from the west. A large wall built of polygonal blocks is visible on the hillside beneath the temple- it probably served as a terrace wall and foundation for a processional way, as well as forming a further boundary between the tenemos and the residential part of the city. The temple would also have been accessible from the theatre' (<i>Neritan Ceka. ibid p39</i>)</p> <p>'The temple is situated within the Butrint National Park, W-NW of the forum, above the theater. Access to the temple was probably along a terraced roadway and also from the theatre. A large wall built of polygonal blocks is visible at the hillside beneath the temple.</p> <p>Conservation interventions: On the fragments of the opus tessellatum (mosaic 2), some remains of edge repair and filling of lacunae are visible. Two types of materials were used for repairs – one is cement and the other is probably lime mortar mixed with soil. The mosaics were covered with polyethylene sheet posed directly on the floor and with approximately 5cm of sand on the top. Cement border was built to hold the sand in place and it is possible that it intersected part of the preparatory layer of the opus signinum mosaic. To our knowledge, the covering dates from the 80's and it wasn't renewed or maintained since. In 2007 preliminary conservation of mosaics with some infills in the masonry. The mosaic was then covered.</p> <p>Current condition: The stairs are unstable; Stones have fractures and one is fragmented; metal cramps connecting the stones is rusty and kept only in segments; Masonry does not have large problems; Only in some sections cracks and partial loss of mortar in joints is evident; Inner side of the masonry is covered in lichens as well as the back side. Plaster is in a poor condition; Plaster originates from 2 periods; the one part kept is the left side of the monuments. The later periods structures are in vulnerable condition.</p> <p>Recommendations/actions:</p> <ul style="list-style-type: none"> - Vegetation management - Studying and understanding the structures behind the wall of the temple on its northern side - Cleaning the masonry from lichens and moss and its consolidation - Cleaning of mosaic floors - Conservation of both mosaics - Conservation of plaster - Creating and placing a replika of fragments with snake detail removed in 90'2 - Probable removal of cement boundaries of mosaic floors with more appropriate material; or similar more appropriate interventions

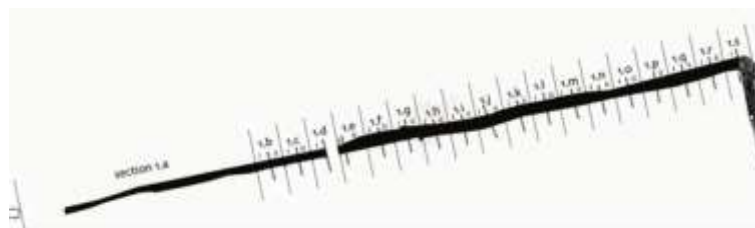
Brief description: The earliest components of this section of the lower circuit walls have been dated to the late antique period and earlier, with additions built in subsequent campaigns of fortification. The period of late antique building incorporated earlier standing buildings into the wall.

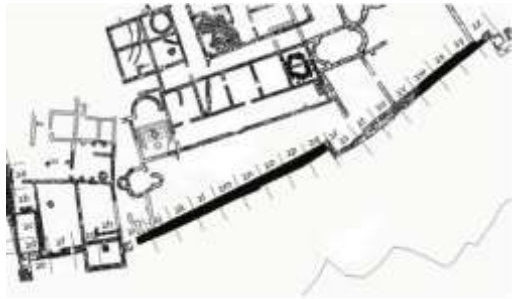
Wall 2 Triconch	
Position	plan

<p>Brief description: The lower circuit wall turns sharply towards the Vivari Channel at the western end of the Triconch complex, it borders the 'merchant's house' before continuing along the Channel side to the eastern end of the Triconch area where it is punctuated by a tower.</p> <p>Materials and construction: The wall is almost entirely constructed from irregularly coursed and sized limestone blocks with some variations such as infill tile usage and differently shaped putlog holes depending on the period of build.</p> <p>Conservation interventions: In 2008 vegetation growing on the monument has been removed, as well as all vegetation 5m from the wall on both sides; The masonry was cleaned and consolidated. In 2010/2011 the wall was further conserved and consolidated; The walls were grouted using lime mortar and the outer side towards Vivari channel was levelled using the fallen stone and locally allocated debris.</p> <p>Current condition: For much of its length the wall leans outwards, the result of undermined foundations on the water side exacerbated by the growth of large overhanging trees in the wall.</p> <p>Recommendations/Actions:</p> <ul style="list-style-type: none"> - Vegetation monitoring and management; removing all vegetation in the buffer of 2m using herbicide on the wall <p>structures; while outer zones need to be cleaned mechanically</p> <ul style="list-style-type: none"> - Periodical monitoring of the wall - Further reinforcement of the outer shore; to prevent the washing off of the infill - Conservation study as to understand the reasons for wall leaning outwards - Possible interventions relating to outcomes of conservation studies -

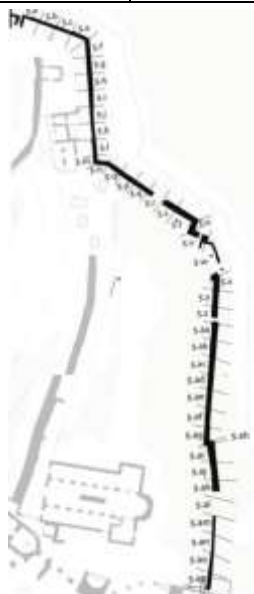
Brief description: Wall 5 runs from the Water Gate to the lake gate. Adjacent to the water gate the wall is rough, built in dry and appears hastily made whereas at the other extremity below the small church and the Hellenistic buildings the wall includes sections of the original Hellenistic wall and some fine medieval infill masonry using Hellenistic spolia. There is more visible of the wall from the lakeside than there is from the land, the result of much of the inner side of the wall especially to the north having been infilled over time. The wall now acts as a retaining wall and perhaps to greater or lesser extent always did.

Conservation interventions: From 2009 vegetation around as well as pile of organic debris were removed and walls were cleaned and somewhat consolidated. In 2012 the wall section in a vicinity of the Lake Gate was consolidated, and a viewpoint platform for visitors was created.

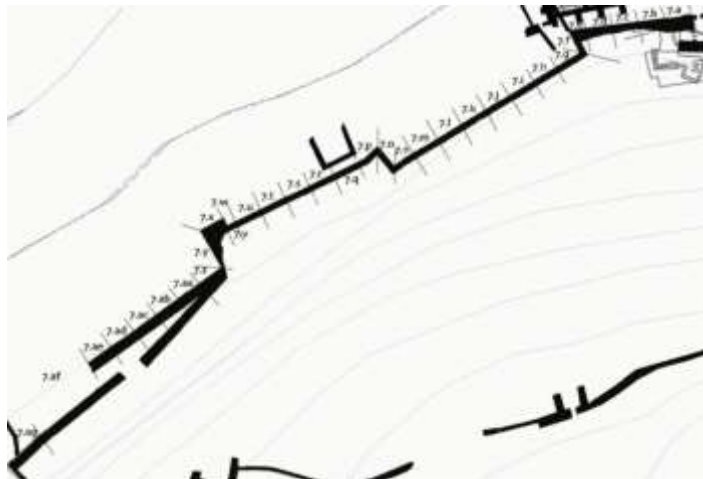
Brief description: Wall 7 largely follows the 4th Century BC lower circuit and the masonry of this ancient wall is still present at low level (and in some places to great height) along the length of this major wall. Major because it is probably the tallest surviving section of wall in Butrint. The wall incorporates the Cemetery building and the North gate at the extremities of its length and towers over the Roman necropolis.

Conservation interventions: Some consolidations were undertaken in 2007/2008; in 2012 Park has undertaken a full cleaning of lower vegetation in the lower sections of the walls as to provide as safe passage for visitors

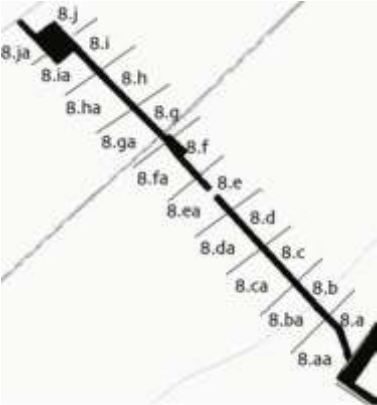
<p>Brief description: A medieval wall which runs from north west to south east from the junction of walls 7 and 9 to the shoreline. The wall gets less accessible the close to the water one reaches.</p> <p>Conservation interventions: Vegetation clean up was conducted in 2007; in 2013 wall was partially consolidated.</p> <p>Current condition: Semi-stable</p> <p>Recommendations/Actions:</p> <ul style="list-style-type: none"> - Conclude conservation interventions started in 2013 - Vegetation monitoring 	
Category 2– stable needs minor works

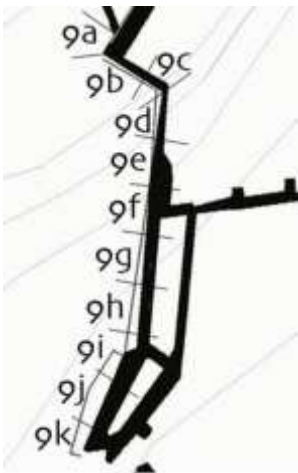
<p>Brief description: Wall 9 is a mixed period and materials continuation of Wall 7, the lower circuit wall with its origins in the 4th Century BC. The ground rises steeply from the point of juncture with the later spur wall, wall 8 and continues to rise until it reaches the West gate area. From the lake the wall is obscured by dense vegetation which grows on the steep bank between shore and wall. There is an earth cut access path which is now eroding but access to this wall is difficult and the vegetation encroaches.</p> <p>Conservation interventions: Vegetation clean-up was conducted in 2007/2008; No conservation was undertaken</p> <p>Current condition: Stable with loose upper sections of masonry; Extremely difficult terrain</p> <p>Recommendations/Actions:</p> <ul style="list-style-type: none"> - 9a-9b sections needs cleaning and consolidation of crack - 9k-9g sections needs to be cleaned of vegetation in its upper sections and across the surface and consolidated - Vegetation clean up and monitoring

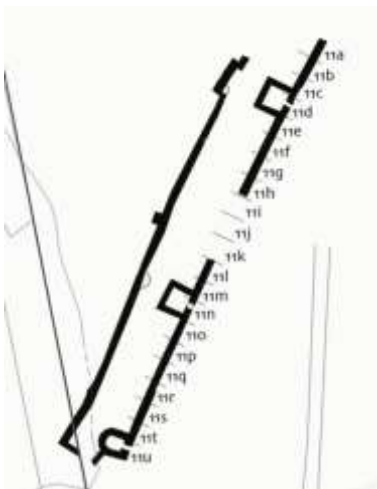
<p>Brief description: This wall is a continuation of the western sections of the wall with Fortification Towers. The wall is majorly medieval.</p> <p>Conservation interventions: The wall was consolidated in 2003 and 2004 with further interventions conducted in 2013 and 2014;</p> <p>Current condition: Condition is stable</p> <p>Recommendations/Actions:</p> <ul style="list-style-type: none"> - Vegetation management and monitoring on both sides of the wall 	
Category 1 – Stable and maintainable

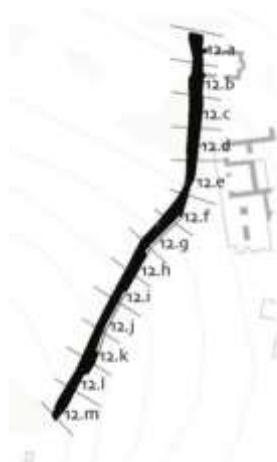
Brief description: This wall is classified as a wall built in the early Roman times (N.Ceka); On one section of the wall there are 2 evident masonry techniques: opus quadratum with spolia and a technique of non coursed stone with lime mortar joints which is considered medieval.

Conservation interventions: In 2009/2010 vegetation was cleaned from and around the wall sections; In 2014 a section of the wall collapsed and it was restored in 2017.

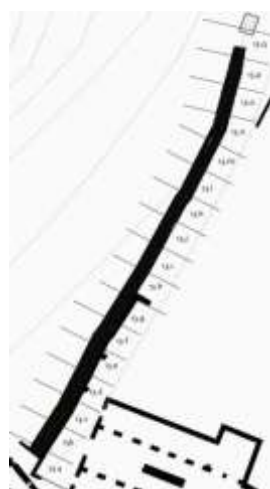
Brief description: This wall section starts in the vicinity of the Tower Gate, it goes along Great Basilica and Roman Baths following tourist trails and it discontinues in the parts where the medieval wall of Vivari channel starts. The wall is most probably from the 4th century BC which is obvious from its construction of large stone blocks built in dry. It is not in situ along all its length. In some sections only one line of stone is still in place.

Conservation interventions: The vegetation was cleaned around the monument alongside major cleaning actions in 2007

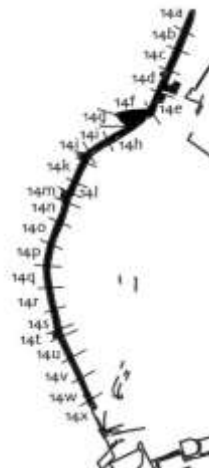
Brief description: Wall 14 runs from the area of the West gate to immediately north of the western defenses. This wall is largely of medieval phase 2 construction with some unique features such as the triangular bastion shown below. The combination of large block stonework, presumably spolia and almost decorative brick and limestone infill is very striking.

Conservation interventions: The wall was conserved in 2015;
