Butrint National Park

Integrated Management Plan (2020-2030)

FINAL ISSUE April 2020

PRINCE+PEARCE

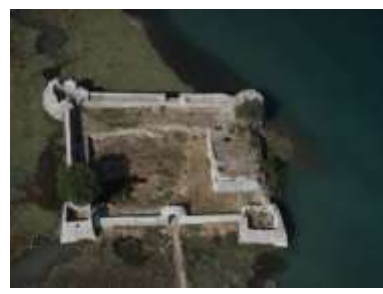
<p>Brief description: A small fortress at the mouth of the Vivari Channel has often been attributed to Ali Pasha, although it appears on the Venetian cadastral map of 1718. The channel-mouth fort as it stands is a small rectangular structure (22 x 30m) with battered walls. The earliest building within the later fort is a large rectangular tower supported by three barrel-vaulted rooms. The main area of occupation would have been in the upper levels of the tower (now destroyed). Around this tower is a later circuit wall, which is paralleled by another of Ali's fortifications with cannon emplacements set facing the sea, Agios Georgios in Preveza. The Vivari Channel fort's circuit includes two battered round towers with firing embrasures on it's seaward side and two irregularly sized battered square towers, again with firing loops or windows, looking up the channel towards Butrint.</p> <p>The principal entrance of the fort lay beneath the former dwelling place to the north, where the central vaulted chamber, protected by musket ports, opened directly onto the Vivari Channel; it is fair to assume that in this phase the fort functioned as a small naval base, with it's central area filled with water and steps leading up to parapet level. The parapet ran round three sides of the fort and provided cannon platforms. The south wall has comparatively fewer firing loops than elsewhere, largely because of the two arched gerderobes, with rails for screens and chutes out into the extramural area and a central low arch with a similar chute, perhaps for slops; there is also a circular firing loop adjacent to the southwest corner tower. (Andrew Crowson: Venetian Butrint p85)</p> <p>Conservation interventions: In 2011 partial conservation measures were undertaken; The north corner of the walls had a crack which was consolidated as well as a section of the wall on north; After 2011 major cleaning of vegetation was undertaken with masonry consolidations across the entire section of the castle</p> <p>Current condition : Stable</p> <p>Recommendations and actions</p> <ul style="list-style-type: none"> - South east side of the castle is in instable condition - Overall Geophysical study to be undertaken as to define the consolidation measures - Stone gabions around the walls are necessary to install

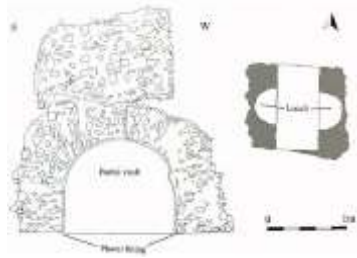
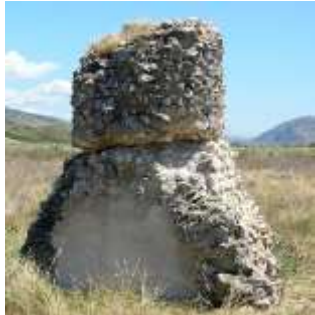
<p>Brief description: The substantial remains of a masonry tomb can still be seen on the Vrina Plain, situated on a slight rise some 300m to the east of the settlement nucleus. The ruin was first recorded by Ugolini, along with other funerary remains at 'Zara' in the late 1920's more or less in the condition it is seen today. The tomb survived the 1960's clearance of the plain and since its exposure it has been employed as a sheep pen and as a shelter for shepherds on the otherwise exposed plain. A consequent and highly noticeable deterioration in the tomb's physical appearance since the mid-1990 prompted a drawn, photographic and measured survey, in part as a heritage management exercise. The tomb consists of two elements: a vaulted chamber with a solid tower-like superstructure above. Any traces of facing stones, or plastered outer surfaces, have long since disappeared. The surviving structure measures 2.85m wide across the vault and 1.80m along its length. The vault walls average 0.57m in thickness and the entire lower section is 1.95m high. Above this, the superstructure is 1.40m in diameter and 1.24m high; the tomb presently stands 3.19m above ground level. Below ground it appears to be constructed on very shallow foundations.</p> <p>The Tomb chamber itself is quite well preserved. This is a vaulted space 1.57m long, 1.50m wide and 1.06m high. In the centre of the eastern and western walls are two semi-circular <i>loculi</i> for cinerary urns. Each measures 0.44 x 0.42 x 0.56m. Their bases are raised 0.15m from the floor of the chamber. Both the northern and southern walls have largely been demolished to permit its use as a shelter, though enough remains to show that the southern wall was once continuous. The access to the tomb chamber must, consequently, have been from the north, that is, from the side facing the lake. The surface of the interior (the vault, the floor and the <i>loculi</i>) is entirely covered with a layer of plaster up to 20mm thick. Limescale (<i>sinter</i>) covers much of the remaining plaster and may have contributed to its survival. This does, however, make it difficult to discern whether the interior was ever painted.' (1)</p> <p>Conservation interventions: The structure was conserved from 2007 to 2009</p> <p>Current condition : Stable</p> <p>Recommendations and actions :</p> <ul style="list-style-type: none"> - Clear the surrounding area adjacent to the tomb of vegetation on a bi-annual basis. remove any vegetation growing on the masonry itself - Consider building a shelter to dissuade shepherds from damaging the tomb. -

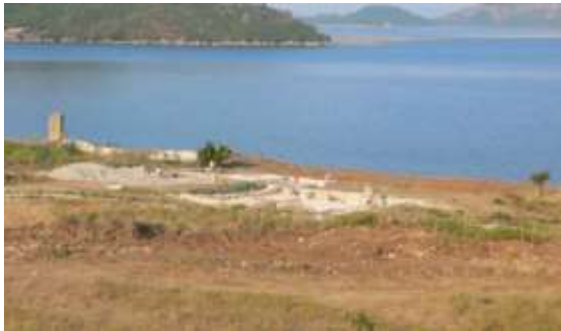
<p>Brief description</p> <p>The standing ruins, mostly low walls, at Diaporit consist of an early Christian basilica, a Roman villa and a Roman bath-house complex. All excavated in the first decade of the 21 century they were conserved between 2005 and 2006, over two seasons. The Basilica is the most self-contained of the buildings with a complete perimeter and interior walls preserved. The villa and bath-house are less self-contained and do not present as complete a picture to the onlooker.</p> <p>'In the early decades of the 1st century AD, at the very end of the reign of the emperor Augustus and as Butrint benefited from substantial imperial investment, a new Roman villa was constructed. Much of this building now lies beneath the waters of the lake, which have risen since the Roman period, or was destroyed in later building activity, but enough survive to show that it followed the alignment of the earlier Hellenistic villa, facing towards Lake Butrint. Around AD 40-80 a much larger and more grandiose villa was laid out across the site. Arranged over a series of terraces, it included an elegant east wing with rooms decorated with mosaic and painted wall plaster. The west wing of the villa included a monumental nymphaeum fountain set close to the water's edge. This may conceivably have been attached to a porticoed walk, giving the villa an imposing aspect when approached from the lakeside, and providing dramatic vistas towards Butrint when viewed from inside the west wing of the building. The southern wing was dominated by a major bath complex that by the late 2nd century included an apsidal room with a cold plunge pool, a large hexagonal room and an elegant internal courtyard. A striking innovation of this new villa was its different orientation. No longer facing the lake, the design of the new villa was instead orientated directly towards Butrint. We don't know who its owner might have been, but its definite visual links to Butrint make it at least likely that it belonged to one of the new local elite dominating the political life of the city.</p> <p>This luxury residence was not without its quirks. Though lavish in design, structurally the work – especially the 2nd-century refurbishments of the bathhouse – appears carelessly and hastily executed. It is possible that the villa during the later period of its life was not permanently occupied, but owned by a person who was resident elsewhere coming only occasionally to Butrint.' <i>(a description of the villa from the Butrint.org website)</i></p> <p>Current condition : Stable</p> <p>Recommendations and actions :</p> <ul style="list-style-type: none"> - - The site needs extensive weed and low shrub eradication. For at least three seasons the early growth of, especially, thistles, should be treated with systemic weedkiller to avoid the setting of seed and greater proliferation. All shrubs and plants on masonry and within four metres of the perimeters of buildings should be pulled or cut, roots poisoned. Wall tops in the villa should be seeded with hardy, drought resistant grasses. - The Diaporit jetty should be rebuilt to allow visits by boat. - The signage, bridges etc that once existed to mark the pathway from Butrint should be reinstated to allow for visits by foot. - The local leisure economy such as it is has been damaged by the washing out of sections of the track to Diaporit. The pebble beach is much used in summer by people from Xarra who this year were unable to reach by normal means their traditional bathing site. Thought should be given, within the National Park rules to repairing this trackway for the benefit of both visitors to the ruins at Diaporit and for those who visit for other reasons. <p>Category 2 – stable needs small but urgent works</p>
