# Roșia Montană

## *Mining Landscape*

**State of Conservation Report UPDATE**

**February 2023**

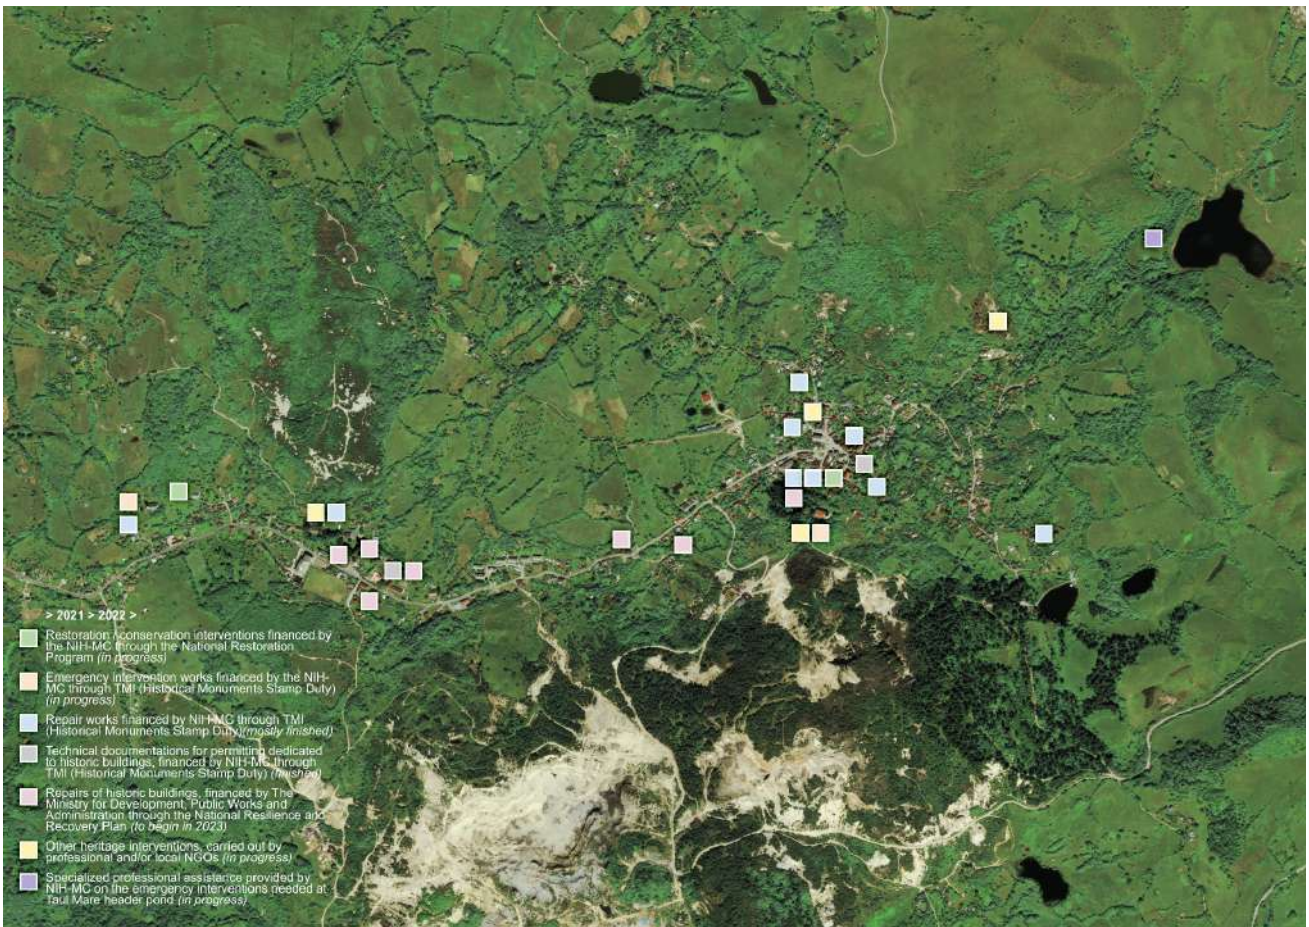
\_ location of main heritage interventions within the property finalized in the last 2 years, in progress or to start in 2023.

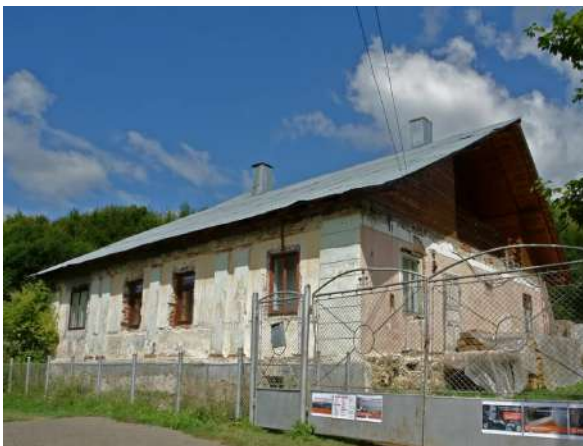
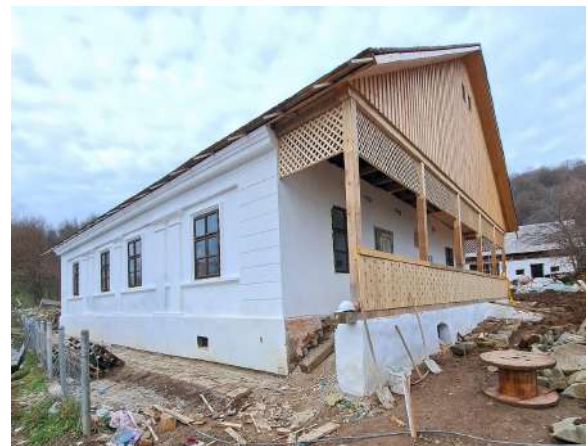
The house follows the traditional rambling typology, but has a more complex functional layout, determined by historical transformations. The adjoining annex was probably built together with the parish house in 1864, and the annex at the back of the plot was built in 1864. In the vicinity of the stone annex there is another wooden annex, probably also built in 1864, for storing wood.

\_photos: the main building before and during the intervention, detail from the project.

The intervention aims to recover the community role of the parish house and the premises, becoming an important centre for the community. The intervention aims to preserve the historic material and restore it in such a way as to ensure continuity and preservation in its formal integrity and authenticity. The restoration works will be completed in 2023.

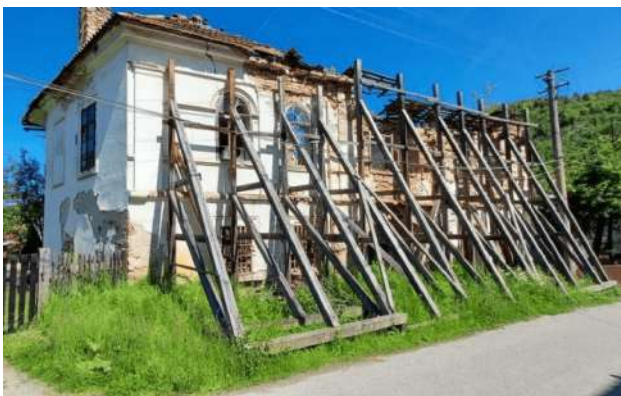
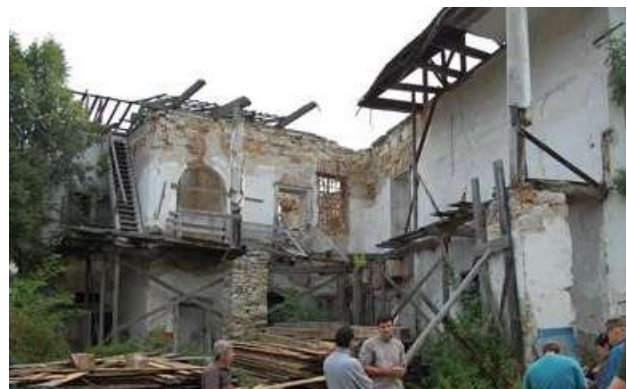
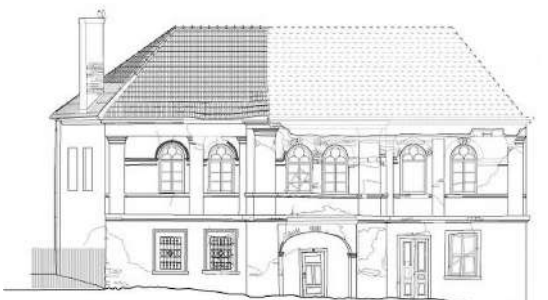
The Reformed Parish House was built in the mid-19th century as a parish office and dwelling, with commercial premises on the ground floor facing the street. In the post-war period it functioned as a pharmacy and a pharmacist's house. After 1990 the commercial space was also used as a general store and grocery store. Since the 2000s the building has not been used and has steadily deteriorated to its present state of ruin.

\_photos: state of conservation and excerpt from the survey and the intervention design.

- local plastering, preservation of original plaster and replastering using lime plaster and traditional techniques, restoration of historical mouldings, based on traces preserved, using traditional materials
- the outer gallery will be restored according to preserved traces (sockets in masonry, wooden elements, etc.) and archive photographs
- the roof volume will be rebuilt and shingle roofing will be made, according to archive pictures, which show that all the houses in the area were shingled and had dormer windows, and chimneys will be restored, the basement and attic will be renovated and a staircase to the attic
- the joinery will be rebuilt according to the models retained, respecting the dimensions, profiles and ironwork, and in the areas housing the interior glazing be fitted with two sheets of glass.

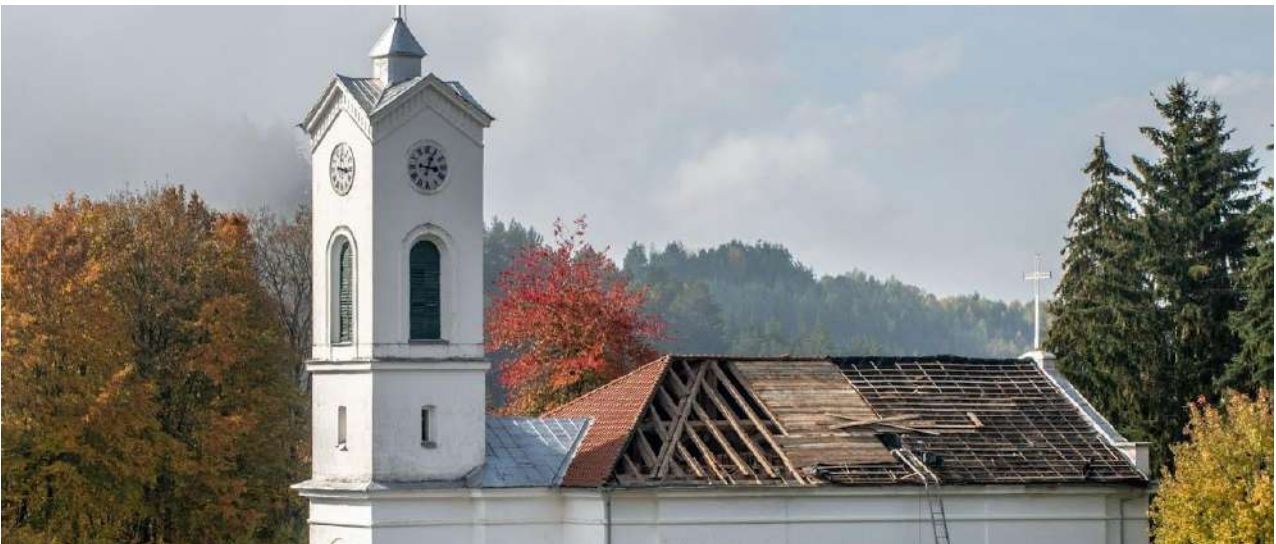
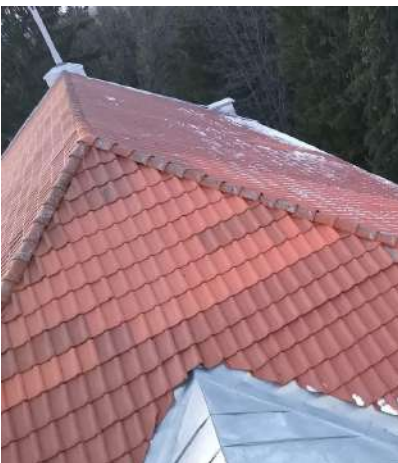
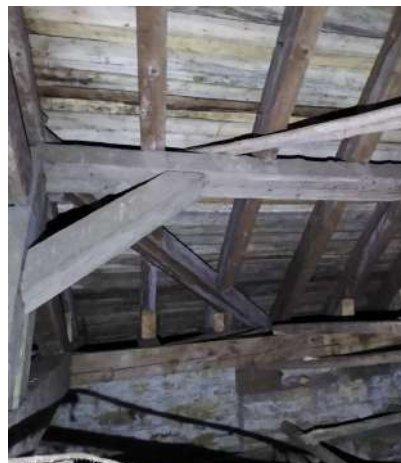
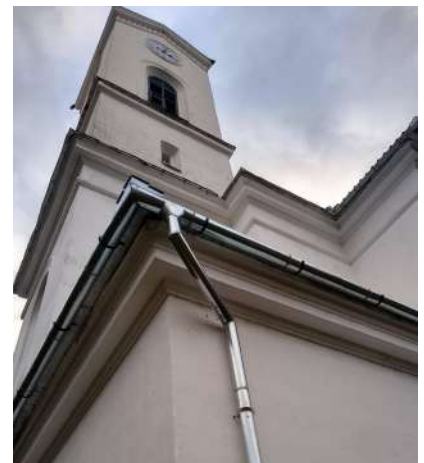
State of conservation: the roofing, due to inadequate repairs, deterioration is advanced in areas essential for the stability of the roofing. The dynamics of deterioration were active, with severe intensity, sometimes critical. The tile cladding mounted on small section battens (3x5 cm) in relation to the large spacing between the rafters (85-90 cm) did not ensure the watertightness of the roof. The connections of the tile cladding with the sheet metal cladding were improvised and large areas, such as the connection of the roof to the eave, did not have sheet metal flashings. Thus, the degradation caused by infiltration at the rafter level reached a critical stage at the joint between the chords and the rafters. Works carried out: replacement of degraded parts of the roofing, revision and re-roofing, introduction of flashings and revision of the rainwater collection and routing system.

\_photos: images during the intervention works/ rosiamontana.community (partner).

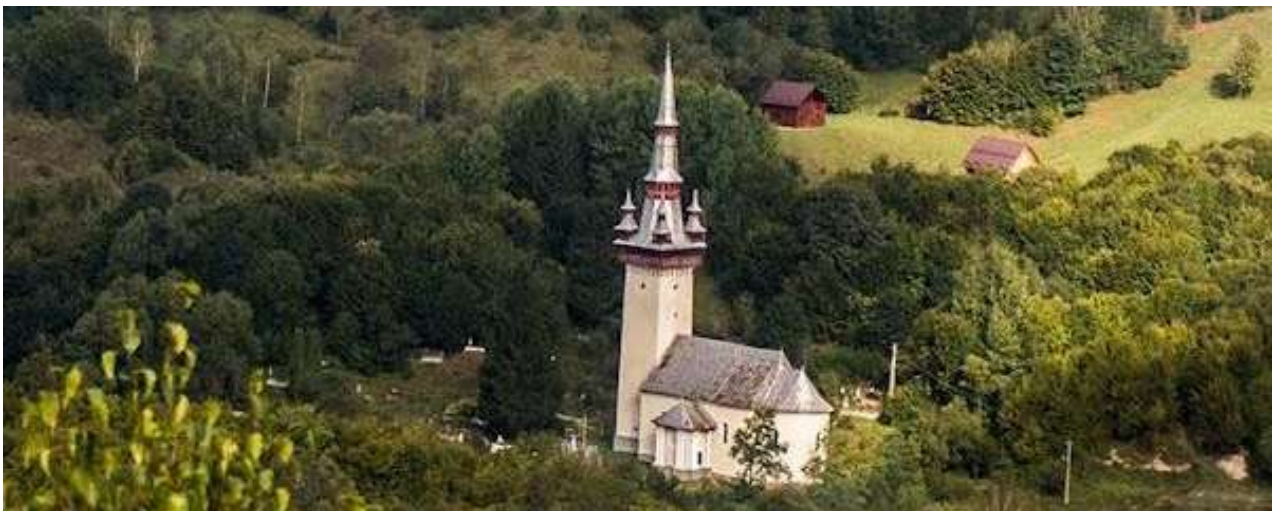
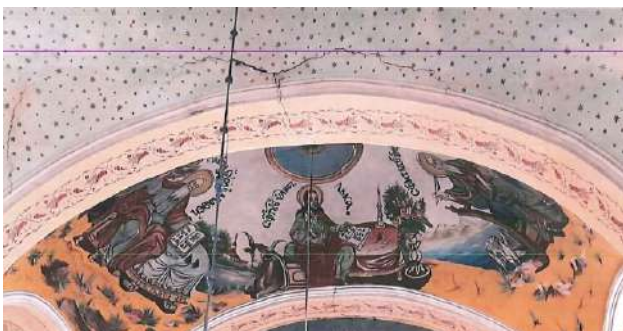
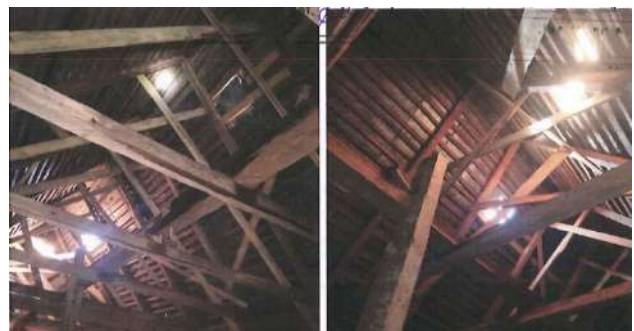
The building currently has structural issues (masonry cracks and fractures), mainly in the area of the superstructure of the altar apse, but also in the vaulting system of the nave, marked by a series of cracks along the longitudinal axis. The dynamics of deterioration is active, with severe intensity, sometimes critical (arches/vaults); superficial or deep damage to the building material, especially to the wood of the complex structures of the nave and tower roofs. Materials from former interventions, incompatible with the historic ones, in particular Portland cement, are a risk factor for the long-term protection. The dynamics of deterioration is active, with mild and severe (locally) intensity.

\_photos: the main problems addressed by the intervention / rosiamontana.community (partner).

Works to be carried out by June 2023: The construction of three transverse metal tie rods, mounted at the arch's spring, to take the lateral thrust of the arches and vaults; Reinforcement of the load-bearing masonry of the main transverse arches by restoring/realizing the continuity at cracks, fissures or in the area of the non-woven joints of the different construction stages; the continuity of the masonry will be restored by injecting the cracks with specific injection materials for historic buildings and weaving the deeper cracks with metal inserts, or by locally reinforcing them with reinforcement in horizontal joints; Local replacement or reinforcement of all compromised, displaced, broken, decayed roofing elements; Removal of all improper roofing interventions; Inspection of all joints between roofing elements and restoration of compromised joints; Replacement of degraded sheet metal cladding with original shingle cladding on nave and aisle; Review of rainwater collection and routing system.

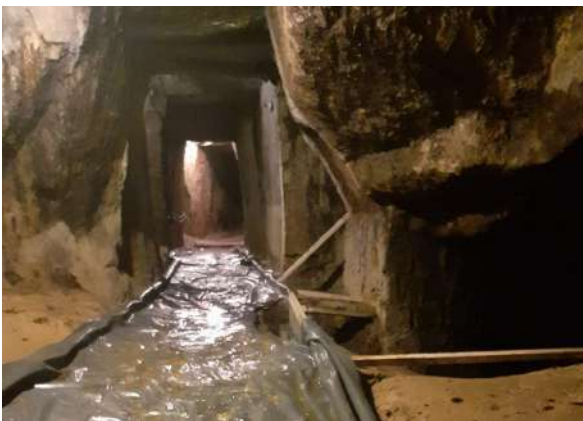
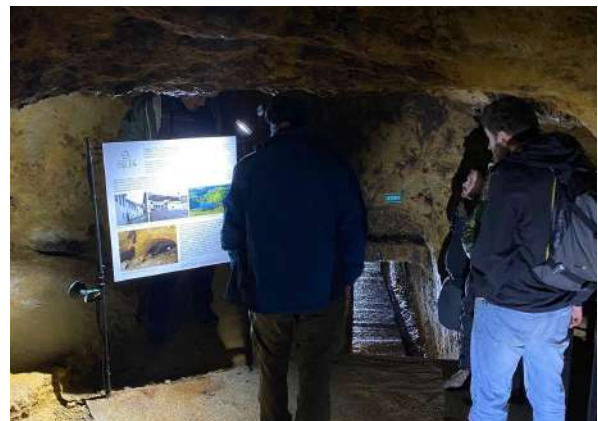
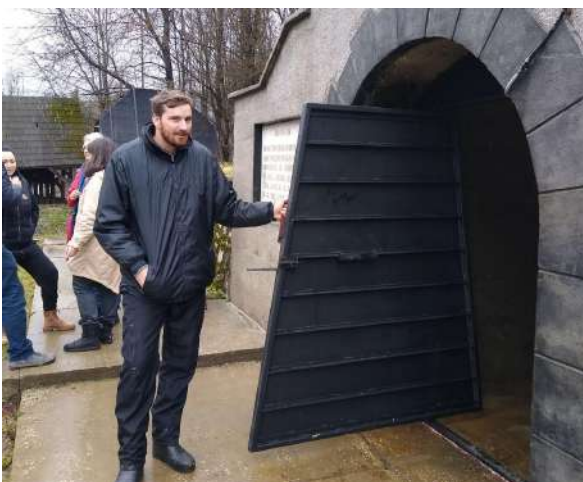
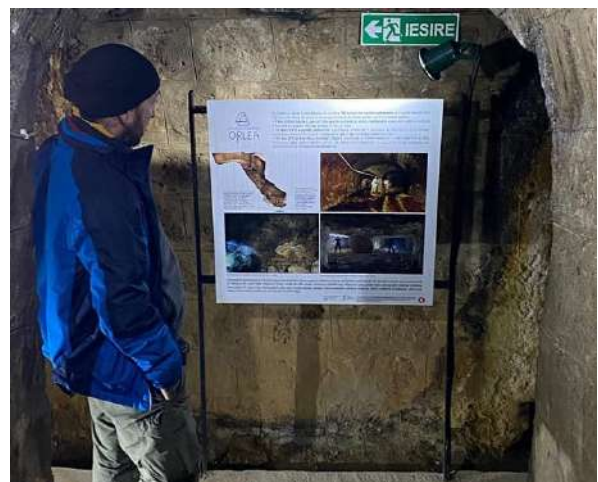
State of conservation before the intervention: Since the closure of mining activities in 2006, minimal maintenance work has been carried out (wooden deck, removal of tailings, local scaffolding, replacement of light bulbs), but in the absence of approval for more substantial investments, the degradation process has already taken hold. The mine drainage facilities were locally degraded. The underground route must ensure safe and optimal conditions for visitors, without areas of earth deposits, without broken steps and with adequate lighting. It was also necessary to introduce a minimum explanatory infrastructure, accessible to all categories of visitors.

\_photos: images during and at the end of intervention / [rosiamontana.community](https://rosiamontana.community) (partner).

Works carried out: Repairs to the entrance portal, repairs to inclined access planes and horizontal gallery (cleaning and completion of steps and side rails, evacuation of soil (sterile) and repairs to treading surfaces), repairs and reconfiguration of lighting system, parapets and rebuilding of demonstrative timber support. Installation of explanatory panels for presentation and interpretation. Since the 15th of December 2022 the mine is again open to visitors.

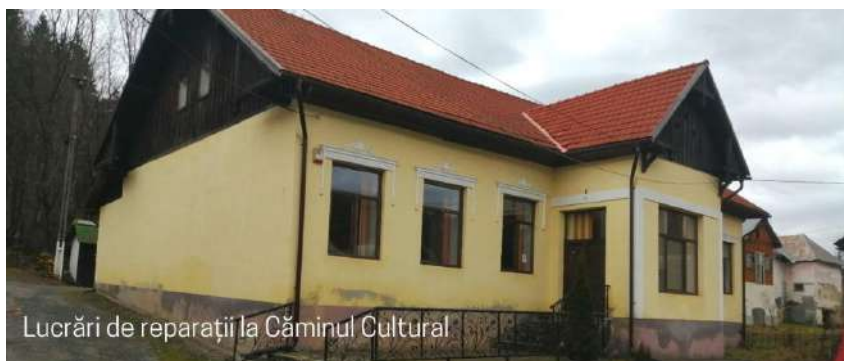
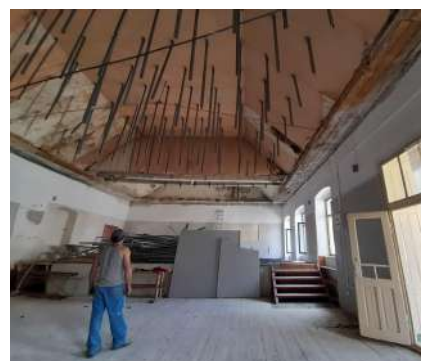
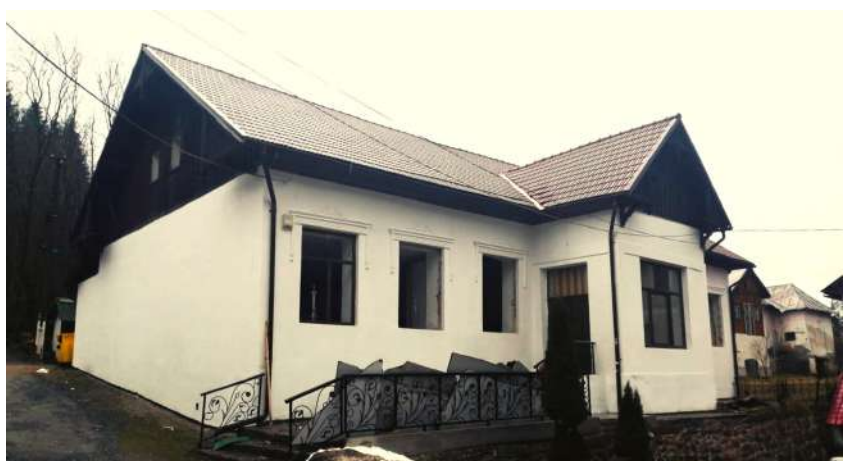
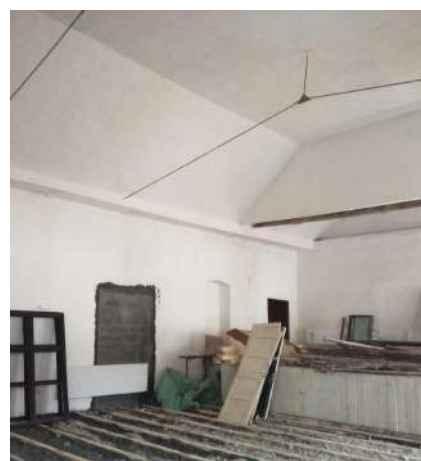
The state of conservation was average, with active deterioration processes determined also by recent excessive use during the previous year's floods as emergency shelter for evacuees. The necessary repairs must be properly coordinated, in keeping the character of the historic building, so that the consequences of previous inadequate repairs can be resolved.

\_photos: before and during the intervention.

The project that will be finished early 2023 aims not only to restore the original use of the historic building, and repair all the elements that require intervention, but also to restore the way the community relates to the building. Thus, through maintenance works, the building will be able to host again the current community events for which there is constant demand, but also a series of new events in relation to the project partner, Simion Balint Secondary School in Rosia Montana, which thus gets access to additional spaces so necessary for extracurricular activities that they run and that in recent years have increased in number and interest.

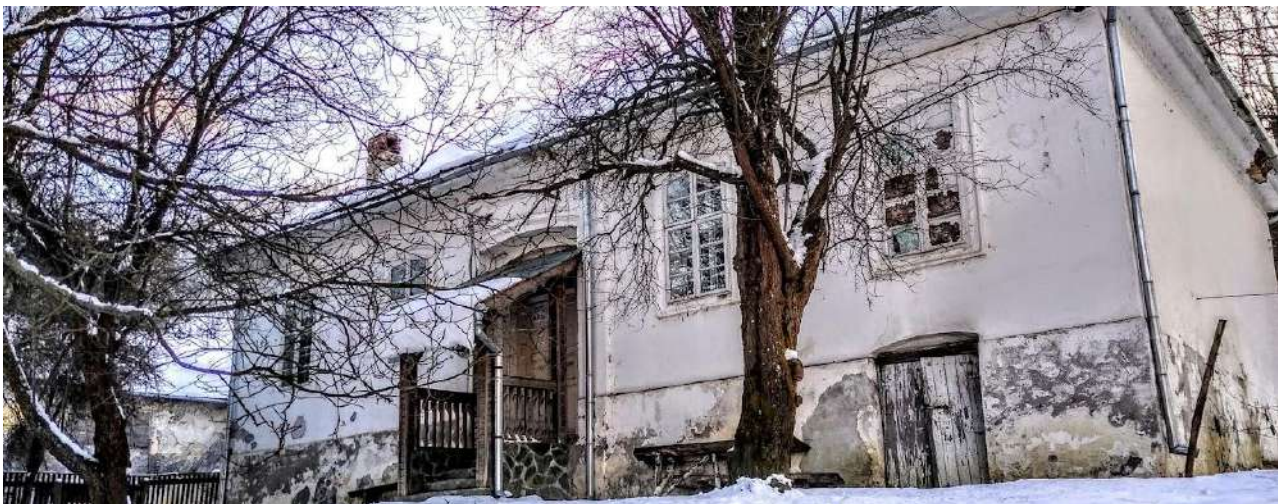
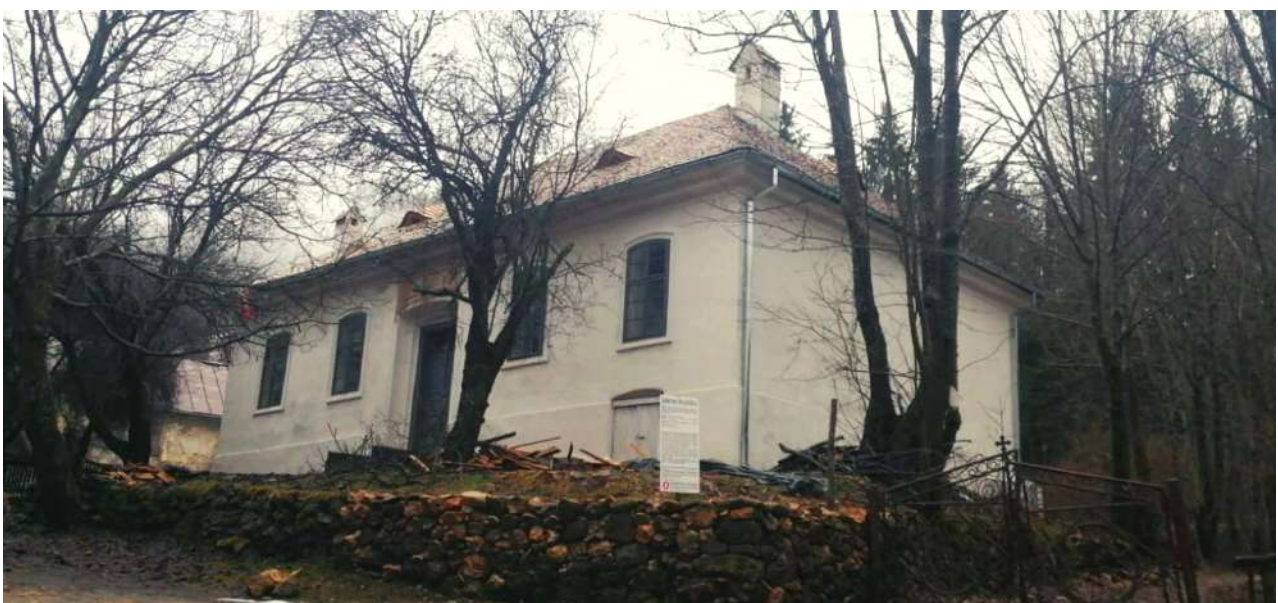
The lack of routine maintenance works has led to a process of deterioration, which is becoming more and more extensive year by year. To bring it back into use, interior work, heating installations and various repairs were needed. Outside, the degree of deterioration was more advanced.

\_photos: before and during repairs / rosiamontana.community (partner).

Works carried out: removal of cement mortar plastering, filling of gaps with lime mortar, repairing molds with lime mortar and lime washing, repairing and painting carpentry, adding glass sheets, inserting shingle cladding.

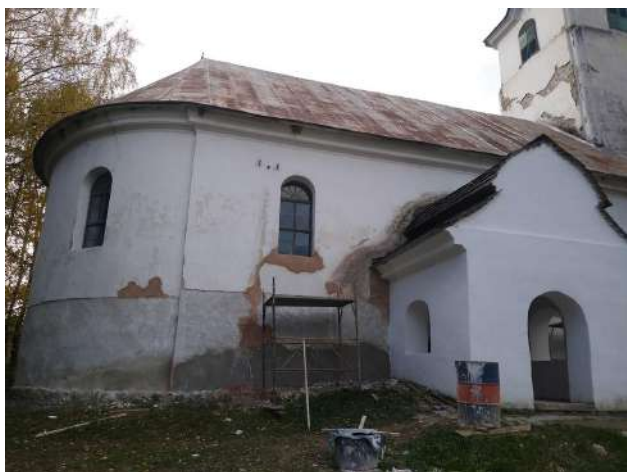
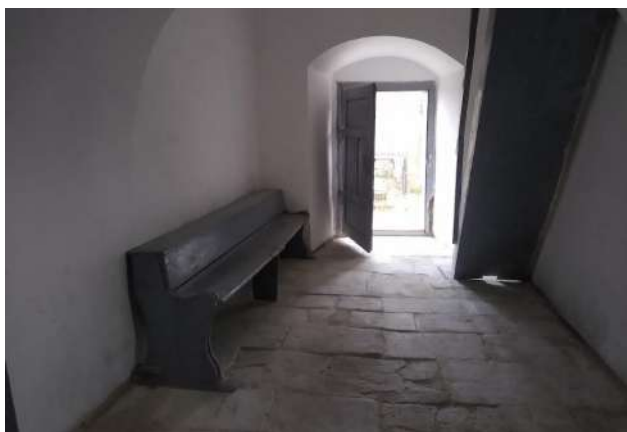
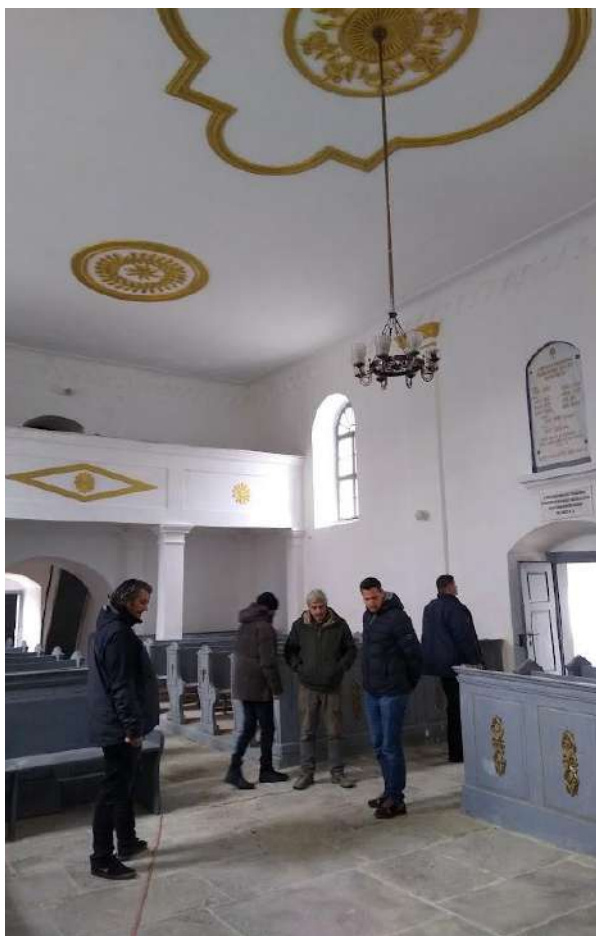
State of conservation. The interior and exterior plasterwork, inadequately repaired with cement mortars, shows particularly marked deterioration at the base, caused by capillary damp, over a height of about 2 m, while on the remaining exterior plastered surfaces there are isolated gaps in the underlying layer or areas of peeling. The interior floor, made of rectangular stone slabs, shows signs of degradation due to lack of ventilation and routine maintenance. The woodwork is still functional, but requires routine repairs, caulking and rust cleaning of the ironwork. The fixed furniture is functional but requires local repairs, cleaning and painting.

\_photos: during and after intervention works / rosiamontana.community (partner).

Works carried out: removal of cement-based plaster, filling gaps with lime mortar, repairing mouldings with lime mortar and painting, cleaning stone floors, painting carpentry and repairing degraded components, cleaning and repairing gutters and downspouts, traditional stone paving around the church.

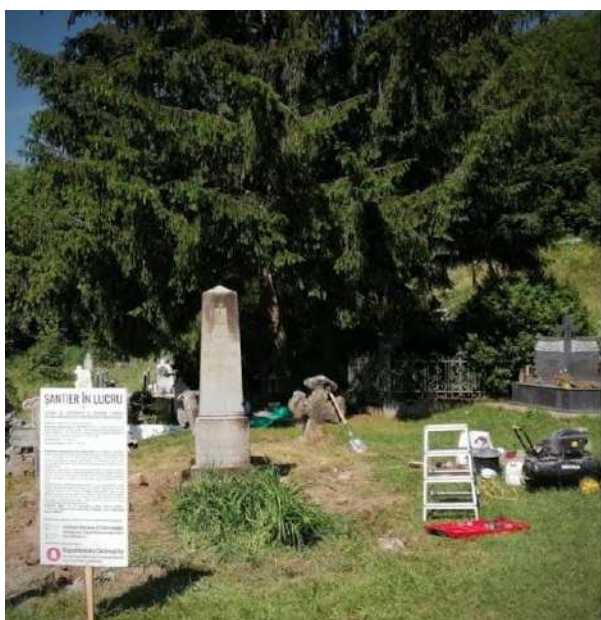
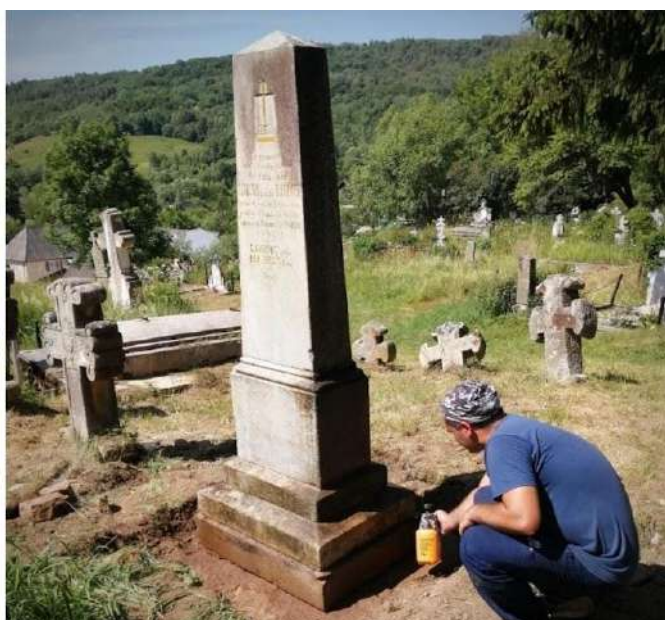
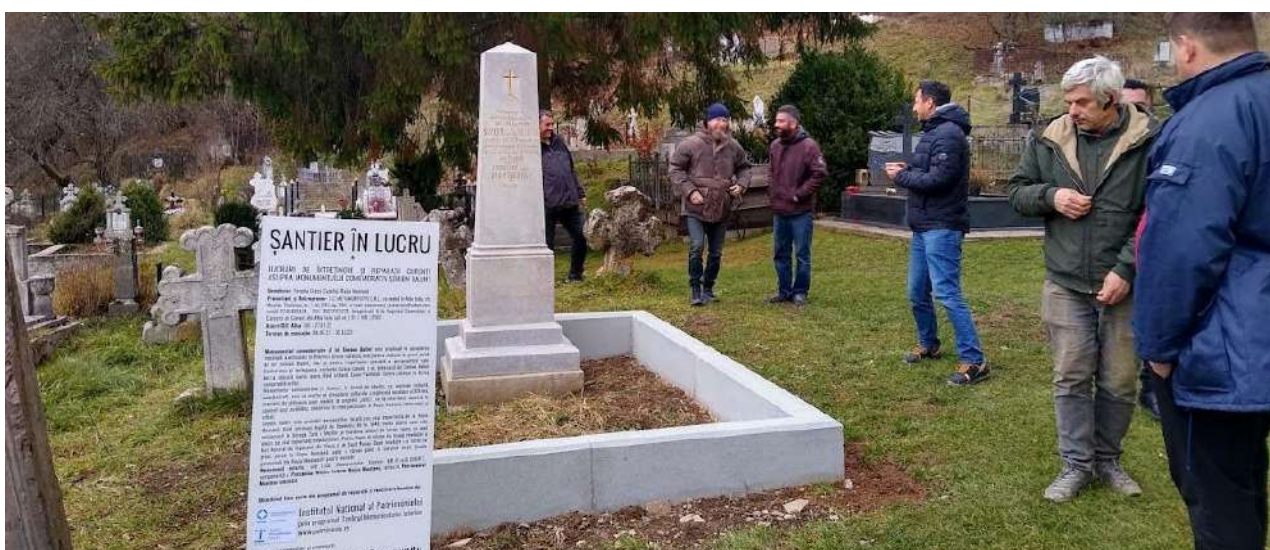
State of conservation: Damage was caused by the monument's location in the environment, being in direct contact with climatic factors: physical factors, temperature, solar radiation, the action of humidity and water, the repeated phenomenon of frost/thaw (one of the most harmful), air currents, climatic factors and biological factors.

photos during and after intervention works / rosiamontana.community (partner).

Works carried out: prophylactic interventions aimed at preventing the development of major deterioration (biocide, cleaning of crusts, consolidation, hydrophobization); the environment of the monument itself is addressed by works to eliminate recent harmful interventions.

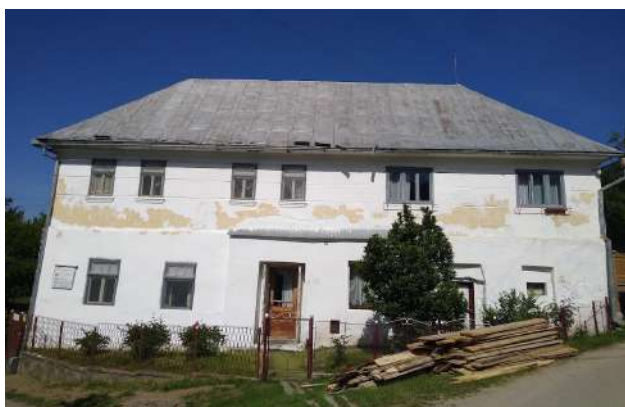
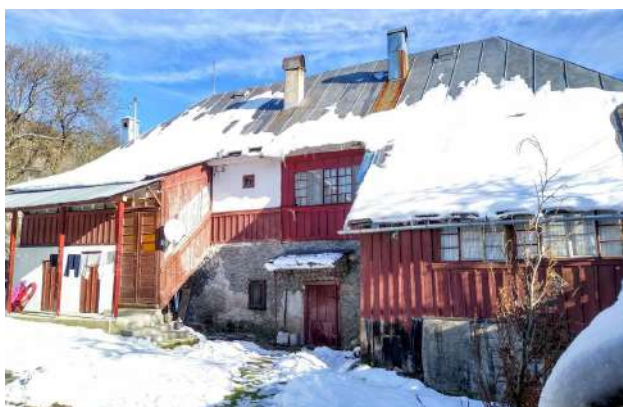
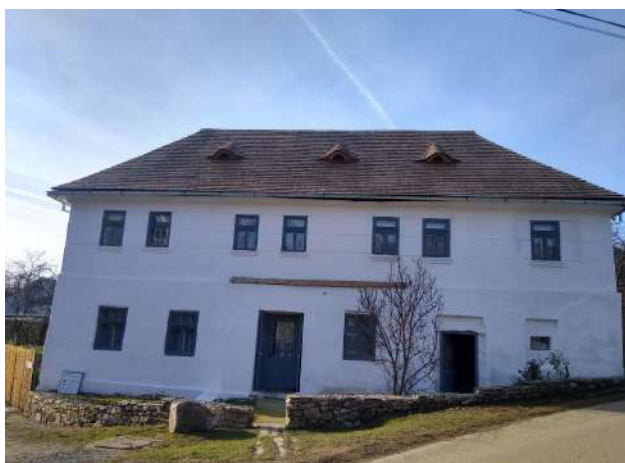
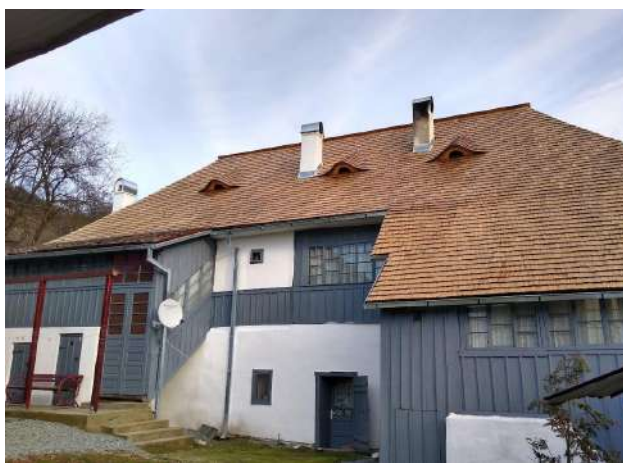
State of conservation: The building was in an average state of preservation, with deterioration mainly caused by inappropriate local interventions (sheet-metal fencing, tin cladding, cement mortar repairs).

\_photos during and after intervention works / rosiamontana.community (partner).

Works carried out: Reinstatement of traditional shingle cladding, introduction of necessary flashing to ensure water tightness at chimneys; replacement of dysfunctional rainwater system; removal of cement mortar; filling of gaps with lime mortar; repair of drawn profiles with lime mortar; limewashing; removal of parasitic elements - awnings, cables, aerials, roof-mounted service; removal of sheet metal finish of chimneys; plastering; repair carpentry, painting, reintroduction of carpentry in altered areas; repair/replace fence bases, dry stone walls, reintroduction of wooden fence/gate.

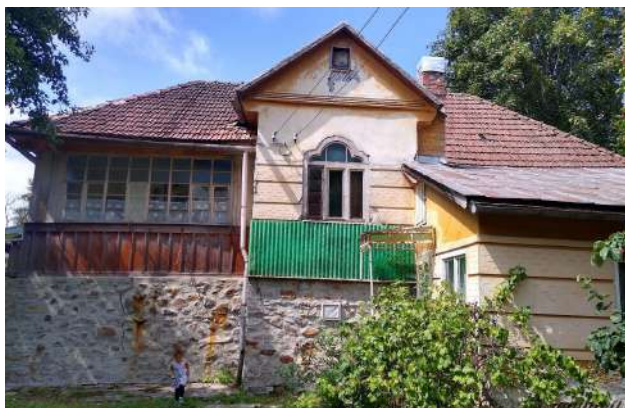
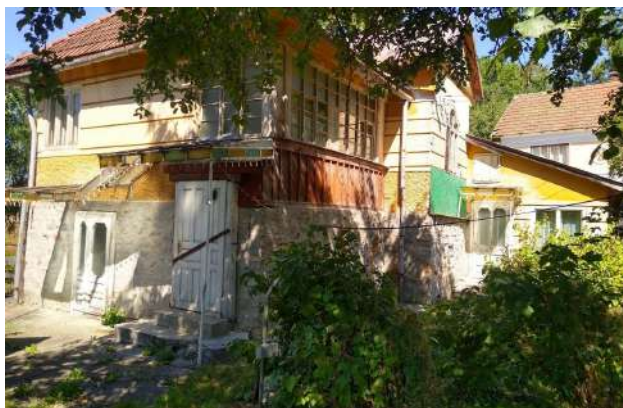
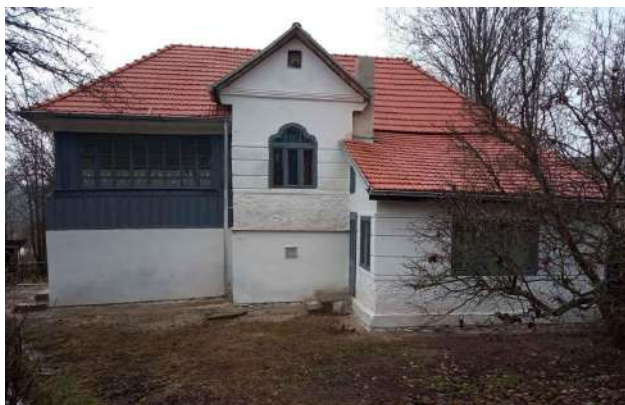
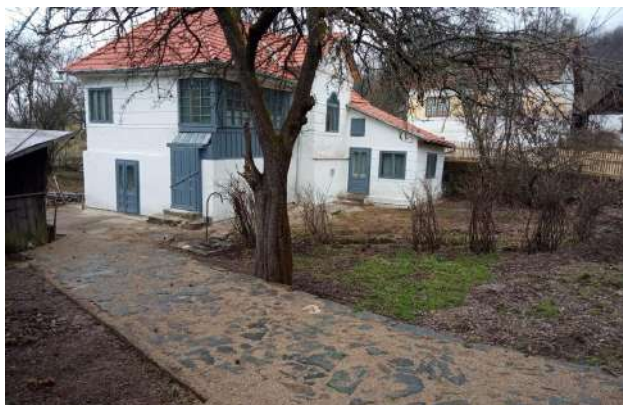
State of conservation: Interior works and various repairs were needed to bring it back into use. On the outside, the architectural elements and surfaces have deteriorated, the tile and sheet metal cladding has deteriorated, allowing water and snow to penetrate locally, the rainwater catchment and drainage system has deteriorated, and the plasterwork, particularly at the base, has deteriorated more markedly. The window cases are still functional, requiring routine repairs and replacement of glass sheets, the wooden fencing is degraded, the wooden gate requires minimal interventions, the retaining walls require minimal repairs on the north side and more extensive on the east side.

\_photos during and after intervention works / rosiamontana.community (partner).

Works carried out: Cement mortar removal, removal of parasitic elements - awnings, roof-mounted service connections, repairs to plaster and drawn profiles - local additions, consolidation, painting; repairs/replacement of tile coverings, flashings; painting, additions to glass sheets; repairs/replacement of gutters and downpipes; repairs to dry stone walls; repairs, completions, replacements to wooden fencing; repairs to wooden gates; repairs to paving and guttering.

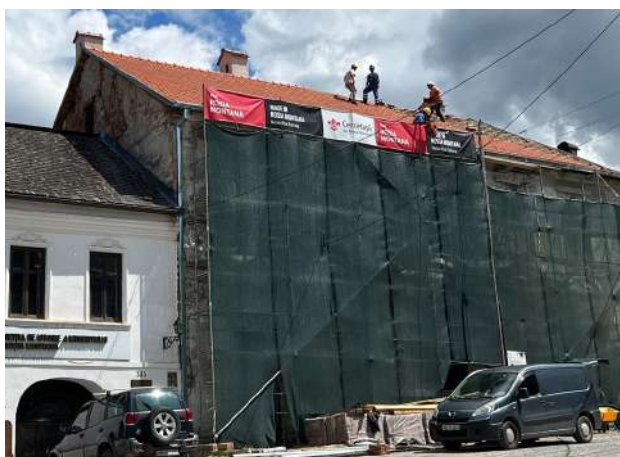
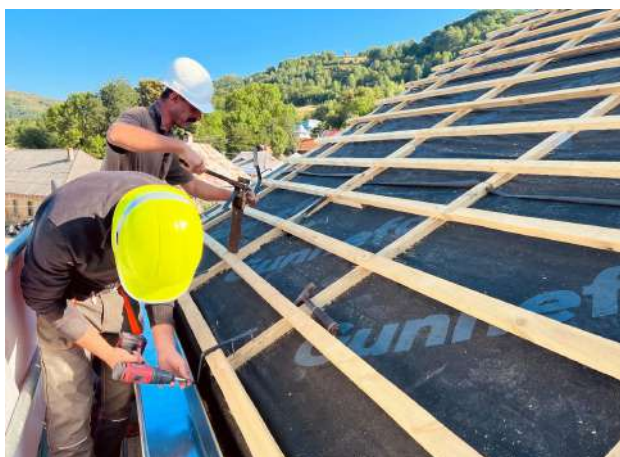
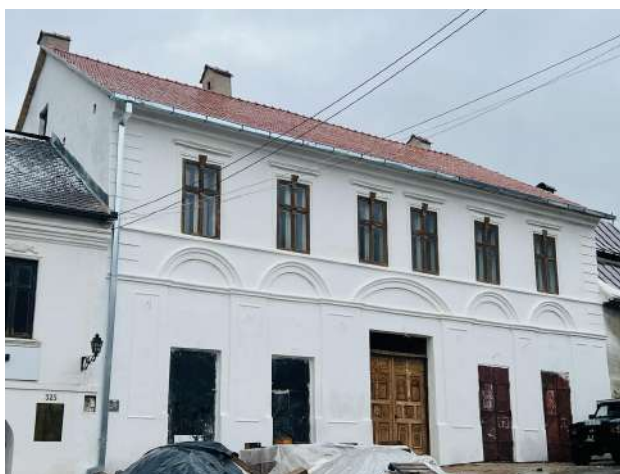
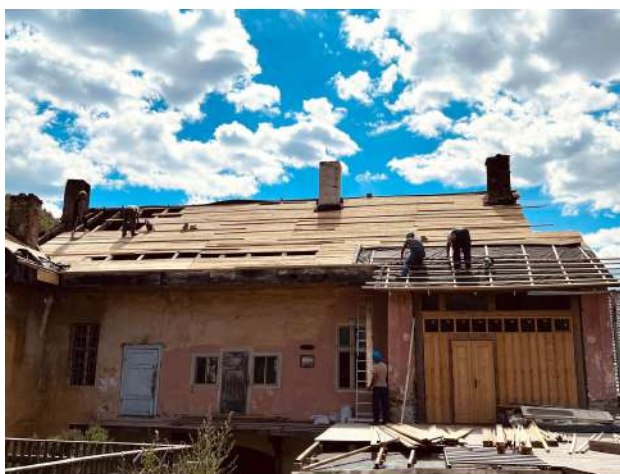
\_photos: during and after intervention / Local Scouts Center (partner).

Repair works carried out: Current roof repairs: Repair of the roofing with vented tile, laid on asphalt and foil, making sheet metal flashings in the chimney area, gables; plastering chimneys; Rainwater collection and drainage system: revision of existing system - replacement of non-functional components; installation of gutters and downspouts; centralized rainwater collection from roof and courtyard. Carpentry: restoration of access corridor gate - repairs, additions; repair of floor hinges and frames - ensuring watertightness (grouting); painting.

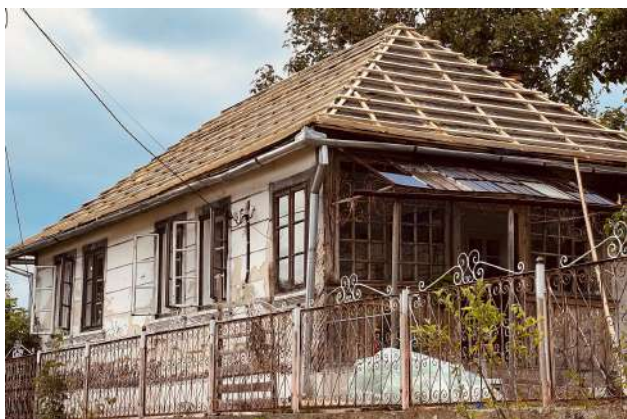
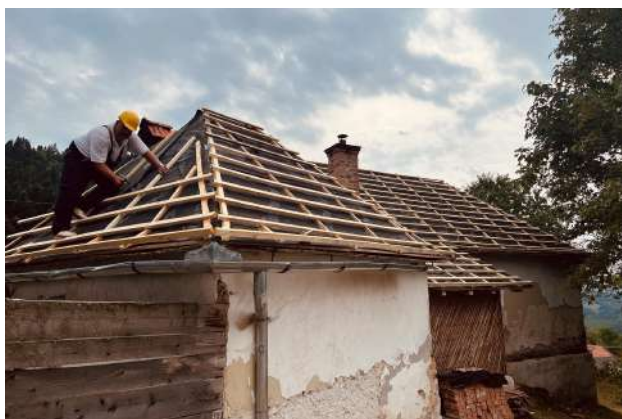
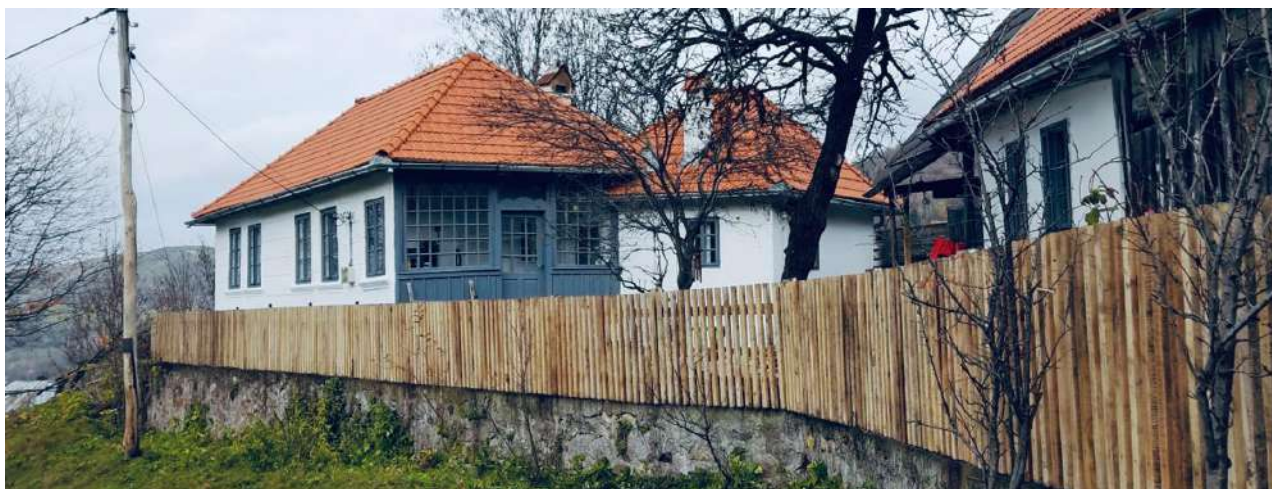
photos: during and after the intervention / Local Scouts Center (partner).

Works carried out. Roof repairs: Revision of roofing of dwelling and outbuildings - replacement of damaged or missing tiles, repointing of displaced ridge or field tiles; Rainwater collection and drainage system: overhaul existing system - replace non-functioning components; installation of gutters and downspouts. Façade finishing: Fill in gap areas with lime mortar; cleaning of areas with exfoliated plaster, integration of gaps, finishing; limewashing; Windowcases: Revision windows, doors - repairs, additions; repairs to sashes, frames - ensuring tightness; painting. Household annexes: filling of gaps with lime mortar; cleaning areas with exfoliated plaster, filling gaps, finishing; limewashing; revision of plank closures - repairs, additions. Fencing: removal of cement-based plaster; removal of parasitic elements (metal fencing).

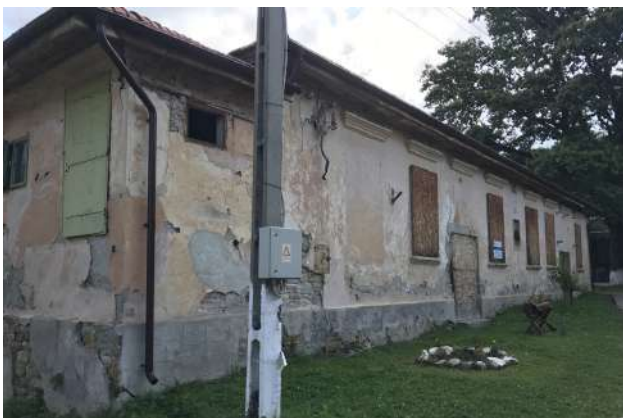
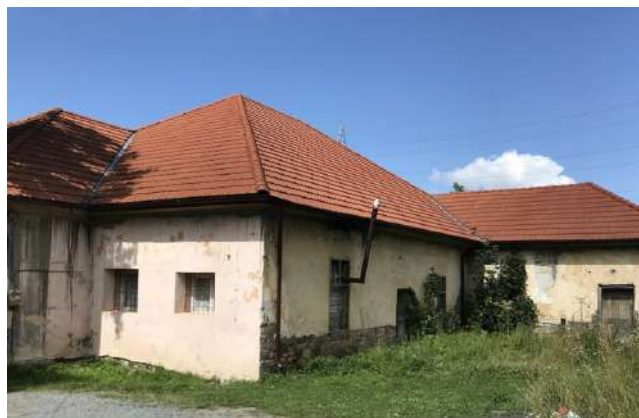
The building is located in the administrative center, next to important public buildings - town hall, school, police, museum, in an area with high exposure and with great potential for inclusion in a museum-tourism scenario while maintaining the necessary food/service functions. The building was erected, along with a large part of the buildings on the site of the historic Mining Enterprise, between 1850 and 1900, to house the Mining Enterprise's staff. Later, during the communist period, the building was nationalized and transformed into a Cinema hall. After the 2000s the building fell into disrepair and could no longer be used.

\_photos: state of conservation of the main facades.

For the conservation-restoration of the monument were proposed: Elimination of the harmful interventions carried out when the building was transformed into a cinema: projection room, accessways to the cinema from the main road; Restoration of the image of the main facades, in accordance with the "mining architecture" consistently preserved in the Mining Enterprise Ensemble (window cornices, shape and design of window openings, sills, etc.); Differentiated presentation of the valuable building stages of the construction; Preservation of all original elements: Masonry, plasterwork; Restoration of masonry, plasterwork, mouldings on the basis of existing in situ evidence; Stratigraphic surveys to determine the original color scheme; Archaeological surveys, necessary for the geotechnical study and structural assessment, will aim to identify possible dispositions of some of the partition walls in the area of the present cinema hall; The materials used for restoration will be historical - lime-sand mortar - the recipe will be determined by specialist analysis; The joinery will be reproduced according to the existing elements in situ and based on historical information; The solutions for the consolidation of the resistance structure must not compromise the architectural and structural configuration of the original construction by the introduction of additional elements; The interventions of recent date, where it is not possible to completely eliminate the harmful elements, will be treated differently, but at the same time the possibility of obtaining an integrated, non-contrasting image will be sought. For the refurbishment, provision has been made for: the introduction of installations. For the valorisation of the site, it was planned to introduce some outdoor circulation and landscaping; to introduce a sanitary block and a minimal preparation area, necessary for the events; to host an exhibition in the space of the former cinema hall, presenting the cultural, natural and intangible heritage values of the site; a special emphasis could be given to the history of the heritage films made in Roșia Montană; to host an information point for the Roșia Montană site; to host secondary spaces for related activities - workshops; the existing commercial space could be arranged and extended for the development of related services: serving refreshments, coffee, small snacks in indoor and outdoor spaces.

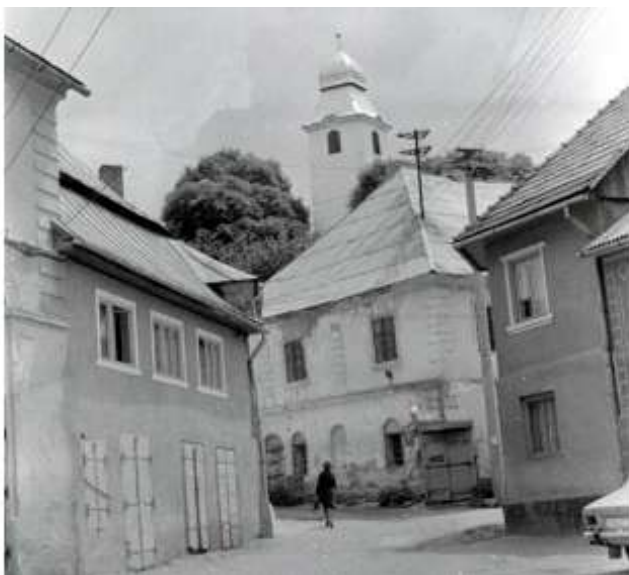
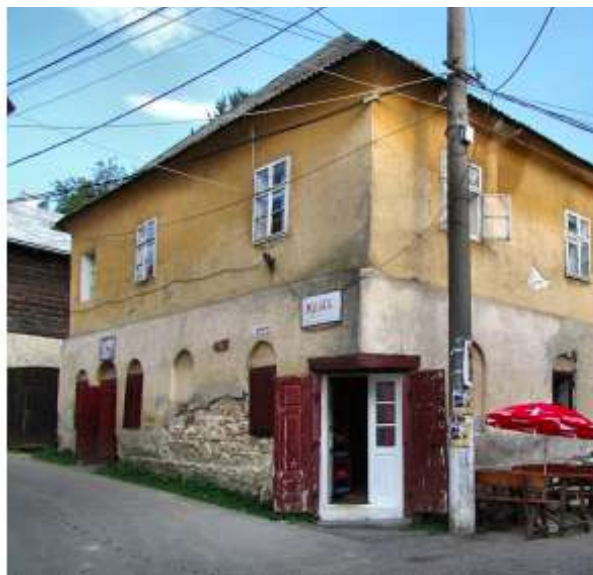
\_photos: historic image and state of conservation / rosiamontana.community (partner).

Conservation-restoration operations of the monument: Elimination of all harmful interventions carried out over time; Restoration of the image of the main facades, in accordance with the historical information and the preserved traces; Reintroduction of the shingle roof, characteristic of all the historical buildings of Rosia Montana, public or private buildings erected during the 18th and 19th centuries; Conservation of all the original elements: masonry, plastering; Archaeological surveys, necessary for the preparation of the geotechnical study and structural assessment; The materials used for restoration will be the historical ones - lime-sand mortar - the recipe will be determined by specialized analysis; The original windows and doors will be restored; Special attention will be paid to the carved carpentry elements of the porch pillars; Carpentry will be reproduced from existing in situ witnesses and based on historical information where not preserved; Reinforcement solutions to the resistance structure that do not compromise the architectural and structural configuration of the original construction by introducing additional elements; Invasive structural interventions will be removed (concrete beams).

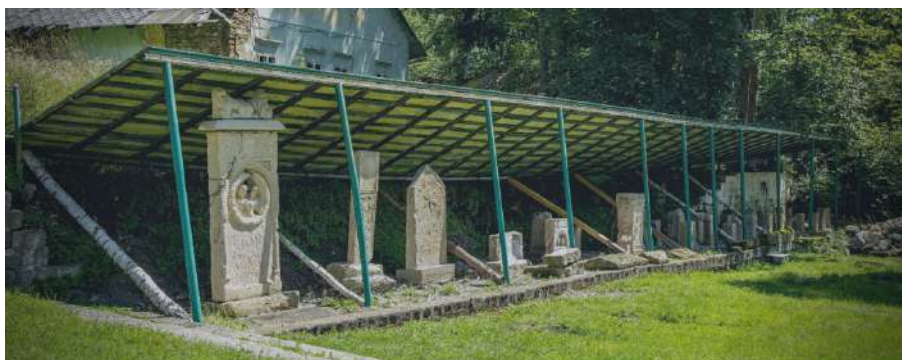
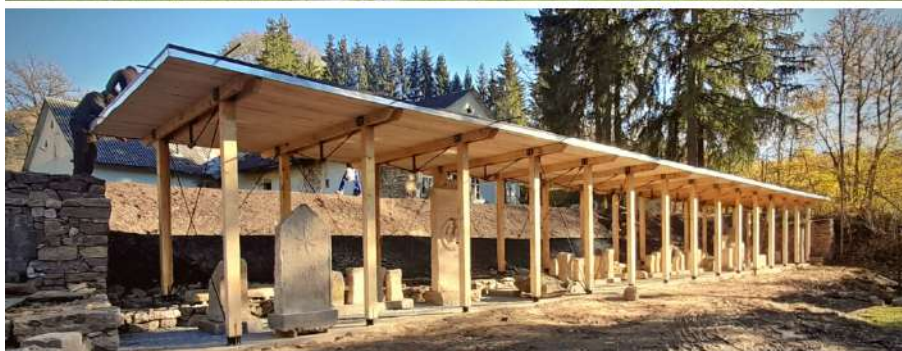
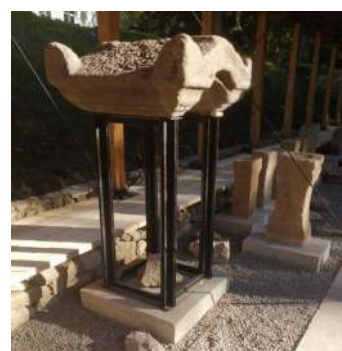
Under the weight of the snow, the makeshift metal structure in the courtyard of the Mining Museum in Rosia Montana, which protected the Lapidarium, collapsed. The retaining wall and metal structure collapsed, endangering the Roman artefacts on display here. ARA mobilized volunteers and funding and managed to build a new protection structure, and also provide new, relevant information for the touristic purpose of the ensemble.

\_photos: before and after the intervention, details / ARA.
