# Roșia Montană

## *Mining Landscape*

**State of Conservation Report UPDATE**

**February 2023**

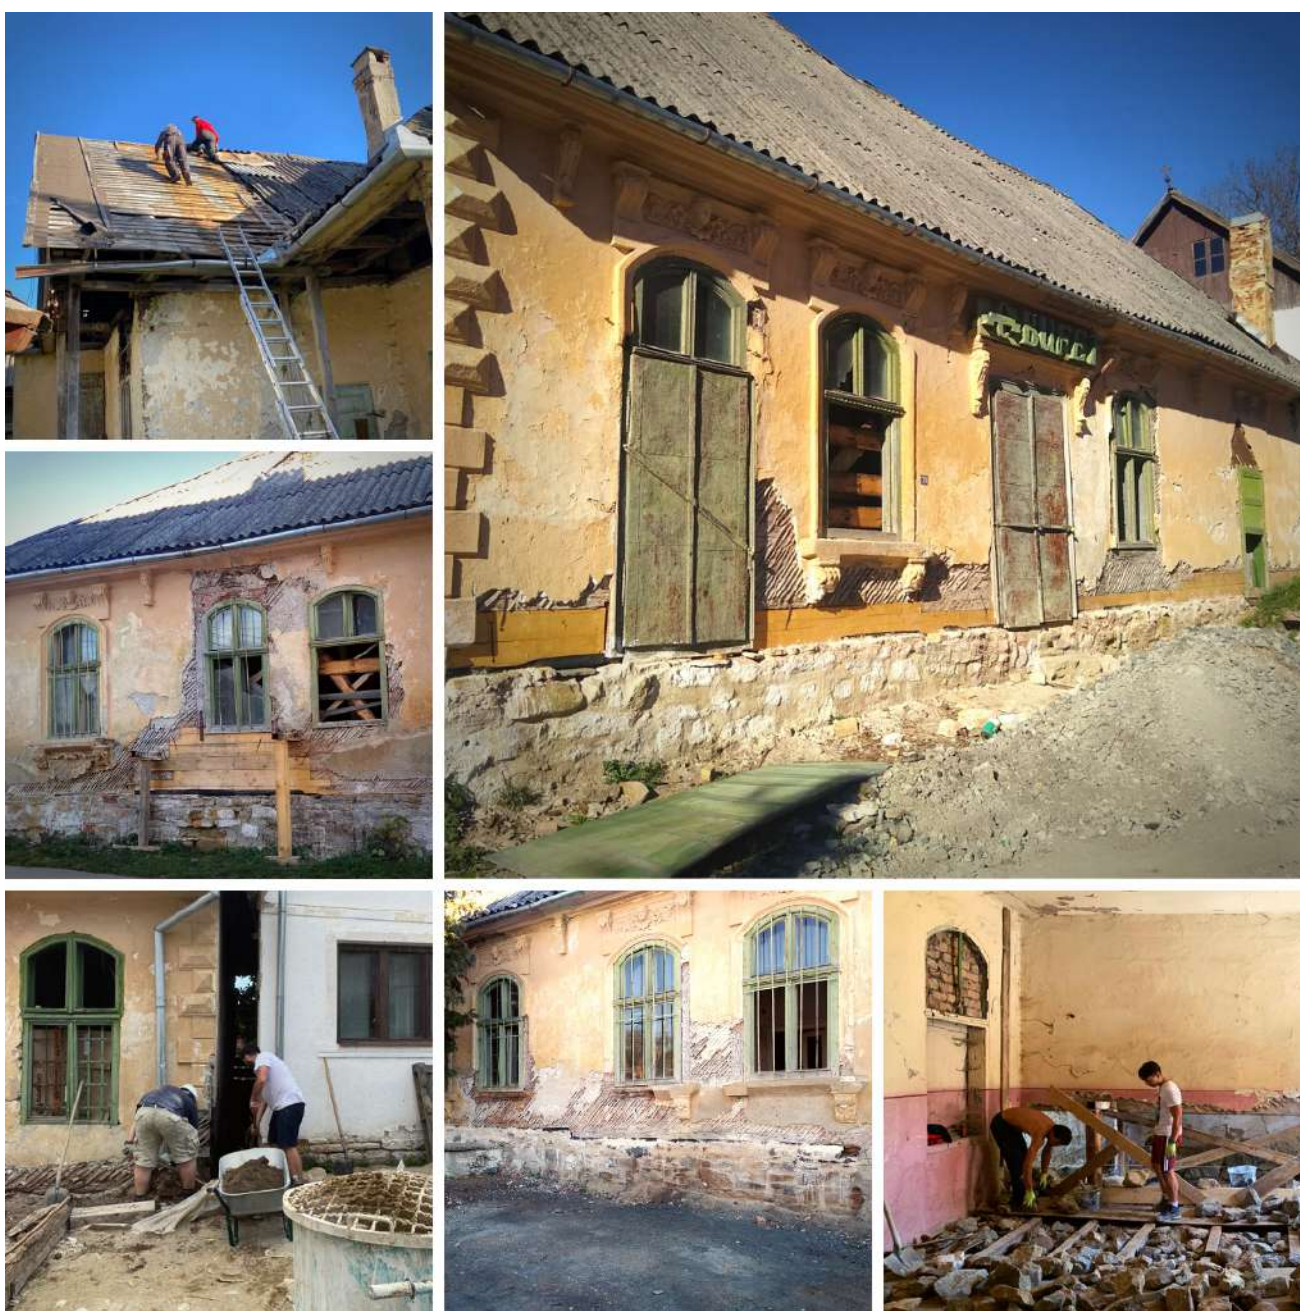
In partnership with the local administration, ARA obtained permits from the County Directorate for Culture for emergency works on what used to be the most vivid place in the historic center: the local casino. The building is in a severe state of conservation, so in 2022 the intervention began with works on the roof, foundations and wood beams that were replaced or repaired. A more complex restoration project is under work, along with the clarification of the legal status of the building.

\_photos: during the intervention / ARA.

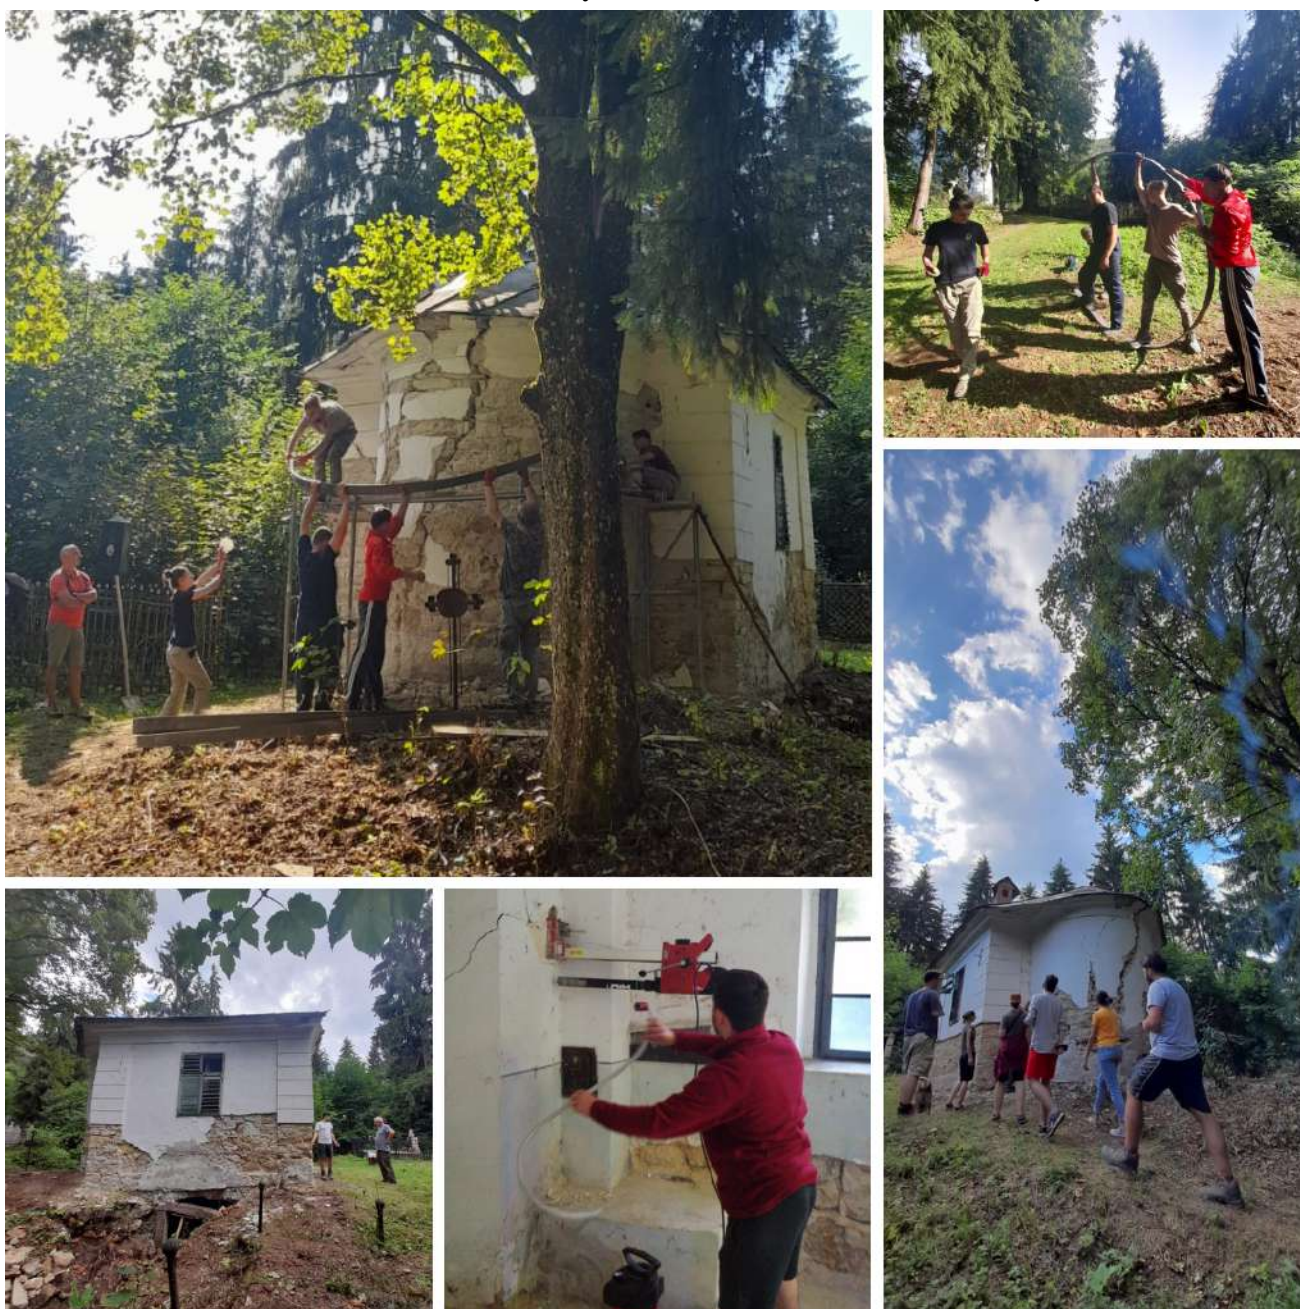
\_photos: during the intervention / ARA.

The main objective of the interventions started in 2022 by ARA volunteers was to urgently halt the process of deterioration: the cement mortar plaster was stripped and metal belts for the apse area were installed to prevent the large fractures in the east wall from becoming more pronounced. Extensive work on the foundations, replastering with lime mortar, replastering the roof, interior finishes and furnishings of the chapel is next. The long term objective is to open it to visitors, making it suitable for a small exhibition on the history of the Roman Catholic community.

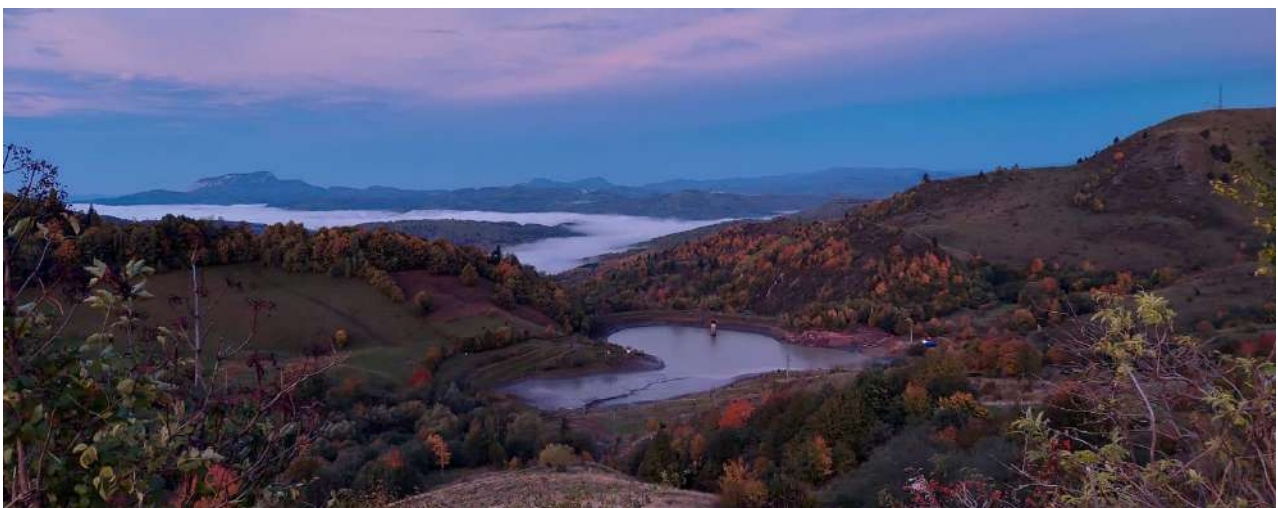
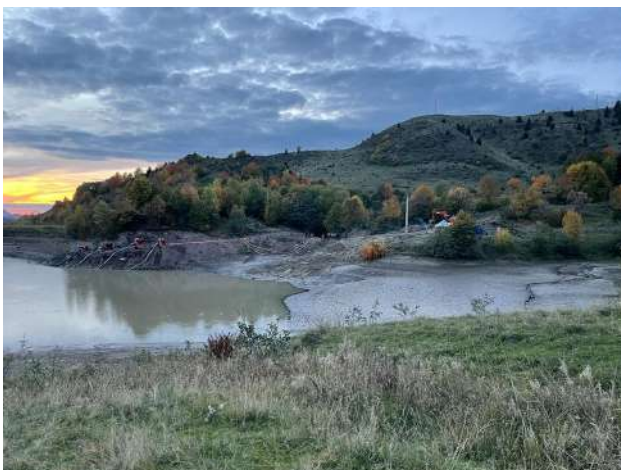
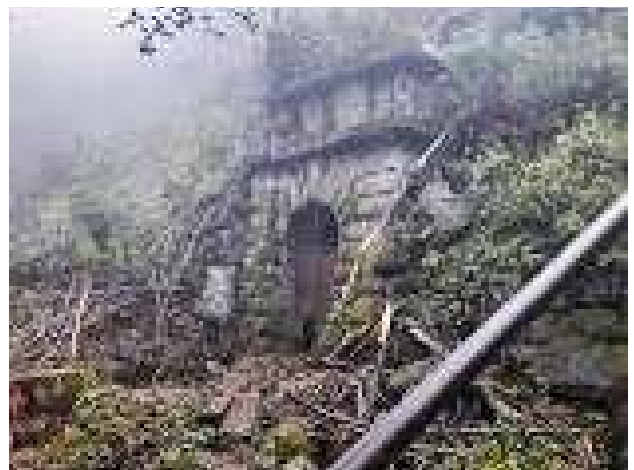
On October 2, 2022, a depression in the embankment occurred in the historic dam structure (18th/19th century, with 20th century interventions) of the Tăul Mare header pond. That determined emergency drainage of the header pond for safety and inspection purposes. The situation was immediately taken over by the Emergency Situations Department and other specialized institutions and the danger was removed with emergency works carried out by the local authorities, with the support of several other institutions.

\_photos: Tăul Mare during the emergency interventions in October 2022

This highlighted again the necessity of a thorough inspection and maintenance plan for the 18th/19th century header ponds as well as the need for the authorities to cooperate and act with an integrated common approach. Monitoring is ensured to detect any change in the current condition and the principle of 'safety first' is acknowledged. Any further action will be heritage/conservation-led and carefully respect authenticity and integrity while also ensuring safety. The final desired state of conservation should be an 'invisible' structural repair, conservation-led restoration of the dam face (especially if affecting masonry) and installations, followed by reinstatement of the water as a feature of the cultural (mining) landscape. A preliminary report was elaborated by INP together with the appropriate Agencies and technical experts and a more thorough plan is under preparation. Possible sources of funding to support the work required to restore the complex are currently being evaluated by the Municipality and other Agencies, a process in which the INP-MC has consistently participated with its specialty advice.
