## **THE HISTORIC TOWN AND ARCHAEOLOGICAL SITE OF GEDI MANAGEMENT PLAN**

**Management Plan 2022-2027**

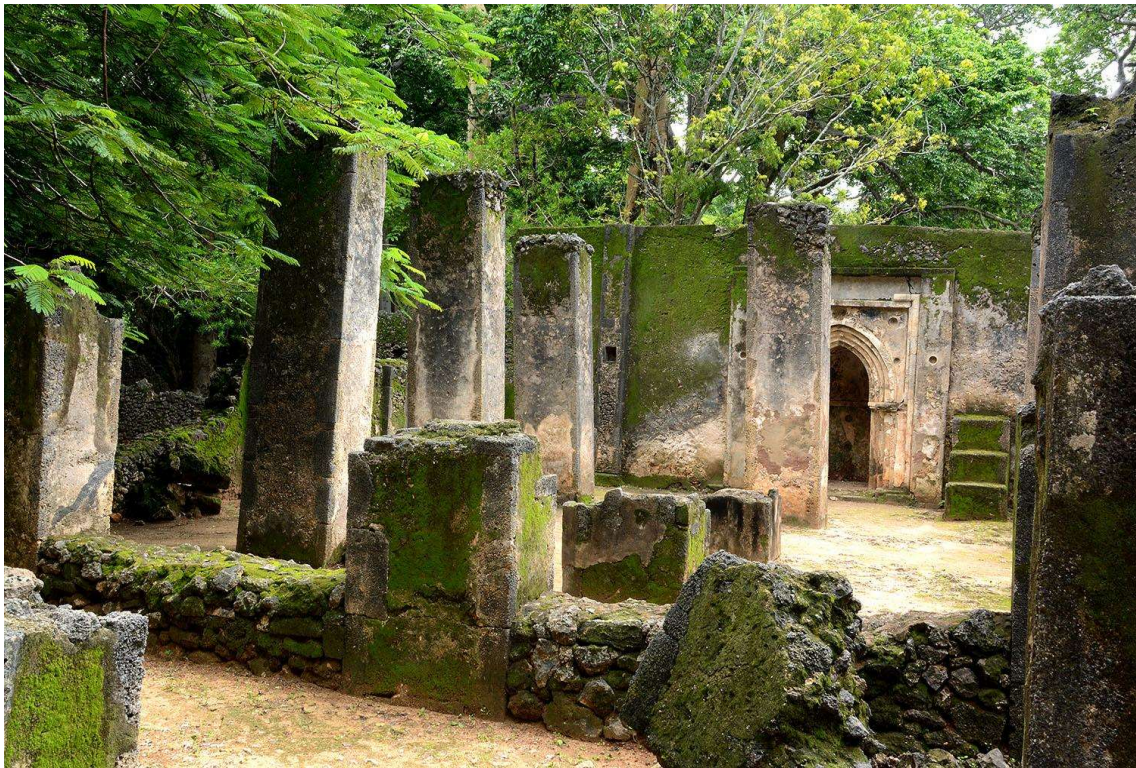
*Figure 2. The Great Mosque*

facilities (Fig 2). Various forms of tombs, one with weather-beaten remains of an Arabic engraving on its tombstone and another with an engraving of a ship (Fig 3). The site has a remarkable palace and precincts covering an area of over two thousand square meters that still has a complete arrangement of a floor plan that cannot be compared with any other palace along the East African Coast (Fig 4 & 5).

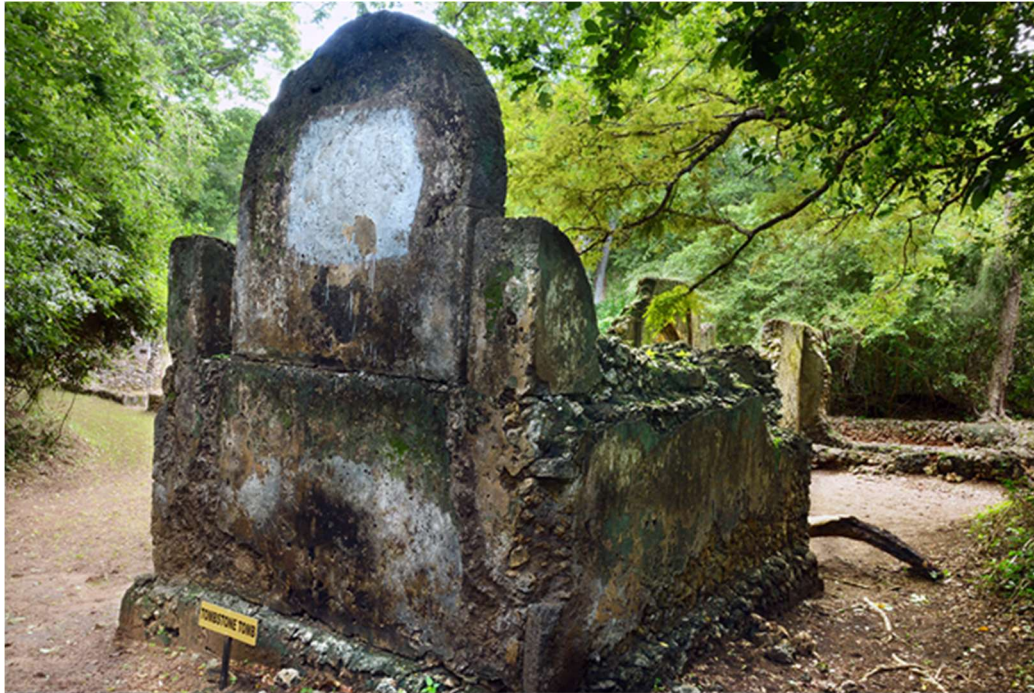
*Figure 3. The Dated Tomb*

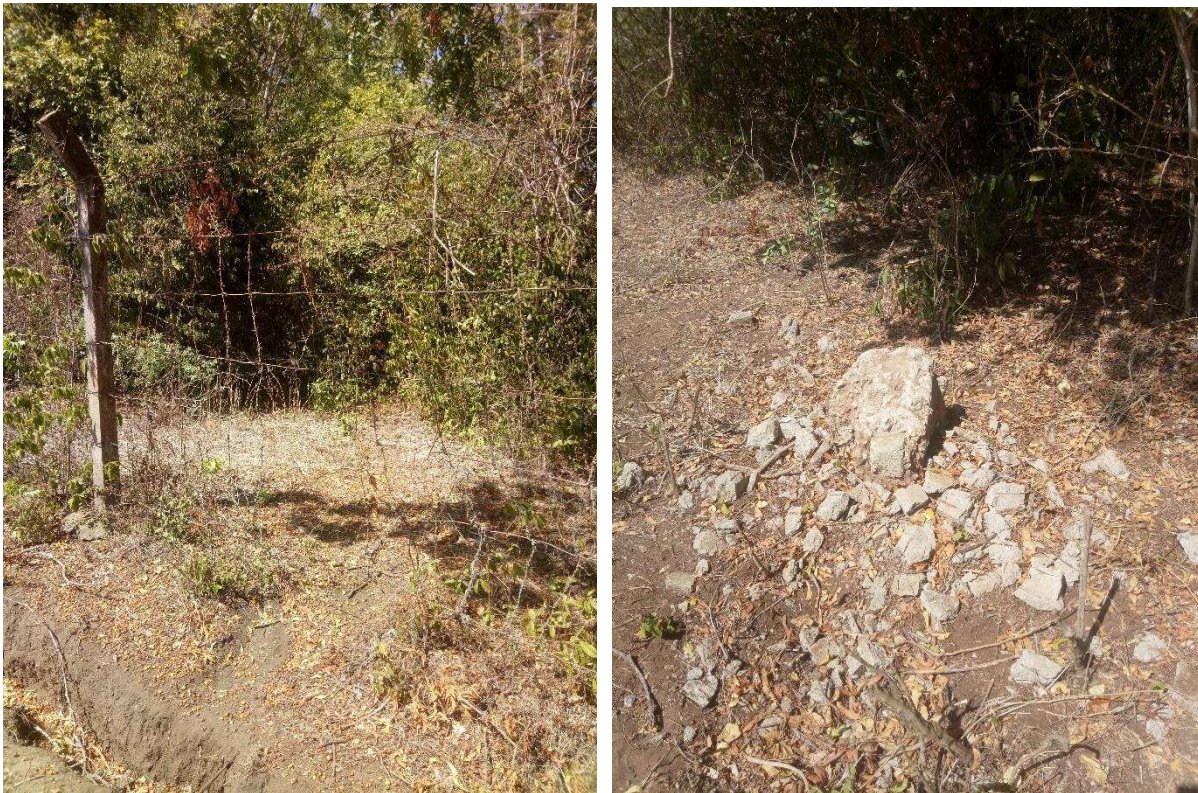
Despite the long history of legal protection, Gedi is affected by several challenges which can be categorized as; human factors, environmental and resource constraints. The main negative human factor is uncontrolled visitors' pathways at the site and vandalism particularly on the installations. The perimeter fence that secured the site from malefactors has been vandalized in some sections. This vandalism has exposed the site to illegal entry by people who engage in poaching game meat. The fence has not been repaired due to inadequate resources.

*Figure 4. Broken sections of perimeter fence*

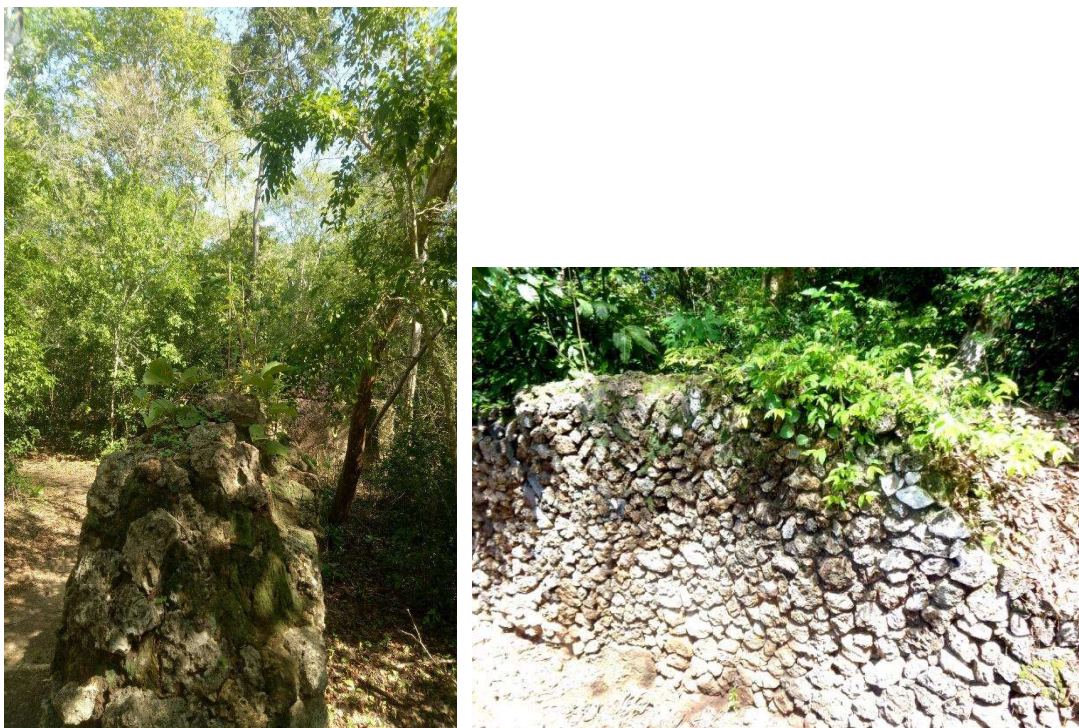
The most anticipated challenge is that of tree roots undermining foundations of the monuments, falling trees, vegetation growth on the walls, humidity and rain water. The proposed mitigation measures include:

*Figure 5. Vegetation growing on walls*

- i. regular pruning of tree branches overhanging the walls,
- ii. regular removal of vegetation growing on the walls,
- iii. stabilizing the walls where necessary,
- iv. periodic monitoring of the monuments.

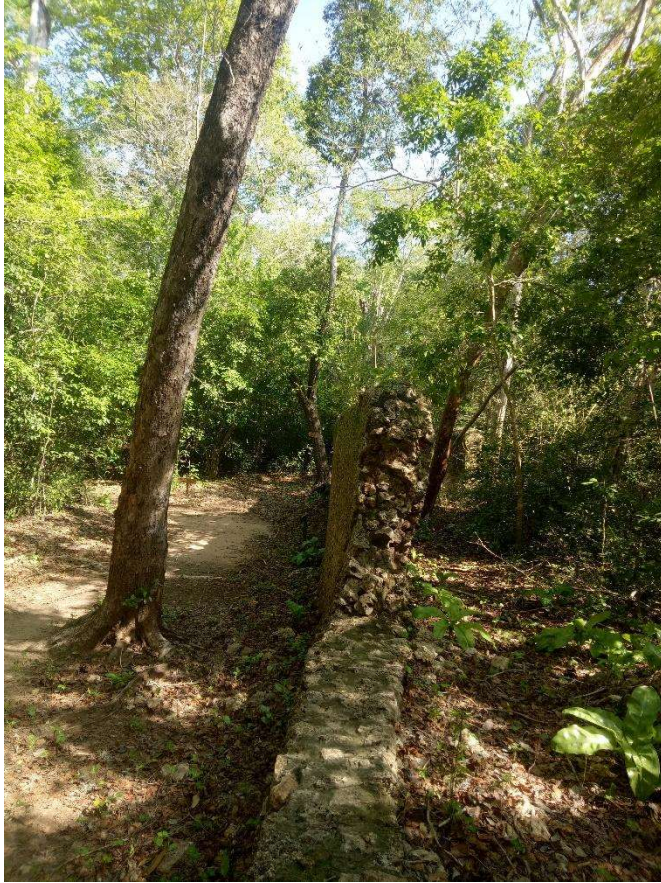
*Figure 6. A section of wall inclining off the vertical axis*

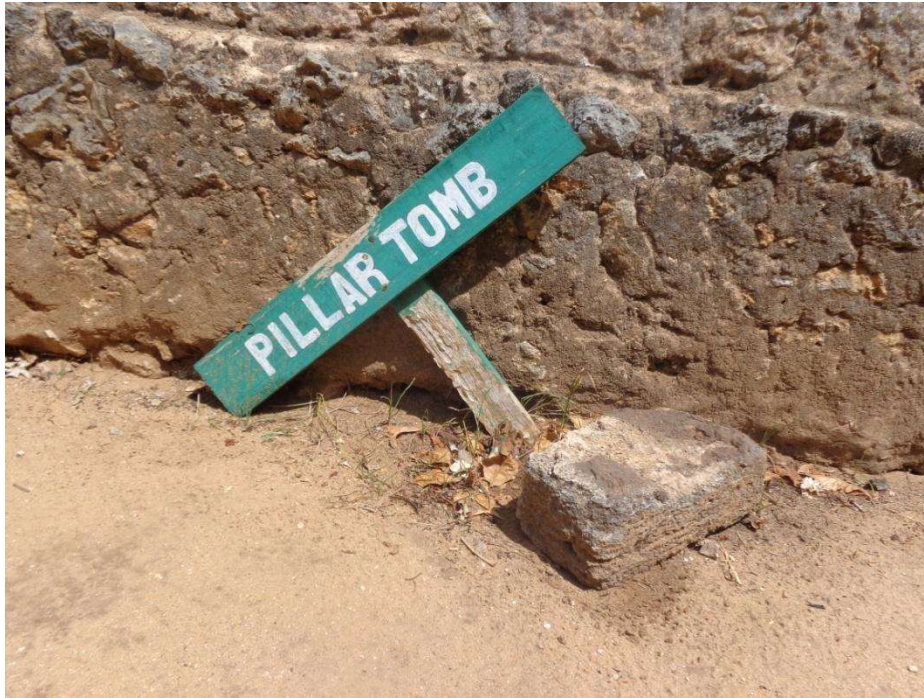
*Figure 8. Wooden signage affected by rot due to harsh tropical climatic conditions*

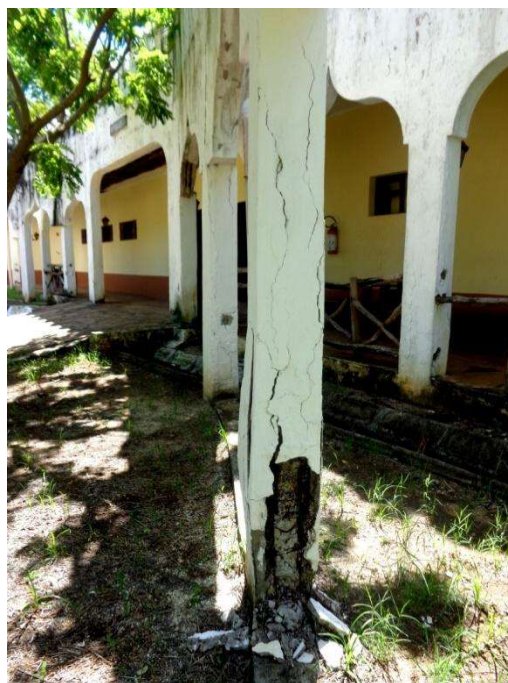
*Figure 9. deteriorated walk way due to weather effects*

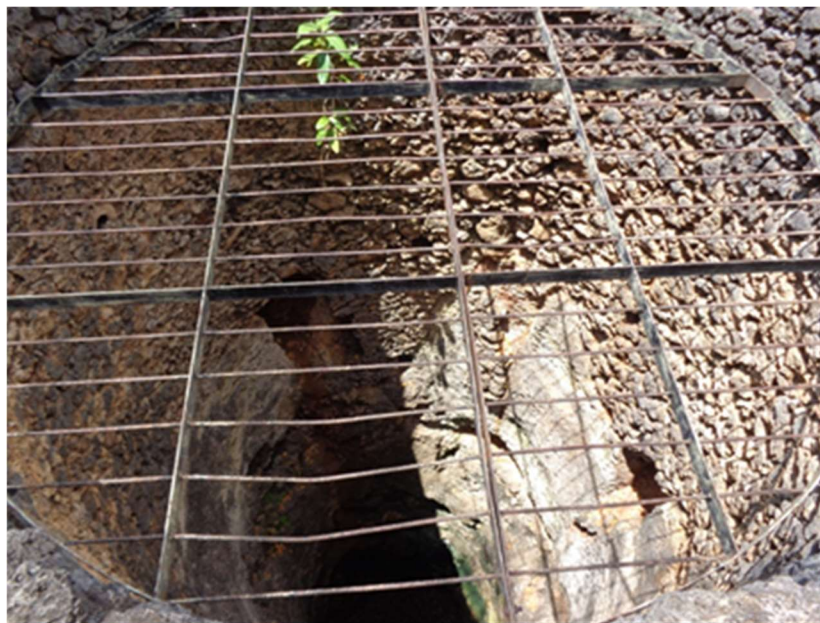
Challenges related to visitors at the site, the major identified risk is the threat of accidental falling into the deep wells found at the site. Though all of the wells at the site are guarded with metal grills, many of the grills have rusted. to a point that they cannot hold substantial weight. To eliminate the risk of accidental falls into the wells, all the metal grills will be replaced with sturdier grills to ensure safety of visitors and particularly; children.

*Figure 11. One of the drilled deep wells at Gedi*
