2023 SOC REPORT

Forts and Castles, Volta, Greater Accra, Central and Western Regions (Ghana) (C 34)

PROJECT REPORT

STABILIZATION AND CONSOLIDATION OF FORT AMSTERDAM ABANDZE CENTRAL REGION

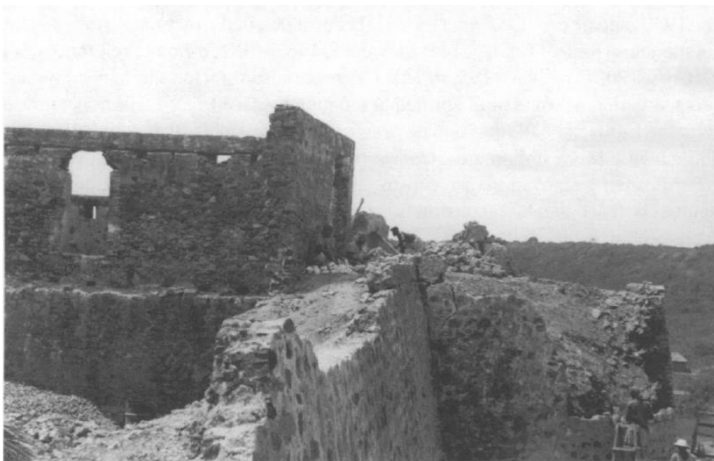
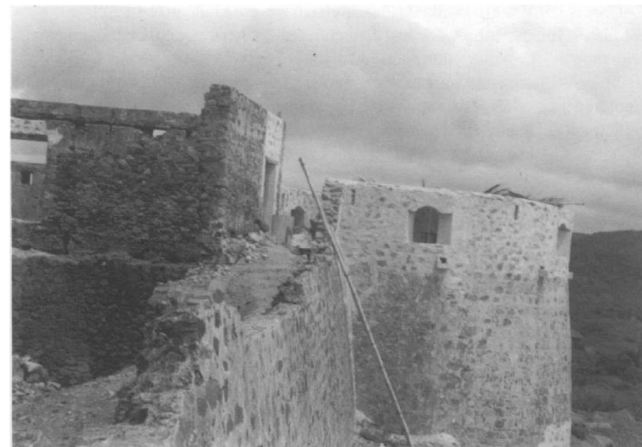
Restoration work at the Fort in 1951 by AW Lawrence. A view of the North Eastern Bastion before and after it was restored

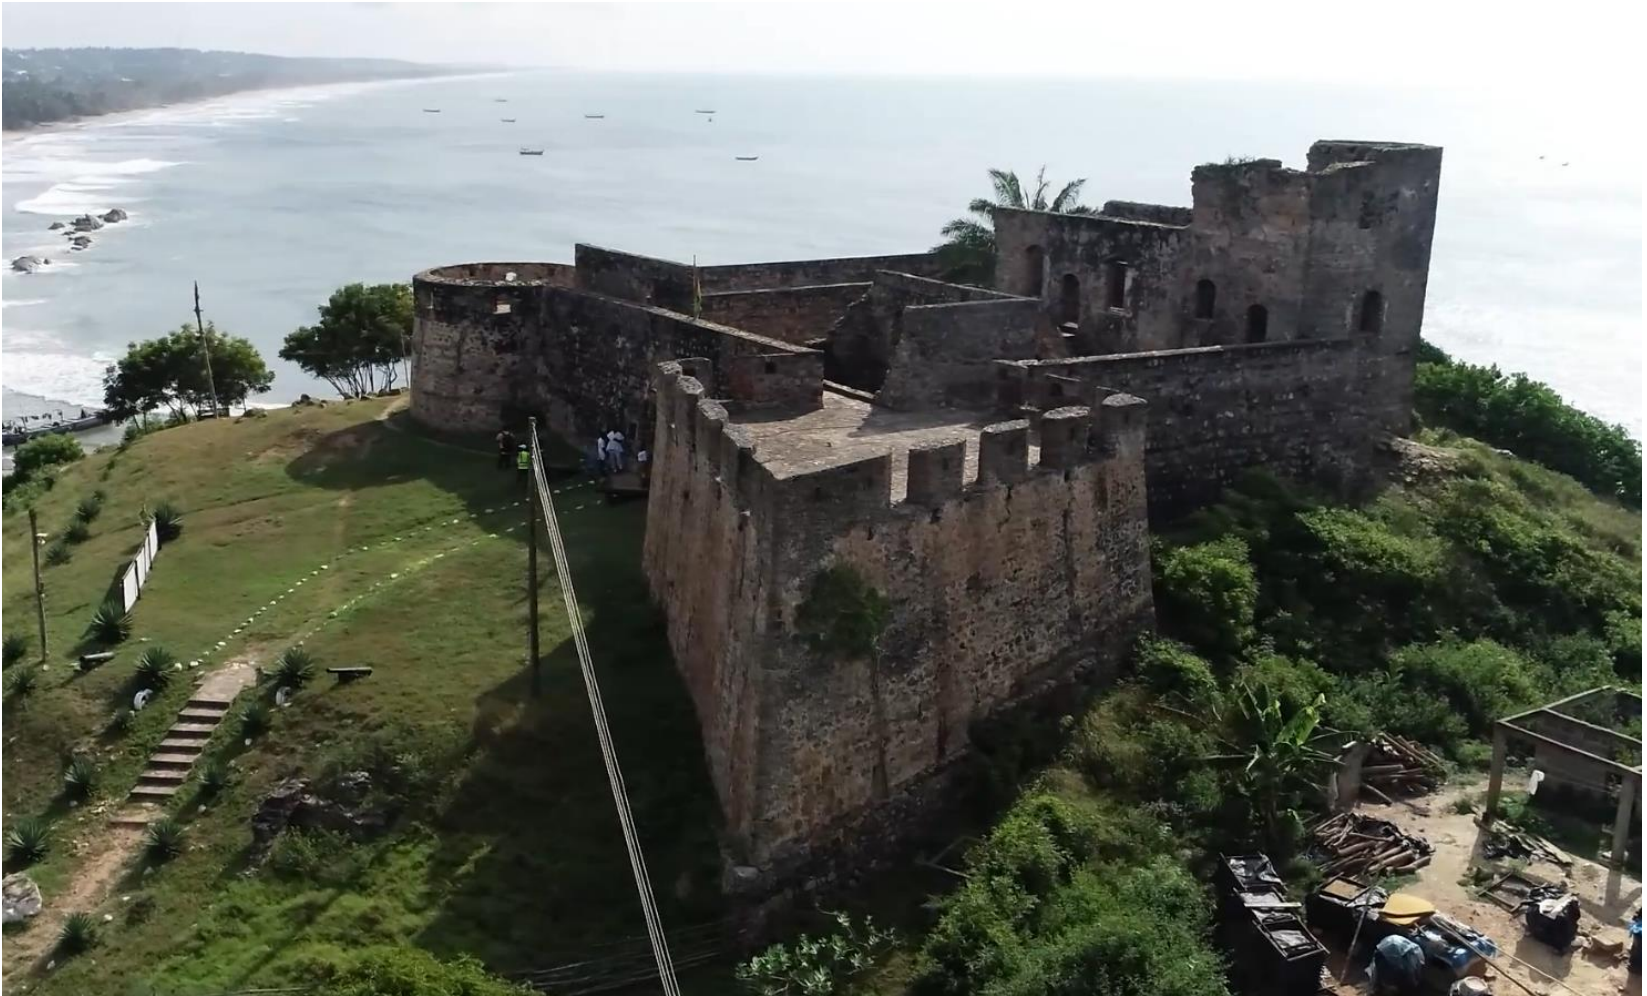
The fort as at 5th January 2023

The defects of the fort are numerous and are caused by varying factors including earth tremors. Several cracks are clearly visible on the full height of the bastions walls. The cracks that are present on the top of the bastion and the walkways allow rain penetration which have caused large cracks in the bastion walls. These have caused the separation of the bastion from the floor at the edges.

- **Repair all cracks** on the walls Repairing cracks will involve injection of a special lime grout into the cracks by a pump action pressure gun to achieve maximum penetration. The work executors will need ladders and scaffolds that will have to be firmly attached to the walls without perforation. Specification will be provided by the engineer

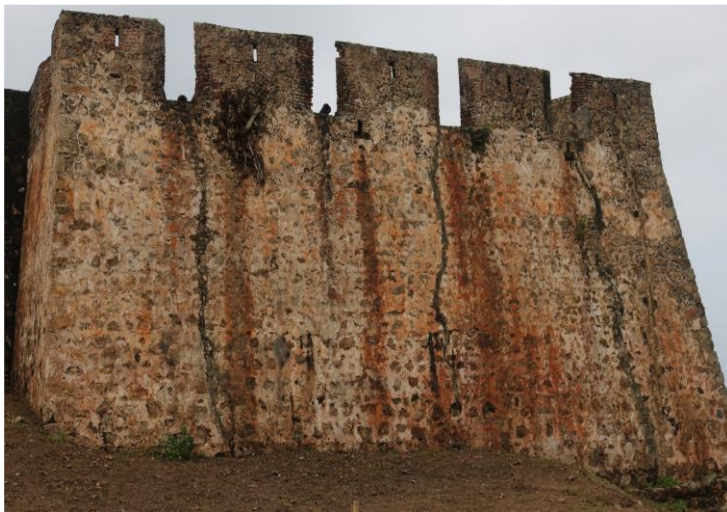
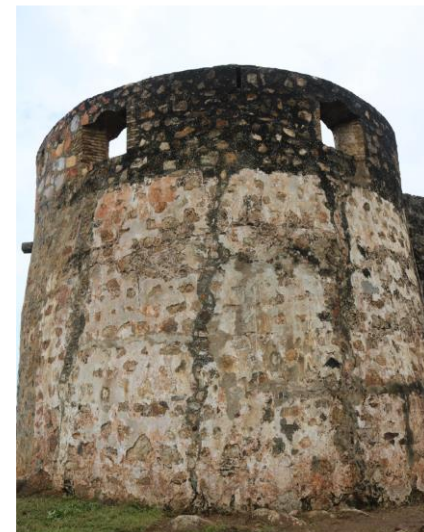
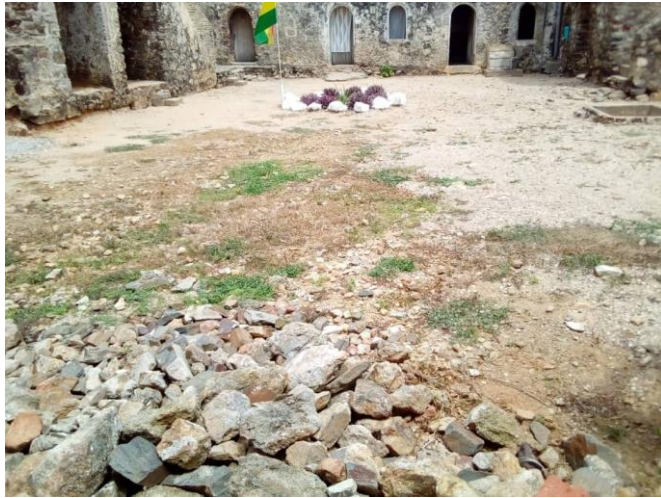
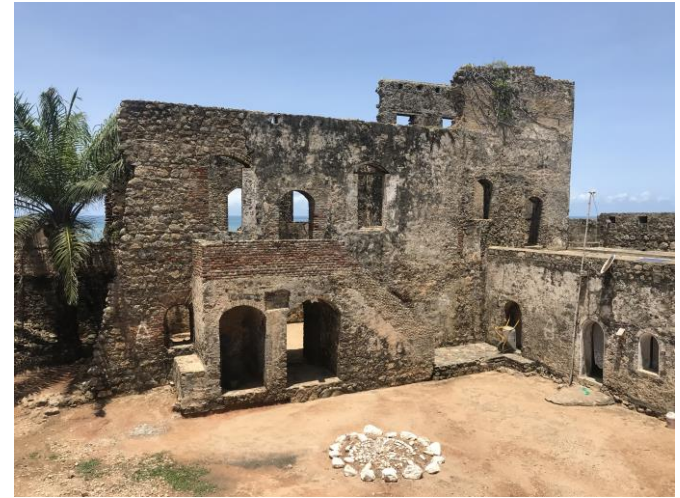
The courtyard of the fort has undergone erosion leaving the foundation walls of the inner building's exposed. This revealed that the water run off the surface and gathered in the soldier's rooms during a down pour. Since there are no outlets the water sinks into the foundation causing instability to the structure. The vegetative growth on the walls have grown strong roots causing large cracks in the bastions . The vines that grow within the bricks need specialized attention as the roots fuse with the earth brick and cant be removed without damaging the walls.

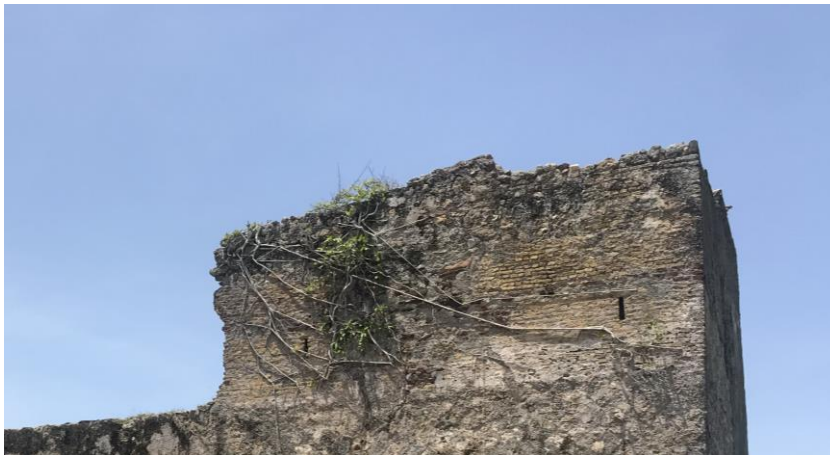
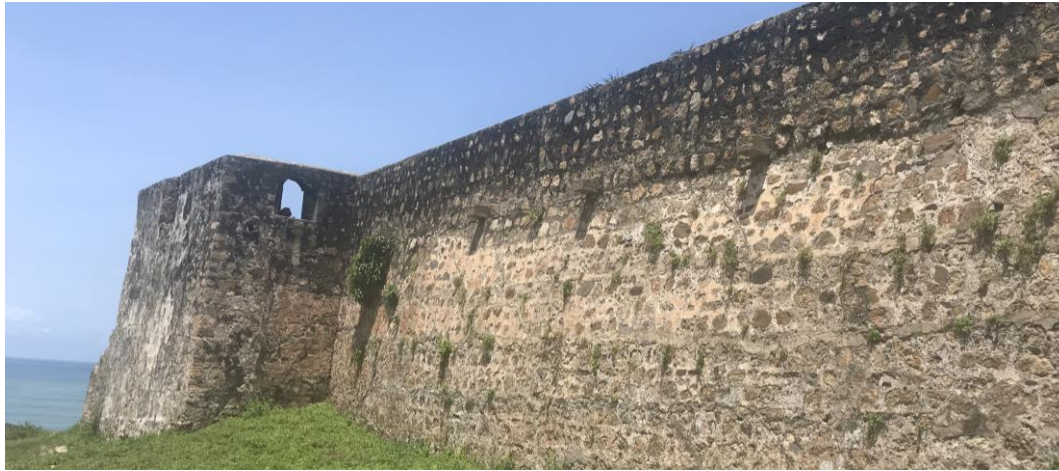
The Eastern curtain wall is inundated with vegetative growth fed by water seeping in at the top of the walkway and cervices within the walls. The sloped nature of the walls also allow it to collect sand material in which seeds germinate.

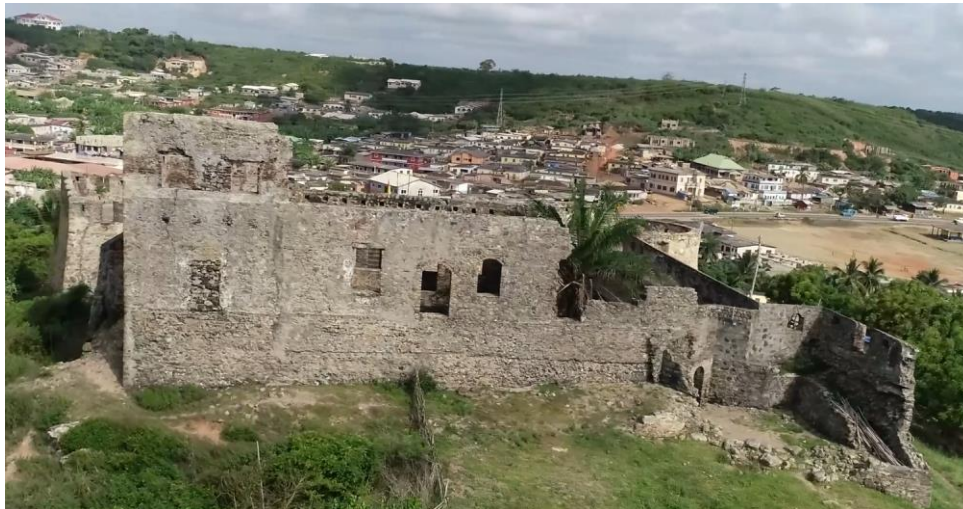
The missing southern walkways and bastions have left the inner foundation walls exposed . Without the support of the walkway, the walls are developing long cracks at various places. High winds and driving rain have also played their role in destabilizing the walls.

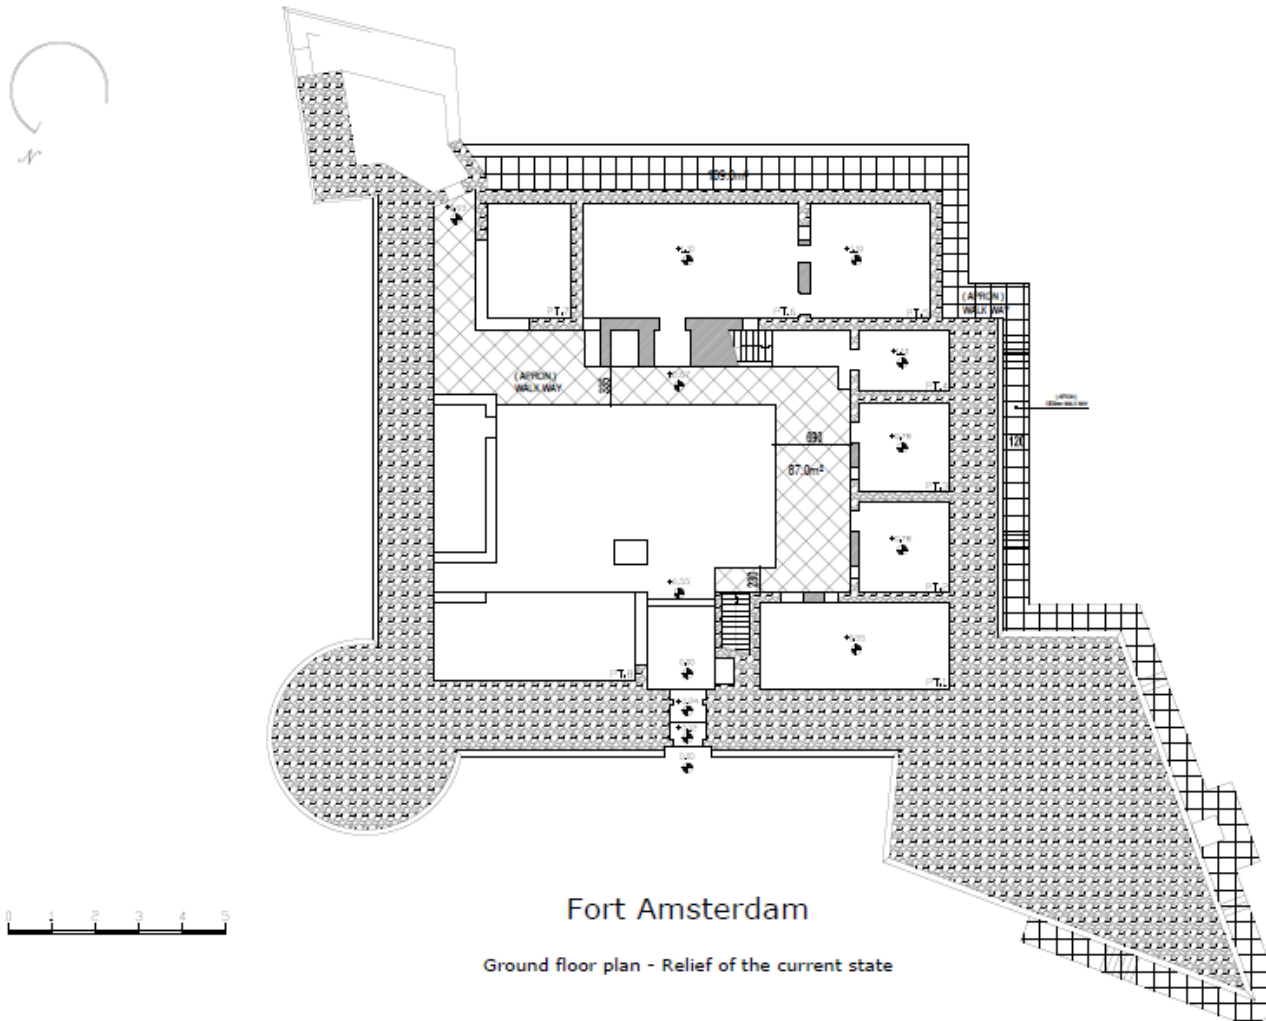
Surveys of cracks

FORT AMSTERDAM FRACTURES SURVEY
R. Perucchio, J. Sun, M. dos Santos, L. Anderson
University of Rochester, Rochester, NY
17 June 2019

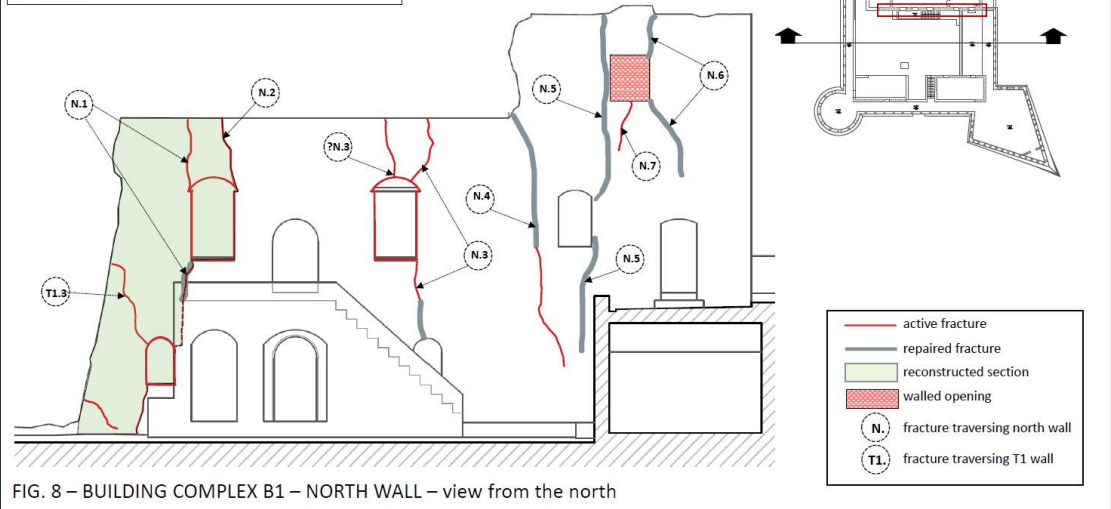
FORT AMSTERDAM FRACTURES SURVEY
R. Perucchio, J. Sun, M. dos Santos, L. Anderson
University of Rochester, Rochester, NY
17 June 2019

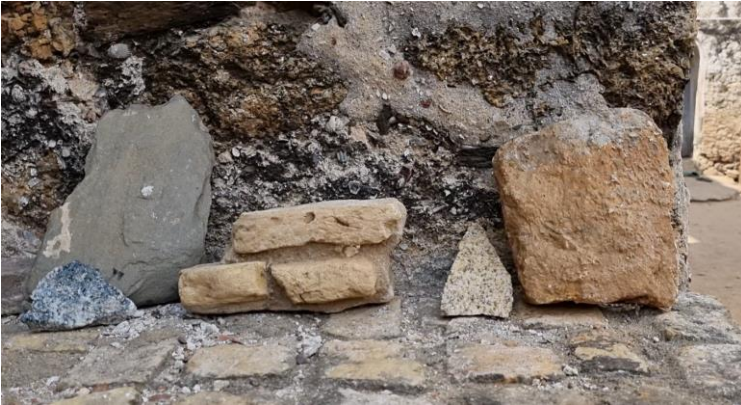
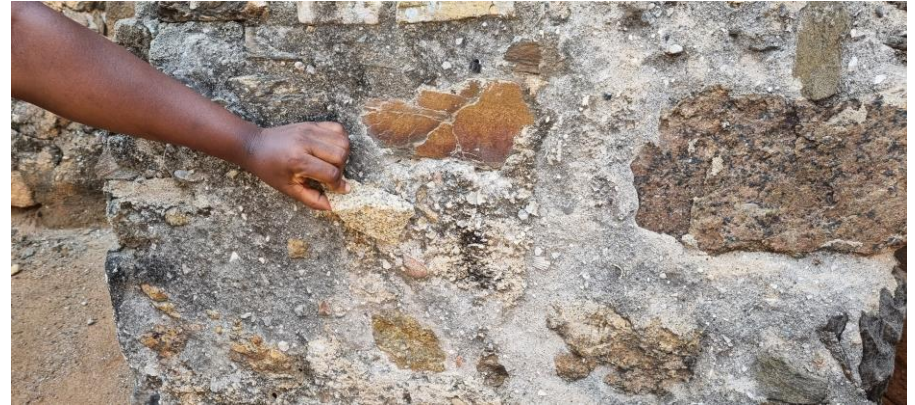
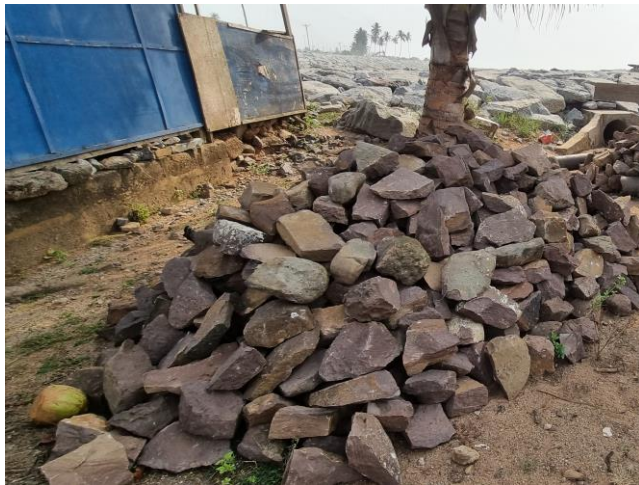
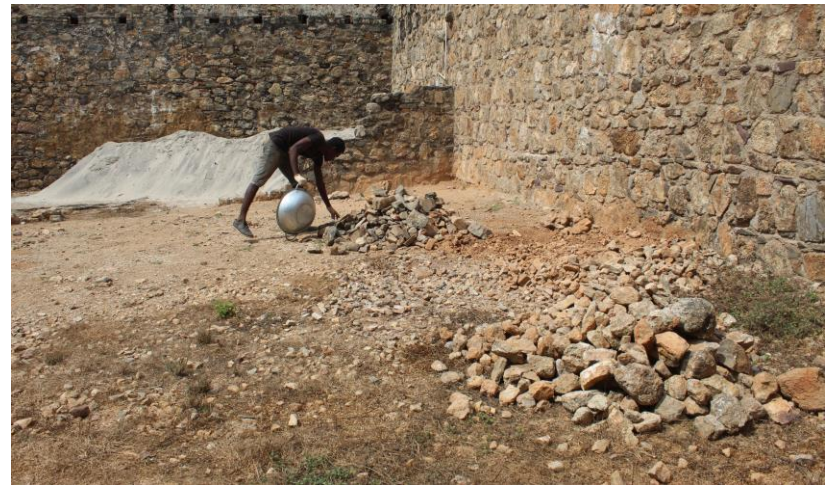
Stone was the main material for the project . Samples of loose stone and rocks were taken from the building site to prepare a color match for the walkway . Materials to be used for the project was obtained locally. Stones and small boulders hewn from the coast at low tides were plentiful in supply. However , the color and size varied . They also varied in porosity . The non-porous ones which were darker in color were used for the foundations.

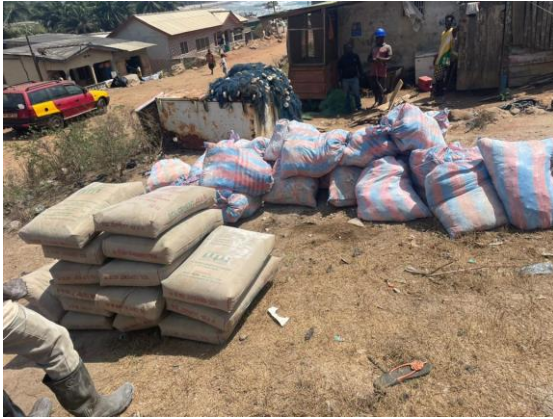
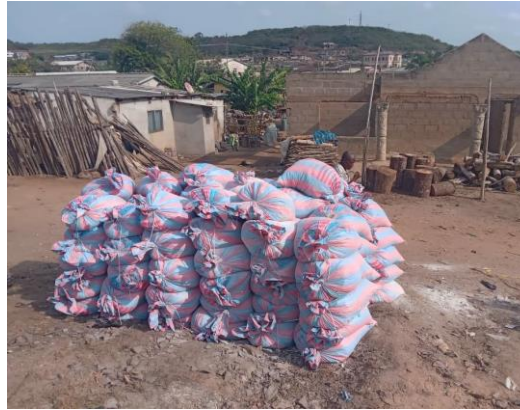
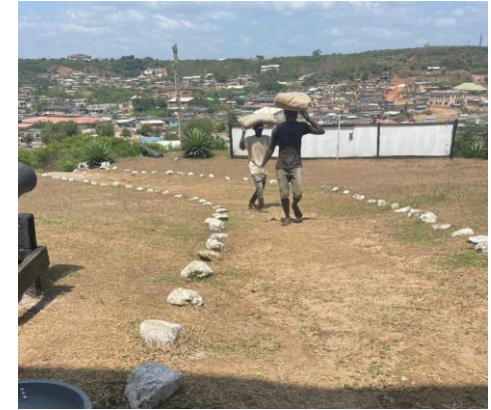
The cost of material haulage up hill was significant part of the budget. Tons of material had to be carried up manually by head-load count and pay method . Bags of cement and lime, stones and boulders, river sand , rough sand and water were hauled up-hill by a group co community volunteer usually women form the locality who offered their services during low fishing season.

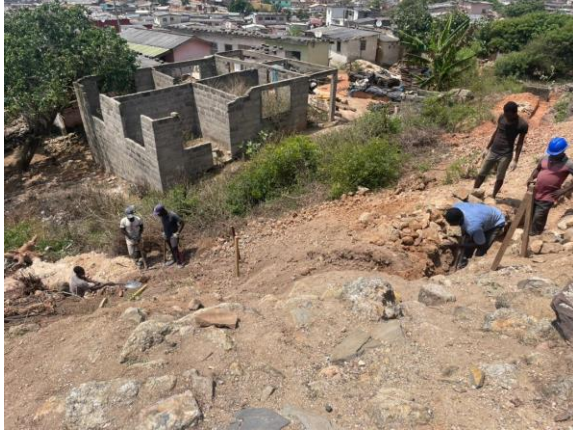
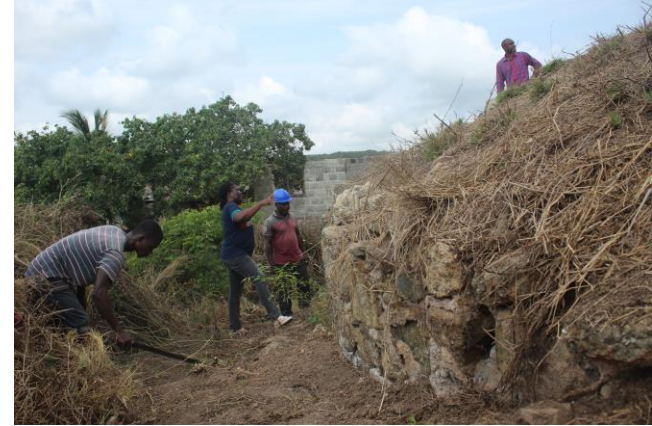
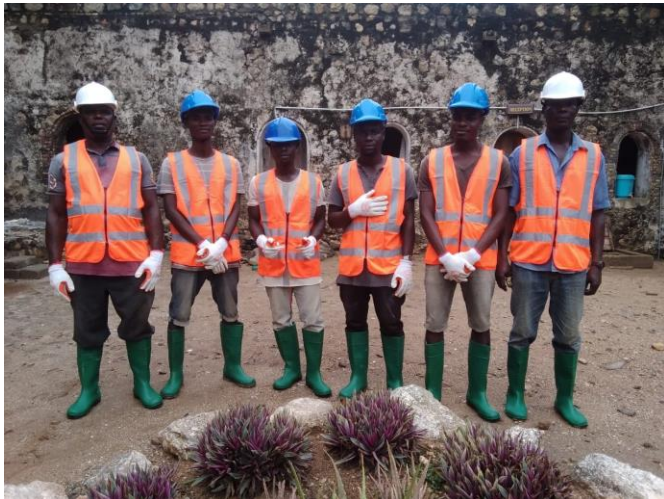
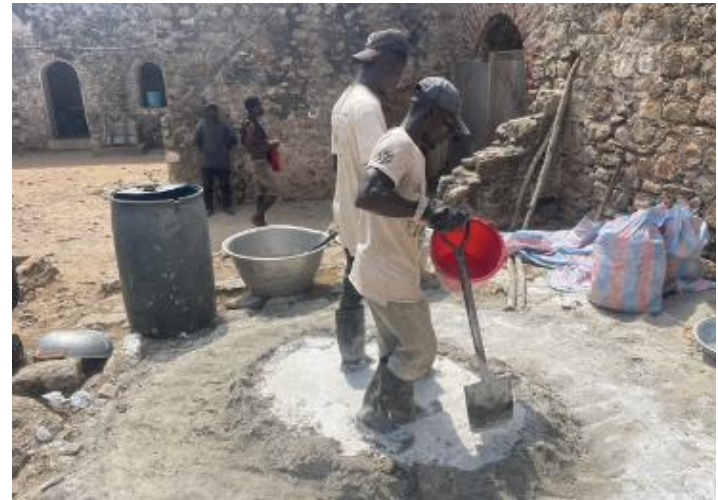
Before construction of the walkway-apron began, the site was cleared and a survey of lines taken to determine how high the foundation walls would be at various points along the slopes. Clearing was done around the lost round bastion. Safety wear and gear was provided for the workers . Various test mixes for lime-sand consistency and suitability for foundation stones were done .

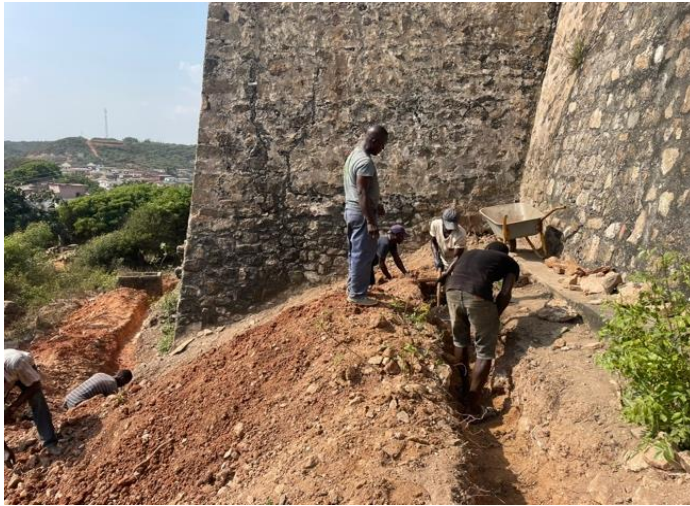
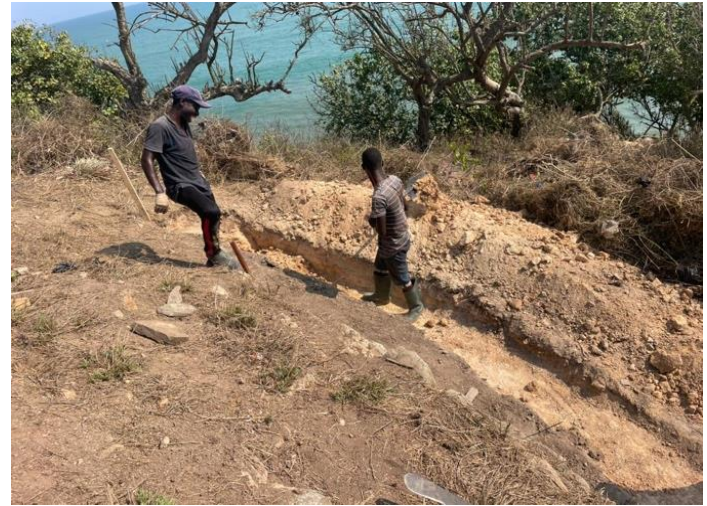
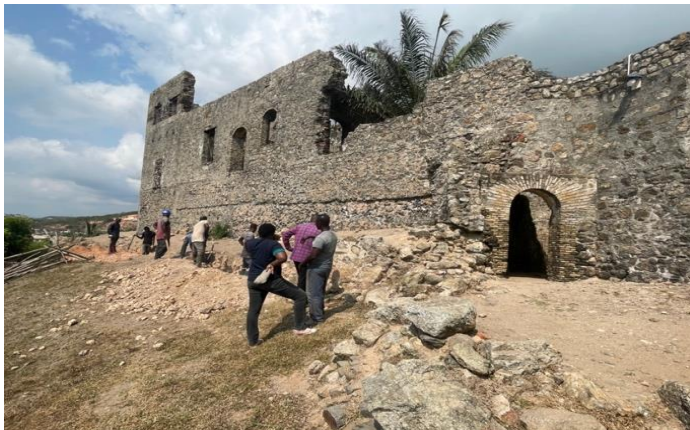
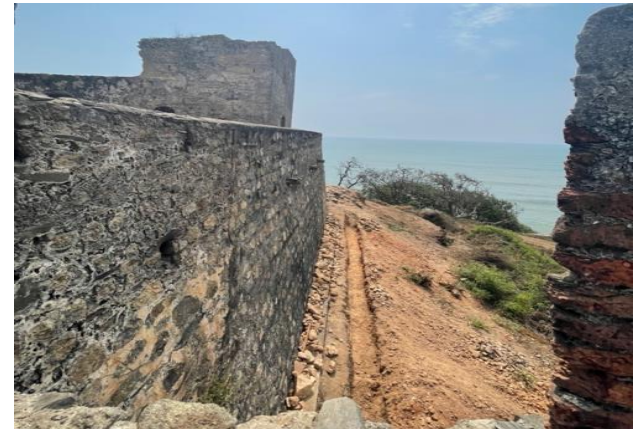
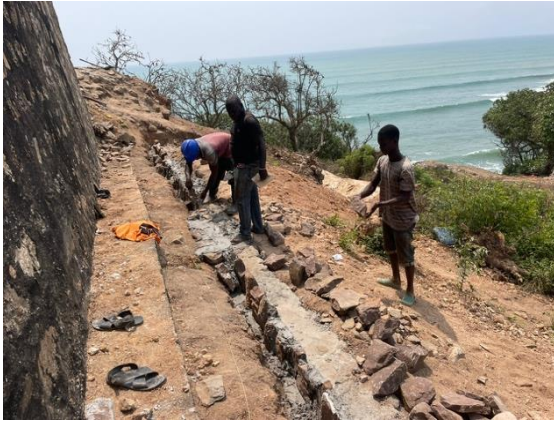
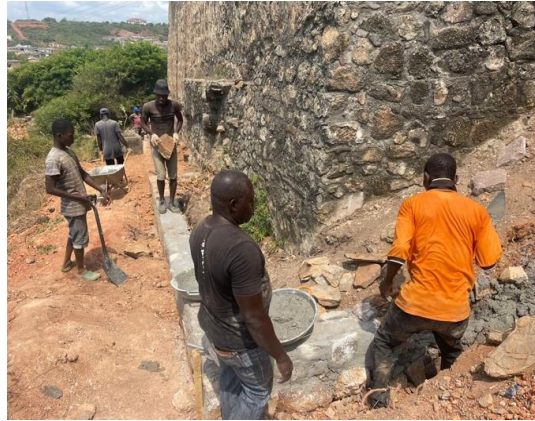
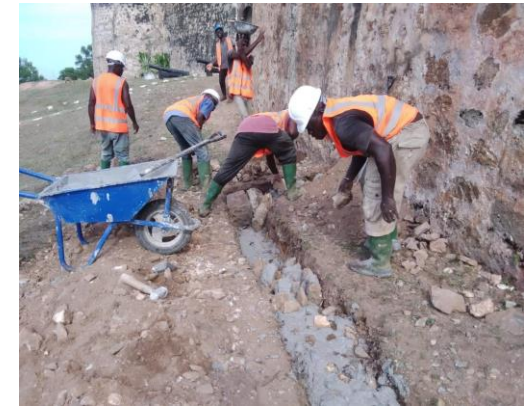
After setting out the lines for the foundations of the walkway, community volunteers provided digging services . Foundations of widths of 2 feet on the average were dug up to depths of 8 inches to 1 foot . The depths varied depending on the height of the wall to be built. The width of the walkway away from the fort walls was altered at different points ensure that the walkway walls were not too high needing more materials.

A foundation concrete mix of sand: lime: cement (S:L:C) 8:6:8 head-pan proportions was laid at a thickness of 6 inches within the foundation trenches. Large size boulders delivered by head-load and wheelbarrow were used for the foundation walls below ground level. Cement sand lime mixes of ratios were used to bind the boulders. Men from the community supported with the labor as carriers of stone.

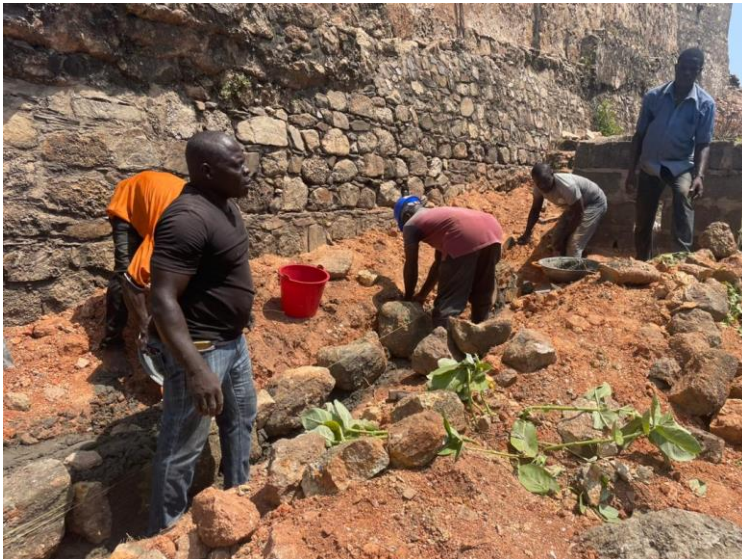
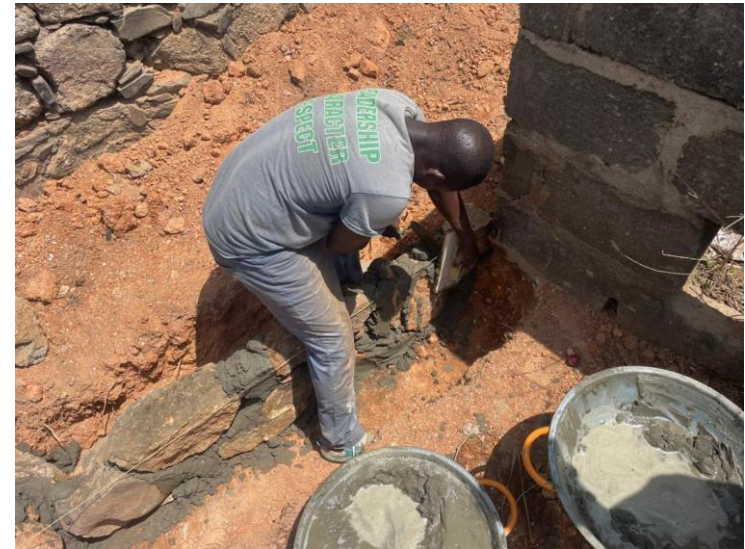
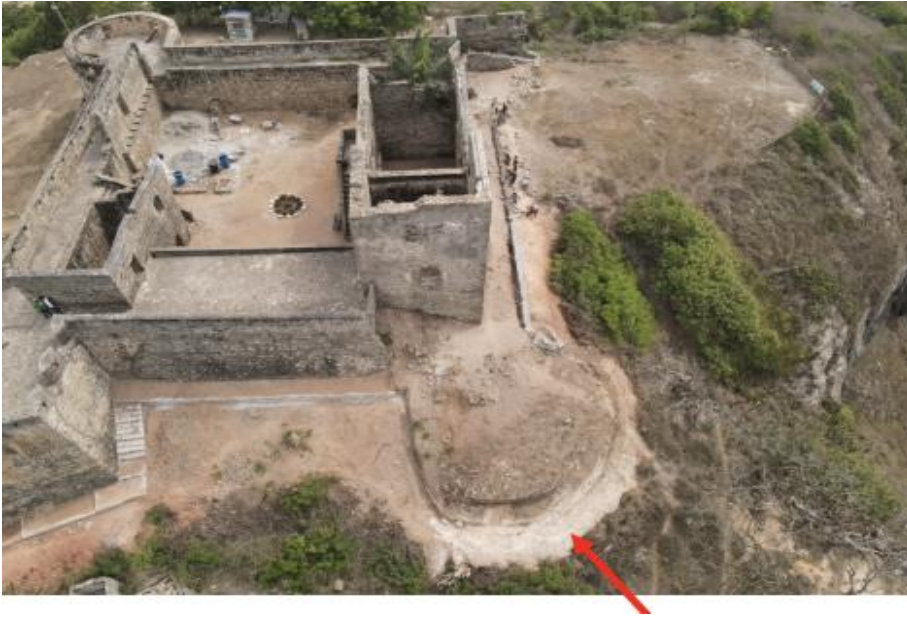
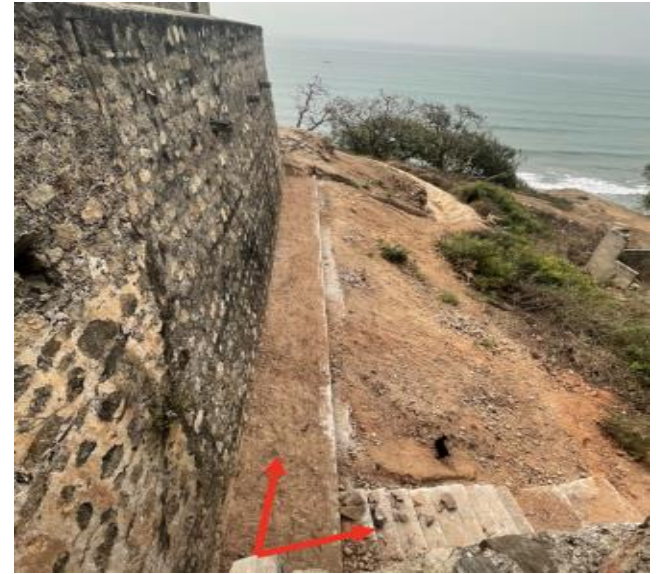
A decision was made to recover the memory of the round south-west bastion by extending the walkway around the remnant of stones left from it positioned in the valley. The foundations of the walkway dug and stones laid to mark it. It was designed with descending and ascending steps to give a sensation of experience . The foundations were now filled laterite and sand and given a firm compaction to prepare it for the laying of flat stones.

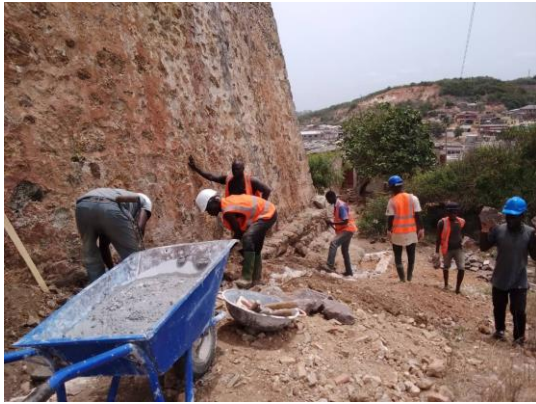
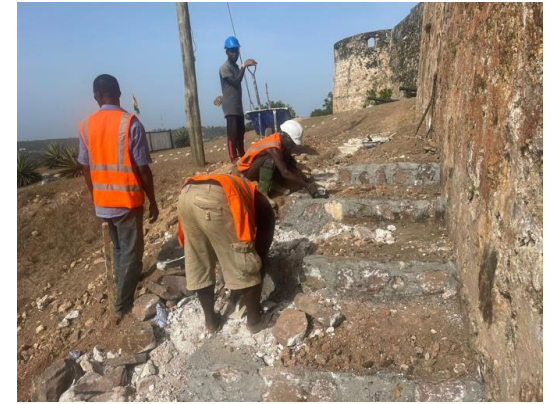
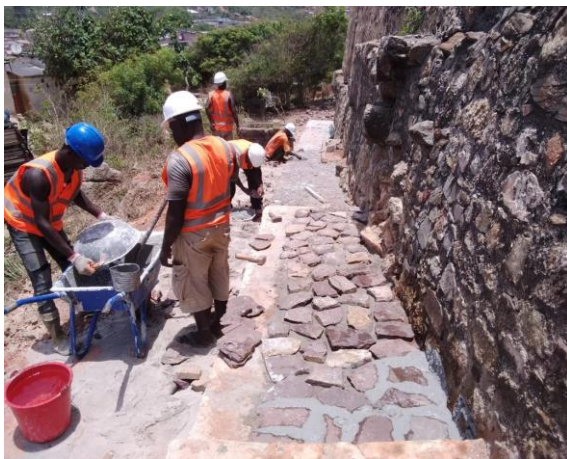
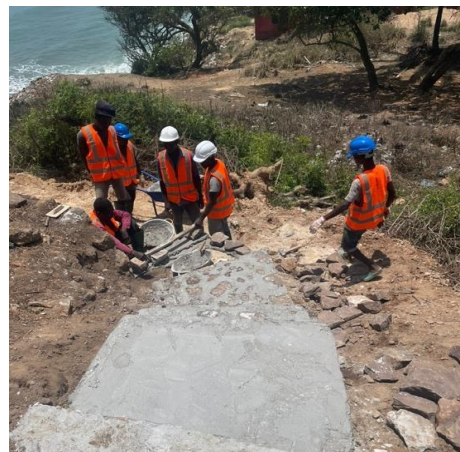
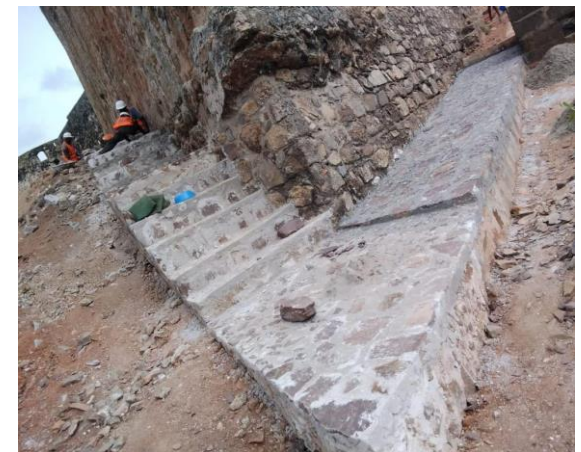
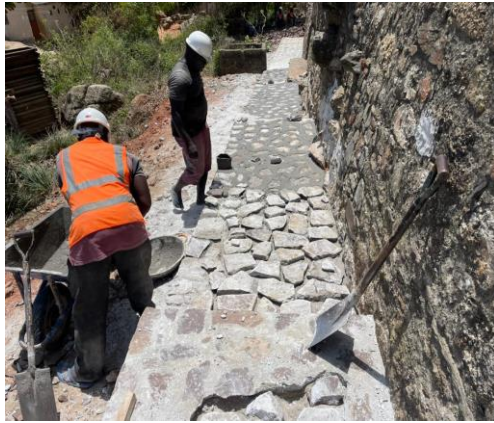
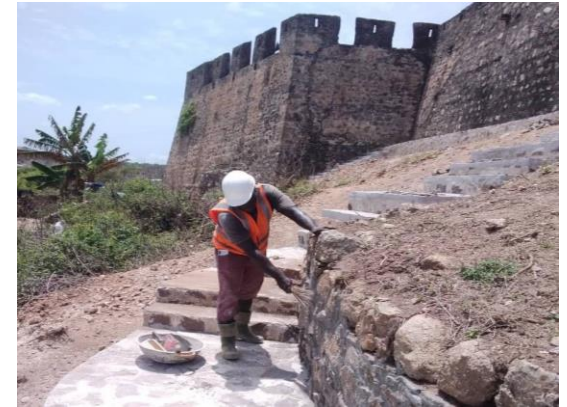
Flatter stones to act as flagstones were selected for the top of the walkway and carefully and meticulously arranged on the compacted walkway bed. An S:L:C mix of 6:6:1 was to lay the walkway. It was noted that slightly increased cement content helped to make a more stable walk way. The manufactured lime mortar proved weaker on horizontal surfaces compared

Much care was taken to provide a walkable surface. Checks were done on the surfaces week after week to make sure that the application of lime mortar was suitable. Loose flagstones were replaced. Strengthening the remains of the lost south-western bastion. Paving the southern walkway, topping up the fill with sand to level and sloping it so rainwater would not settle on it.

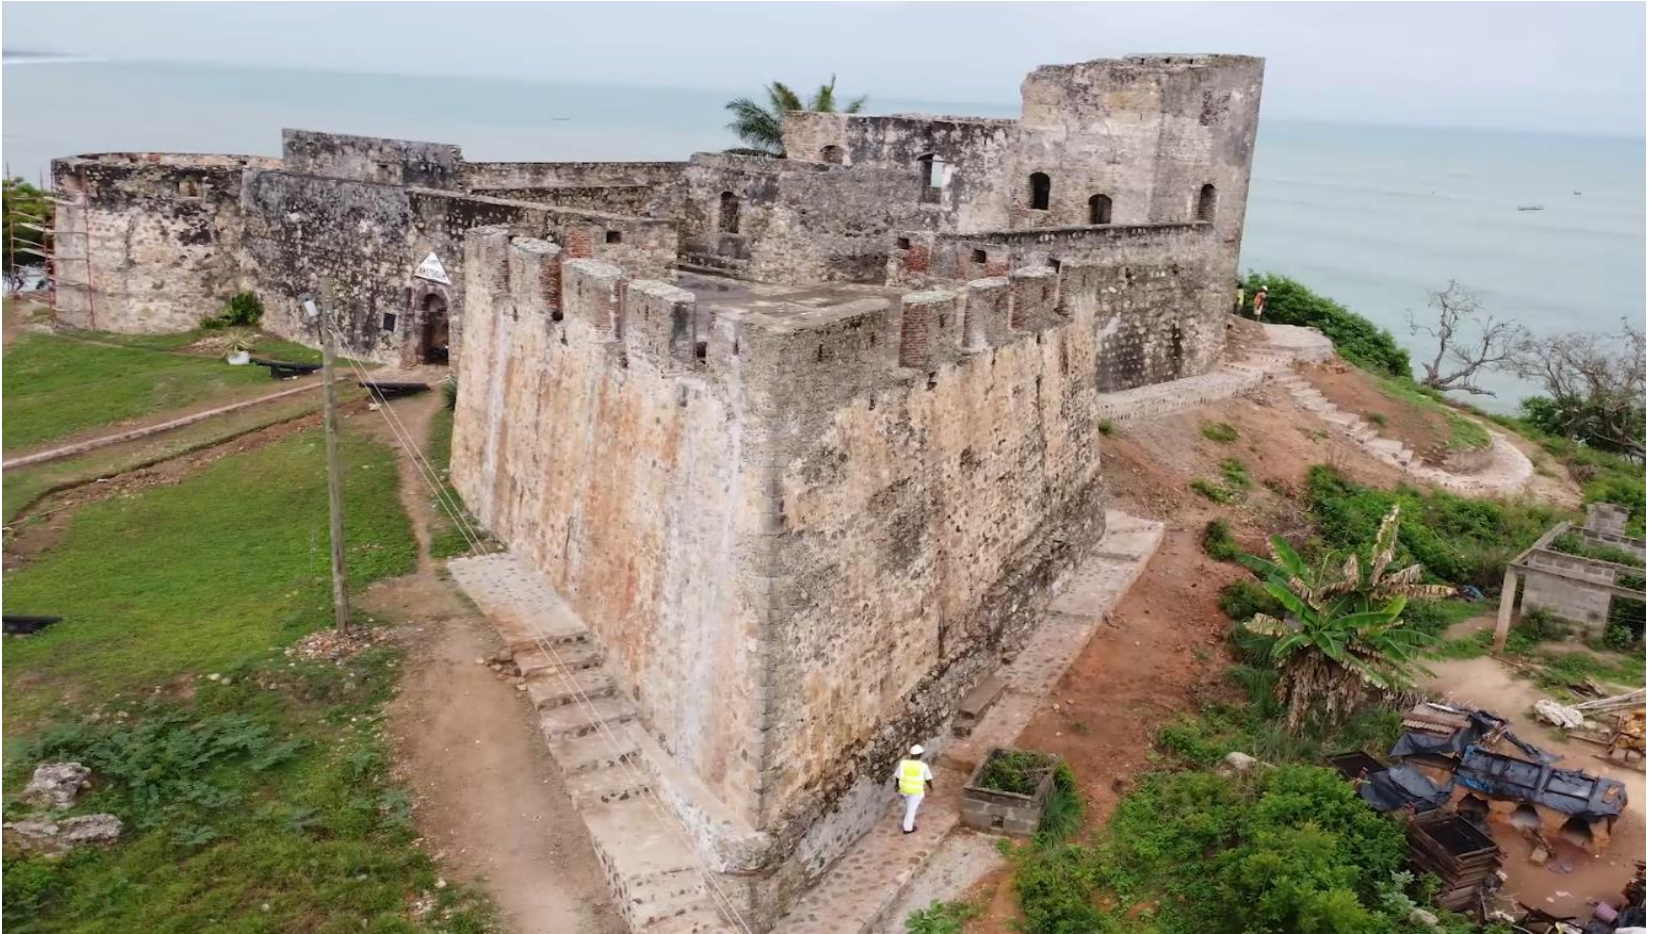
Northern parts of the walkway –apron complete

Completion of the southern walkway –apron around the lost bastion

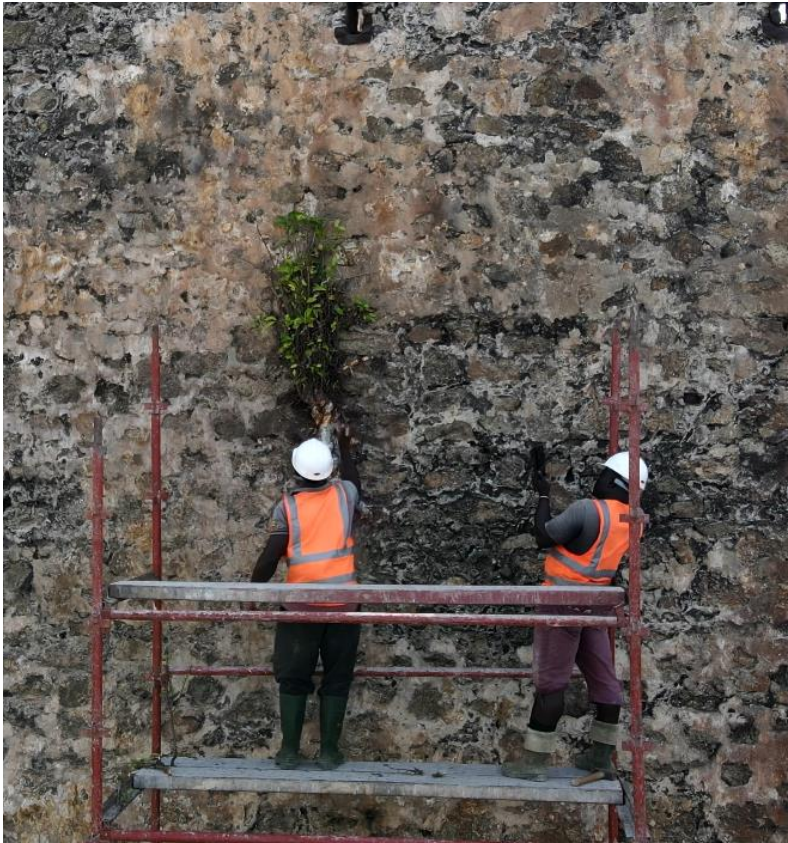
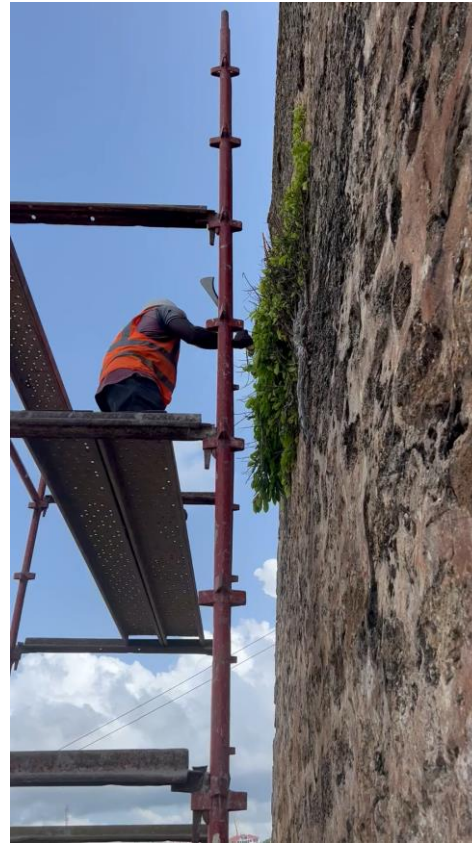
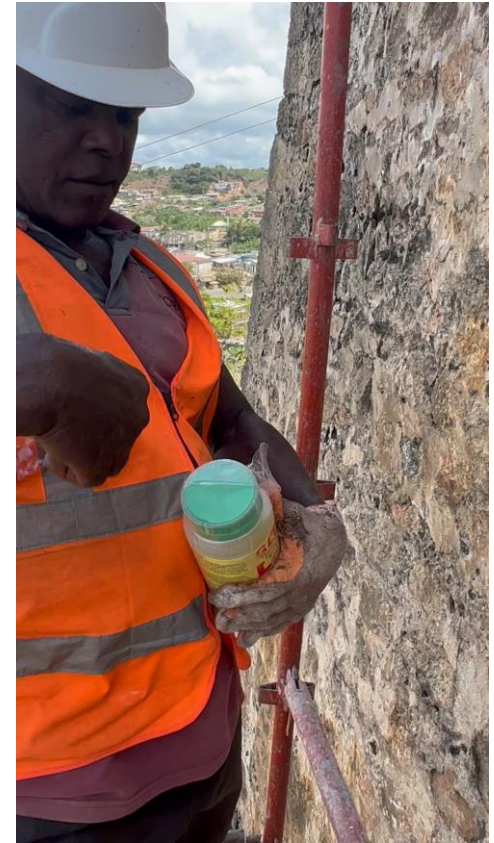
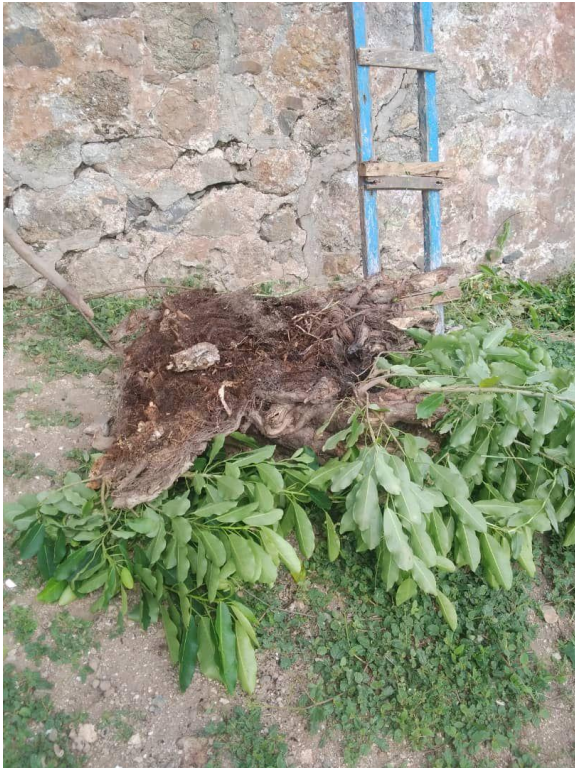
The removal of vegetation was not as simple as assumed. The roots were buried so deep into the bastion that it was impossible to remove. The decision was to cut the branches and regularly apply the recommended chemical such as Champion , a brand of weed killer which must contain 2,4-D, triclopyr, MCP, glyphosate. This was done for all grown vines along the walls

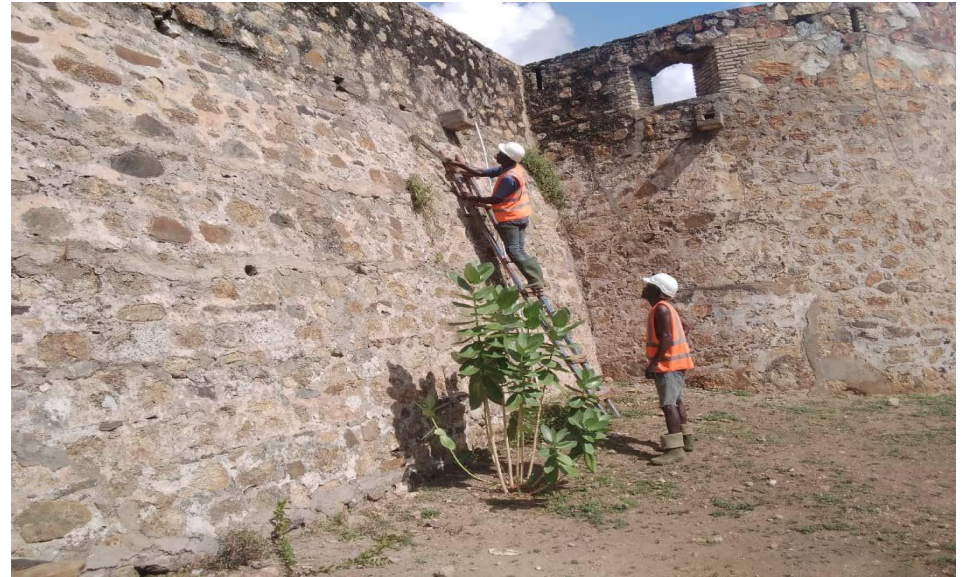
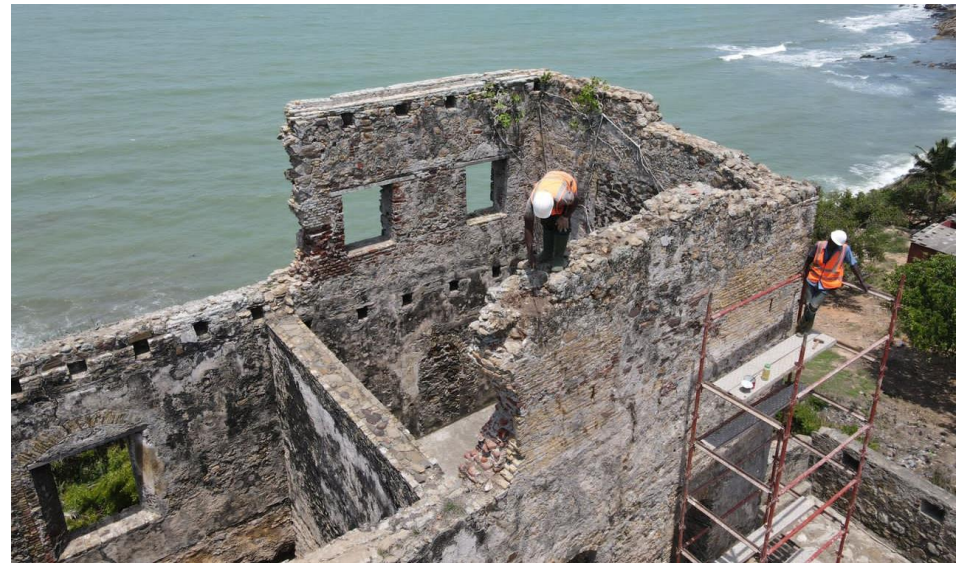
Some of the vegetation removed from the wall had different system of roots than expected . Some were light and had not penetrated deep into the walls. Others had a netlike system of roots that spread with the cervices. Others were small grasses growing on top of highest point of the ruins which was dangerous and difficult to reach.
