2023 SOC REPORT

Forts and Castles, Volta, Greater Accra, Central and Western Regions (Ghana) (C 34)

PROJECT REPORT

STABILIZATION AND CONSOLIDATION OF FORT AMSTERDAM ABANDZE CENTRAL REGION

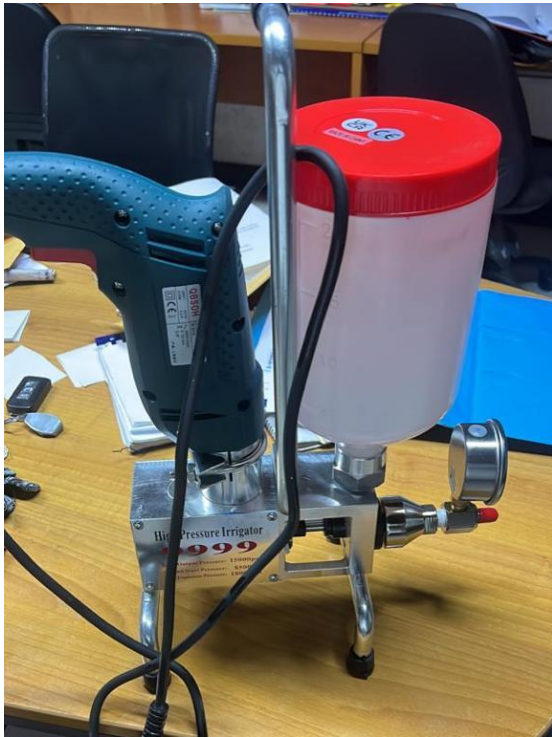
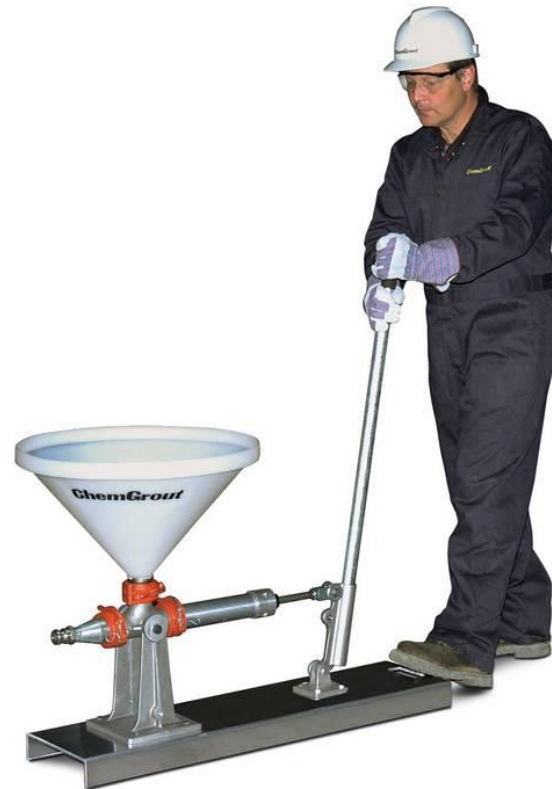
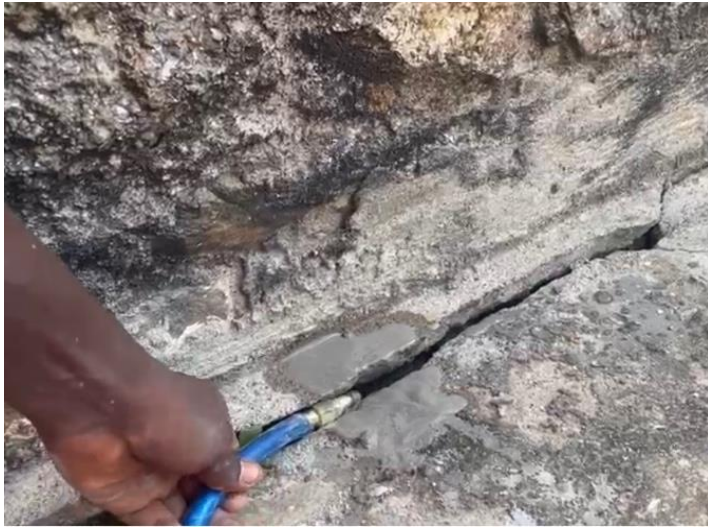
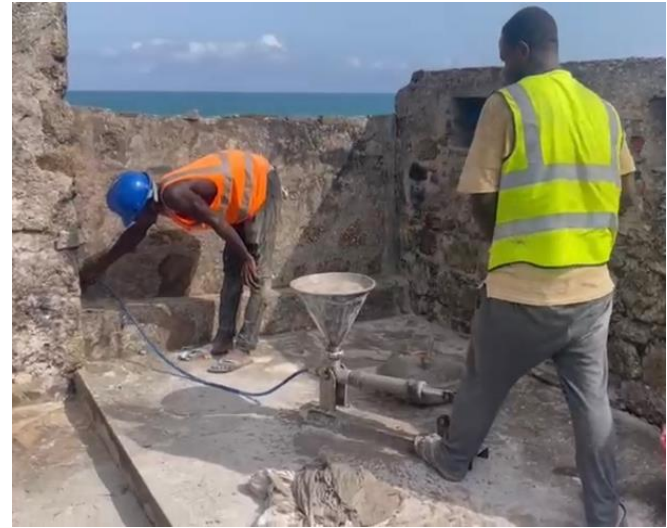
In preparing to fill the cracks with lime mortar, it was realized that some of the cracks were deeper and long . It was not sufficient to patch them at the surface as had been done in previous time. We devised a way to fill the cracks using power pumps that would pump grout deep into the fissures and cracks at high pressure . The company invested in a power operated grout pump for use in filling smaller cracks. However its use was limited due to power fluctuations at the fort. The company alternatively had a custom manually operated pump manufactured at Agbogloshie in Accra and used it extensively in filling cracks .

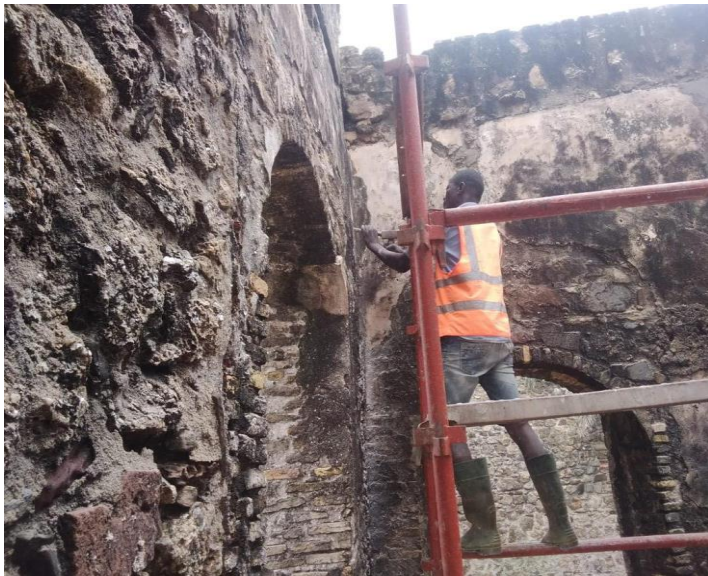
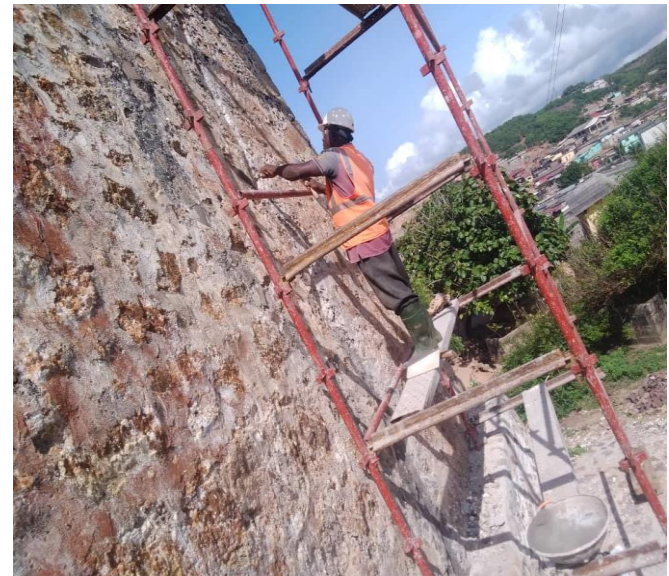
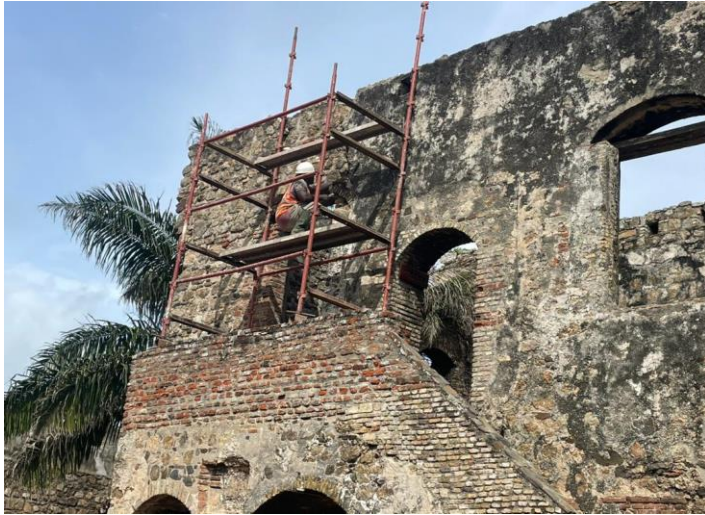
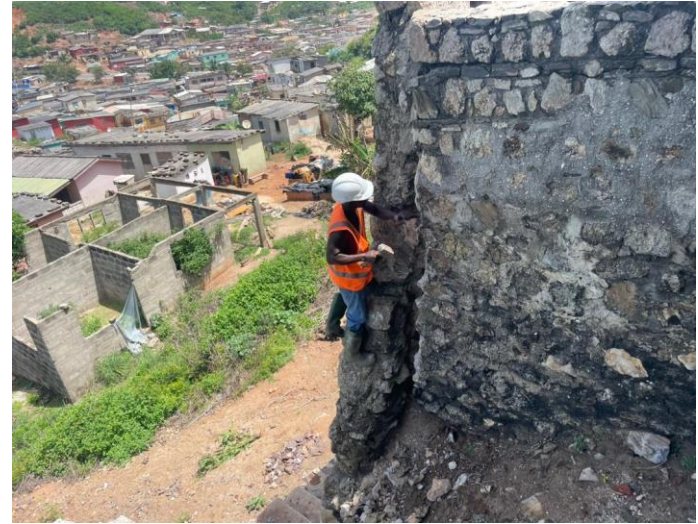
A mix ratio of S:L:C 6:6:1 was pumped at high pressure into deep cracks that could not be easily filled by trowel. Other large cracks were filled manually by trowel.

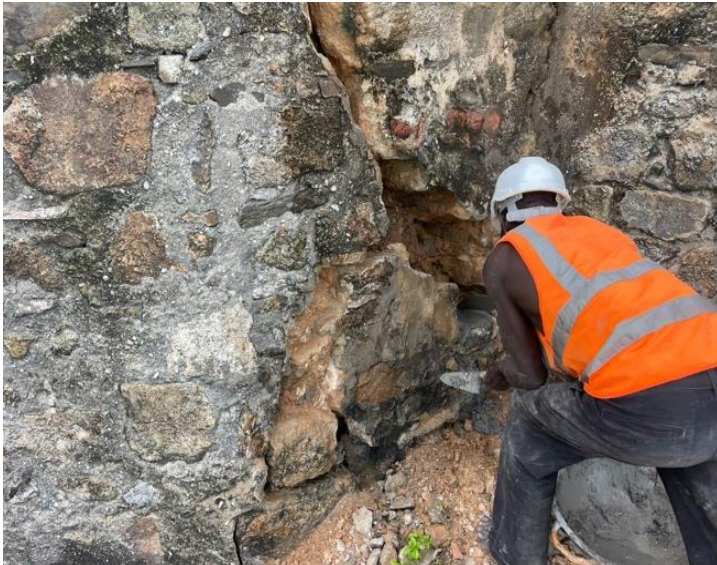
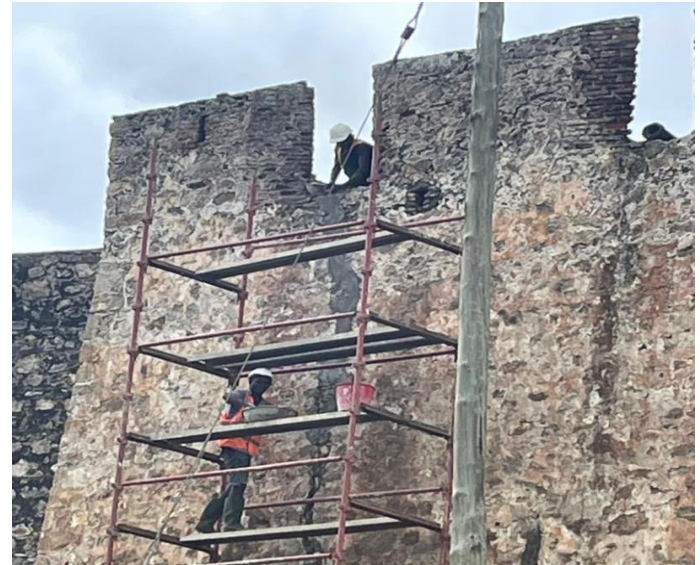
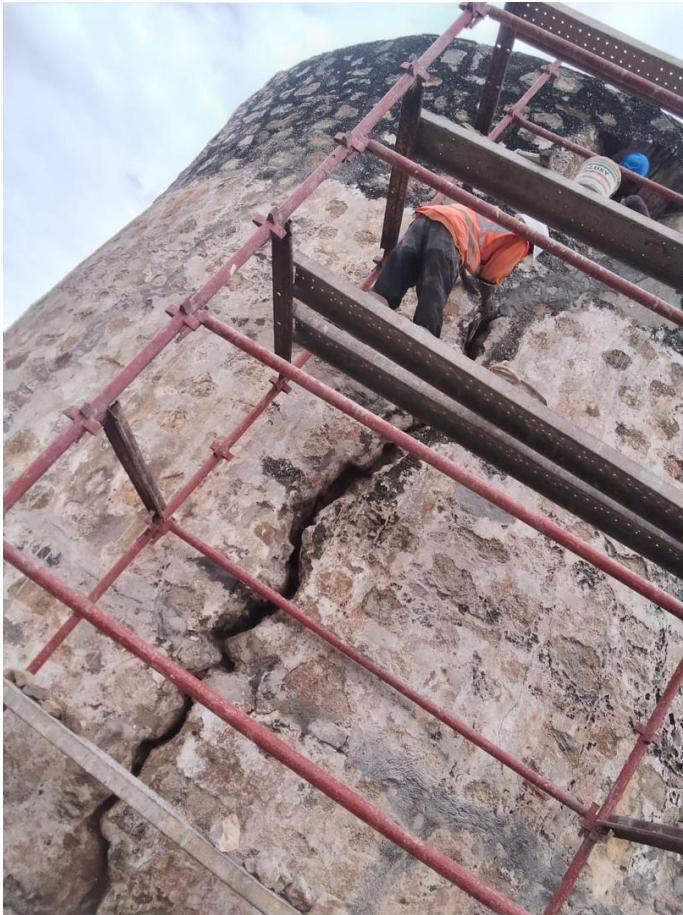
Crack repairs continued intensively . It was realized that different parts of the forts needed different mixes of mortar. This is because of the inconsistency of materials used in constructing the fort at different times.

The nature of the stones in the eastern bastion demanded a more binding material for the lime mortar hence the addition of minimal Portland cement.

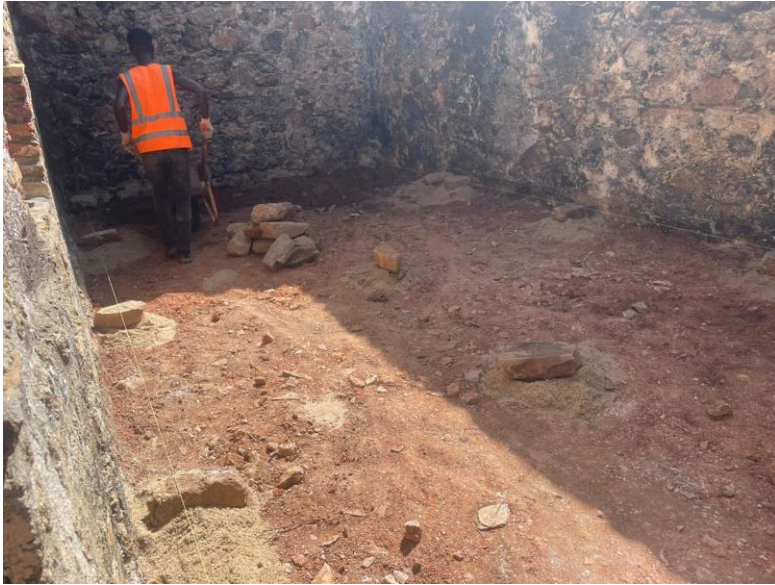
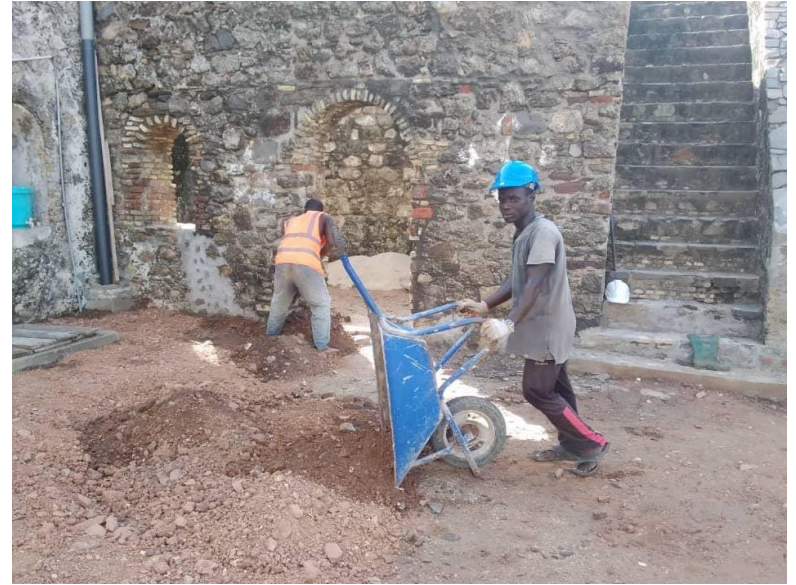
The courtyard was filled with laterite from the surrounding hillside. The level was raised to cover the bases walls in the interior which had been washed by rain water flow. The filling was sloped slightly to allow heavy rain to flow toward the entrance instead of gathering in pools in the corners of the yard. The soldiers room was also filled as water gathered there seeped into the foundation creating perpetual dampness.

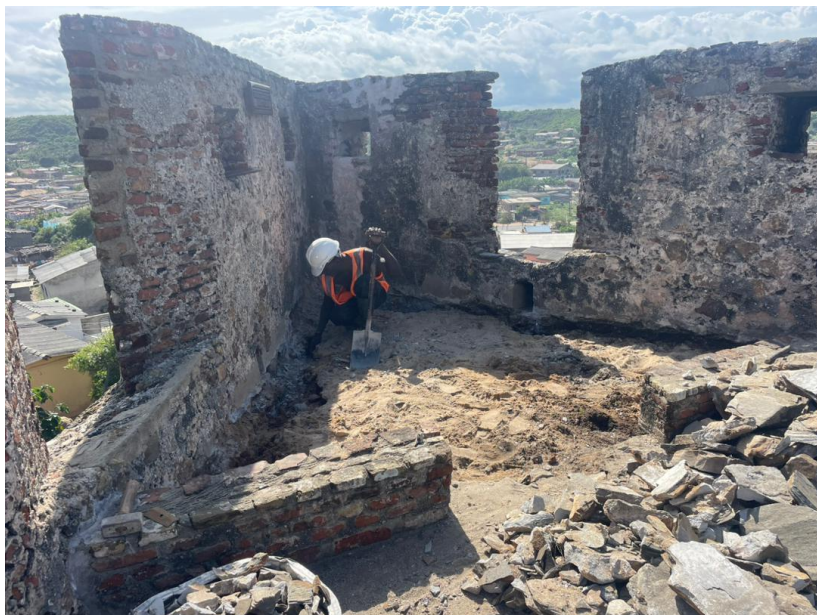
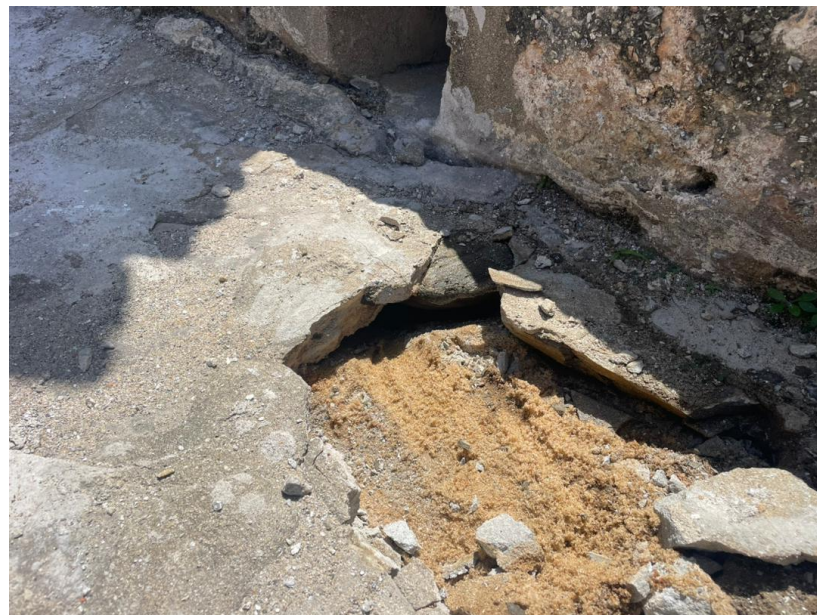
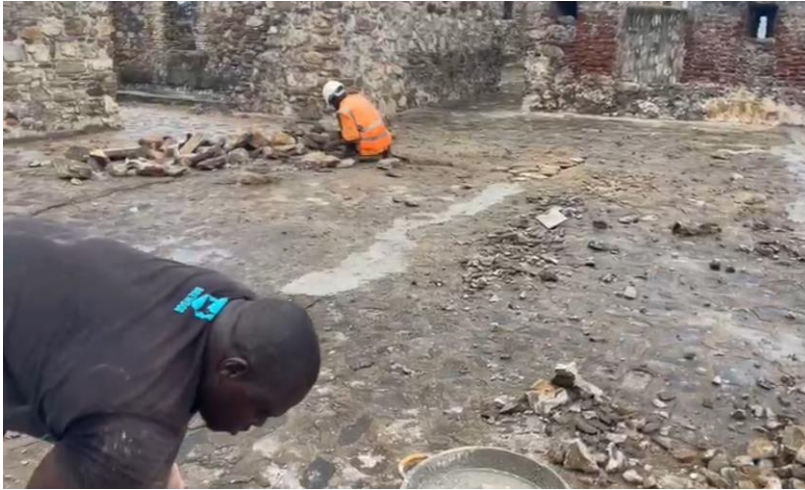
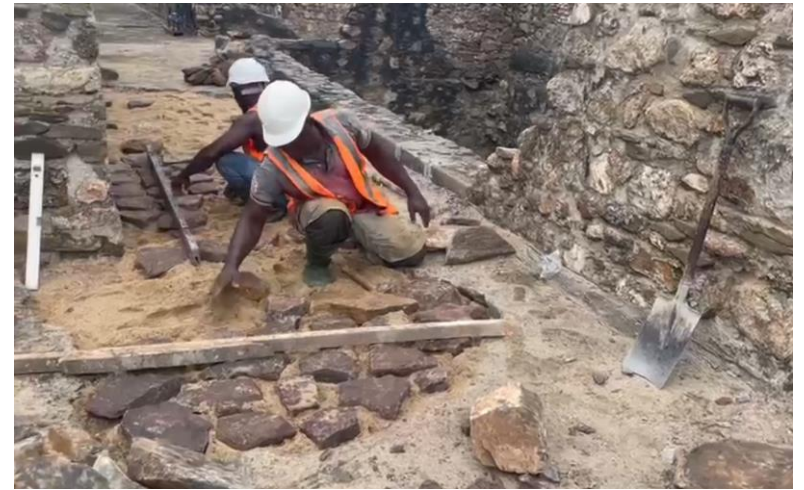
The bastion tops posed a great problem . The edges of the bastion floor had separated from the walls leaving a deep cervices through which water would pass. The depressions were marked and levels taken .After removing parts of it, we found that the sand fill had sunk behind under the flagstone top and created spaces within which water would seep and flow to the edges of the bastions causing cracks and feeding the plants that grow on the external of the bastion. We believe that repairing the cracked bastion floors would eventually solve the long cracks in the bastion walls.

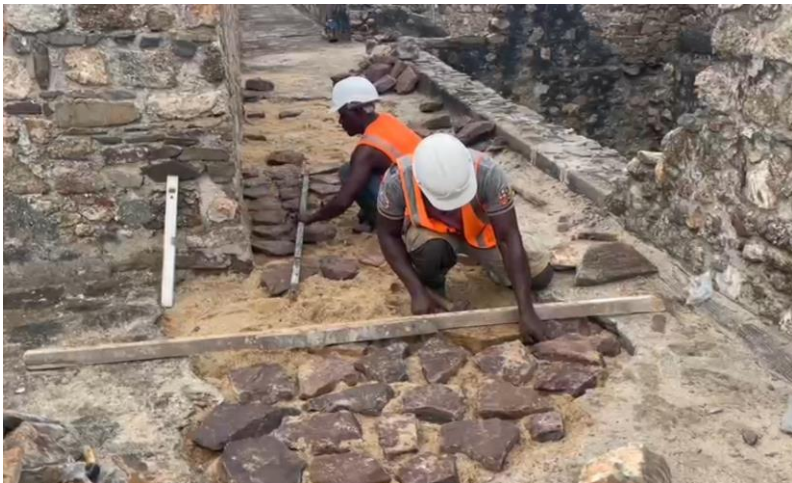
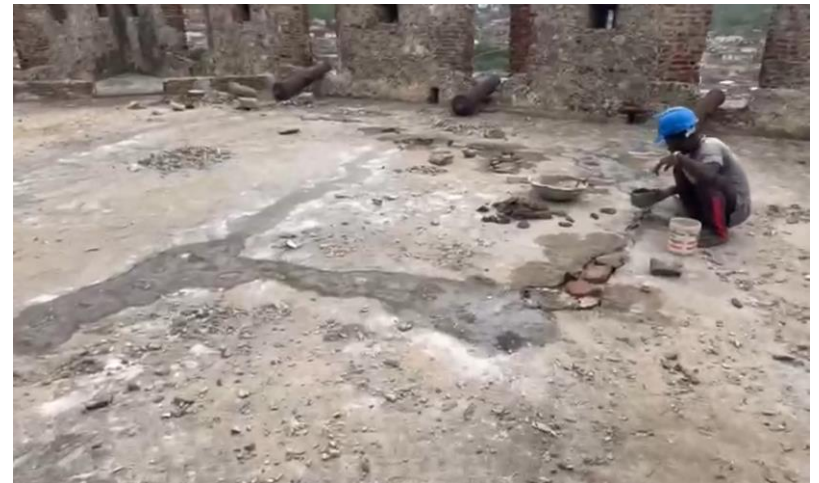
Much of the top had to be removed , refilled and re-laid to slope towards the spouts. It was necessary to remove and fill parts of the walkways and align them to the new slopes. S:L:C 6:6:1 was used to reset the flagstone on the bastion floor

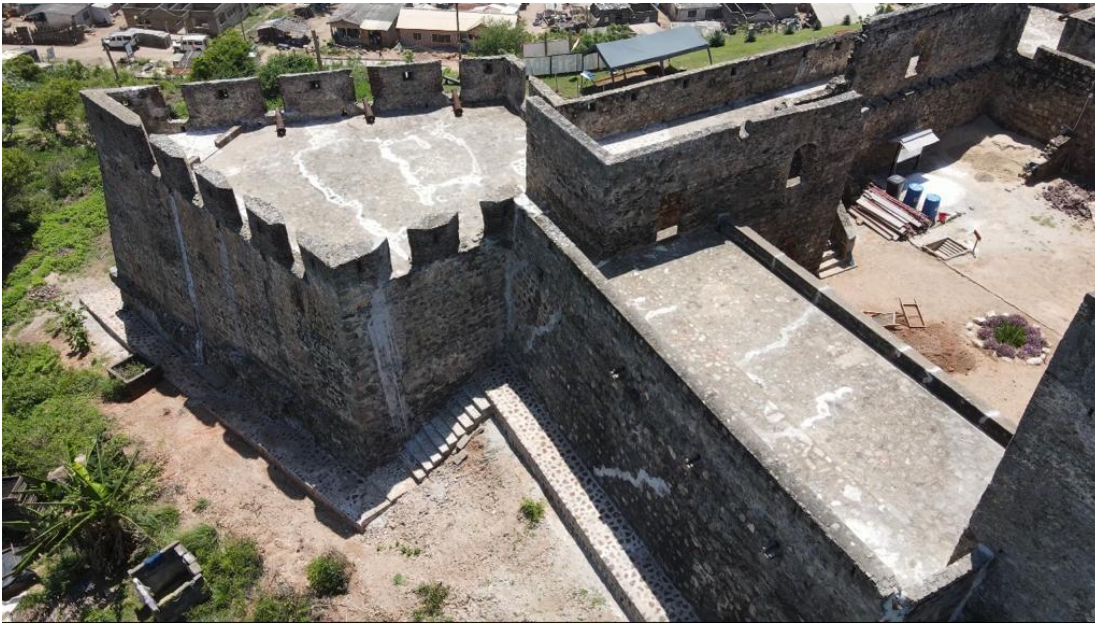
The repaired north-western bastion floor.

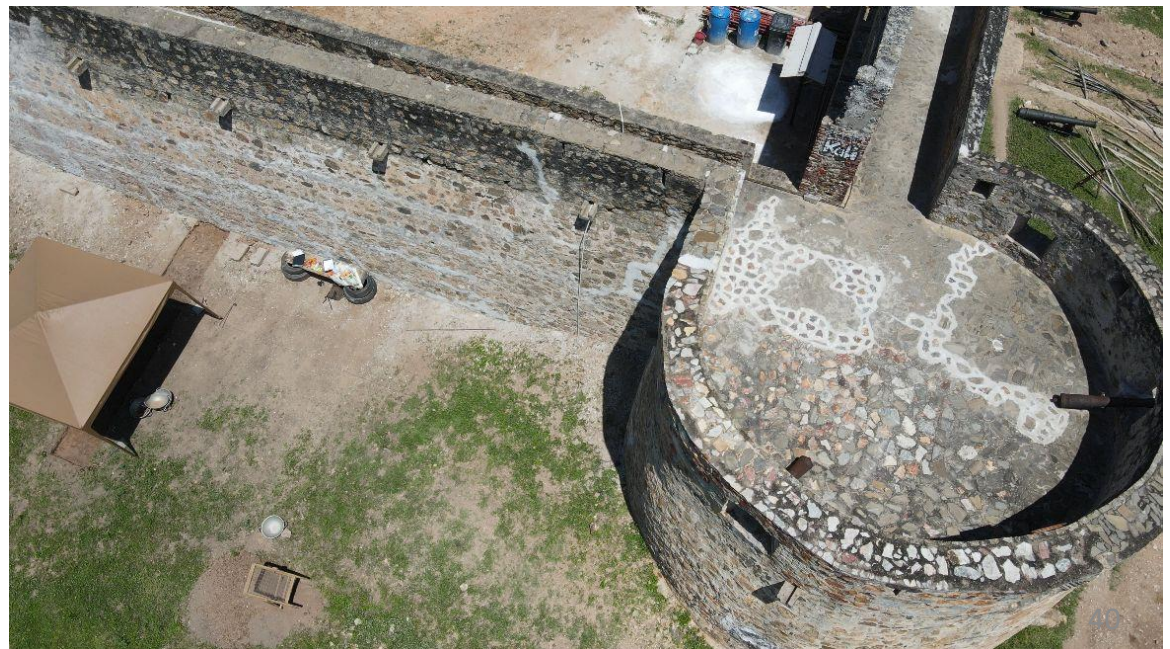
The repaired north-eastern bastion floor.
