# REPORT ON THE MISSION to the “Gusuku Sites and Related Properties of the Kingdom of Ryukyu” (Japan)

**From 13 to 14 June 2023**

**Joint Reactive Monitoring Mission undertaken by  
World Heritage Centre, ICOMOS and ICCROM**

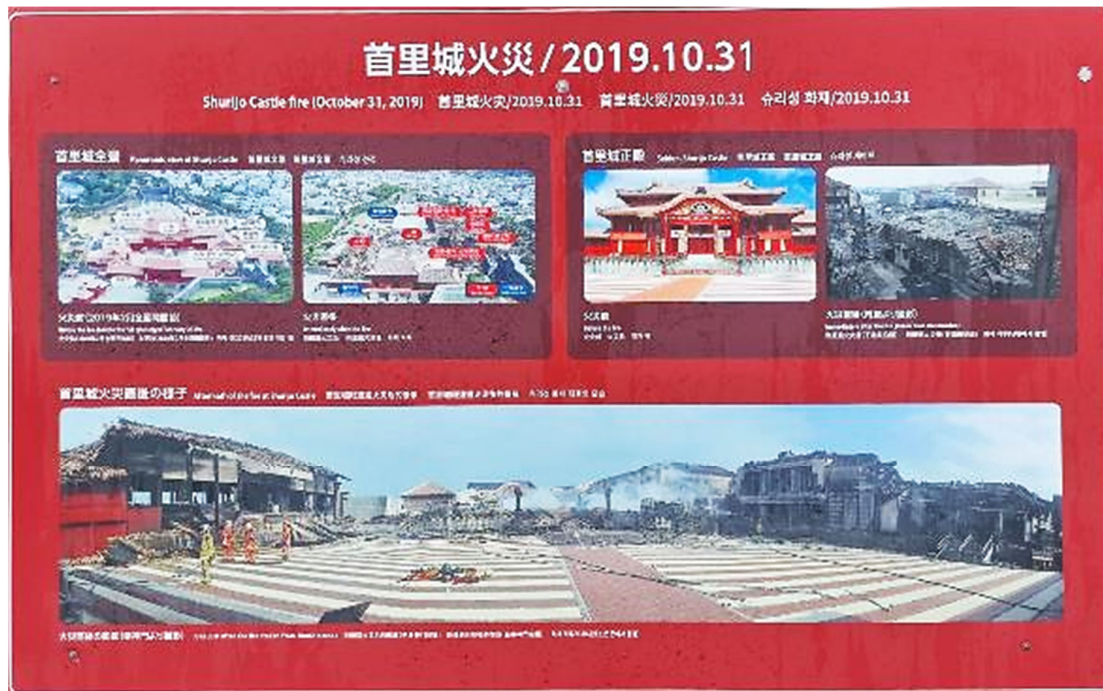
Interpretation panel showing the impact of the fire on the buildings surrounding the central courtyard.  
© Rohit Jigyasu 2023

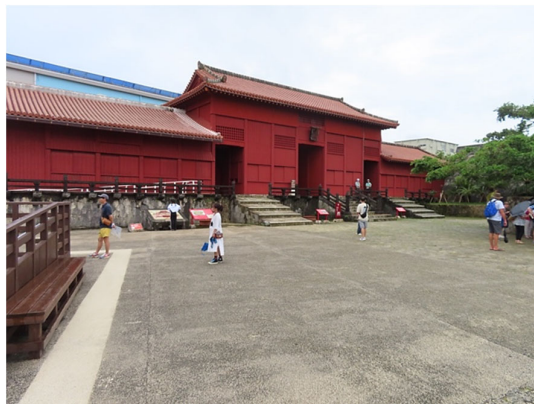
The Hoshimmon gate, which provides entry to the central part of the castle complex, was damaged in the fire, but has been restored. Visitors enter the site through this gate. © C.Forbes 2023

- The Hoshimmon gate has been repaired and provides entry to the central precinct for visitors.
- Temporary buildings located in the courtyard in front of the gate provide ticketing and other visitor facilities.

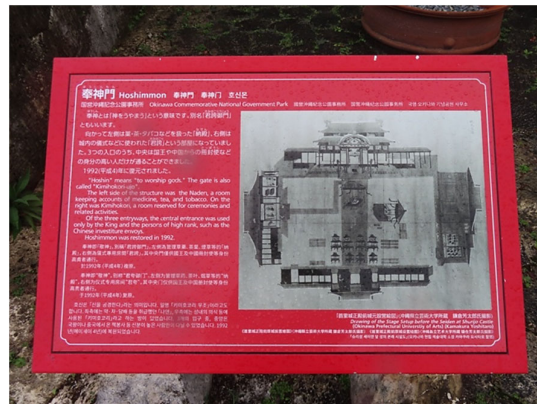
Interpretive signage shows the principal buildings of the castle complex arranged around a central courtyard. The State Hall (Seiden) is shown standing directly opposite the Hoshimmon gate. © C.Forbes 2023

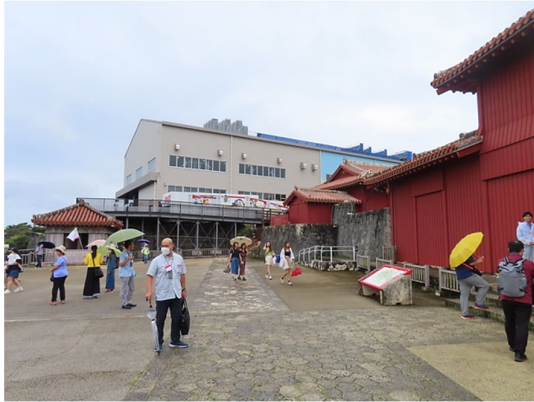
A large workshop has been built over the courtyard at the centre of the Shuri-jō Castle complex to facilitate the reconstruction of the destroyed replica buildings. It is built on an elevated platform and is clearly visible on approach to the site. © C.Forbes 2023

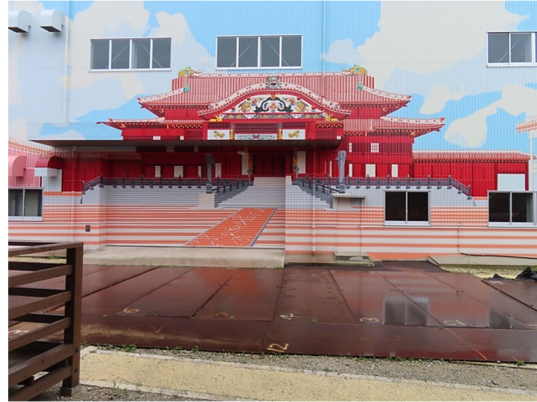
The side of the workshop is painted with an image of the Seiden, which stood the opposite the Hoshimmon gate across the courtyard. © C.Forbes 2023

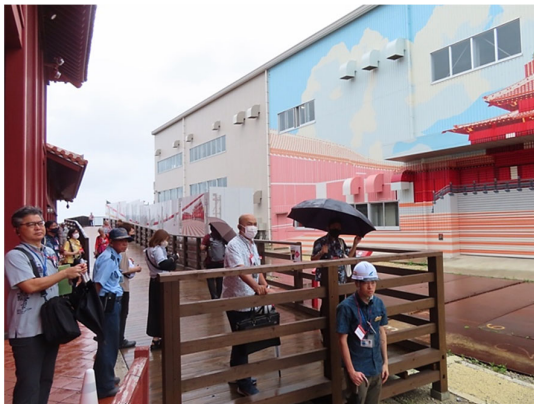
Visitors enter through the Hoshimmon gate and are taken around the site on raised walkways. © C.Forbes 2023

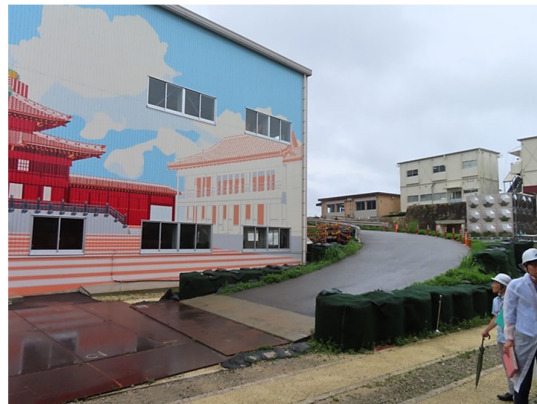
Temporary access has been provided to the site for construction vehicles, materials and equipment. © C.Forbes 2023

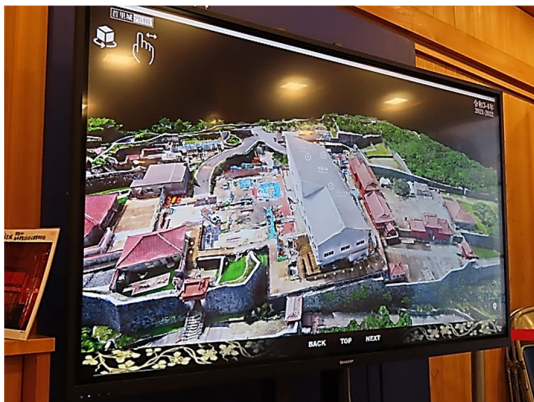
Video image showing the workshop built on a raised platform over the central courtyard to ensure minimal impact on the archaeology below. © C.Forbes 2023

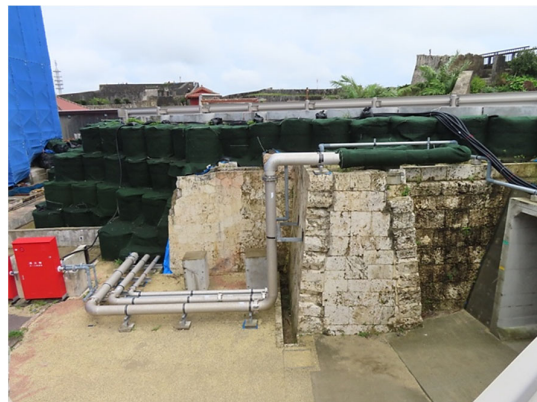
Temporary structures and services have been provided to enable the reconstruction of the replica buildings. These have been designed and installed so as not to impact the significant attributes (archaeology, ramparts) of the site and will be removed on completion of the work. © C.Forbes 2023

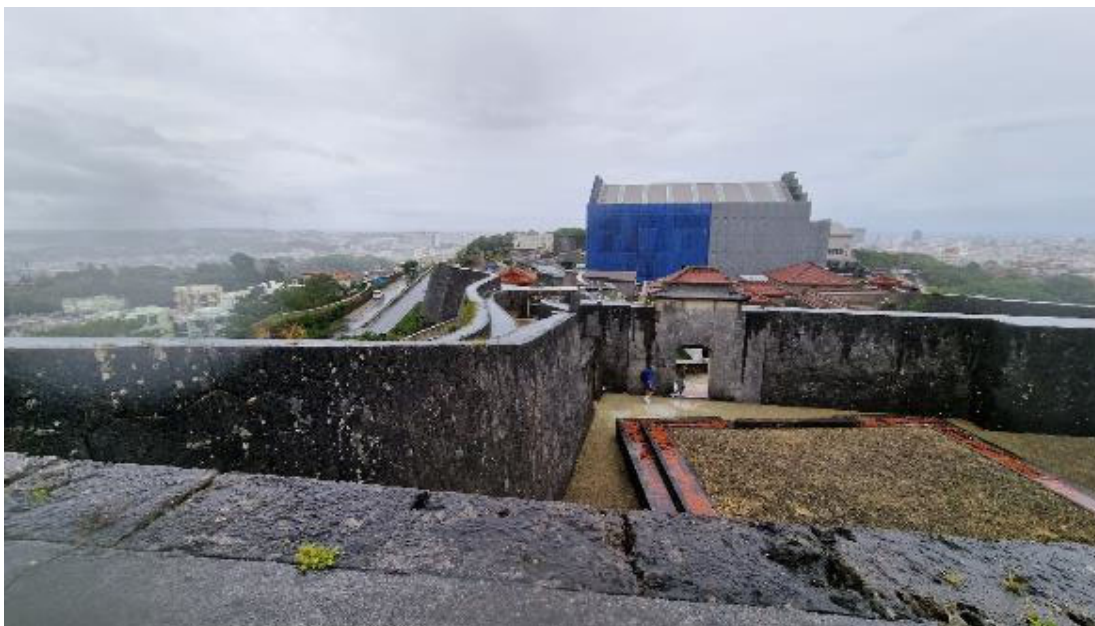
A large shed has been erected over the site of the Seiden to protect it during reconstruction. View from the highest point of the site. © Rohit Jigyasu 2023

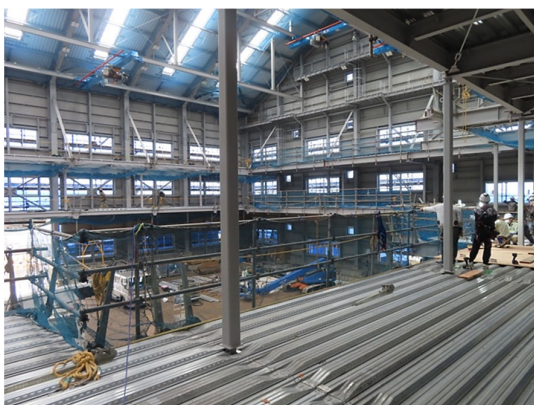
A large shed protects the site of the Seiden and the archaeological remains while the building is being rebuilt. © C.Forbes 2023

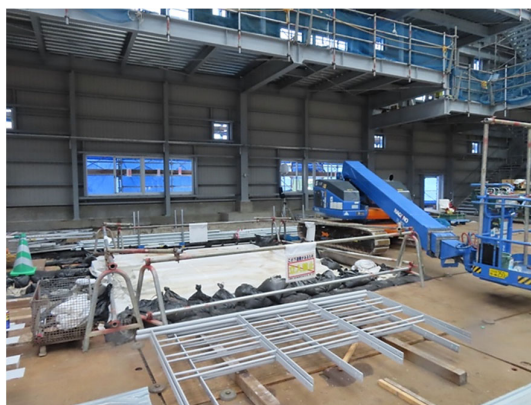
The archaeological remains that were damaged in the fire have been stabilised and covered with temporary protective layers for the reconstruction of the Seiden. The ground surface and archaeology beneath are protected from vehicles and heavy equipment by large steel plates. © C.Forbes 2023

- The fire had minimal impact on the surviving archaeological remains of Shuri-jô as these are generally protected underground. Only two very small portions of the remains were impacted by the fire (0.05%) – those that were exposed inside the Seiden as part of the interpretation of the site to the public.
- The stone and mortar in these areas were damaged resulting in some loss of strength.
- The affected portions have been cleaned and stabilised with resin to prevent further decay.
- They have also been temporarily covered by a protective layer of sand, fabric and polystyrene foam to protect them during the reconstruction of the Seiden, which is to be rebuilt over the top of them.

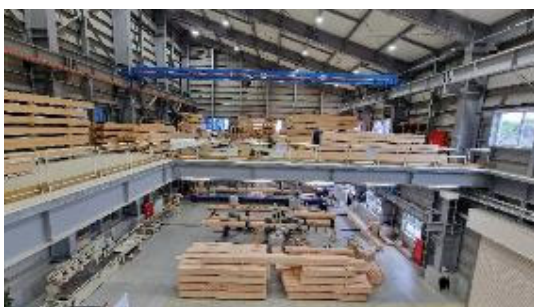
Interior of the workshop where the timber is milled, carved and prepared for the reconstruction of the Seiden. © Rohit Jigyasu 2023

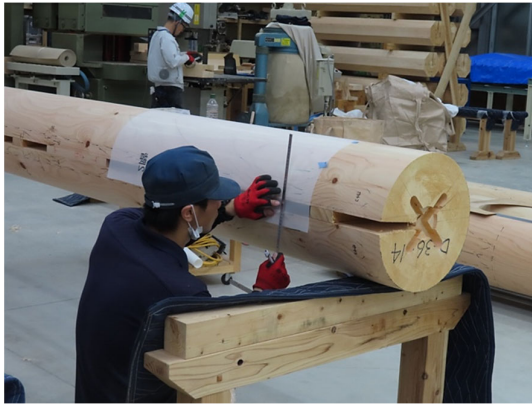
The large timber elements are mechanically milled and carefully measured. © C.Forbes 2023

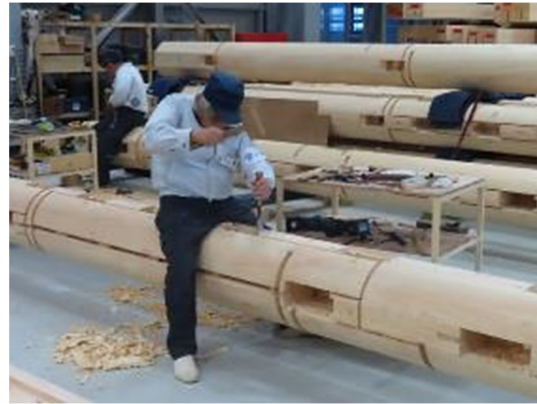
Joints are finished by hand to ensure a tight fit. Carvings will also be completed by hand. © C.Forbes 2023

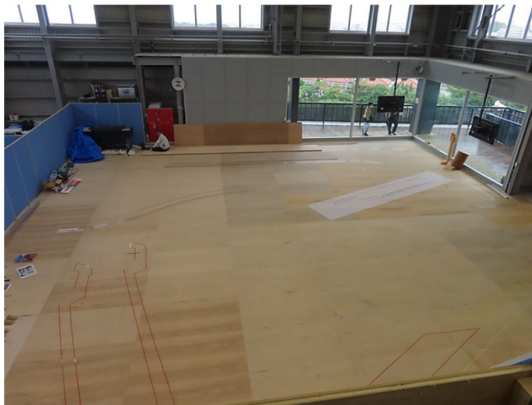
A large space is used for full scale drafting of individual elements for reconstruction. Large windows in the workshop walls allow visitors to see the work in progress. © C.Forbes 2023

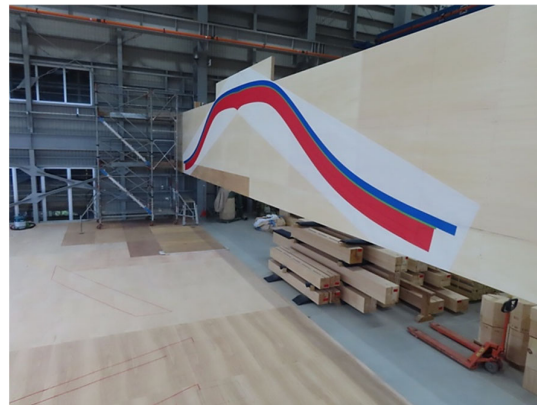
Full scale drawing of curved gable end to be reinstated over the entrance to the Seiden. © C.Forbes 2023

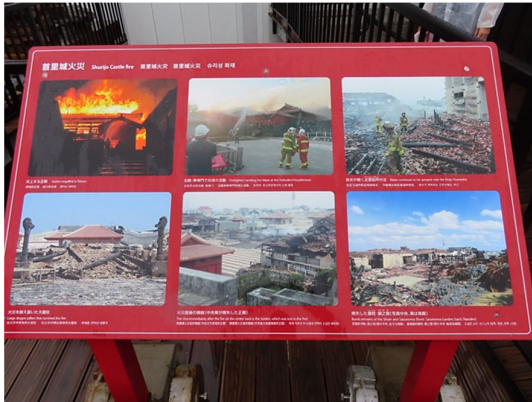
Interpretation panels show the fire and its impact. © C.Forbes 2023

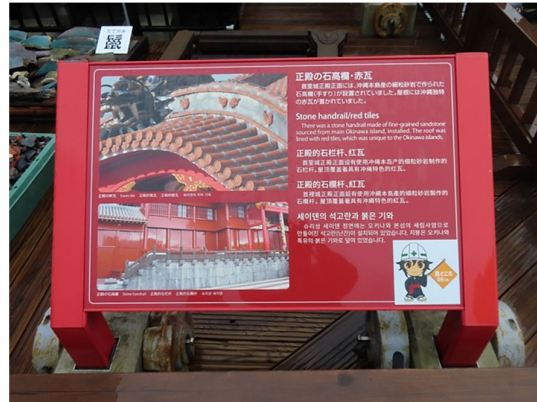
Interpretation panels show details of the Seiden and explain the work involved in their reconstruction. © C.Forbes 2023

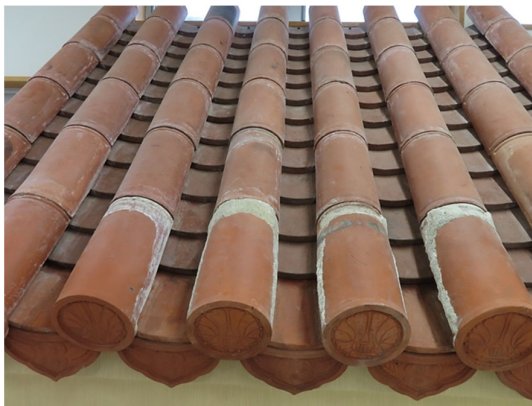
Roof tiles that survived the fire have been salvaged and cleaned for reinstatement on the reconstructed building. © C.Forbes 2023

Where possible building materials, such as roof tiles, were salvaged and cleaned for reuse. Members of the local community were engaged as volunteers in cleaning undamaged tiles and grinding damaged ones so that the clay could be used in the manufacture of replacement tiles.

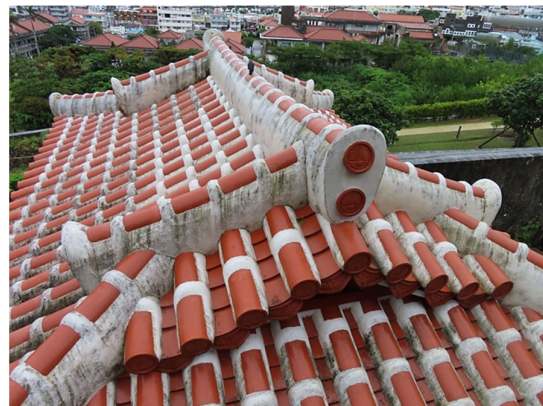
The roof on one of the surviving buildings on the site shows the traditional use of lime mortar to make the tiles weathertight. © C.Forbes 2023

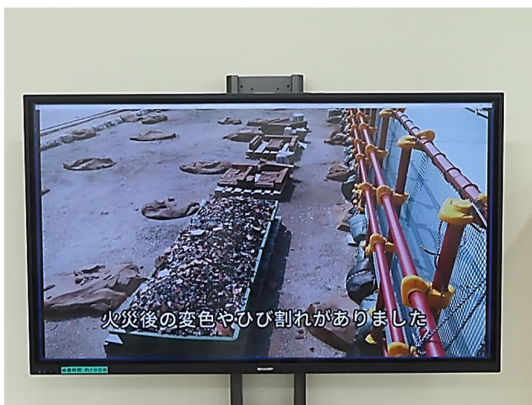
Image from a video display on the site showing the damaged foundation stones and the debris that has been salvaged. © C.Forbes 2023

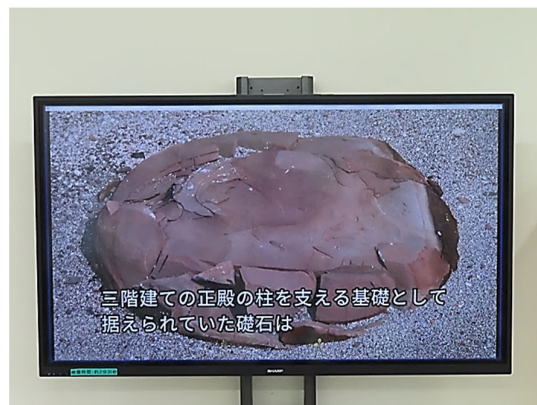
Image from a video display on the site showing the damage to the foundation stones. These have since been ground by community volunteers to enable the material to be used as a base coat for the lacquer to be applied to the reconstructed building. © C.Forbes 2023

- Severely damaged foundation stones have been ground to provide a base coat to the new lacquer work.
- Steel will be used for seismic strengthening in line with the current Japanese building code for new buildings.

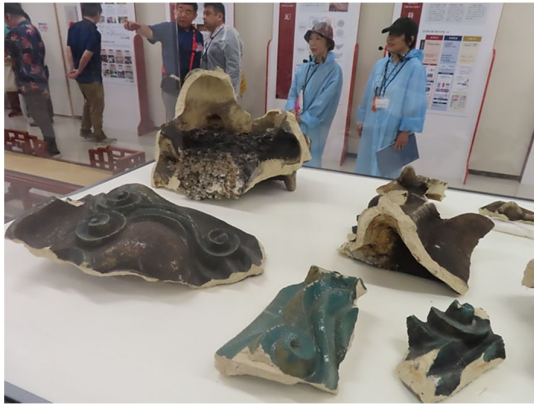
Salvaged ceramic elements from the dragons mounted on the Seiden roof on display for visitors. © C.Forbes 2023

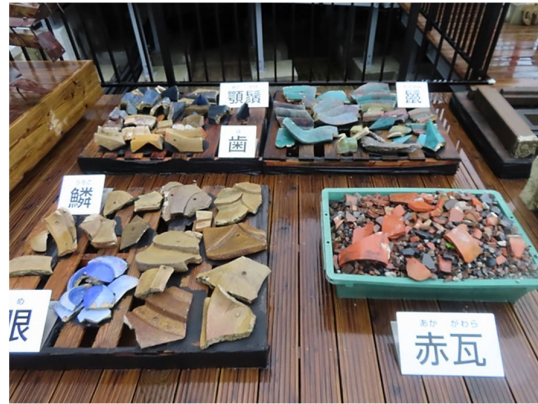
Salvaged artefacts from the destroyed replica buildings on display for visitors. © C.Forbes 2023

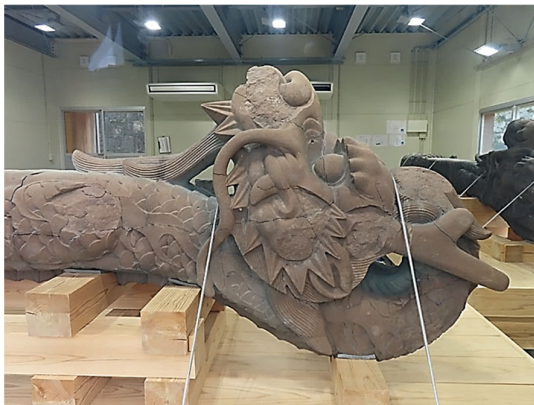
Fire damaged stone dragon from the entrance to the Seiden. © C.Forbes 2023

Decorative elements, most of which were severely damaged and beyond repair, such as the glazed terracotta dragons from the roof of the Seiden and the carved stone pillars in front of the Seiden, were salvaged for analysis and for use as models for replication and reinstatement on the reconstructed buildings.

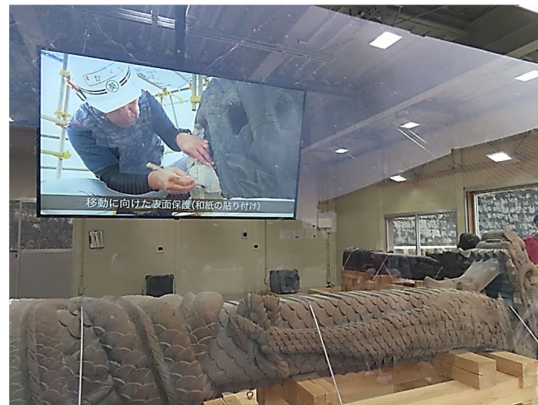
Salvaged stone dragon is displayed with a video showing the analysis of the fire damage to the stone. © C.Forbes 2023

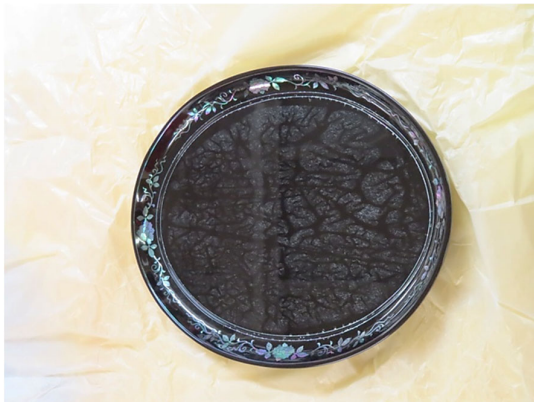
Fire damaged lacquerware salvaged from the site. © C.Forbes 2023

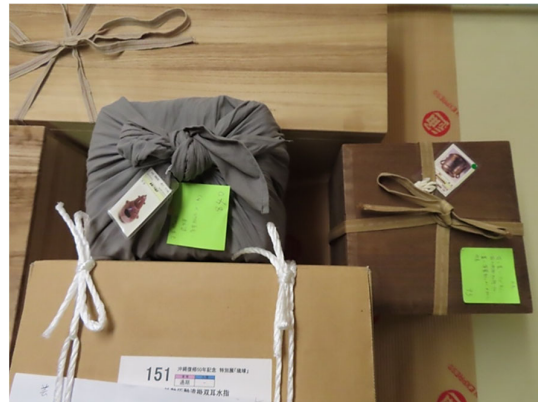
Salvaged artefacts from the Shuri-jō Castle collection are safely packed, labeled and stored at the adjacent University. These will be restored by specialist craftspeople, conservators and students. © C.Forbes 2023

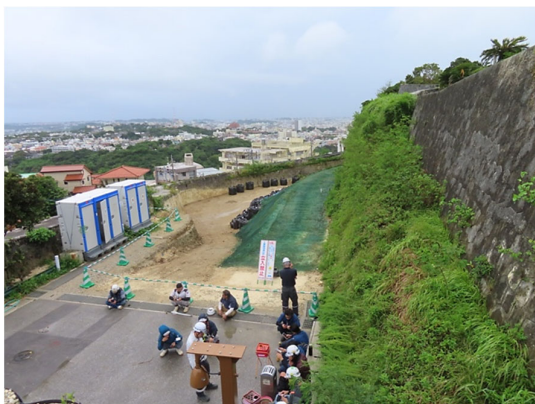
New water tank being excavated adjacent to castle to provide backup supply for future fires. © C.Forbes 2023

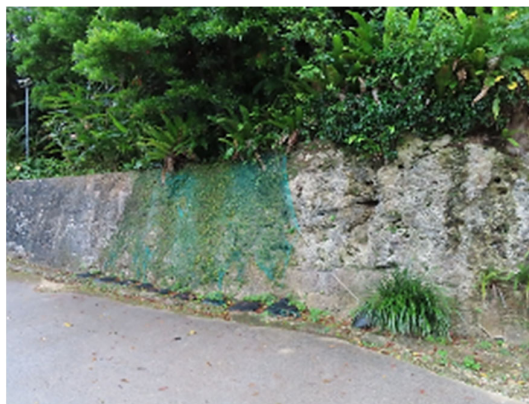
Sections of wall failing due to groundwater pressure have been temporarily stabilised and are to be repaired and site drainage issues resolved. © C.Forbes 2023

Although a disaster risk management plan has been prepared by the State Party for the site, it could not be reviewed by the mission team as it is only available in Japanese. Common hazards such as typhoons and long periods of torrential rain were discussed by the mission team and State Party, but no details were provided by the State Party on how the risks are being managed. Nor has information been provided on the management of risks to other attributes of the site, such as the castle walls and ramparts. In some areas of the site bulging retaining walls provide some evidence of drainage issues that need to be addressed.

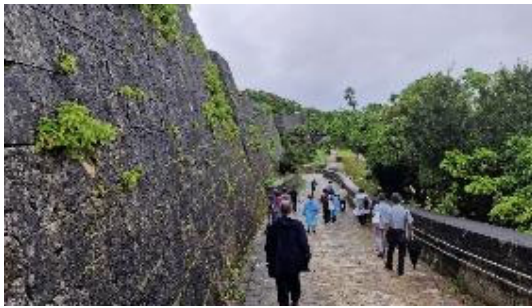
The castle walls and ramparts remain intact following the fire. © C.Forbes 2023

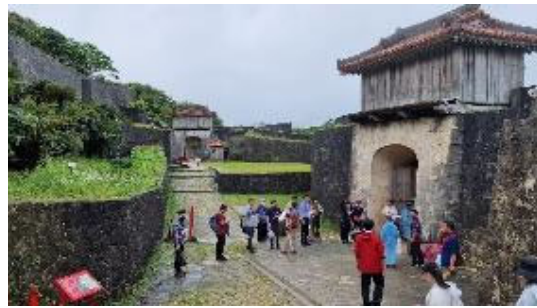
The castle gates remain intact following the fire. © C.Forbes 2023
