Report to UNESCO
State of Conservation Report
The property of Archaeological Sites of the Island of Meroe

Property: Archaeological Sites of the Island of Meroe

Meroe Pyramids Site State of Conservation

Meroe Royal City Site State of Conservation

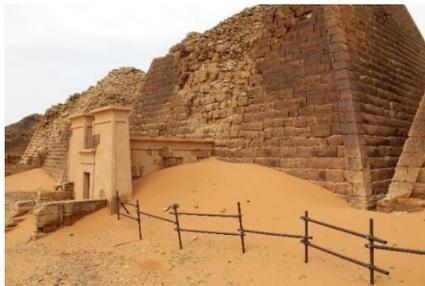
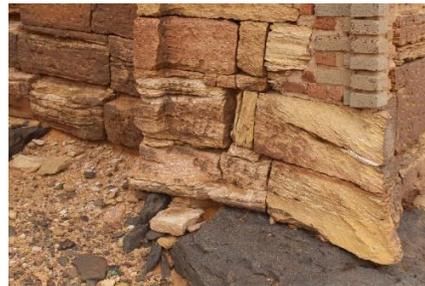
Currently the most obvious destruction can be observed with the sandstone blocks of the chapels and with the corners of the pyramids. Especially the reliefs are exposed to the harsh conditions and endangered. The rate of destruction as to the chapel reliefs is alarming.

Currently, the main threat to the pyramids is the accumulation of sand, which remained the greatest threat to the site. This has been evident after the last rain season in September 2023, when the region of Meroe received the highest record of rain and flash floods. In fact, this situation is continuing at the moment since we are in the middle of the rain season of 2024, and the area is recording high rain records. Sand surrounding chapels kept humidity and rain water penetrate through chapels walls from outside to inside chapels where walls are decorated with inscriptions and unique depictions. We have noticed this threat for example in pyramid Beg. N.12. Sand is accumulated on the northern wall of its chapel, and on the same wall from inside we found the sand stone blocks are wet, and there is presence of salt in whitish colour covers the wall, and also in crystals form coming out of these blocks. This is the first time to observe such a phenomenon at Meroe pyramids.

Sand accumulation and the erosion of corners

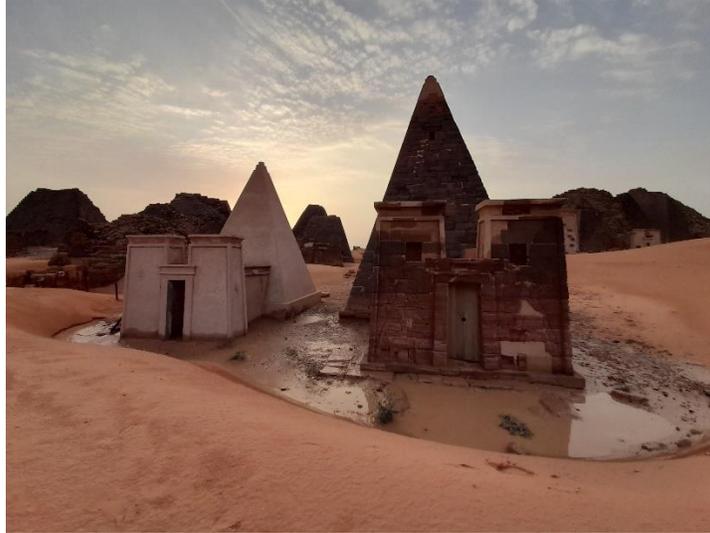
In addition, rain water is normally stuck around pyramids located in the lower part of the cemetery, and stay for long period, which affect the monument with the increase of humidity. The main reason of this is the sand dunes and also because there is no drainage system can allow water to pass these pyramids. This is one of the risks that need urgent treatment, because its impact on the pyramids is very clear as we noticed some new cracks in Beg. N 19.

Rain water around pyramid Beg. N 19

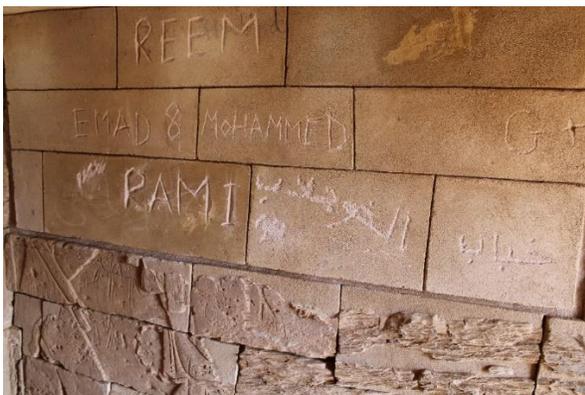
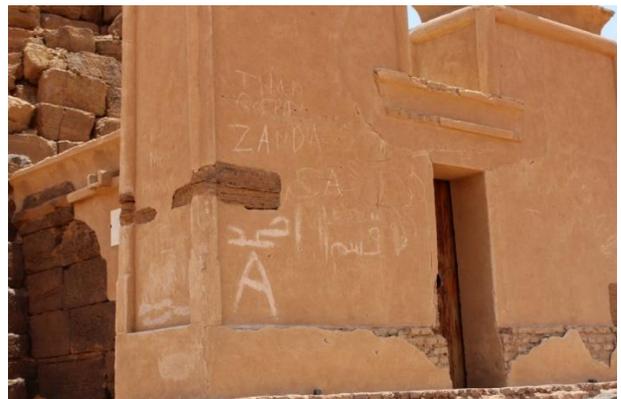
The site is nowadays a destination for visitors from surrounding villages that have been overpopulated by displacement from Khartoum state. The negative impact is evident in the increase of visitor's writings on the walls of the pyramids and the negative behaviour of climbing on the pyramids, which results collapse of stone blocks.

Visitor's writings on the walls of the pyramids

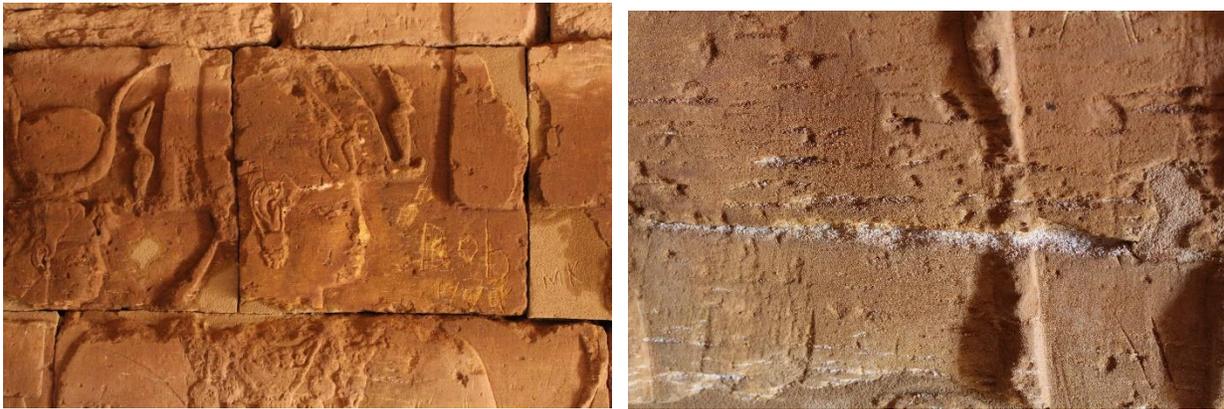
The impact of global climate change on the site is evident through the increase of the rain records in the area during the past years. This is together with the accumulation of sand. This combination of sand and rain remained the greatest threat to the site. This has been evident after the last rain season in September 2023, when the region of Meroe received the highest record of rain and flash floods. Sand surrounding chapels kept humidity and rain water penetrate through chapels walls from outside to inside chapels where walls are decorated with inscriptions and unique depictions. We have noticed this threat for example in pyramid Beg. N.12. Sand is accumulated on the northern wall of its chapel, and on the same wall from inside we found the sand stone blocks are wet, and there is presence of salt in whitish colour covers the wall, and also in crystals form coming out of these blocks. This is the first time to observe such a phenomenon at Meroe pyramids.

Humidity and rain water and the presence of salt

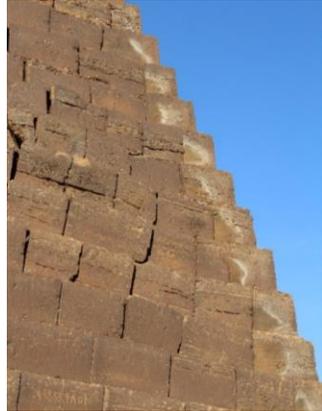
The impact of the last rain could be seen also in all the pyramid blocks in the whitish colour appeared in most of the sand stone blocks of the structure of the pyramids, which is also presence of salt resulted from rain water stuck on top of the pyramids for long time. This feature is also been recorded for the first time.

Presence of salt

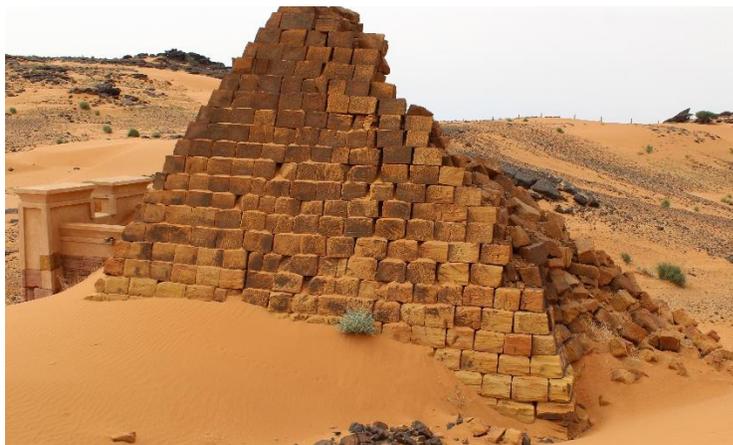
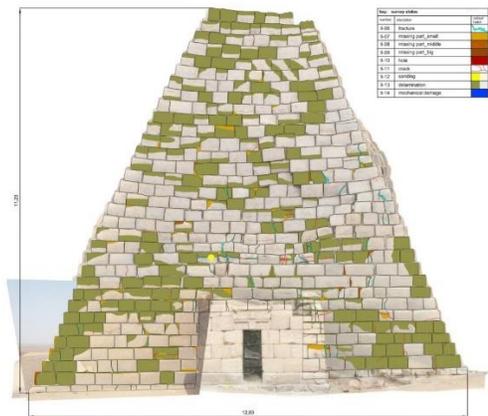
All pyramids at Meroe are highly affected by ancient looting that cause loosing of the top parts of the pyramids. This problem allow rain water to penetrate through the pyramid structure and weakened the sand stone blocks and the rubble core, which results partially collapse in number of pyramids like Beg. S 10 and distortion on the structure such as pyramid Beg. N 9.

Partially collapse in Beg. S 10 and distortion in pyramid Beg. N 9

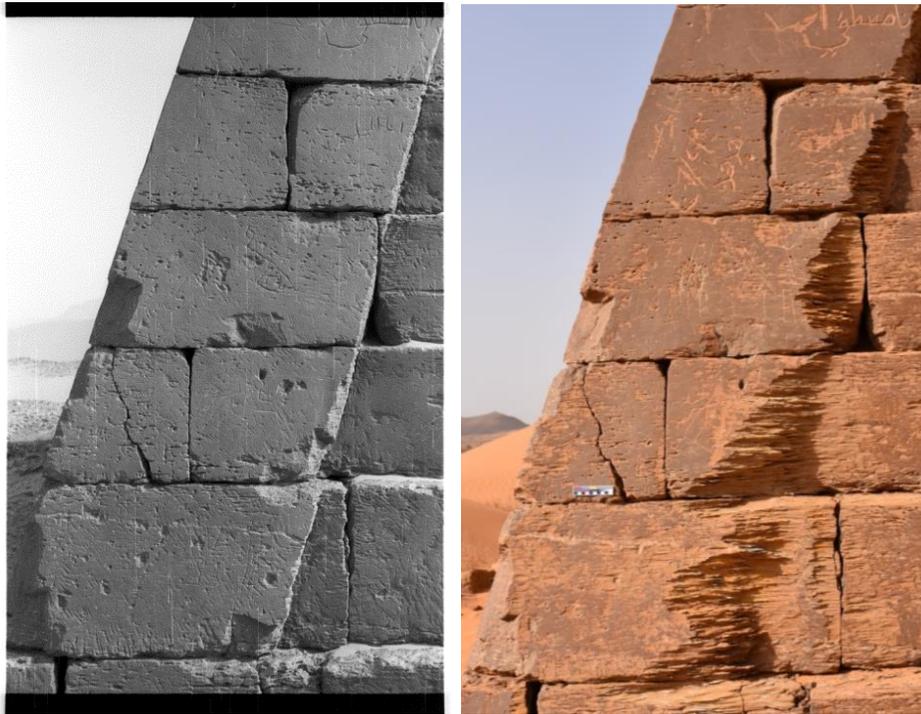
The sand stone of the pyramids at Meroe is soft and delicate kind of stone. Therefore, signs of degradation caused by natural impact can easily be traced. Sand erosion is the major problem and

it cannot be solved by conservation only. Small animals and insects are also causing problems by living in these stones and digging small holes.

Sand erosion 1985 left and 2015 right

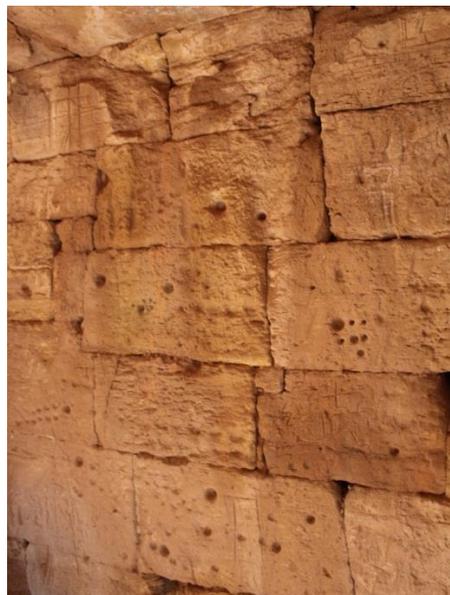
Holes in the wall made by small insects

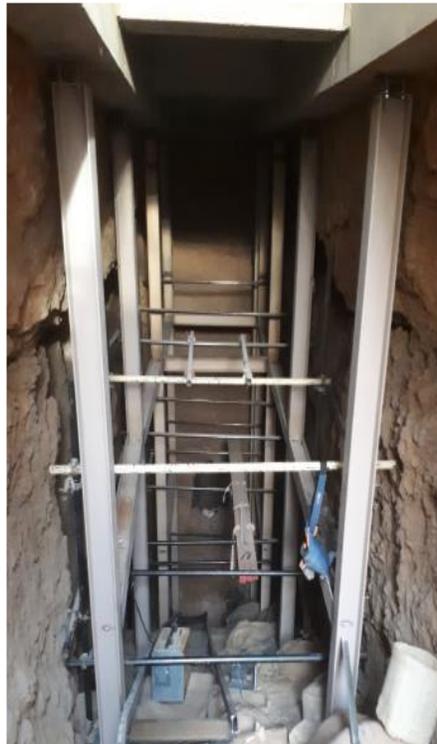
All parts of the site which witness conservation work during the years of the project are in good condition, but the unfinished conservation work at the reopened burial chambers has become one of the threats, because for example in Pyramid Beg. N. 9 the metal props used for security measures are corroded as a result of humidity and rain water penetration.

Unfinished conservation work

Concerning the site current condition there is a need for urgent conservation work following the conservation concept developed by QMPS. This work should concentrate at least on finishing work at Beg. N 9, Beg. N 12 and Beg. N 13.

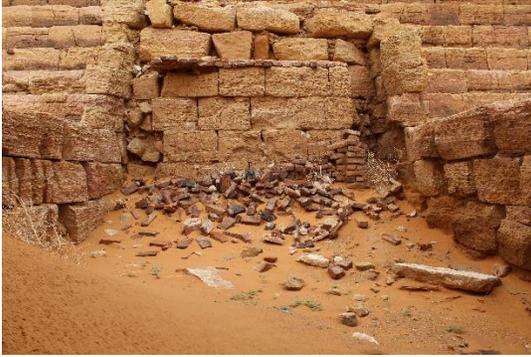
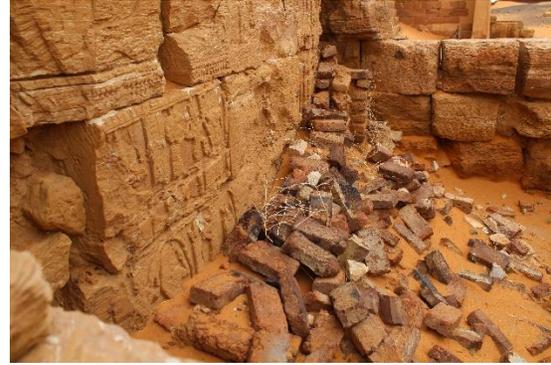
Also the rescuing of some well-preserved chapel reliefs by applying tissue paper (so-called ‘Japan paper’) and protecting them by a brick wall it didn’t survive after the heavy rain of last year. It was kind of temporary treatment need to be followed by actual conservation work, but because of the postponement of the projects this is not happening. So, some conservation work is dramatically converted to real threat to the monuments.

Protection by a brick wall

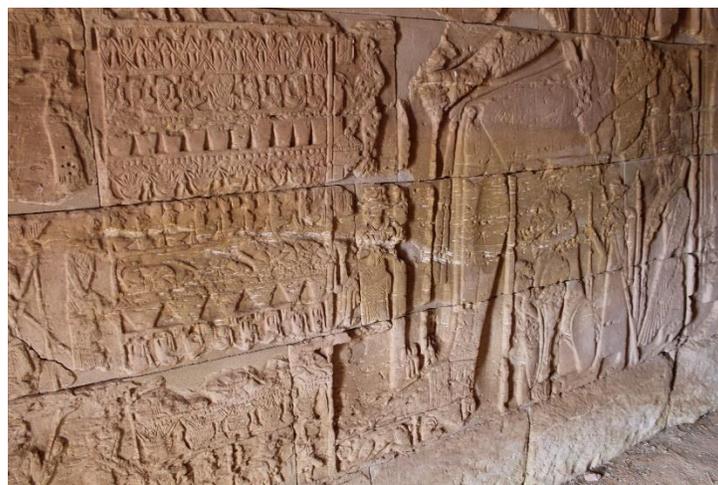
The potential impact of identified risks can be seen in the sand surrounding chapels that kept humidity and rain water penetrate through chapels walls from outside to inside chapels. However, it is important to note that, the walls of the pyramid chapels were often decorated with striking reliefs. On the inner walls the majority here of illustrate funerary scenes. On the outside the remaining pylons are often adorned with relief decorations, showing for instance motifs of the king and queen defeating their enemies. Additional graffiti can be found all over the chapel as well as the pyramid walls dating from ancient Meroitic times to early and contemporary visitors.

Decorated chapel

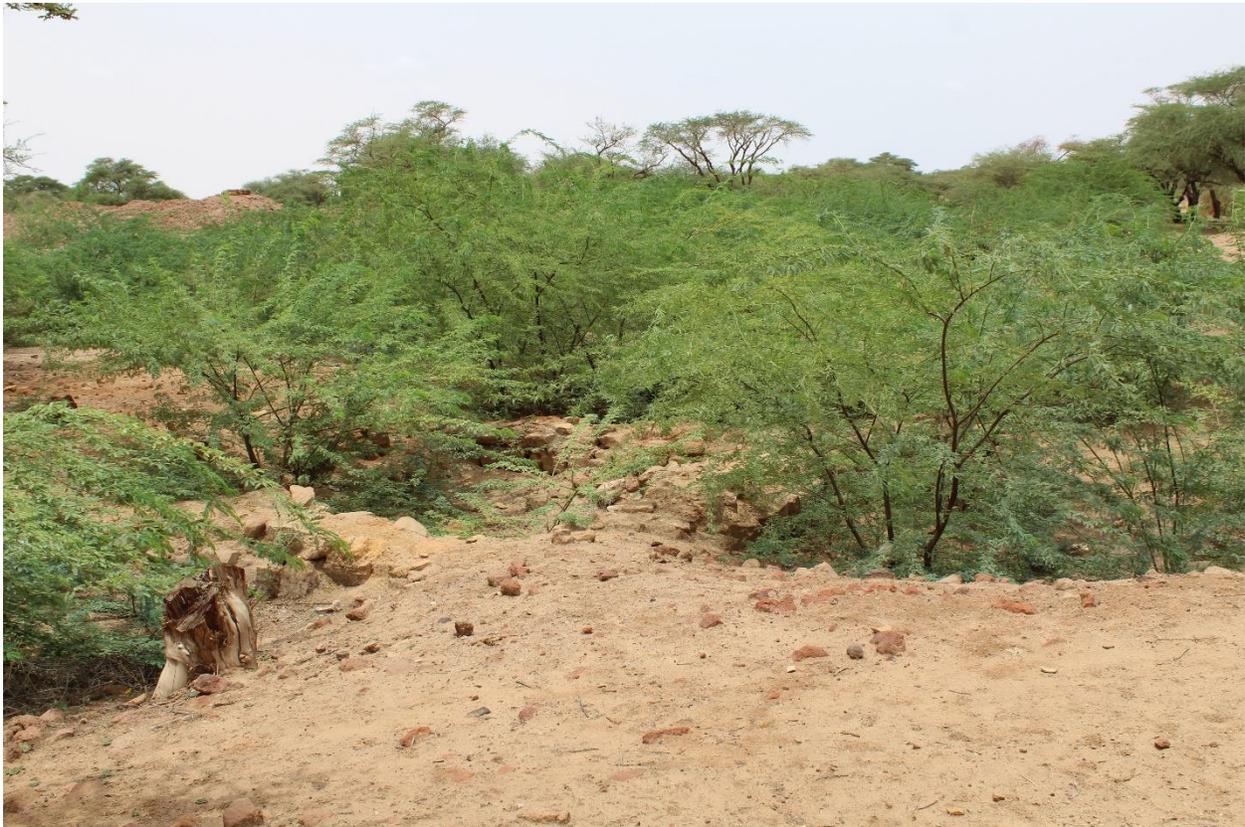
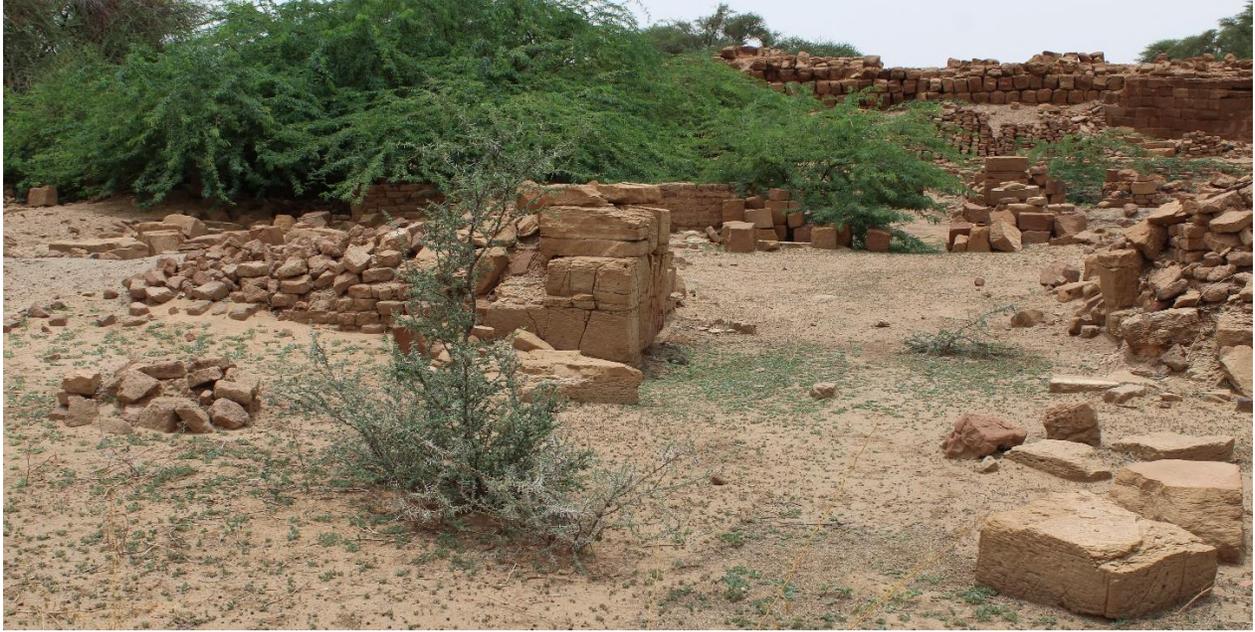
Natural elements such as rain have impacted the site conservation condition at Meroe Royal City. The last rain season was considered the heaviest during decades. The result of rain could be seen in the growing of vegetation all over the site and its monuments. Temples and palaces walls are now covered with trees, which considered clear threats to the monuments.

The absence of a drainage system at Meroe Royal City is one of the major problems, which cost direct threats to the monuments and result growing of uncontrolled trees. That can be seen in Amun temple and in other buildings. Also during our recent inspection we have noticed newly broken stone, it is one of alters at the sanctuary of Amun temple.

Uncontrolled vegetation

The newly grown vegetation at the site is considered direct threats to the monuments, therefore conducting rescue campaign aiming to cut properly all trees over and around temples and palace is highly recommended urgently.

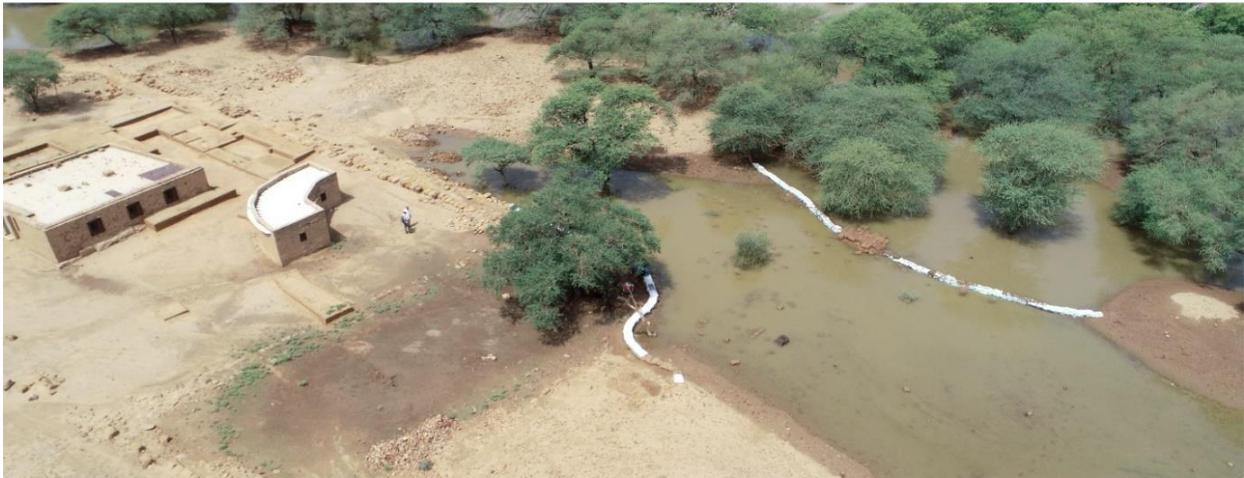
Nile flood is one of the contentious risk to the site. The flood of the Nile in 2020 reached record level and caused dramatic threats to some of the ancient buildings at Meroe Royal City. To stop strongly the threat, a dyke was built on the western side of the royal city to prevent any incursion of the Nile. The protection operations conducted at the site aimed to prevent the water to enter inside the archaeological area.

Nile Flood in 2020

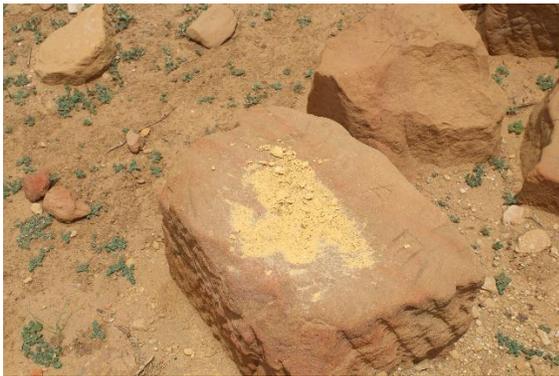
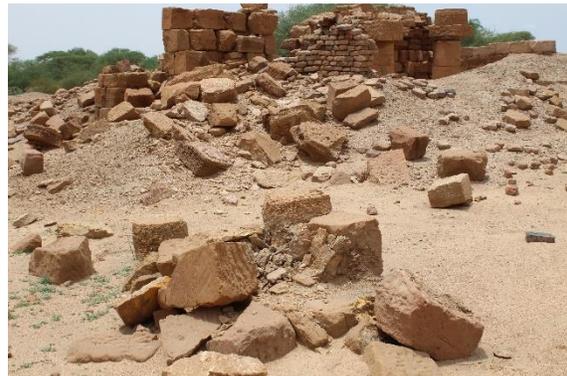
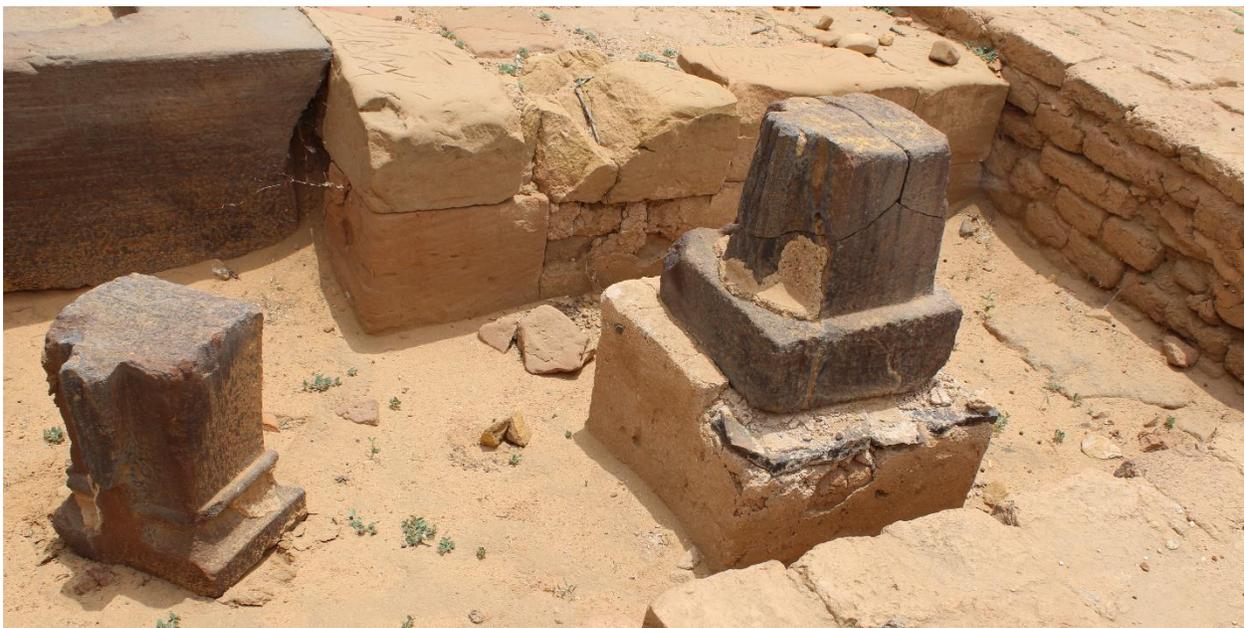
At the royal city of Meroe, the Amun Temple in particular is in a very poor state and requires immediate attention in terms of consolidation, presentation and visitor management. The Amun temple is exposed to the greatest traffic from visitors. The site is nowadays a destination for uncontrolled visitors from surrounding villages that have been overpopulated after the war by displacement from Khartoum state and yet there is completely no interpretation or presentation of the heritage and how to go around it. The result is that people just move all over including on delicate walls, and this is the greatest threat to the monuments. Due to the trotting of both humans and domestic animals on the site, and the mass continuous excavations the state of conservation is precarious with walls chipping off and loose grounds and archaeological material washing away.

Newly broken stone blocks and the alter at Amun Temple

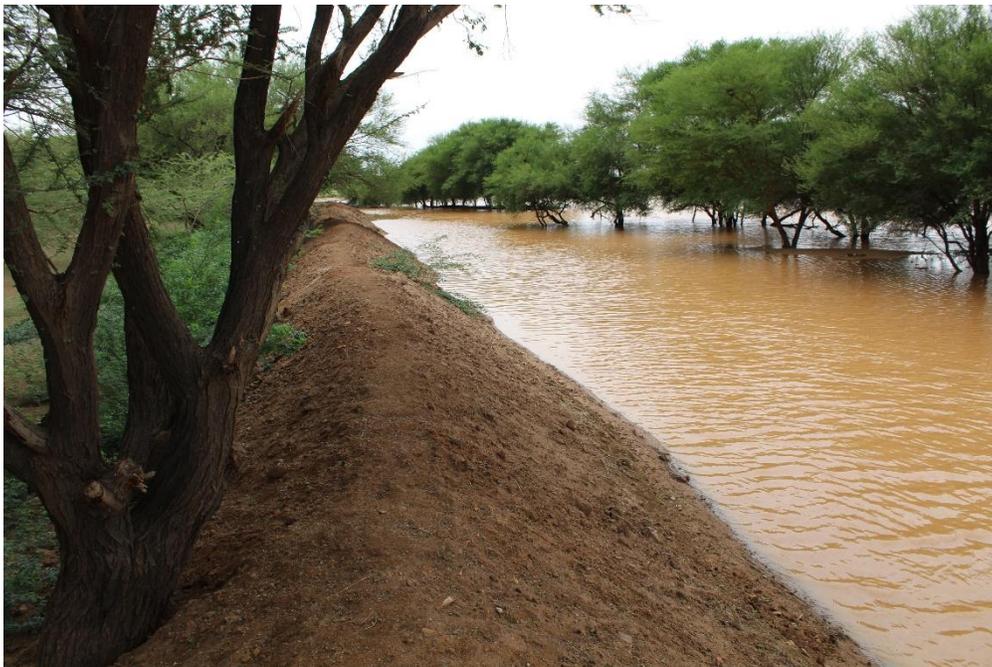
In addition, and after the recent visit to evaluate the indirect impacts of Sudan war on the site we noticed that, the earthen dyke made to protect the site from the Nile flood is in poor condition, and it will not protect the site properly. The dyke is broken in many parts because of the movement of animals passing over it, and also because of a negative attitude of locals by making use of the materials we used for the dyke, such as bags and building materials for their own needs.

The earthen dyke protecting the site from flash floods

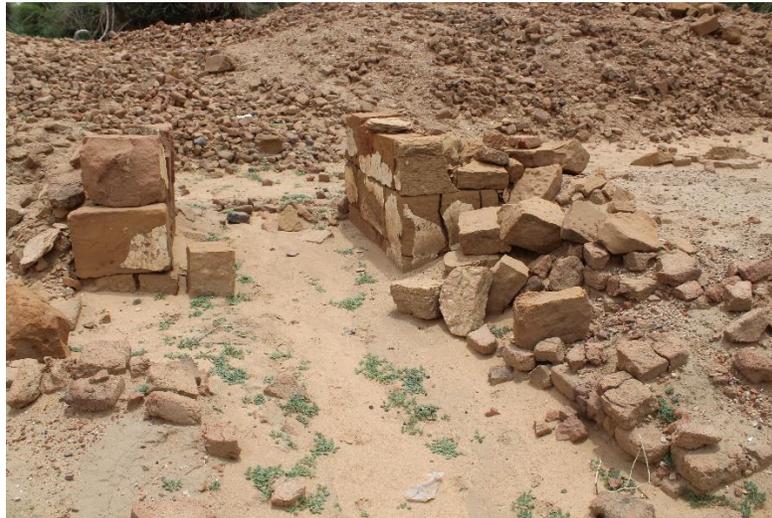
degradation is clear and the impact of erosion and destruction can be seen all over the site with no exception.

Construction materials condition

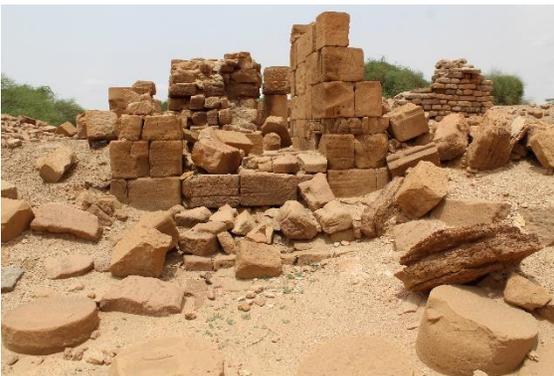
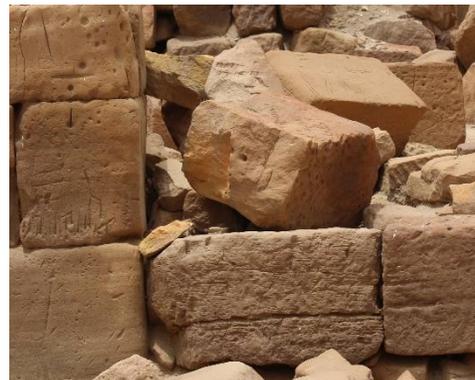
Augustus Temple (M 292):

This building is attracts particular attention because some parts of it are still standing. Also because of its historical importance as constructed to the god of victory, and the head of the Roman emperor Augustus was buried there. Current condition of this building is alarming and we witnessed recent collapse of some stones of the building, and clear damages in the standing walls and columns of the temple. Therefore, urgent comprehensive work combining excavations and conservation work in highly recommended.

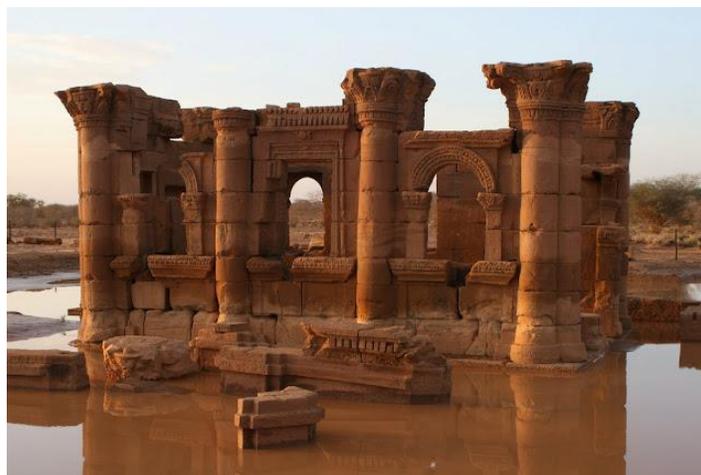
The site at Naga is located in an area normally receives heavy rain during summer. So, the rain water has a direct impact on the site and its monuments. Also, flash floods are one of the major threats to the site especially the area of the Lion Temple and the Roman Kiosk. The low area around these temples allow water from the wadi to enter and stuck around these monuments every year. This fact has a direct impact on the preservation of these buildings.

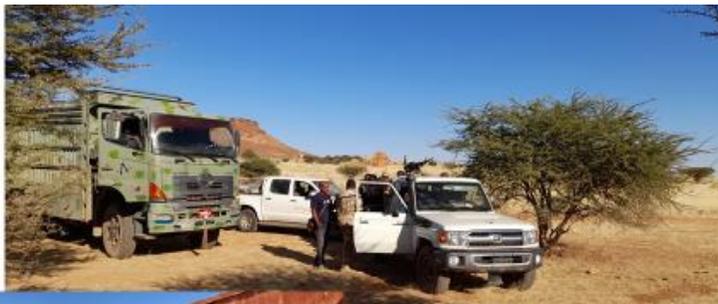
**Visiting Naga
3 December
2024**

Unfortunately the mission house was badly plundered. In fact, the house includes stores for archaeological materials and objects recovered during field work of almost the last twenty years. We have compared what is there now in the store rooms with the lists of stored materials at the house provided by the mission, and we can confirm missing of number of objects. This looting is associated with the presence of RSF at the site in January 2024.

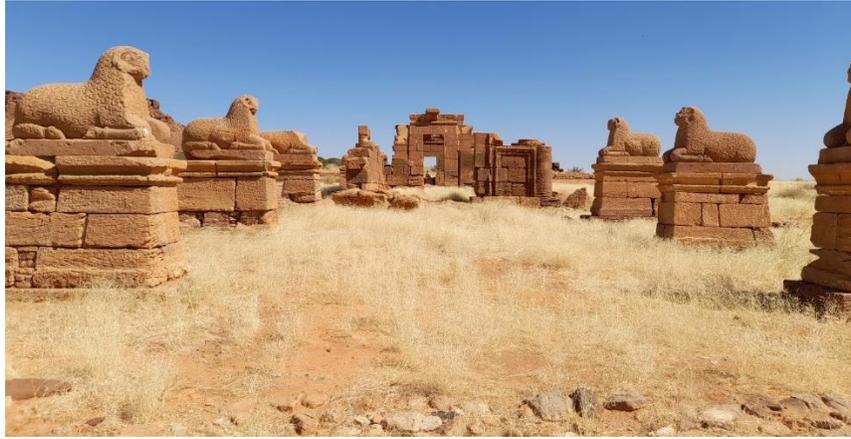
In the 3rd of December 2024, a team from the Regional Antiquities Office accompanied by military armed forces visited Naga. We have informed that we have a limited time to be at the site; therefore, we made a quick tour to the Lion temple and Amon temple and all monuments at the site and we can confirm that there is no clear damage on the walls of the temples or the inscriptions decorating these walls and the site is in a good condition.

Recent Photo Amun Temple at Naga 3rd December 2024

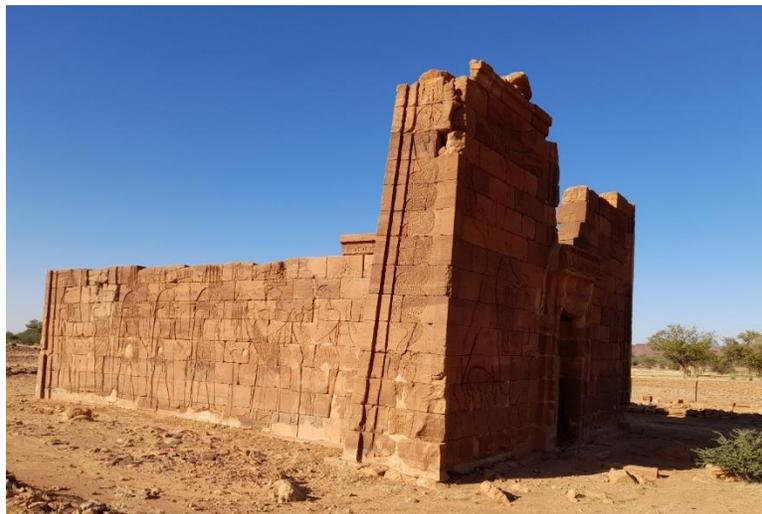
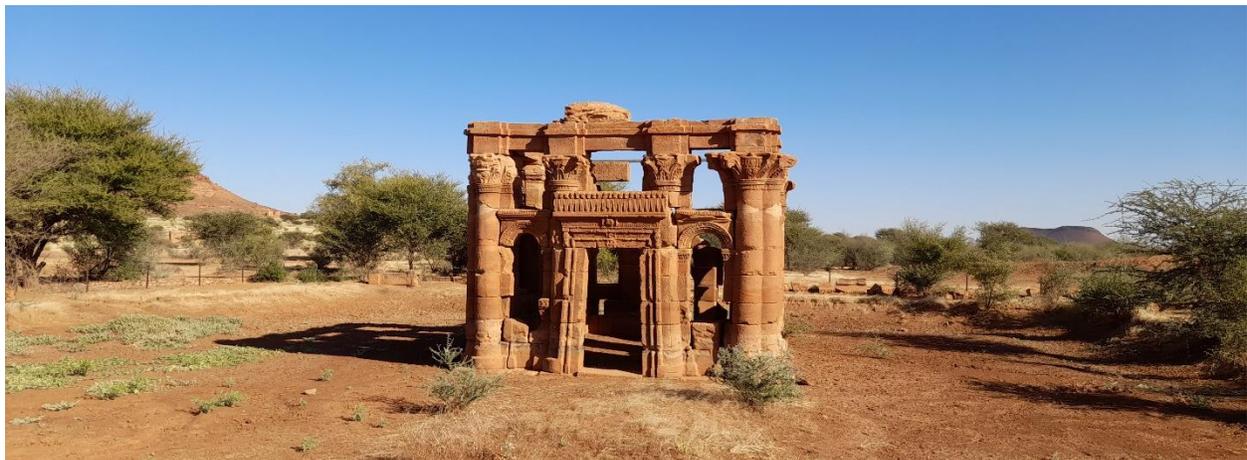
Recent Photo Lion Temple and Hathor Chapel at Naga 3rd December 2024

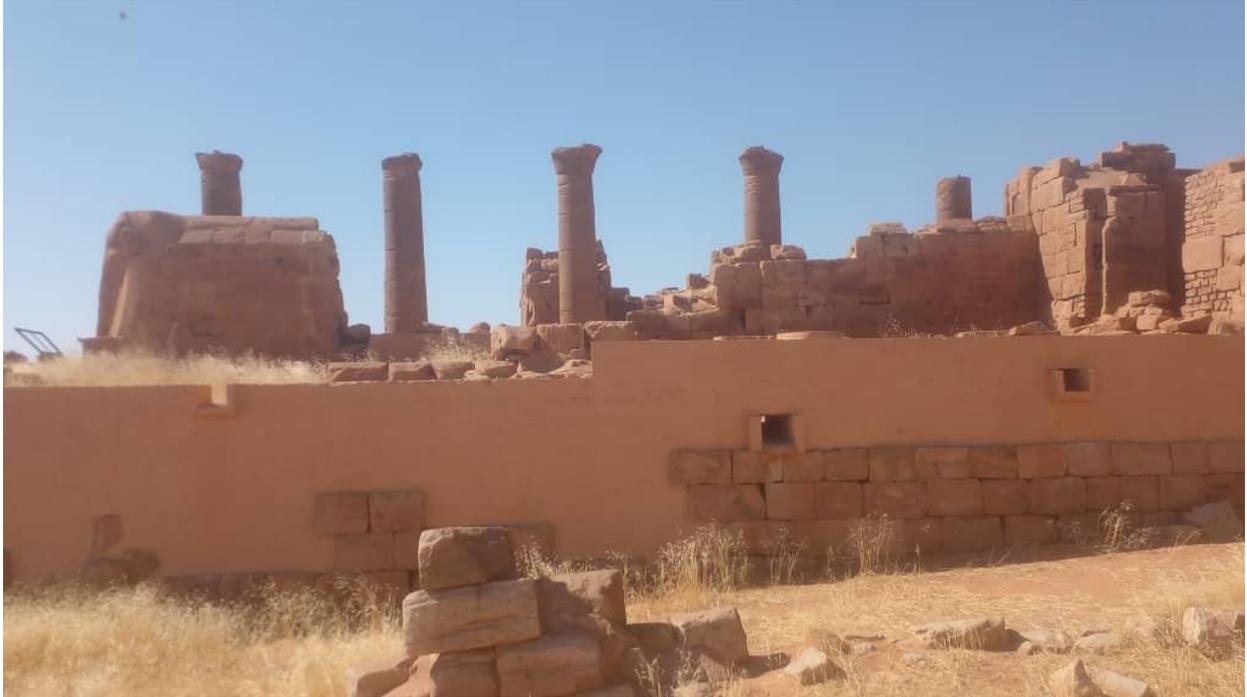
Heavy rains and storms during the 2023 rainy season have caused substantial damage to parts of the archaeological site of Musawwarat es-Sufra and its protective and visitor installations, such as fences. Further risk could be seen in the walls of the Great Enclosure, which are being eroded by rain water entering and washing out their fill. Such measures need to be addressed in the near future.
