REPORT
of the joint World Heritage Centre/ICOMOS/ICCROM
Reactive Monitoring mission
to the World Heritage property 'Gelati Monastery' (Georgia)
23-27 September 2024

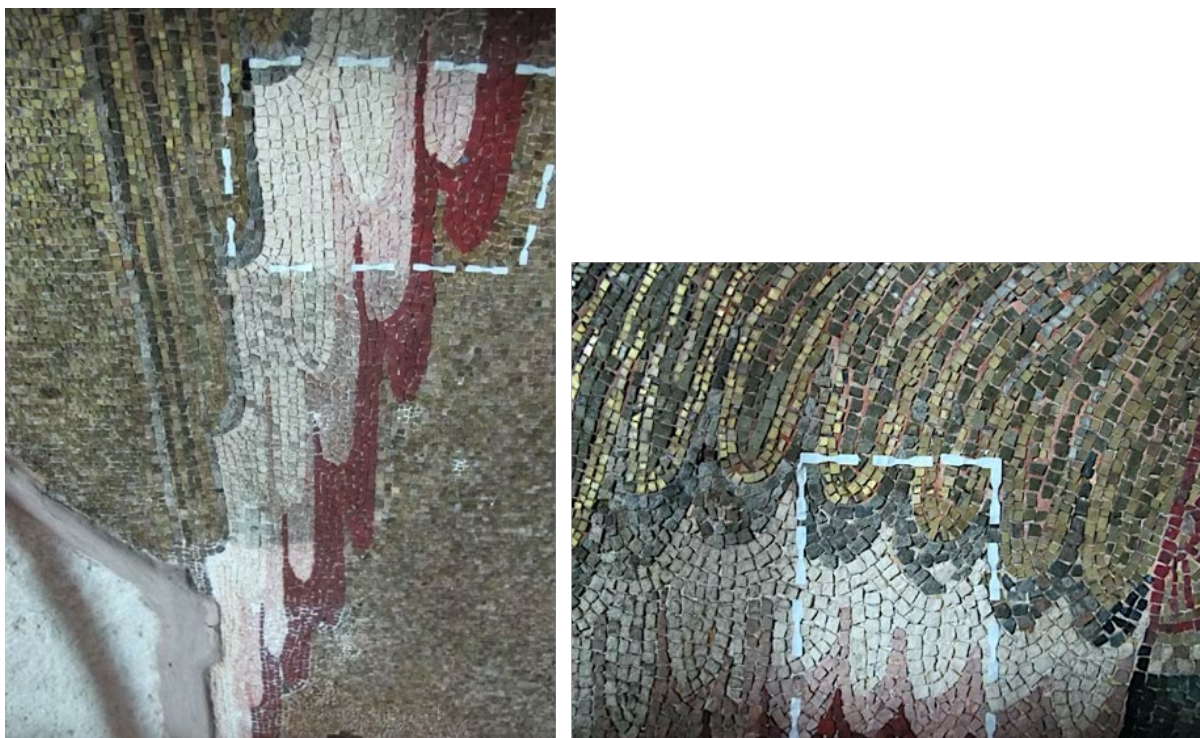
Fig. 10, 11. Cleaning tests (from R. Nardi - Interim Report, 24 July 2024)
