WHC-99/CONF.209/INF.17B

Paris, 22 November 1999

**Information Document: Findings of the World Heritage Centre mission in October 1999 on the state of conservation of Kathmandu Valley World Heritage site, Nepal, responding to questions raised by the World Heritage Committee in previous sessions.**

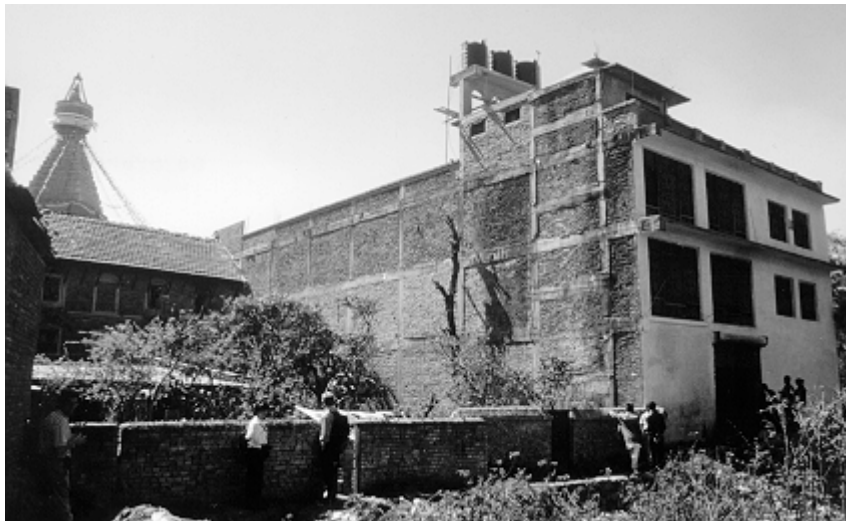
(Left top) Façade of traditional buildings facing the Bauddhanath stupa, at the time of inscription. Photo taken in 1970's. The centre building was illegally demolished in 1998.

(Left bottom) This illegal demolition was followed by new construction with illegal elevation and rear extension, blocking the view of the stupa. Photo taken in March 1998.

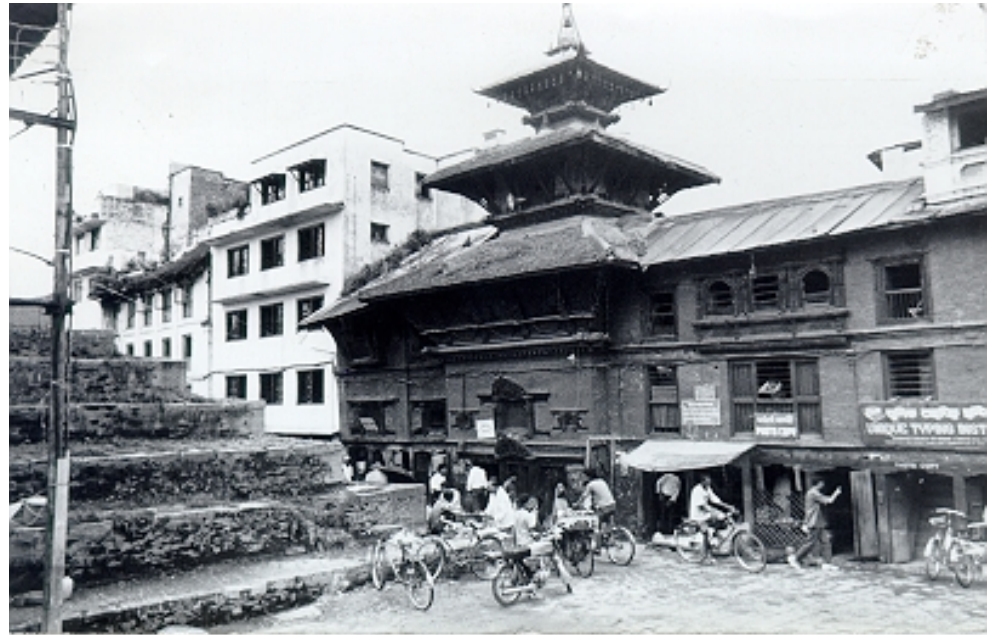
In October 1999, the Secretariat noted the demolition of the flanking wing of Joshi Agamche, a fine traditional building recommended in 1998 by ICOMOS to be restored *in-situ*.

(Right) 1994 photo of Joshi Agamche, showing exceptional wood-carved windows on both flanking wings.

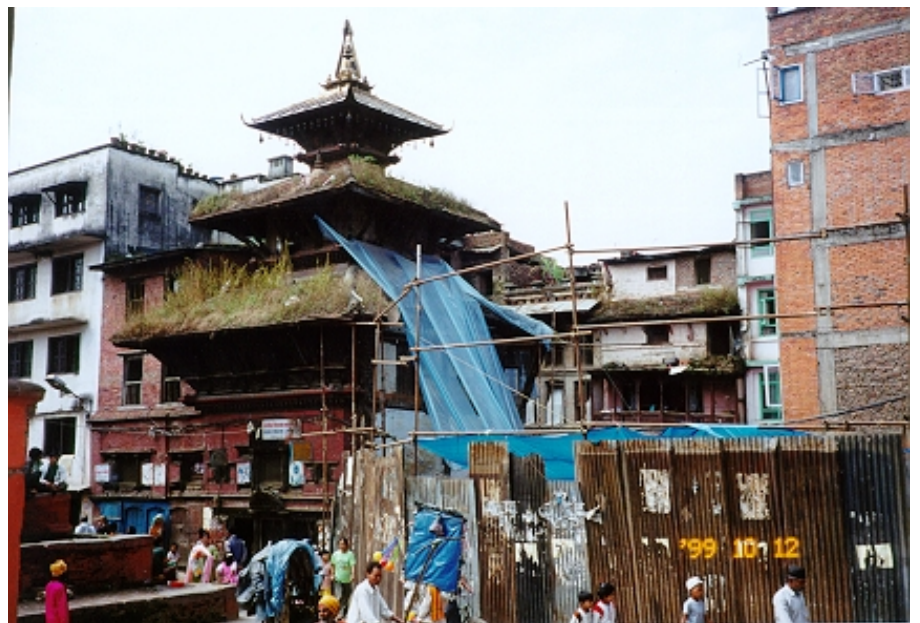
(Right) 1999 photo of Joshi Agamche, showing replacement of exceptional window by modern floors for smaller flanking wing, and complete demolition of other flanking wing. In October 1999, UNESCO witnessed construction of new concrete-frame building with new wood carvings.

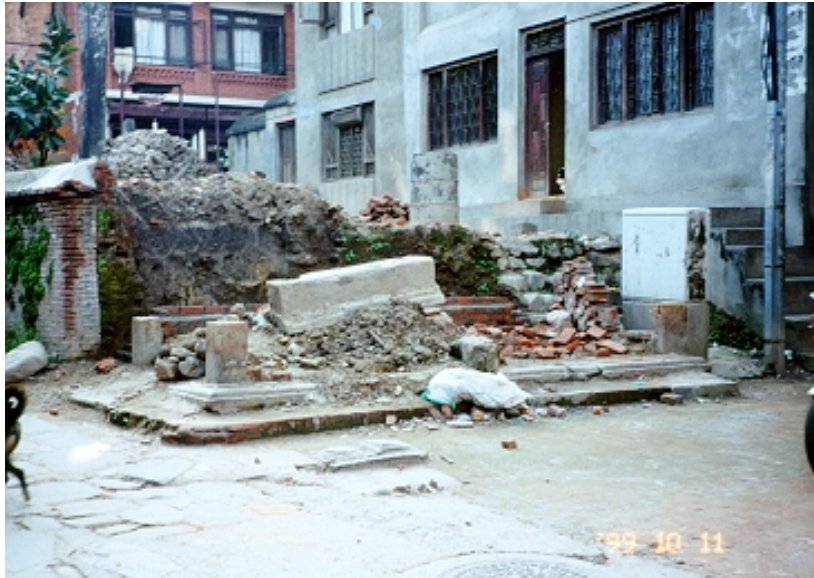
(Below) Demolition site of a “pati”, (a traditional public rest-house) where new cement and brick walls were being constructed in October 1999.

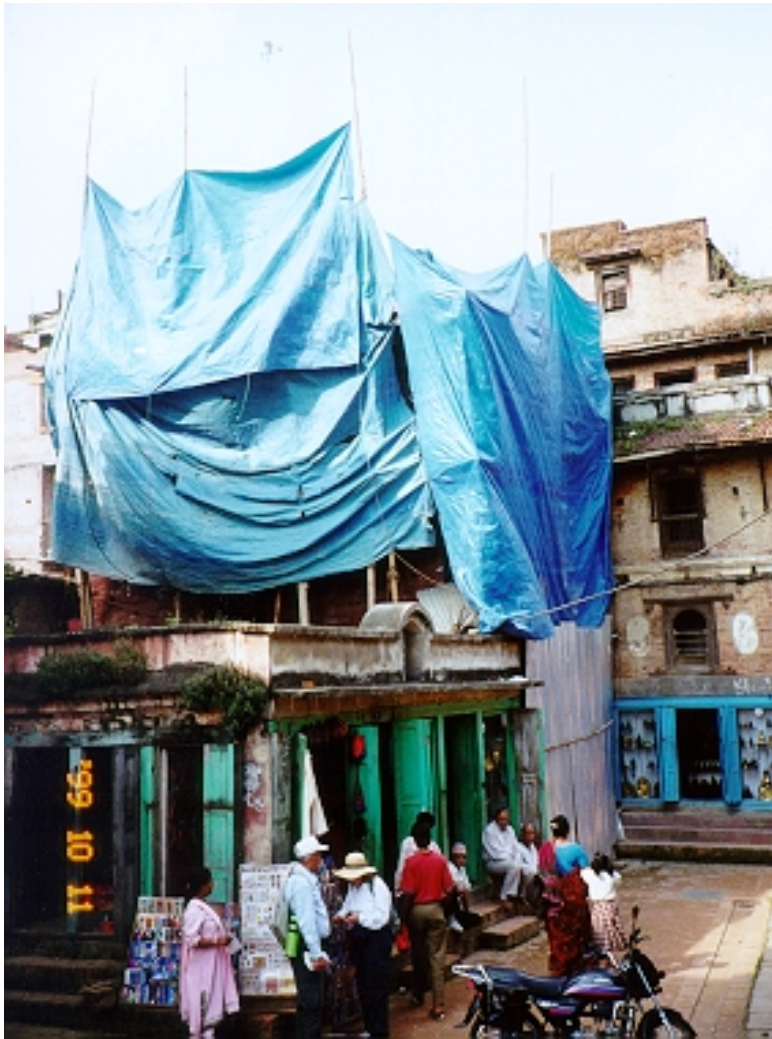
(Left) Demolition and new construction site of a house facing Patan Darbar Square, which ICOMOS had recommended restoration *in-situ* in 1998.

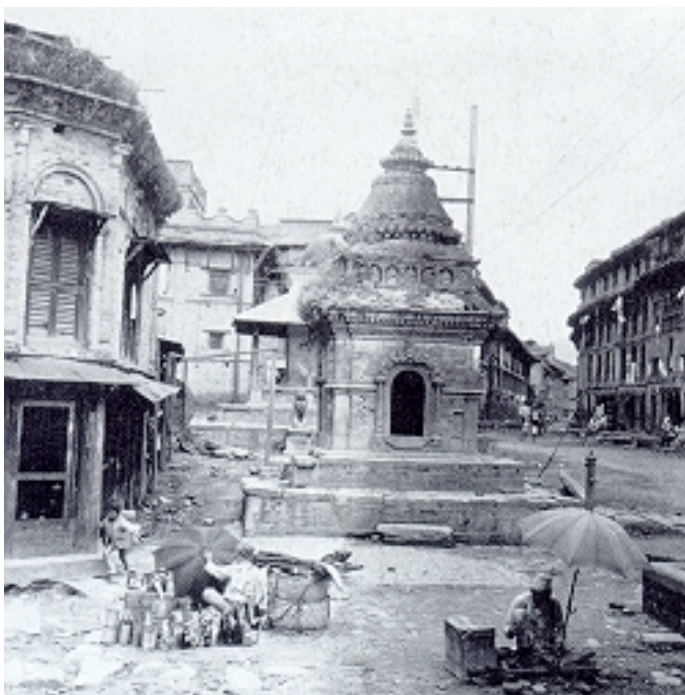
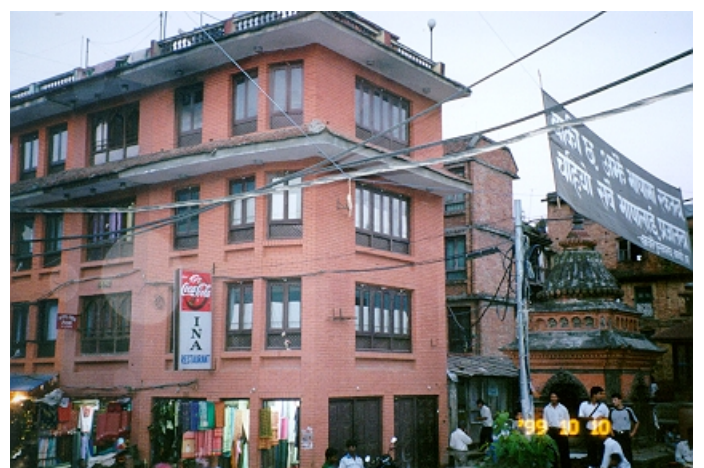
(Below left) Photo showing fine curved corner house next to Naksmi Narayan Temple, Patan, from 1979 nomination form. (Below right) Photo showing new house at same location, which replaced original traditional building in 1996.

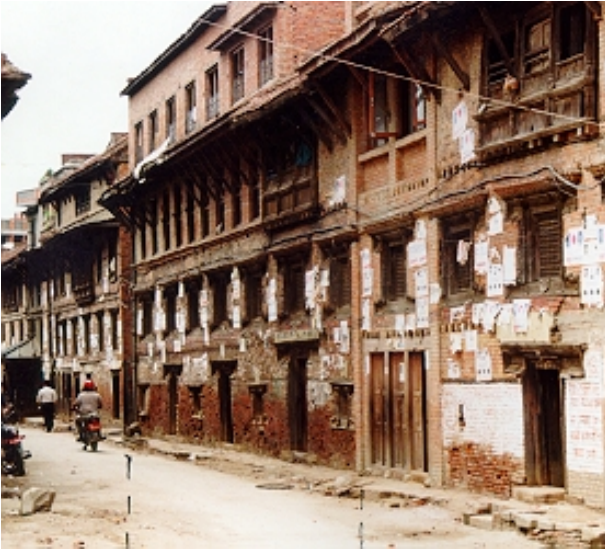
(Below left) The ground floor of a fine traditional building in Patan was replaced in 1998 with a concrete framed ground floor (below right), with modern openings. 4 traditional windows have disappeared.

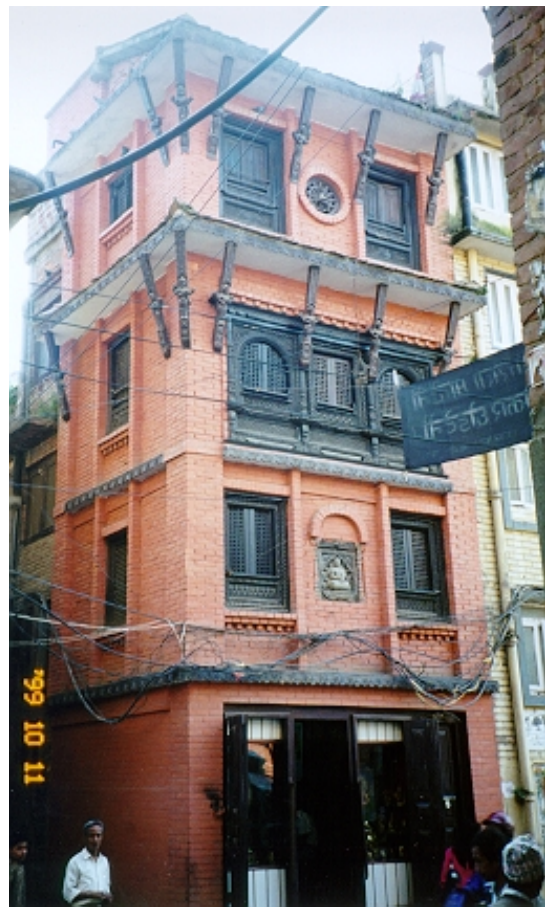
(Right) New building which replaced traditional house in Patan. This new concrete building, whose design was approved by the authorities, has false struts and old wood-carved windows fitted into a new modern design building.

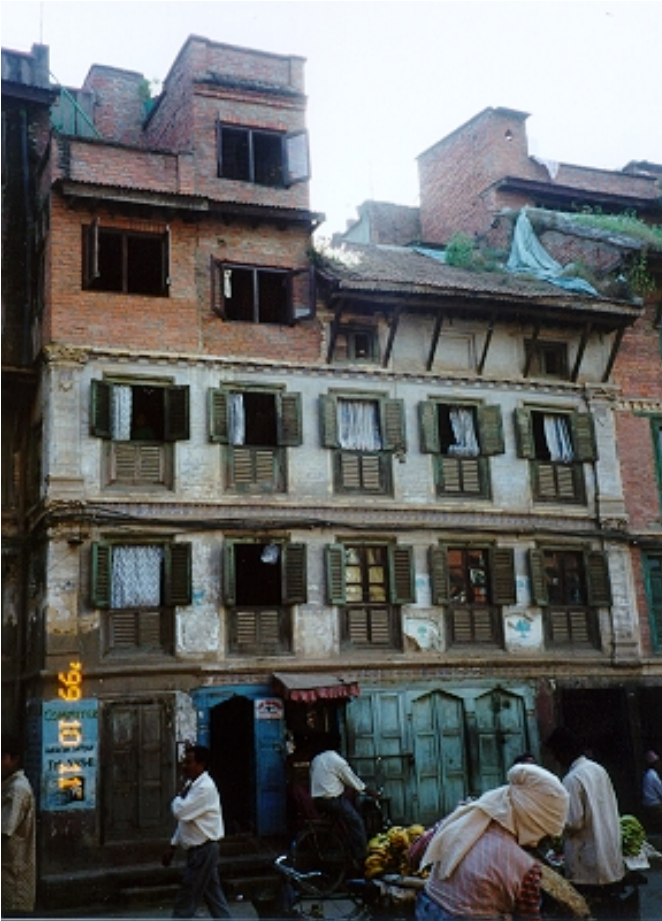
(Above) Two new floors were added in March 1999 after partial demolition of the original sloped roof.

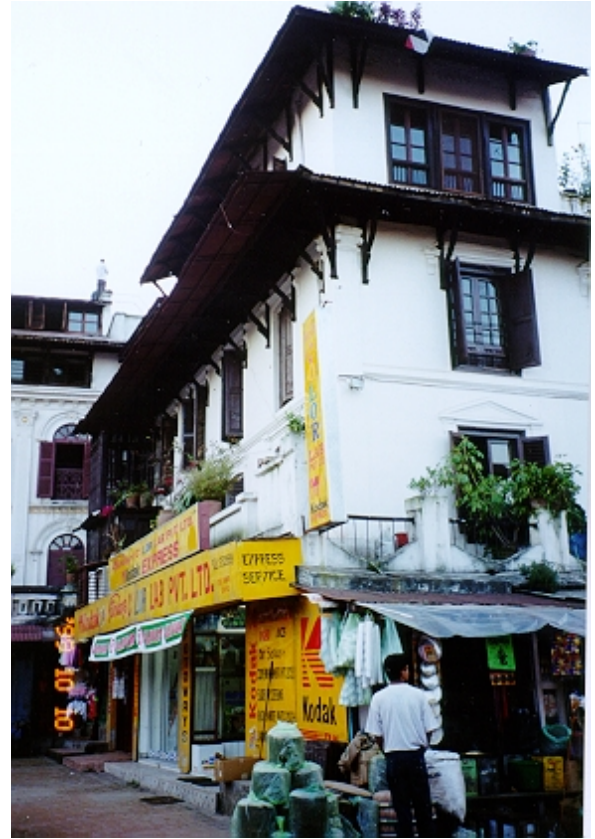
(Above) In October 1998, the original wooden shutters of this building, facing the Patan Darbar Square, were widened and replaced with metal shutters. Simultaneously, the entire ground floor was covered with inappropriate large bright advertisement which is illegal within the protected Monument Zones.

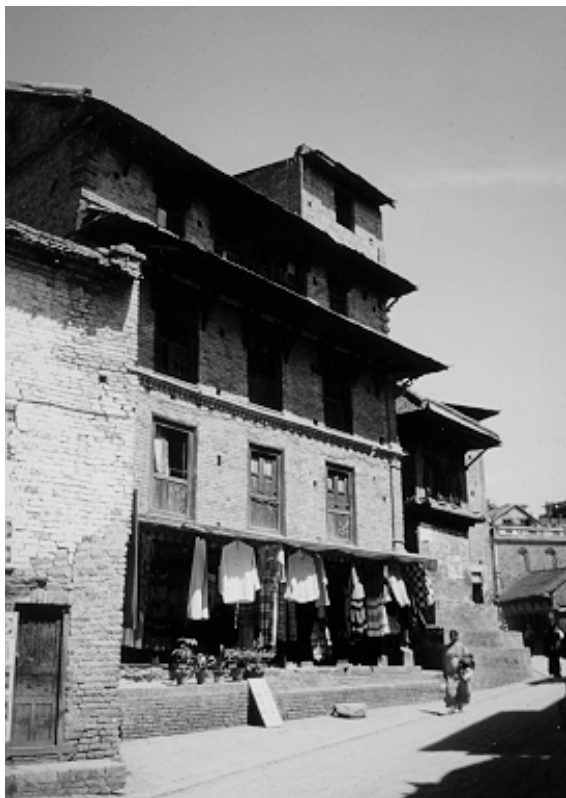
(Above) Original Rana period building in 1998 before demolition.  
(Ci-dessus) Bâtiment d'origine de la période Rana avant démolition en 1998.

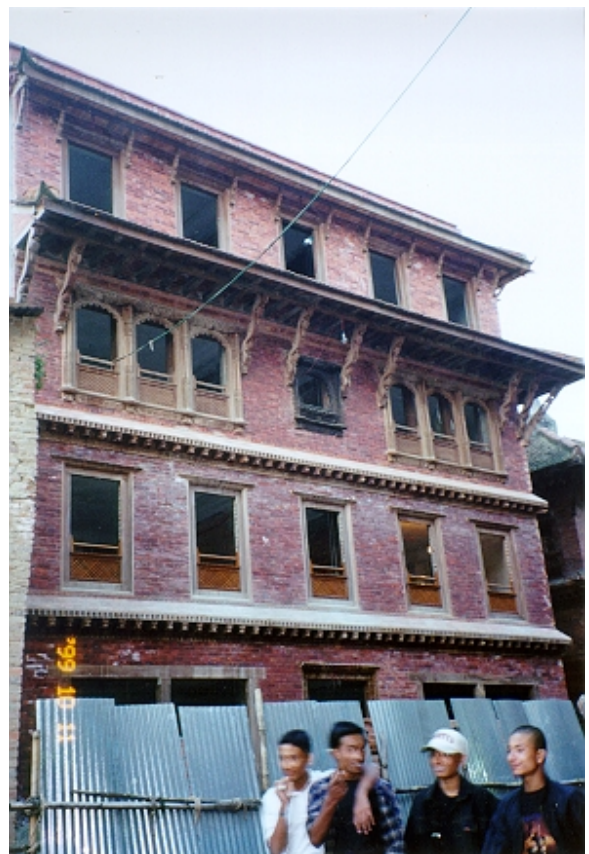
(Above) New concrete frame building completed in October 1999.  
(Ci-dessus) Nouveau bâtiment à armature en béton achevé en octobre 1999.
