**WORLD HERITAGE LIST: REACTIVE MONITORING MISSION  
TO KILWA KISIWANI  
AND SONGO MNARA  
IN THE REPUBLIC OF TANZANIA, EAST AFRICA**

**Report of the ICOMOS Mission, 23-27 February 2004**

**Dr George H.O. Abungu**  
Heritage Consultant,  
Okello Abungu Heritage Consultants

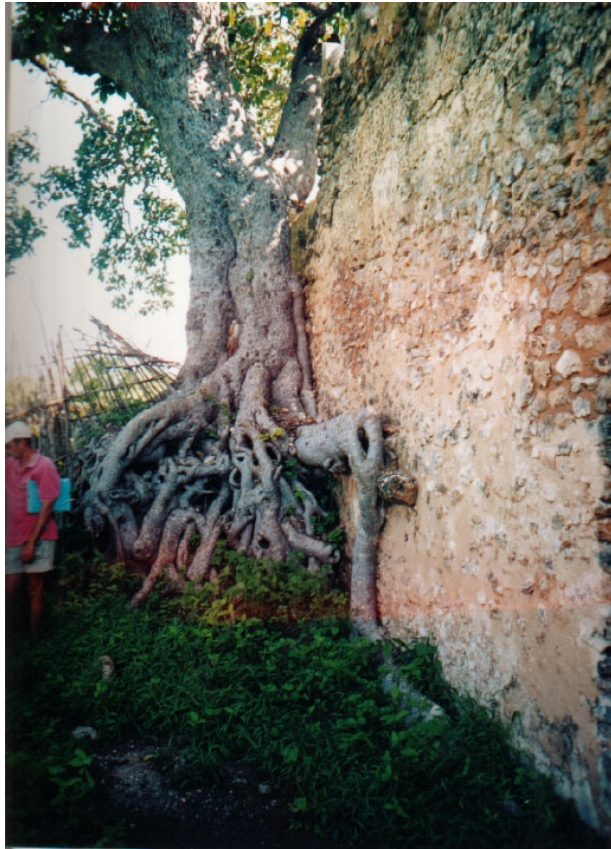
Fig I: A tree growing on a wall at Kilwa

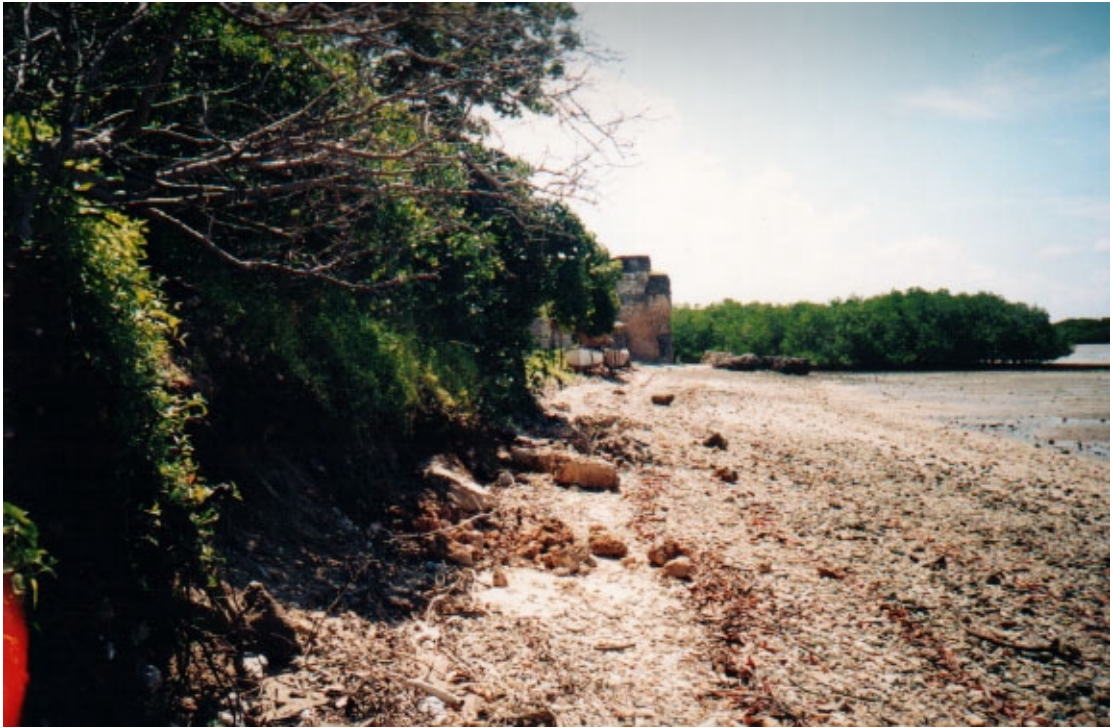
As noted above, the beach has continued to be eroded on a daily basis, removing wall foundations and large amounts of material. The small Malindi mosque by the beach, not far away from the Fort, Gereza, is threatened by active erosion, which has taken quite a portion. There is a need for a sea wall, similar to some found in Swahili towns such as Lamu.

Fig IIIa: Beach erosion at Kilwa

2. The erosion that currently takes place along the beach at Kilwa Kisiwani is of great concern. It does not only pose a danger to the Gereza but to the whole site. There are alternatives to solving this problem but the most obvious would be to construct a sea wall as those found in Lamu and Zanzibar. However, in doing this, there is a need for research to ensure that by putting up of the sea wall this will not lead to an erosion problem elsewhere in the island. The other alternative would be tide breakers in the form of large boulders put along the shore, like what is found on the pier at Robben Island. This however will not only be quite expensive but may change the cultural landscape/seascape of Kilwa, deforming its original look. Furthermore, the mangroves by Gereza should, as much as possible, be protected and if possible extended through continued growing. This will reduce the ferocity of the water but not completely stop the erosion of the

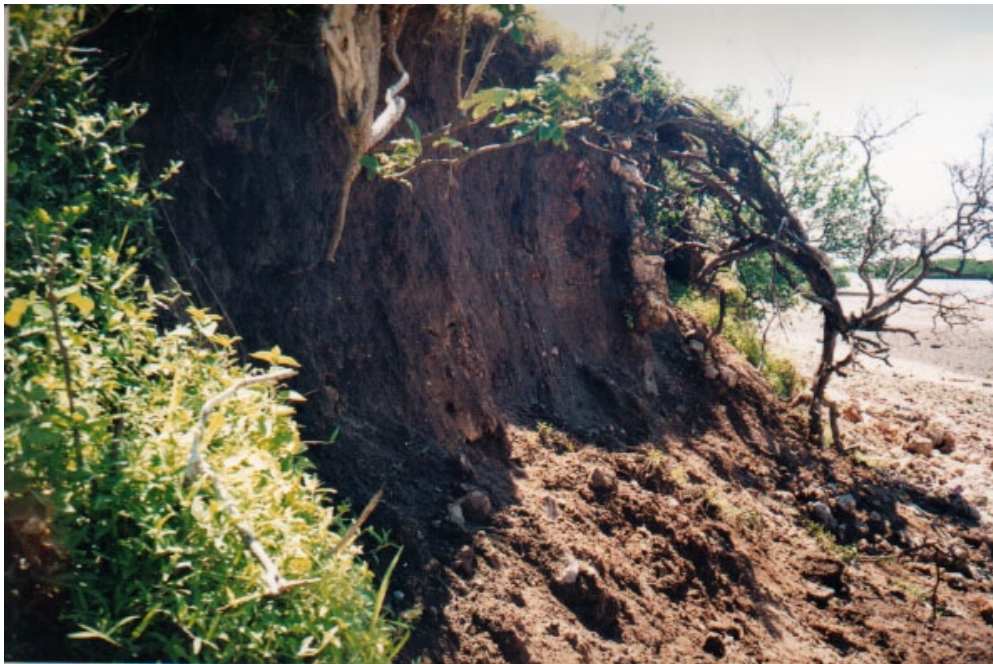
Fig III b: Beach erosion at Kilwa

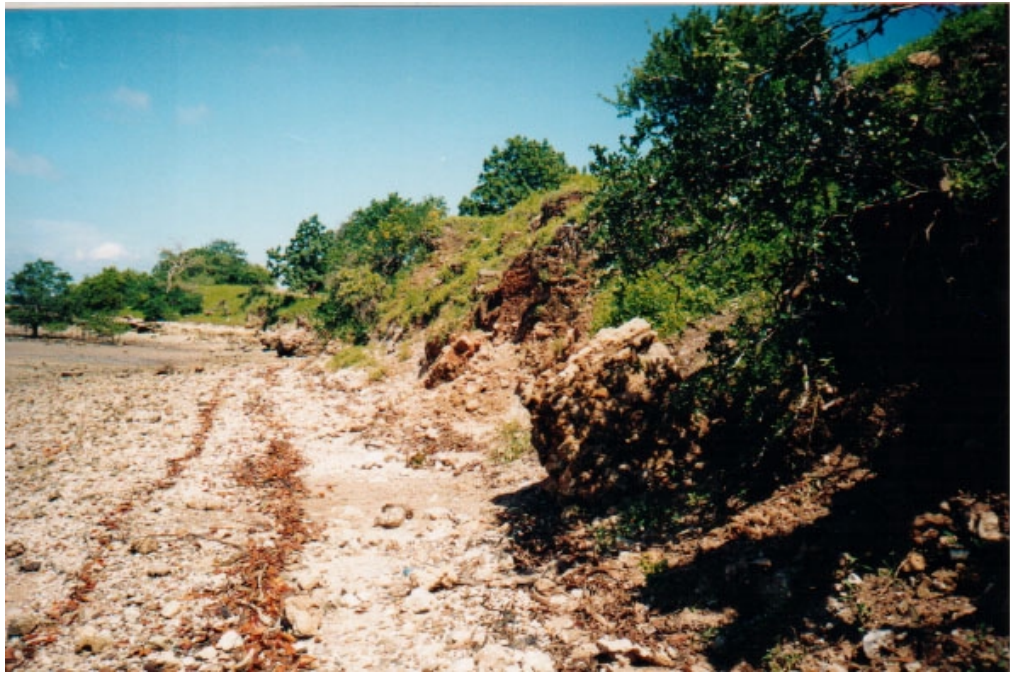
**Fig III c:** Pieces of Malindi Mosque by the beach

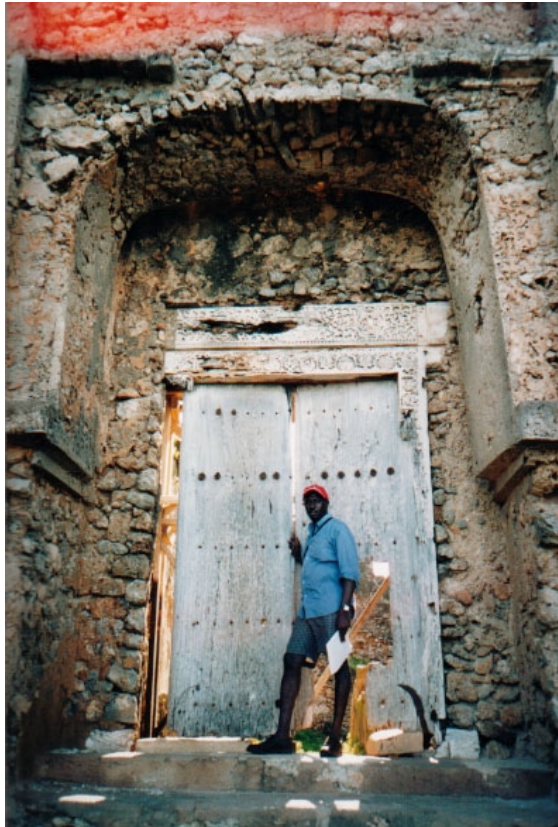
It is also important to note that the once beautiful wooden door on the main entrance is now 50% lost and requires urgent conservation work if the main parts are to be retained. It can also be said that although the sea erosion is a bit slow, this is unpredictable and any major rise in water level would cause serious damage.

Fig VI a: Gereza, wooden main door

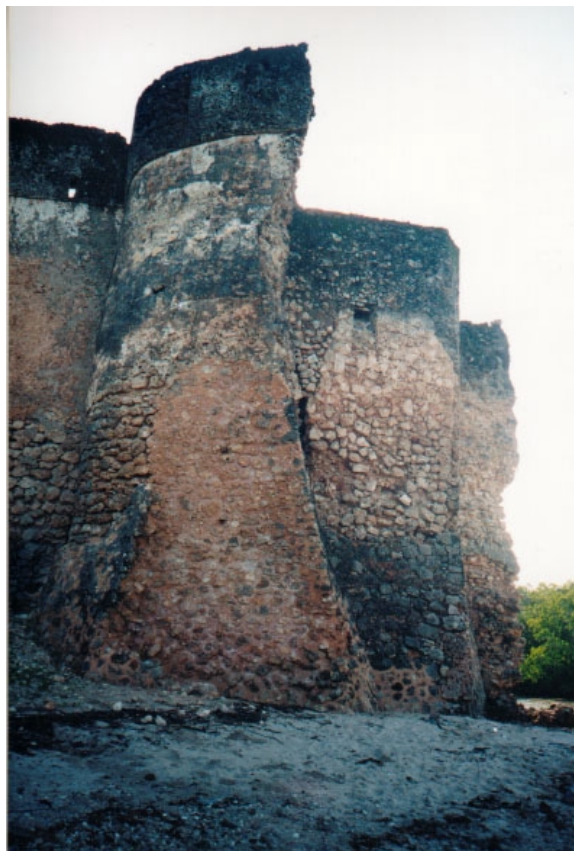
Currently, part of the fort is protected by the huge boulders that fell from the outer tower, added to the Portuguese one by the Omanis; they act as wave breakers. In addition, part of the southern part of the fort is protected by a line of mangroves that also serve the same purpose. This however is not a solution to the numerous problems befalling the structure and require urgent attention. The project noted by Bertolini in his report, which was supposed to be supported by Calouste Gulbenkian Foundation for the renovation of the Gereza, has not materialised and there is no indication that it will ever take off.

Fig VI b: Gereza, Outer Arab tower added to the Portuguese one

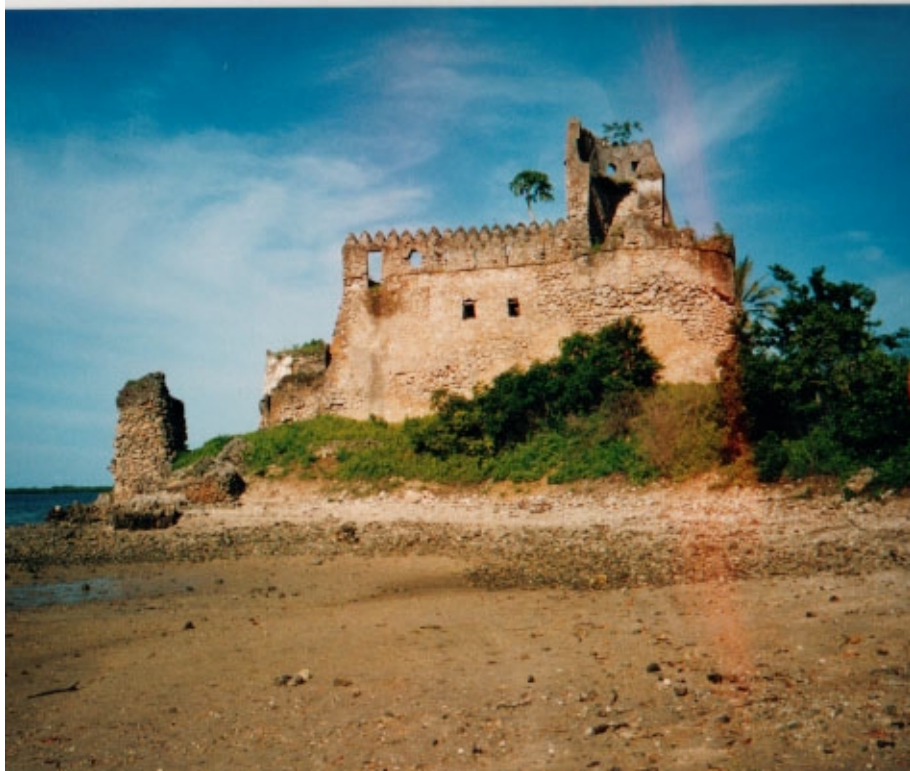
Gereza (Fort), while it has somehow has remained stable up to now, has portions of it within the high water mark. Both sea waves and the salt spray in the air are constantly causing damage to the fabric (See fig. VI).

The northern wall of the Fort has collapsed. The arch and the flat roof on the main entrance have also recently collapsed and many other portions may follow. Other walls that were observed show signs of large cracks and may soon collapse.

Fig VI c: The Gerezza, High water mark with collapsed northern wall

3. Gereza needs urgent attention addressing both the erosion threat as well as the collapsing building fabric. There is an urgent need to rehabilitate the building through a conservation strategy that will involve strengthening the structural integrity, addressing all the cracks and the collapsing roof portions as well as urgent conservation of the door. There is also need to address the material composition for restoration, particularly the lime. Already the plaster patchwork that had recently been done is already peeling off at a very fast rate. It appears that the lime used currently either has a lot of salt content and does not match with the existing fabric, or the combination of the lime and sand is not done in a proper way. However, the Zanzibar Stone Town Conservation Development Authority (STCDA) has done good work with lime-making and it may be important that they get involved in the project or asked for advice on the same.

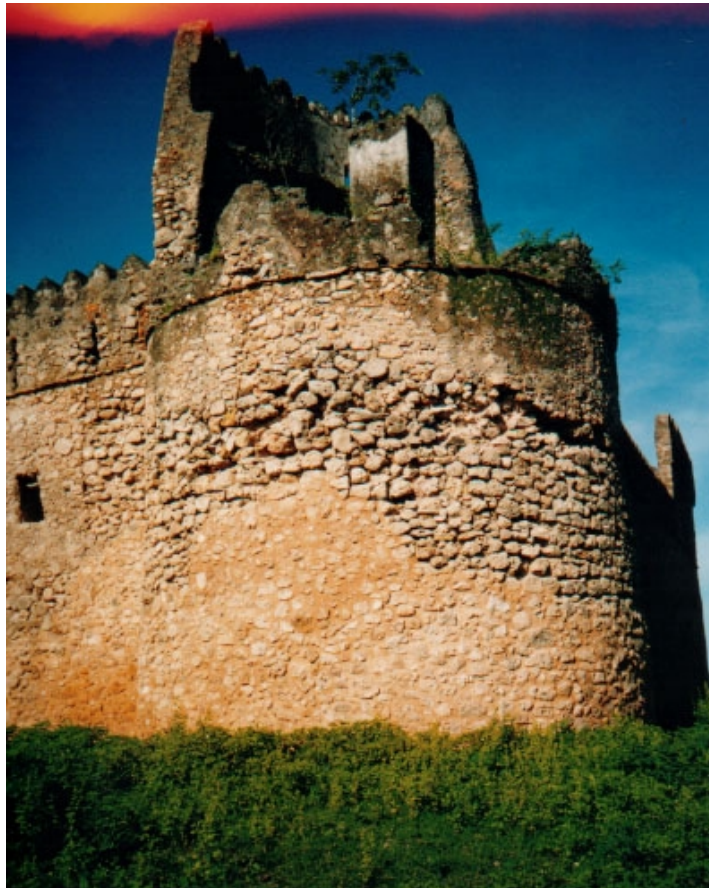
Fig VI d: Gerezza, Damage to wall fabric by weathering

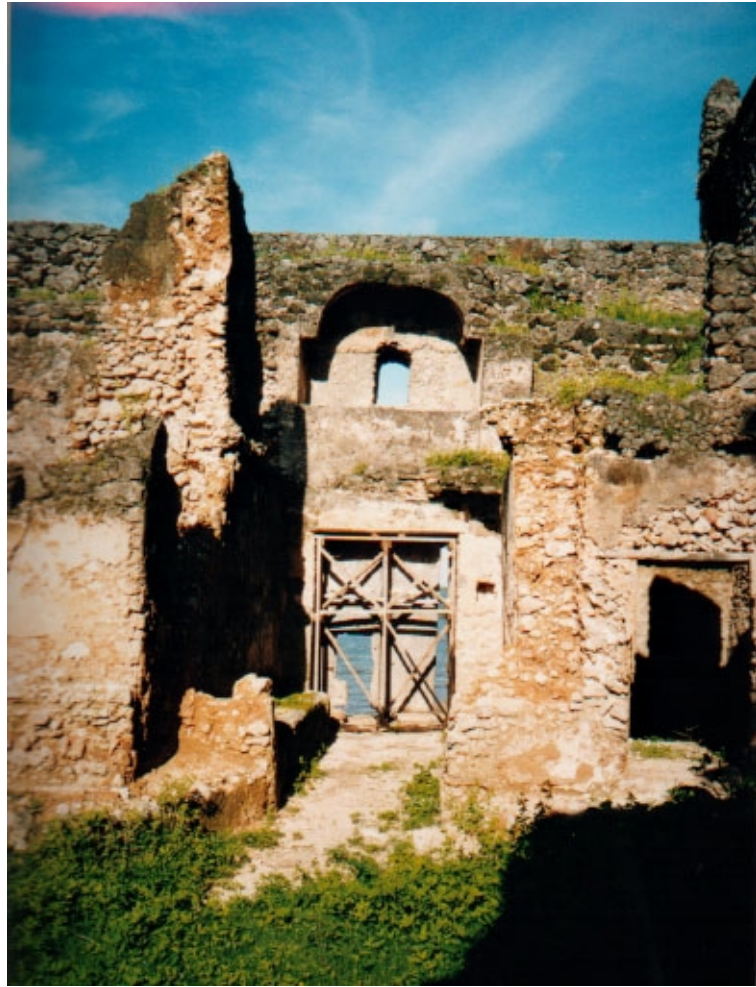
Fig VI e: Gerez, Collapsed arch and flat roof

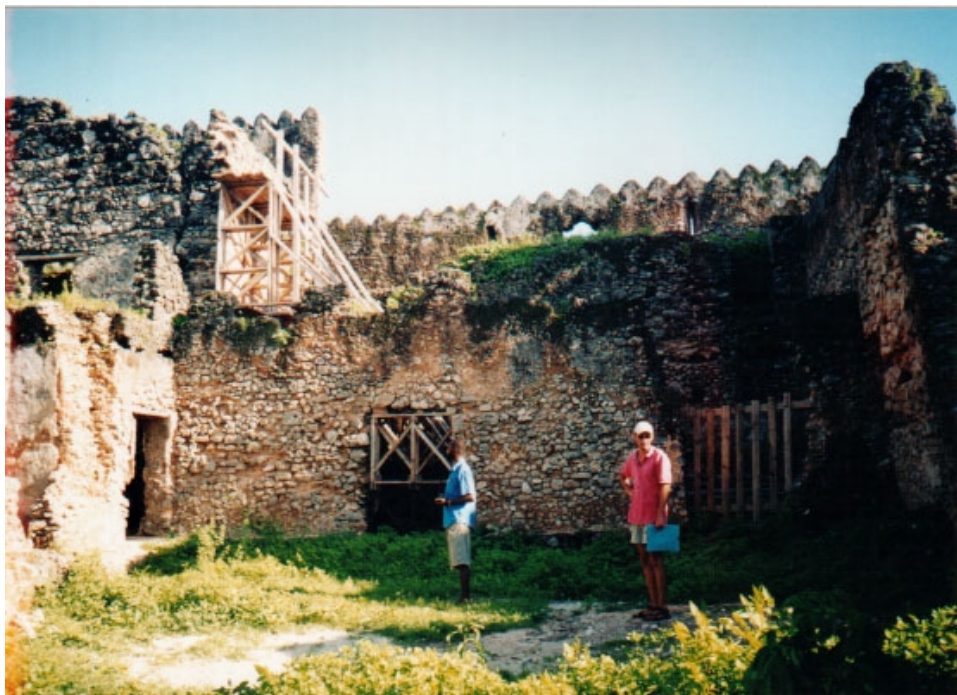
The tower on the Fort is also cracking and although the French team has done some strengthening, this will not last for long. According to Pierre Blanchard, one of the architects, the work that has been done here was to avoid disaster, which was eminent; however, this was not part of their programme and they do not intend to do any further work. With what has been done, the Fort may be safe for up to a maximum of five years, but not more.

Fig VI f: Gerez, Temporary repairs showing cracks on the left

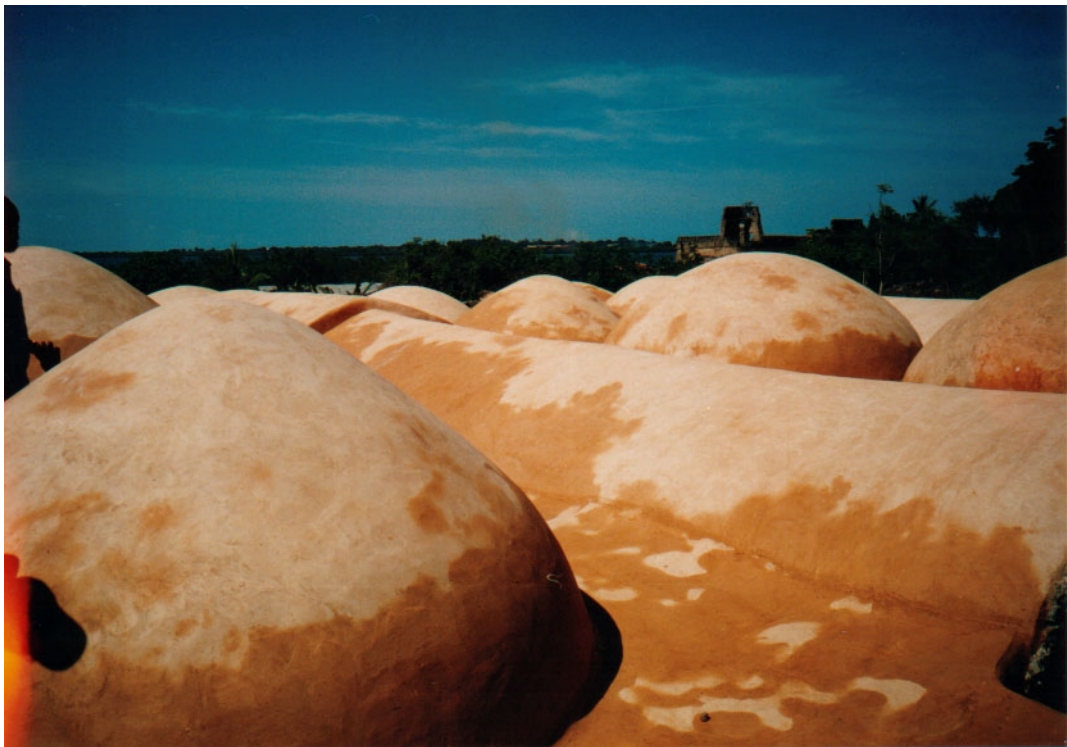
walls have been repaired, cracks repaired and missing key stones on the pillars and arches replaced. The replacements have been marked to show which are the original and which are new materials. The team has done a commendable work in this site and it is now the responsibility of the Antiquities Department and the community to stop the damage caused by, among other things, goats that frequent the structure, climbing up to the roof and posing danger to weak parts. There is also need to keep the site clean through constant upkeep, including constant repairs where necessary. After three weeks of renovations, there were already weeds growing on the wall; this needs to be addressed. The other problem which is common to all the site is the population pressure. The mosque is surrounded on three quarters of its periphery by domestic dwellings and any more pressure may interfere with the structure as people set up little kitchen gardens all around. This too is the responsibility of the state party to put controls. Otherwise there are no more structural problems. Behind the great mosque and adjacent to it is the Great House that could have been used to host visitors. Today however only a half the wall covered in green moss remains. There are also plants and weeds growing on the wall and there is a need for constant upkeep.

Fig VII d: Great Mosque Roof after renovation combination of barrel vaults and domes

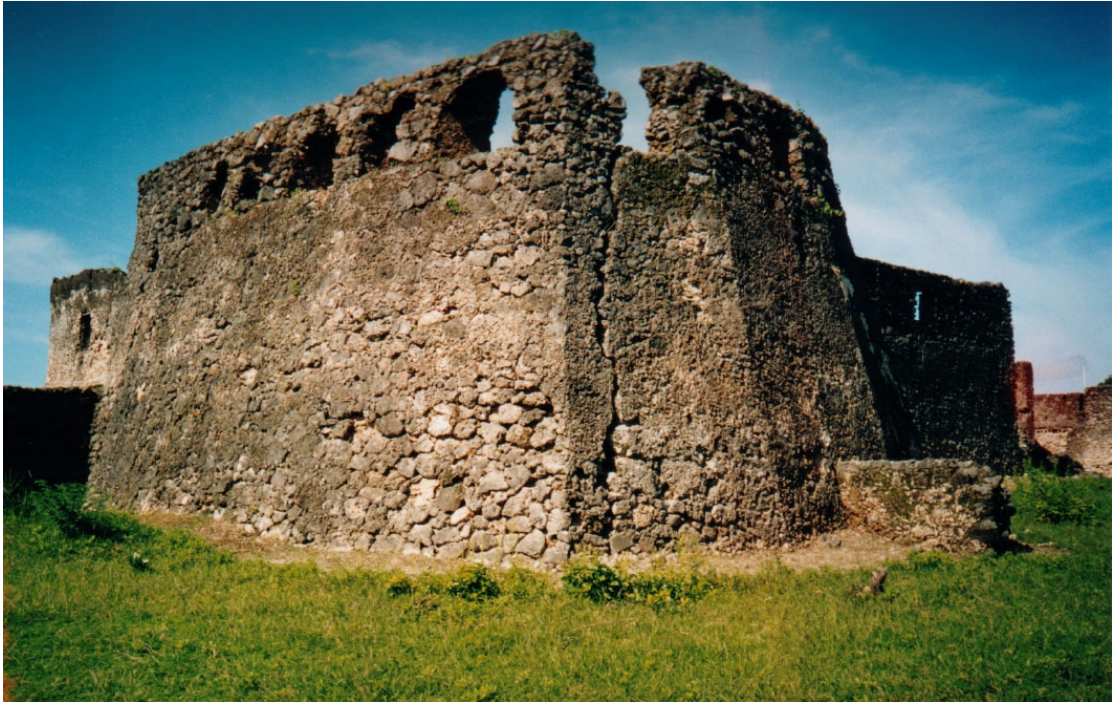
Fig VIII a: Makutani palace with cracked wall

4. The re-enforcement of the structurally weak monuments should apply to all the other monuments having the same problems, eg. the numerous huge cracks found in nearly every building at Songo Mnara and Kilwa Kisiwani.

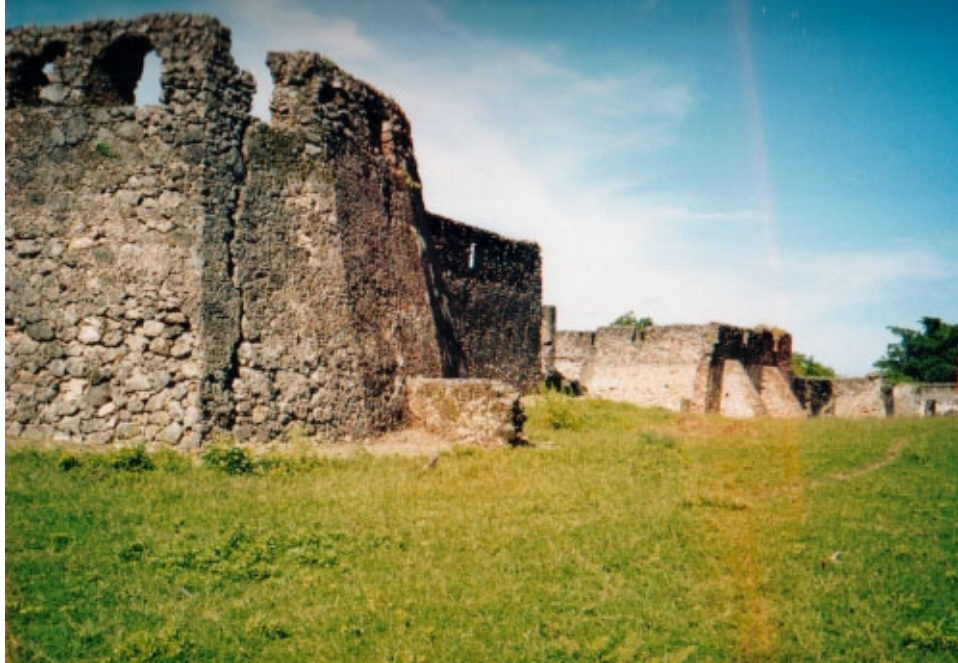
Fig VIIIc: Makutani palace with wall support

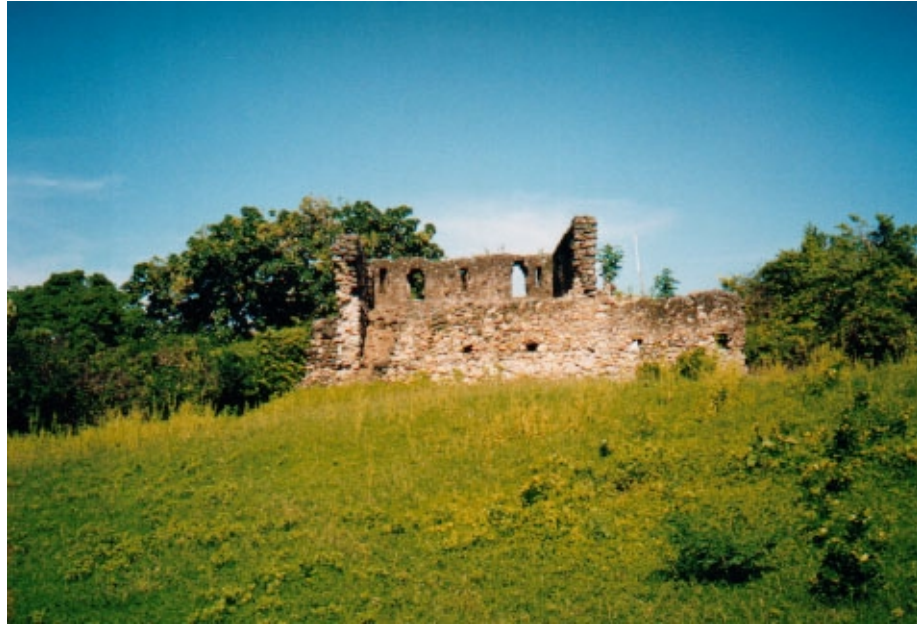
There is a House F (according to H. N. Chittick's naming) which appears to have serious structural problems. This house is now exposed to both rain and sunshine with no cover and with very weak walls, full of cracks both inside and outside the walls (see fig. IXb).

Fig IXb: House on the edge of Makutani Complex with exposed and cracking walls

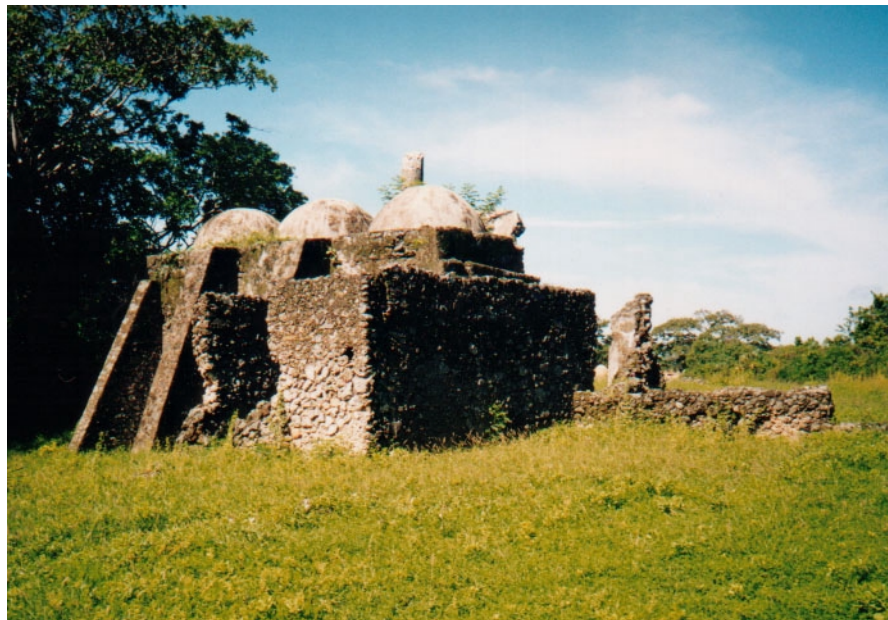
Located between the Great Mosque and Makutani Palace area, it is a small beautiful mosque with a domed roof, although some domes have fallen (fig Xa). The inner part of the roof is decorated with bowls in similar form and style as the Sultan's Office at Songo Mnara. The mosque has no structural problems; however there are cracks which allow water to infiltrate the structure; there is therefore a need for quick restoration work and removal of the trees growing on the walls. There is already a threat of the outer door pillar collapsing.

Fig X a: Small domed Mosque

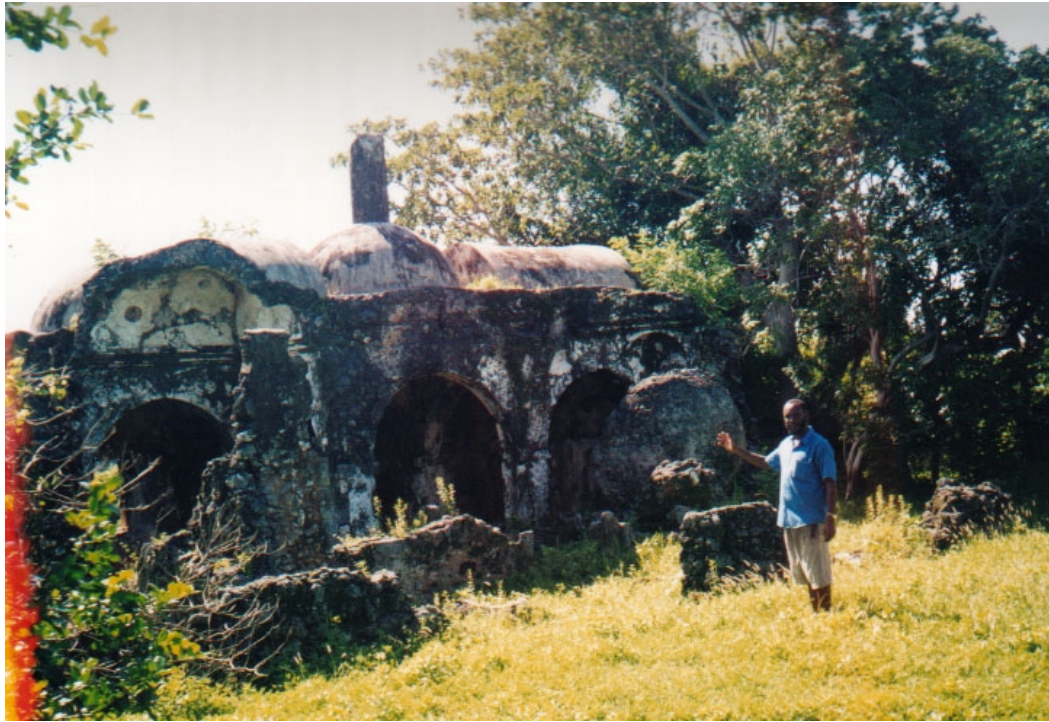
Fig X b: Small domed Mosque with collapsed roof. Outer door pillar collapsing

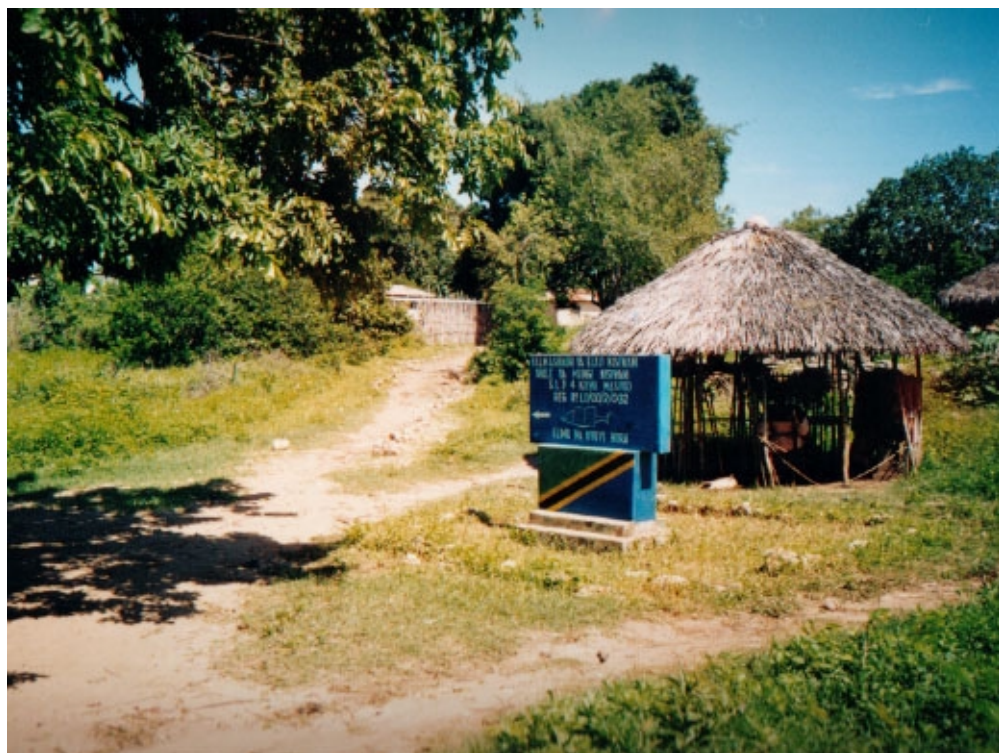
Fig XI a: A pathway to school marked by stones from monuments

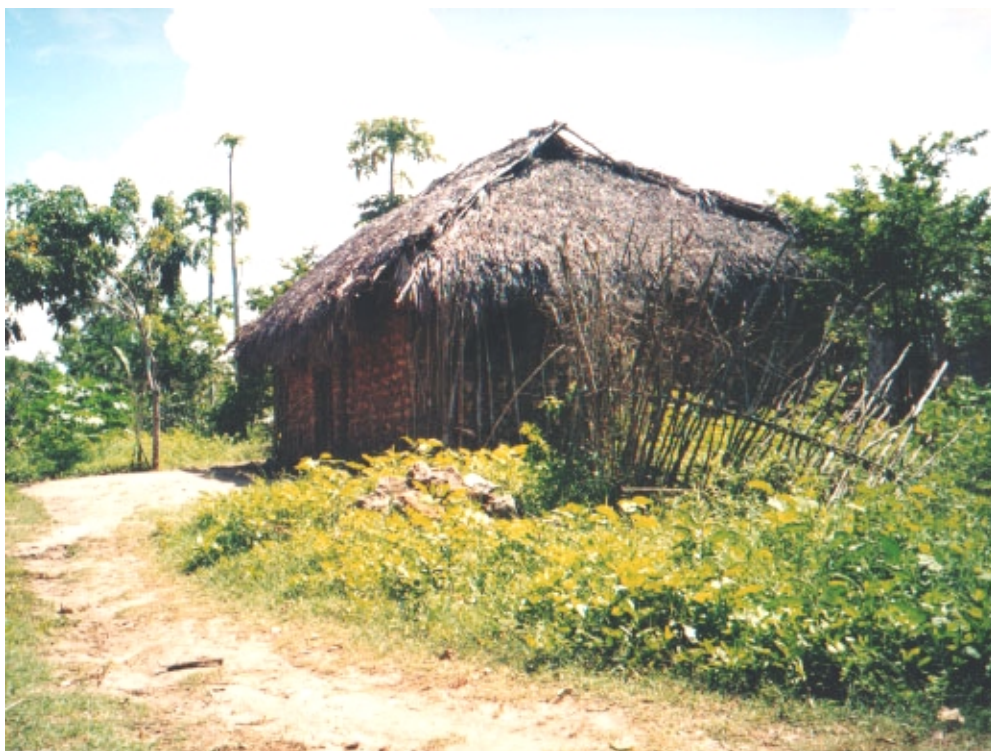
Fig XI b: A modern house partly built with stones from the monuments

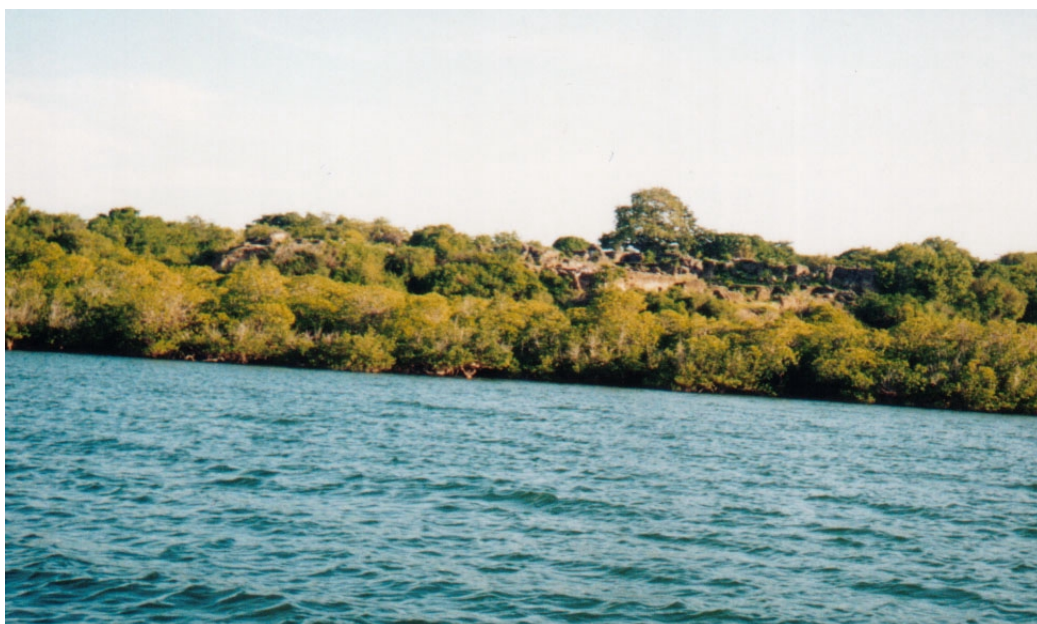
The site however faces a major threat to its structural integrity. Husuni Kubwa is built on a cliff of yellow porous sandy soil (fig XIIa). This soil is open to water infiltration and penetration which is what is happening currently. As opposed to the Fort-Gereza where the threat is coming from sea water, Husuni Kubwa's stability is threatened by rain water which is penetrating the soil and rendering it loose and collapsible. Already the palisade has fallen, the small mosque is gone, there was a small structure at the end of the stairs which also disappeared, part of the stair case has collapsed and the other will soon go if nothing is done. The front part of the Sultan's viewing room has also gone. While many of these disappeared in the 1950s and 60s, the remaining threatened portions have been slowly disappearing. It is a problem of the ground on which the

Fig XIIa: Husuni Kubwa from the sea

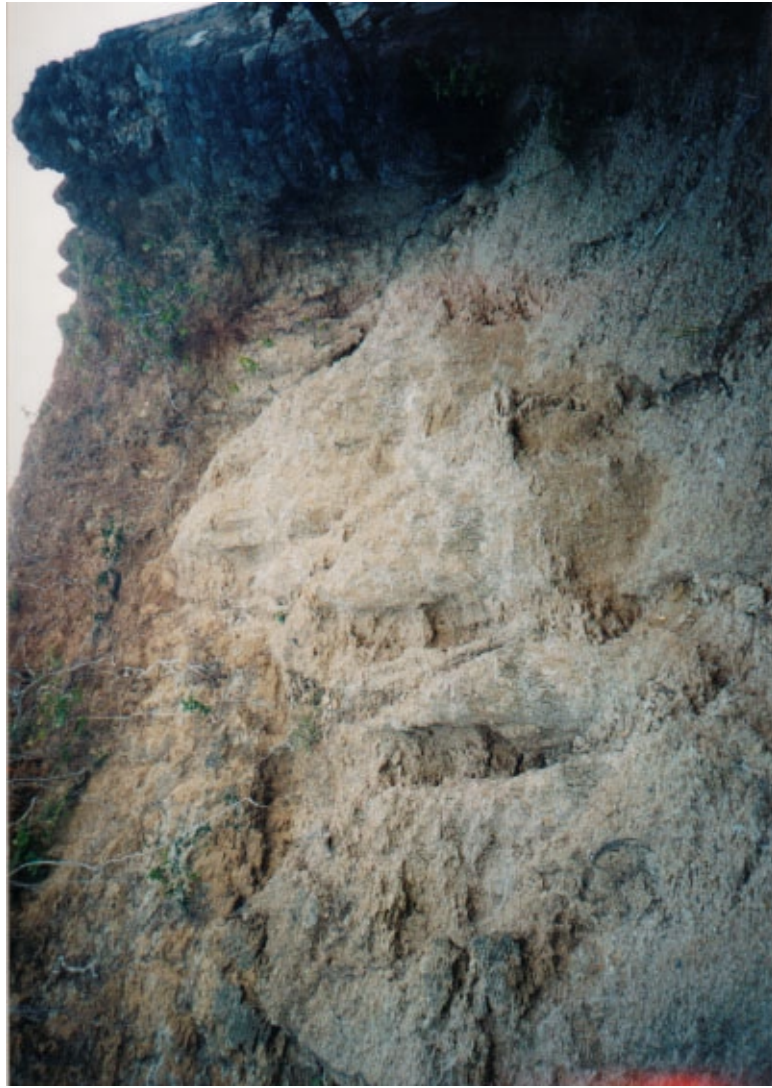
Fig XII b: The red porous sandy soil forming the cliff at Husuni Kubwa
