# State of Conservation 2016

## **Group of Monuments at Hampi (241 bis)**

State Party: India

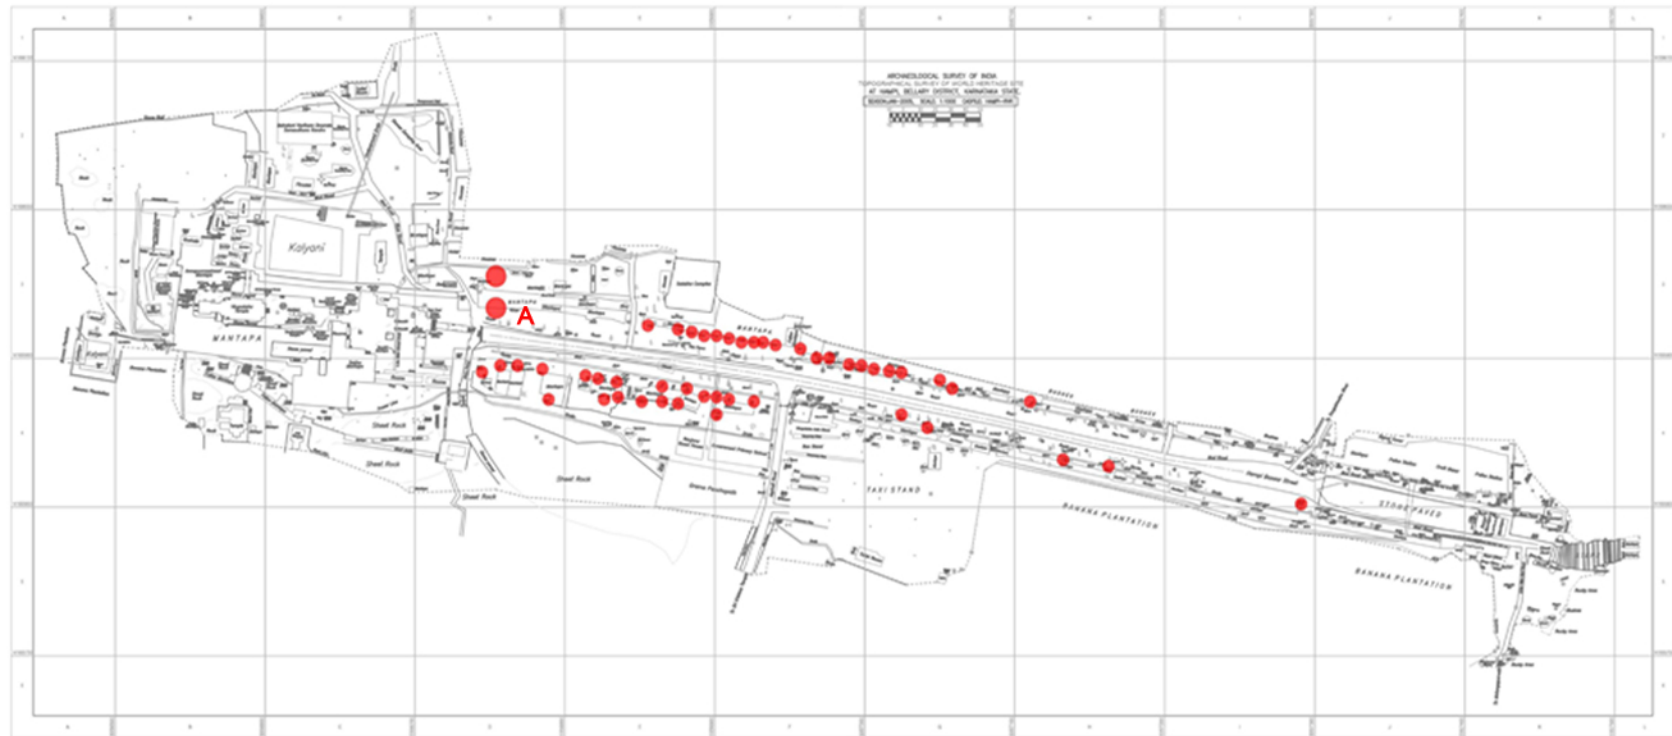
Figure no. 27: Map showing location of trial excavation pits in the Virupaksha Bazaar, Hampi and detail at trench A (2014)

- Excavation of 78 trial trenches measuring approximately 1 meter x 1 meter and 2 trenches in front of the first north-eastern mandapa measuring 5 meters x 5 meters to study the original levels, original surface finish and foundation details (Refer to Figure 27 indicating all trenches)
