SOC REPORT MALOTI DRAKENSBERG WORLD HERITAGE SITE

STATE OF CONSERVATION REPORT FOR THE MALOTI-DRAKENSBERG WORLD HERITAGE SITE

December 2016

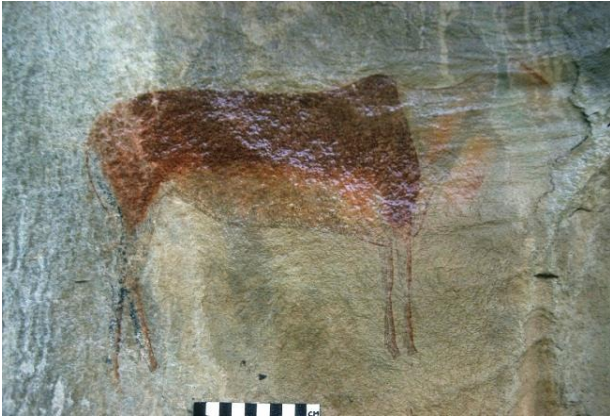
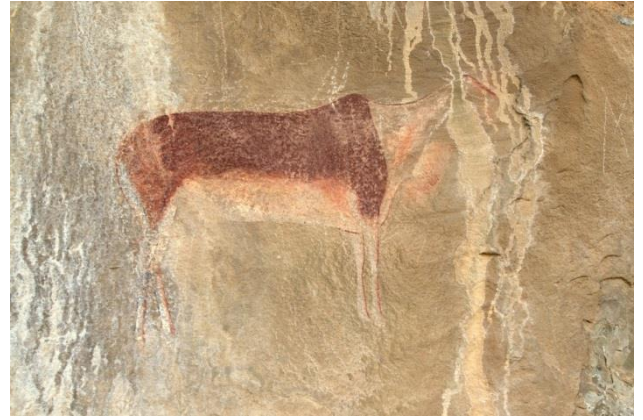
Panel A is in a good state of preservation, though the head of the polychrome eland is affected by washes and has faded somewhat. There is also scratching over the image. Panel B is a smudged, indeterminate patch of paint.

Figure 4. ARAL photograph 1980

Figure 5. MARA photograph 2015

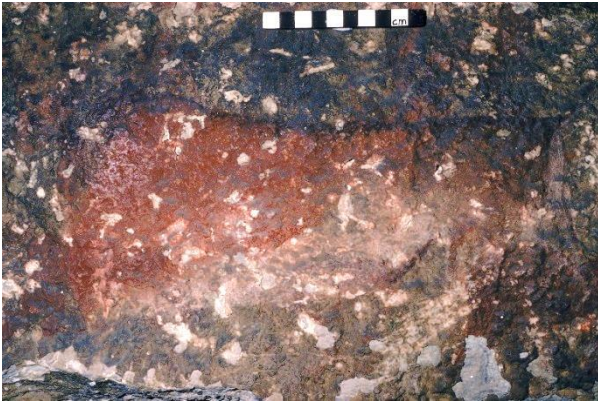
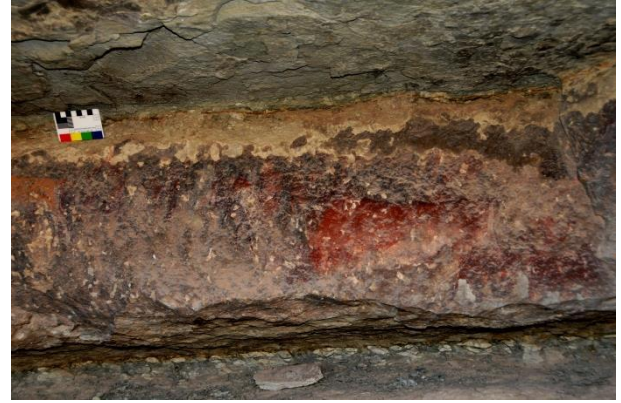
This site has considerable evidence for intensive human occupation and various factors are affecting the preservation of the site. The rock face is covered in dust, there has been animal rubbing along the back wall and there appears to be calcite build-up on some of the panels, contributing to the flaking of paint from the rock face. The surface of the rock face appears also to be friable, and large sections of it have flaked off and lie on the shelter floor – although none with paint could be discerned.

Figure 8. ARAL image 1980, B31 panel G

Figure 9. MARA image 2015, B31 panel G

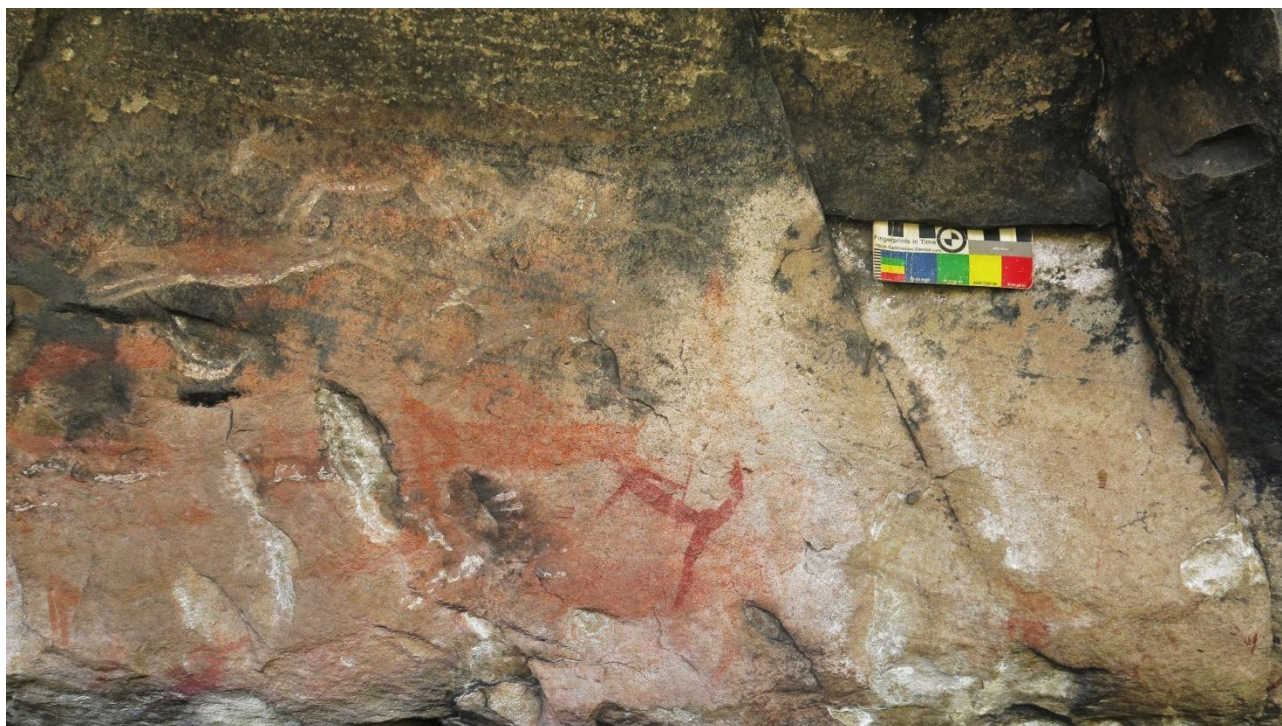
Figure 14. B33 shelter B, panel E.

Bottom centre- right panel E: human figures in red and dark red. These are very faded by wash. 1 large (30cm long) polychrome eland: back legs and hindquarters have faded away. At the far right of the bottom of the panel are 2 separate white areas of paint. These are certainly paint but have no identifiable features. The left-hand area of white paint is 8cm in height while the right-hand measures 12cm in height.

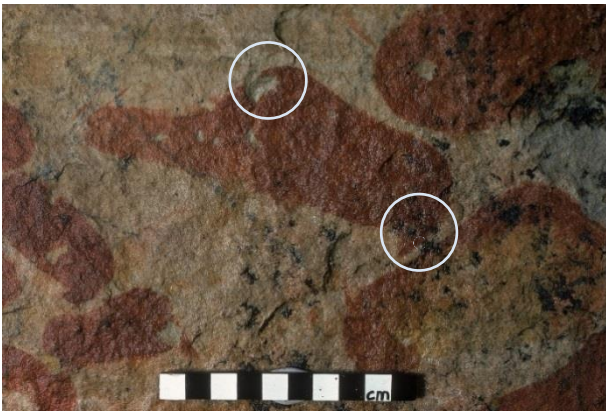
Salt and water washes appear to be main factors affecting preservation at C17. Consequently, the site is extensively flaked and very faded. Panel C, however, is extremely clear.

Figure 17. ARAL image (wet) 1980, C17, panel C. Circles indicate areas to compare with the 2015 image

Close-up photographs taken by ARAL were done so when wetted by spray, making it difficult to assess on a like-for-like basis. However, close scrutiny of the ARAL images shows that there has been some deterioration in the last 35 years – illustrated in the slight increase in spalling shown in the images above.

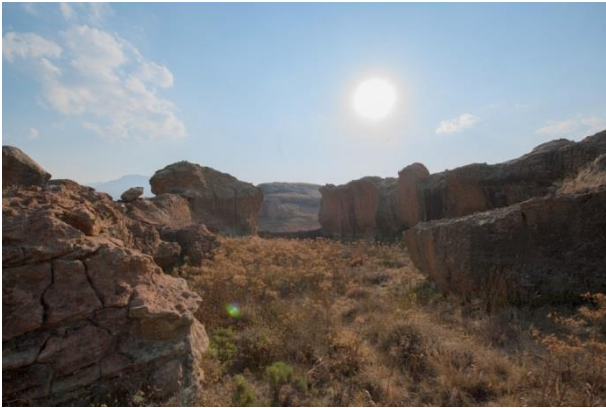
Figure 22. Locating shot of D04 environs, showing retaining/dam wall that has created marsh conditions.

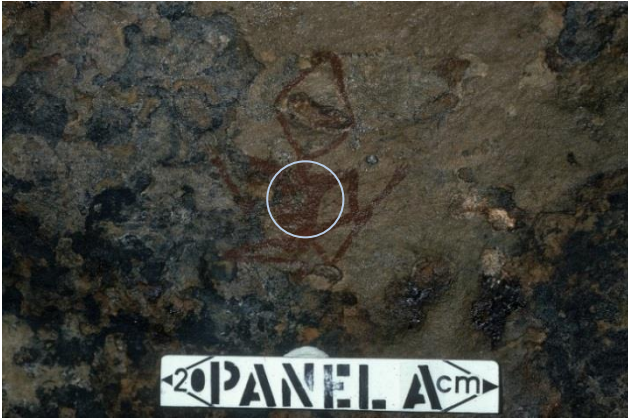
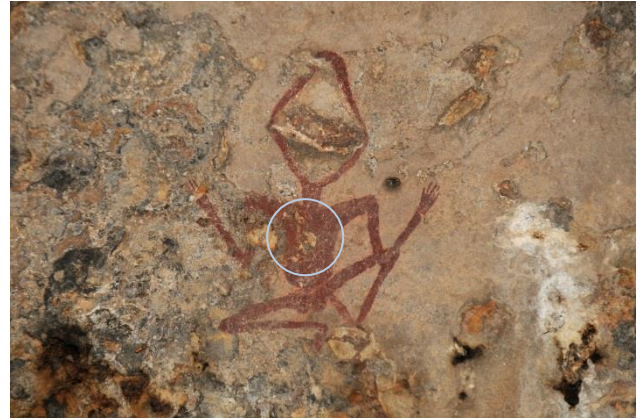
Although the human figure is clear and appears largely undamaged, the floor of the shelter is very damp. There are wash-zones surrounding the image and foliage growing below it. These may in future affect the preservation of the image.

Figure 24. ARAL image 1984. D04a panel
A.

Figure 25. MARA image 2015. D04a panel
A.

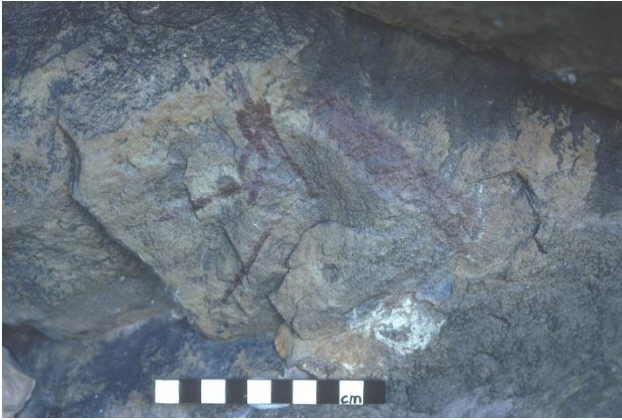
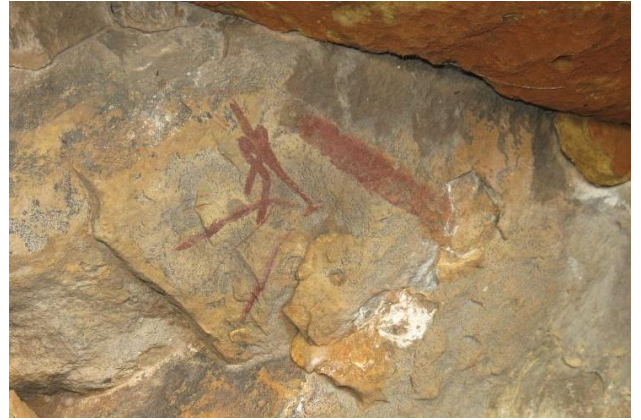
The majority of the art (bar panel C) is faded and subject to various forms of damage including dust, wash and flaking. Panel A is located within a stonewalled structure and it is therefore likely that human presence in this dwelling has contributed to damage.

Figure 30 ARAL image 1980. Close-up of left half of panel D including possible large finger-smear and 'seated' or bending-forward human figure in red with crossed arms and arrows above shoulder.

Figure 31. MARA image 2015. Close-up of left half of panel D including possible large finger-smear and 'seated' or bending-forward human figure in red with crossed arms and arrows above shoulder.

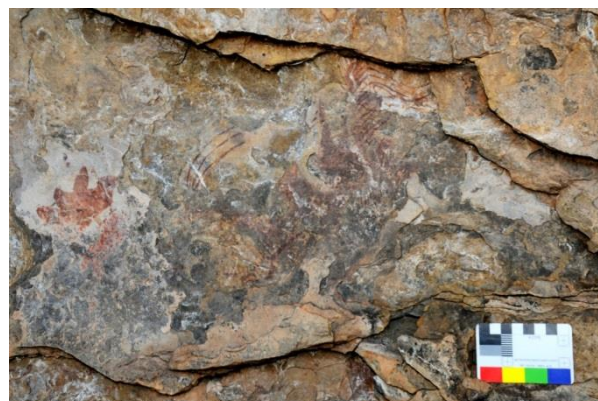
Figure 36. Panel G: note the red castellated image and the wavy lines appear to go into cracks in the rockface.

Panel G is on the furthest right panel at D28. This panel is located about 50cm from the shelter floor. This panel is extensively flaked and damaged by wash.

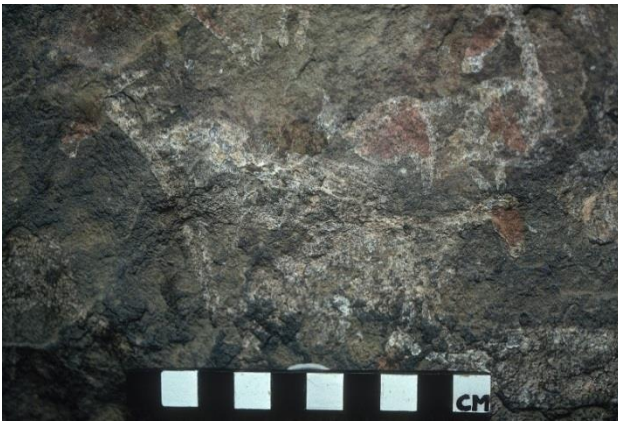
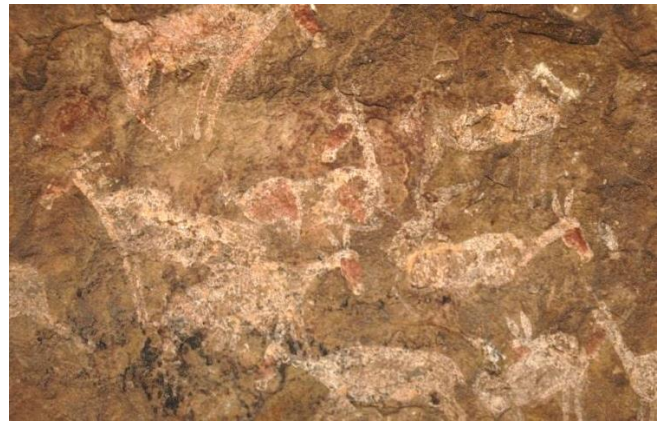
Figure 39. ARAL image 1980, E01 panel F.

Figure 40. MARA image 2015, E01 panel F.

The majority of ARAL images accord with those of the MARA survey shots at E01, and little further damage or deterioration has accrued since 1980. However, this is such an important site that a conservator must be brought in to make a detailed appraisal.

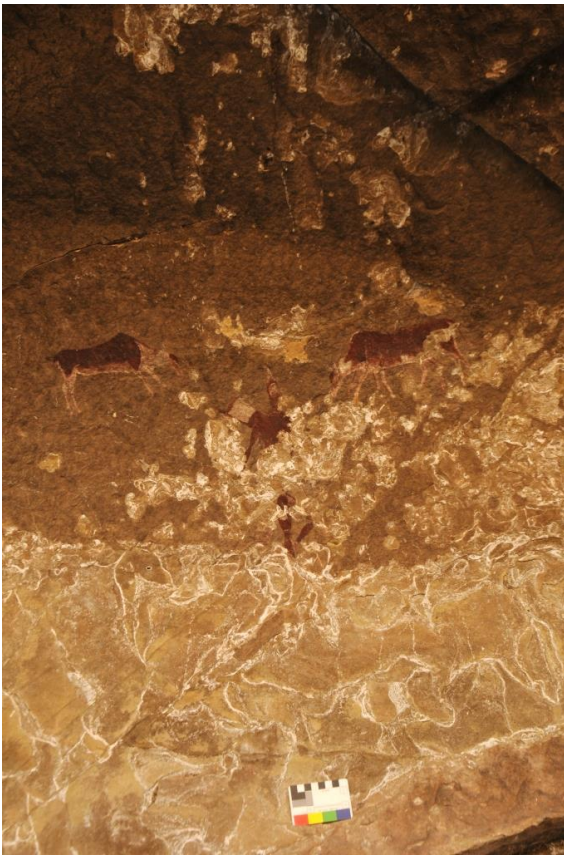
Panel M contains one polychrome eland, one large red and white human figure with quiver and a second polychrome eland with many legs. The two polychrome eland face in different directions, towards each other, over the head of a large dark red human figure - approximately 30cm tall. The human figure is very badly flaked by salt seepages, but what remains is exquisite. The figure has one knee raised, a white face, white dots around the neck, and white arrows in its hunting bag, which also contains a bow.

Figure 44. E01 panel M to show very clear, highly detailed, yet badly exfoliated rock art.

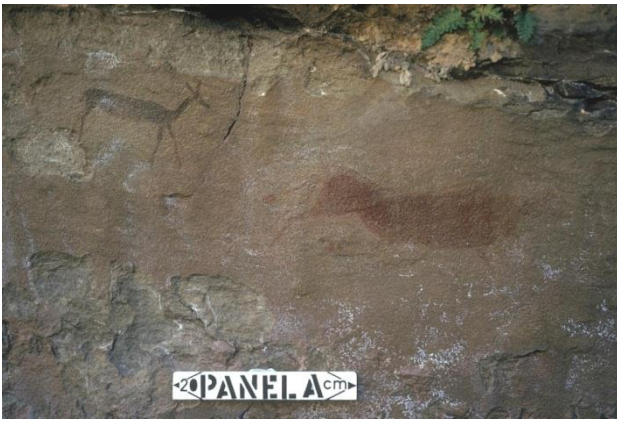
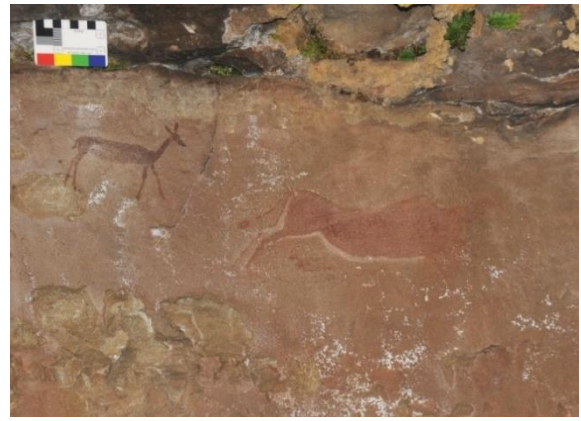
The 2 images painted at F22 are in good condition. They are very clear, though the head of the eland on the right of the panel has faded away. This is due to salt seepage and wash

Figure 56. ARAL image 1980, F22 panel A.

Figure 57. MARA image 2015, F22 panel A.

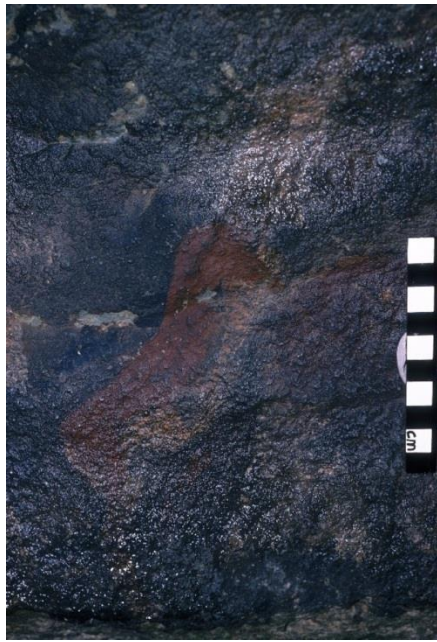
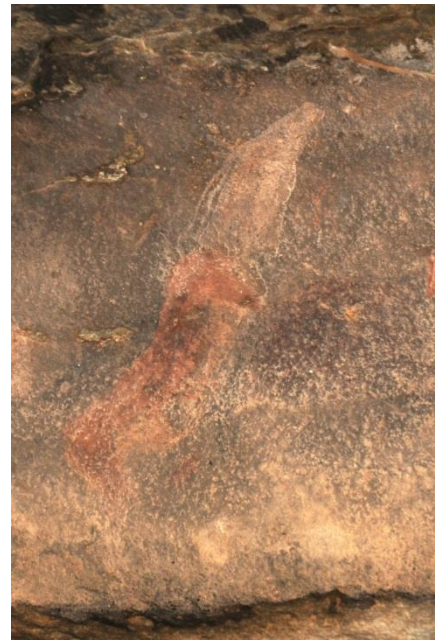
A large proportion of the rock art at J01 is faded. The site is subject to various environmental deteriorating factors such as wind exfoliation, washes and soluble salts. The site has also been damaged by animal rubbing. This is due to it being used as a kraal (stonewalling present at site). There is a large amount of human damage to the site as well. It has been extensively pecked and hit, as well as scratched.

Figure 61. ARAL 1980 wet/spray image. Panel D: dark red eland body superimposed by strange eland body painted on hind legs with head facing ceiling of shelter.

Figure 62. MARA 2015 image. Panel D: dark red eland body superimposed by strange eland body painted on hind legs with head facing ceiling of shelter.

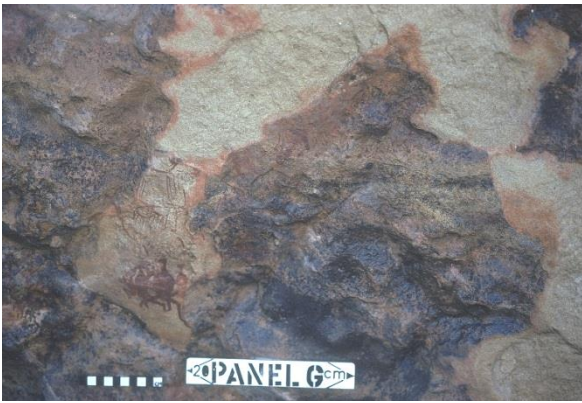
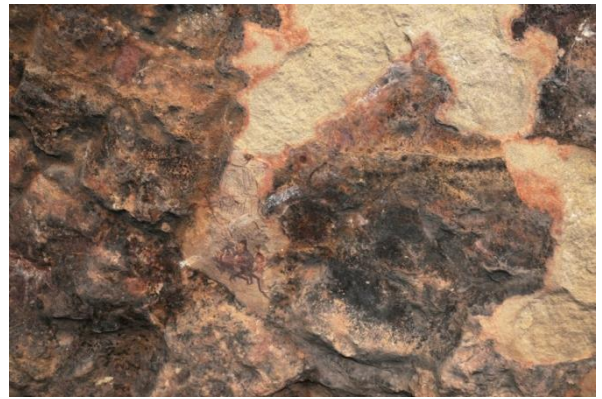
J04 is relatively well preserved. However, as this boulder does not have a shelter roof, the art is open to the elements and therefore the art is affected by rain, dust and sunlight.

*Figure 73. ARAL image 1980, panel H (ARAL panel G)
General shot panel H: seated human figures, red lines
and red dots.*

*Figure 74. MARA image 2015. General shot panel H:
seated human figures, red lines and red dots.*

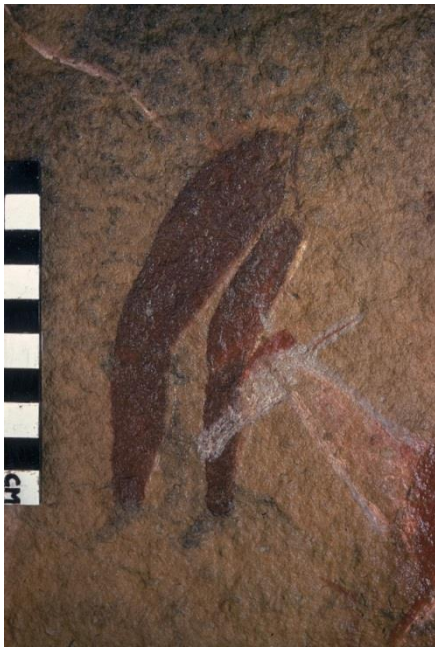
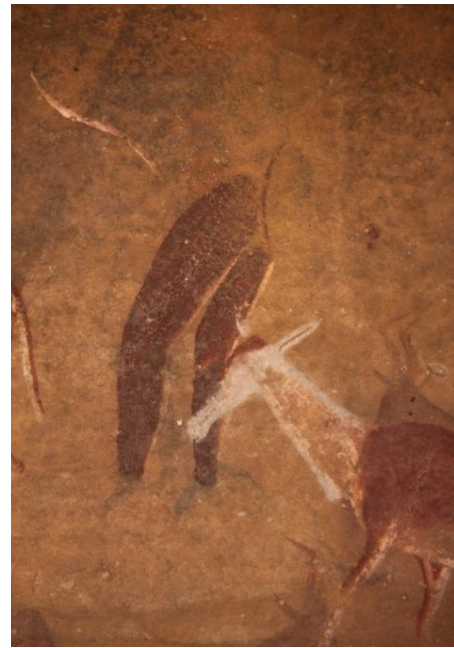
Figure 81. ARAL image 1980: close-up section of top left panel A, showing human legs in dark red, and head of right-hand eland.

Figure 82. MARA image 2015: close-up section of top left panel A, showing human legs in dark red, posterior and tail of left eland, head of right eland with hartebeest head and horns visible behind shoulder.

As mentioned previously, Site J10 is very well preserved. An examination of the 1980 ARAL record shows that there has been little to no deterioration in the last 35 years. The wetting of the images in 1980 makes it difficult to compare photographs on a like-for-like basis.

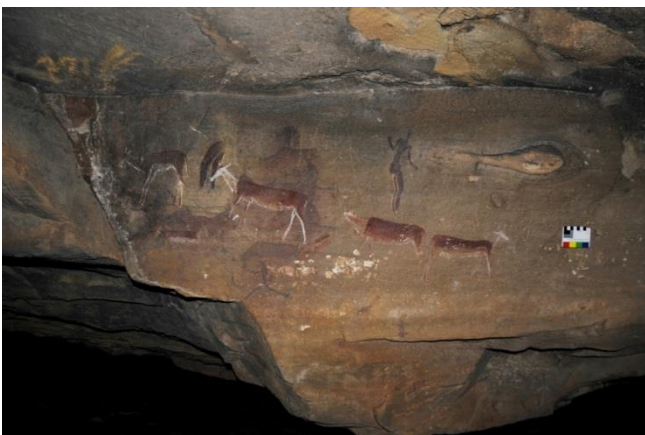
Site J10 is exceptionally well preserved. Panel A is in a better general state of preservation than panel B. The paintings are, on the whole, clear and bright. The older images that have been superimposed by others are still visible and have not faded too badly. Details in the paintings are still clear. There has been some flaking, fading and dust damage but not to the extent observed at other sites within the park. Panel B is more faded than panel A.

Figure 83. Site J10, panel A, showing the clarity and complexity of the subject matter. This site is recommended as one that might be opened to the public.

Visitation. This site is highly recommended as a visitor site. It contains extremely well preserved images which the average visitor will be able to see clearly. It might be considered for inclusion on a hiking or horseback trail that includes other sites in the valley such as J01 and J04. Should it be opened to the public, a qualified conservator should be called in to camouflage the scratch marks. In any event, the site should be monitored regularly.

Access. It is recommended that access be controlled by putting in place a non-intrusive barrier. A guiding barrier will ideally take visitors close enough to the images, while keeping them out of arms' reach. It will also prevent people from walking in the dust.

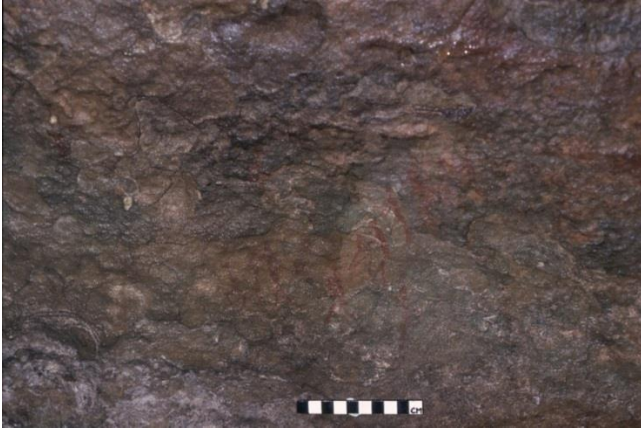
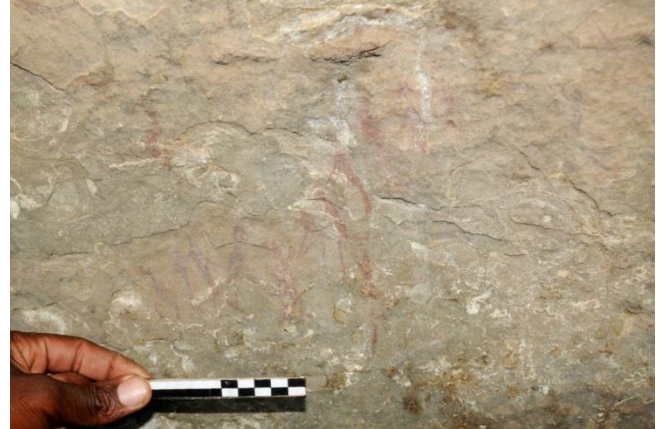
Although the images in panel C are clear, there has been significant flaking- some images are badly damaged by this. Panels A and B contain only the remnants of paintings and these are faded and indeterminate. Panel B is close to a fireplace and covered in soot.

Figure 87. ARAL image 1980. Close-up bottom centre panel C including procession of dark red human figures .

Figure 88. MARA image 2015. Close-up bottom centre panel C including procession of dark red human figures .

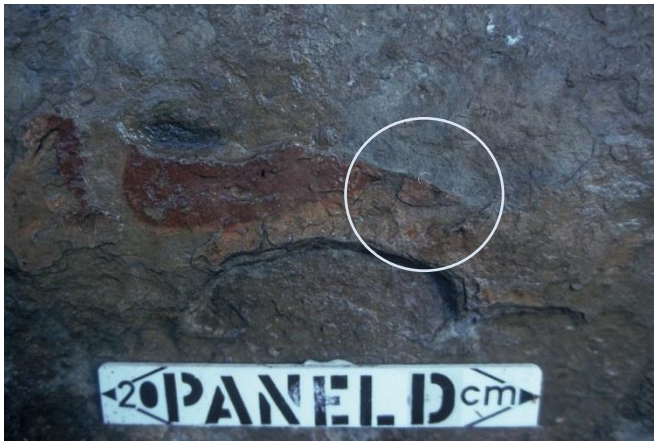
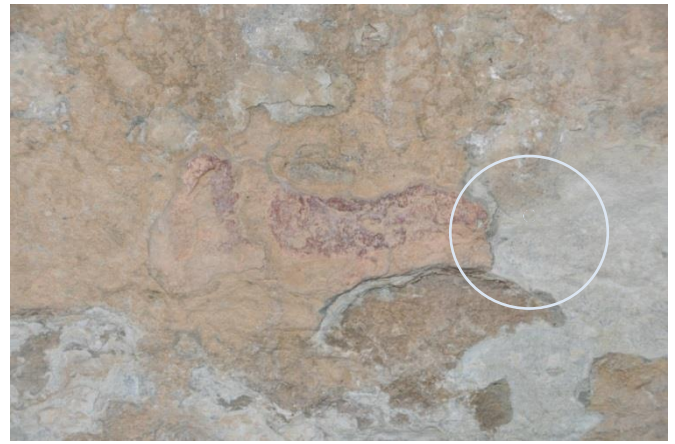
H05 is badly damaged. Much flaking and water damage. Construction of stone structures has affected the art in H05b. It is likely that the shelter's use by people in contact and historical times has been the major factor affecting the rock art. This, coupled with the poor integrity of the rock face, means that, overall, the rock art is not clear and would not, by itself draw visitors.

Figure 105. ARAL image 1980: close-up far right panel A, Shelter A, taken when the rockface was wetted with water spray. Indeterminate subject.

Figure 106. MARA image, 2015: close-up far right panel A, Shelter A, Dry. Indeterminate subject.

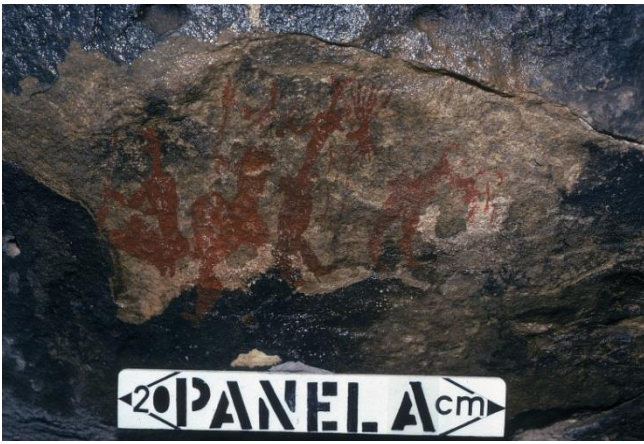
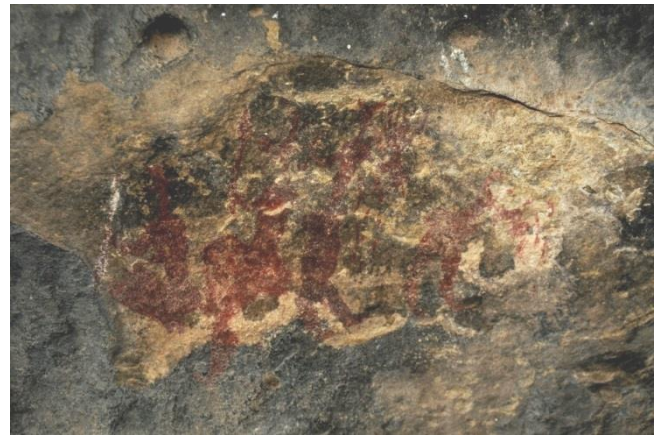
Damage to paintings at J02 includes flaking and pecking, and the greatest damage appears to have been caused by deliberate striking of the images with a hard object such as a stick or throwing stones. Many of the paintings are faded.

Figure 109. ARAL image 1980. Panel A: panel A including four human figures: two with headdresses, two with possible spears.

Figure 110. MARA image 2015. Panel A: panel A including four human figures: two with headdresses, two with possible spears.

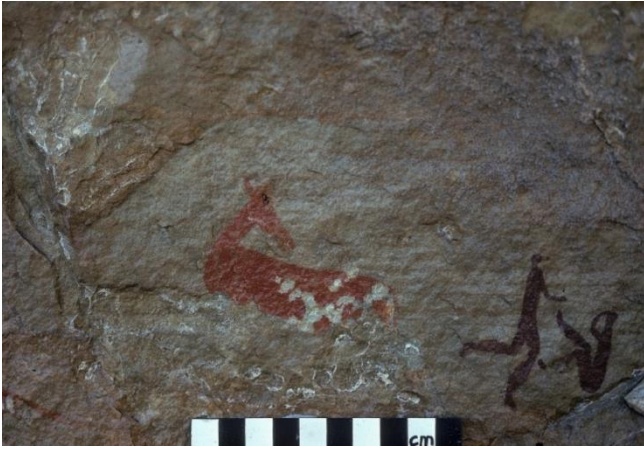
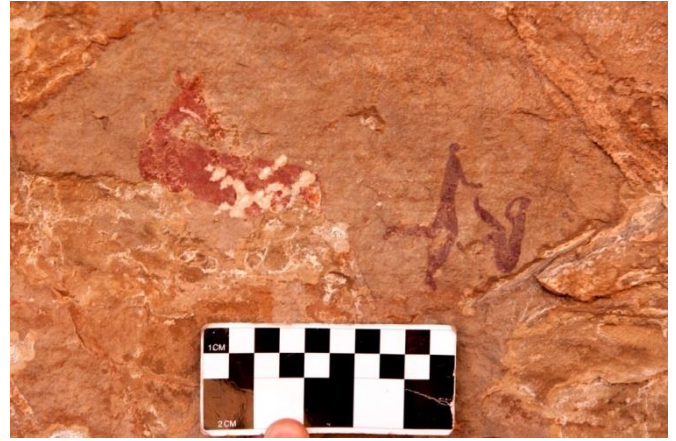
Much of the art is faded and flaked, some of this caused by extensive salt/calcite build-up on the rockface as well as by human scratching. Some of the figures are faded so severely that they are very difficult to make out.

Figure 116. ARAL image 1980. Panel A: 1 red hartebeest lying down and looking back over its shoulder; two human figures in dark red, one falling with hand to head.

Figure 117. MARA image 2015. Panel A: 1 red hartebeest lying down and looking back over its shoulder; two human figures in dark red, one falling with hand to head.

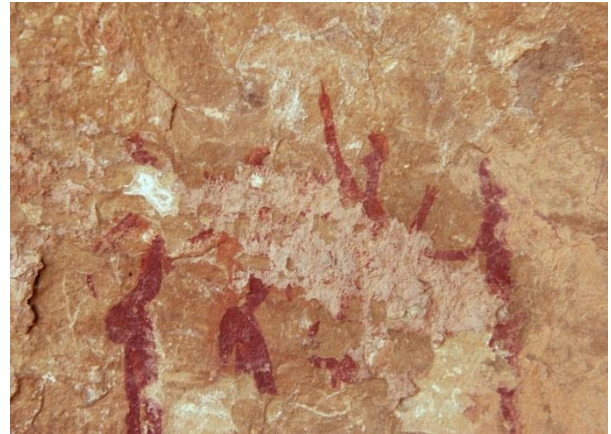
Figure 120. General shot panel G: flaked and scratched human figures with sticks and unidentifiable bird (?crane) shape, and human figures with arms raised

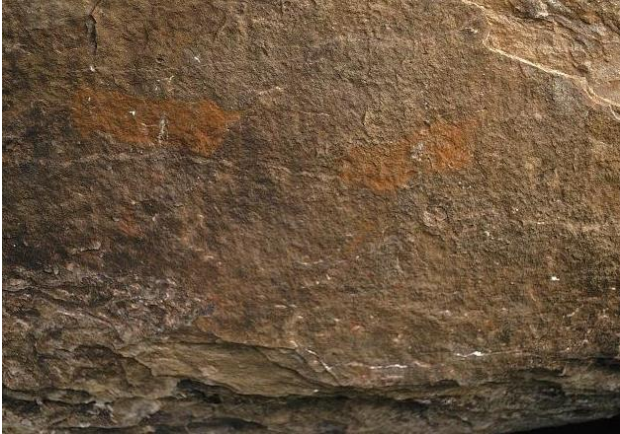
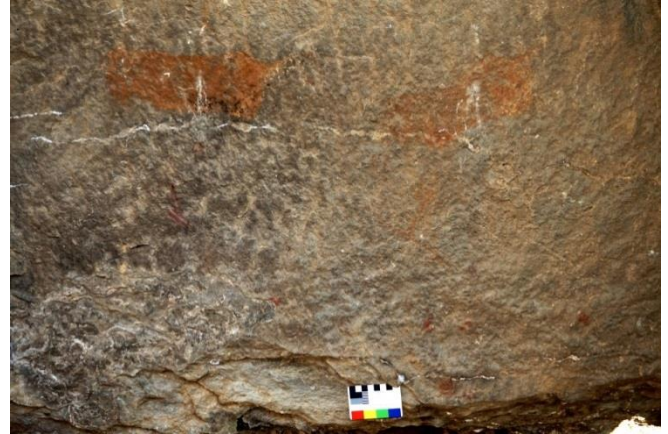
The site is subject to damaging factors such as animal activity (rubbing), dust and faking. The paintings themselves are not, at this stage, affected by flaking but the shelter's back wall shows flaking. This may affect the art at a later stage. The paintings are faded.

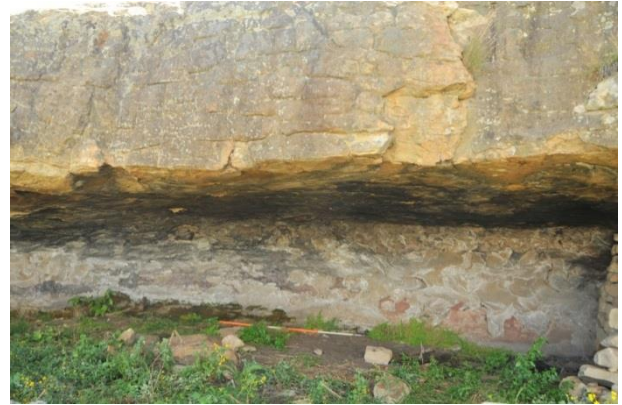
Figure 129. General shot of panels to show extent of exfoliation/spalling in site D25.

D25 is subject to damage by extensive salt washes (causing flaking), animal rubbing damage, fire damage and dust. The majority of paintings are faded. Some are very difficult to make out.

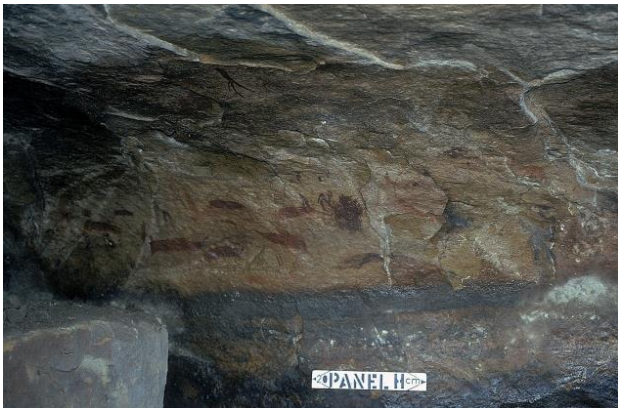
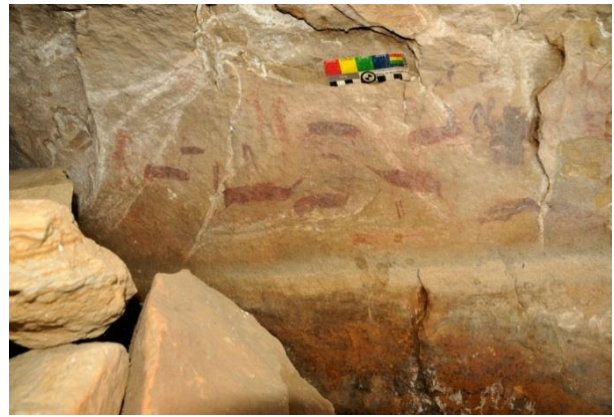
Figure 130. ARAL image 1980. D25 panel F.

Figure 131. MARA image 2015. D25 panel F.

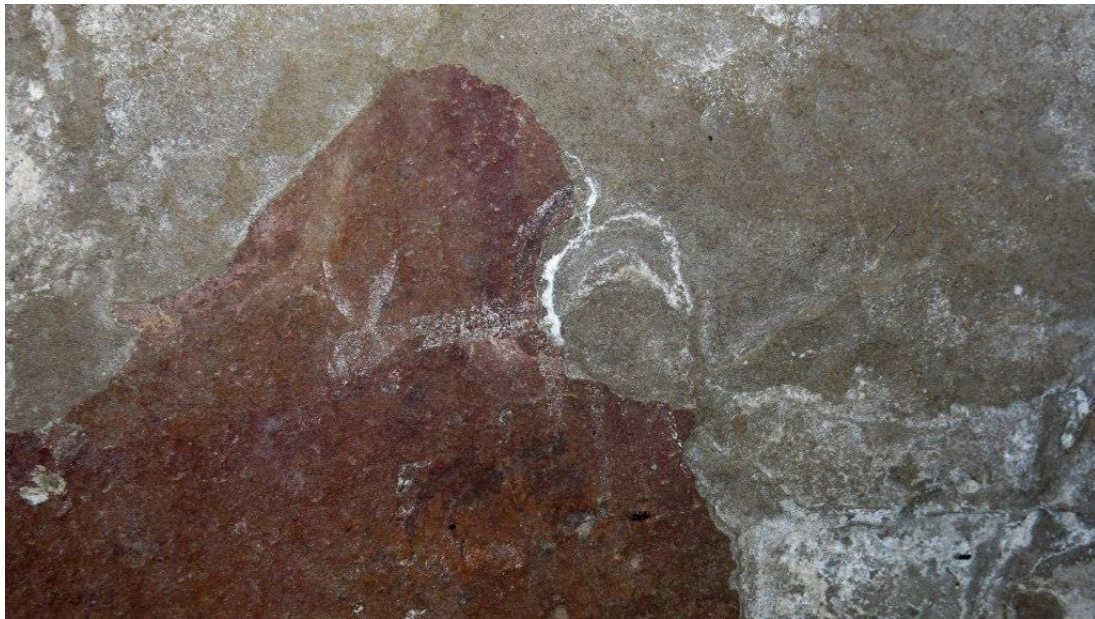
Figure 132. Close-up of D25 panel A showing head, neck and shoulders of a white rhebok against a very badly flaked red background that contains remnants of red figures. NB the accretion of salt crystals on the antelope's neck.

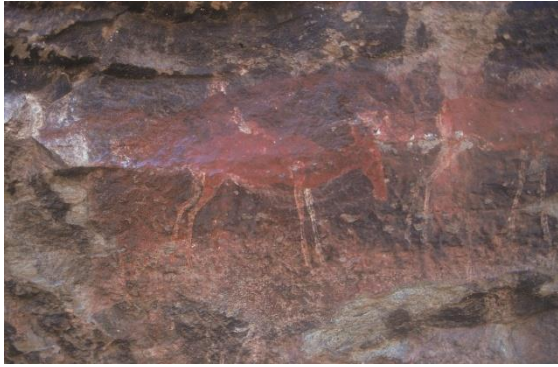
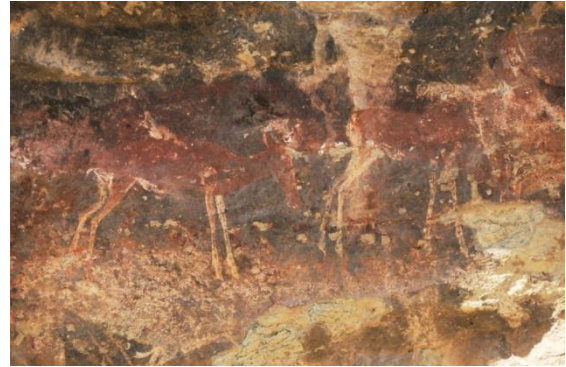
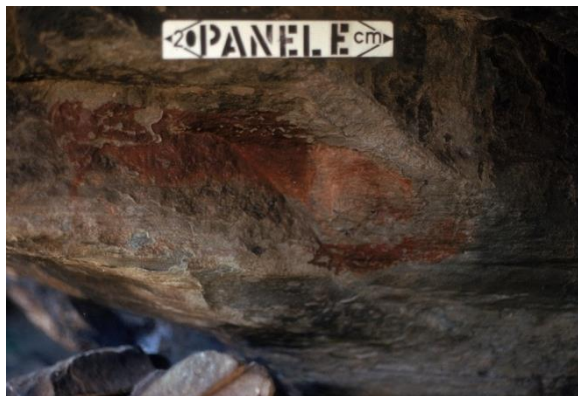
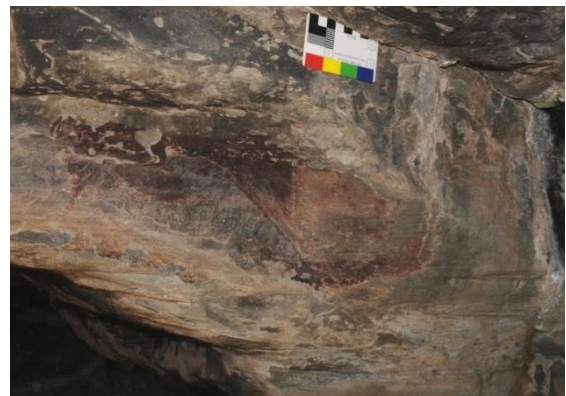
The general preservation of paintings at H20 is relatively poor owing to multiple deteriorating factors. The shelter is very shallow and therefore the back wall is exposed to the elements (including wind, wind-blown rain and direct sunlight). The site has also had considerable animal activity, though much of the evidence of animal rubbing is below the surviving panels. Panel C is affected by a stone wall (the southern wall of the dwelling) that has been built against it, knocking the art. Panels D-G are within the dwelling on the back wall of the shelter and are affected by soot. Much of the art is faded and flaked.

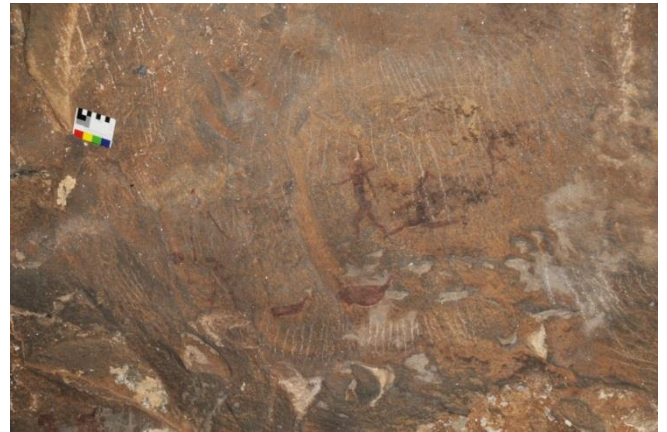
Panel C: Although still quite clear, panel C has been subject to human defacement in the form of scratching. There are multiple vertical lines over much of the figures in panel C.

Figure 148. Panel C, showing the striding and running figures with white faces and antelope-eared caps, as well as the red and white rhebok below. The entire panel is covered in vertical scratch marks.

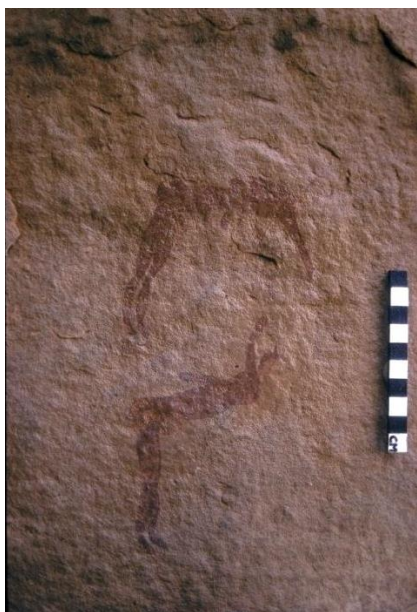
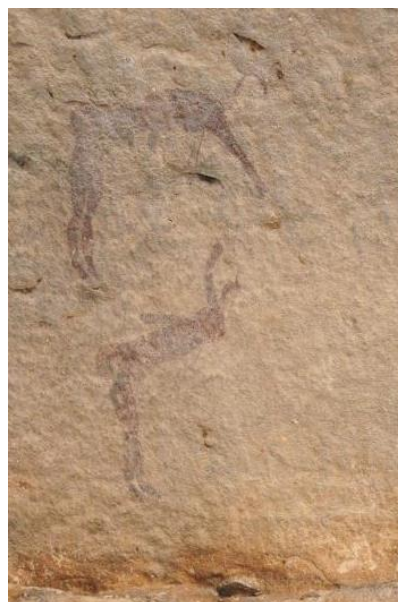
S03 is subject to various deteriorating factors such as flaking, smudging and fading. These have been caused by dust, wash, lichen and salt/calcite seepage and build-up. Panel F is the most severely damaged; a large proportion of this panel is badly smudged. This smudging could be caused by human action or animals rubbing against the rock face.

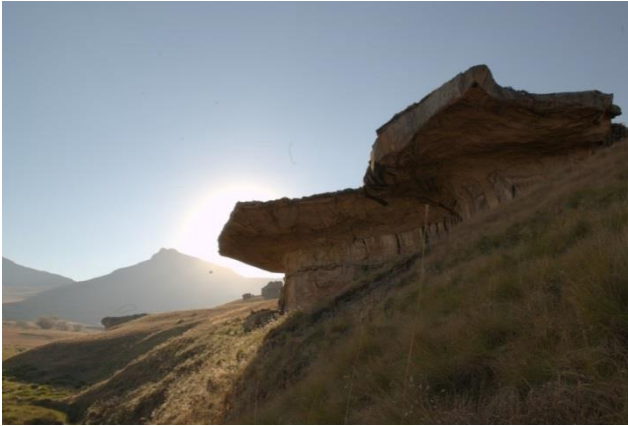
B01 – Rock art and stonewalled site

Figure 2. Locating shot of B01 looking north

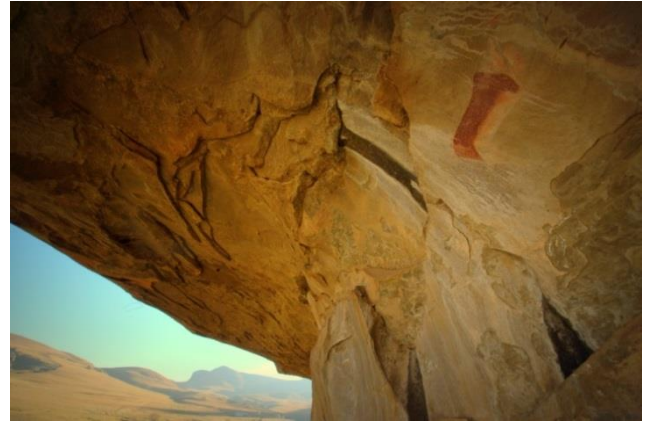
Figure 3. Site B01, oblique shot of panel A

It appears there has been very little deterioration in the polychrome eland since the ARAL photograph (only one picture) was taken in 1980. The extent of salt washing appears to be the same, both on the hindquarters and on the head. The line of the stomach is perhaps a little less clear in the 2015 photograph. Graffiti above and to the right of the eland are not visible for comparison in the ARAL picture because it was tightly framed.

<u>Other Observations</u> Shelter formed on underside of exposed sandstone outcrop. Rock art exists on ledge that is somewhat protected by fallen rocks. This ledge is still accessible and graffiti is present.	
Past treatments:	Y:
N:✓	
General comments: Site is vulnerable because it is located very close to the Old Lodge. Provision must be made for its protection.	
Recommendations: If the site is included on a visitor route provision needs to be made to protect the rock art further. Good site for visitors due to raised rock art panel. Scratched graffiti may be removed or camouflaged by a qualified rock art conservator. `	
ASMIS Site Condition Assessment Value:	Good:
Fair:✓	Poor:
Destroyed:	Unknown:
Assessor: SAM CHALLIS	
Affiliation: WITS - (MARA)	
Contact: DR SAM CHALLIS (sam@rockart.wits.ac.za)

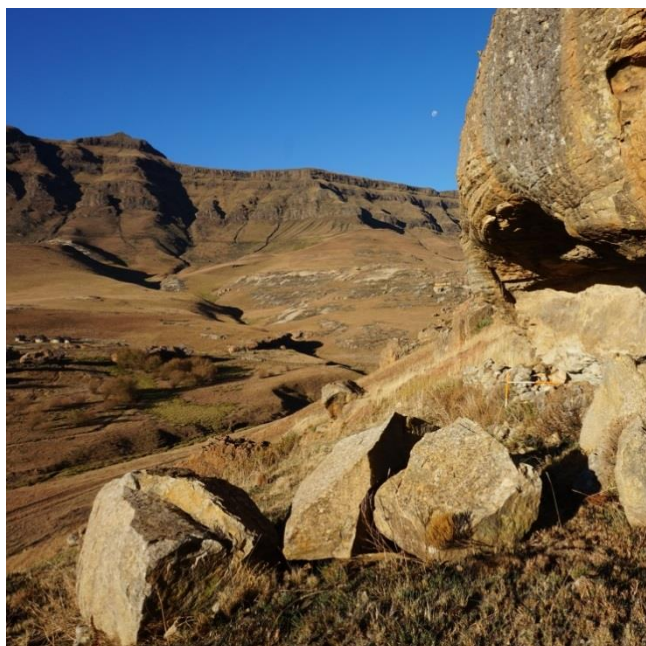
B05 – Rock art and stonewalled site

Figure 6. Locating shot of B05 looking east showing reception gate in background.

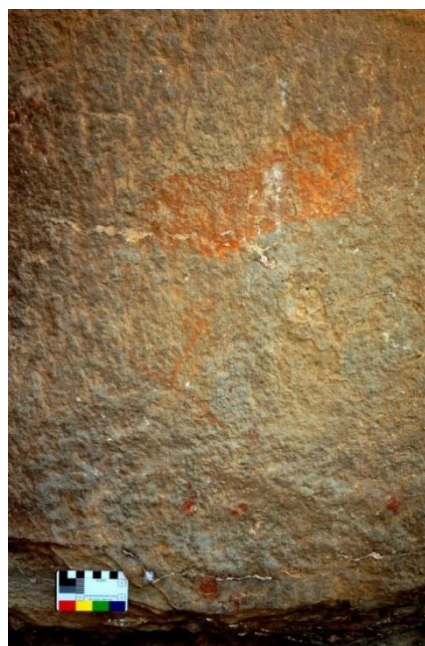
Figure 7. Portion of Panel B, site B05.

The site is subject to damaging factors such as animal activity (rubbing), dust and faking. The paintings themselves are not, at this stage, affected by flaking but the shelter's back wall shows flaking. This may affect the art at a later stage. The paintings are faded.

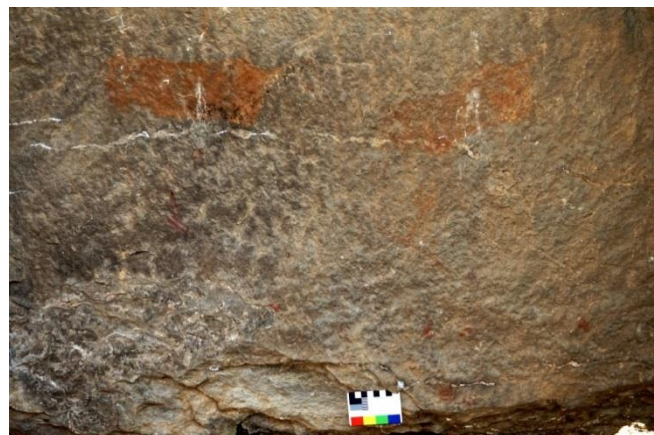
Figure 9. MARA image 2015

<u>Other Observations</u> Located above staff quarters and is frequented regularly due to litter present at the site (condoms etc.). Shelter formed on underside of exposed sandstone kranline. Rock art exists within small overhang. Site exists within small enclosure which may have contributed to the abrasion of the panel.	
Past treatments:	Y:
N:✓	
General comments:	
Recommendations: The rock art at B05 is not spectacular but the site is given high significance owing to its proximity to the road, to the new staff accommodation and to the park boundary. It is not recommended that this site be opened to the public, yet is must be monitored regularly.	
ASMIS Site Condition Assessment Value:	Good:
Fair:✓	Poor:
Destroyed:	Unknown:
Assessor: SAM CHALLIS	
Affiliation: WITS - (MARA)	
Contact: DR SAM CHALLIS (sam@rockart.wits.ac.za)

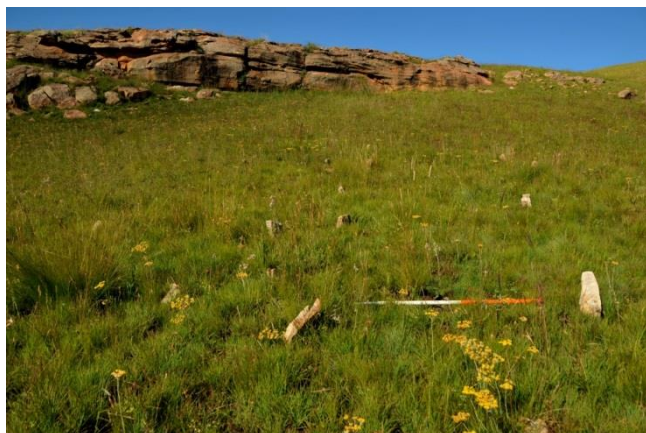
B16A – Burial Site

Figure 10. View across B16a showing collection of ten burials.

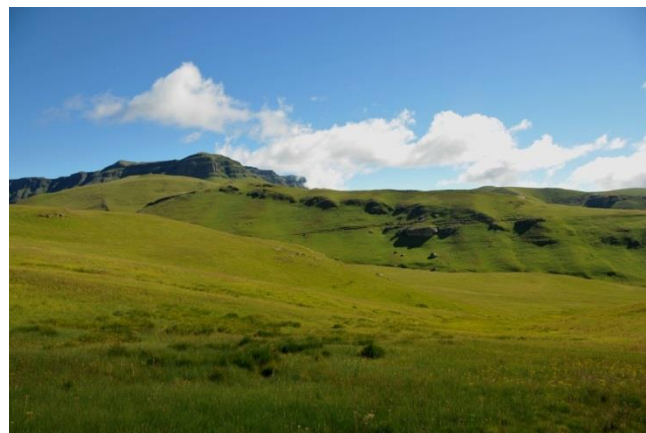
Figure 11. View from B16a facing North-east.

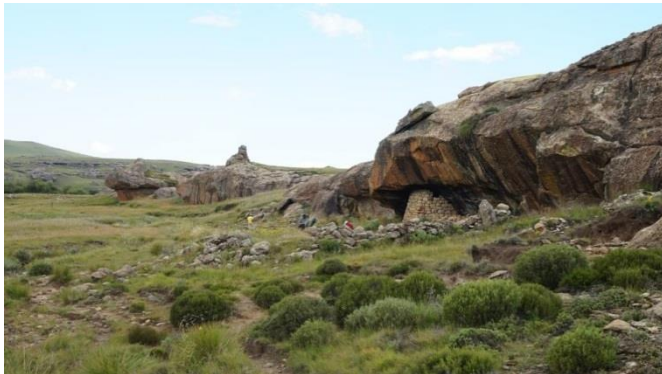
B29 – Rock art and stonewalled site

Figure 12. Locating shot of B29. Gated fence to the Old Lodge can be seen far left.

B29 is located very close to the Old Lodge. It could be a site to which tourists are taken. This increases the site's vulnerability. Previous cultural damage includes the construction of stonewalled structures directly in contact with the rock art in panel C. This damage does not appear to be recent. Further damage must be prevented when taking tourists to B29.

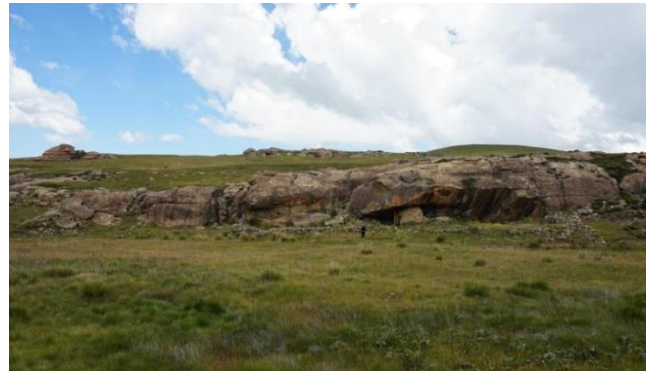
Figure 13. Locating shot of B29 facing south.

B29 is affected by natural salt seepage and washes. Panel C, shelter B, has been damaged by the construction of a stonewalled dwelling. This dwelling, built abutting the back wall of the shelter, directly affects and obscures some of the paintings in the panel. Many of the paintings at B29 are badly faded, and some are flaking.

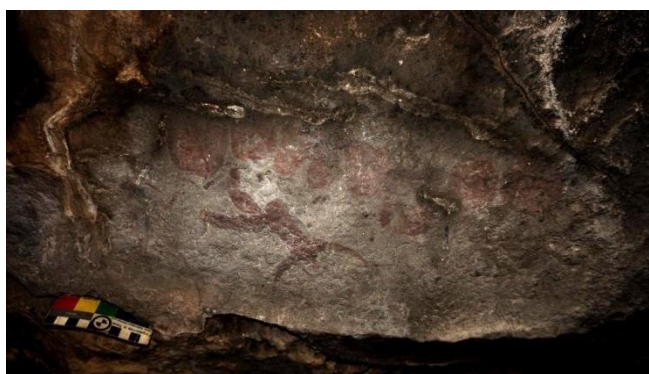
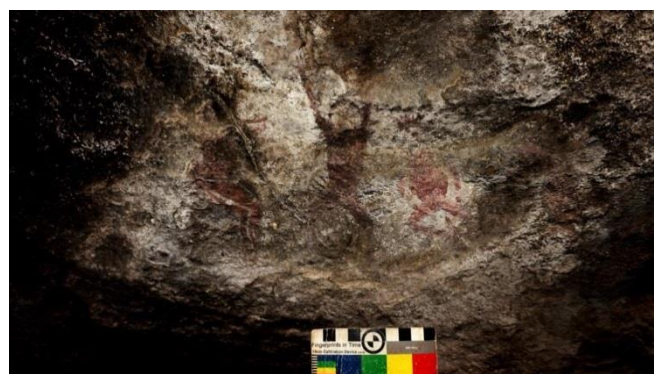
Figure 14. B29, shelter B, panel B.

<u>Other Observations</u> B29 is affected by natural salt seepage and washes. Panel C, shelter B, has been damaged by the construction of a stonewalled dwelling. This dwelling, built abutting the back wall of the shelter, directly affects and obscures some of the paintings in the panel. Many of the paintings at B29 are badly faded, and some are flaking/spalling.	
Past treatments:	Y:
N:✓	
General comments: B29 is located very close to the Old Lodge. It could be a site to which tourists are taken. This increases the site's vulnerability. Previous cultural damage includes the construction of stonewalled structures directly in contact with the rock art in panel C. This damage does not appear to be recent. Further damage must be prevented when taking tourists to B29.	
Recommendations: Because Site B29 is close to the Old Lodge, it may be chosen as a visitor site. If it were opened to the public it would have to be cleaned by a qualified rock art conservator. Visitor groups would have to be small (no more than five plus compulsory guide) and the dust kept down.

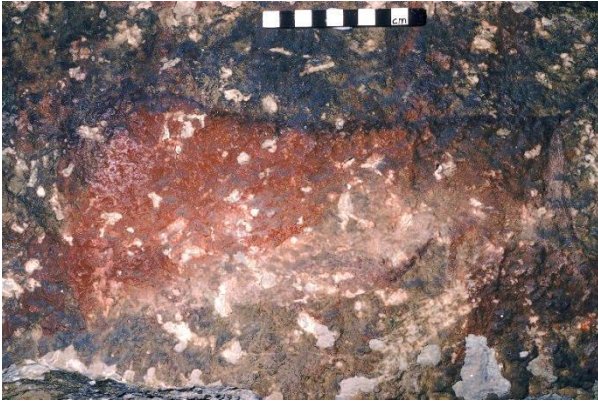
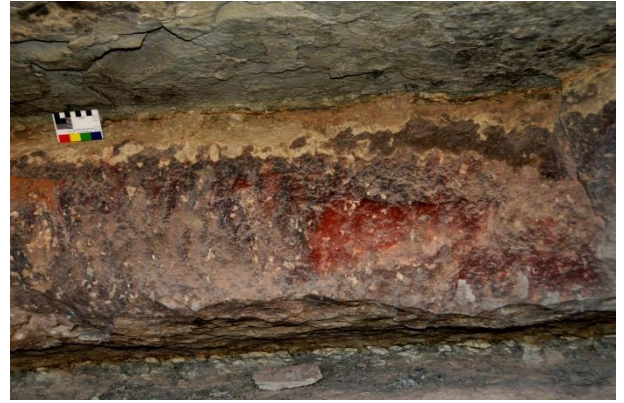
Figure 18. ARAL image 1980, B31 panel G

Close inspection of the images of the eland in panel G suggests that in this panel at least, there has been little change in the state of preservation in the last 35 years. Other panels show signs of having gathered more dust and some further spalling was observed. Please see condition assessment forms.

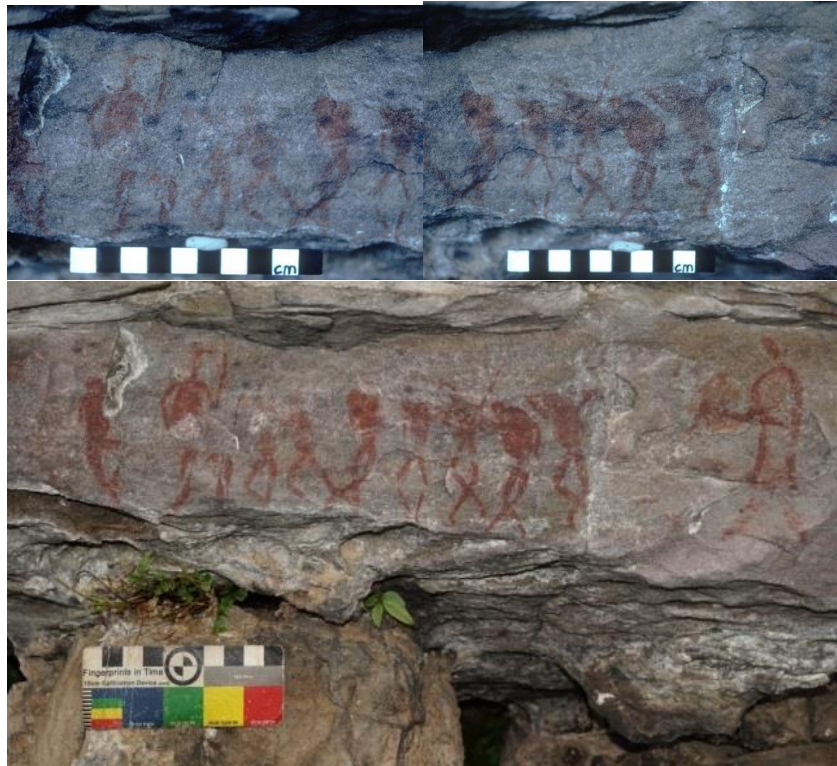
Figure 22. Above: ARAL image 1980. Below: MARA image 2015.
B33 shelter A, panel G.

Much of the art in B33 is faded. The site is affected by washes, salt-seepage and animal activity. B33 is located very close to the Tsoelikane River. This proximity to the river appears to contribute to damp conditions within the site as a whole.
