SOC REPORT MALOTI DRAKENSBERG WORLD HERITAGE SITE

STATE OF CONSERVATION REPORT FOR THE MALOTI-DRAKENSBERG WORLD HERITAGE SITE

December 2016

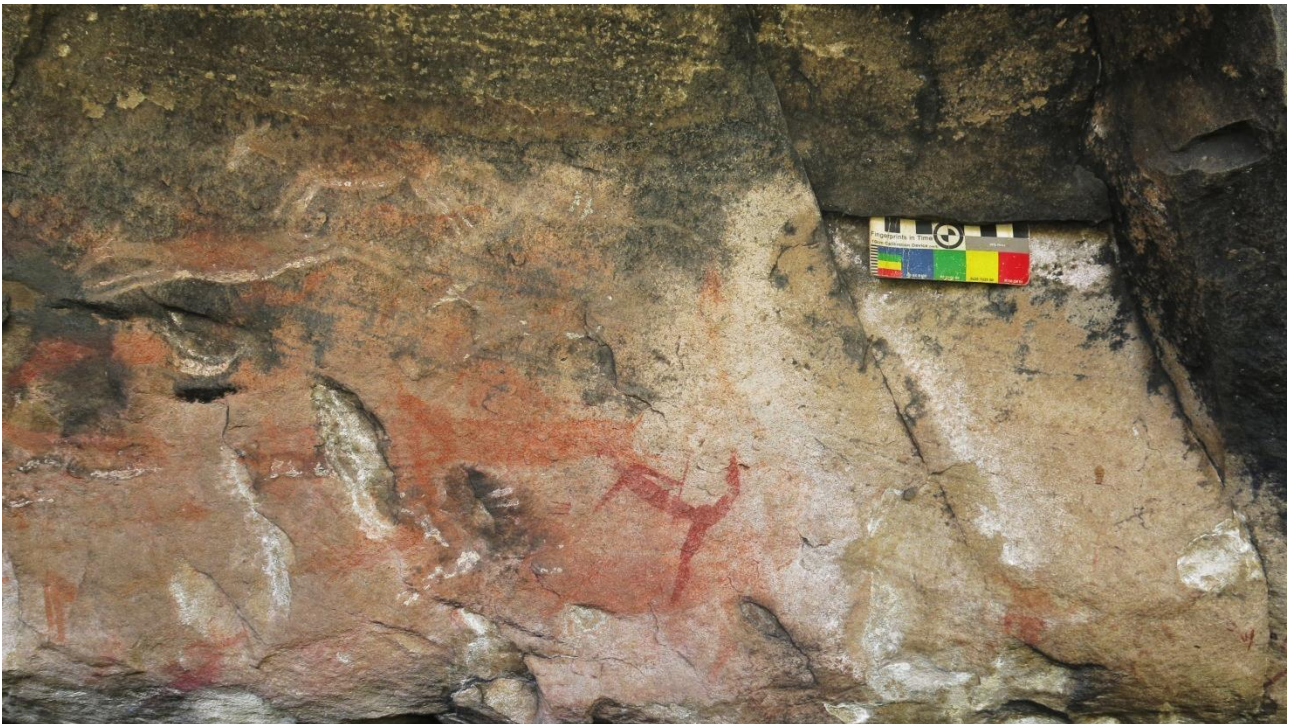
Figure 24. B33 shelter B, panel E.

Bottom centre- right panel E: human figures in red and dark red. These are very faded by wash. 1 large (30cm long) polychrome eland: back legs and hindquarters have faded away. At the far right of the bottom of the panel are 2 separate white areas of paint. These are certainly paint but have no identifiable features. The left-hand area of white paint is 8cm in height while the right-hand measures 12cm in height.

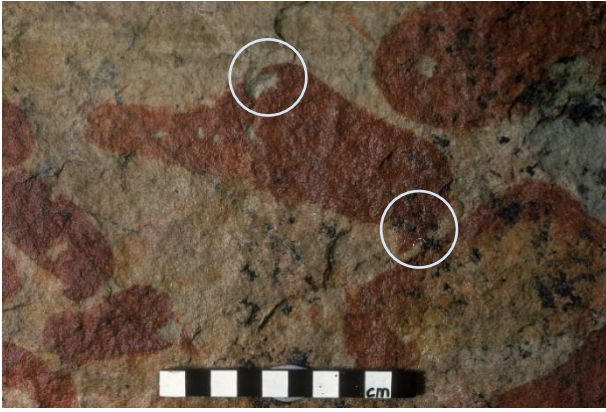
Figure 27. ARAL image (wet) 1980, C17, panel C. Circles indicate areas to compare with the 2015 image

Close-up photographs taken by ARAL were done so when wetted by spray, making it difficult to assess on a like-for-like basis. However, close scrutiny of the ARAL images shows that there has been some deterioration in the last 35 years – illustrated in the slight increase in spalling shown in the images above.

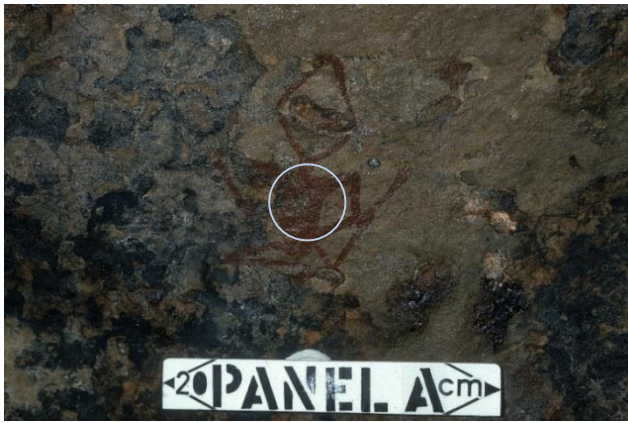
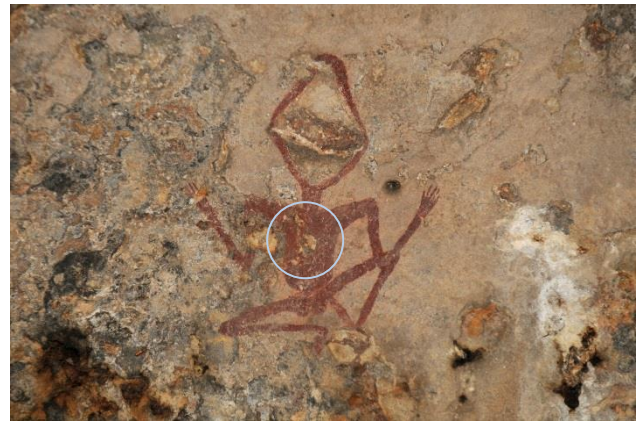
Figure 34. ARAL image 1984. D04a panel A.

Although the human figure is clear and appears largely undamaged, the floor of the shelter is very damp. There are wash-zones surrounding the image and foliage growing below it. These may in future affect the preservation of the image.

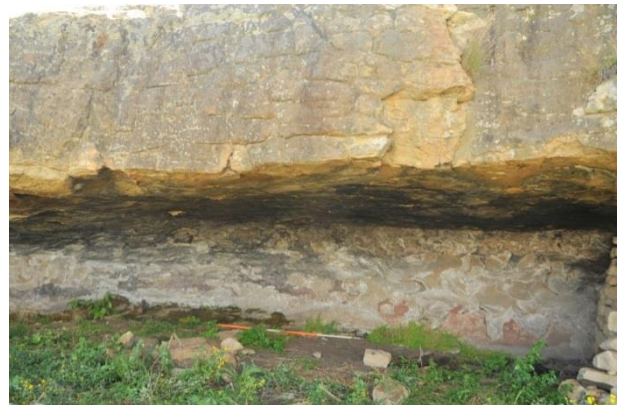
Figure 42. General shot of panels to show extent of exfoliation/spalling in site D25.

D25 is subject to damage by extensive salt washes (causing flaking), animal rubbing damage, fire damage and dust. The majority of paintings are faded. Some are very difficult to make out.

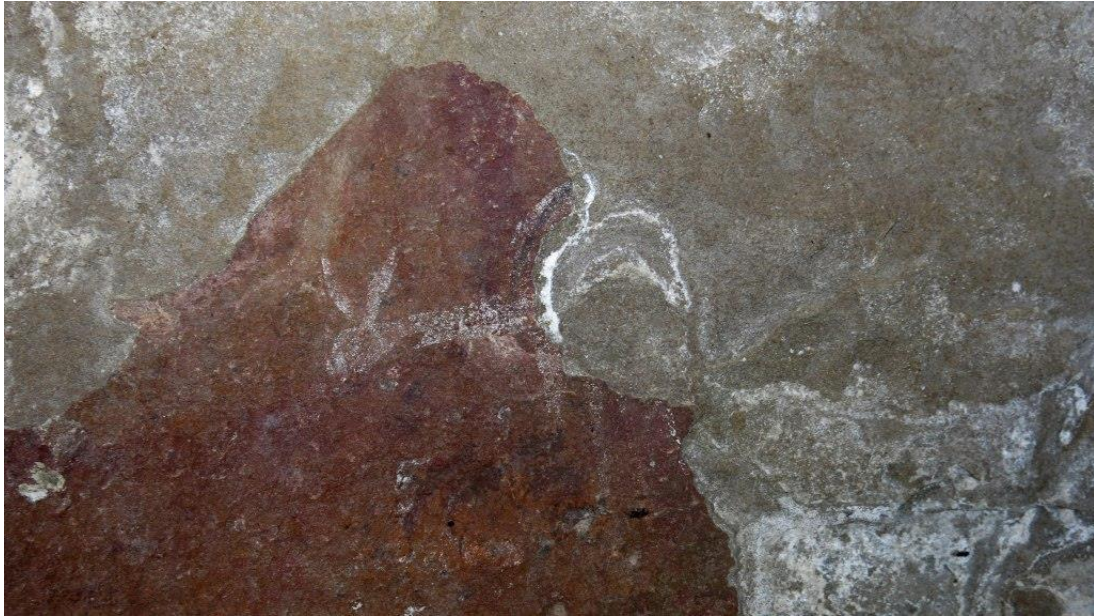
Figure 45. Close-up of D25 panel A showing head, neck and shoulders of a white rhebok against a very badly flaked red background that contains remnants of red figures. NB the accretion of salt crystals on the antelope's neck.

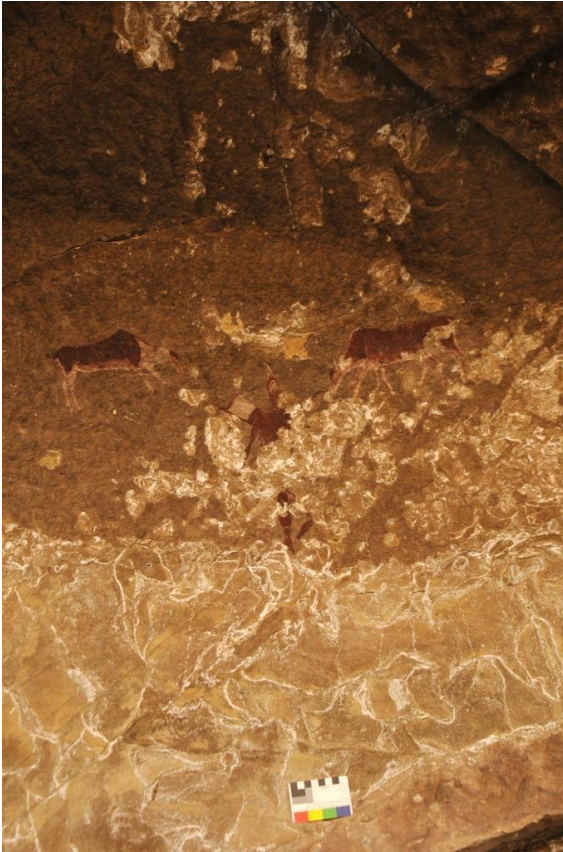
Figure 62. E01 panel M to show very clear, highly detailed, yet badly exfoliated rock art.

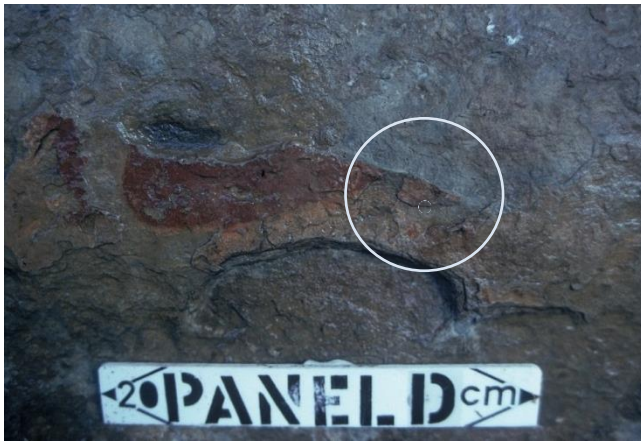
H05 is badly damaged. Much flaking and water damage. Construction of stone structures has affected the art in H05b. It is likely that the shelter's use by people in contact and historical times has been the major factor affecting the rock art. This, coupled with the poor integrity of the rock face, means that, overall, the rock art is not clear and would not, by itself draw visitors.

Figure 84. ARAL image 1980: close-up far right panel A, Shelter A, taken when the rockface was wetted with water spray. Indeterminate subject.

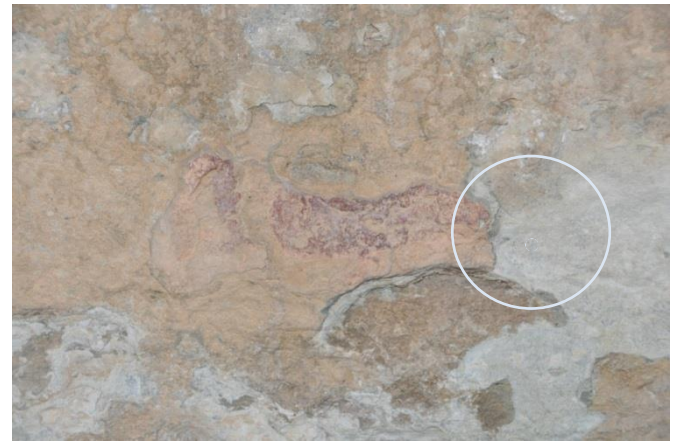
Figure 85. MARA image, 2015: close-up far right panel A, Shelter A, Dry. Indeterminate subject.

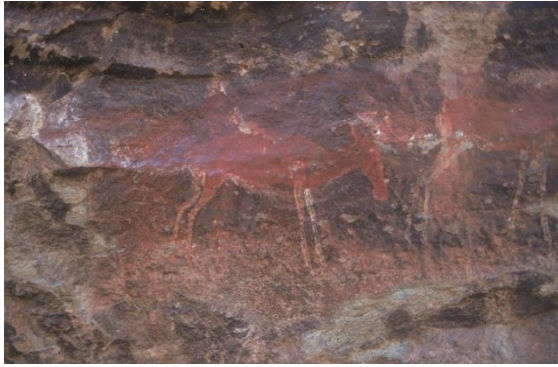
The general preservation of paintings at H20 is relatively poor owing to multiple deteriorating factors. The shelter is very shallow and therefore the back wall is exposed to the elements (including wind, wind-blown rain and direct sunlight). The site has also had considerable animal activity, though much of the evidence of animal rubbing is below the surviving panels. Panel C is affected by a stone wall (the southern wall of the dwelling) that has been built against it, knocking the art. Panels D-G are within the dwelling on the back wall of the shelter and are affected by soot. Much of the art is faded and flaked.

Figure 88. ARAL image 1980: Close-up top centre panel A

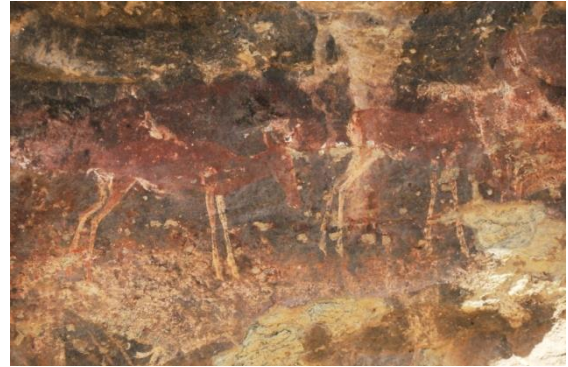
Figure 89. MARA image 2015: Close-up top centre panel A

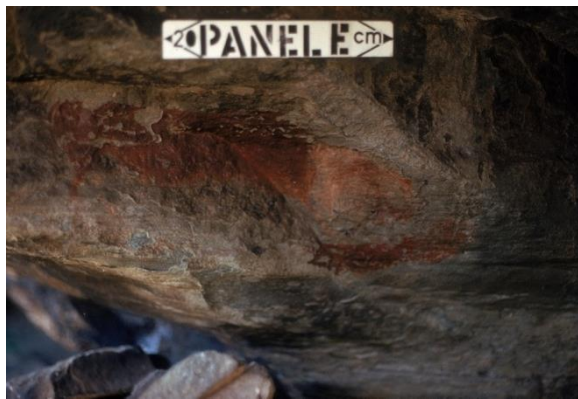
Figure 90. ARAL image 1980: H20 Close-up eland panel D.

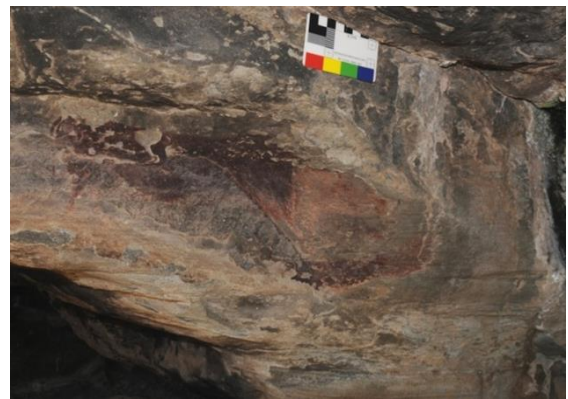
Figure 91. MARA image 2015: H20 Close-up eland panel D.

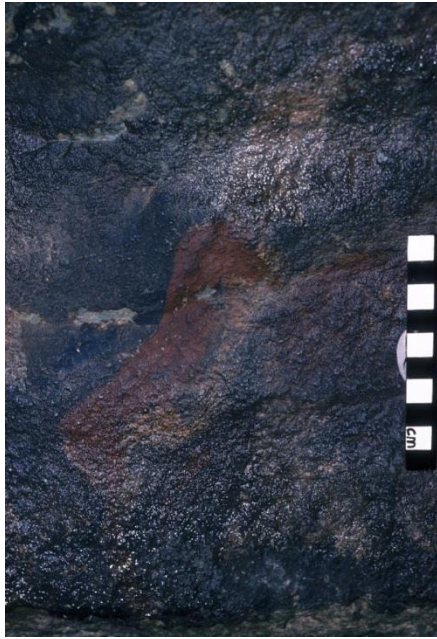
A large proportion of the rock art at J01 is faded. The site is subject to various environmental deteriorating factors such as wind exfoliation, washes and soluble salts. The site has also been damaged by animal rubbing. This is due to it being used as a kraal (stonewalling present at site). There is a large amount of human damage to the site as well. It has been extensively pecked and hit, as well as scratched.

Figure 96. ARAL 1980 wet/spray image. Panel D: dark red eland body superimposed by strange eland body painted on hind legs with head facing ceiling of shelter.

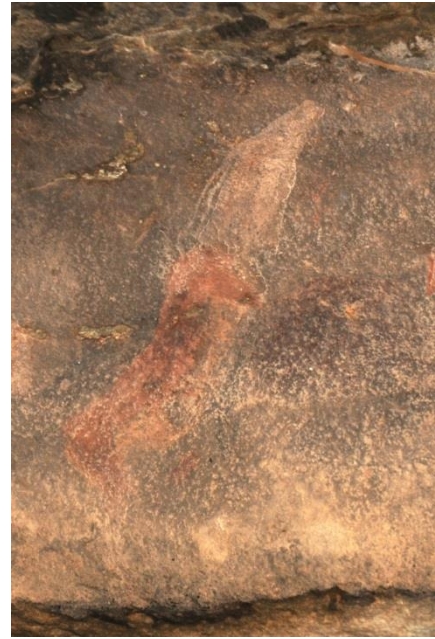
Figure 97. MARA 2015 image. Panel D: dark red eland body superimposed by strange eland body painted on hind legs with head facing ceiling of shelter.

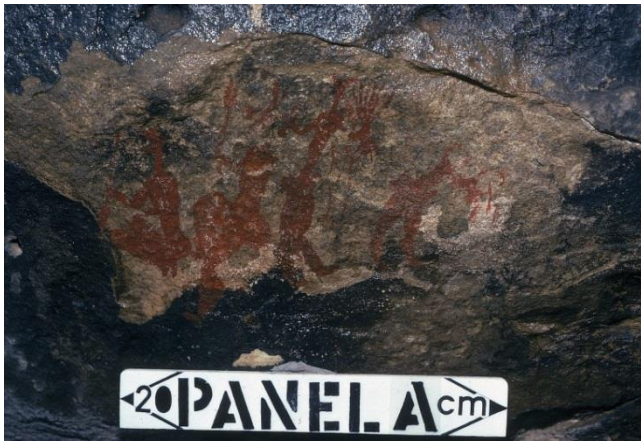
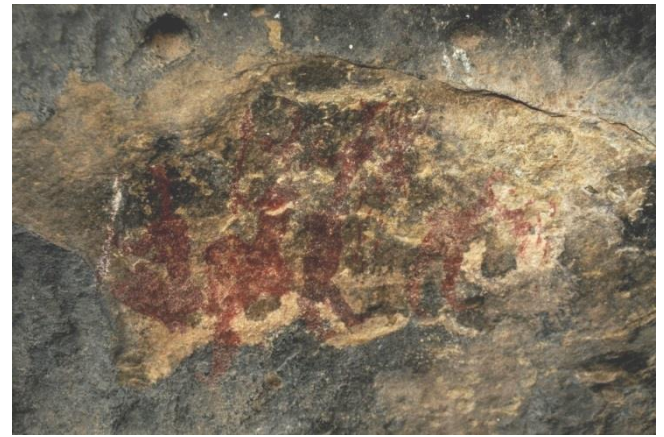
Damage to paintings at J02 includes flaking and pecking, and the greatest damage appears to have been caused by deliberate striking of the images with a hard object such as a stick or throwing stones. Many of the paintings are faded.

Figure 108. ARAL image 1980. Panel A: panel A including four human figures: two with headdresses, two with possible spears.

Figure 109. MARA image 2015. Panel A: panel A including four human figures: two with headdresses, two with possible spears.

Although site J02 is very badly damaged, a comparison with the ARAL record reveals that most of this damage occurred before 1980. The water-spraying of the rockface in the ARAL photographs makes it difficult to assess the extent of the scratching and lighter-shaded parts of the flaked rockface (e.g. panel A), but the removal of large flakes by striking in panel E are exactly the same in the shots taken in 1980 and in 2015.

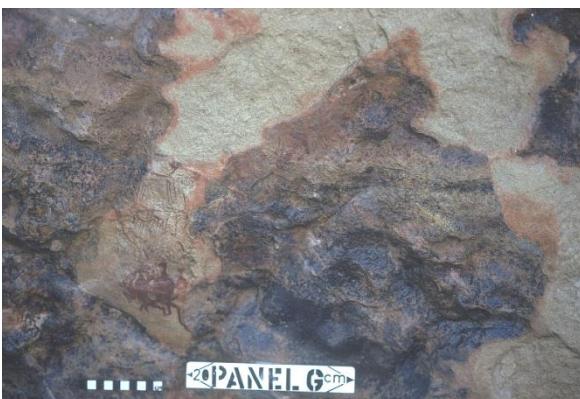
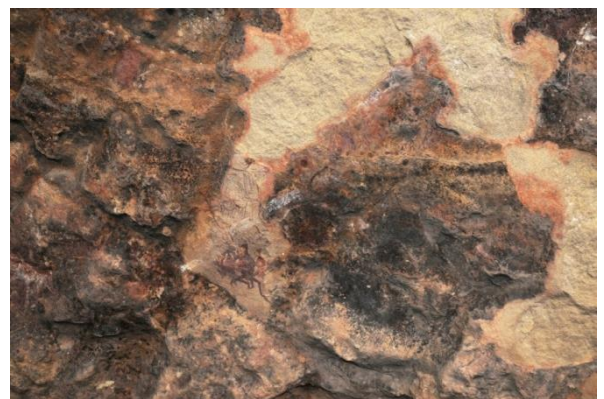
J04 is relatively well preserved. However, as this boulder does not have a shelter roof, the art is open to the elements and therefore the art is affected by rain, dust and sunlight.

*Figure 115. ARAL image 1980, panel H (ARAL panel G)
General shot panel H: seated human figures, red lines
and red dots.*

*Figure 116. MARA image 2015. General shot panel H:
seated human figures, red lines and red dots.*

AN examination of the 1980 ARAL record of site J04 shows little deterioration

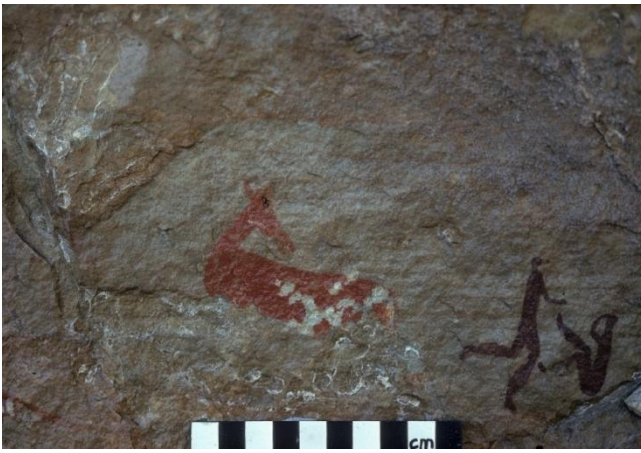
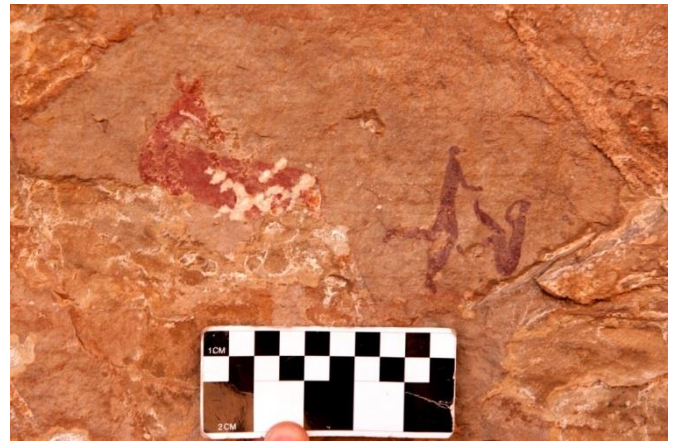
Much of the art is faded and flaked, some of this caused by extensive salt/calcite build-up on the rockface as well as by human scratching. Some of the figures are faded so severely that they are very difficult to make out.

Figure 123. ARAL image 1980. Panel A: 1 red hartebeest lying down and looking back over its shoulder; two human figures in dark red, one falling with hand to head.

Figure 124. MARA image 2015. Panel A: 1 red hartebeest lying down and looking back over its shoulder; two human figures in dark red, one falling with hand to head.

The close-up images in the ARAL record for site J05 were taken when wet, therefore it is difficult to make a comparison on a like-for-like basis. However, it is apparent in the images such as those in panel A, above, that most of the damage to the paintings had occurred before 1980.

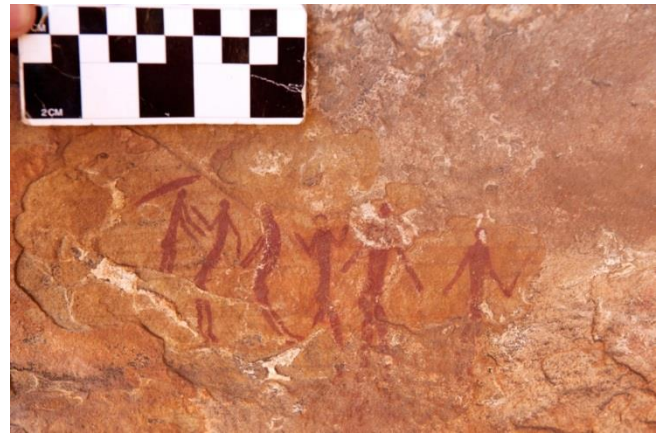
Figure 126. Close-up of the top left of panel E, showing 6 human figures in red, rightmost with white face and holding a stick

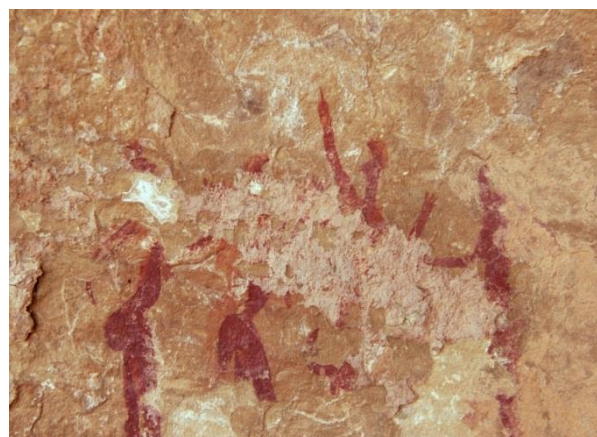
Figure 128. Close-up of central figures in panel G, one with arms back, one with arms raised and one pointing upwards

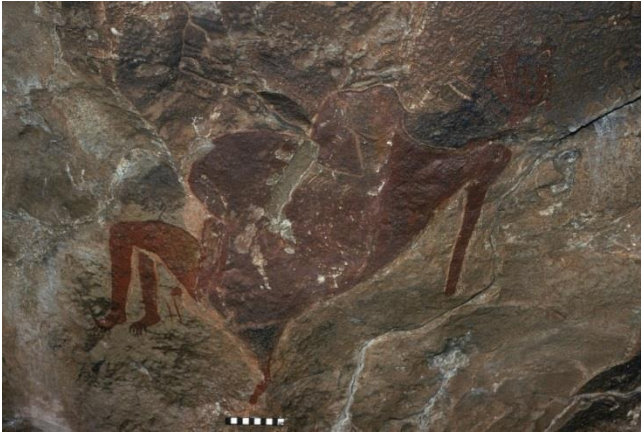
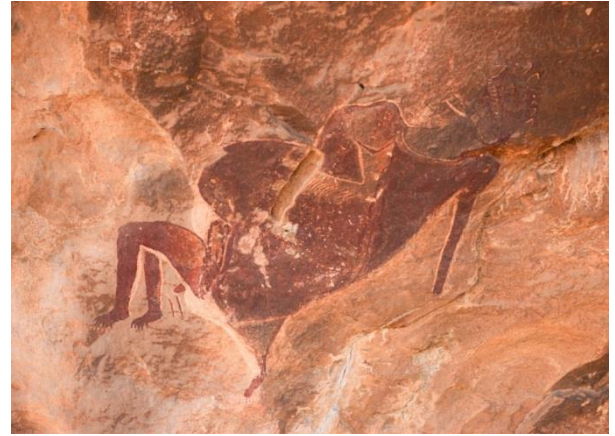
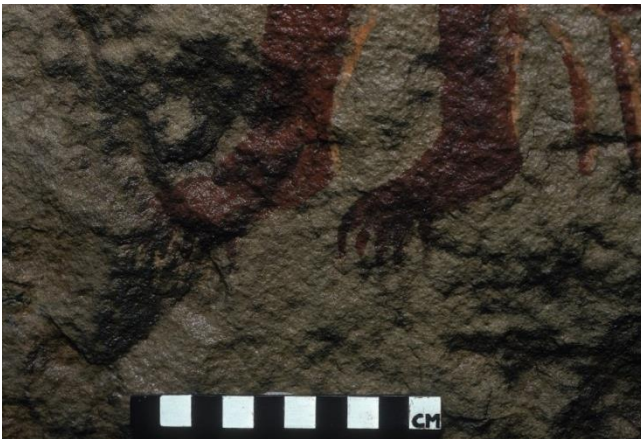
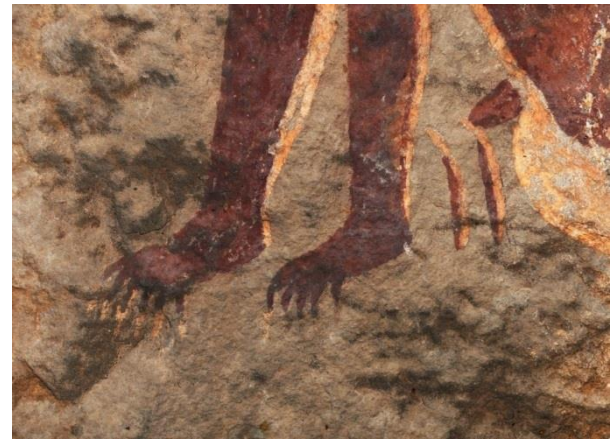
Panel B: Very well preserved. This figure (a giant polychrome human figure with extensive detailing on all parts of the body) appears to have escaped serious damage. This is surprising for the site as a whole as there is evidence, in the form of stonewalling, that this shelter was used as a kraal. The height of the paintings may be the reason for this. This figure is very clear.

Figure 131. ARAL image 1980: panel B showing single, very large, human figure with three legs, clawed feet and tusks.

Figure 132. MARA image 2015: panel B showing single, very large, human figure with three legs, clawed feet and tusks.

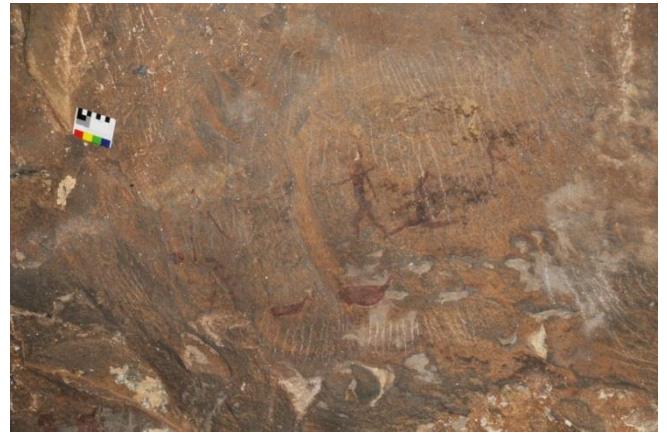
Panel C: Although still quite clear, panel C has been subject to human defacement in the form of scratching. There are multiple vertical lines over much of the figures in panel C.

Figure 136. Panel C, showing the striding and running figures with white faces and antelope-eared caps, as well as the red and white rhebok below. The entire panel is covered in vertical scratch marks.

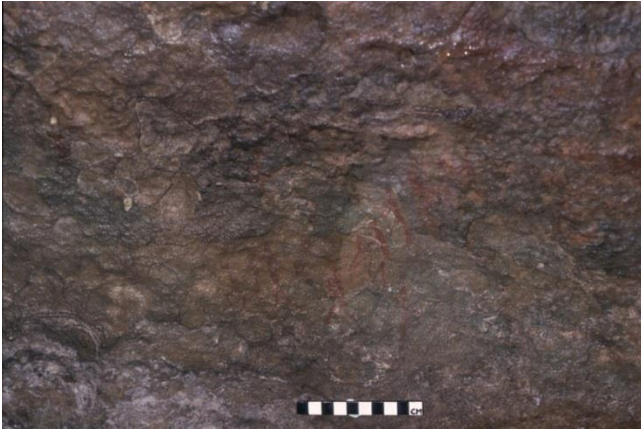
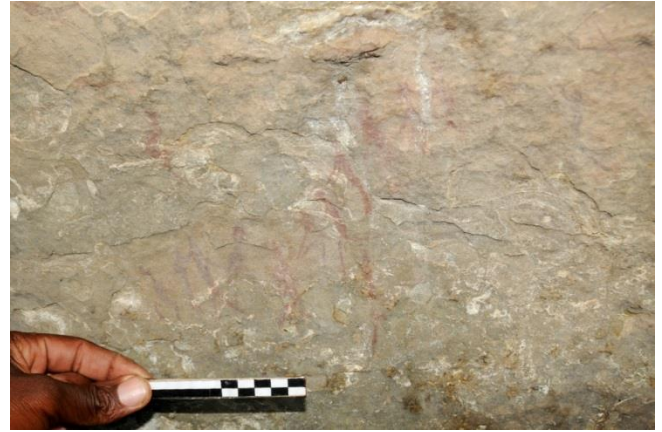
Although the images in panel C are clear, there has been significant flaking- some images are badly damaged by this. Panels A and B contain only the remnants of paintings and these are faded and indeterminate. Panel B is close to a fireplace and covered in soot.

Figure 151. ARAL image 1980. Close-up bottom centre panel C including procession of dark red human figures .

Figure 152. MARA image 2015. Close-up bottom centre panel C including procession of dark red human figures .
