**Mission report** on the preparation of the reconstruction of

# Muzibu-Azaala-Mpanga Tombs of Buganda Kings at Kasubi

A World Heritage property of Uganda

#### A World Heritage property of Uganda (C 1022)

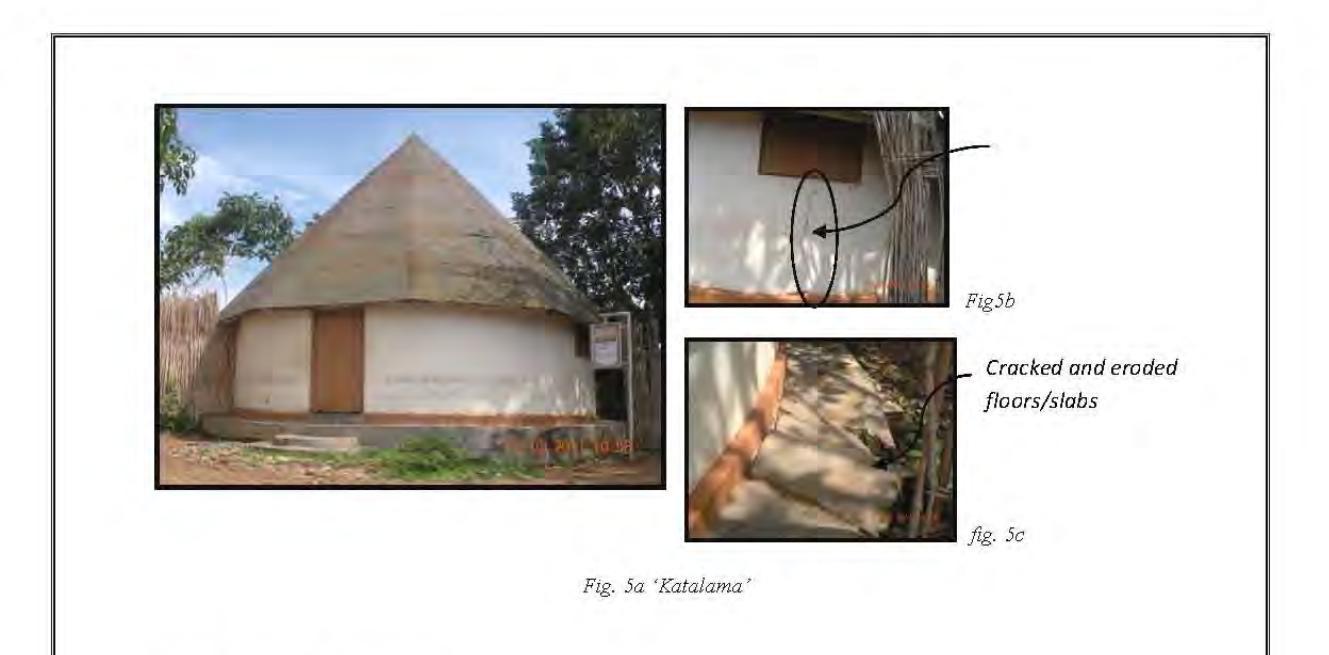
The flooring is finished with cement screed. The splash apron, approximately 600mm high, constructed of concrete is eroded at the ground level, exposing part of the foundation, also deeply cracked at different points within its circumference. The walls are

circular, and deeply cracked at different points.

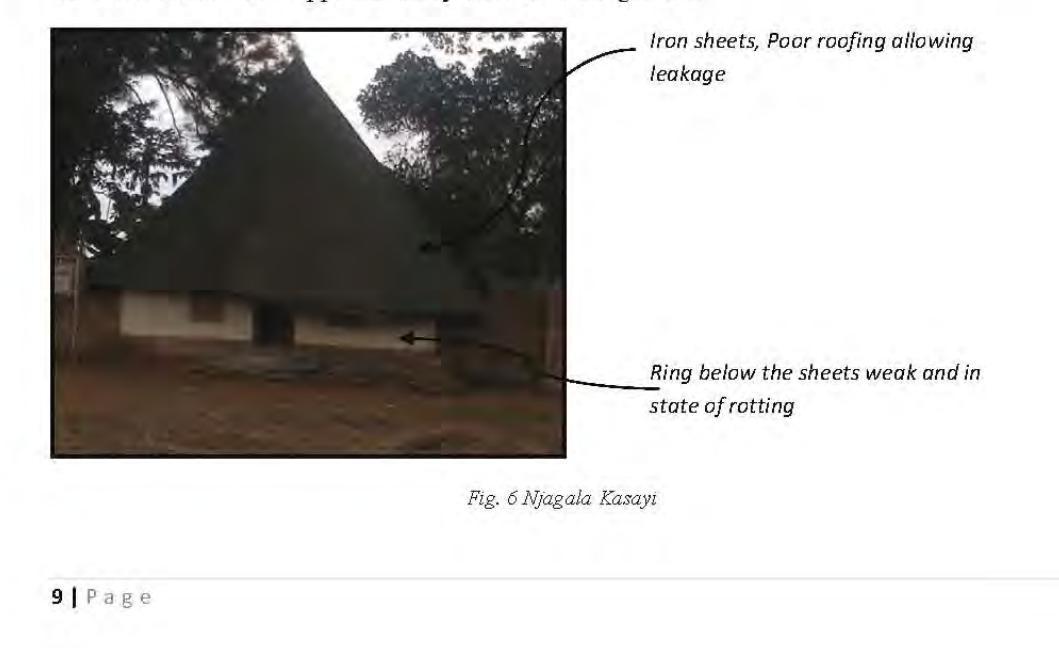
#### 3.3.6 Njagala kasayi

This is a house for one of the wives of the Kabaka.

It is a rectangular modern building, and just like the previous house, the building materials are the same. The roof is conical despite the shape of the form by the walls. The problems presented are similar: cracks in the walls and floor, as well as leakages from poor roofing technique. The rings just below the sheets are in a rotting and unmaintained state. The structure is also raise approximately 600mm from ground.

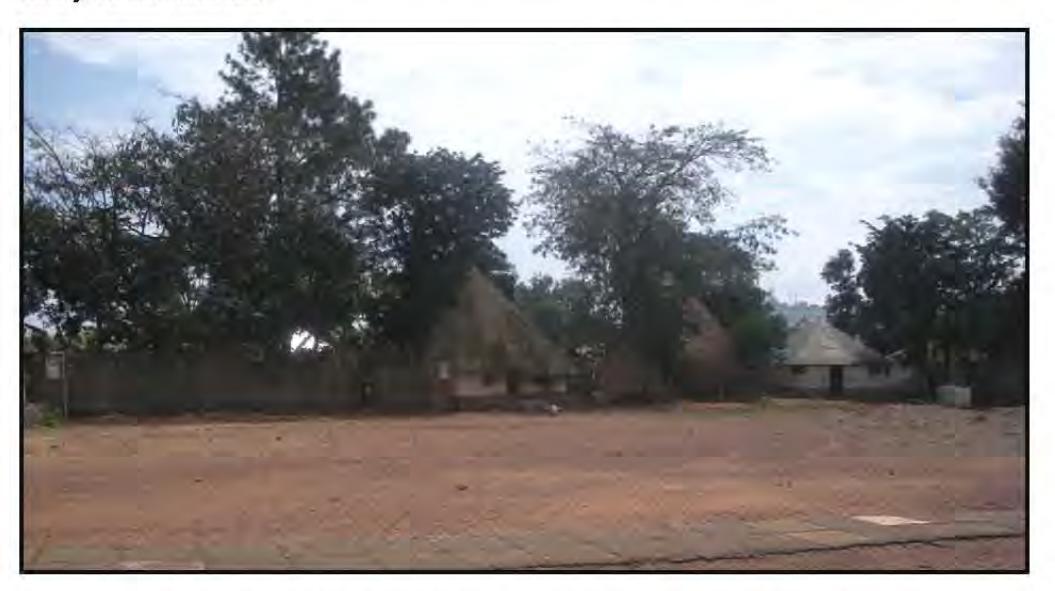
Similar to the other modern buildings earlier mentioned, Gazimbe is rectangular, built with modern materials, rather than traditional. The roof is at a lower angle/gentler slope than the previous buildings, proving to have more leakage problems. Electricity points point out on the exterior wall, next to the entrance, raising a matter of concern for the safety of the residents.

Fig. 7 view across the 'olugya' showing Njagala Kasayi, Kajjaga, and Gazimbe (L-R)

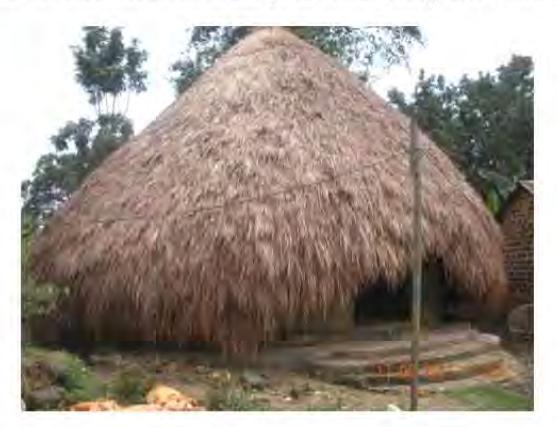
This structure is under construction. Currently the thatching is a little way from completion.

Fig. 8 'Abalongo Abasimbiri', structure still under construction

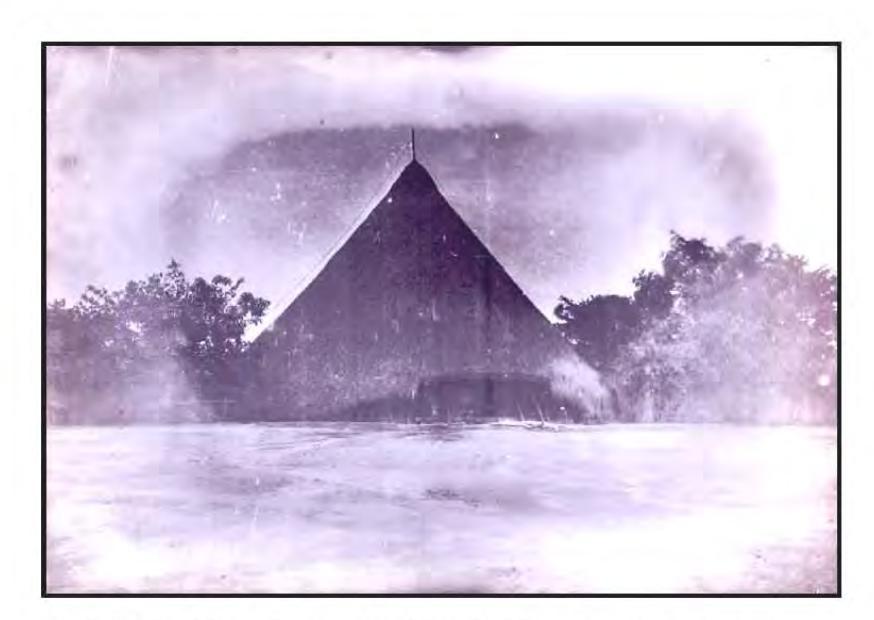
From the research done in reference to this restoration, it has been noted that the roof slopes were much steeper before (1891), (refer to figure below) as compared to the recent structure. The recommendation is therefore to adapt what used to be in the restoration process, to bring back the true picture of the beginnings of the magnificent structure that symbolised Buganda's core.

Fig. 13: the Royal Palace at Kasubi in 1891. (Source: Royal Geographical Society, London)

With further reference to Figure 13, the courtyard used to have a slight slope, yet the current courtyard has a much bigger slope. The reasons as to why this is have to be further researched, and issue amended or addressed for the final product of the restoration.

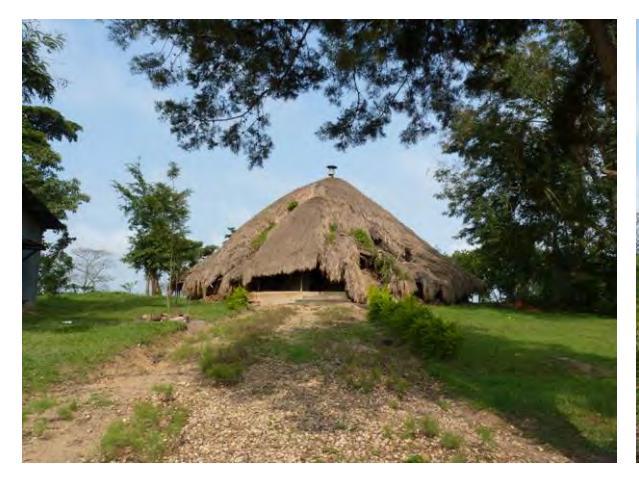
Front elevation of the tomb building (Batanda Bezaala)

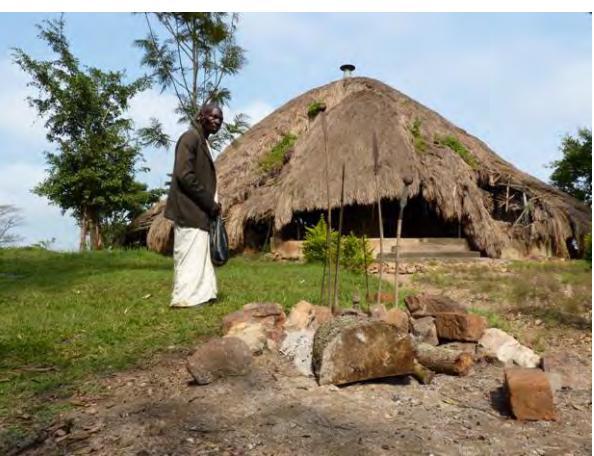
Sacred fire place in the courtyard

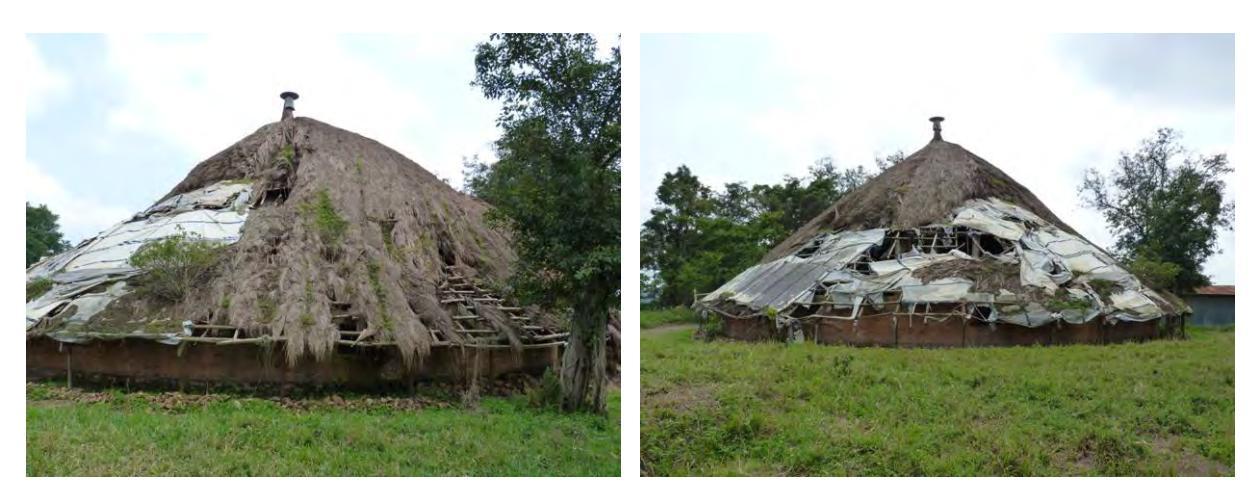
Eastern side of the tomb building
